Organizational Results Research Report

September 2009
OR10.007

Development of Hand-held Thermographic Inspection Technologies

Prepared by University of Missouri -
Columbia and Missouri Department
of Transportation

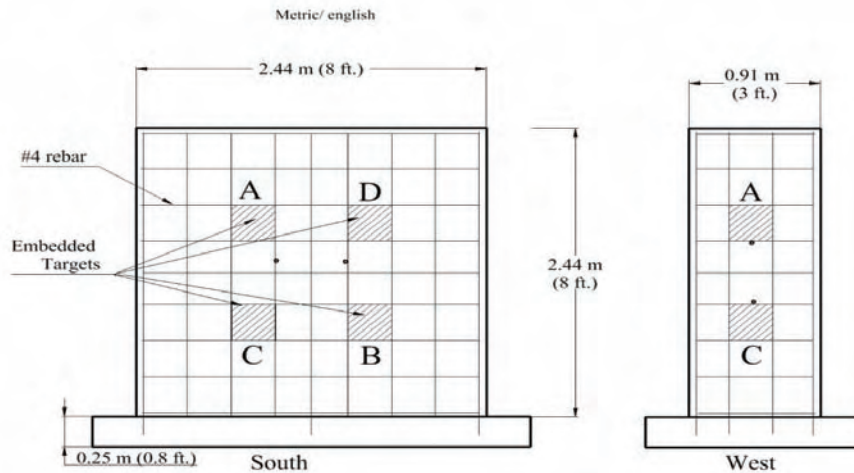
Figure 3.2 : Schematic diagram of the south and west faces of the test block.

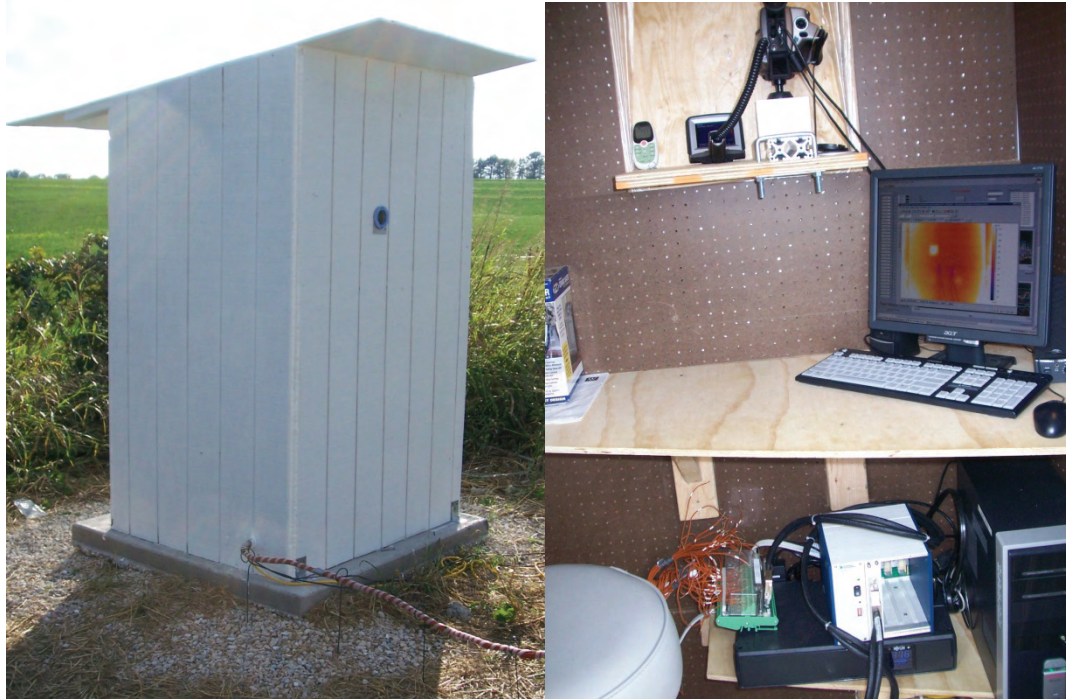
Figure 3.5 : Data house and inside layout with thermal imaging camera, standalone PC, and data acquisition (DAQ) equipment.

The computer and vital equipment were also powered through surge protection and an Uninterruptible Power Supply (UPS) to account for short power failures and surges in the area. The UPS could run the vital equipment for up to 30 minutes in the case of a short power failure.

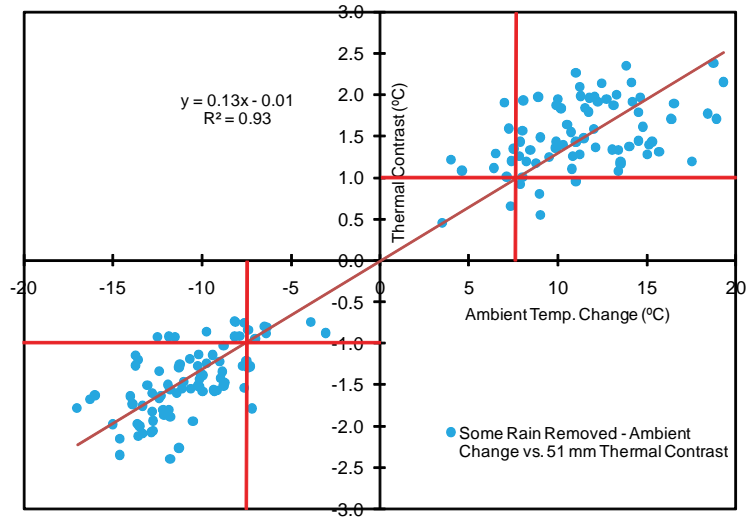
Figure 5.9 : Thermal contrast in north side of test block compared with ambient temperature changes, with days including rain removed.

Figure 5.9 shows the correlation between the thermal contrast and the ambient temperature changes when all of the criteria are met (80 days positive, 83 days negative). As the figure shows, this method of rain removal had little effect on the correlation between the ambient temperature variations and thermal contrast.

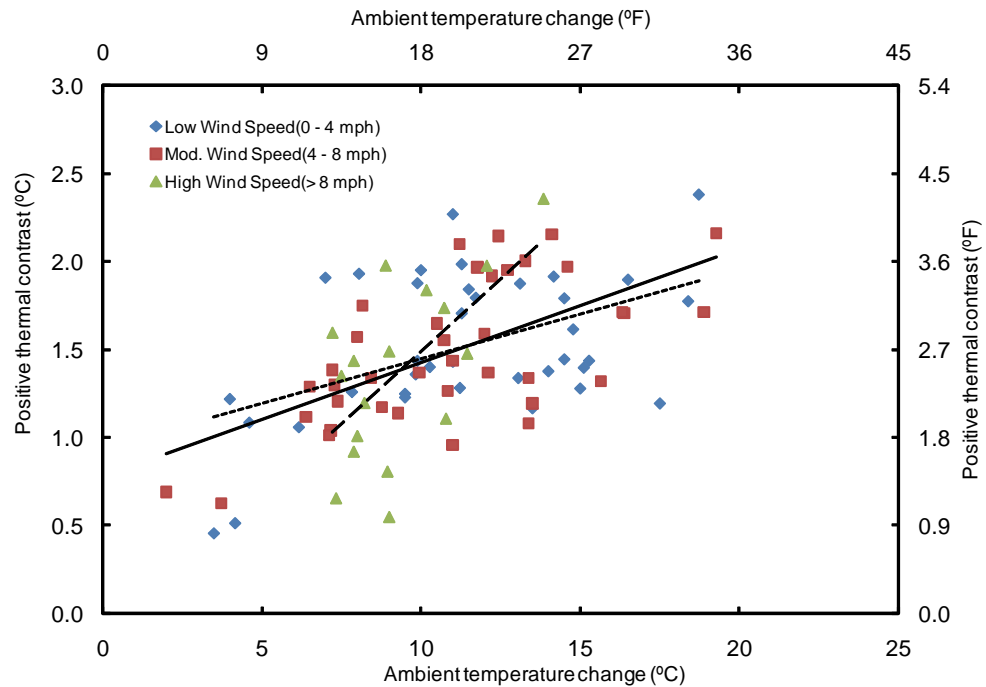
Figure 5.10 : Scatter plot showing positive thermal contrast developed vs. ambient temperature change, with wind speed categories of high, moderate and low. North side, 2nd quarter.

for the heating of the block, the high wind speeds may actually assist in the development of thermal contrast by increasing convective heat transfer. However, the scatter of the data is so substantial that it is difficult to determine if this is a real effect or just a statistical anomaly for this particular data set.

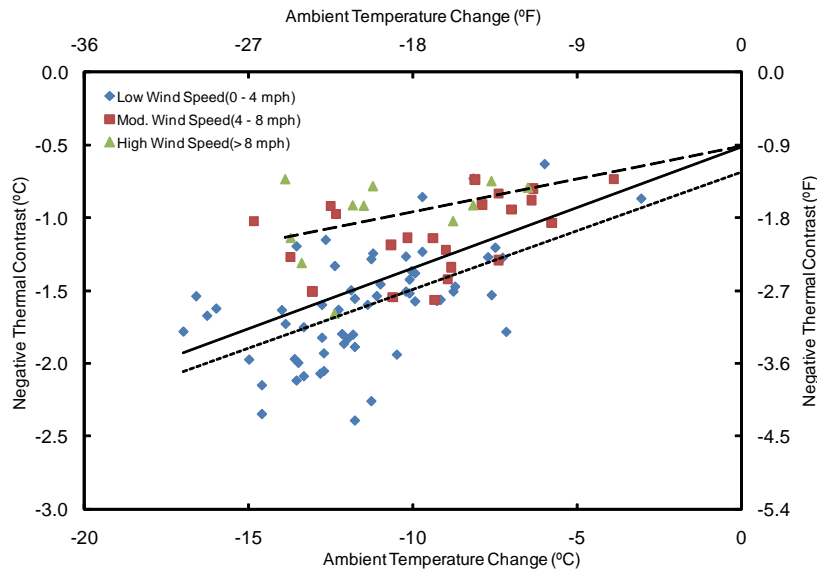
Figure 5.11 : Scatter plot showing negative thermal contrast developed vs. ambient temperature change, with wind speed categories of high, moderate and low. North side, 2nd quarter (night time).

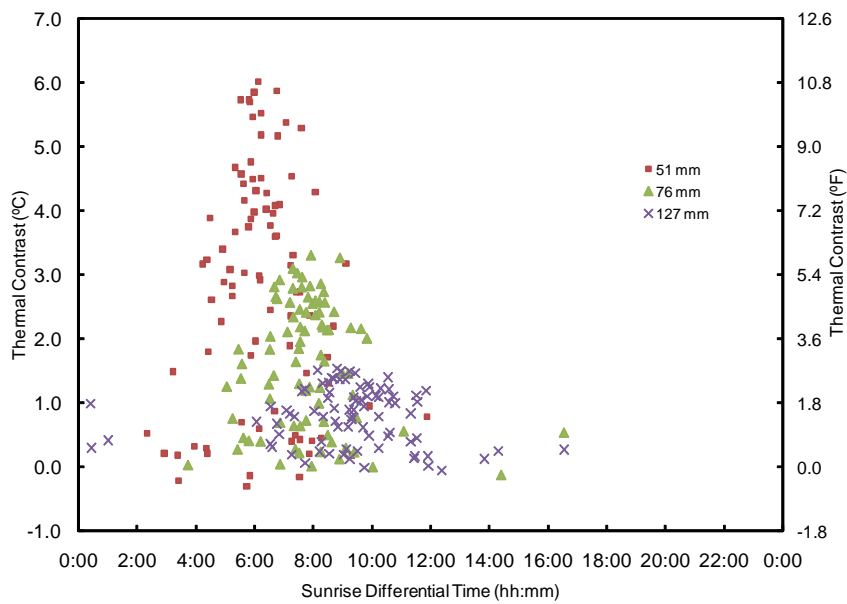
Figure 5.15 : Scatter plot of sunrise differentials against maximum contrast for 51, 76 and 127 mm (2, 3 and 5 in.) targets.

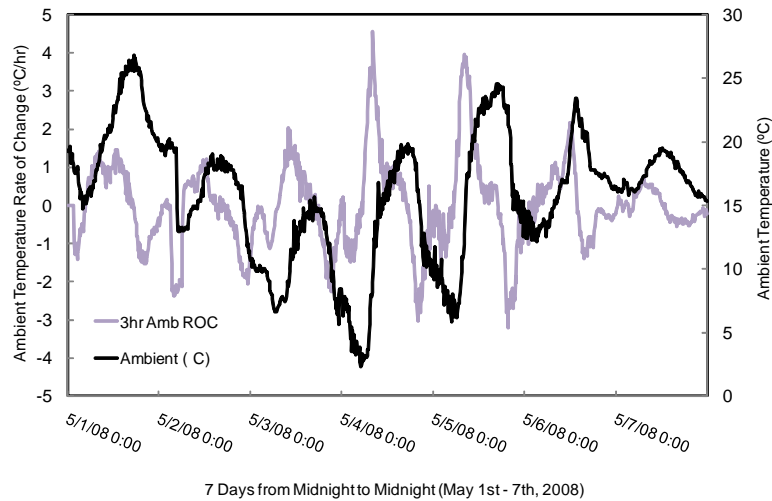
Figure 5.17 : Ambient temperature variations and the ROC for the variations for 1 week.
