Organizational Results Research Report

OR07.003

**Assessment of Karst Activity at Construction
Sites Using the Electrical Resistivity Method
(Greene and Jefferson Counties, Missouri)**

**Assessment of Karst Activity
at Highway Construction Sites
Using the Electrical Resistivity Method
(Greene and Jefferson Counties, Missouri)**

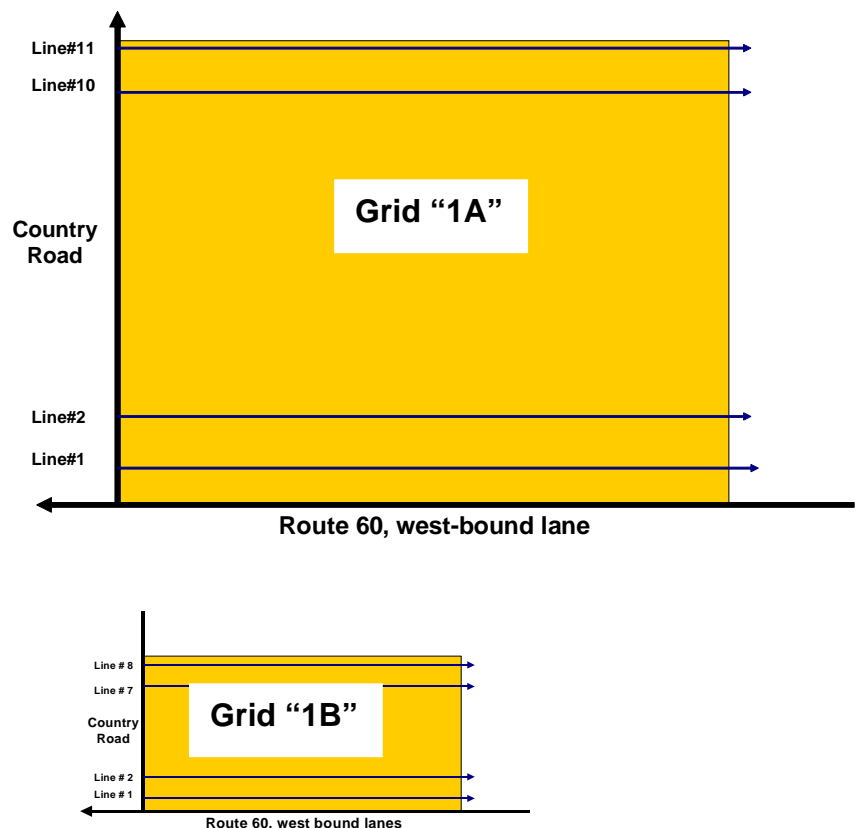
Figure 4: Two grids of electrical resistivity profiles were acquired at the Greene County site. Grid “1A” data, consisting of 11 profiles spaced at 25 ft intervals, were acquired using 68 electrodes spaced at 5 ft intervals. Grid “1B” data, consisting of 8 profiles spaced at 10 ft intervals were acquired using 40 electrodes spaced at 3 ft intervals.

The district geologist was concerned that the small active sinkholes might be connected to one or more larger air-filled voids that could compromise the integrity of the planned intersection and authorized the acquisition of two grids of electrical resistivity profiles (grids “1A” and “1B”; Figure 4). The primary objective was to locate any and all substantive air-filled cavities. It was anticipated that such cavities would have developed along solution-widened joints, so the resistivity profiles were oriented west-east (W-E) effectively perpendicular to the NNW-trending dominant joint system (Figure 4).

Resistivity grid “1A” consisted of 11 W-E traverses, spaced at 25 ft intervals (Figure 4). The grid encompasses the current Route 60 ROW, the current Route 125 ROW and the area across which a planned westbound Route 60 exit ramp will extend. The 2-D profiles were acquired using a 68-channel SuperSting Resistivity unit, a dipole-dipole array configuration and an electrode spacing of 5 ft. Representative 2-D profiles are displayed as Figures 5, 6 and 7. The processed profiles consist of rectangular pixels with widths of 5 ft and heights that vary from 2 ft (minimum depth) to 5 ft (maximum depth). During processing each pixel was assigned an average “resistivity” value. The pixel size is one estimate

The second grid (grid "1B") of resistivity profiles acquired at the Greene County site Resistivity grid "1B" consisted of 8 W-E traverses, spaced at 10 ft intervals (Figure 4). The grid

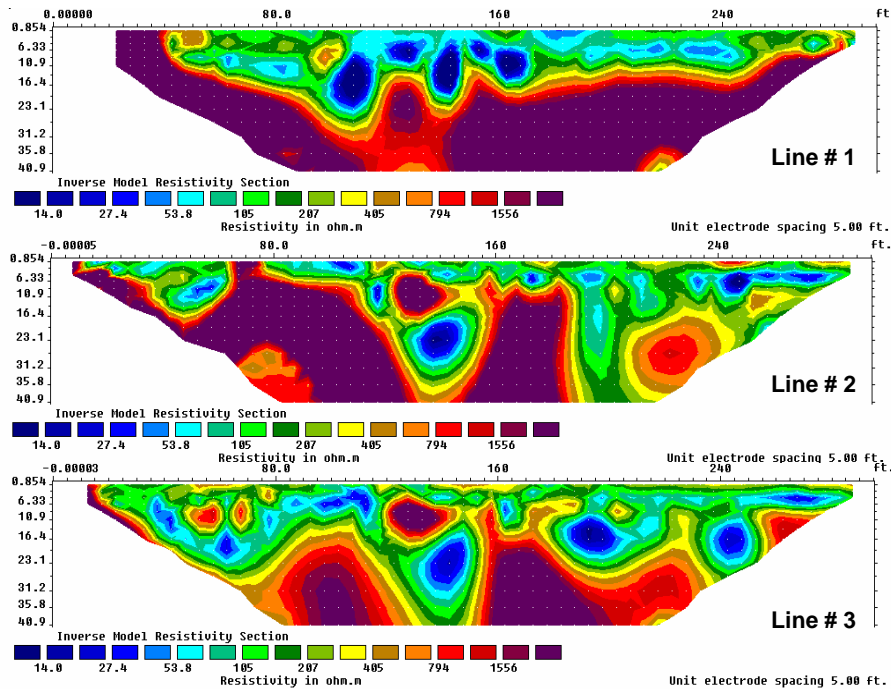
Figure 5: Grid "1A" electrical resistivity profiles 1, 2 and 3 (Figure 4).

The interpretation of the resistivity profiles was relatively straightforward in terms of differentiating and mapping lithologic units. Units with resistivities greater than 405 ohm-m were mapped as limestone; units with resistivities less than 105 ohm-m were mapped as moist soil or clay; units with resistivities greater than 105 ohm-m but less than 405 ohm-m were interpreted as transitional zones probably consisting of moderately to intensely fractured and/or weathered limestone with clay in-fill (Figures 5, 6 and 7).

The interpretation of the resistivity data was used to generate a geologic model of the study area. The model consists of a basal limestone unit which constitutes geophysical bedrock (Figure 8). The depth to the top of geophysical bedrock varies from ground surface (e.g. west end of profile 1; Figures 5 and 8) to in excess of 40 ft (e.g. profile 6; Figures 6 and 8). This bedrock unit appears to be dissected by at least four prominent solution-widened NNW-trending joints (Figure 8). The solution-widened joints of most concern to MoDOT are those that underlie the planned westbound off-ramp. These features are of concern because they are in-filled with thick clays that could densify or be subject to piping under load.

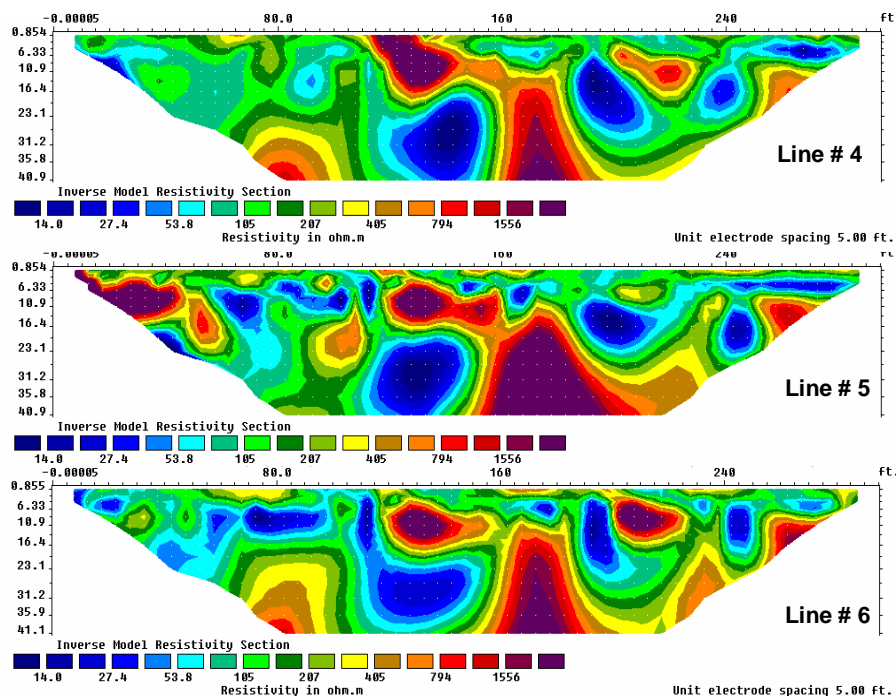
Figure 6: Grid "1A" electrical resistivity profiles 4, 5 and 6 (Figure 4).

Bedrock is interpreted as overlain by soil or clay, and in places (e.g. profile 6; Figures 6 and 9) by relatively continuous limestone lenses (outliers) and intervening clay. The limestone outliers are interpreted as the remnants of karstic processes.

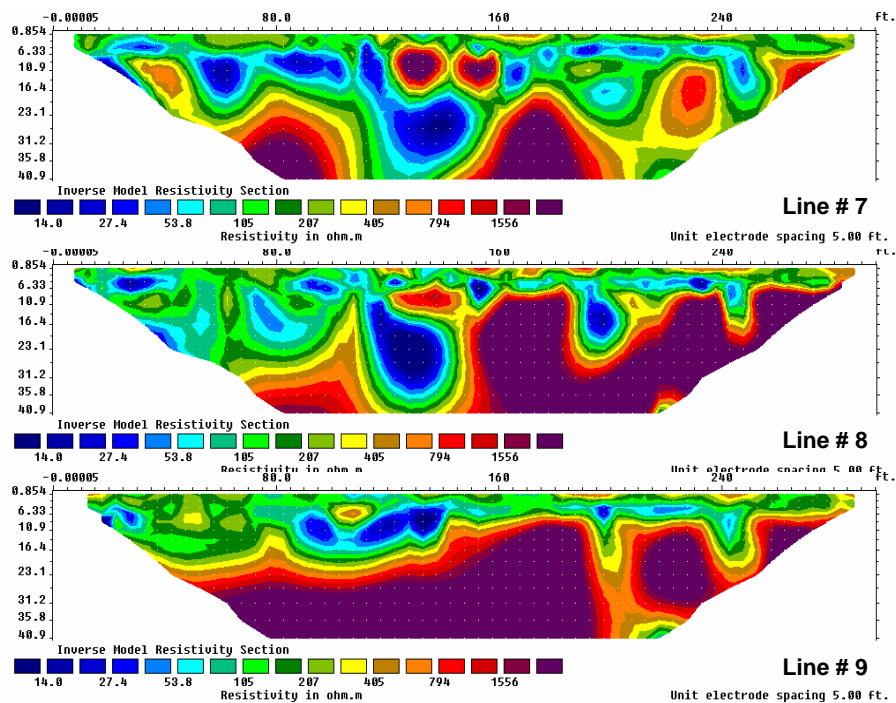
Figure 7: Grid "1A" electrical resistivity profiles 7, 8 and 9 (Figure 4).

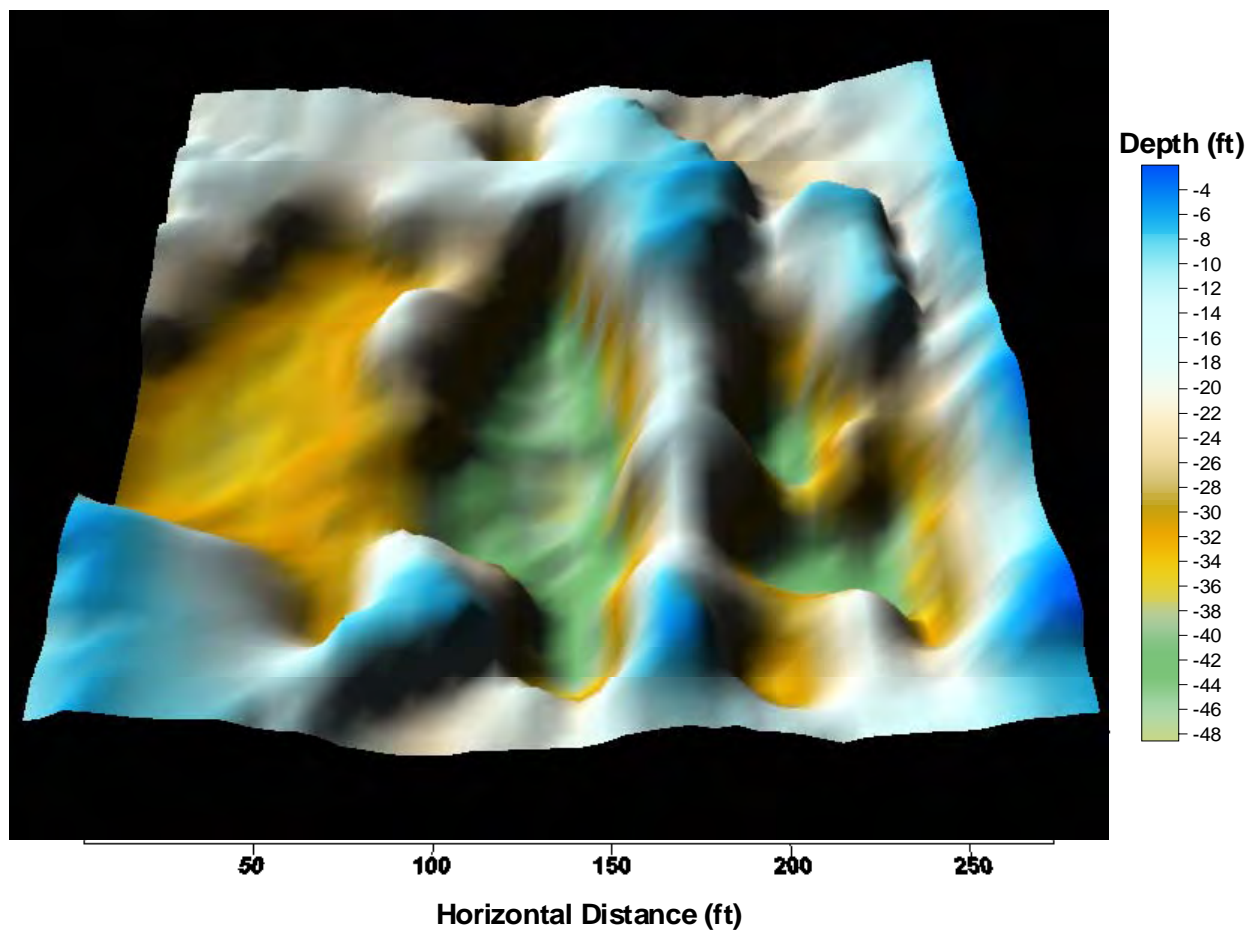
Figure 8: Grid "1A" contour map showing interpreted depth to bedrock.

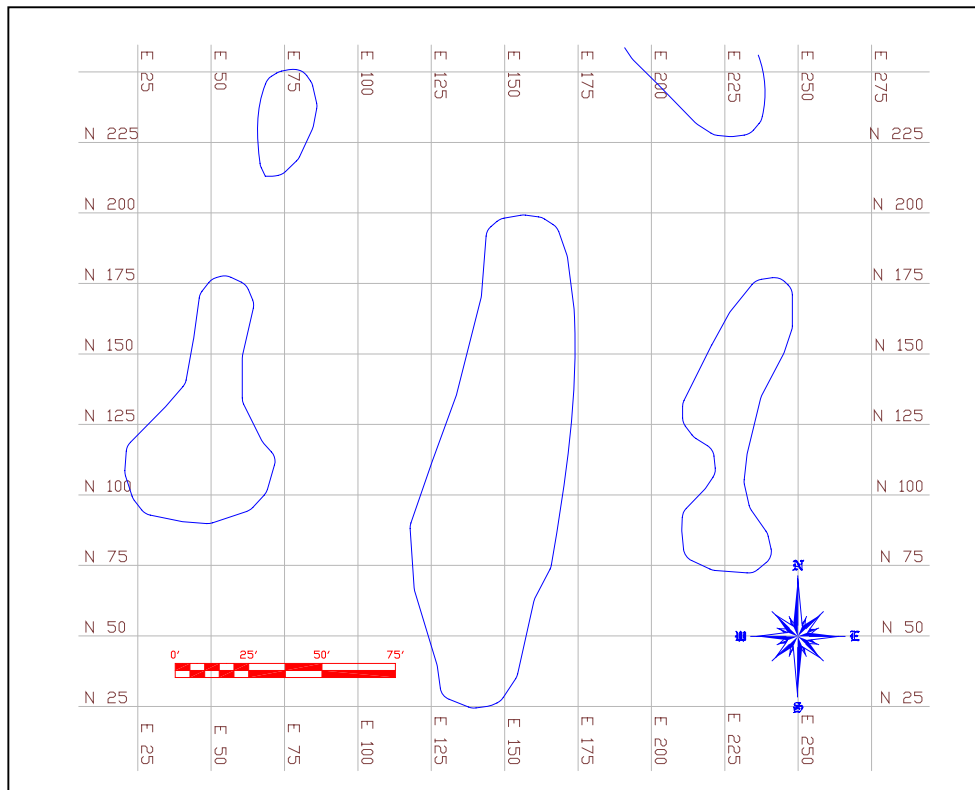
Figure 9: Grid "1A" map showing interpreted location of shallow limestone lenses.

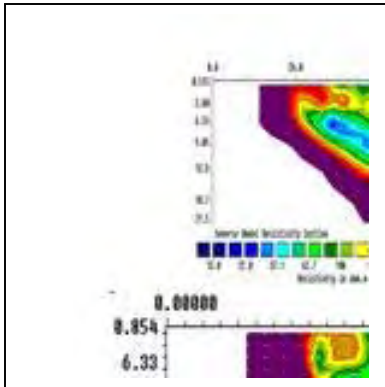
Figure 10: Comparison grid “1A” electrical resistivity profile 1 and grid “1B” electrical resistivity profile 1.

encompasses the current Route 60 ROW. These 2-D profiles were acquired using a 40-channel SuperSting Resistivity unit with a dipole-dipole array configuration. However, an electrode spacing of 3 ft. was employed, providing for better spatial resolution but less depth of investigation. For comparison purposes, a representative grid “1B” 2-D profile and the corresponding grid “1A” profile are presented as Figure 10. The two profiles appear to correlate very well, the grid “1B” data simply providing better resolution but less depth of investigation. There was no evidence of substantive air-filled voids on any of the grid “1B” profiles.

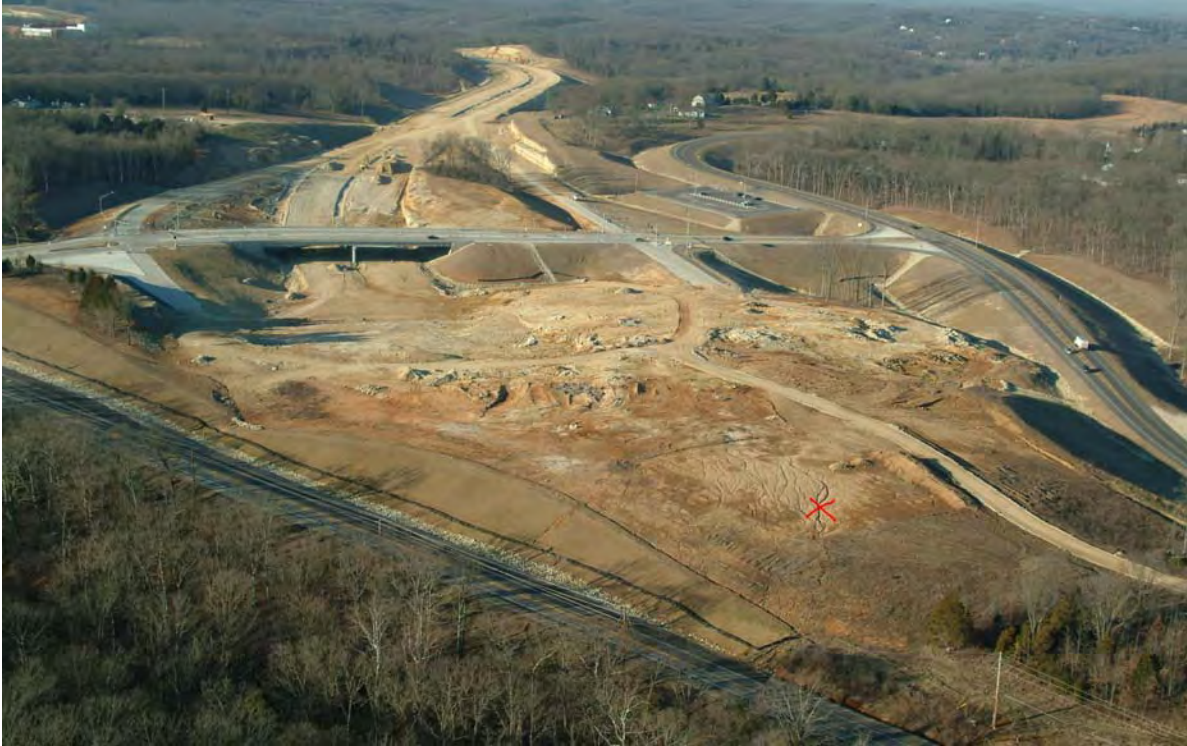
Figure 11: Aerial photograph of the Jefferson County site, prior to the “emptying” of the sinkhole. The approximate location of the sinkhole has been superposed on the photograph.

Jefferson County Site #2 encompasses the northbound lanes of new Route 21, approximately 0.4 miles north of the existing interchange of Route A and new Route 21 (Figures 1 and 3). A relatively dense grid of electrical resistivity data was also acquired at this site because a large clay-filled previously-unidentified oval-shaped sinkhole (Figures 11-14) near the centerline of the northbound lanes emptied overnight. The “emptying” of the sinkhole was preceded by the stripping of topsoil (to limestone bedrock in much of the study area) and heavy rains, the run-off from which was channeled towards the sinkhole by pre-existing topography on the top of recently exposed rock.

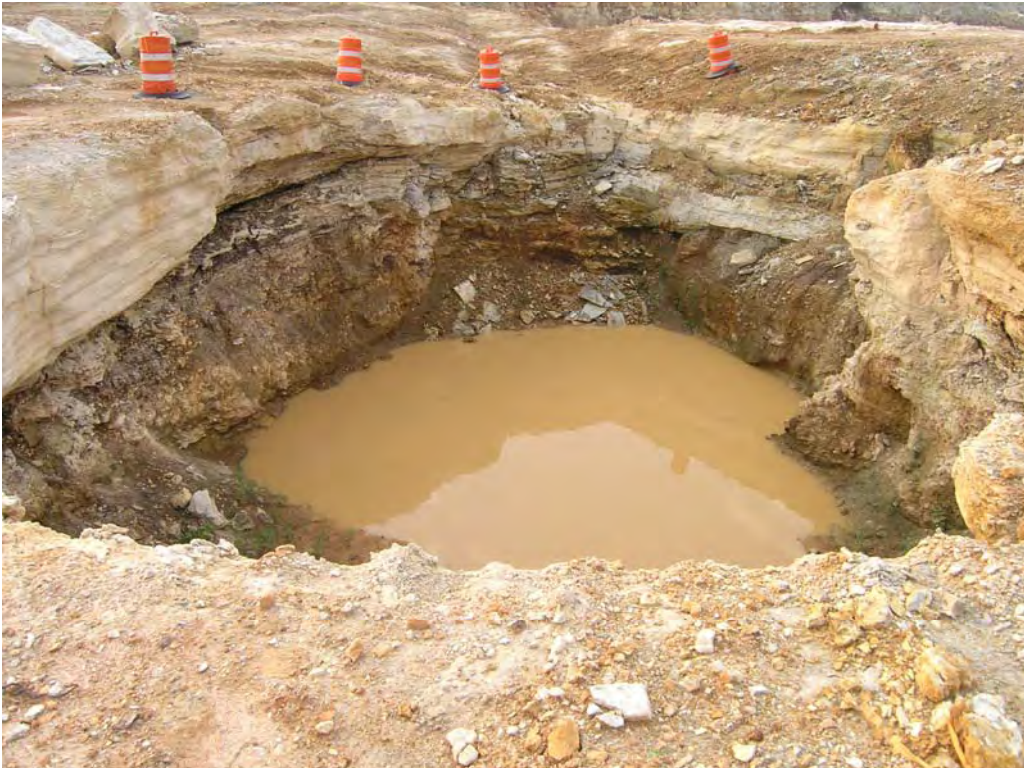
Figure 12: Photograph of the sinkhole, taken from a location immediately to the south of the feature.

The “emptied” sinkhole was oval-shaped, approximately 50 ft long, 35 ft wide and 15 ft deep (top of ponded water to top of sinkhole). The base of the sinkhole was not visible because it was covered with up to 2 ft of ponded water and up to 2 feet of soft clay which proved to have sufficient strength to support 8 ft long vertically-imbedded copper electrical resistivity electrodes (Figures 12-14).

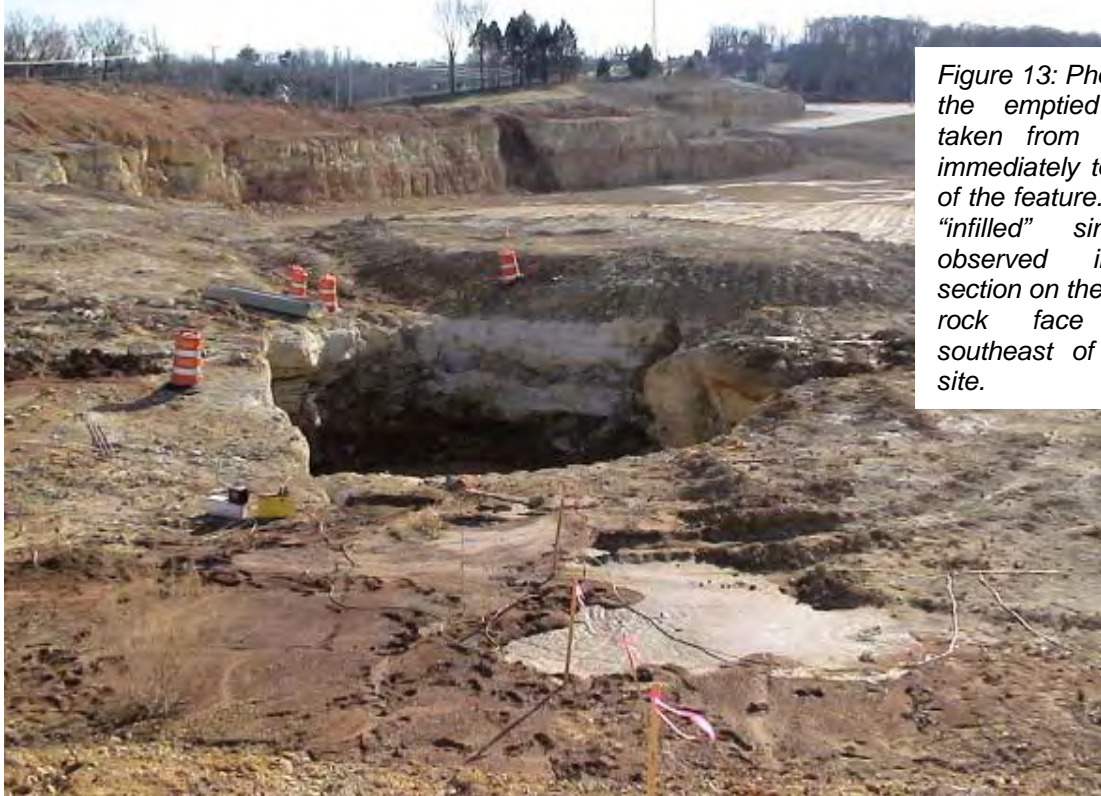
Figure 13: Photograph of the emptied sinkhole, taken from a location immediately to the north of the feature. A second “infilled” sinkhole is observed in cross-section on the excavated rock face to the southeast of the study site.

Visually, the “emptied” sinkhole appeared similar to a second clay-filled sinkhole located several hundred feet to the southeast, near the eastern edge of the construction site (Figures 13 and 15). This second sinkhole had been essentially dissected by excavation equipment, and in cross-section appeared to have near-vertical walls and a relatively flat base comprised of intact limestone (Figure 15).

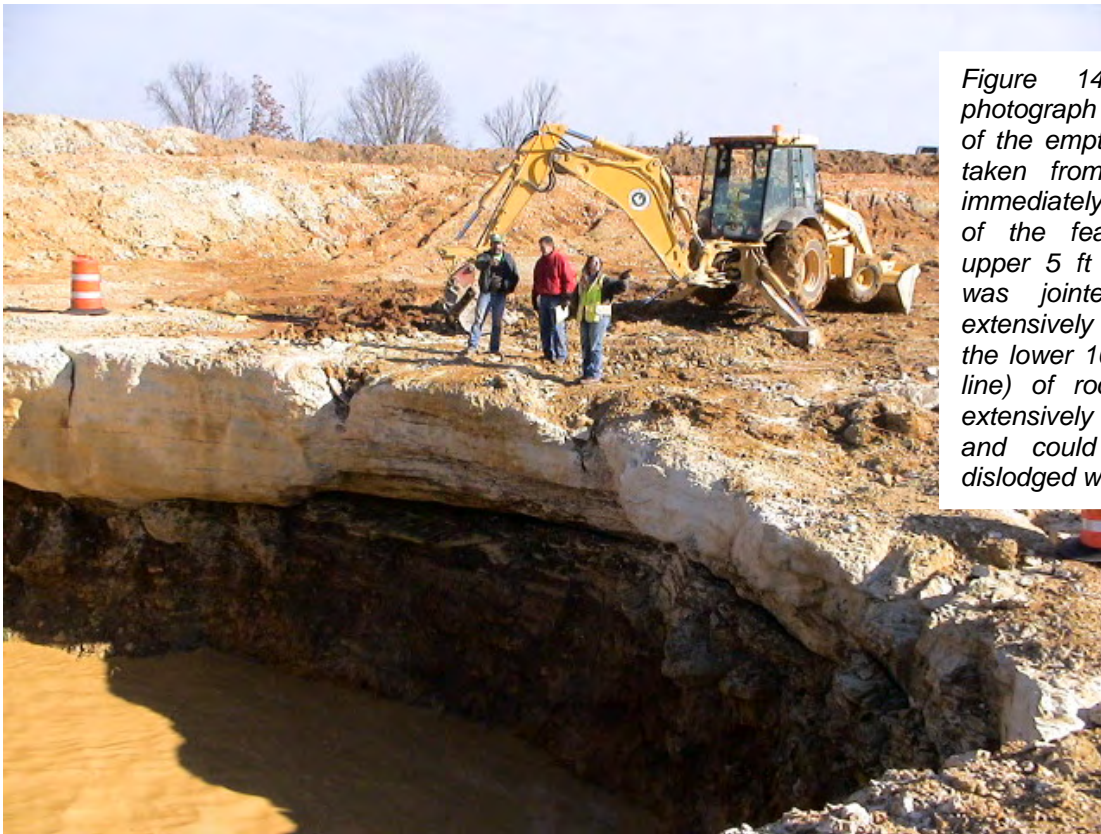
Figure 14: Close-up photograph of the walls of the emptied sinkhole, taken from a location immediately to the south of the feature. The upper 5 ft of rock wall was jointed but not extensively fractured; the lower 10 ft (to water line) of rock wall was extensively fractured and could be readily dislodged with a shovel.

The walls of the “emptied” sinkhole were both steep and weathered, supporting the thesis that the sinkhole was a pre-existing feature that had been rapidly emptied of clay, rather than a newly-developed catastrophic collapse feature (Figure 14). The upper ~5 ft of exposed “cap” rock was dissected in places by prominent NNW-trending and near-orthogonal solution-widened joints, but was otherwise relatively intact; the lower ~10 ft of exposed rock was much more intensely jointed and weathered.

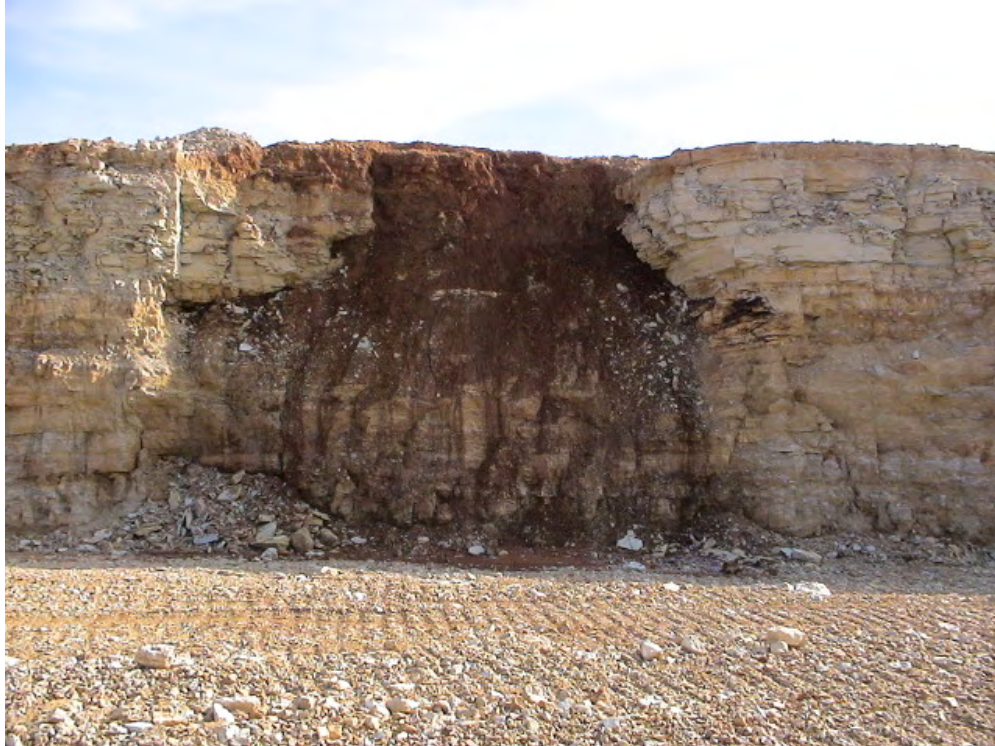
Figure 15: Close-up of second in-filled sinkhole, located approximately 500 ft SSE of the “emptied” sinkhole. The walls of the second sinkhole were fairly steep; the base was relatively flat.

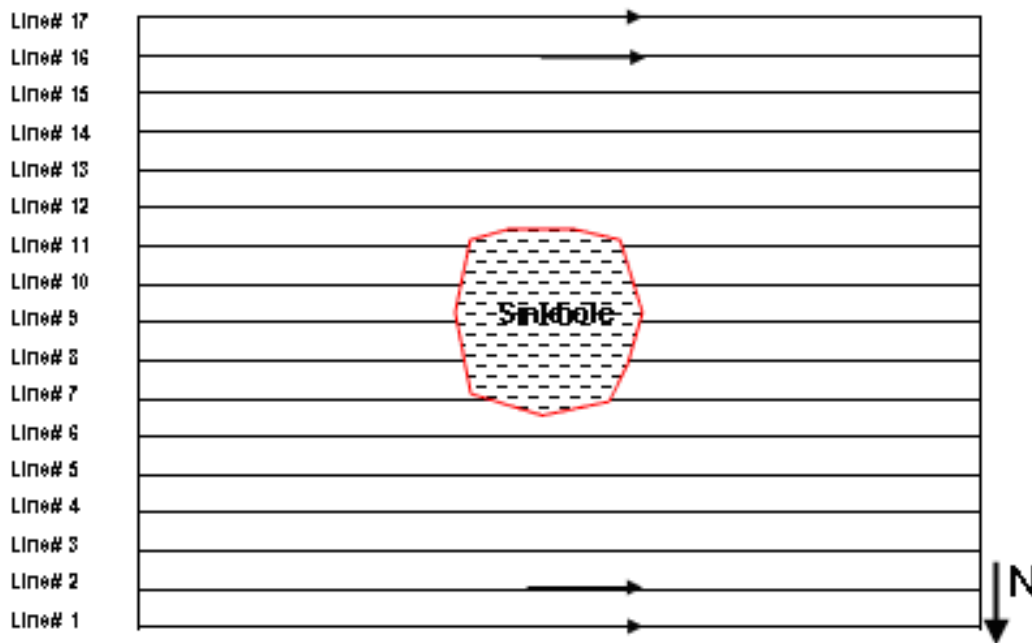
Figure 16: A single grid of electrical resistivity profiles was acquired at the Jefferson County site. The grid consisting of 17 profiles spaced at 25 ft intervals, were acquired using an electrode spacing of 12 ft.

In an effort to image the subsurface below and in proximity to the “emptied” sinkhole to depths on the order of 80 ft, the supervising MoDOT geologist authorized the acquisition of a grid of electrical resistivity profiles (Figure 16). The resistivity profiles were oriented west-east (W-E) effectively perpendicular to the long axis of the oval-shaped sinkhole and the most prominent solution-widened joints, both of which trend northnorthwest (Figure 4). Profiles 1-17 were 420 ft long and spaced at 20 ft intervals. The resistivity data were acquired using a SuperSting resistivity unit with an electrode spacing of 12 ft. A suite of representative electrical resistivity profiles are presented as Figures 17, 18 and 19.

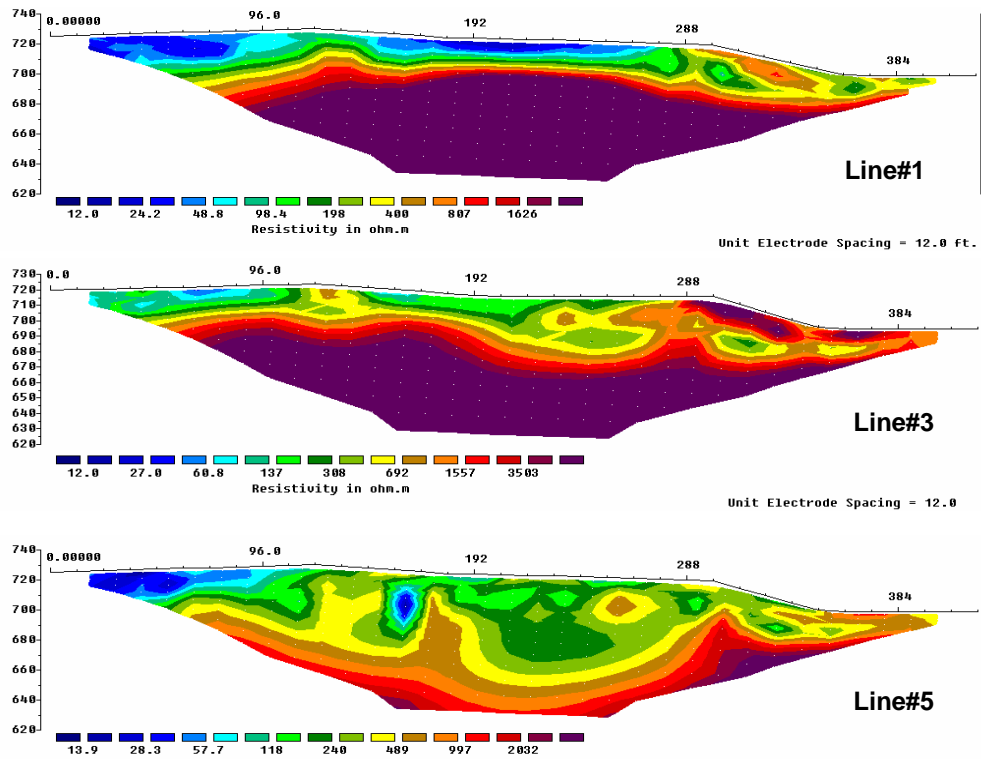
Figure 17: Electrical resistivity profiles 1, 3 and 5.

The uppermost ~20 ft of the subsurface in proximity and to the immediate south to the sinkhole is characterized mostly by resistivities of between 100 ohm-m and 400 ohm-m (Figures 17, 18

and 19). Lower resistivities are observed at the base of the sinkhole, presumably because of the presence of saturated clay and ponded water. Localized lenses of higher resistivity (>400 ohm-m) are observed in the shallowest subsurface (depths <10 ft). Overall, these resistivity values and patterns are very consistent with visual observations at the sinkhole, where remnant surficial soil and ~5 ft of jointed limestone overly at least ~10 ft of intensely weathered rock.

At depths below 20 ft, bedrock beneath and adjacent to the sinkhole (except immediately to the north of the feature) is characterized by resistivities in excess of 400 ohm-m, but less than 2000 ohm-m (Figure 17, 18 and 19). These resistivity values support the interpretation that the sinkhole is not underlain by either a large air- or fluid-filled cavity.

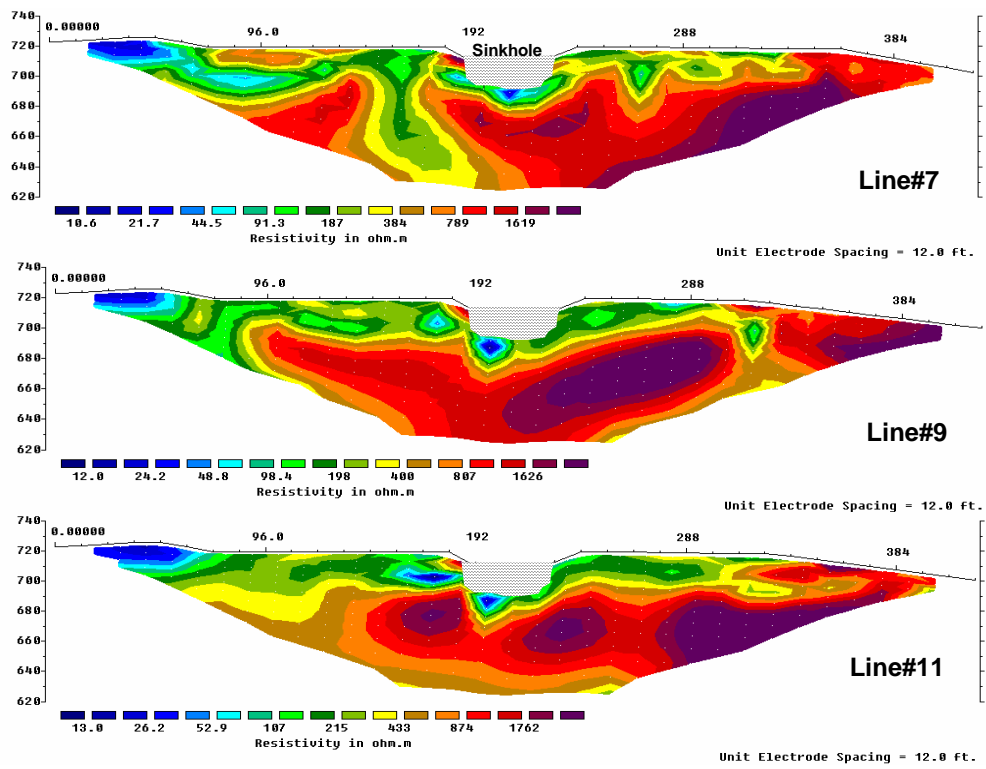
Figure 18: Electrical resistivity profiles 7, 9 and 11.

The subsurface immediately to the north and northeast of the sinkhole is characterized by a different pattern of resistivity values. More specifically, a vertical-trending narrow (<10 ft wide) zone consisting of anomalously low resistivity values (between ~127 and 400 ohm-m) is observed immediately to the east of the sinkhole on profile 8 (Figure 18). This feature is interpreted as a prominent clay-filled solution-widened joint or zone of intensely fractured rock with clay-infill, and extends across profiles 7, 6 and 5. A prominent zone of relatively low resistivities is also observed at depths of between 40 ft and 70 ft on profile 6 immediately to the north of the sinkhole (Figure 18).

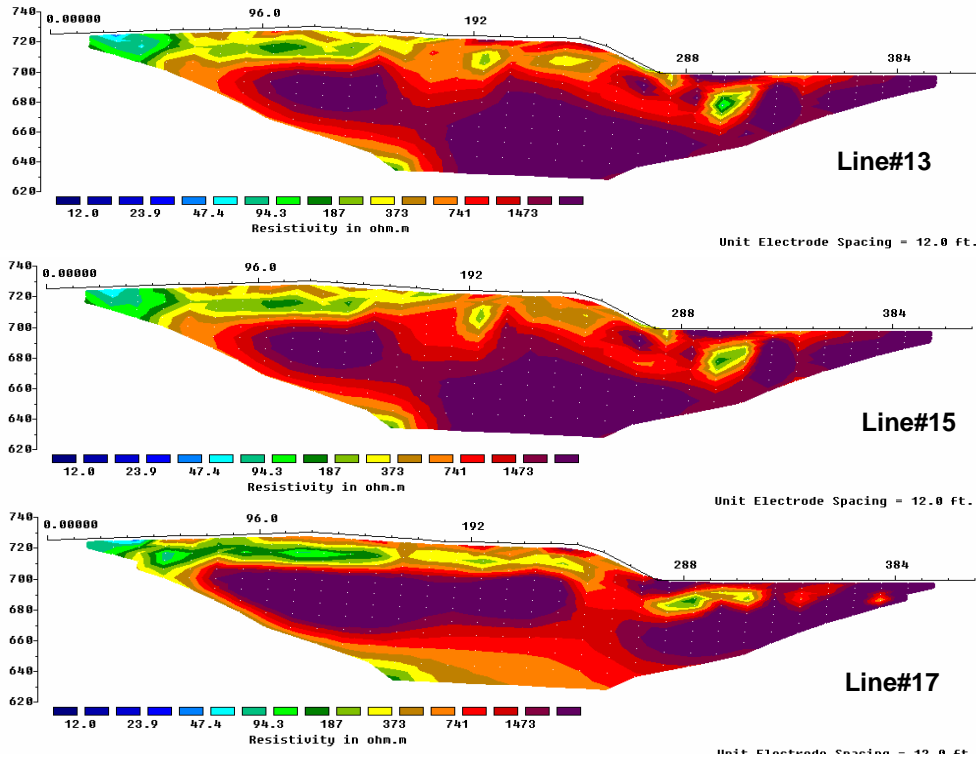
Figure 19: Electrical resistivity profiles 13, 15 and 17.
