**Report No. CDOT-2009-8**  
**Final Report**

# **CONCRETE DECK PERFORMANCE RELATIVE TO AIR ENTRAINMENT**

**Chetana Rao**  
**Ahmad Ardani**

**December 2009**

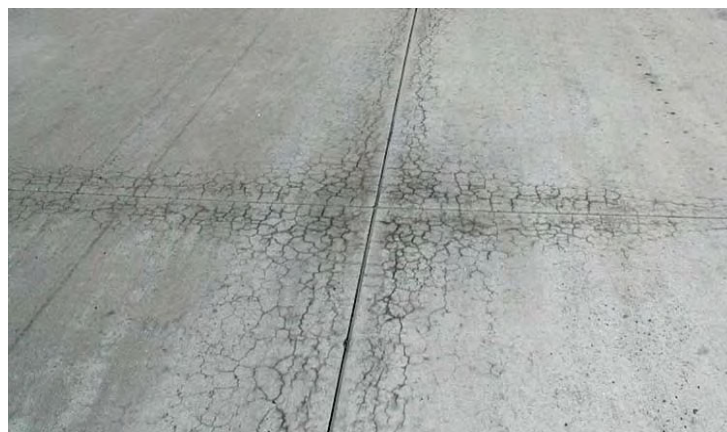
*D-cracking* results from freezing and thawing of frost-susceptible coarse aggregate that manifests itself in the form of hairline cracks adjacent and nearly parallel to transverse and longitudinal joints and at the free edges of pavement slabs (see Figure 2). Frost-susceptible aggregates are of sedimentary rock origin and are composed primarily of limestone, dolomite, or chert aggregate. Bond failure between the aggregate and the cement paste and disintegration of the paste are major indications of D-cracking. Currently, the only ways to prevent D-cracking

**Figure 2. Early development of D-cracking**

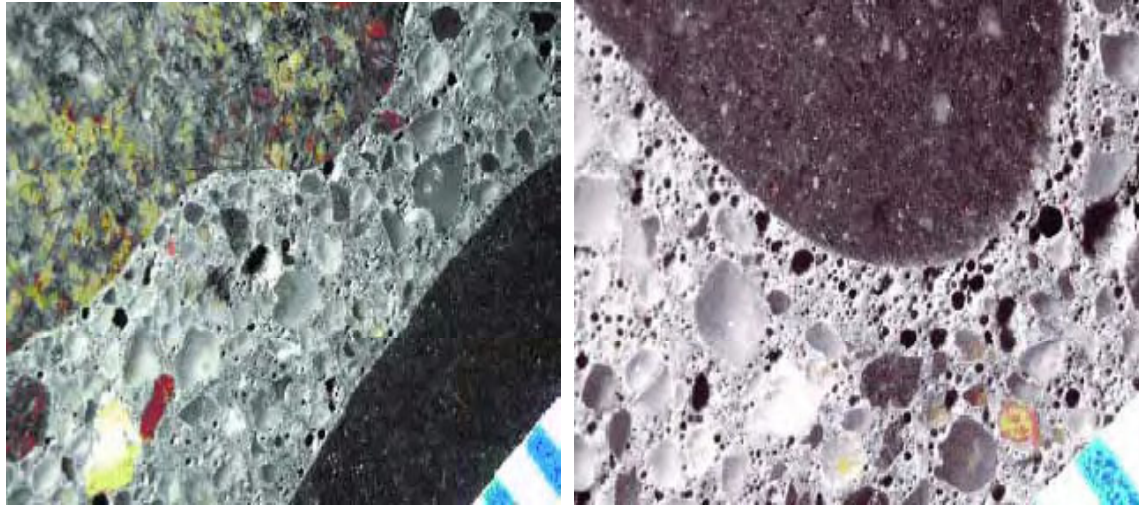
A laboratory study conducted by Kozikowski et al. (2005) linked air-void clustering (AVC) to certain types of AEAs and late addition of water to concrete. According to this study, AVC in concrete is a randomly occurring phenomenon that can result in a significant decrease in compressive strength. As the name implies, AVC is the concentration of entrained air voids around coarse aggregate particles at the paste/aggregate interface, creating a localized zone of weakness. Such mixes could possess lower compressive strengths because applied loads cannot be transferred effectively between the paste and aggregate particles. Figure 4 depicts examples of concrete with and without AVC.

**Figure 4. Concrete with and without AVC (Kozikowski et al., 2005)**

- AVC did not occur in concrete mixes made with Vinsol resin based admixtures.
- A late addition of water to concrete mixes containing non-Vinsol resin admixtures regularly caused clustering to occur.
- The severity of the AVC increased when the retempered concrete was mixed for a longer time.

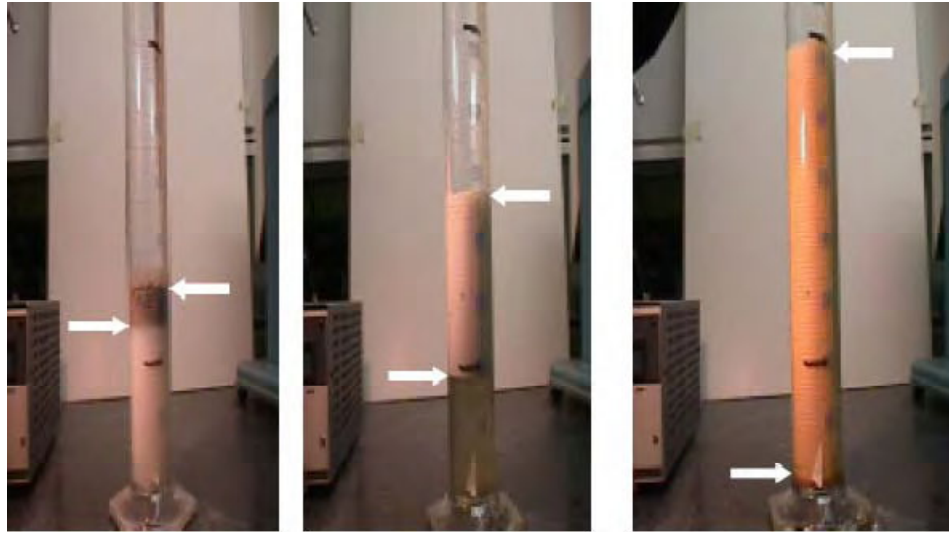
Air void stability can be evaluated using the foam drainage test. In general, a stable air void system has a lower drainage rate and retains more water than an unstable system (Nagi et al., 2007). Figure 5 shows the evaluation of three different AEAs using a foam drainage test for a South Dakota study (Cross et al., 2000).

**Figure 5. Foam drainage testing of three different AEAs (Cross et al., 2000).**

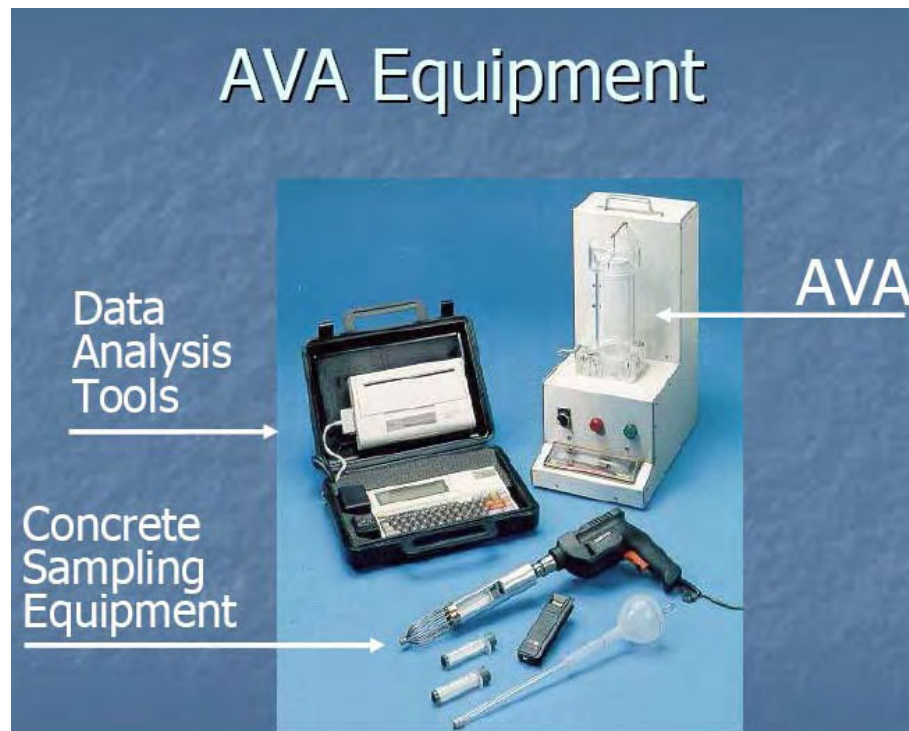
Recently, transportation agencies have been experimenting with the AVA system in monitoring the air void characteristics of fresh concrete mixes. The AVA, shown in Figure 6 is a portable device that measures the air content, specific surface, and spacing factor of fresh concrete in real time, taking approximately 30 minutes. The results correlate closely with ASTM C 457 values obtained on hardened concrete. The Kansas Department of Transportation has been using this technology since April 2001 and has developed a State specification that it uses routinely (AASHTO, 2006). The formation of an AASHTO Technology Implementation Group (TIG) and the subsequent round robin tests conducted under this effort has led to the implementation of this technology by other agencies.

**Figure 6. AVA system (courtesy National Concrete Pavement Technology Center)**

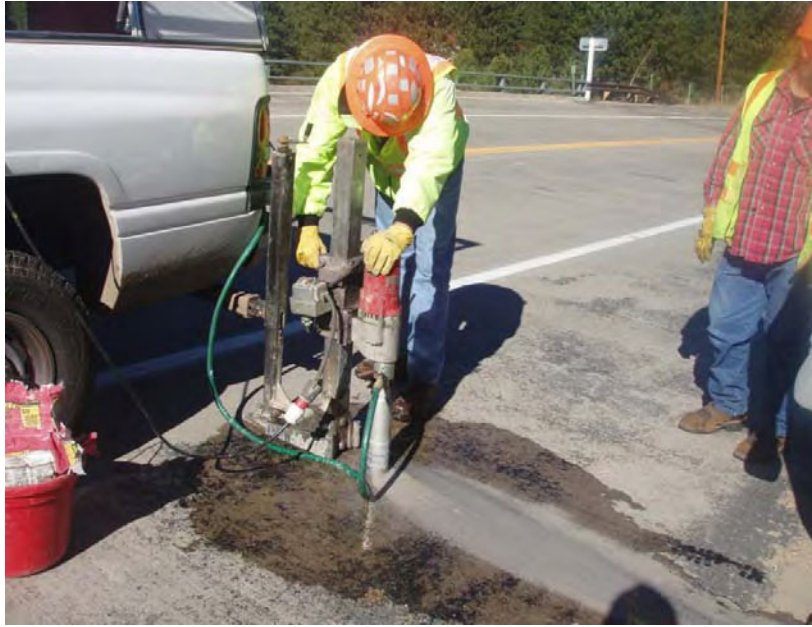
**Figure 7. Bridge deck coring**

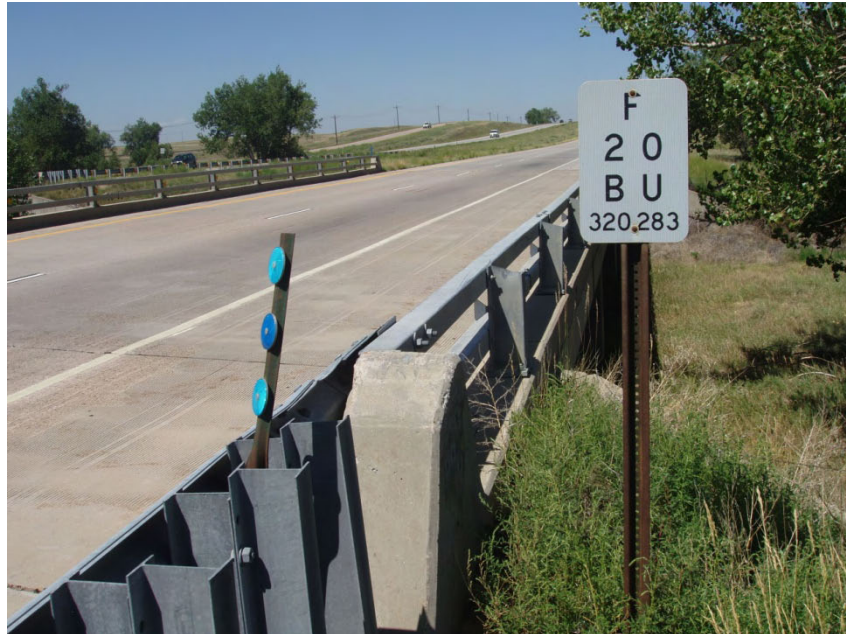
Structure F-20-BU, with average daily traffic of 5750 vehicles, is located on eastbound I-70 over Rattle Snake Creek at milepost 320.215, approximately 4.4 miles (7 km) east of the town of Byer. The structure was built in 1989 and presently is in fairly good condition with isolated transverse cracking. The bridge is shown in Figure 10.

**Figure 10. Structure F-20-BU**

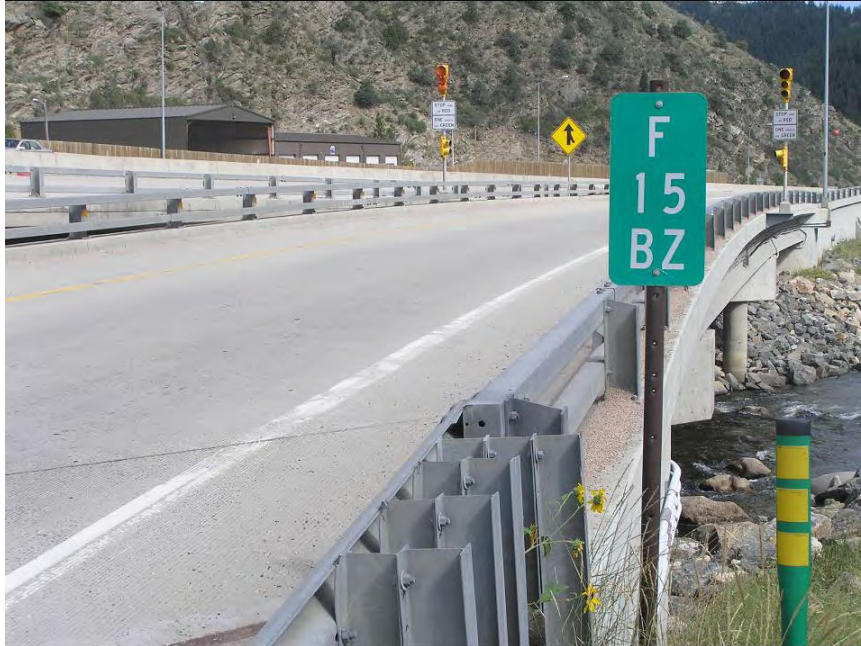
Structure F-15-BZ over Clear Creek was built in 1999 and currently carries 428 vehicles per day. The structure is the on-ramp to I-70 eastbound, located just west of Idaho Springs (Figure 11). Distresses at this location included transverse cracking that covered the entire deck's surface in approximately 2 to 4-ft (0.6 to 1.2-m) intervals with no visible signs of F-T (Figure 12).

**Figure 11. Structure F-15-BZ west of Idaho Springs**

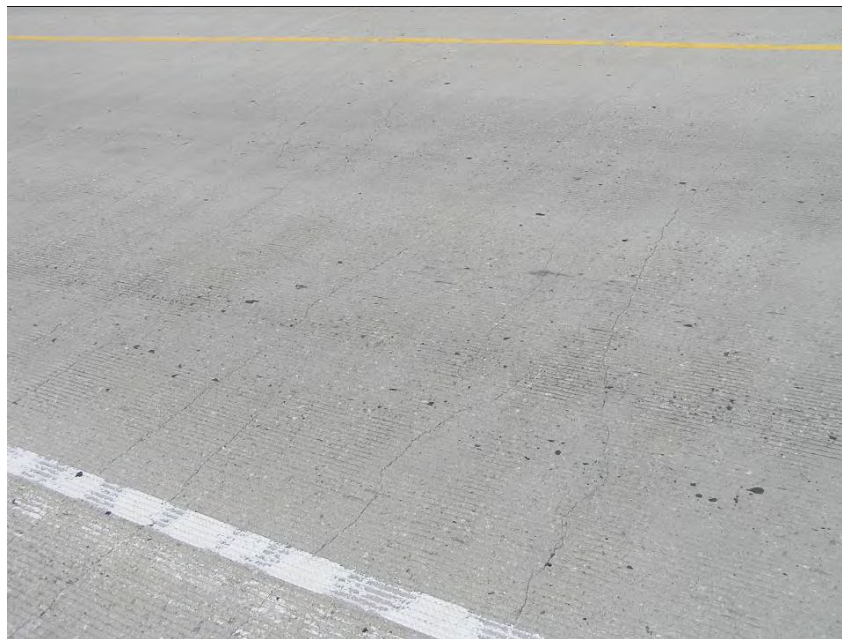
**Figure 12. View of transverse cracking at structure F-15-BZ**

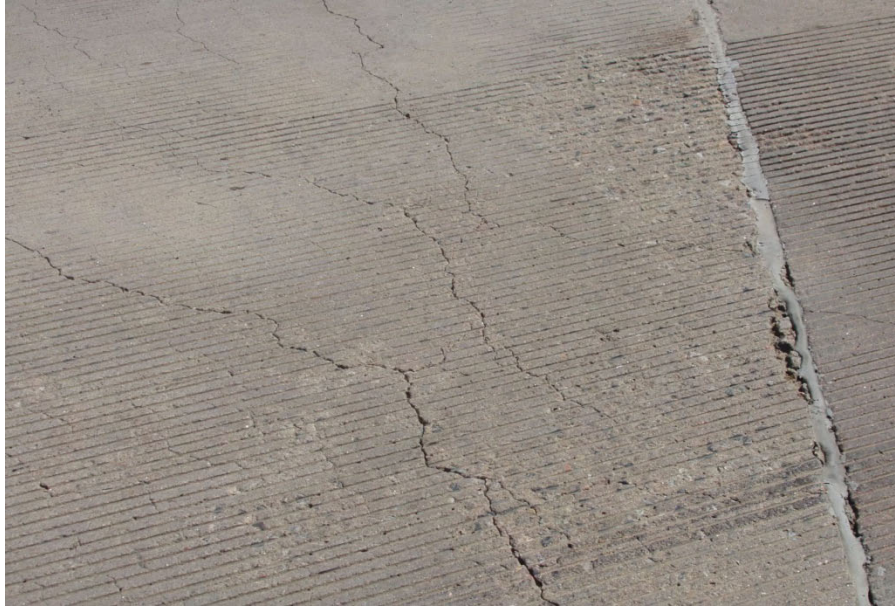
Structure G-22-BZ, built in 2000, is located on US 24 at milepost 376.63 over a railroad, immediately south of the town of Limon. With an average daily traffic of 4600 vehicle per day, the deck of this bridge exhibited irregular diagonal cracking with isolated minor scaling, as shown in Figure 14.

**Figure 14. Structure G-22-BZ**

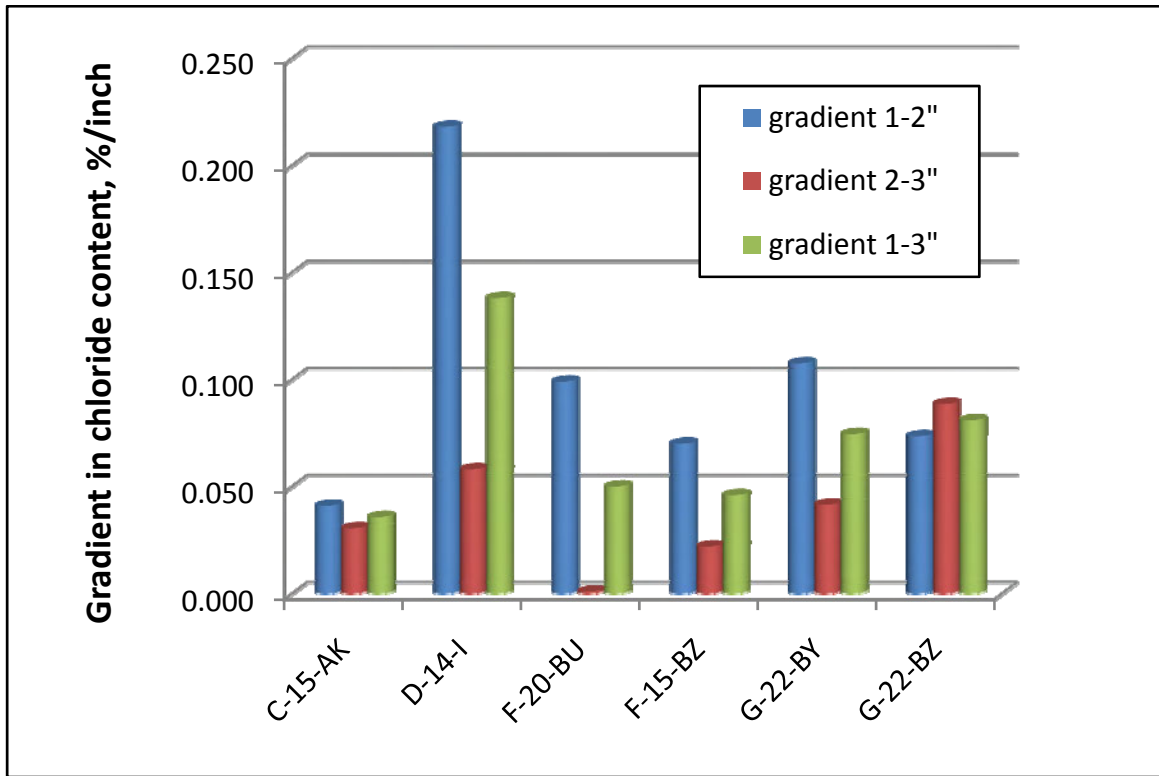
**Figure 22. Chloride ion content gradient at three levels in the selected structures**

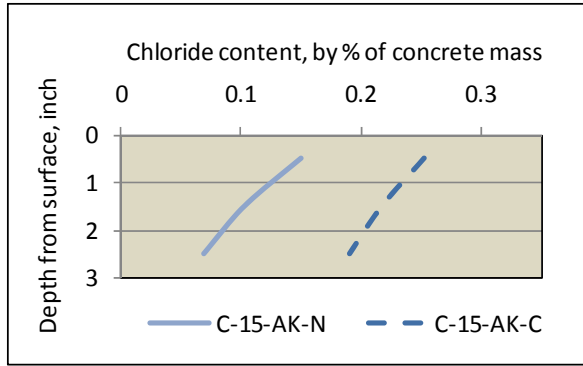
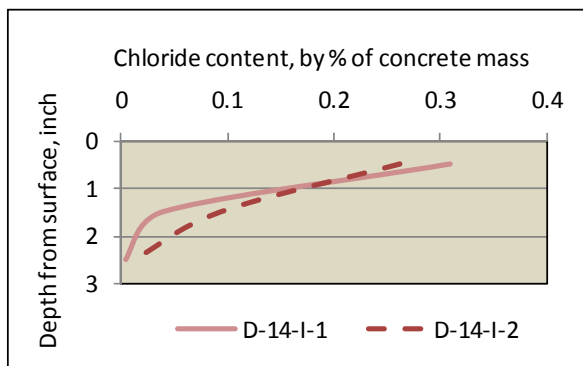
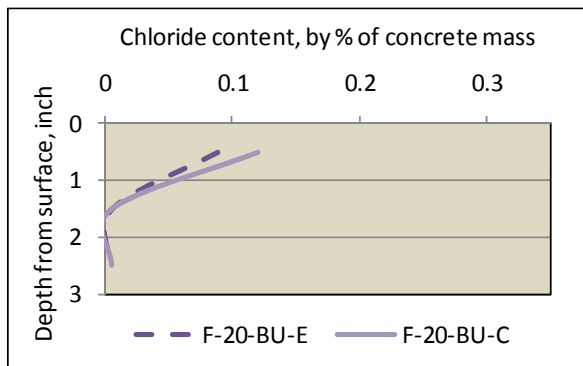
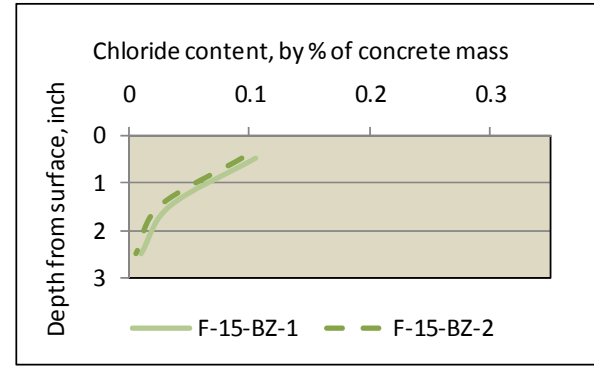
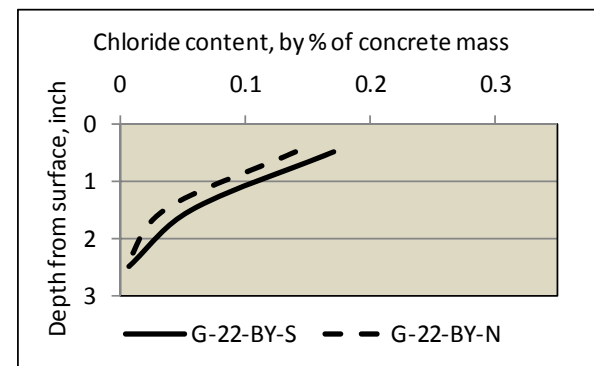
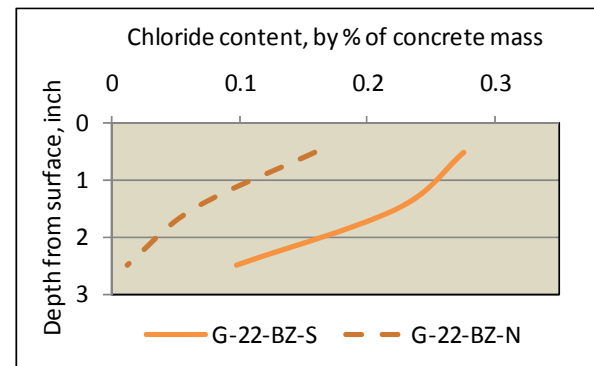
Structures C-15-AK and G-22-BZ show higher variability within the structure. However, the gradients are the same between the two cores from the structure. Also, as discussed previously, the chloride contents are within critical levels and do not signify a difference in durability of the mix or the performance of the structure. The plots shown on the same scale also illustrate the relative chloride ion contents across all structures and across specifications. The results suggest, again, that there is no significant difference in the chloride ion penetration in structures constructed under the two specifications.

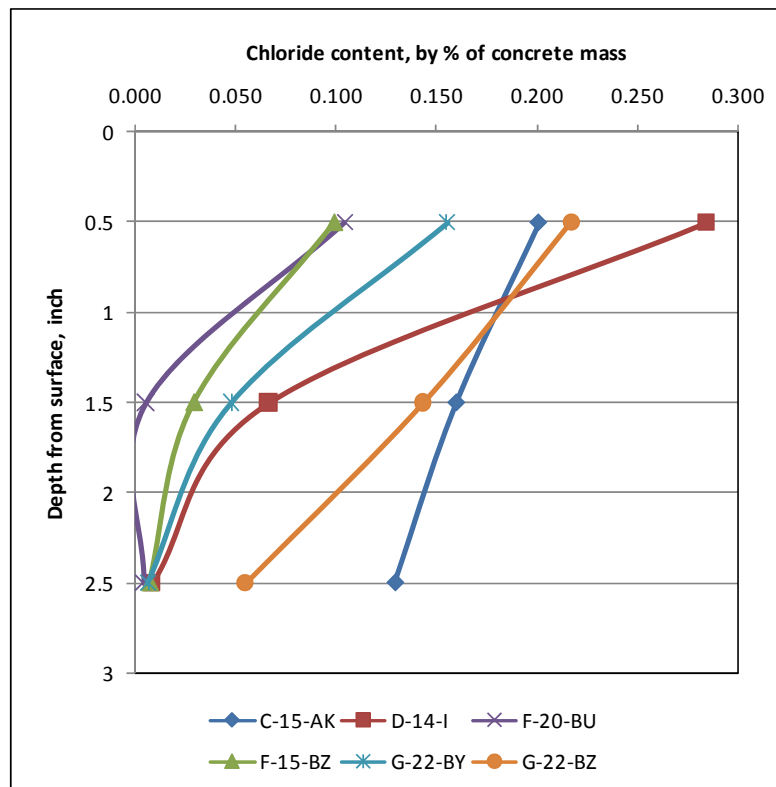
are no clear trends in the distribution that could indicate any change in durability due to the change in specification. Structure D-14-1 shows a higher concentration near the surface, but perhaps it has a low permeability mix design that has maintained low chloride levels at lower depths, comparable to those in the relatively newer structures. Also, it is reasonable to say that the chloride analysis results are consistent with the findings of the air void analysis testing.

**Figure 24. Average chloride ion concentration for all structures**

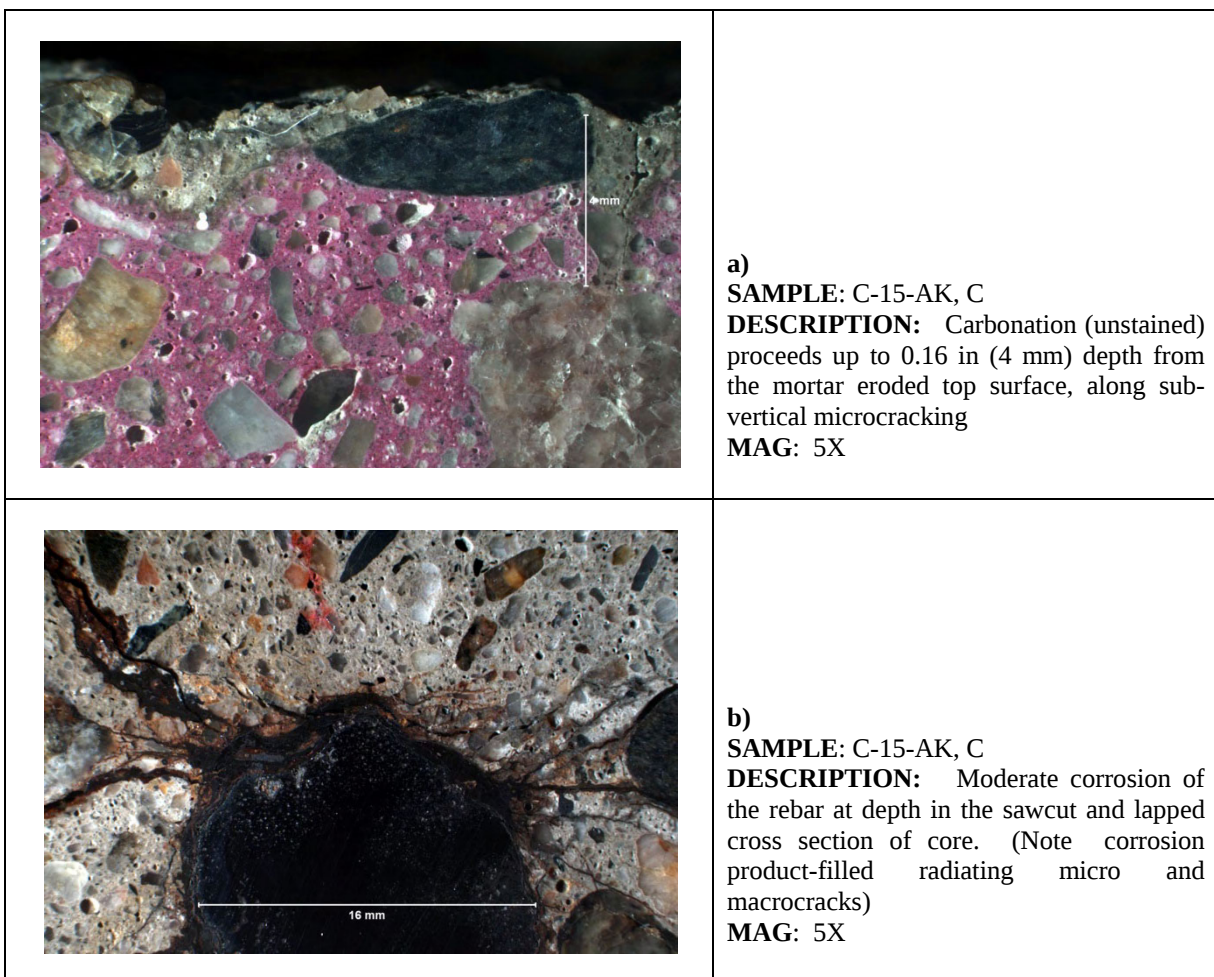
Magnified images of the two cores are presented in Figures 25, 26, and 27. The cores from this structure had a rough mortar eroded surface on the top with exposed coarse aggregate surfaces. Carbonation extended about 0.16 to 0.32 in (4 to 8 mm) from the surface (see Figure 25a, 26a). Several drying shrinkage microcracks were observed up to depths of 0.48 to 0.6 in (12 to 15 mm), and finer air voids at depths below an inch were filled with secondary ettringite (Figure 26c and 27b). This concrete was rated as having limited to poor F-T resistance.

**Figure 25. Magnified images of sample C-15-AK, C under petrographic examination**

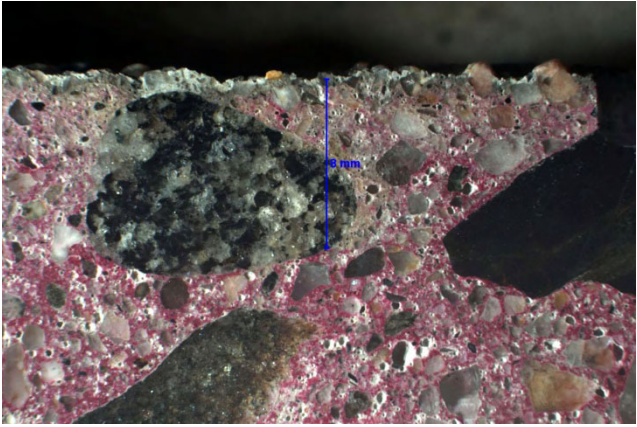
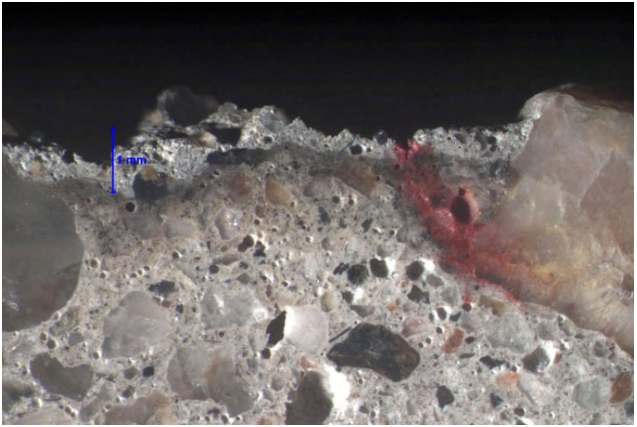
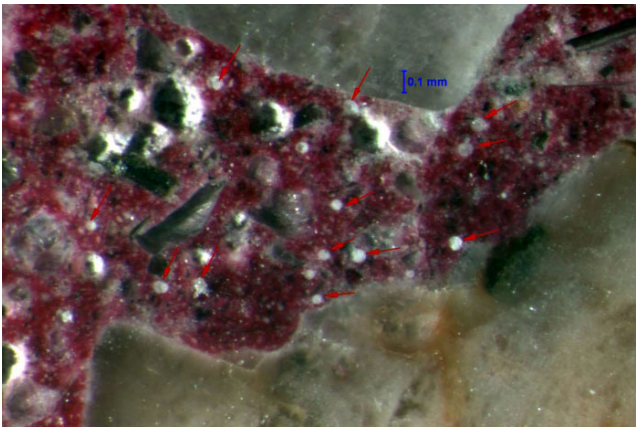
| | <p><b>a)</b><br/> <b>SAMPLE:</b> C-15-AK, N<br/> <b>DESCRIPTION:</b> Carbonation (unstained) ranges from negligible up to 0.32 in (8 mm) depth from the mortar eroded top surface.<br/> <b>MAG:</b> 5X</p> |
| | <p><b>b)</b><br/> <b>SAMPLE:</b> C-15-AK, N<br/> <b>DESCRIPTION:</b> The top up to 0.04 in (1 mm) on the concrete was characterized by a very soft, white paste.<br/> <b>MAG:</b> 15X</p> |
| | <p><b>c)</b><br/> <b>SAMPLE:</b> C-15-AK, N<br/> <b>DESCRIPTION:</b> White, ettringite-filled entrained air void spaces in phenolphthalein-stained paste at 0.71 in (18 mm) depth from the top surface of the core.<br/> <b>MAG:</b> 50X</p> |

**Figure 26. Magnified images of sample C-15-AK-N under petrographic examination**

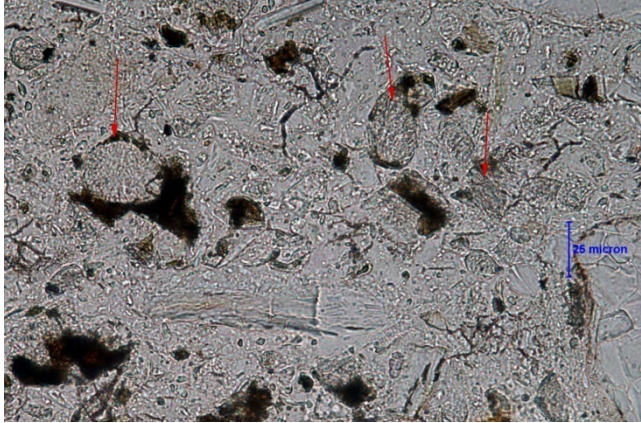
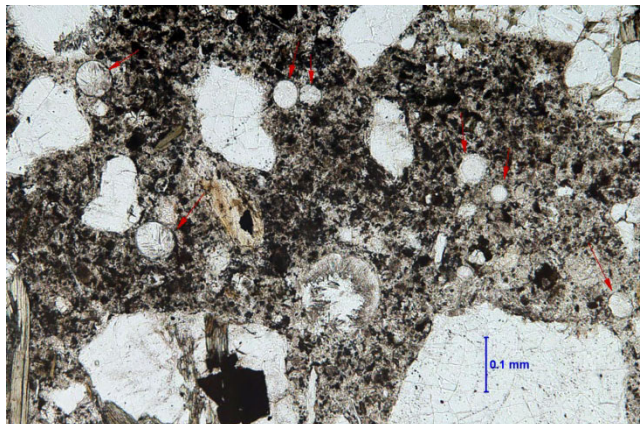
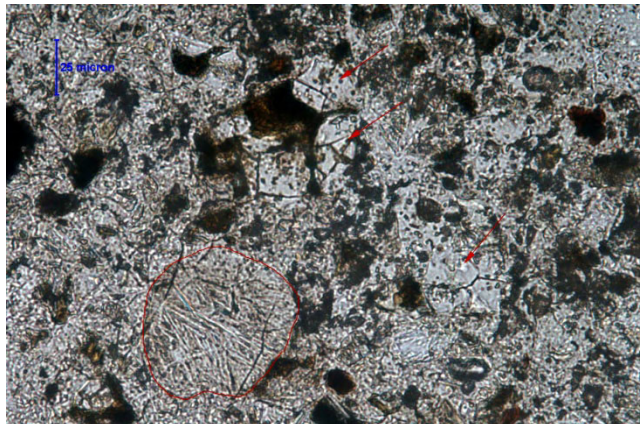
consisted mostly of granite, gneiss, schist, quartzite, sandstone, and some shale. w/c ratio was estimated to be 0.45 to 0.5, and the alites and belites were fully hydrated. (Figures 27a, 27c)

| | <p><b>a)</b><br/> <b>SAMPLE:</b> C-15-AK, N<br/> <b>DESCRIPTION:</b> Fully hydrated belites portland cement clinker relicts in thin section of concrete paste under plane polarized light.<br/> <b>MAG:</b> 400X</p> |
| | <p><b>b)</b><br/> <b>SAMPLE:</b> C-15-AK, C<br/> <b>DESCRIPTION:</b> Ettringite-filled entrained air void spaces (arrows) in thin section of concrete paste under plane polarized light<br/> <b>MAG:</b> 100X</p> |
| | <p><b>c)</b><br/> <b>SAMPLE:</b> C-15-AK, C<br/> <b>DESCRIPTION:</b> Fully hydrated alites (arrows) and belites (circled) portland cement clinker relicts in thin section of concrete paste under plane polarized light.<br/> <b>MAG:</b> 400X</p> |

**Figure 27. Examination under plane polarized light for structure C-15-AK**

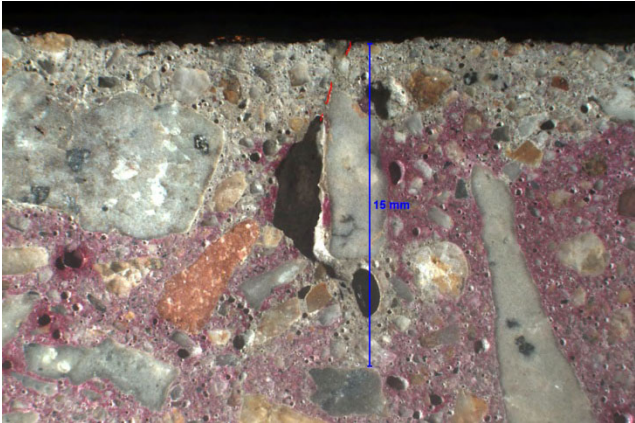
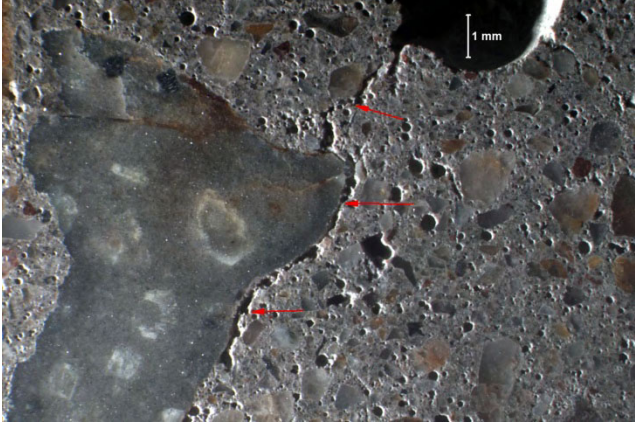
| | <p><b>a)</b><br/> <b>SAMPLE:</b> D-14-I (1)<br/> <b>DESCRIPTION:</b> Carbonation (unstained) proceeds up to 0.63 in (16 mm) depth from the mortar eroded top surface, along consolidation void space. Microcrack is mapped in red dash line.<br/> <b>MAG:</b> 5X</p> |
| | <p><b>b)</b><br/> <b>SAMPLE:</b> D-14-I (1)<br/> <b>DESCRIPTION:</b> Sinuous bleed water void space/channel proceeds along paste-coarse aggregate boundary at depth in the core.<br/> <b>MAG:</b> 10X</p> |

**Figure 28. Magnified images of sample D-14-I (1) under petrographic examination**

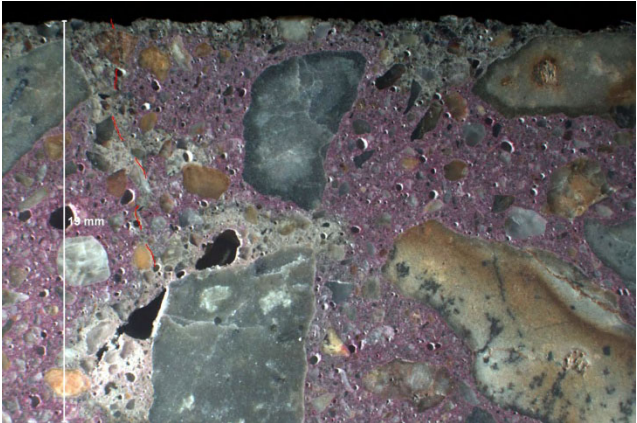
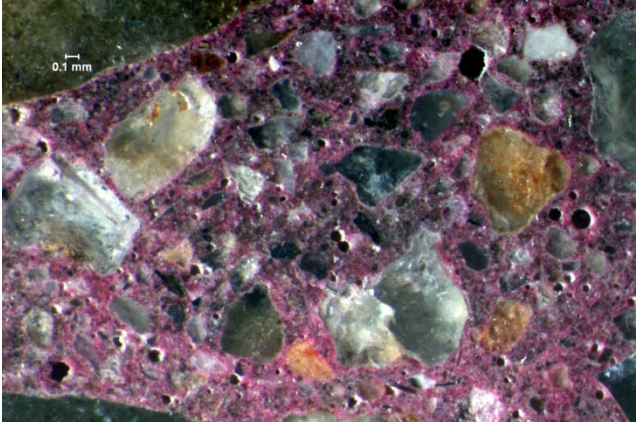
| | <p>a)</p> <p><b>SAMPLE:</b> D-14-I (2)</p> <p><b>DESCRIPTION:</b> Carbonation (unstained) proceeds up to 0.75 in (19 mm) depth from the mortar eroded top surface, along sub-vertical microcracking and consolidation void space. Microcrack is mapped in red dash line.</p> <p><b>MAG:</b> 5X</p> |
| | <p>b)</p> <p><b>SAMPLE:</b> D-14-I (2)</p> <p><b>DESCRIPTION:</b> Fine air void spaces relatively clean and free of secondary ettringite fillings.</p> <p><b>MAG:</b> 30X</p> |

**Figure 29. Magnified images of sample D-14-I (2) under petrographic examination**

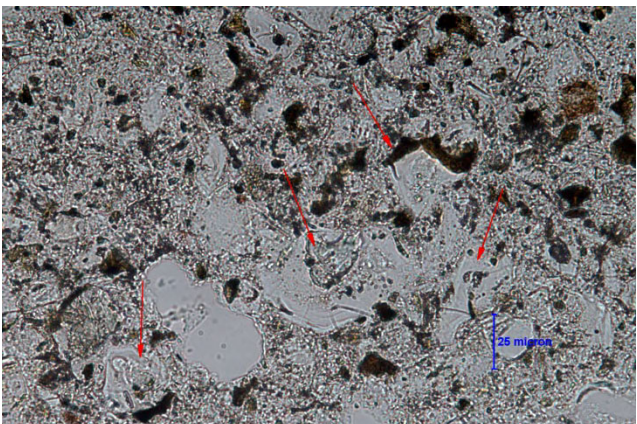
Coarse aggregate was 1-in (25 mm) maximum sized crushed trap rock composed of felsites, and well graded and uniformly distributed. The w/c ratio was estimated to be between 0.43 and 0.48, and the alites and belites were well to fully hydrated (see Figure 30).

| | <p>a)</p> <p><b>SAMPLE:</b> D-14-I (1)</p> <p><b>DESCRIPTION:</b> Well to fully hydrated alites portland cement clinker particles in thin section of concrete paste under plane polarized light</p> <p><b>MAG:</b> 400X</p> |

**Figure 30. Examination under plane polarized light for structure D-14-I**

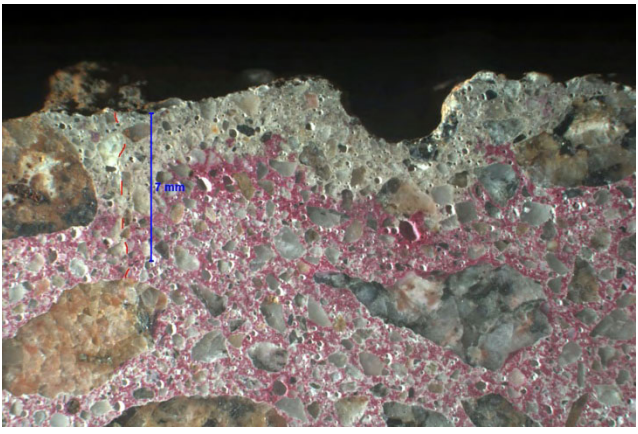
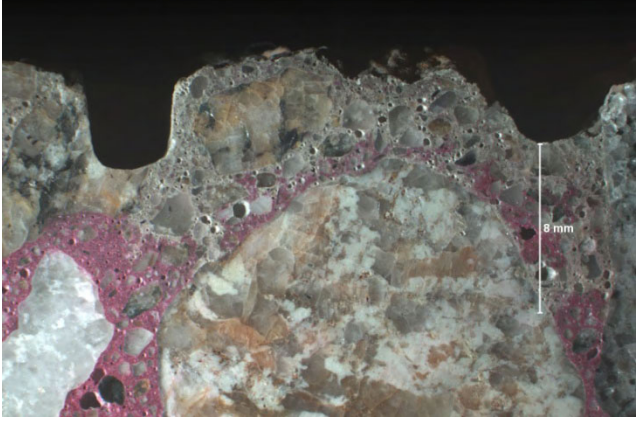
Magnified images of the two cores are presented in Figures 31 and 32. The cores from this structure had a rough mortar eroded surface with exposed fine aggregates. The cores also showed evidence of diamond sawn transverse tining, 0.16 in (4 mm) wide and 0.10 in (2.5 mm) deep. Drying shrinkage microcracks were observed up to comparable depths in both cores, 0.47 in (12 mm) in one core and 0.60 in (15 mm) in the other. Carbonation was not extensive in this structure, but where observed, it extended 0.28 to 0.35 in (7 to 9 mm) deep (see Figure 31). The concrete was considered to offer only limited F-T resistance.

| | <p><b>a)</b><br/><b>SAMPLE:</b> F-20-BU, E<br/><b>DESCRIPTION:</b> Carbonation (unstained) ranges from negligible up to 0.28 in (7 mm) depth, intermittently, from the top surface of the core.<br/><b>MAG:</b> 5X</p> |
| | <p><b>b)</b><br/><b>SAMPLE:</b> F-20-BU, C<br/><b>DESCRIPTION:</b> Carbonation (unstained) ranges from negligible up to 0.28 in (7 mm) depth, intermittently, from the top surface of the core.<br/><b>MAG:</b> 5X</p> |

**Figure 31. Magnified images of structure F-20-BU under petrographic examination**

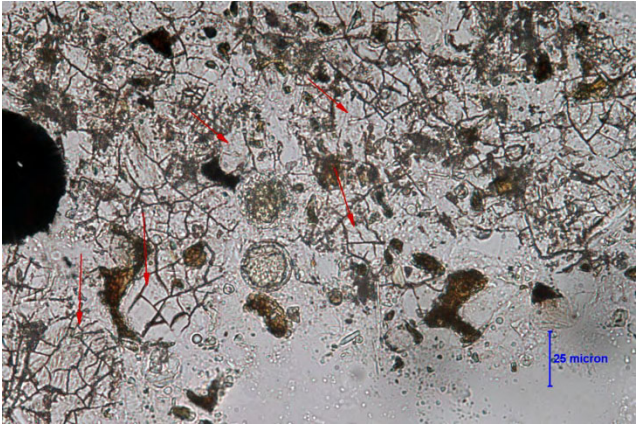
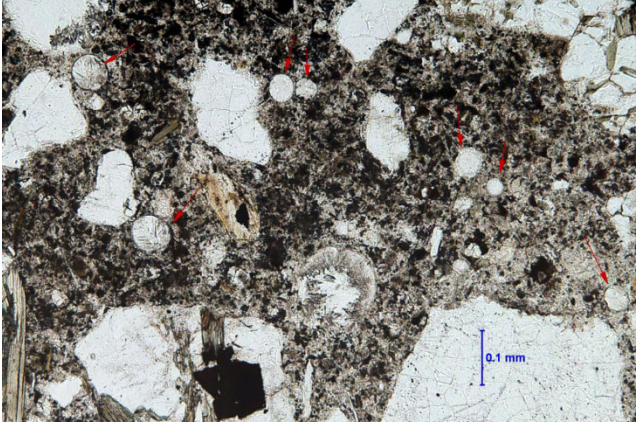
| | <p><b>a)</b><br/> <b>SAMPLE:</b> F-20-BU, E<br/> <b>DESCRIPTION:</b> Well to fully hydrated alites portland cement clinker particles in thin section of concrete paste under plane polarized light. Note spherical fly ash pozzolan particles.<br/> <b>MAG:</b> 400X</p> |
| | <p><b>b)</b><br/> <b>SAMPLE:</b> F-20-BU, C<br/> <b>DESCRIPTION:</b> Well to fully hydrated portland cement clinker particles in thin section of concrete paste under plane polarized light. Note spherical fly ash pozzolan particles.<br/> <b>MAG:</b> 100X</p> |

**Figure 32. Examination under plane polarized light for structure F-20-BU**

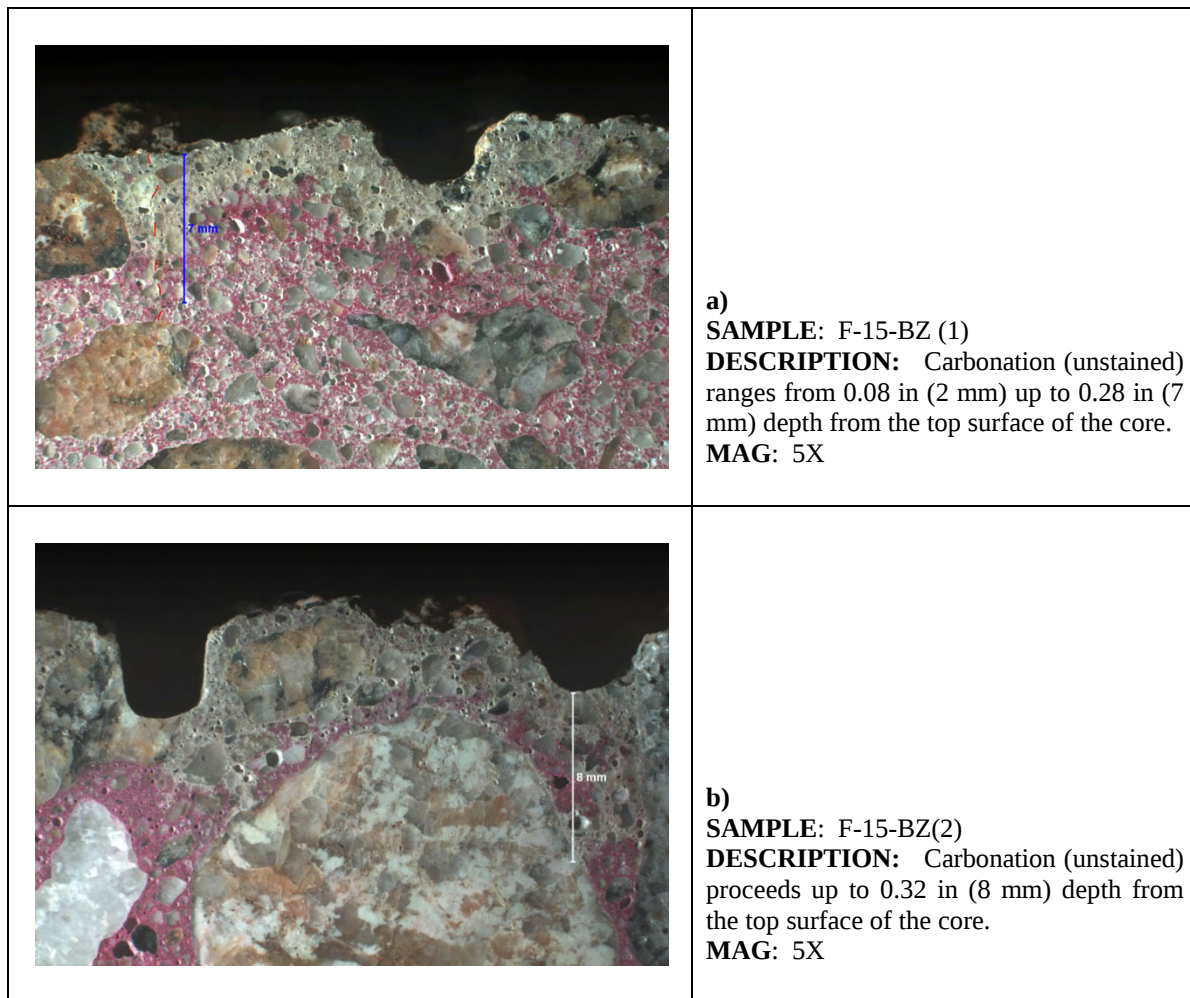
**Figure 33. Magnified images of structure F-15-BZ under petrographic examination**

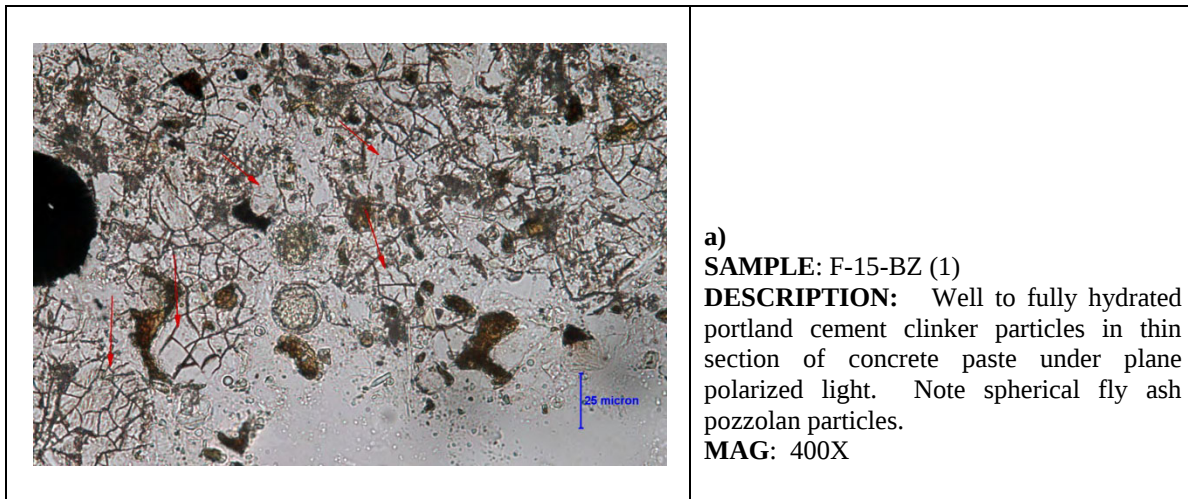
Coarse aggregate was ¾-in (19 mm) maximum sized crushed natural granite rich gravel, with small amounts of basalt, sandstone, and quartzite. The w/c ratio was estimated to be between 0.42 and 0.47, and the alites and belites were mostly fully hydrated (see Figure 34).

**Figure 34. Examination under plane polarized light for structure F-15-BZ**

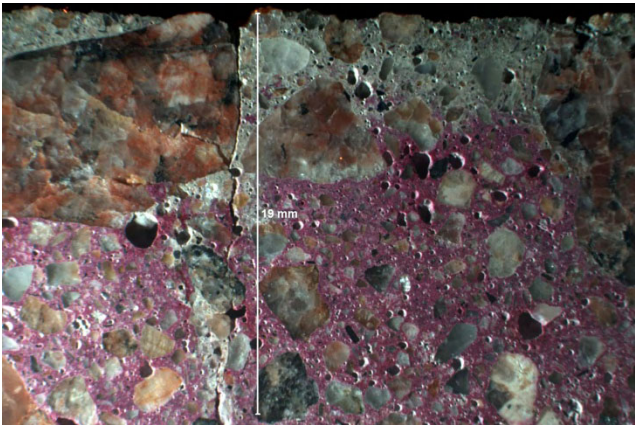
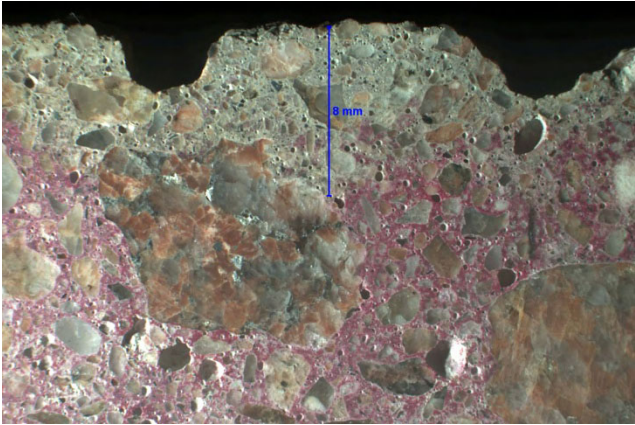
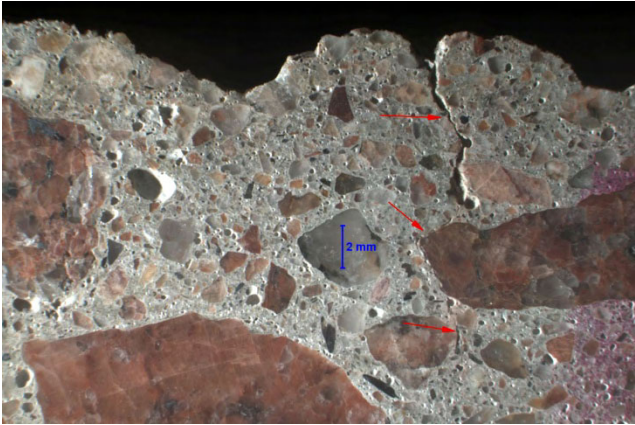
| | <p>a)</p> <p><b>SAMPLE:</b> G-22-BY, N</p> <p><b>DESCRIPTION:</b> Carbonation (unstained) proceeds up to 0.75 in (19 mm) depth, intermittently from the top surface of the core, along sub-vertical microcracking.</p> <p><b>MAG:</b> 5X</p> |
| | <p>b)</p> <p><b>SAMPLE:</b> G-22-BY, S</p> <p><b>DESCRIPTION:</b> Carbonation (unstained) proceeds up to 0.32 in (8 mm) depth from the top surface of the core</p> <p><b>MAG:</b> 5X</p> |
| | <p>c)</p> <p><b>SAMPLE:</b> G-22-BY, S</p> <p><b>DESCRIPTION:</b> Plastic shrinkage macrocrack proceeds intermittently from the top surface of the core.</p> <p><b>MAG:</b> 5X</p> |

**Figure 35. Magnified images of structure G-22-BY under petrographic examination**

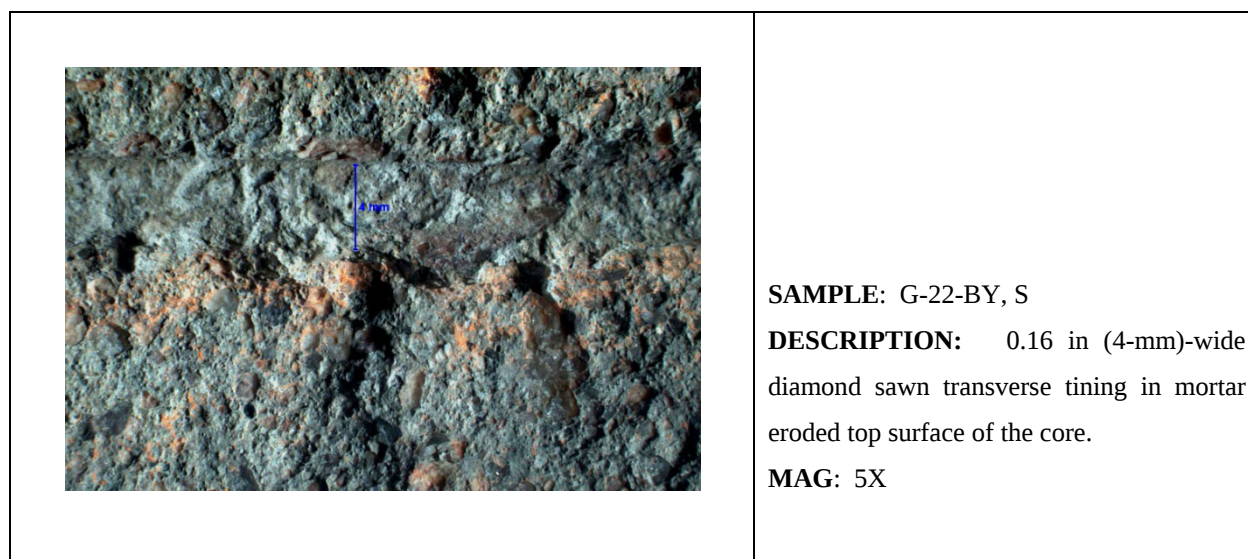
**Figure 36. Transverse tining visible in the magnified image for structure G-22-BY**

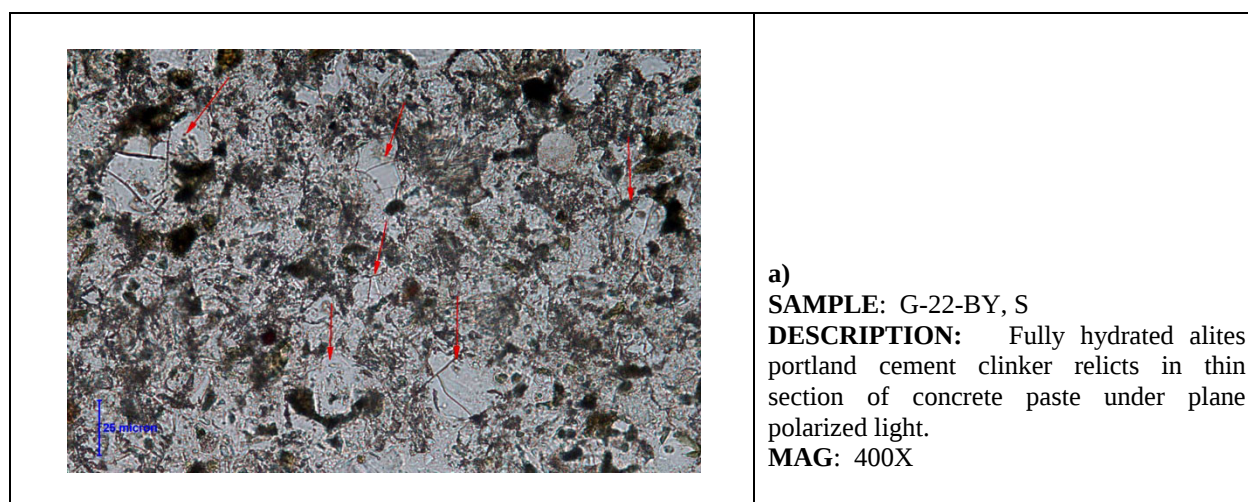
Coarse aggregate was ¾-in (19 mm) maximum sized crushed granite with well graded and uniform distribution. The w/c ratio was estimated to be between 0.39 and 0.44, and the alites and belites were mostly fully hydrated (see Figure 37).

**Figure 37. Examination under plane polarized light for structure G-22-BY**

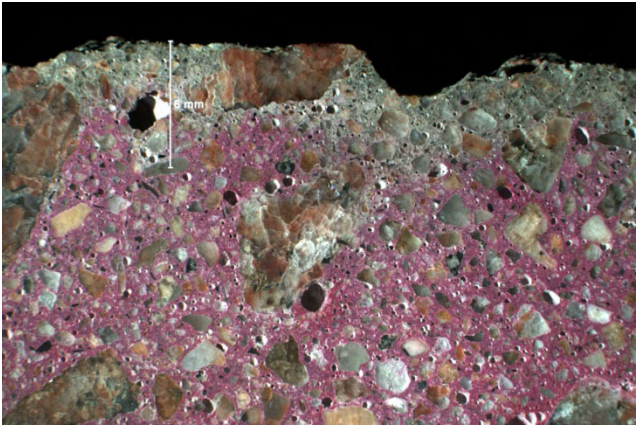
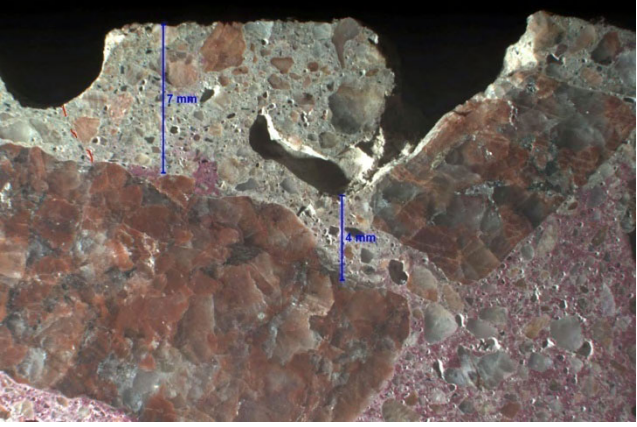
| | <p><b>a)</b><br/><b>SAMPLE:</b> G-22-BZ, N<br/><b>DESCRIPTION:</b> Carbonation (unstained) proceeds up to 0.24 in (6 mm) depth from the top surface of the core.<br/><b>MAG:</b> 5X</p> |
| | <p><b>b)</b><br/><b>SAMPLE:</b> G-22-BZ, S<br/><b>DESCRIPTION:</b> Carbonation (unstained) proceeds up to 0.28 in (7 mm) from the mortar eroded top surface of the core. Note additional carbonation depth along consolidation void space.<br/><b>MAG:</b> 5X</p> |

**Figure 38. Magnified images of structure G-22-BZ under petrographic examination**

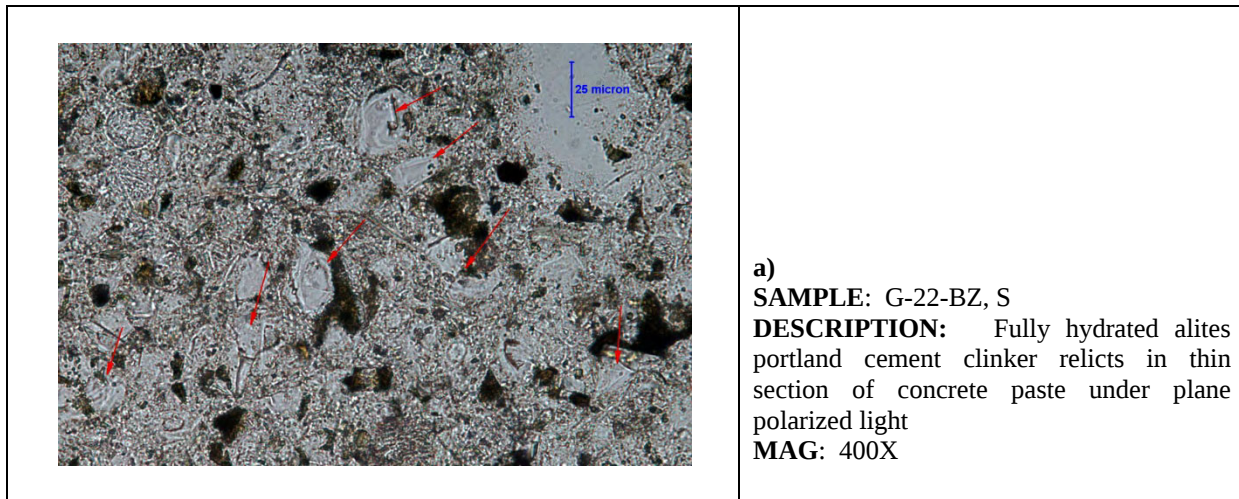
Coarse aggregate was ¾-in (19 mm) maximum sized crushed granite with well graded and uniform distribution. The w/c ratio was estimated to be between 0.39 and 0.45, and the alites and belites were generally well to fully hydrated (see Figure 39).

**Figure 39. Examination under plane polarized light for structure G-22-BZ**
