The Columbus Metropolitan Freeway Management System (CMFMS) Effectiveness Study: Part 2 - The After Study

for the
Ohio Department of Transportation
Office of Research and Development

August, 2006

1. Report No. FHWA/OH-2006/19		2. Government Accession No.		3. Recipient's Catalog No.	
4. Title and subtitle The Columbus Metropolitan Freeway Management System (CMFMS) Effectiveness Study: Part 2 - The After Study				5. Report Date August 2006

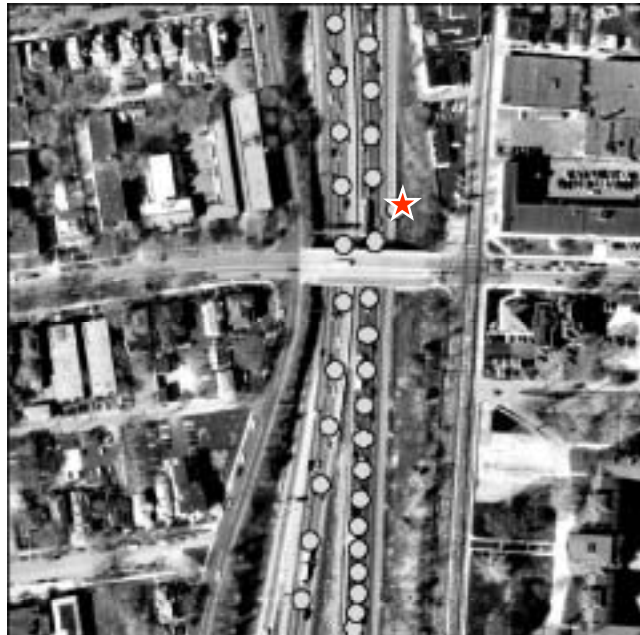
Figure 5, GPS position error from travel run data, highlighted with a star.

Since GPS data quality depends on visibility of satellites by a GPS receiver, GPS position errors cannot be avoided. Structures, terrain and even dense foliage can block signal reception or cause multipath interference, resulting in position errors or possibly no position reading at all. Figure 5 shows the GPS position measurements for one round trip, superimposed on an aerial photo of the region. The point highlighted with a star in the figure shows an example of a position error due to an overpass interfering with signal reception. Fortunately, most GPS errors are local in nature, and they do not accumulate from one measurement to the next.

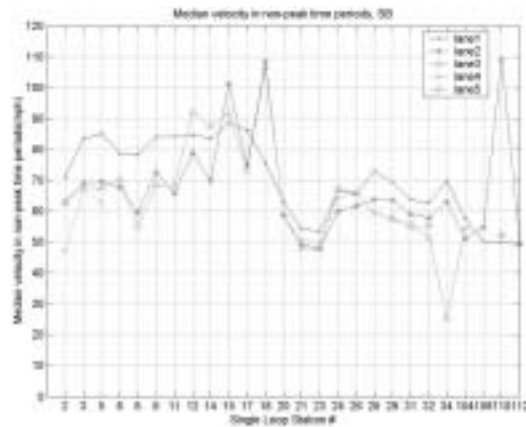
Figure 14, Median speeds in non-peak time periods at single loop detectors A) Northbound direction, B) Southbound direction.

In most cases the discrepancies arise due to variations in detector sensitivity, though some of the lower readings appear to be due to systematic variations in the vehicle fleet (more long vehicles in the particular lane). To correct these speed estimation errors at single loop detectors we calculate a multiplicative correction factor individually for each loop, as follows. First, the daily median speed is taken from speed in off-peak time periods (9a am-3 pm), and this process is repeated for all weekdays in a month. Next, the median of the daily speeds is found, e.g., Figure 14. The correction factor is then defined as the posted speed limit divided by this daily median speed. For example, in this study, the median speed in lane 2 at station 26 northbound is 81mph (130 km/h), so the correction factor is 0.8 (the quotient of 65 mph and 81 mph). Naturally one could use a radar gun or other measurement device to validate the speeds more accurately, which is exactly what we do with the probe vehicle data. To verify the process of generating correction factors is valid, the corrected single loop speeds are compared against the corresponding GPS velocity measurements from the probe vehicle runs. Figure 15 shows a scatter plot of loop speed as the probe vehicle passed versus GPS velocity in lane 2 at station 26 northbound (recall that the GPS probe vehicle runs in lane 2). Without the correction factor the loop speeds exhibit a systematic bias, with almost all estimates being too high (Figure 15A), while this bias is removed
