**Precast Concrete Deck Panel  
Performance On Long Span, High Traffic  
Volume Bridges**

**Final Report**

Report No. FHWA-NH-RD-13733D

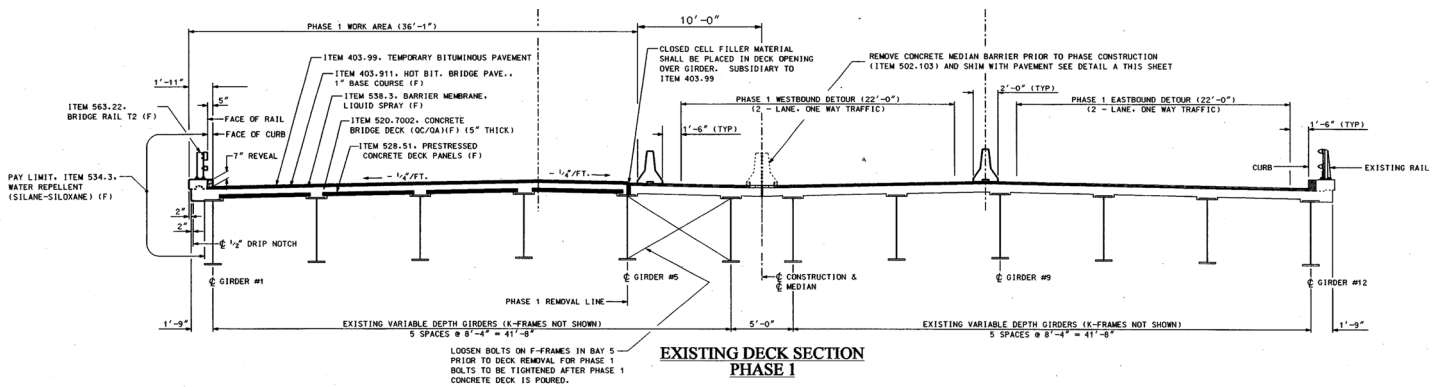
**Figure 2 – Construction Phase 1**

(Left side labeled “Phase 1 Work Area” is location where Phase 1 and Phase 2 cores were taken and where traffic was routed during construction of the remainder of the bridge deck.)

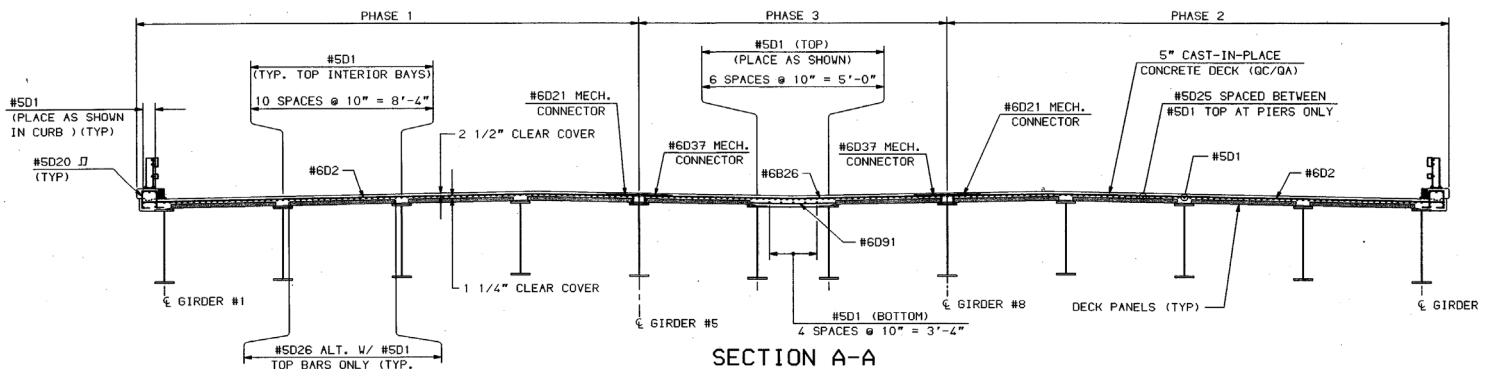
**Figure 3 – New Composite Deck Section**

The deck replacement was completed using 3.5-inch thick prestressed precast deck panels with a 5-inch reinforced concrete overpour (See Figure 3). The new deck design live load was HS-25 and the 1996 AASHTO Standard Specifications with interims were used for design. The corresponding maximum LL+I deflection is 2.6 inches. Shear studs were added to the negative moment regions. The total amount of top mat reinforcement used at pier locations was #5’s at 5”. The amount added to address AASHTO Section 10.38.4.3 equaled 2/3 of the total amount required. The additional bottom mat reinforcement required by the code was not added to the top mat.

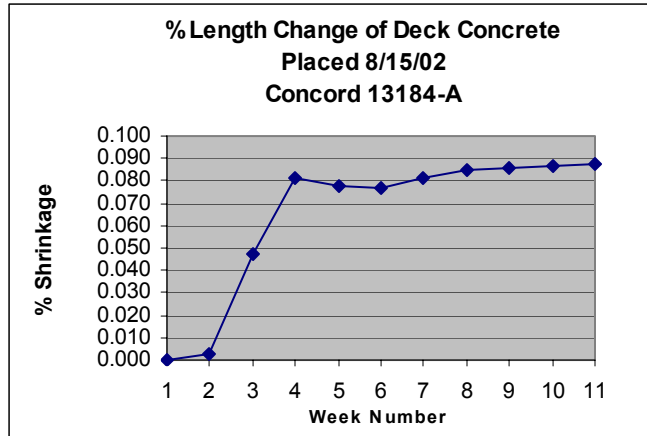
**Table 2 –Average Length Change vs. Time**

The prisms were removed from moist storage seven days after fabrication. The length change was measured and recorded following the same procedure as described previously. Following length measurements, the beams were placed into air storage in a regulated drying chamber. The drying chamber was programmed to maintain 50% relative humidity and a temperature of 23°C. Length change of the beams was checked once a week (Fridays at 9:00 a.m.), for a period of ten weeks. At the end of the 10 weeks, the prisms had an average length change of 0.087% shrinkage from their initial length. Table 2 shows the average change in length over time. A narrative of the shrinkage monitoring can be found in Appendix B to this report.

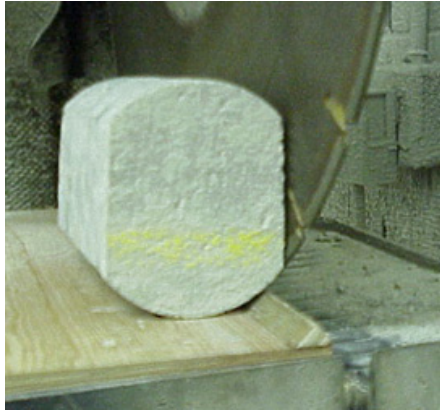
**Figure A-1 - Trimming a core to fit**

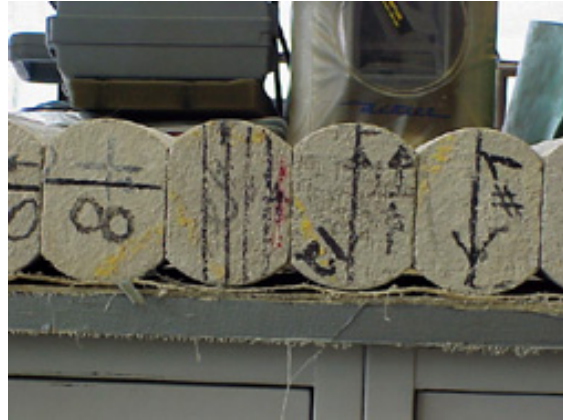
**Figure A-2 - Trimmed deck cores ready for testing**

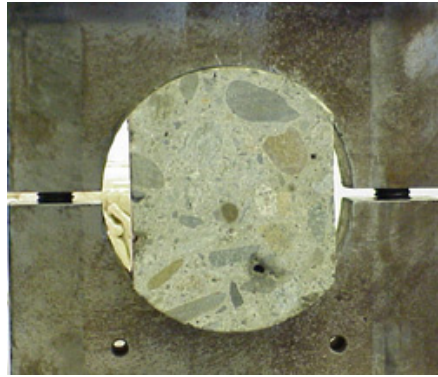
**Figure A-3 - Trimmed core now fits into shear device**

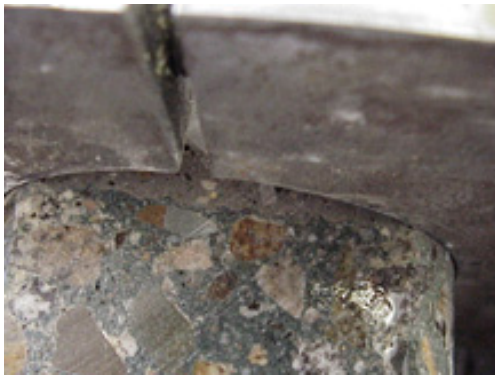
**Figure A-4 - Lining up interface in device**

After trimming, the cores were clamped into the shear device so that the overpour/panel interface was between the two plates sliding past each other, forcing the failure to occur at the interface of the two layers (Figs. A-4-7). The cores were loaded at the rate of approximately 10 lbs/sec until failure (Fig. A-11). The average test results were 275 psi in the parallel direction and 125 psi in the perpendicular direction.

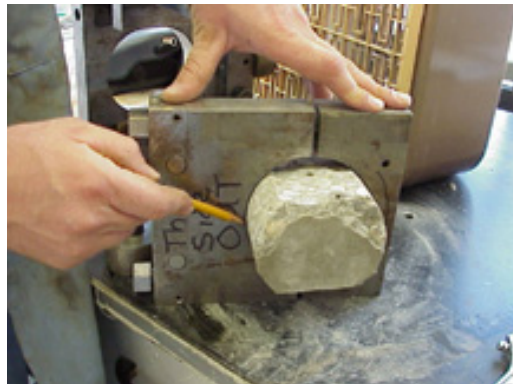
**Figure A-5 - Core is marked for orientation**

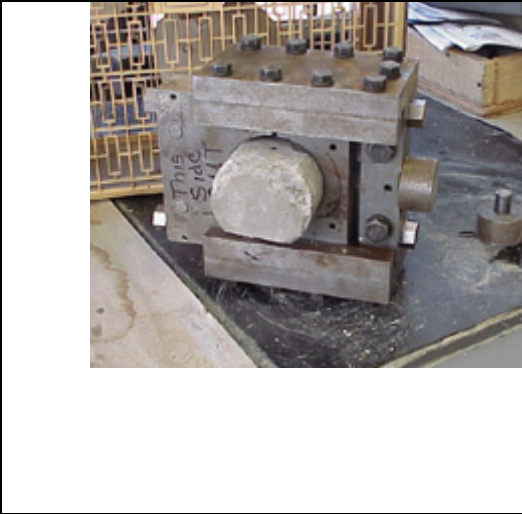
**Figure A-6-Core and shear device are assembled**

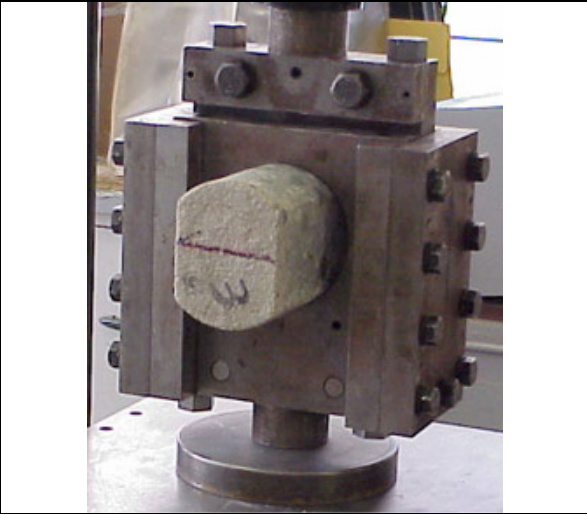
**Figure A-7 - Core loaded in compression machine**

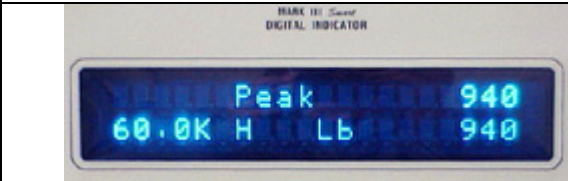
**Figure A-8 - Typical display while loading**

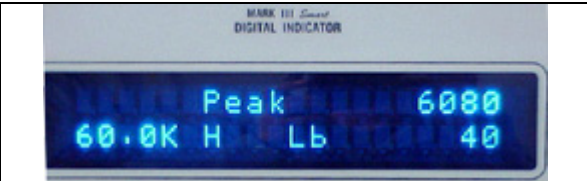
**Figure A-9 - Typical display at failure**

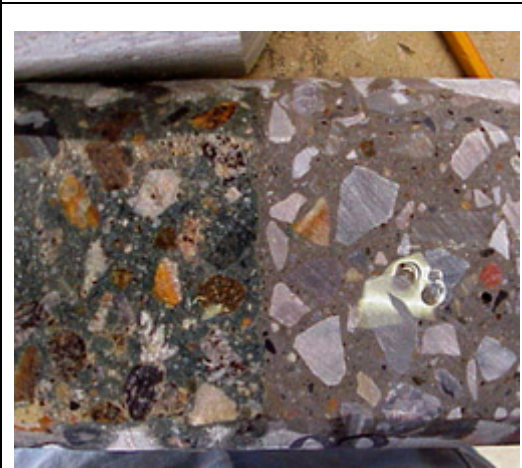
**Figure A-10 - Overpour on left, PCP on right prior to failure**

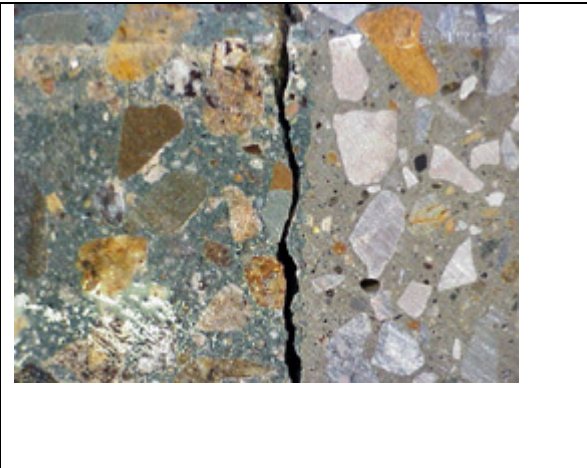
**Figure A-11 - Same core after testing, failure at interface**

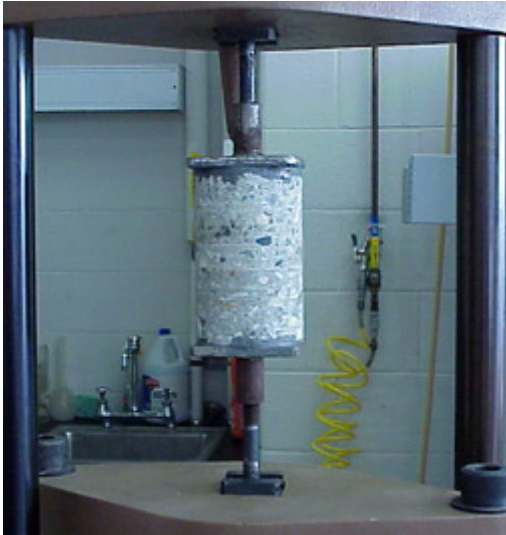
**Figure C-1 – Core loaded for testing**

The prepared cores were placed into the testing machine (Fig. C-1) and loaded at a constant rate of approximately 10 lbs/sec until failure. In all cases the failure occurred at the interface of the precast panel and the overpour. The area was calculated based on the average diameter of the cores. The average tensile strength of the three cores tested by this method was 190 psi.

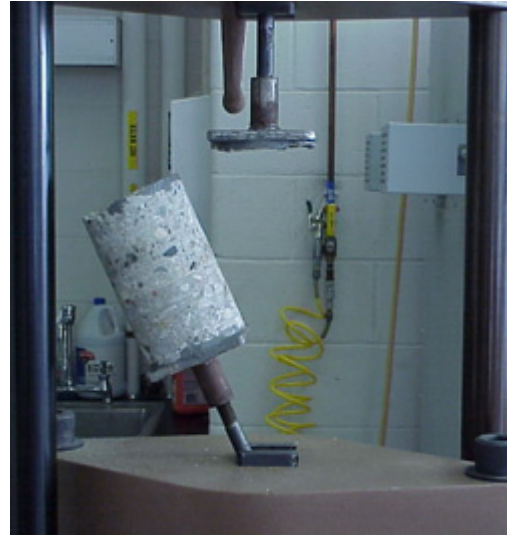
**Figure C-2 – Core after failure in overpour**

Core Nos. CC-17 through CC-19 were tested for tensile strength. Testing was performed following the same procedures previously used. Core CC-17 failed in the over pour concrete instead of at the interface (Fig. C-2). This failure occurred close to the testing plate, but was clearly a failure in the concrete not in the epoxy. The strength recorded at the time of failure was 269 psi, slightly lower than on 9/17/02. The core was trimmed again and the epoxy was reapplied to the plate. Core CC-17 will be retested on 9/18/02, following curing of the epoxy. The surface area of the cores was obtained and the strength was calculated by dividing the total load by the surface area. The average strength for these cores was 199 psi (not including the result from CC-17). Compared with 190 psi as reported on 8/27/02, this result represents little change in strength with approximately two weeks of additional age.

Core Nos. DC-1, DC-4, DC-9 and DC-11 were retested today for tensile strength. No problems were encountered with the epoxy. DC-1 and DC-11 failed in the overpour concrete, close to the testing plate (See Figs. C-2,3). DC-4 and DC-9 failed at the interface between the precast panel and the overpour concrete. Following testing, one set of testing plates was prepared for reuse on core CC-17 (that has twice failed in the overpour concrete). The conventional method of cleaning (scraping with a chisel) was ineffective in removing the epoxy from the plates. The plates were then submerged in trichlorethylene for the weekend, to break down the epoxy.

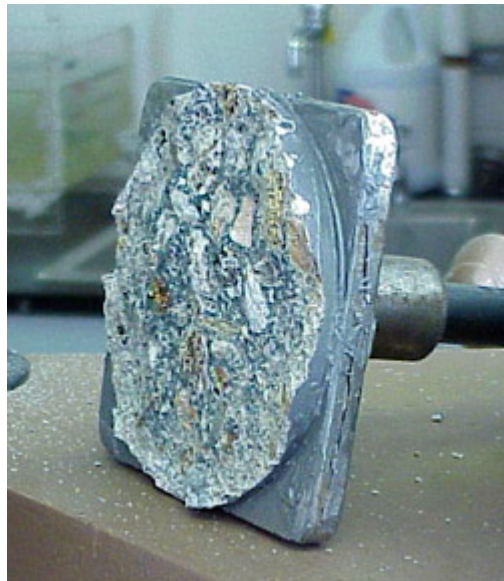
**Figure C-3 – Showing panel/overpour bond is stronger than the overpour**

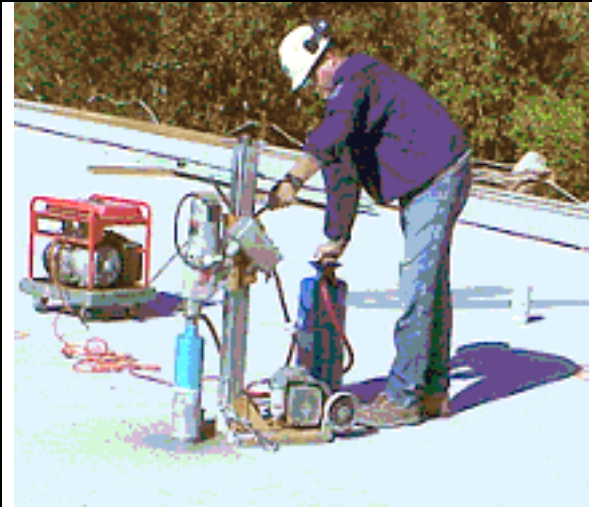
**Figure D-1 – Advancing core bit through deck**

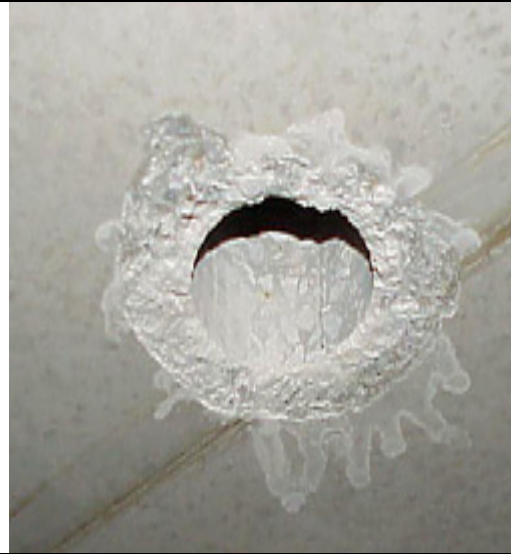
**Figure D-2 – Core location as seen from underneath**

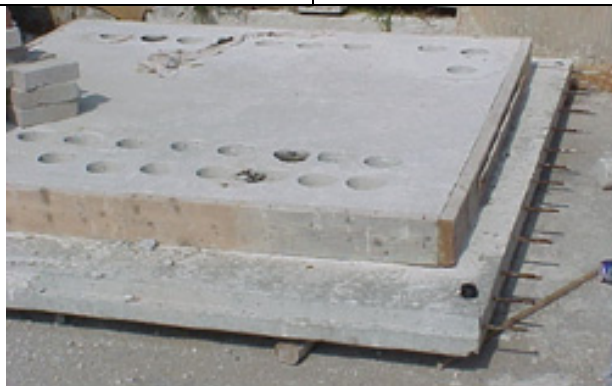
**Figure D-3 – Control Slab with core holes**
