# Real-Time River Channel-Bed Monitoring at the Chariton and Mississippi Rivers in Missouri 2007–09

## **IBRD Sonar Scour Monitoring Project: Real-Time River Channel-Bed Monitoring at the Chariton and Mississippi Rivers in Missouri, 2007-09**

Prepared for  
Missouri Department of Transportation  
Organizational Results

by  
Paul H. Rydlund, Jr.  
USGS

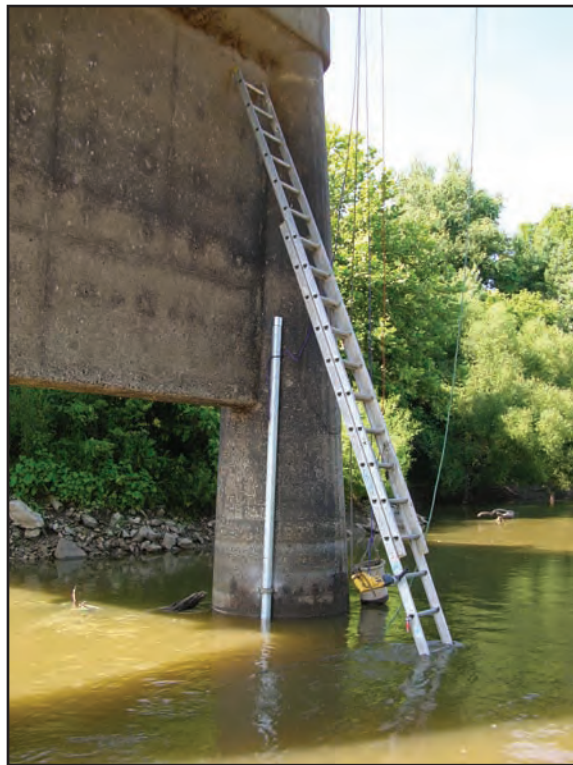
Installation of 3-inch galvanized steel pipe encasing the transducer head and shielded cable on the downstream side of the upstream conical column of pier 4.

as conduit to protect the transducer head and shielded cable at the lower portion of the pier (fig. 4).

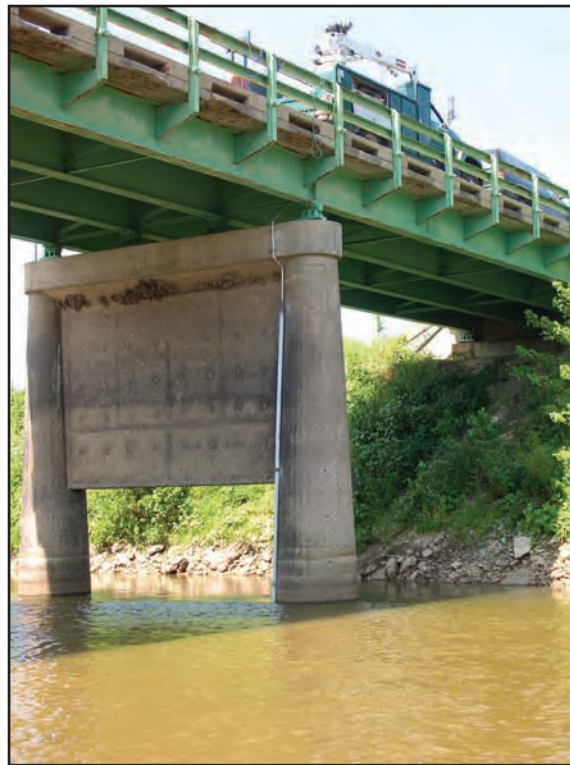
Installation of 1-inch to 3-inch galvanized steel pipe encasing the transducer head and shielded cable on the downstream side of the upstream conical column of pier 4 and between girders.
