Report No. UT-08.24

EVALUATING SHALLOW-FLOW ROCK STRUCTURES AS SCOUR COUNTERMEASURES AT BRIDGES

Utah Department of Transportation
Research Division

Brigham Young University
Department of Civil & Environmental
Engineering

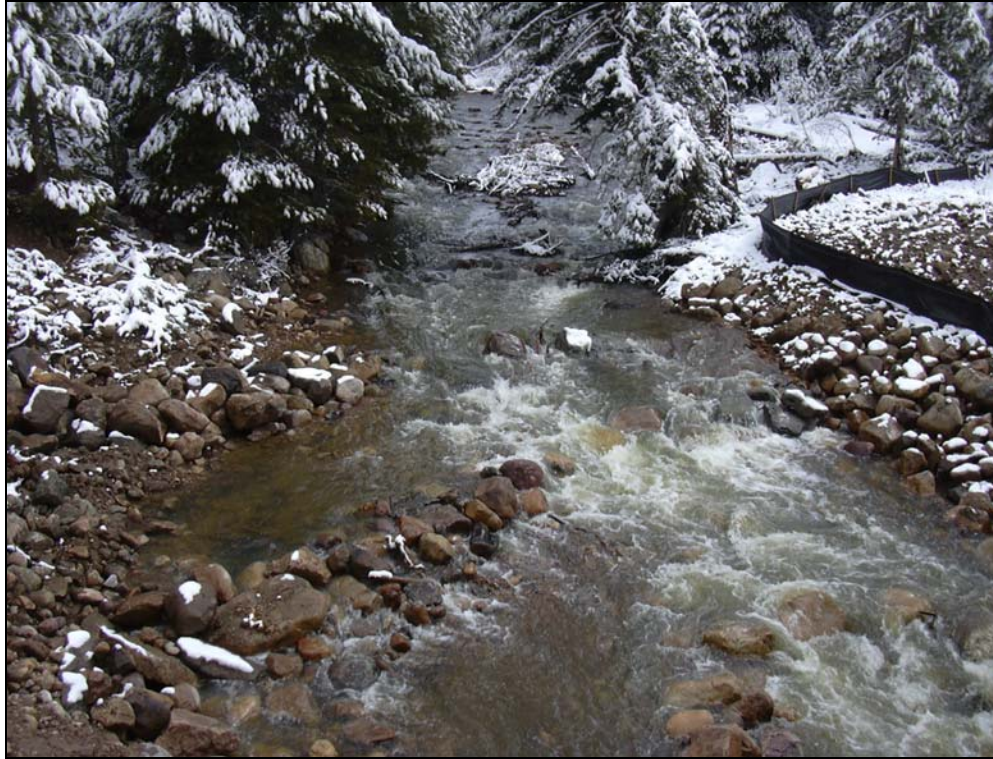
Figure 2-1. Drop Structure on the North Fork of the Provo River.

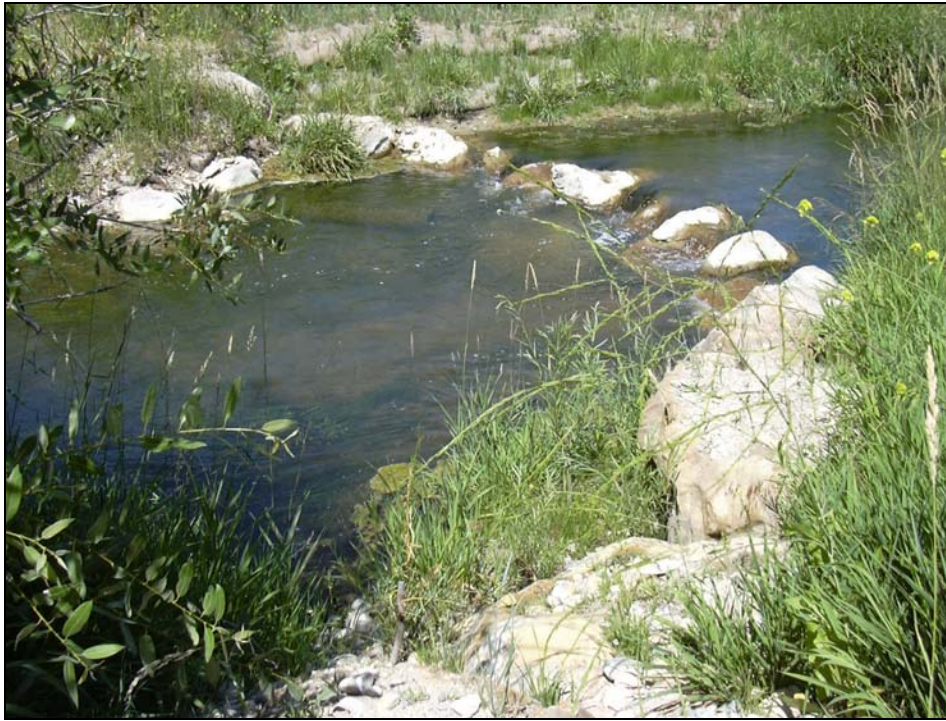
Figure 2-2. Porous Weir on the San Pitch River.

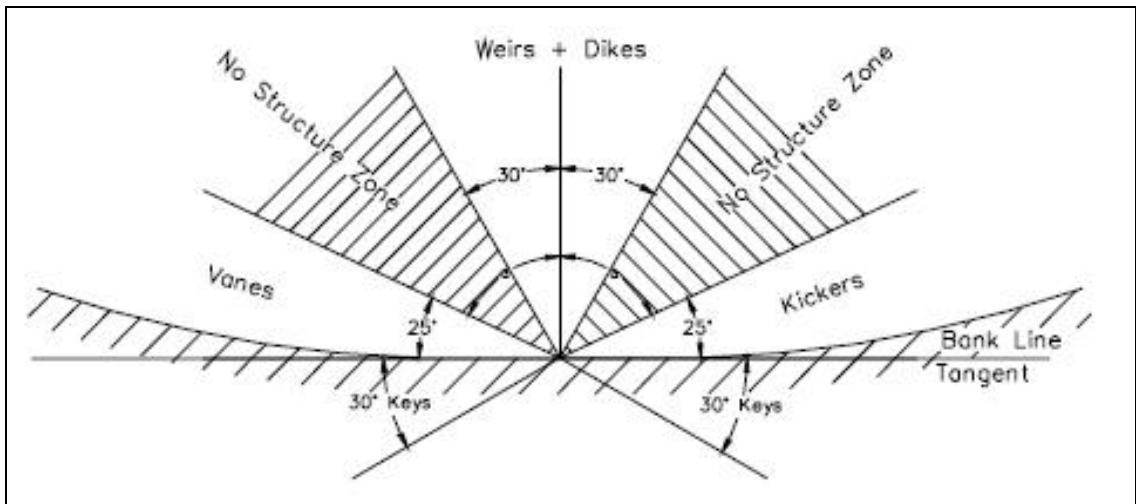
There are two variations with respect to bendway weirs and vanes. The variations of bendway weirs (barbs) and vanes can best be described using Figure 2-3 from *Stream Investigation, Stabilization and Restoration (SISR)* (Freeman 2005¹).

Figure 2-3. Bendway Weir and Vane Variations.

Variations of bendway weirs relate to the orientation of the structures with respect to the streambank. Bendway weir (barb) placement ranges from perpendicular to the bank or up- and downstream 30° from perpendicular. Vane orientation is always upstream as shown in Figure 2-3. Kickers are the mirror reflection of a vane from perpendicular as shown in Figure 2-3. See Figure 2-4 and Figure 2-5 for illustrations of a bendway weir and vane, respectively. Vane theory and design methodologies are found in *Stream Investigation, Stabilization and Restoration* (SISR) (Freeman 2005^{1,2}) and Johnson et al. (2001).

Vanes are oriented upstream 20° to 30° from the bank whereas bendway weirs are perpendicular to the bank give or take 30° (see Figure 2-3). Vanes, for the purposes of this study, have separate design criteria from bendway weirs, but by definition are the same. See the definition for bendway weir and Figure 2-9 for vane weir theory. (Freeman 2005¹). Further, Johnson et al. (2001) described the similarities between vanes and bendway weirs, “bendway weirs are low elevation stone sills similar to vane structures.”

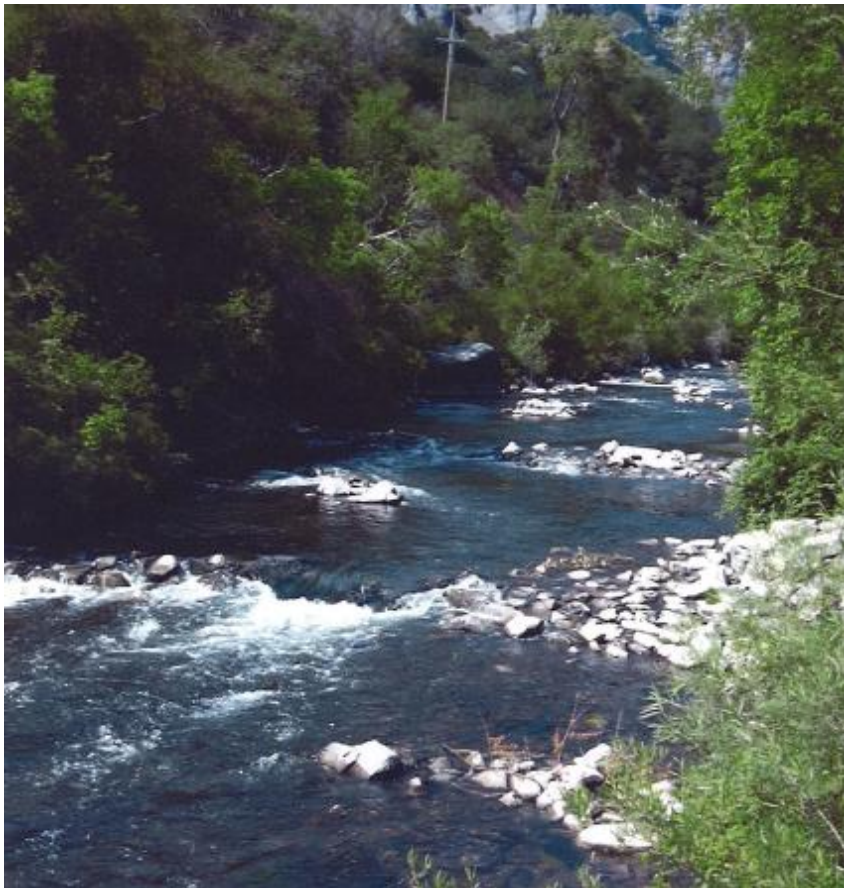
Figure 2-4. Bendway Weirs on the Provo River.

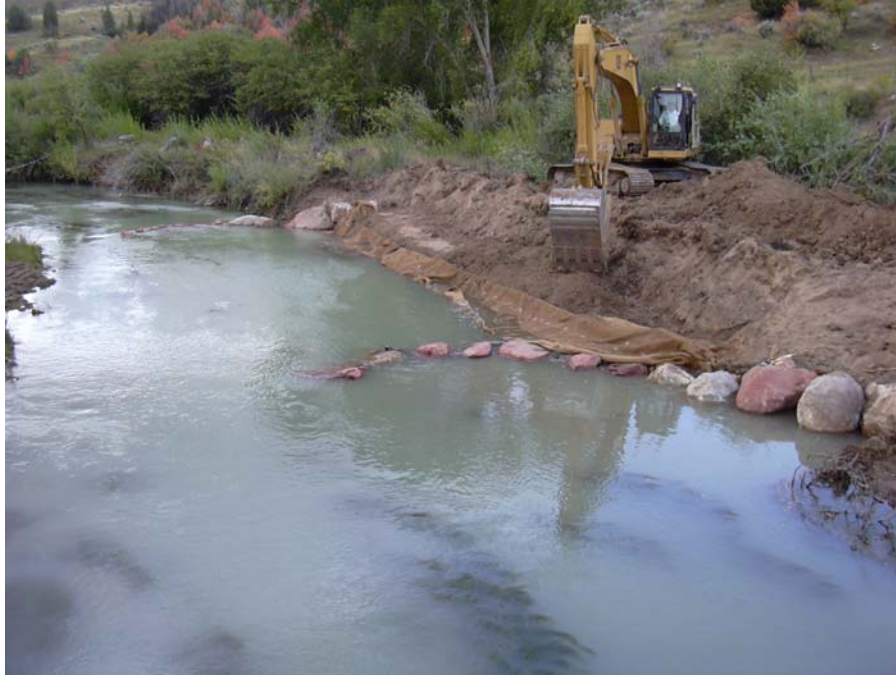
Figure 2-7. J-Hook Vane on the Spanish Fork River.

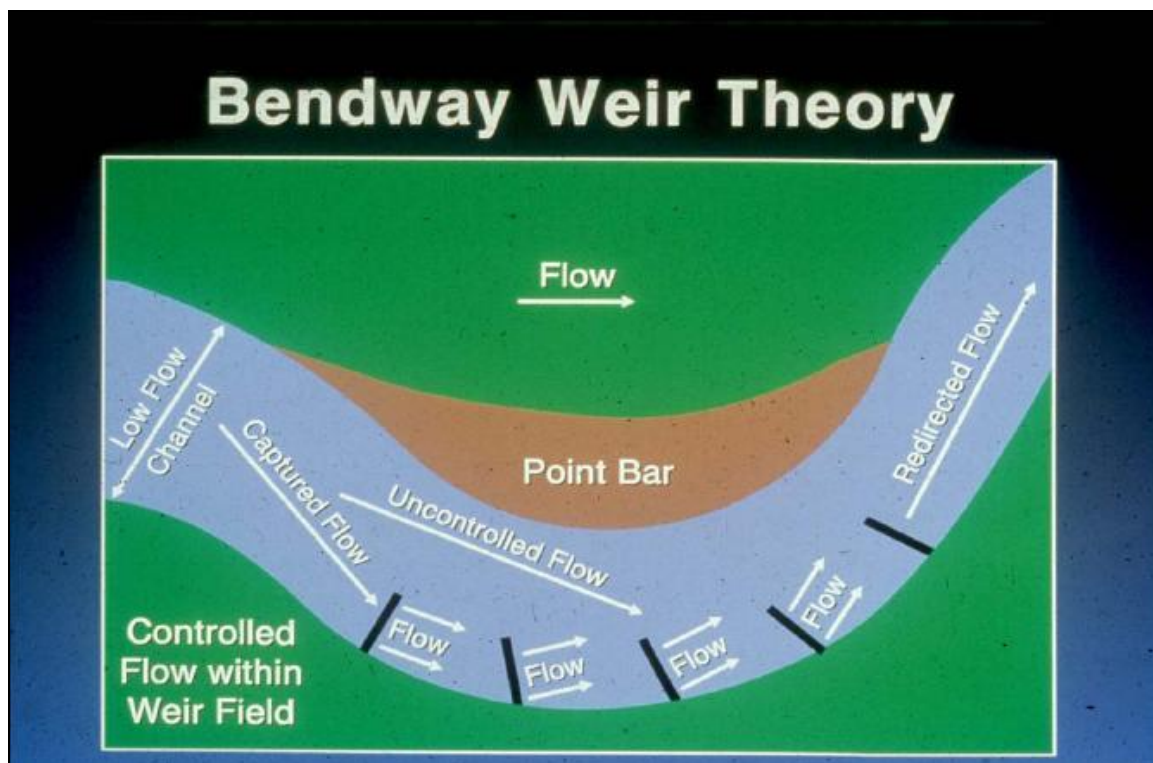
As water passes over a bendway weir, it is redirected downstream perpendicular to the structure as illustrated in Figure 2-8. (Freeman 2005²).

Figure 2-8. Bendway Weir Theory.

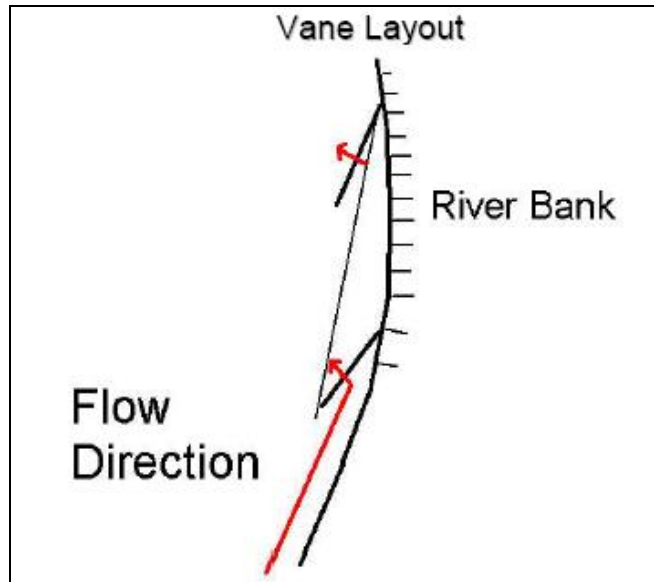
Figure 2-9. Vane Weir Theory.

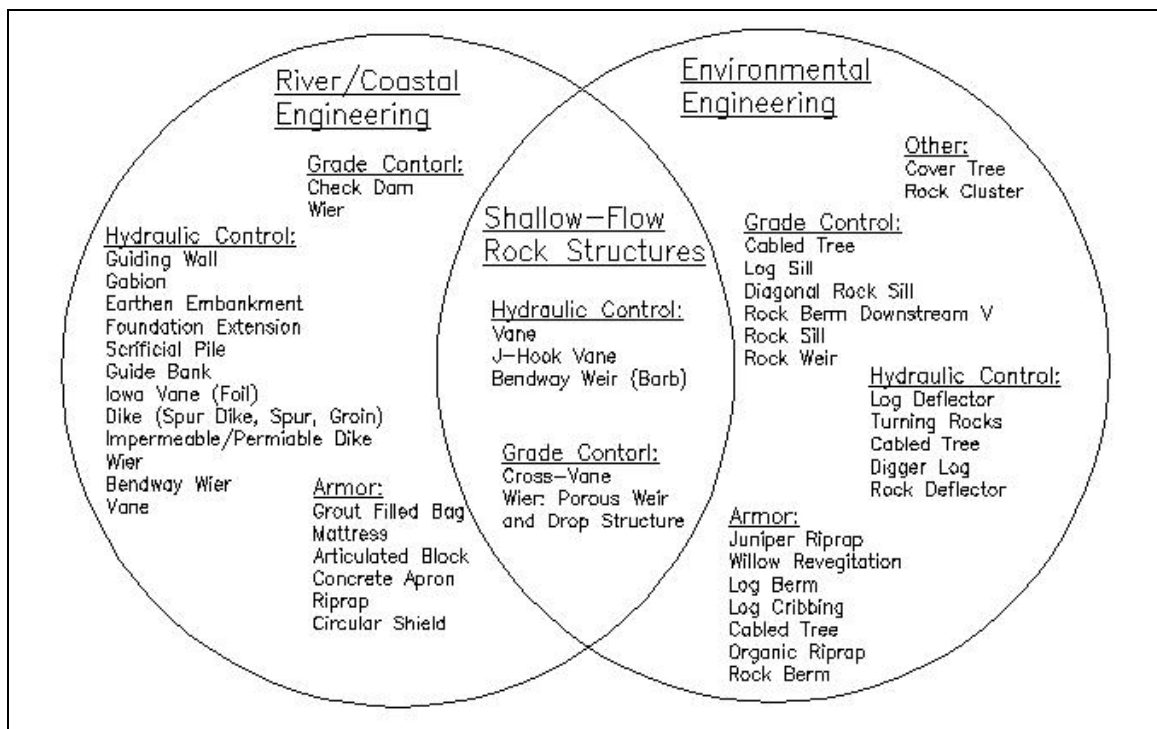
Figure 2-10. Shallow-Flow Structures and River and Environmental Engineering Structures.

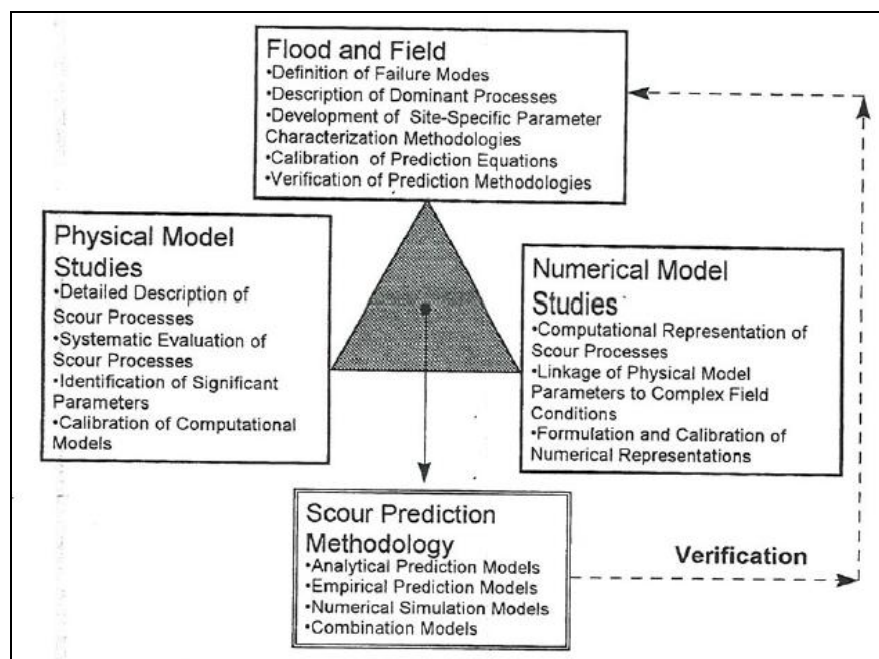
Figure 2-11. Balanced Research Approach Model.

Failure modes are a key component of a balanced research approach (see Figure 2-11) for evaluating scour. Johnson et al. (2004) describes failure mode analysis:

Siting or “...structure placement relative to natural channel features and fluvial patterns...” may increase the reliability of scour countermeasures (URMCC 1995). Recommended structure siting is given in *Stream Habitat Improvement Evaluation Project* (URMCC 1995) in Table 4.48, *Bridge Scour and Stream Instability Countermeasures – Experience, Selection and Design Guidance* (Lagasse et al. 2001) in Table 2.1, *Using Technical Adaptive Management to Improve Design Guidelines for Urban Instream Structures* (Johnson et al. 2002²) in Tables 1 and 2., and class notes sections five and nine of the *2005 Stream Investigation, Stabilization and Restoration Conference* held in Niagara Falls, Ontario (Freeman 2005^{1,2}). Being familiar with common siting practices will enable more consistent monitoring during flood and field studies. See Figure 2-11 for elements of flood and field studies components.

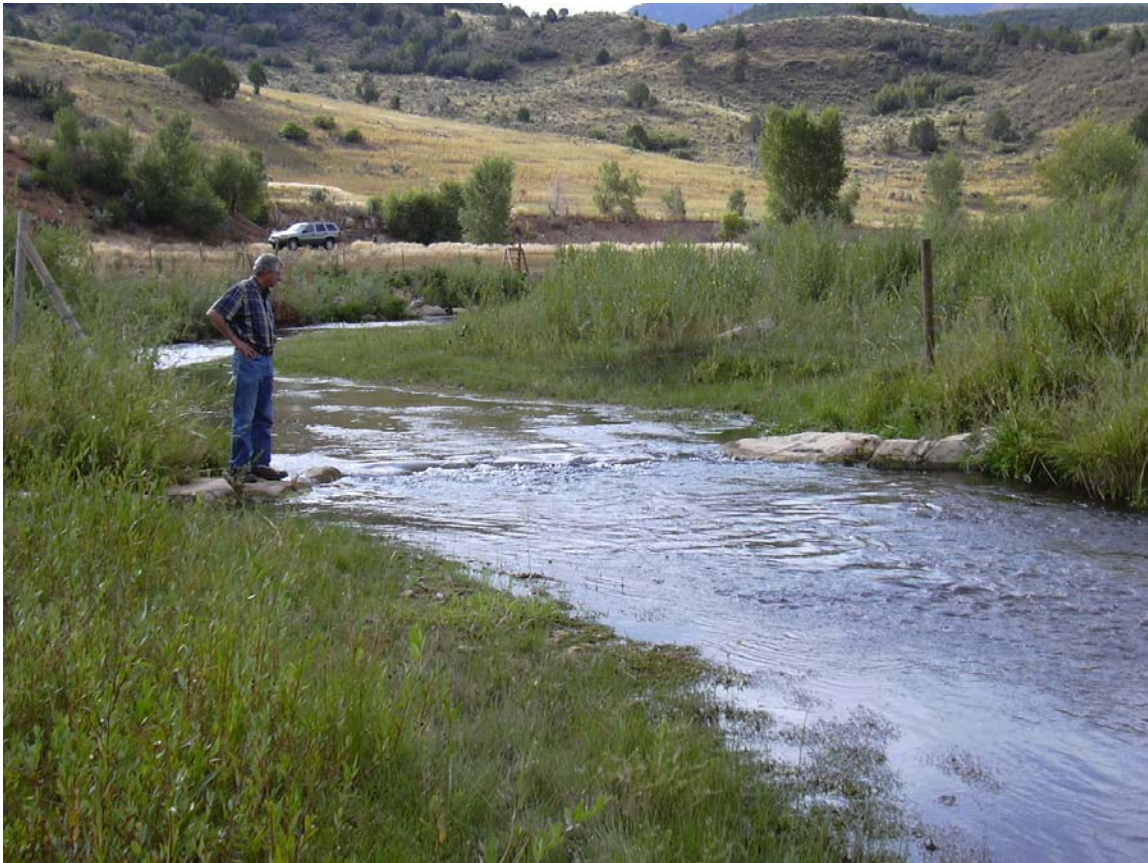
The site chosen for modeling includes many structures including: two cross-vanes, one j-hook and a number of vanes. Figure 3-3 shows the cross-vane modeled. Note the flow approaches the structure mostly on the right side of the channel and moves across the structure. This is reflected in the results of the numerical model.

Figure 3-3. Cross-Vane Structure Observed and Modeled.

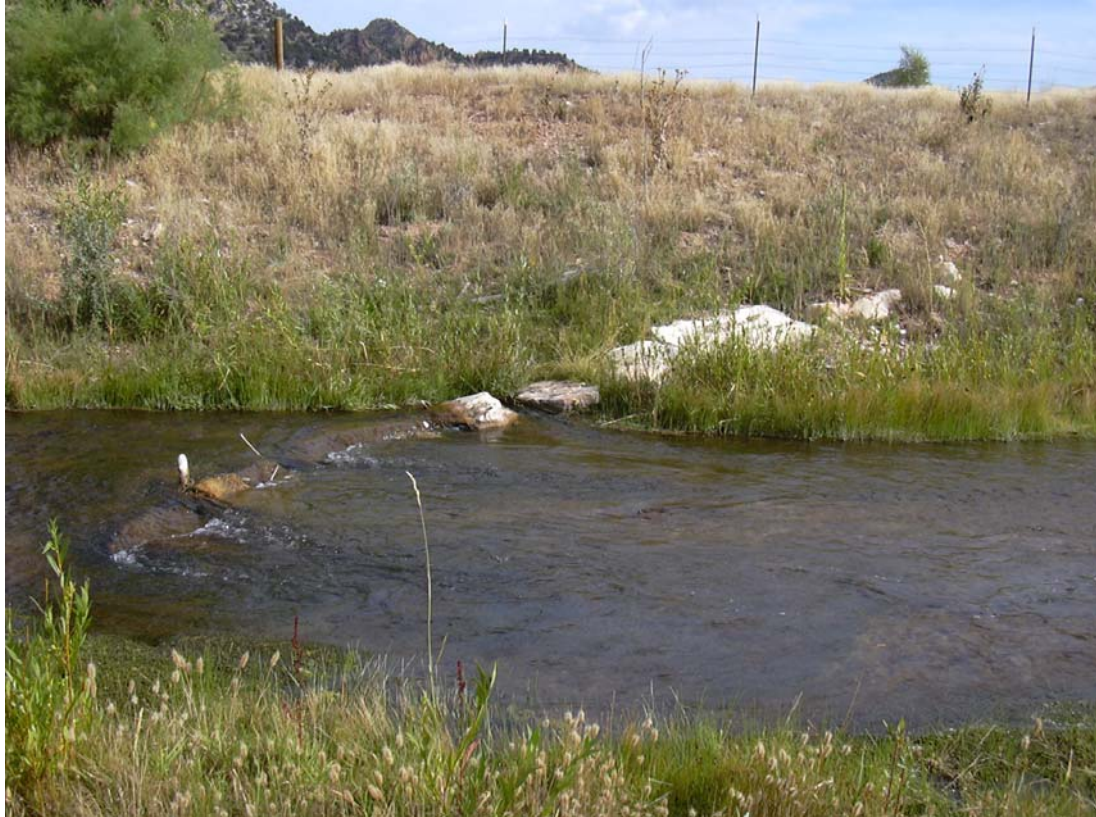
Figure 3-4. J-Hook Structure Observed and Modeled.

Figure 3-4 shows the j-hook structure modeled. Flow is from left to right in the picture. This structure is just downstream around a meander bend from the cross-vane. There is another cross-vane between these two structures on the meander bend. This is part of an ongoing restoration after the mudslide near Thistle, Utah. Also of note in this area is one of four experimental installations (in the study group for this paper) of SFS at bridges. The existing installation is located at Utah County State Park upstream of the Spanish Fork River and Diamond Fork confluence. SFS are installed upstream of a pedestrian-trafficked bridge. Figure 3-5 and Figure 3-6 show the relationship of a j-hook being constructed next to this footbridge.

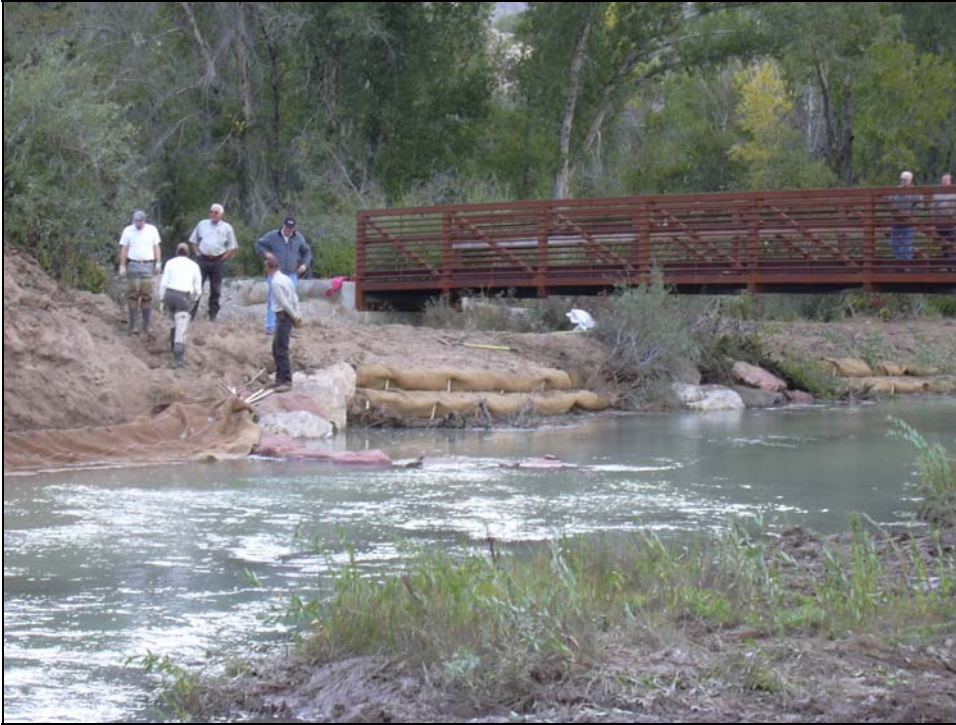
Figure 3-5. View of Construction of Structure Near Footbridge.

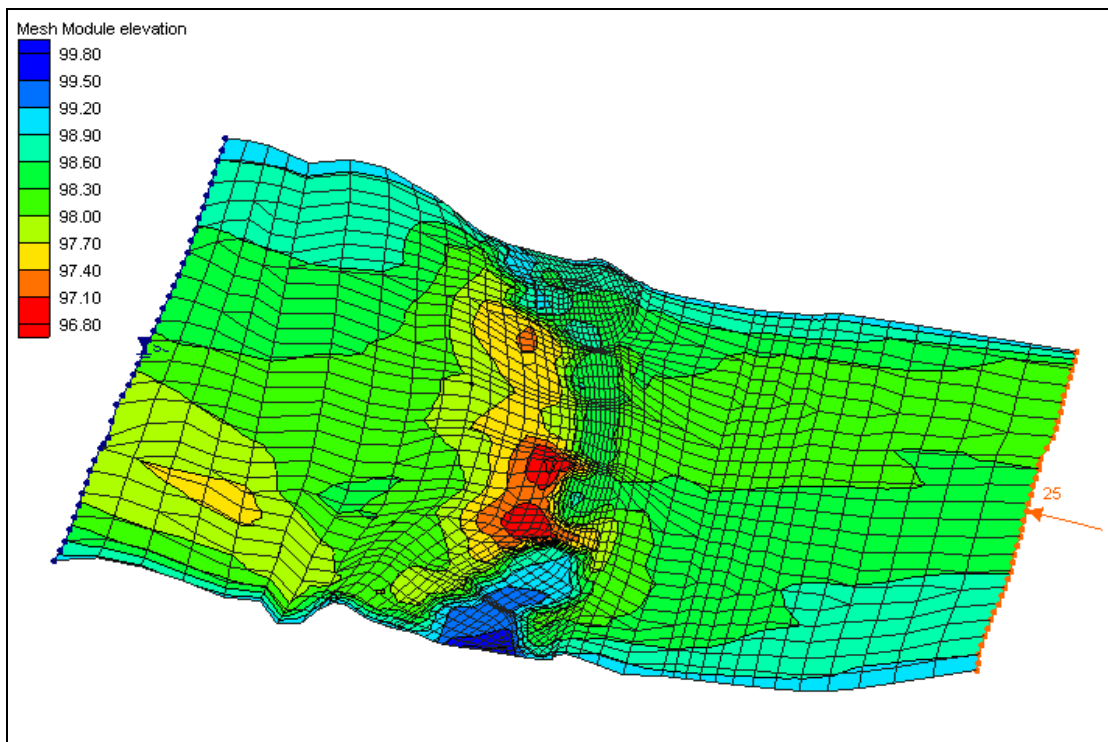
The Thistle Creek site modeled includes two separate finite element meshes. They represent two reaches of the stream that are very close together. The first includes a cross-vane structure and the second includes a j-hook. Figure 3-7 and Figure 3-8 show the meshes constructed around the cross-vane and the j-hook, respectively. The color keys in the upper left-hand corners indicate elevations. The resolution around the structure is very high, defining the elevation of each boulder, the elevation of the chutes between boulders and the pools upstream and downstream of the chutes are also illustrated.

Figure 3-7. Layout of Mesh for the Cross-Vane Model.

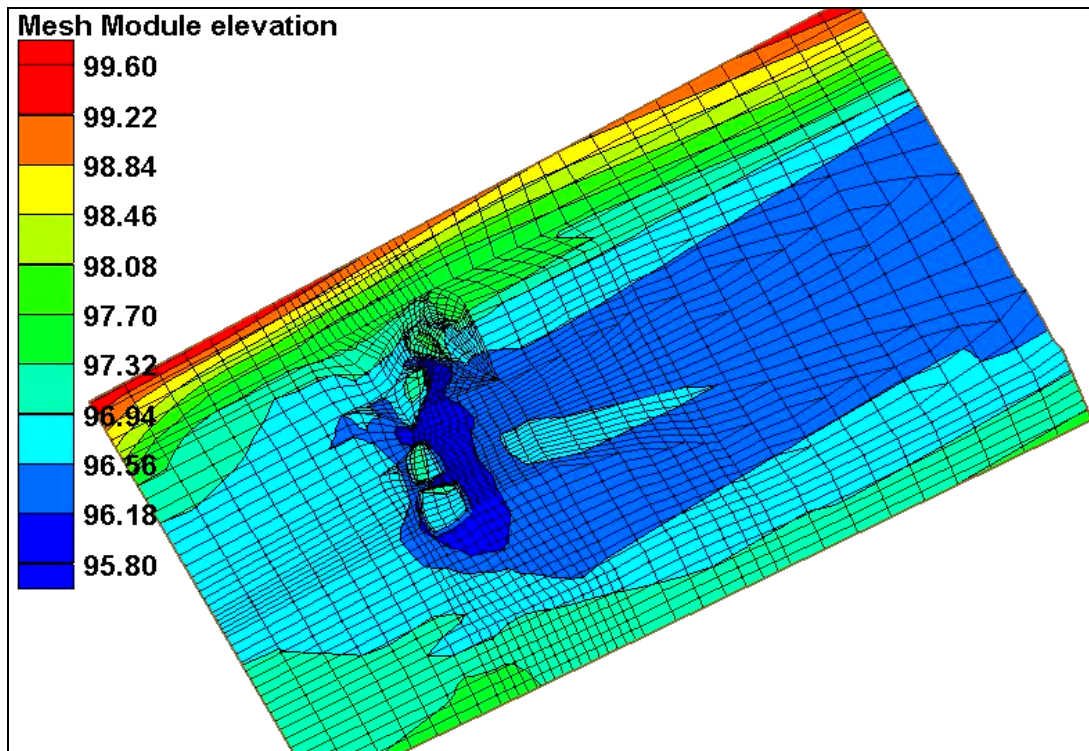
Figure 3-8. Layout of Mesh for the J-Hook Vane Model.

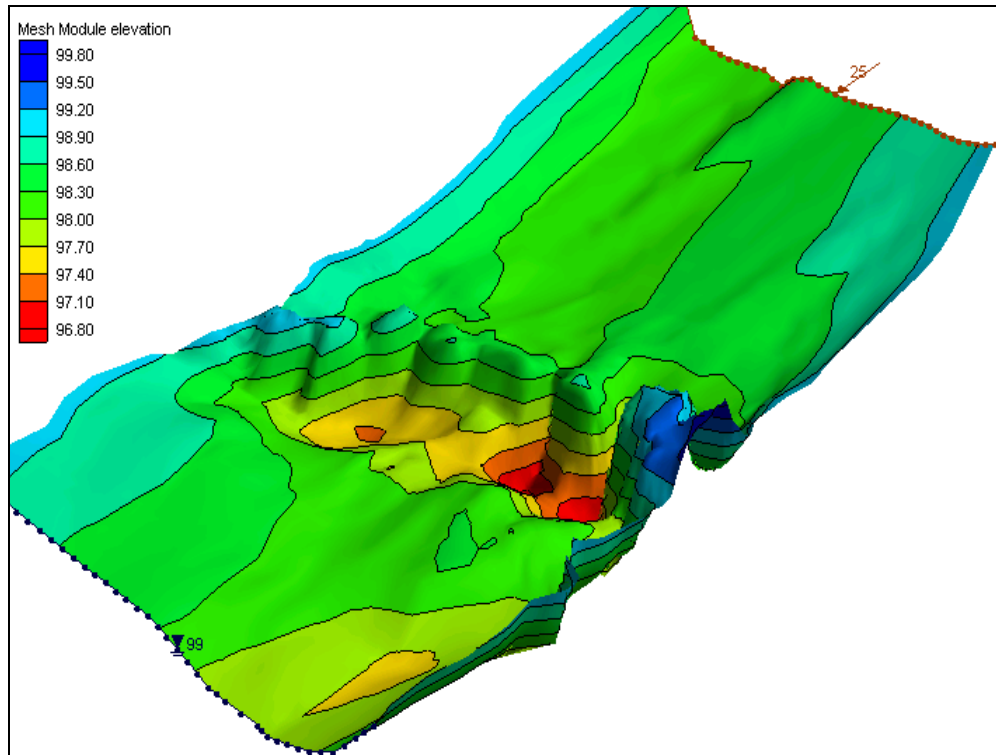
Figure 3-9 and Figure 3-10 show the geometry of the meshes from an oblique view. This view accentuates the scour holes that are developing downstream of the structures. Results shown later in this chapter illustrate additional scour has occurred during the year of phase one monitoring. Also note the scour occurring upstream on the j-hook. Field observations support that failure of SFS occurs not only by downstream scour, but also by an upstream erosion mechanism. The initial elevations came from the survey data that are displayed along with contours of the survey points in Figure 3-11 and Figure 3-12.

Figure 3-9. Oblique View of Geometry of the Cross-Vane Structure.

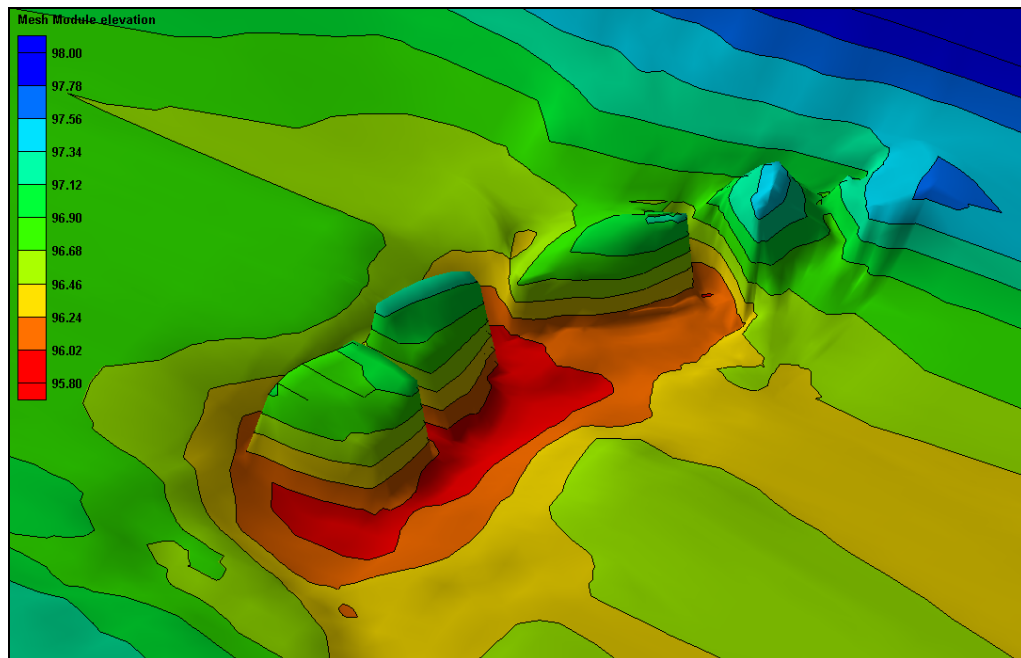
Figure 3-10. Oblique View of Geometry of the J-Hook Structure.

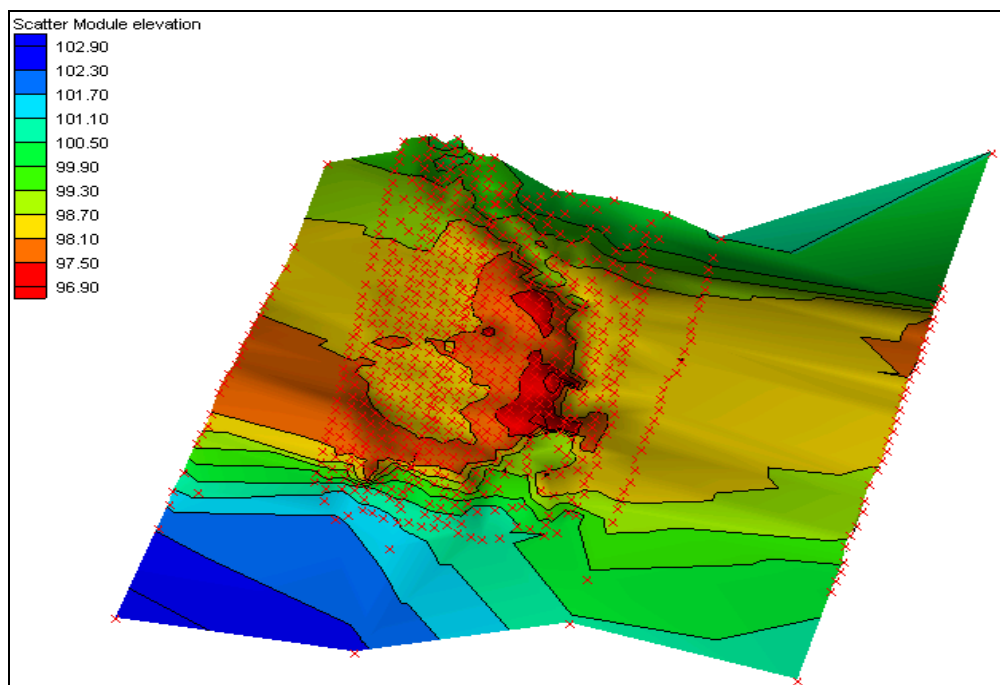
Figure 3-11. Survey Data of Cross-Vane.

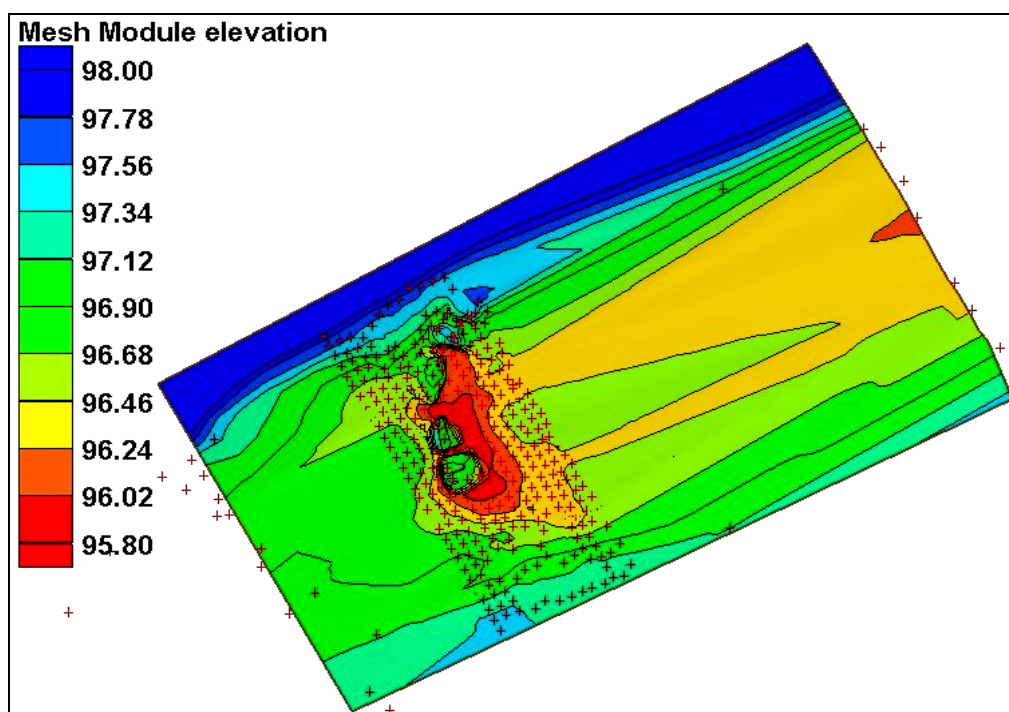
Figure 3-12. Survey Data of J-Hook.

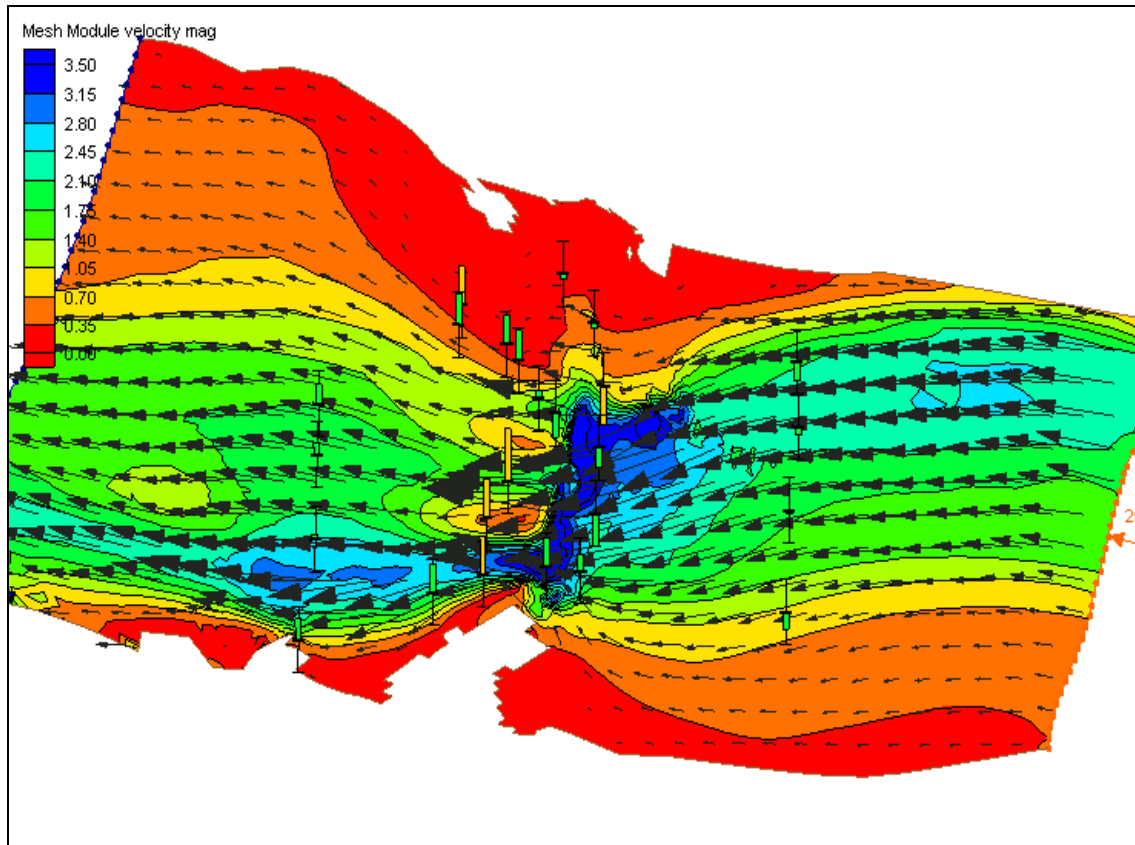
Initially, a flow of 25 cfs was simulated through the two meshes. This corresponds to the flow rate computed from the date when the original survey data was gathered. In addition to bathymetric data at 1-foot intervals, velocity samples were obtained across the cross section and at several points around the structure. The following images display the computed flow directions and magnitudes computed by the model. Note that the model has dried out portions of the rocks and reproduced the flow conditions coming from the right side of the channel and crossing over to the left at the structure.

Figure 3-13. Velocity Magnitudes Computed for Cross-Vane.

Figure 3-13 and Figure 3-14 also show the calibration targets at various sample points. Any target showing a green staff indicates a computed velocity magnitude within .26 ft/sec of the measured value. A yellow staff indicates a computed value within .52 ft/sec of the measured value. The data sets were calibrated using the measured velocities and depths gathered at the site. Based on the calibration results and flow conditions observed during data gathering, it appears that the models are performing reasonably well to predict flow conditions. This includes water depths and flow velocities from which scour forces can easily be computed.

The asymmetrical cross-vane also has erosion problems illustrated in the photos taken in the fall of 2003 and the summer of 2004 during spring runoff (Figure 3-16 and Figure 3-17). In Figure 3-16, two large boulders are visible on the far bank. Figure 3-17 illustrates that due to erosion around the boulder, the left of the two boulders on the bank has shifted and broken. That is why the boulder is not visible in this figure. The erosion is caused by the water moving across the structure from the upstream (north) to the downstream (south) side. The velocity of the water is increased as it runs over the structure and is redirected to the south bank as seen in Figure 3-13.

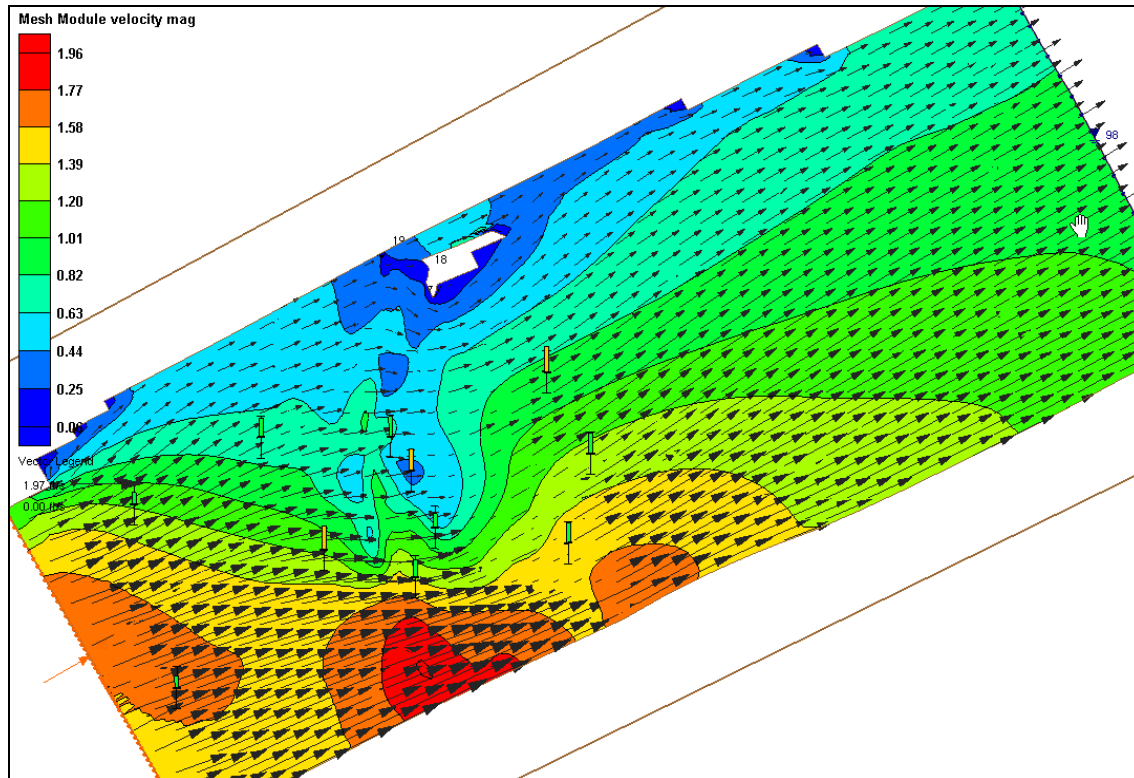
Figure 3-14. Velocity Magnitudes Computed for J-Hook.

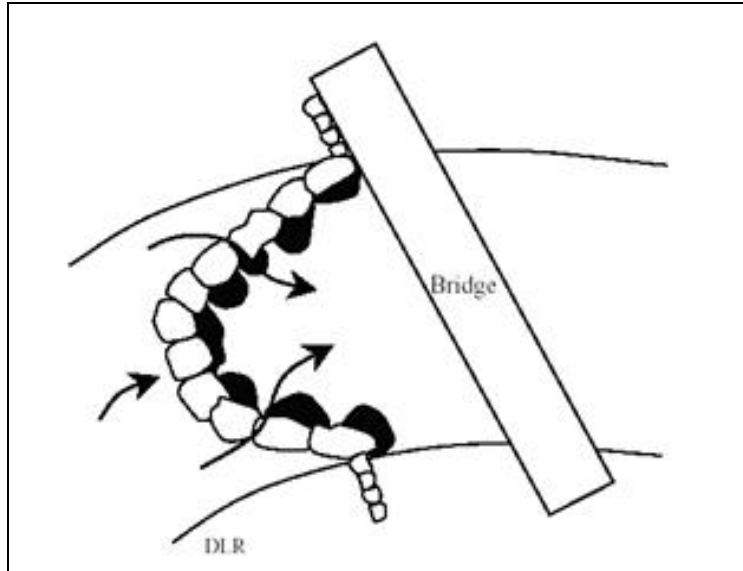
See Figure 3-15 for Rosgen's (2001) proposed cross-vane installation upstream of bridges.

Figure 3-15. Proposed Design Methodology for Cross-Vane Installation at a Bridge.

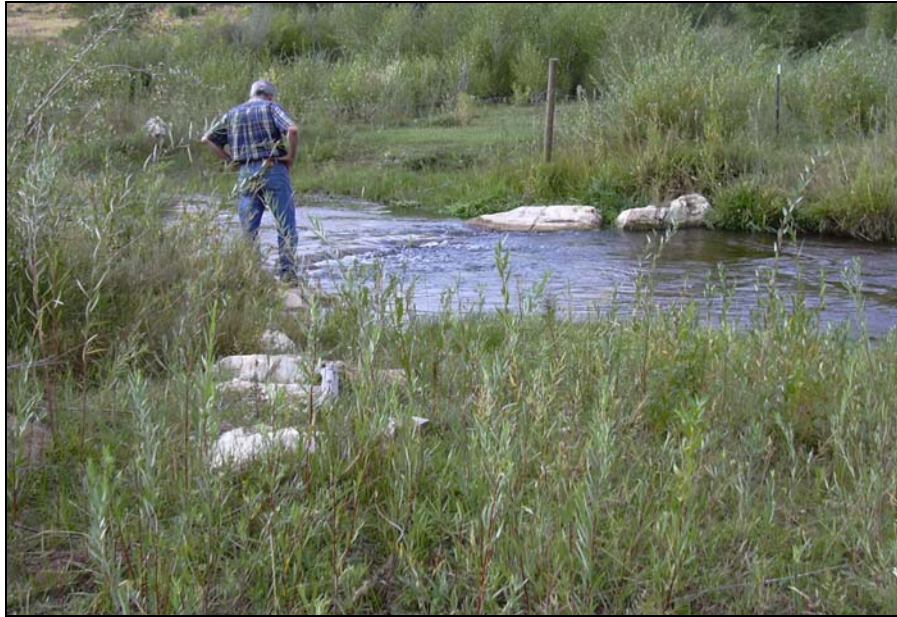
Figure 3-16. Cross-Vane Photo Taken Before Spring Runoff 2004.

This hydraulic condition was observed during the initial survey and appeared to be aggravated after spring runoff as the bank began to fail after spring runoff in 2004 as seen in Figure 3-16 and Figure 3-17. The cross-vane, rather than redirecting the thalweg to the center of the stream channel to reduce bank scour, is in fact redirecting it toward the bank and inducing scour during base flow conditions.

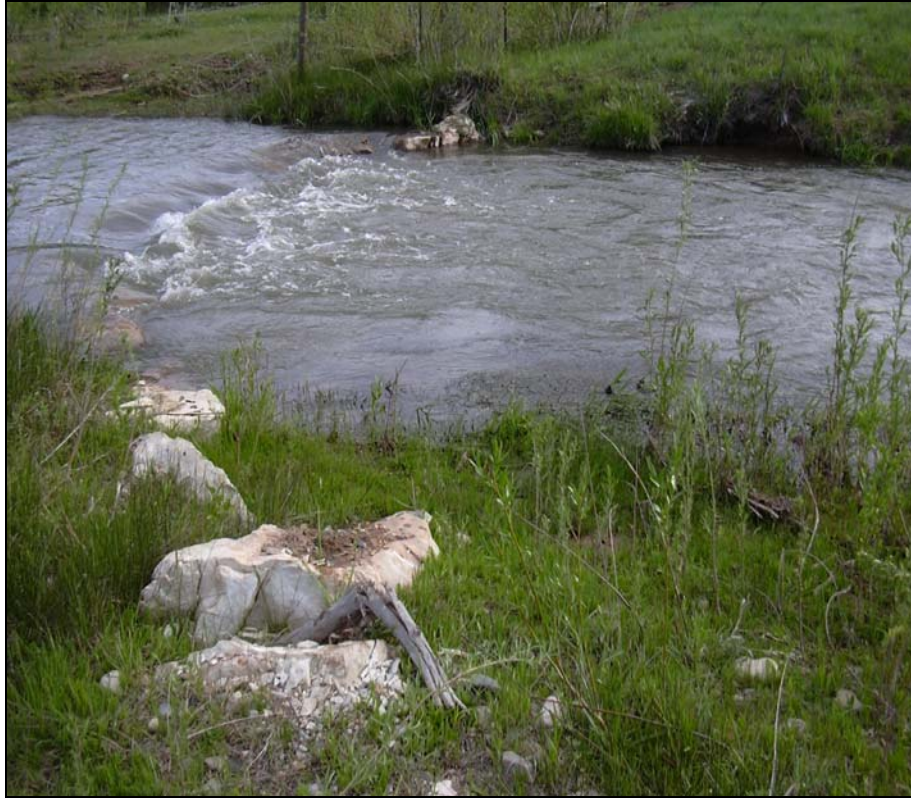
Rock decay was also observed during the study. As noted above, one of the main boulders broke after shifting due to erosion. The crumbling rock in the foreground of Figure 3-17 illustrates the inferior quality of these materials.

Figure 3-17. Cross-Vane Photo Taken During Spring Runoff 2004.

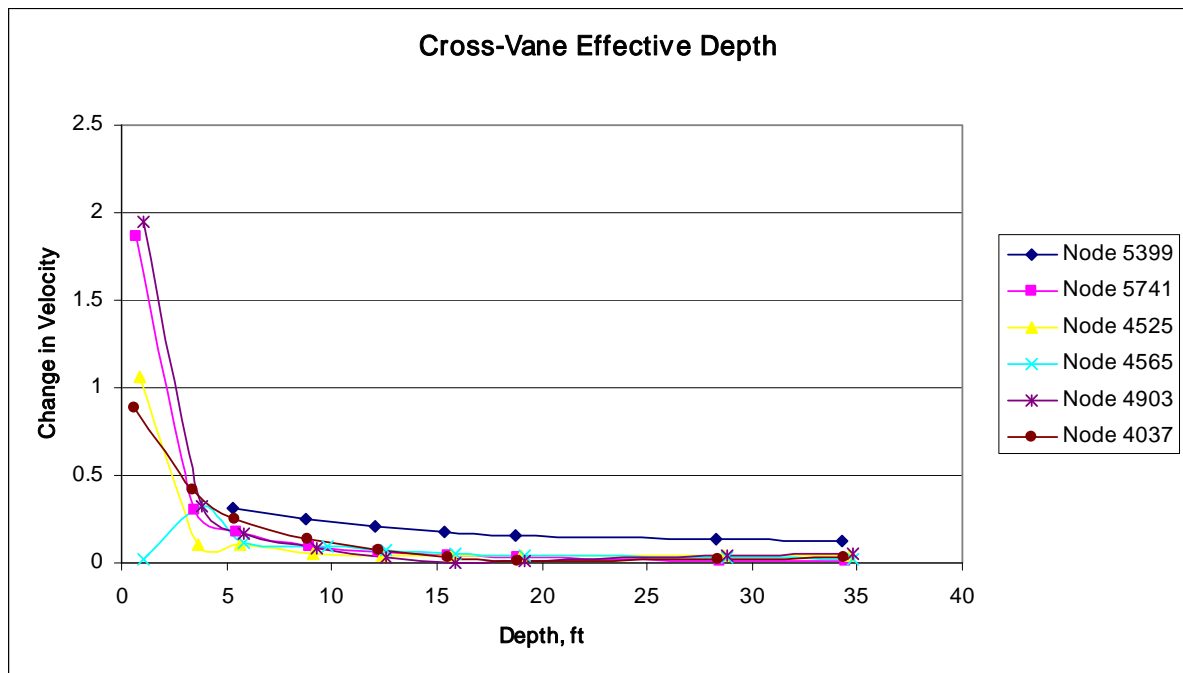
To view the depth verses flow direction, data points were selected across the structure. The depths and directions at that point were recorded for each flow rate. The results are presented in Figure 3-19 and Figure 3-21. To view the change in velocity versus depth, an additional data point was chosen just upstream to correspond with each of the points along the structure. The depth of the upstream point was plotted against the change of velocity between the upstream and downstream points. The results for the second set of data are illustrated in Figure 3-18 and Figure 3-20.

Figure 3-18. Cross-Vane Effective Depth from Change in Velocity Magnitude.

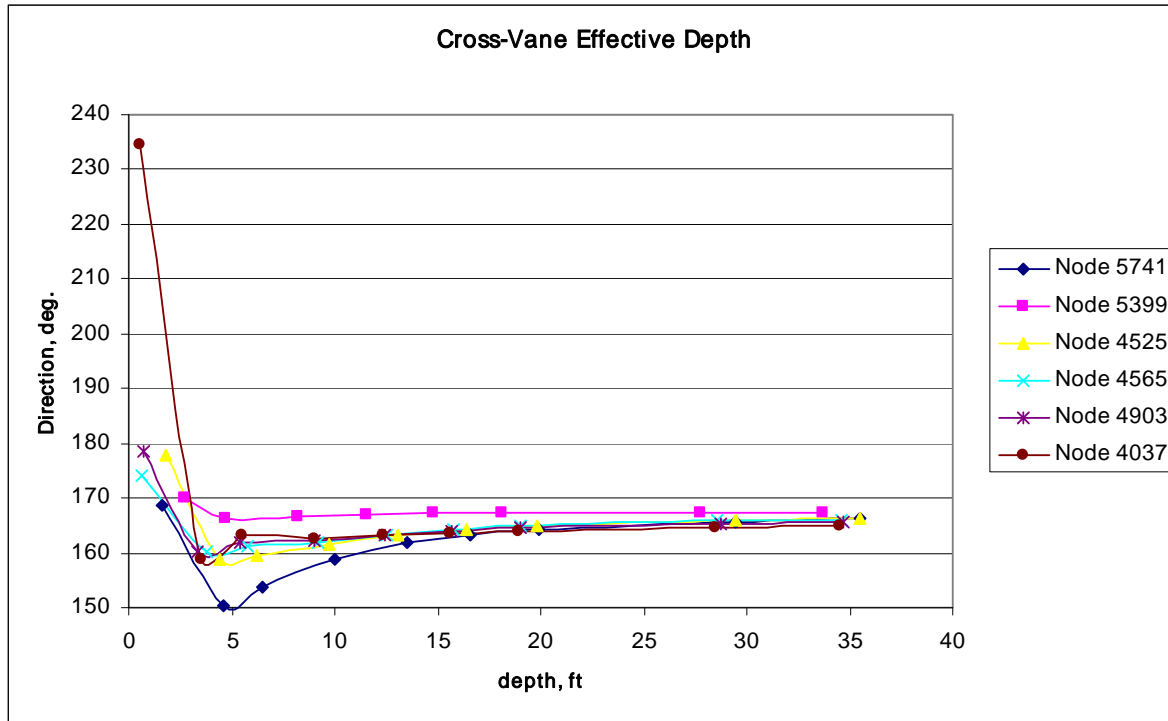
Figure 3-19. Cross-Vane Effective Depth from Change in Flow Direction.

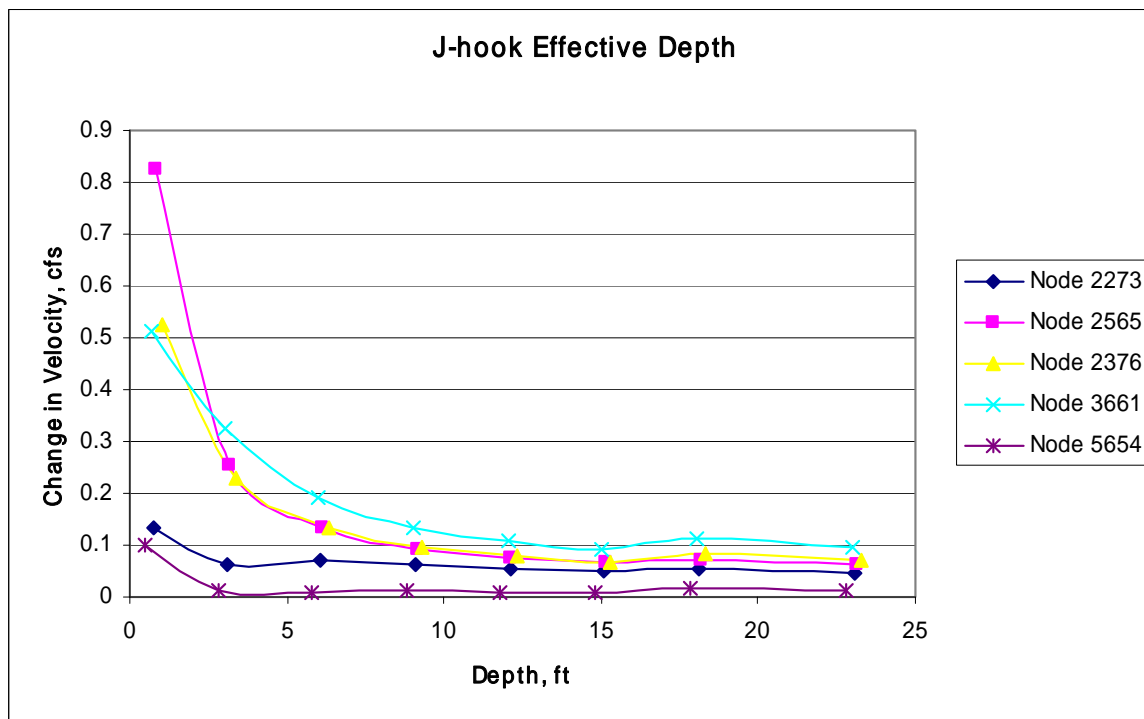
Figure 3-20. J-Hook Effective Depth from Change in Velocity Magnitude.

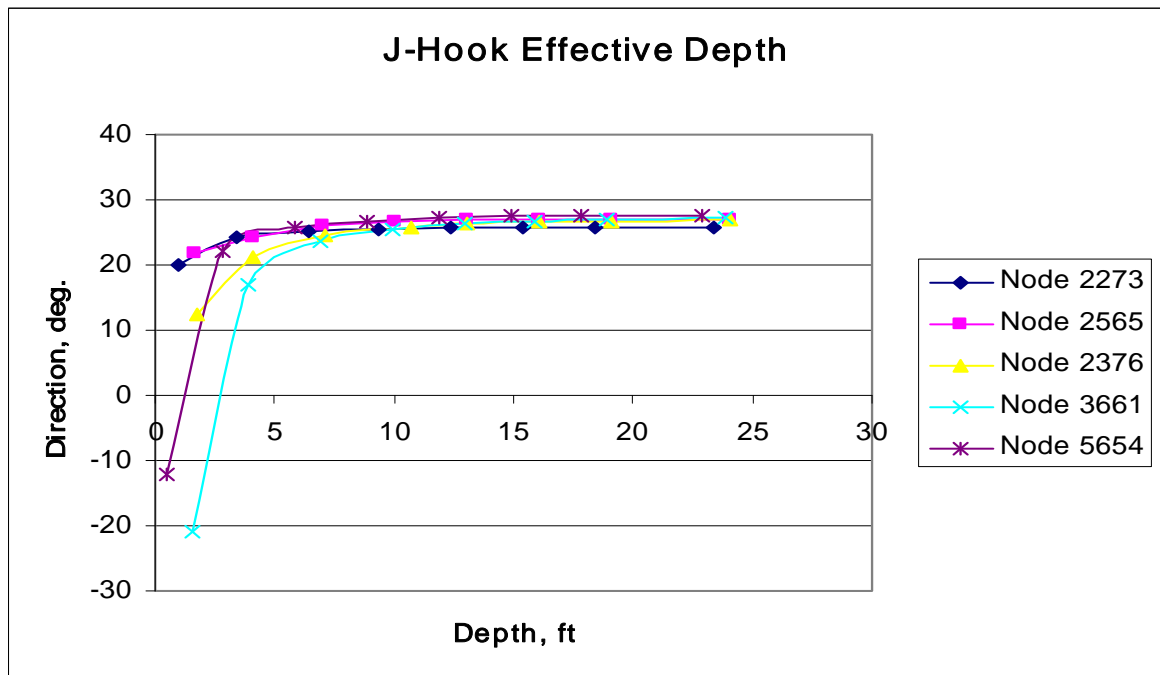
Figure 3-21. J-Hook Effective Depth from Change in Flow Direction.
