Report No. UT-08.24

EVALUATING SHALLOW-FLOW ROCK STRUCTURES AS SCOUR COUNTERMEASURES AT BRIDGES

Utah Department of Transportation
Research Division

Brigham Young University
Department of Civil & Environmental
Engineering

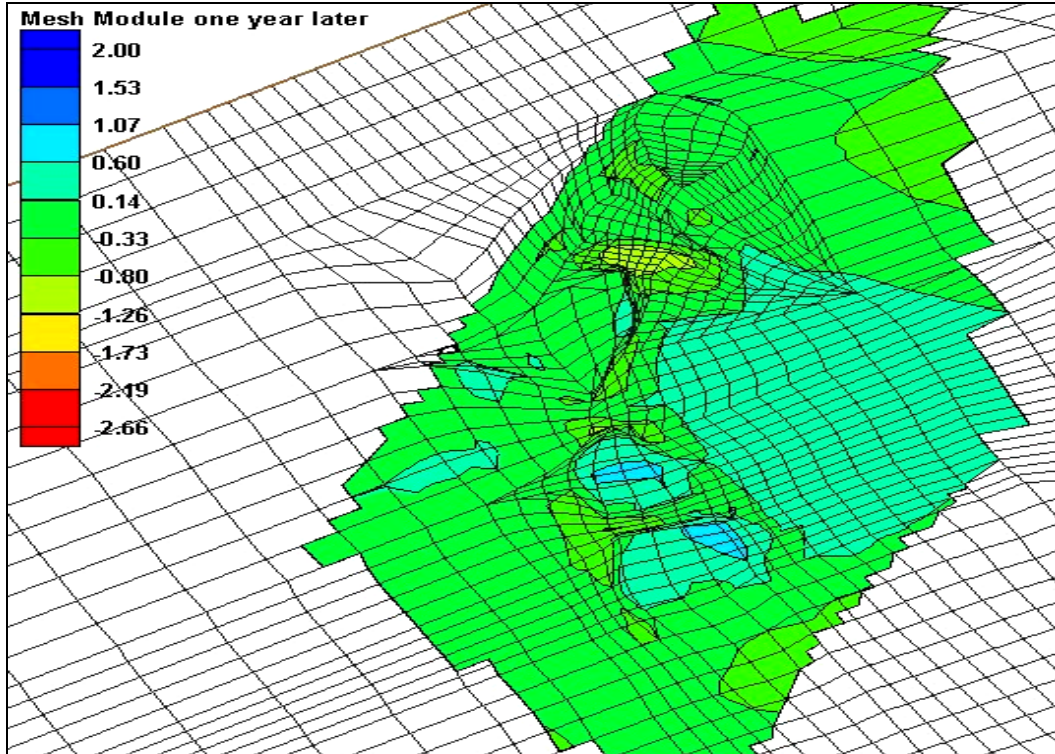
A fourth observation can be made by evaluating the erosion that took place over the year of monitoring at this site (2003-2004). To do this, bathymetric data from the fall of 2003 is compared to post spring runoff measurements in 2004. The results are shown around the vicinity of the structures themselves.

Figure 3-22. Erosion of J-Hook at Thistle Creek Site Between 2003-2004.

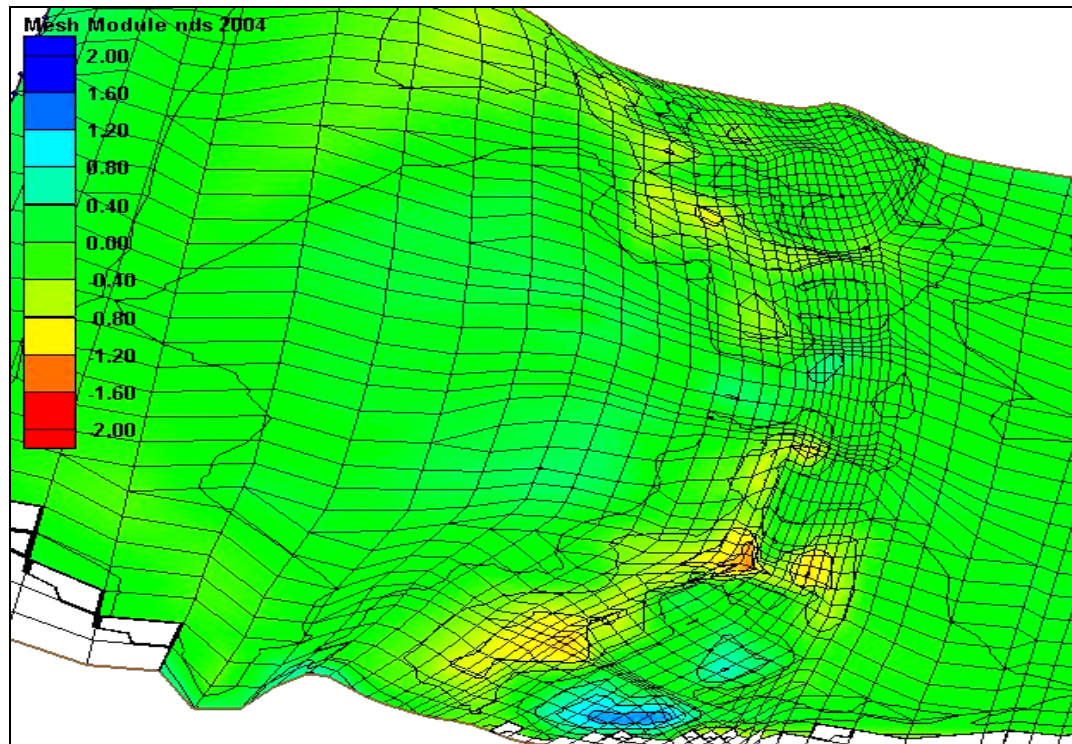
Figure 3-23. Erosion of Cross-Vane at Thistle Creek Site Between 2003-2004.

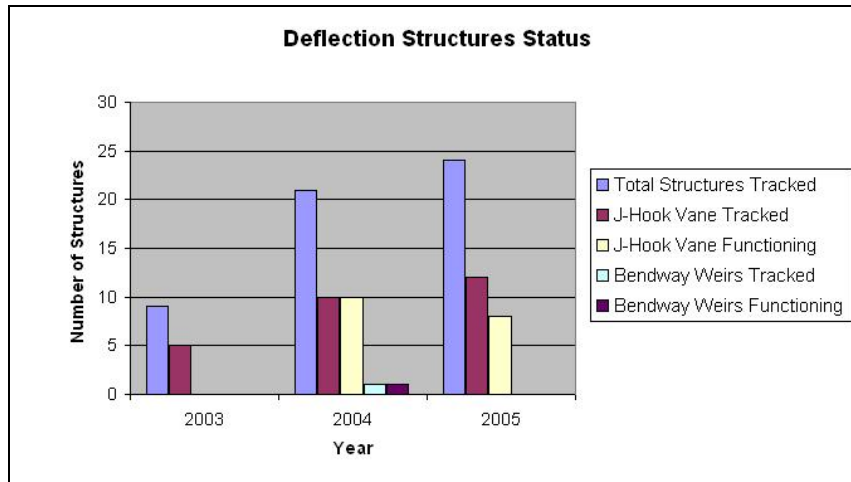
Figure 4-16. River Training Structure Status.

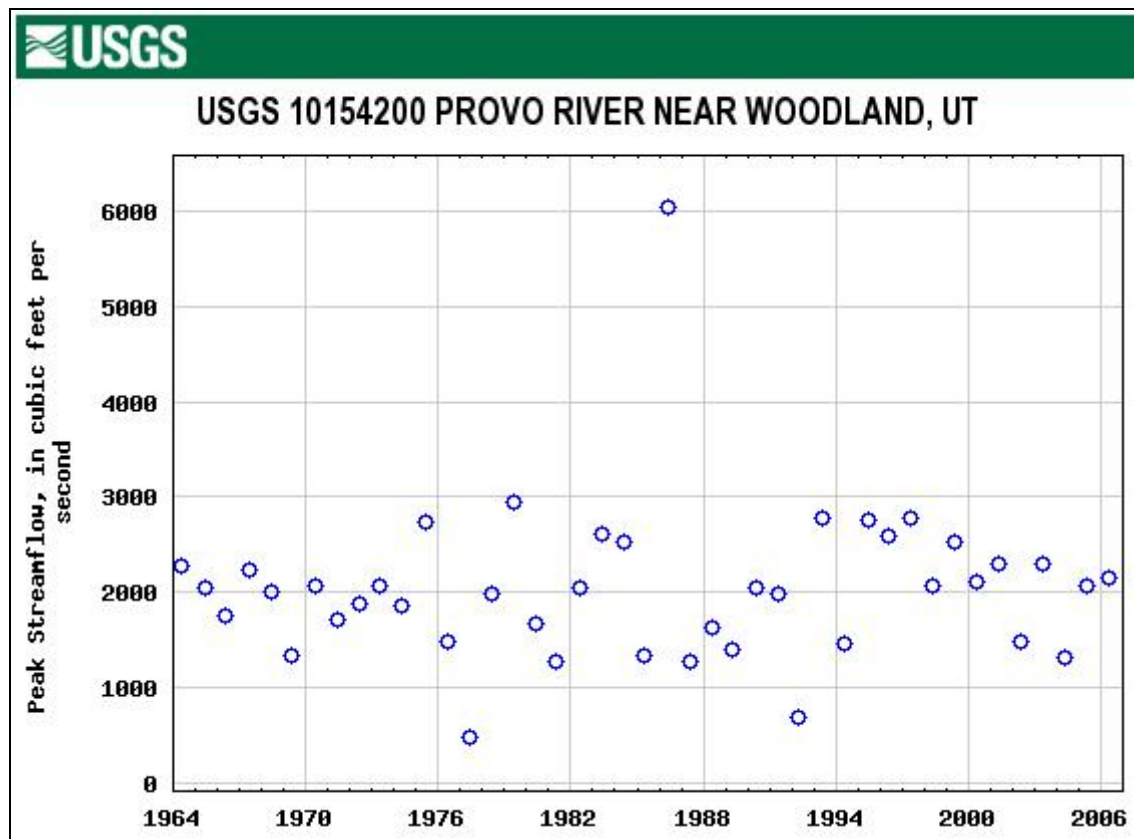
Spring runoff in 2005 was an average event based on data from the U.S. Geological Survey (USGS). The closest monitoring gauge is approximately 9,100 meters downstream (obtained from ArcView in the database) of the site. June gauge records indicate that the peak flow was 2,070 cfs and the mean monthly discharge for the same month was 1,052 cfs. See Figure 4-20 for peak stream flows downstream of the site and Flow Data Record No. 3 in Table 4-2 for stream characterization data.

Figure 4-20. Stream Gauge Data for North Fork of the Provo River Site.

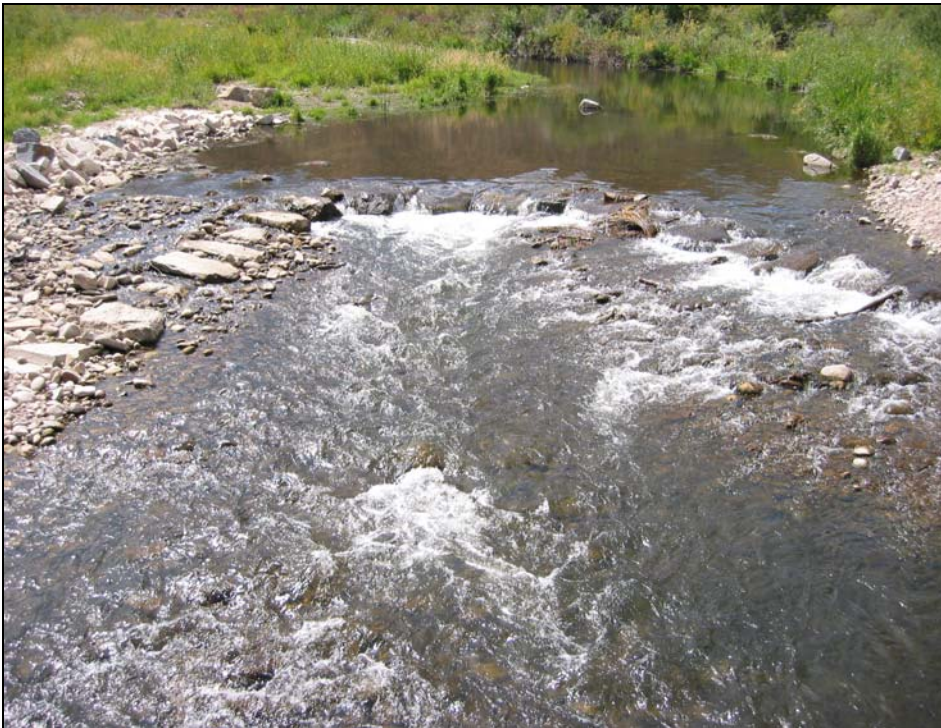
One structure was placed upstream of the bridge at Rockport State Park on the Weber River as shown in Figure 4-25 and Figure 4-26. The structure is a cross-vane placed just upstream of the bridge. The installation did not conform to Rosgen Design Methodology, which dictates the vane arms slope down at a slight angle upstream. In this installation, the vane arms were installed at a slight upstream angle.

Figure 4-25. Rockport Before Runoff.

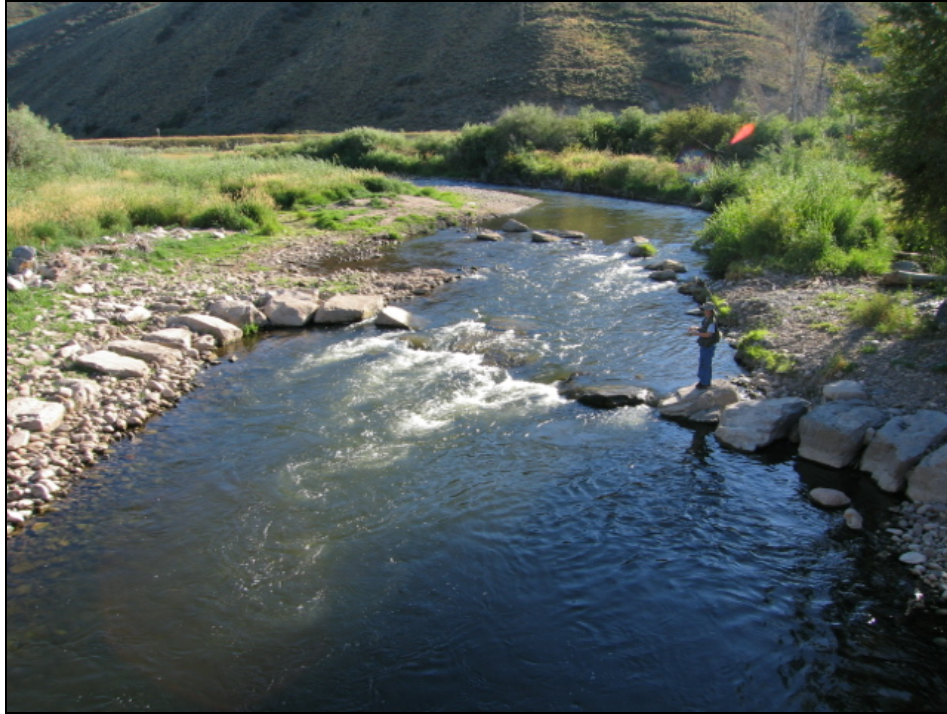
Figure 4-26. Rockport After Runoff.

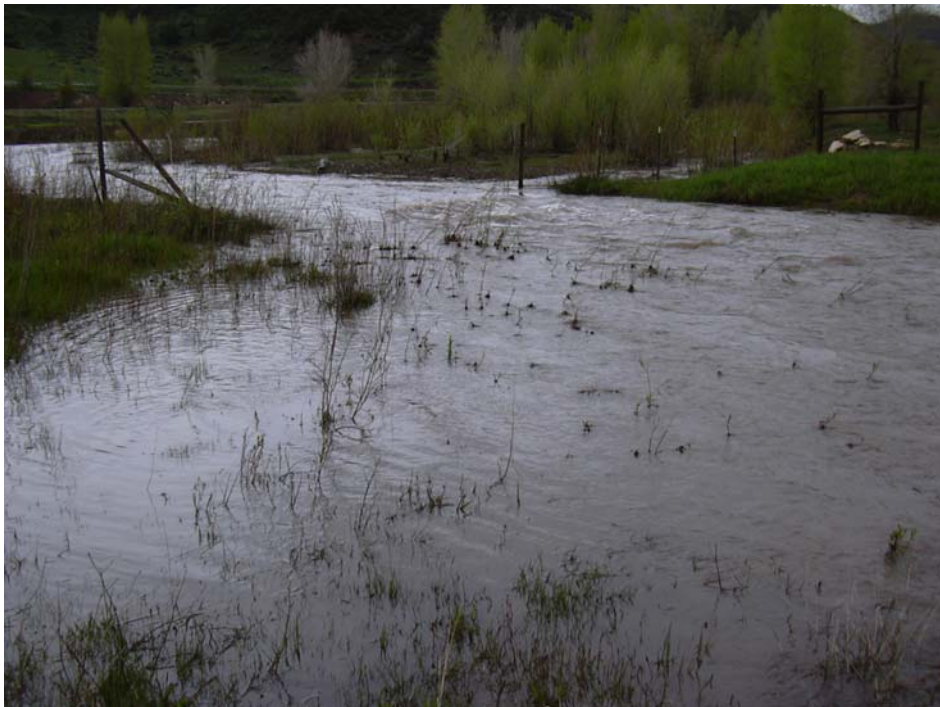
The response of the j-hook and cross-vane was unremarkable under normal flow conditions as compared to spring flows of 2005. In 2005, under average spring flows, both structures were active as water was breaking over the top of them. See Figure 4-27 for cross-vane during 2005 spring runoff. Figure 4-28 and Figure 4-29 were photos taken after 2005 spring runoff.

Figure 4-27. Cross-Vane at Thistle Creek During 2005 Runoff.

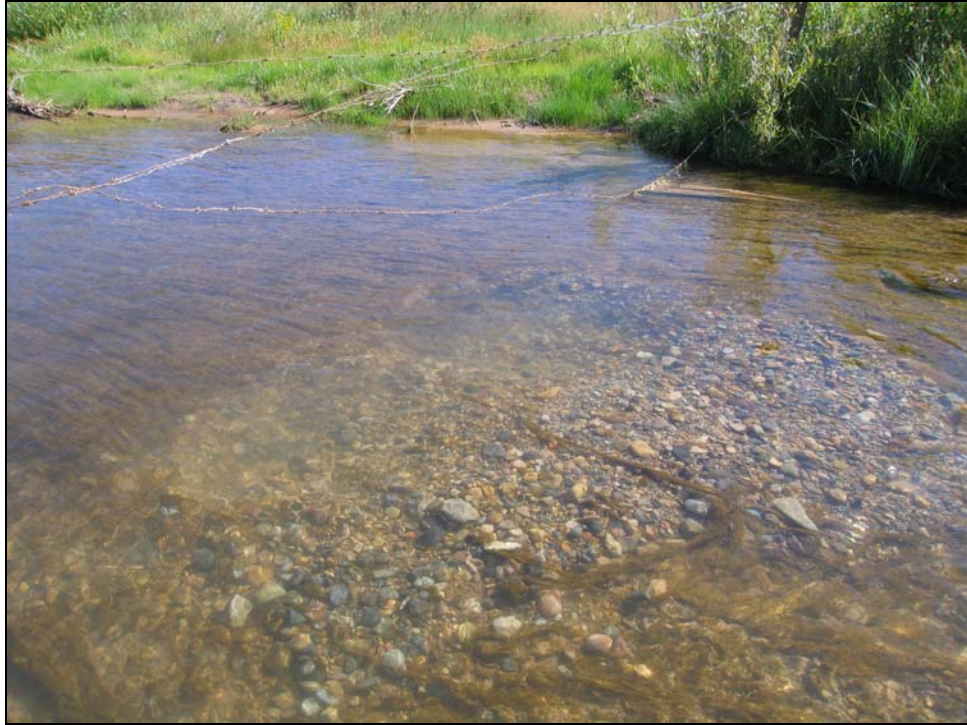
Figure 4-28. Cross-Vane at Thistle Creek After Runoff.

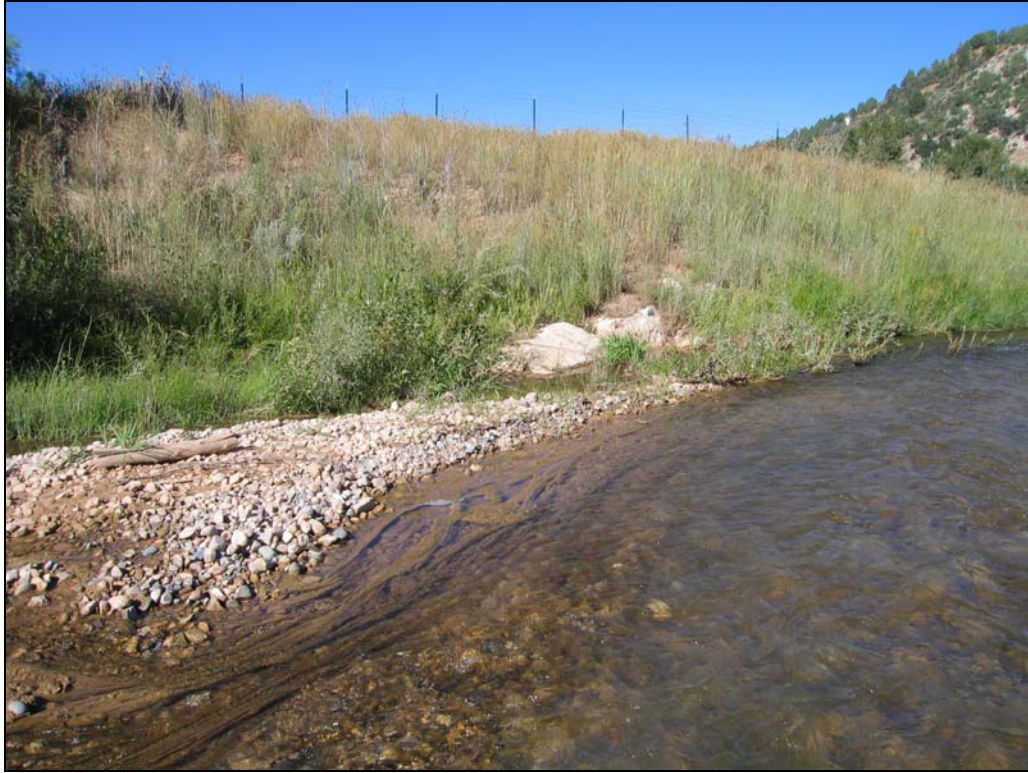
Figure 4-29. J-Hook at Thistle Creek After Runoff.
