# **PLATOON IDENTIFICATION AND ACCOMMODATION SYSTEM IMPLEMENTATION IN BROWNWOOD AND CALDWELL, TEXAS**

Report 5-5507-01-1

Project Title: Implementation of Platoon Identification and Accommodation (PIA) System

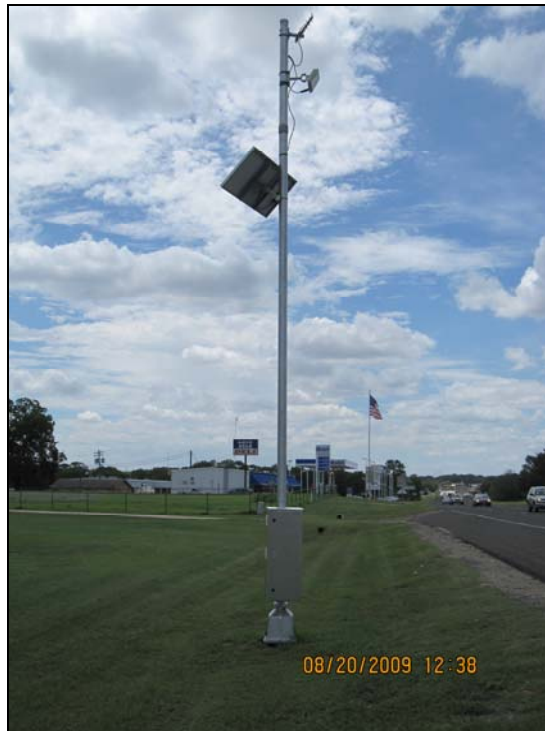
**Figure 5. Reinstalled Equipment at the Caldwell Site.**

On July 20, 2009, a severe thunderstorm (with some reports of a localized tornado) in Caldwell somehow unscrewed and knocked down one of the two poles. This incident damaged the threads on the pole, broke the antenna, shattered the solar panel, twisted the brackets holding the solar panel, and unfastened the sensor and hurled it into a ditch full of water. Researchers sent the sensor to the manufacturer for possible repairs. In the meantime, the district staff fixed the pole and installed it again along with a solar panel supplied by the Bryan District. To avoid any delays in turning on the system, they also installed another antenna and a smart sensor that TTI staff had available from another project. Figure 5 shows the reinstalled equipment at this location.

Luckily, the manufacturer was able to repair the damaged sensor for less than one sixth of the cost (\$500) for a new one. TTI has received the repaired sensor, which will be swapped with the loaner unit as soon as possible.

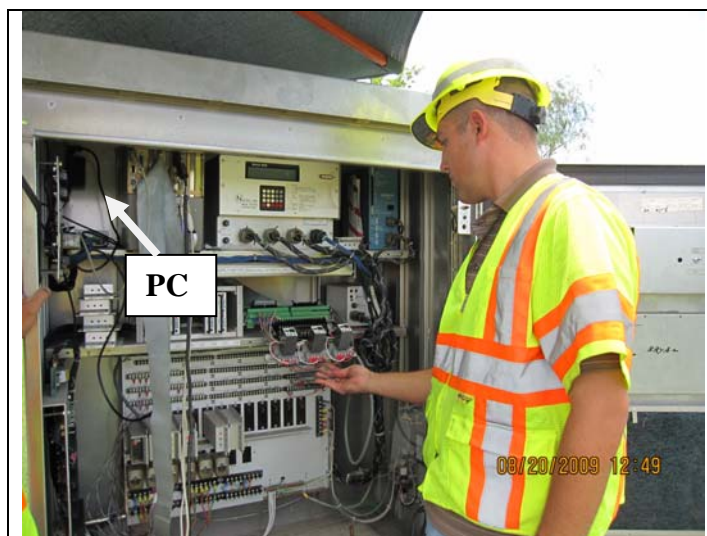
**Figure 6. Equipment Installed in Caldwell Controller Cabinet.**

TTI researchers installed and wired the remaining equipment (PC, radio, and wiring panel) in the signal controller cabinet on August 20, 2009. Figure 6 shows installed equipment in this cabinet.

Final checking of the system components that day revealed that there was a lack of communications in the outbound (to Bryan) direction due to a failed solar charge controller (SCC). TTI researchers decided to go ahead and turn on the system, even though the PIA system was receiving data from only one advance sensor (westbound direction). The researchers watched the operation for a few hours, tweaked PIA parameters, and left the system running. Upon returning, researchers ordered a replacement SCC.
