Advanced Sensors and Applications: Commercial Motor Vehicle Tire Pressure Monitoring and Maintenance

U.S. Department of Transportation
Federal Motor Carrier Safety Administration

February 2014

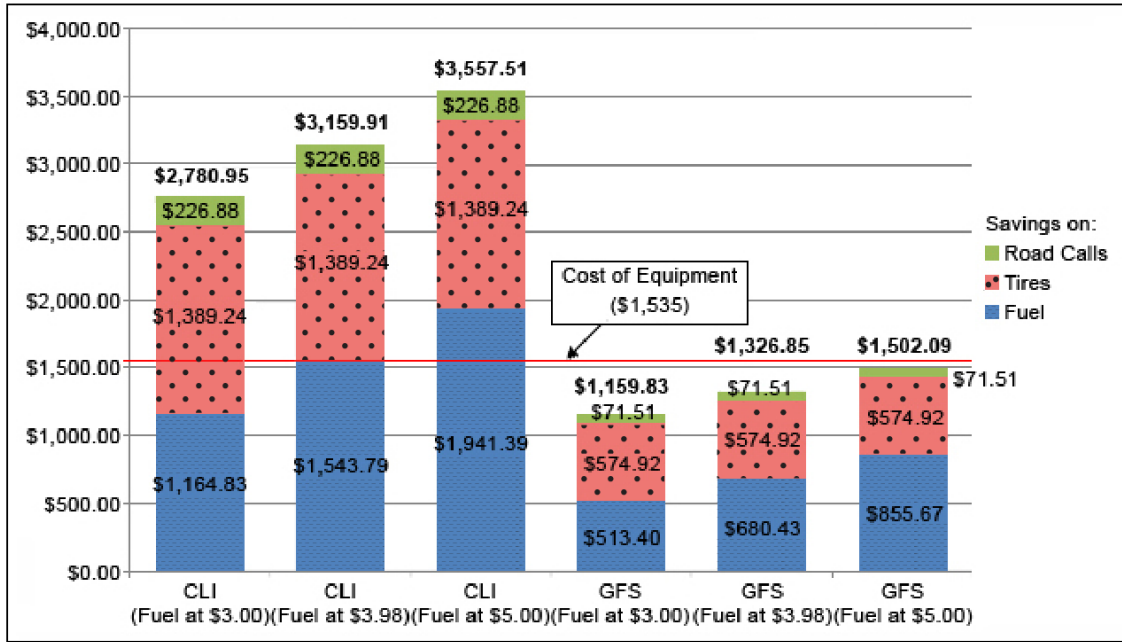
Figure 2. Chart. Annual savings on road calls, tires, and fuel per TPMS/ATIS-equipped tractor-trailer.

The findings from this report may encourage fleets to use TPMS or ATIS equipment due to their potential to reduce CMV operating costs. Researchers conducted a cost-benefit analysis to estimate the fleets' expected return on investment (ROI). The cost of fuel, the cost of tires, and the average mileage traveled influenced the ROI for the TPMS and ATIS equipment. For example, CLI operates a high-mileage fleet with wide-based single tires (a high-cost consumable supply). As shown in Figure 2, CLI would recover the costs of the TPMS and ATIS equipment in less than a year. Although fuel savings offer the highest incentive for TPMS and ATIS use, the high cost of wide-based tires further shortens CLI's expected ROI. In comparison, GFS operates a lower-mileage fleet with standard tires. In addition, the size of GFS's fleet reduces the need to dispatch the entire trailer fleet daily. The annual savings for GFS are less than half of the savings for CLI. At the mid-2011 cost of \$3.98 per gallon of diesel fuel, CLI would save \$3,160 per year for each tractor-trailer, compared to \$1,327 per year at GFS.

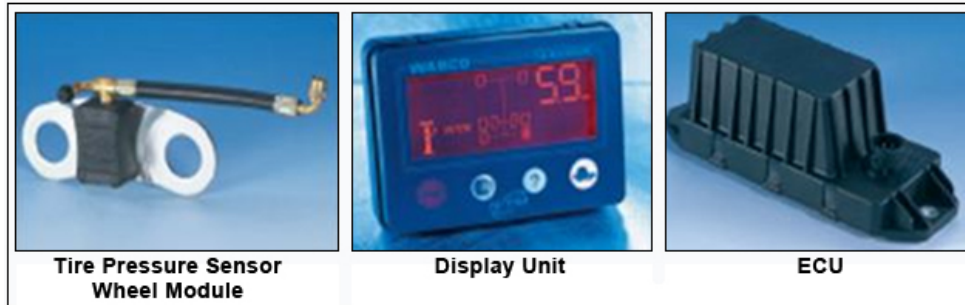
Figure 5. Grouped photo. Wabco tire pressure sensor wheel module (left), display unit (center), and electronic control unit (right).

Wabco (in conjunction with Michelin) developed and launched the IVTM system in 2003. The IVTM system consists of three main components, shown in Figure 5:

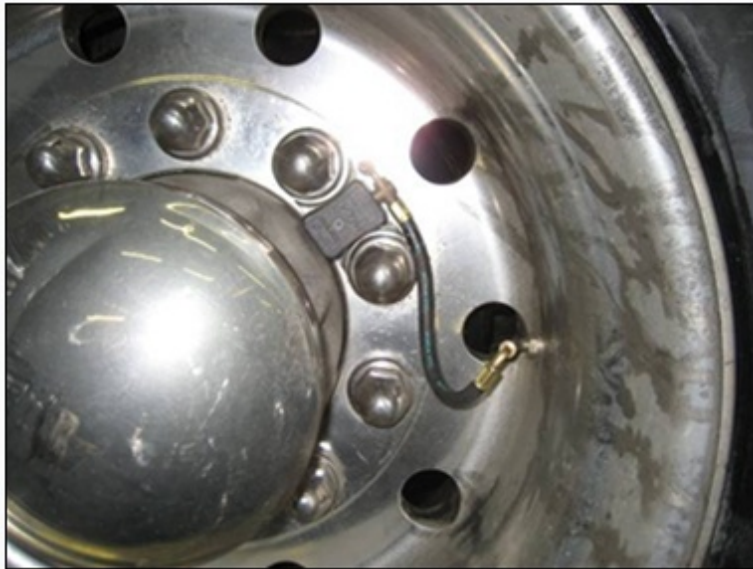
Figure 6. Photo. Wabco IVTM sensor unit mounting system.

In the IVTM system, each tire and wheel assembly is equipped with a sensor unit, which contains a pressure transducer and a transmitter. A built-in lithium battery with a 5-year service life supplies power for the sensor unit. The sensor unit is secured to the wheel rim at a location adjacent to the valve stem using the two closest lug nuts. A pneumatic hose runs between the sensor and valve stem (as shown in Figure 6).

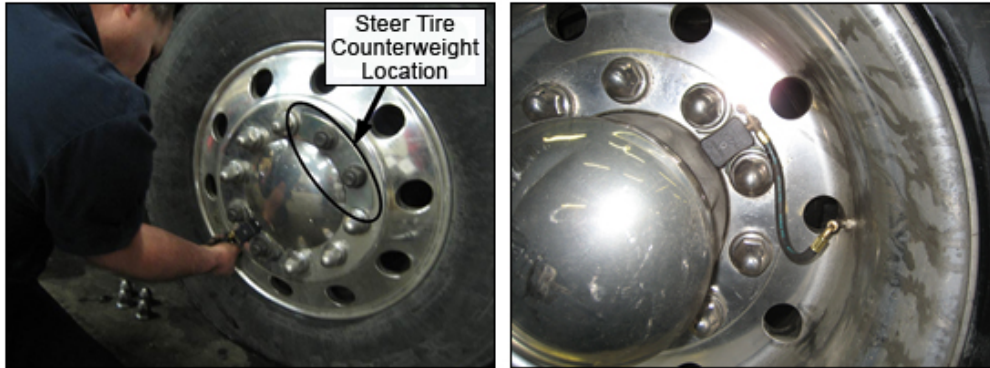
Figure 8. Grouped photo. Module installation of steer wheel (left) and drive wheel (right) with steer tire counterweight location.

a steer tire. As shown in the photos, the steer tires required mounting a counterweight onto the tire, opposite the sensor. The weight countered the effect the sensor had on the rotation of the wheel. Because the sensors were installed near the wide-base single tires' center of gravity, the drive and trailer tires did not require a counterweight.

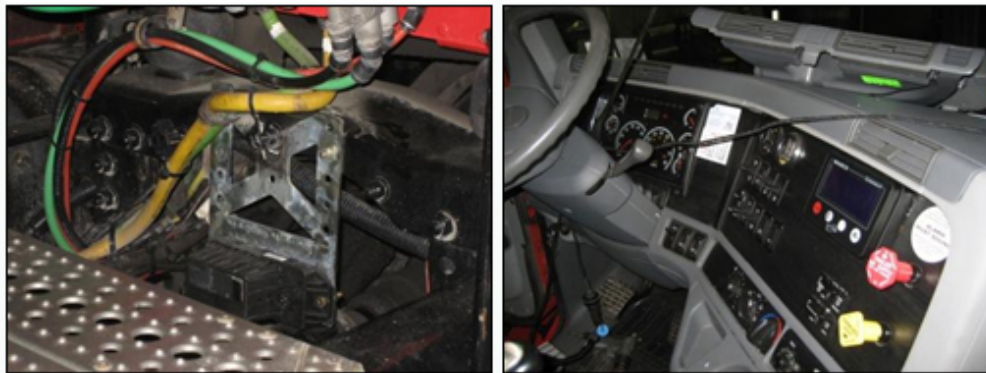
Figure 9. Grouped photo. ECU (left) and display unit (right) installations.

The ECU must be mounted in a centralized location relative to the tire sensors. The ECU was bracket-mounted to the rear cross-member of the cab, equidistant from each of the six sensor locations. The display unit, hardwired to the ECU, was mounted within reach of the driver on the cab's dashboard, as shown in Figure 9. The display was electrically protected by mounting an inline 5-ampere fuse in the glove box.

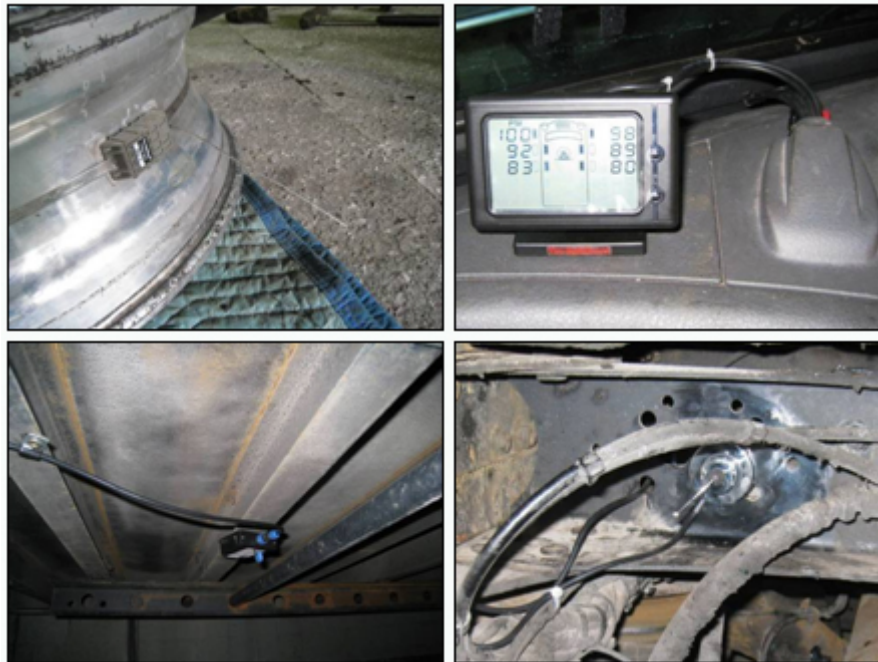
Figure 10. Grouped photo. HCI Tire-SafeGuard components.

Figure 10 shows a wheel module secured to a wheel by a steel band (top left), the dash-mounted DDU (top right), the trailer's chassis-mounted ECU (bottom left), and the tractor's chassis-mounted antenna (bottom right).

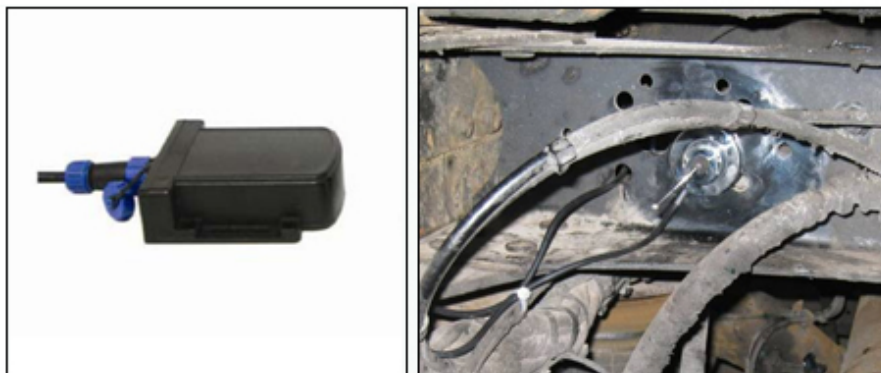
Figure 12. Grouped photo. HCI Tire-SafeGuard antennas.

Engineers installed two receivers for the system (shown in Figure 12). An antenna was mounted in front of the rear axles on the truck frame using a magnetic base, and a coaxial cable was used to connect the antenna to the dash-mounted DDU. The trailer ECU was mounted to the trailer's cross beam (between the trailer tires). Using an antilock braking system (ABS) connector, engineers connected the ECU to the trailer's 12-volt power source.

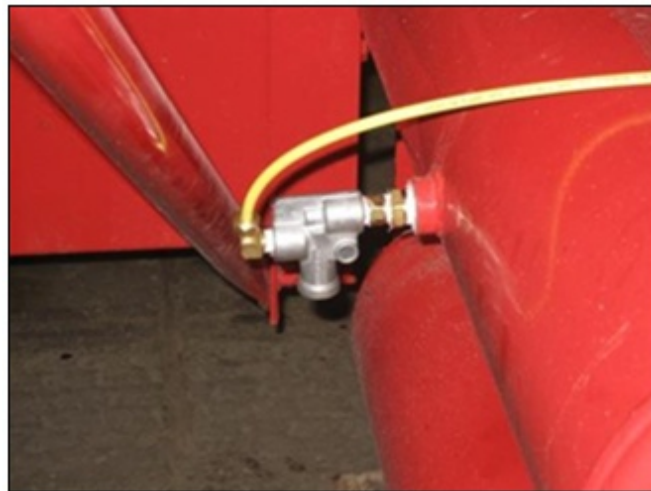
Figure 15. Photo. Pressure protection valve (CLD).

- **Pressure Protection Valve**—Maintains trailer air system at 80 psi in the event of a tire or inflation system failure (Figure 15).
- **Control Unit**—Controls the pressure distributed to each axle end and illuminates indicator light.
- **Press Plug**—Used with hollow axles to seal pressurized axle interior from wheel end (shown in Figure 16).
- **Stator and Through-tee**—Rotary union assembly delivers air from the pressurized axle to the wheel end.
- **Indicator Light**—Illuminates when airflow within the system has been detected.

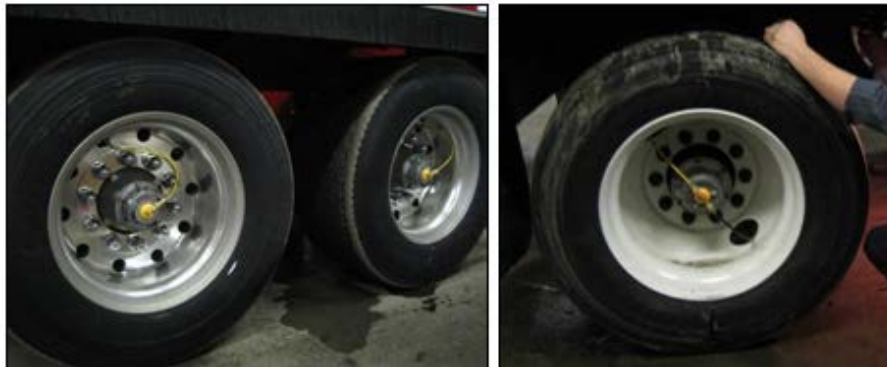
Figure 16. Grouped photo. MTIS, rotary units on wheel ends.

way check valve located in the hose protects each tire against air pressure loss. If a puncture results in the loss of air pressure, the check valve prevents loss of pressure in the other tires.

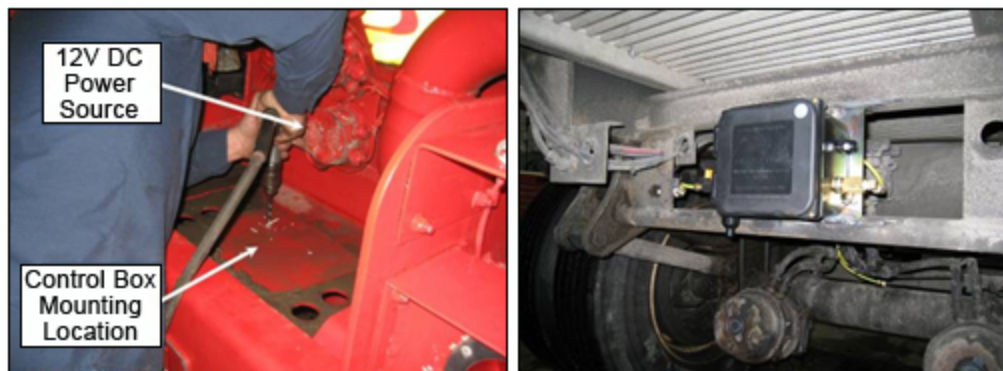
Figure 18. Grouped photo. CLI and GFS control box installation between taillights (right) and on tanker's crossbeam (left).

The installation of the system air components included installing the pressure protection valve, mounting the control box, and routing the hose. The pressure protection valve was installed on the spare port of the trailer's air tank. A hose was routed from the valve to the input of the control box. The GFS control box was mounted on the trailer's crossbeam, forward of the rear axles (as shown in Figure 18, right). The CLI tanker did not have crossbeams under the tanker. For this reason, the CLI control box was mounted at the rear of the tanker in a recessed area between the taillights (as shown in Figure 18, left). From the control box output, a tee split the hosing to deliver air to each of the axle fittings.

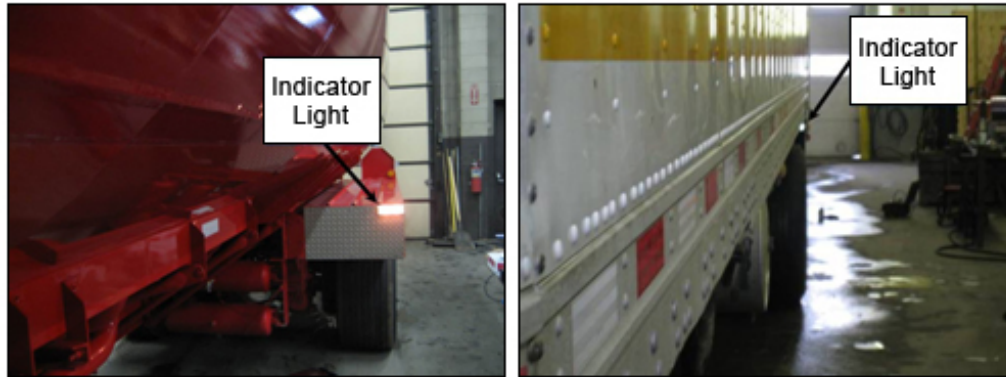
Figure 19. Grouped photo. CLI and GFS indicator light installation on the fender (left) and underside of the reefer pup (right).

The final component of the PSI inflation system is the indicator light. The indicator light was installed in a location that allowed the driver to see the light through the driver's side mirror. On the CLI fleet, the light was mounted on the fender of the tanker (as shown in Figure 19, left). On the GFS fleet, a mounting bracket was fabricated to allow the light to be mounted on the underside of the reefer pup, forward of the axles (as shown in Figure 19, right). The operation of the indicator light required a constant supply of 12-volt power. The CLI fleet used the tanker's seven-way box, and the GFS fleet accessed the ABS wiring via a pigtail connector. Electrical wiring was routed from the indicator light through the identified power source to the electrical contacts of the flow-sensing switch in the control box.

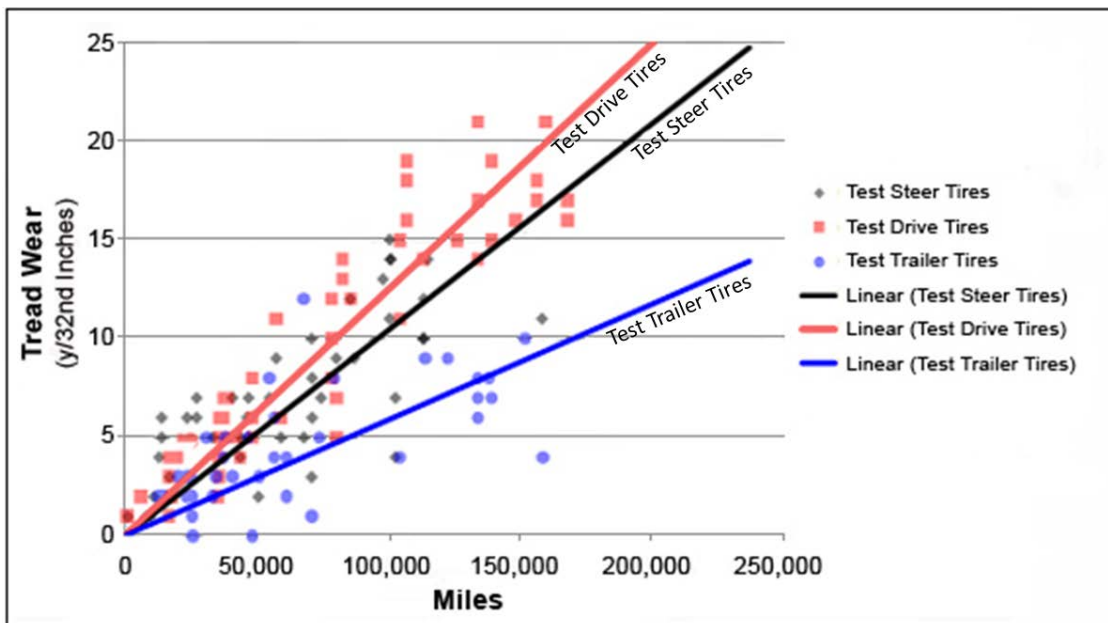
Figure 23. Graph. Tread wear of test fleet tires (CLI).

Figure 22 and Figure 23 show tire wear per mile for the control vehicles and the test vehicles, respectively. The data points chart axle location (steer, drive, or tanker), and the trend lines show the average rate of wear for each axle location. As the slope of the trend line decreases (i.e., becomes “shallower”), the life of the tire increases (more miles per 32nd-inch of wear). Each exhibit shows consistency in tire wear by location. The drive tires for the control and test vehicles had the highest wear rates and were replaced more frequently. The tanker tires had the lowest wear rates.

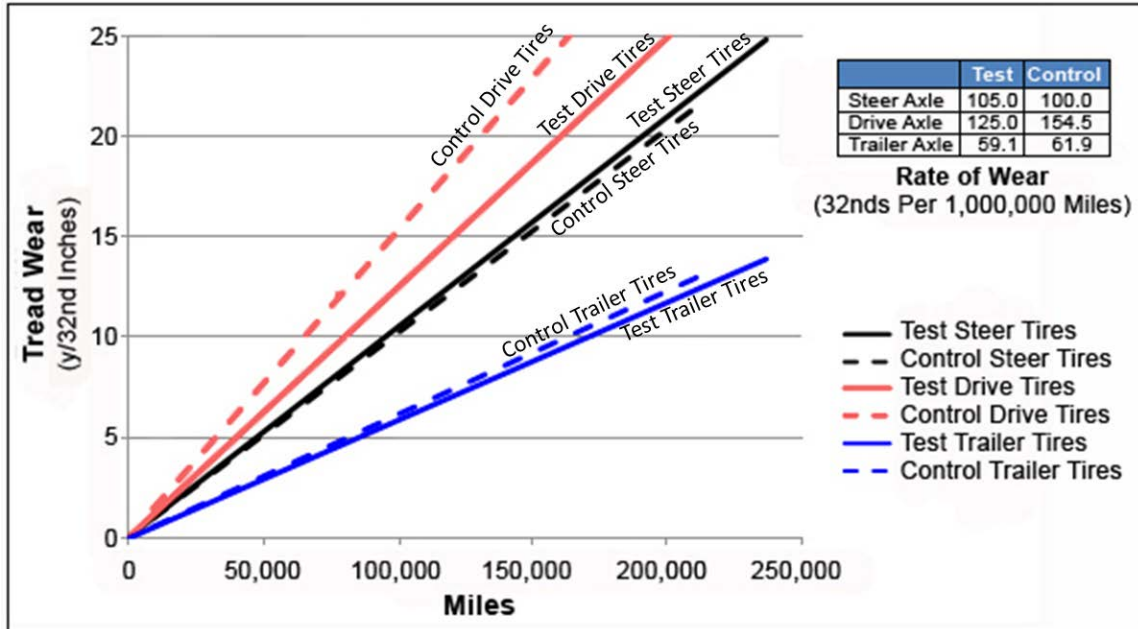
Figure 24. Graph. Tread wear per mile, steer, drive, and trailer axles: control versus test tires (CLI).

Figure 24 presents trend lines from the test and control vehicles in a single chart to compare the tire wear between the two datasets. The solid lines represent the test vehicles, and the dashed lines represent the control vehicles. TPMS and ATIS improved the tire wear for tires installed on the test fleet's drive and tanker axles.

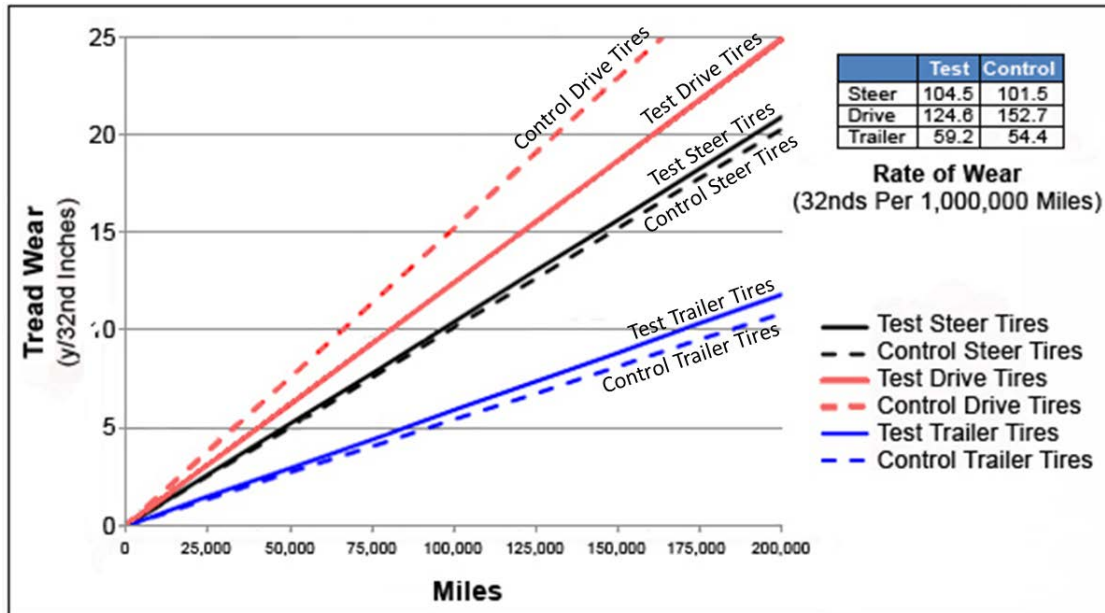
Figure 25. Graph. Regression analysis of tread wear per mile (CLI): control versus test tires.

slower rate of wear than the control fleet’s drive tires. In addition, the wear rate calculations further validate the rate of wear identified for the drive and steer axles. Statistical analysis confirmed the wear rate of the drive tires to be statistically significant at the 95-percent confidence level ($t = 38.4$ [Mileage] and 5.8 [Variable A]). **Note:** Variable A = Tractor Mileage (x-axis) * (1 if test, 0 if control).

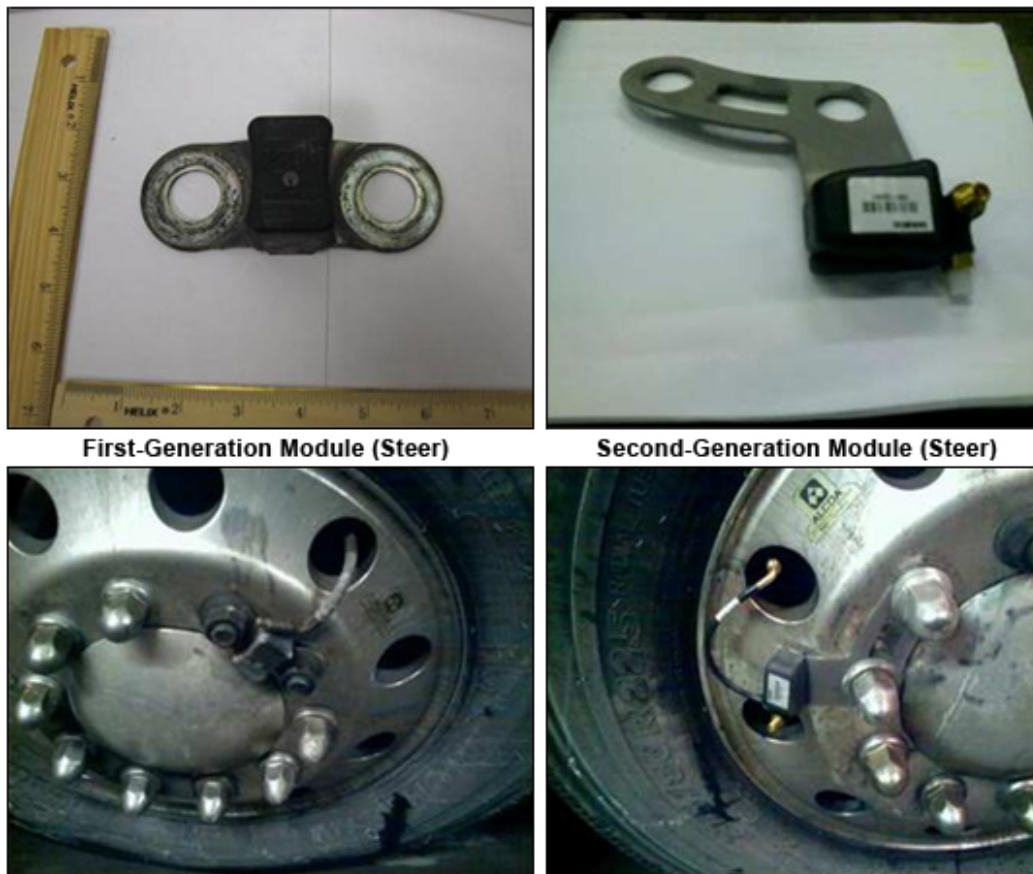
Figure 27. Grouped photo. Wabco wheel modules, side-by-side comparison of first-generation and second-generation modules.

The second-generation modules included notable modifications. First, the modules “stood off” the mounting brackets. As shown in Figure 27, the new modules were not installed between the tire lugs, as they were in the previous generation. Instead, the mounting bracket incorporated an extended metal standoff to prevent the module from lying between the tire lugs, possibly improving the system communications. Second, the technician determined the length of the air tubing during installation, instead of using a predetermined single length during manufacture. The technician identified the required length of tubing and trimmed the excess prior to completing the installation. The technician inserted and locked the trimmed end into the wheel module. The new design permitted the air hose to be adjusted and allowed the use of longer air hoses to ease removal and installation of wheel modules during tire changes.

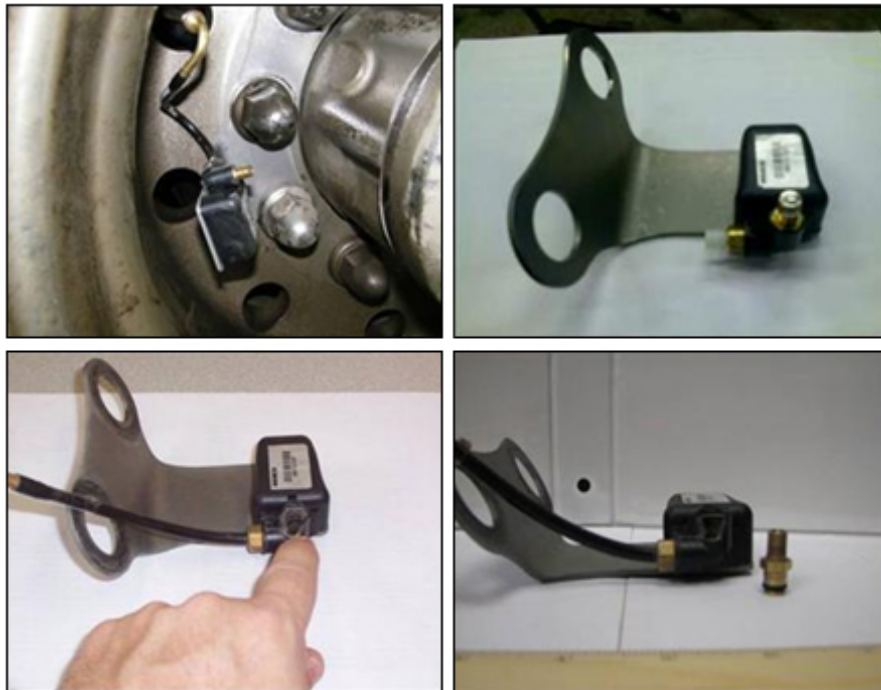
Figure 28. Grouped photo. Second-generation wheel module (fill valve) failure.

The second-generation wheel modules experienced a lower failure rate (27 percent). Of the seven modules that were replaced, one failure was due to improper maintenance. The fill valve of the wheel module (as shown in Figure 28) did not allow users to add air to the tire using traditional methods. A low-clearance tire chuck had to be used in order to access the fill valve properly. When this particular module required additional air, the user did not use a low-clearance tire chuck. Instead, a stick tire chuck was used to fill the tire, and the stick chuck likely was used as a lever: when the stick could not fully engage the fill valve, a large force was applied as a lever, breaking the fill valve on the wheel module.

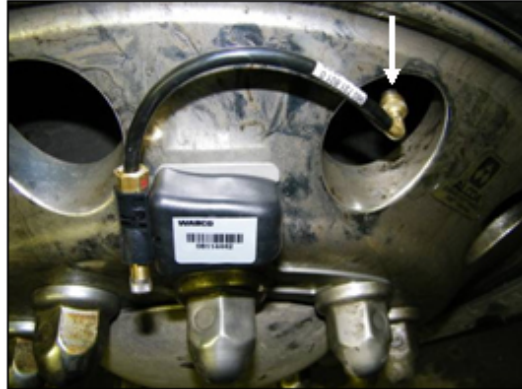
Figure 29. Photo. IVTM wheel module installation.

As described earlier, the wheel modules monitor the tire pressure through a hose connection to the valve stem (as shown in Figure 29). With the hose connected to the valve stem, the tire valve is held in the open position to permit monitoring of the internal tire pressure. As a result, the tires will lose air if the hose-to-valve stem connection is not securely fastened.

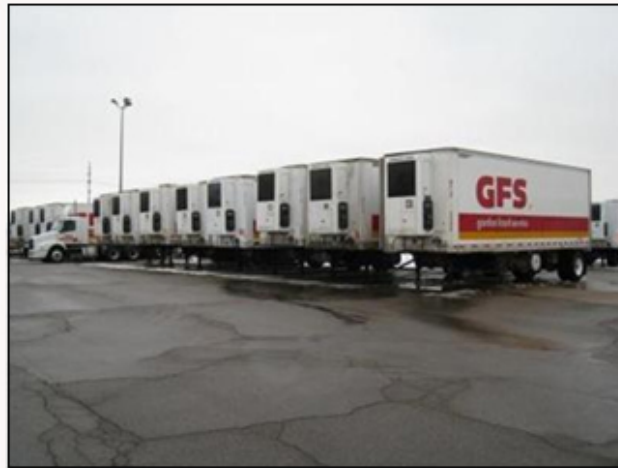
Figure 38. Photo. GFS reefer pups in yard.

Early in the field test, the GFS technicians identified increased tire pressures on several of the ATIS-equipped reefer pups. Tire pressures measured up to 15 psi higher than the fleet's recommended tire inflation pressure. The team identified two conditions that could contribute to the increased pressures: an improperly set regulator valve, or an extended layover period during cold temperatures. The authors contacted PSI to conduct an analysis of the failure. PSI inspected various systems at the facility but could not identify any discrepancies. PSI also tested the pressure setting of the regulators and confirmed the pressure setting of 95 psi.

In addition, the authors reviewed the operation of the GFS fleet and determined that the reefer pups experienced extended layovers between trips. During these layovers, the trailers likely experienced a cold-soak event. A cold-soak event exposes the tires to an extended period of below-average temperatures. As a result, the tire pressure decreases due to the temperature drop. Therefore, during the cold winters and cool evenings in Grand Rapids, the tire pressure dropped during the reefer pup's layover. When the GFS driver hooked up the reefer pup, power was restored to the inflation system, and it re-inflated the tires to the proper pressure. The operation of the trailer throughout its route raised the temperature in the tire, and thus the tire pressure. Depending on the ambient temperature during the technician's maintenance, the tire pressure readings would exceed the pressure set by the inflation system during the startup procedure. If this is the cause for the raised pressures, the tire industry advises not to remove air pressure from tires during a cold pressure reading (after the tire was properly inflated).

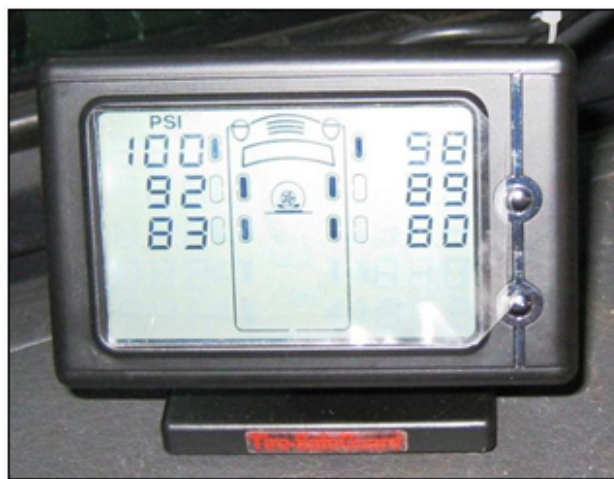
Figure 39. Photo. Tire-SafeGuard reliability, displaying tractor tire data only (GFS).

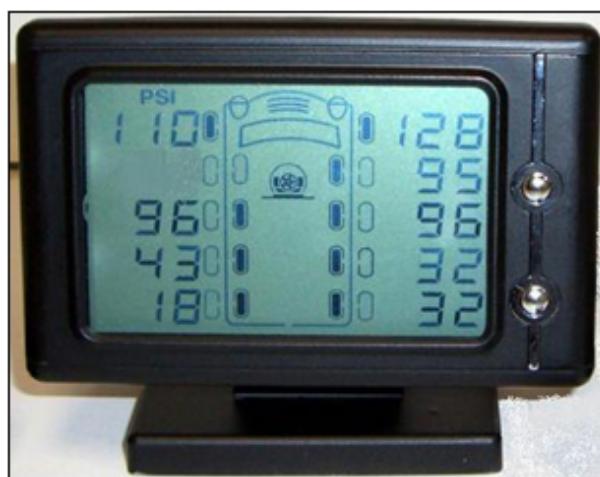
Figure 40. Photo. Tire-SafeGuard reliability; display missing left inside tire data (GFS).

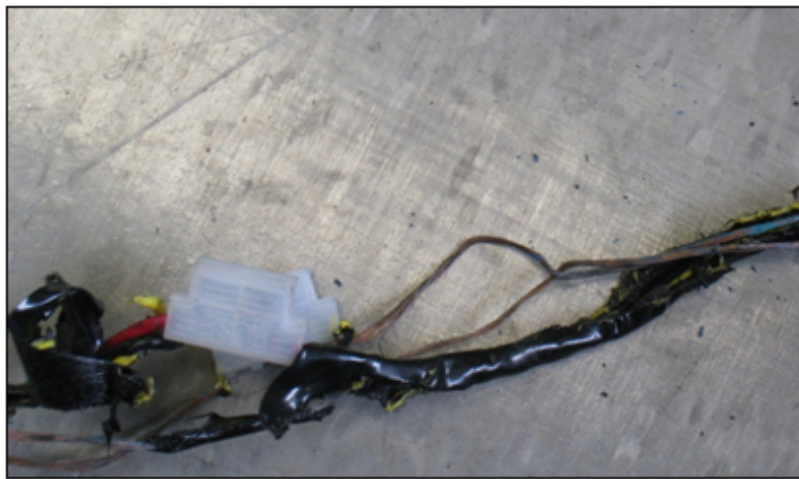
Figure 41. Photo Tire-SafeGuard reliability; failed wire harness.

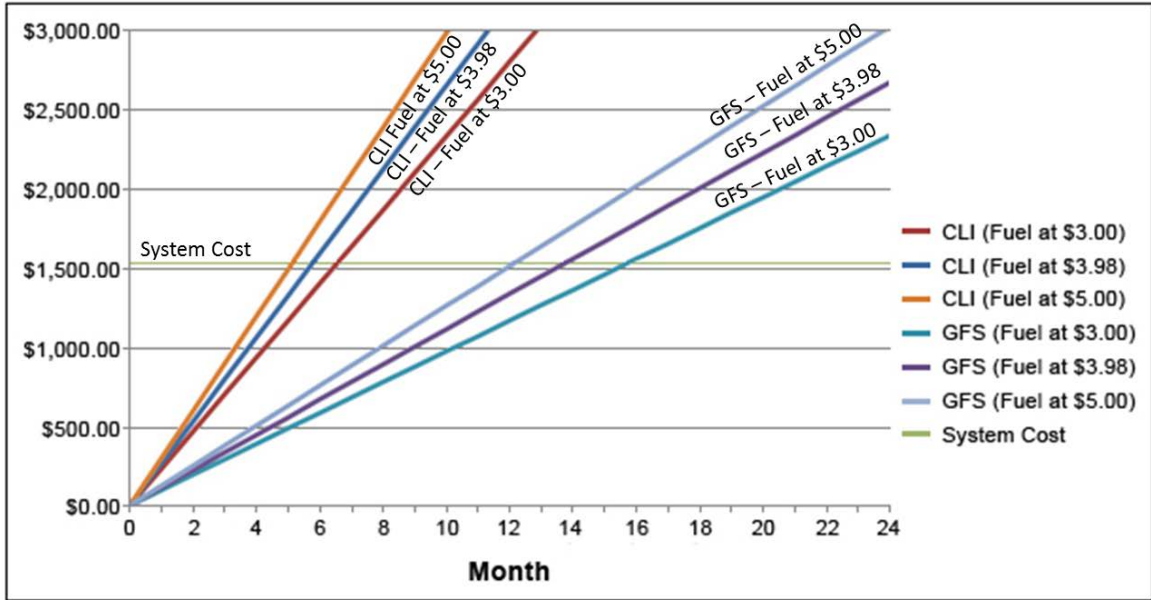
Figure 47. Graph. Accumulated monthly savings per TPMS/ATIS-equipped tractor-trailer.
