| 4. Title and Subtitle<br>SEAL COAT DAMAGE EVALUATION DUE TO SUPERHEAVY<br>LOAD MOVES BASED ON A MECHANISTIC-EMPIRICAL<br>APPROACH | | 5. Report Date<br>December 2009<br>Published: March 2010 | |
| 7. Author(s)<br>Jeong Ho Oh and Andrew J. Wimsatt | | 8. Performing Organization Report No.<br>Report 0-5270-1 | |

**SEAL COAT DAMAGE EVALUATION DUE TO SUPERHEAVY  
LOAD MOVES BASED ON A MECHANISTIC-EMPIRICAL  
APPROACH**

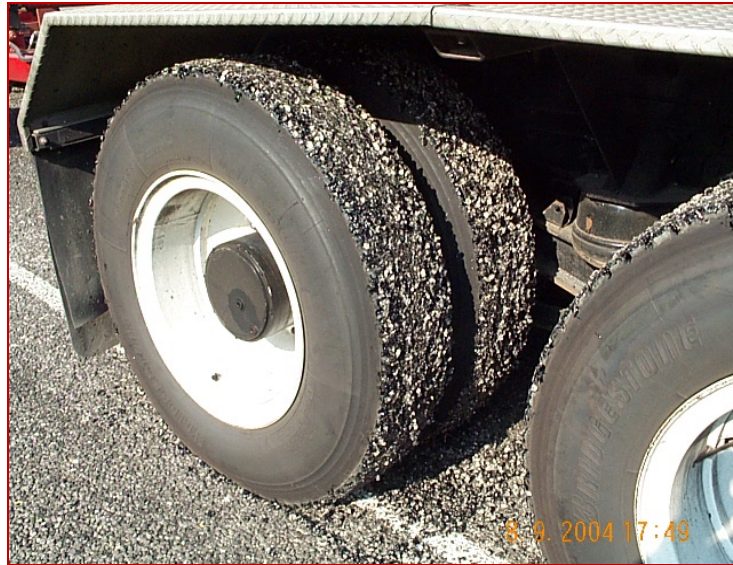
Field monitoring on SHL moves in the past 5 years revealed that the moves primarily caused damage on fresh seal coat pavements typically less than 5 weeks after seal coated as shown in Figure 1. Structural failure rarely occurred from a weak load bearing capacity of underlying layers induced by a sudden increase of moisture content level from considerable amount of rainfall prior to SHL moves made, unsupported pavement edge conditions, and structurally poor condition. Regulating SHL moves travelling along with fresh seal coat pavements has been a challenging task due to the lack of statewide seal coat scheduling and streamlined procedure to evaluate expecting seal coat damage potential. Considering huge mileage of seal coat placed annually (around 20,000 mile/year) by TxDOT for a pavement preservation means, it is imperative to establish an effective guideline to regulate and route SHL moves to mitigate further seal coat damages resulting in significant reducing the cost to repair deteriorated routes. Tentatively, TxDOT adopted a criterion that reroute SHL moves to 5 weeks or older pavements based on the limited field monitoring (1).

**Figure 1. Seal Coat Damage due to SHL Moves.**

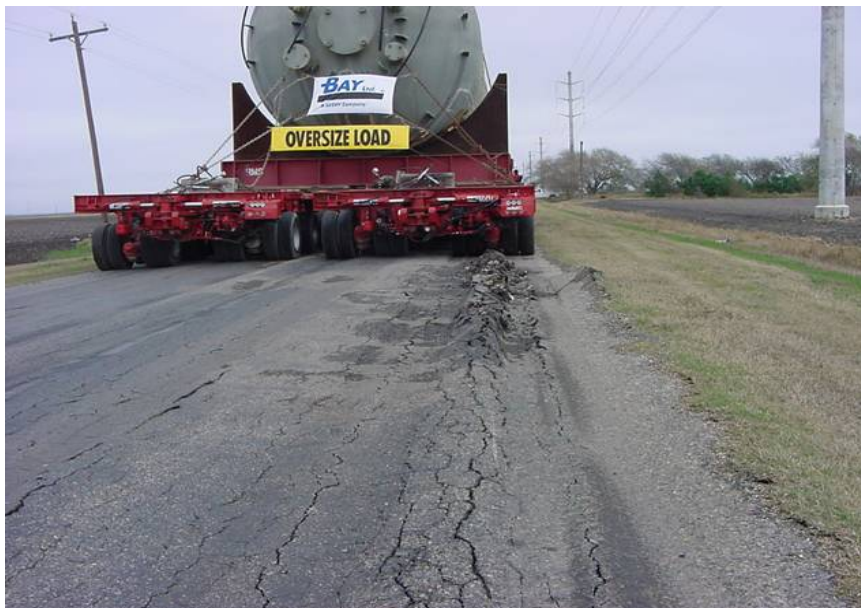
During this move, 8-in of wood mats were placed over culverts and bridges to prevent any damage. Severe pavement damage did occur, however, on FM 796 as shown in Figure 5. According to TxDOT engineers, the area received consecutive rainfall events close to moving day, thus the damage might be due to the loss of load bearing capacity of underlying materials induced by unexpectedly high moisture content. It

indicates that it is extremely important to take into account weather conditions to reduce the likelihood of structural damage, particularly for routes where exhibiting a relatively weak structural capacity or routes built on expansive clay soils that susceptible to moisture.

**Figure 5. Severe Damage on FM 796.**

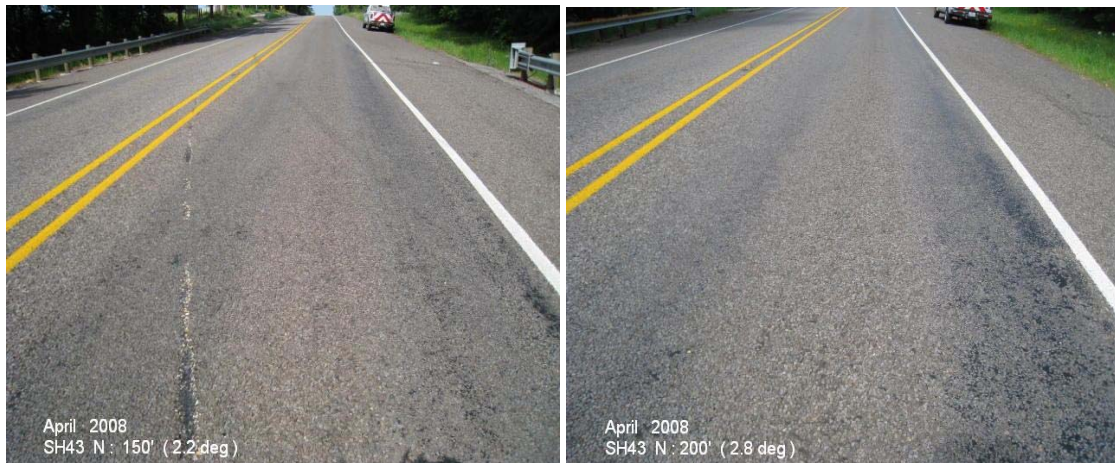
Recent field observations conducted on FM 109, FM 1371, FM 2210, SH 43, and SH 56 showed most of the seal coat damage took place near vertical grades under high pavement temperatures as shown in Figure 8.

**Figure 8. Seal Coat Damage along with Slope.**

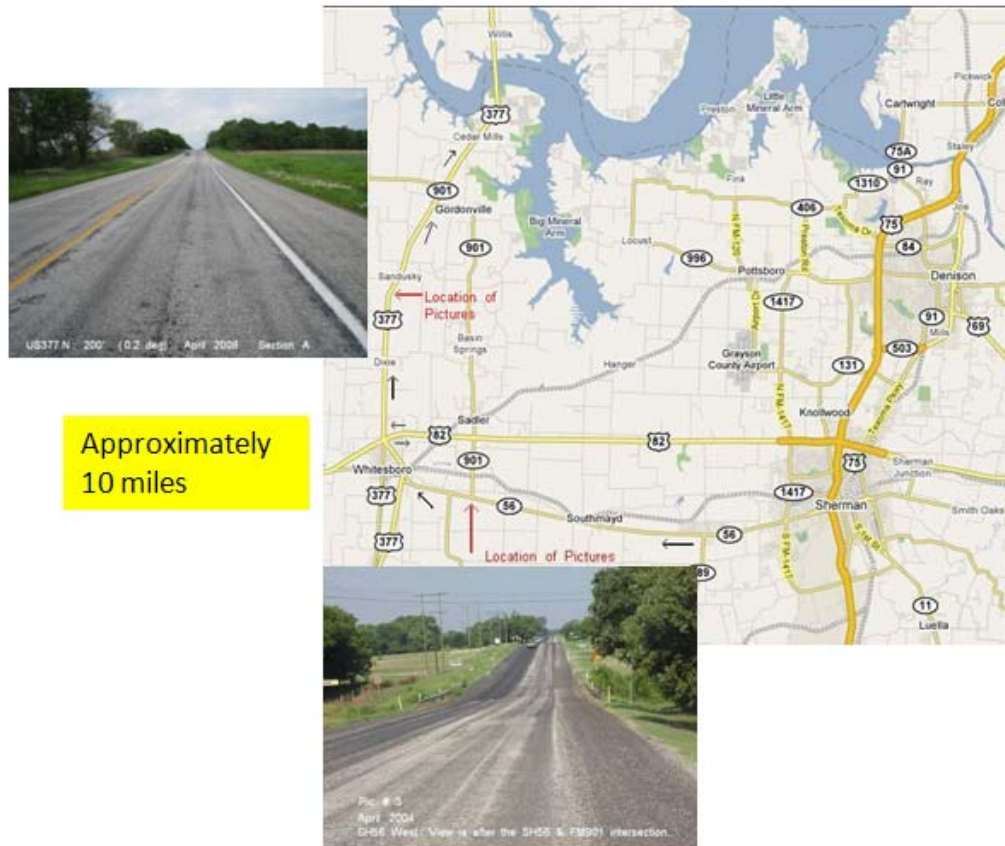
Chen monitored SHL damages that occurred from 2002 to 2005 (20). SH56 and US377 in Paris District experienced fresh seal coat damage during summer in 2005 as shown in Figure 9. Consequently, it was reported that the carrier paid \$265,717 for the damage repair. Considering mileage associated with seal coat damage, which is approximated 10 miles, the estimated repair cost turned out to be \$250,000 based on FY 09 unit cost indicating that the assessment appears reasonable. In June 2005, FM1371 in Bryan District had a mild scraping of seal coat that has been several years old due to SHL moves with 6500 lbs of maximum tire load and 792 kips of gross vehicle weight. The maintenance forces fixed all damaged locations and sent two bills to the carrier. The total bill was \$4,575.78.

**Figure 9. SH56 and US377 Seal Coat Damaged Sections.**

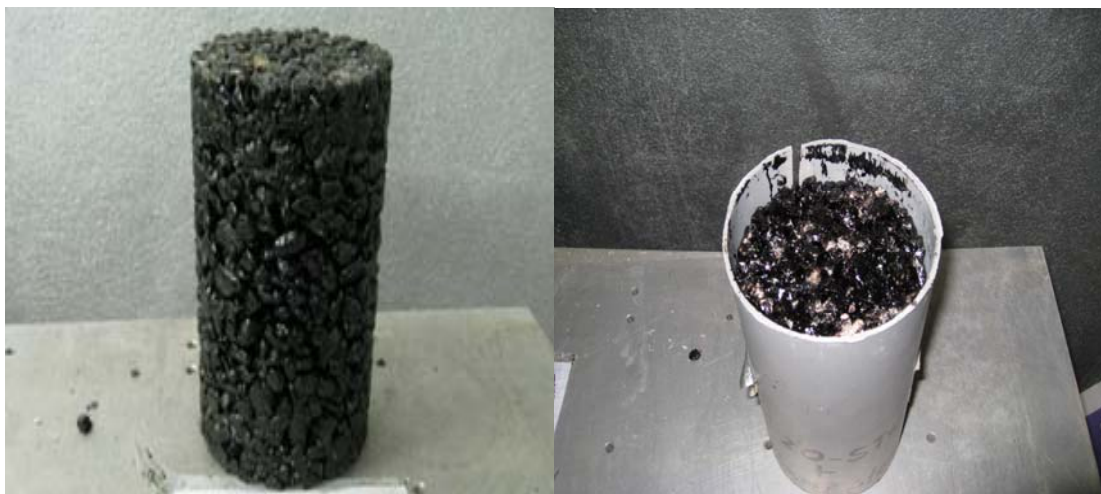
Figure 16. Molded Seal Coat Mixture.

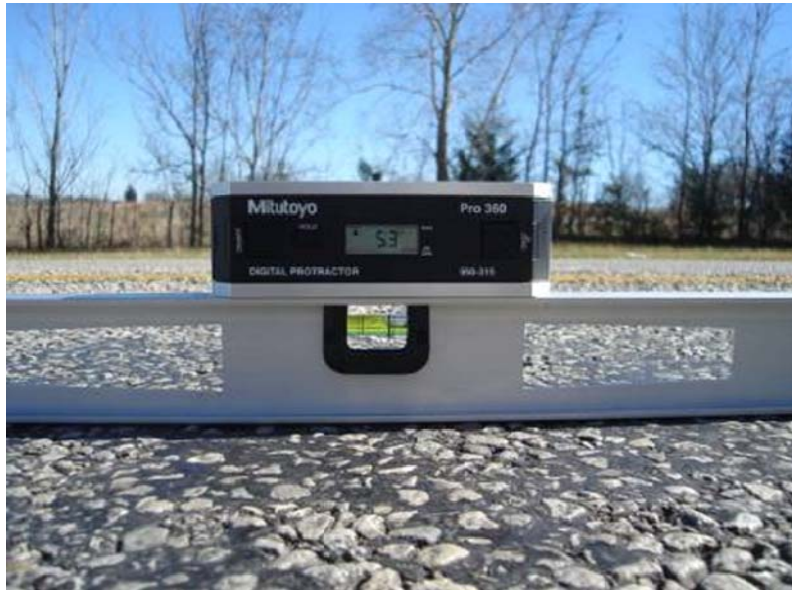
Field tests were planned to conduct at shoulder area not only to prevent damage within the travel lanes but also minimize routine traffic effects on the test results. During the initial survey, researchers measured pavement slopes using a digital protractor as shown in Figure 22. The device was laid over a straight level edge to minimize errors in reading due to irregular shape of aggregate.

**Figure 22. Slope Measurement Using a Digital Protractor.**

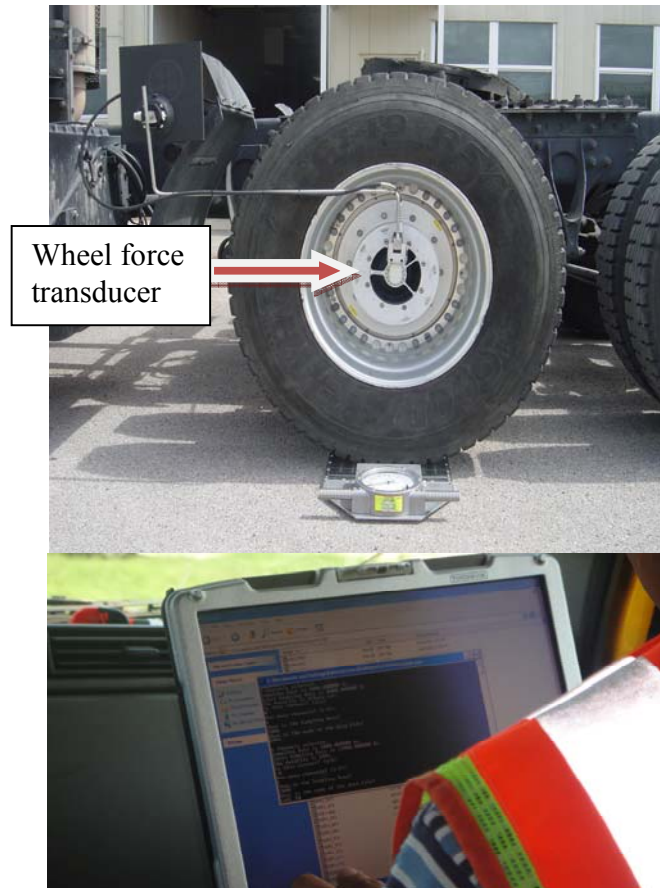
The calibrated wheel force transducer was installed on the test truck and tested with static scale measurements to confirm the workability of the system shown in Figure 24.

**Figure 24. Comparison of Wheel Force Transducer with Static Scale.**

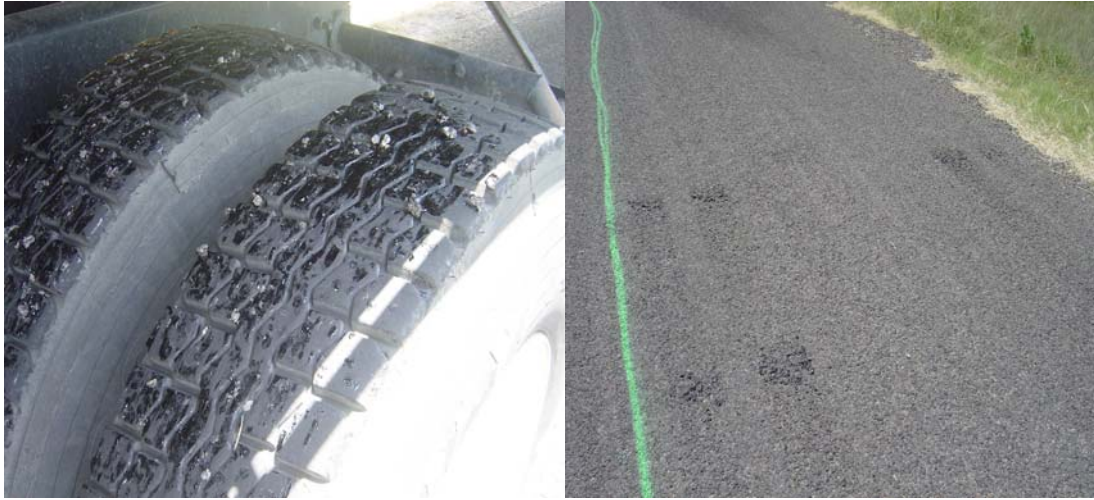
Precise visual surveys were conducted whenever each run was made to rate the extent of damage before and after the truck passage with taking pictures. Three levels of damage were categorized: N for No damage, L for Low damage, and H for High damage. While a low level of damage causing little aggregate segregation accompanied with insignificant bleeding, a case where indicating larger number of aggregate segregation along with severe bleeding of binder was rated a high level of damage as illustrated in Figures 28 and 29.

**Figure 28. Low Level of Damage.**

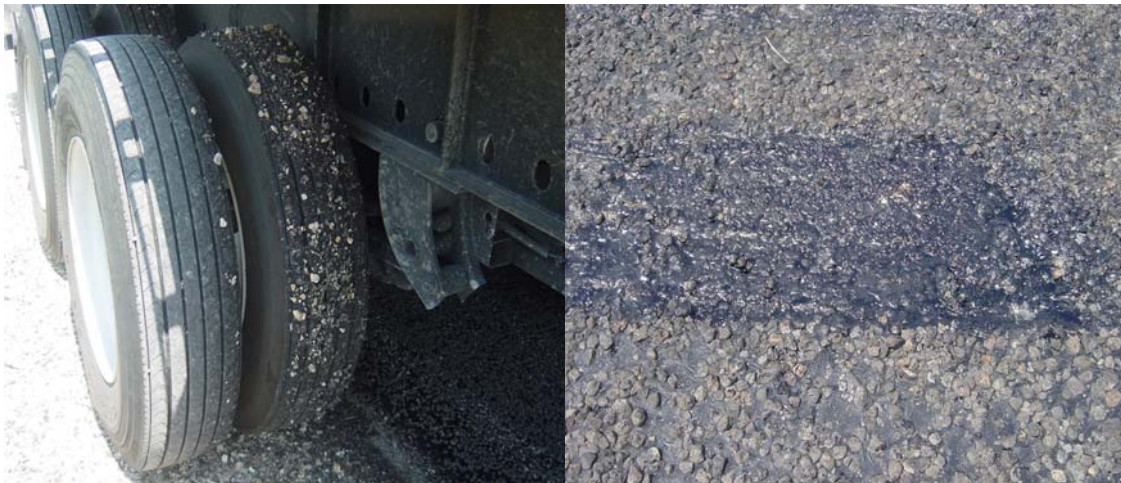
**Figure 29. High Level of Damage.**

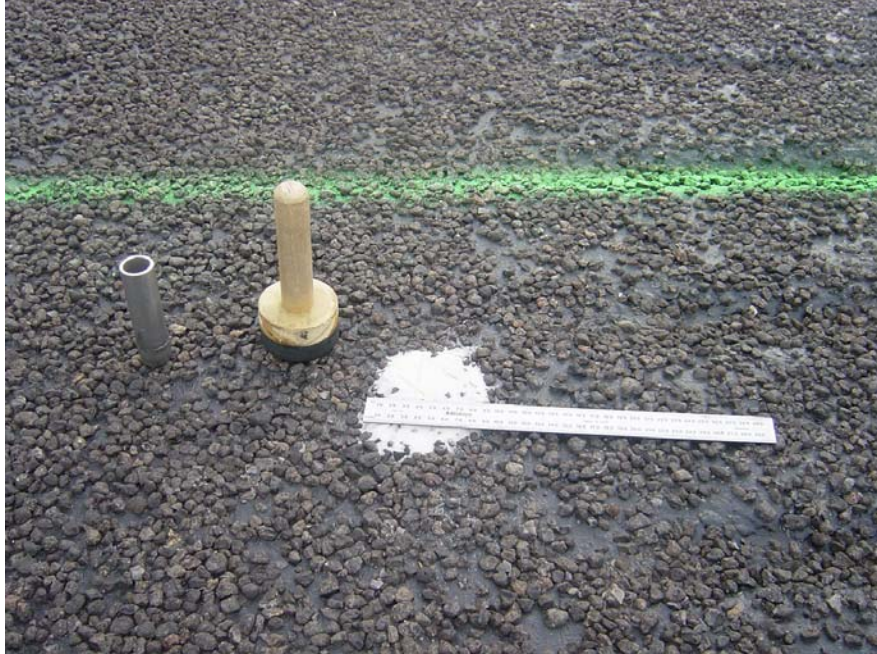
**Figure 32. Sand Patch Test Conducted.**

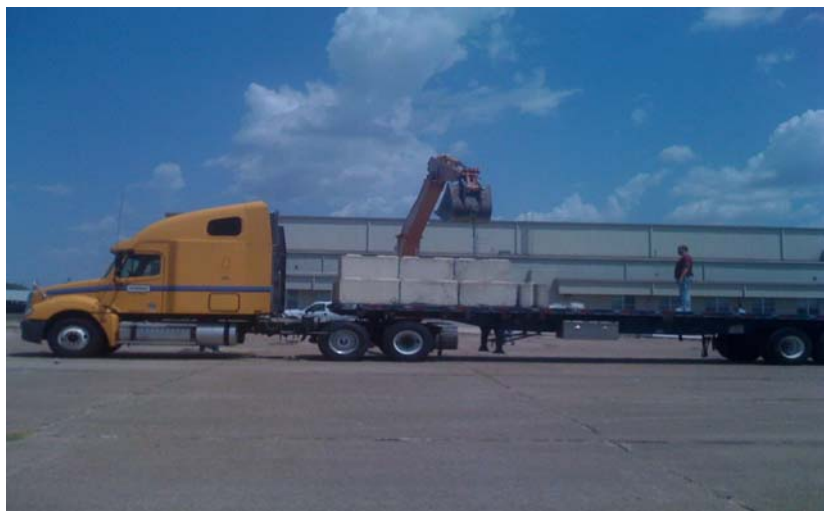
the test truck at the driving axle of trailer to concentrate higher wheel loads at corresponding axle location keeping the GVW below a legal limit of 80 kips for the Bryan District test as illustrated in Figure 35. The measured static scale of dual tires was 11,500 lb, which is approximately equivalent to 5750 lb per tire. The San Antonio District TxDOT engineers provided an annually-permitted test truck as shown in Figure 36. To achieve higher wheel forces, a milling machine filled with a water tank was loaded onto the trailer. The measured static scale of dual tires was 12,500 lb, which is approximately equivalent to 6250 lb per tire. The loaded GVW was 107,500 lb.

**Figure 35. Test Truck for Bryan District Tests.**

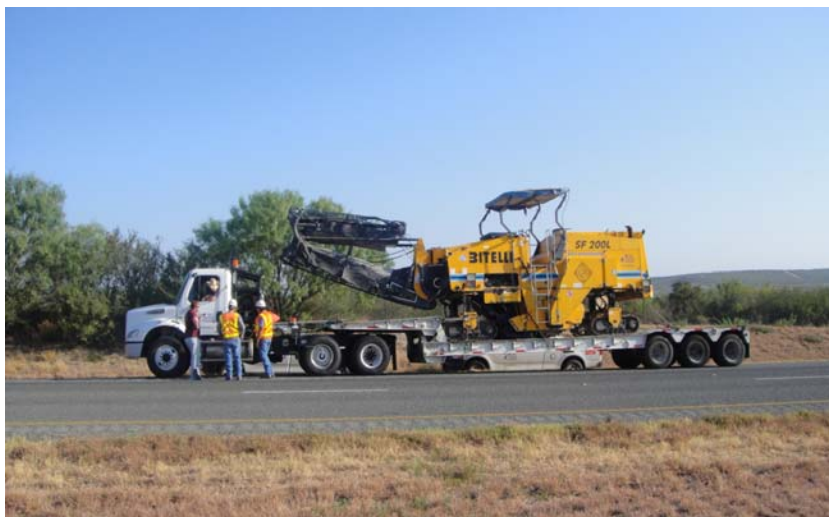
**Figure 36. Test Truck for San Antonio District Tests.**

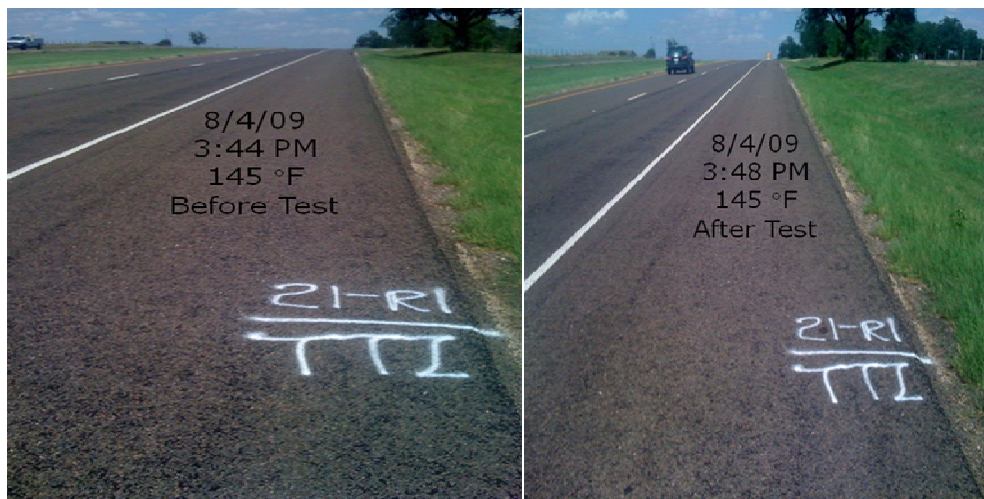
From additional field validations, researchers confirmed that pavement surface temperature is the most critical factor in influencing seal coat damage. It should also be noted that the curing period is associated with the extent of damage. In particular, in spite of hot pavement surface temperature, tests sections on SH 21 that have been aged 1 year rarely revealed any specific damages as illustrated in Figure 38.

**Figure 38. Comparison of Segment Before and After Test.**

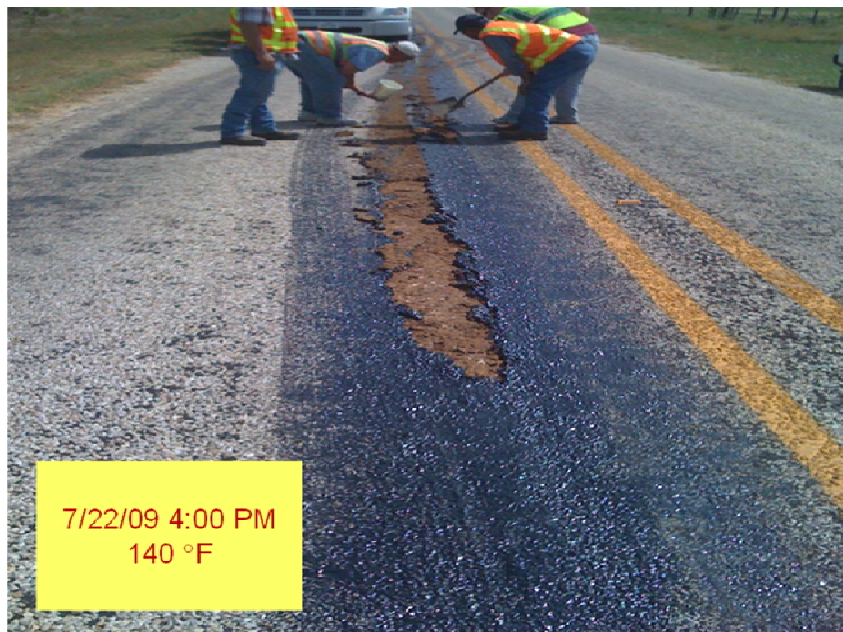
was instead conducted within travel lanes with the permission of the San Antonio District. After the first passage of test truck was made under high pavement surface temperature around 140 °F, several locations along with wheel path came to flushing. During the back up of the test truck to an original location, the surface treatments severely failed as shown in Figure 39. It strongly indicated that special care needs to be taken to the surface treated load zoned roads for routing SHL moves particularly in the event of high pavement surface temperature and steep slope. It is interesting to report that no damage took place when the testing was conducted at the same location in the morning in the event of pavement surface temperature ranging from 80 to 100 °F.

**Figure 39. Severe Damage of Surface Treatments.**

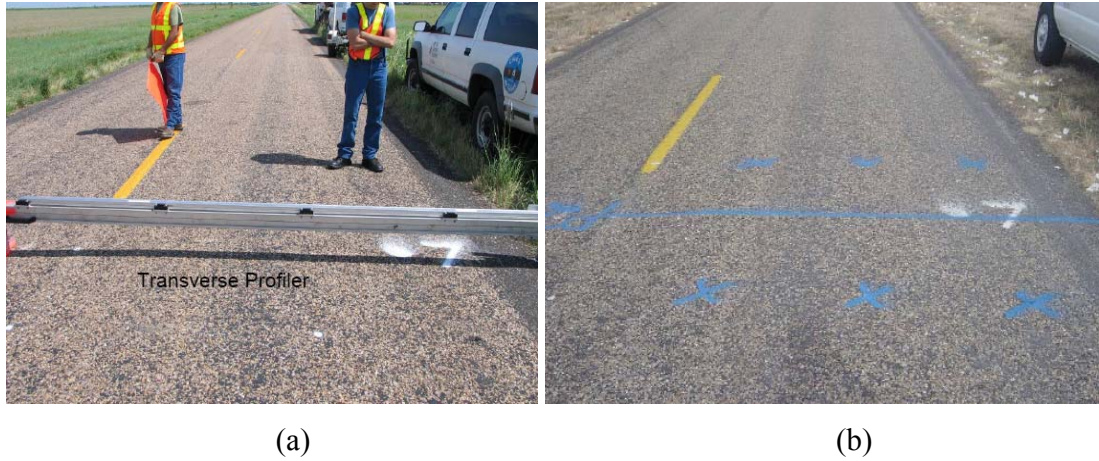
**Figure B10. FM 28 Location 2 on Milepost 182+2100' (a) July 11th; (b) December 6th.**

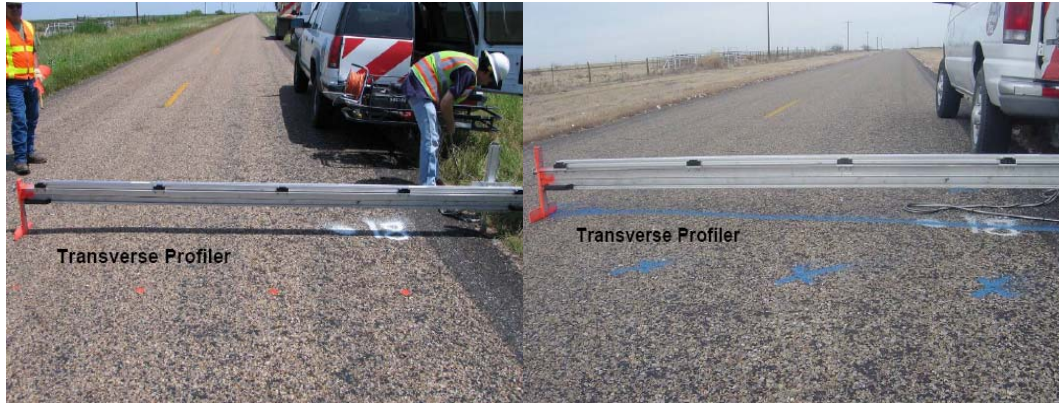
**Figure B12. FM 28 Location 3 on Milepost 182+5400' (a) July 11th; (b) December 6th.**
