**HIGHWAY BRIDGE  
RESEARCH CENTER  
FINAL REPORT— PHASE I**

1. Report No. NM98STR-02		2. Government Accession No.		3. Recipient's Catalog No.	
4. Title and Subtitle Highway Bridge Research Center Final Report – Phase I				5. Report Date January 2005

## **HIGHWAY BRIDGE RESEARCH CENTER FINAL REPORT – PHASE I**

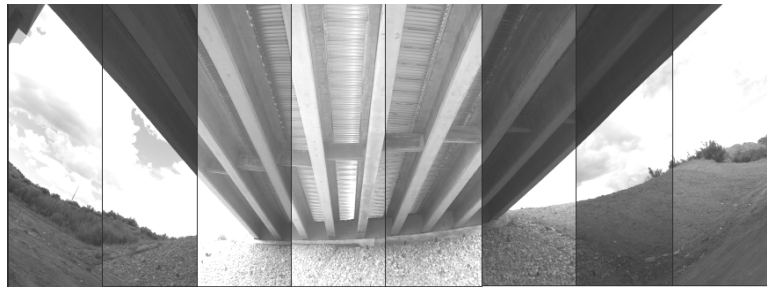
Figure 1. Creation of cylindrical panorama: (a) general process and (b) prestressed concrete bridge example.

*Planning and taking of photographs.* The planning of the photographs primarily involves selecting the nodal positions for the camera, which are simply the camera locations at which a panoramic view of the structure is desired. At each nodal position, a series of individual photographs in equal angle increments are taken which will later be merged into a single panoramic image as illustrated in Figure 1(a).

spherical environment. Cylindrical panoramic creation may be done using the VR Worx program (VR Toolbox, 2003). This program performs stitching automatically by identifying and matching pixels between adjacent images. An overlap of 30% is needed in order for the stitching to work properly. Figure 1(b) shows the merging of 8 individual images taken of the underside of a prestressed concrete girder bridge into a single panorama.

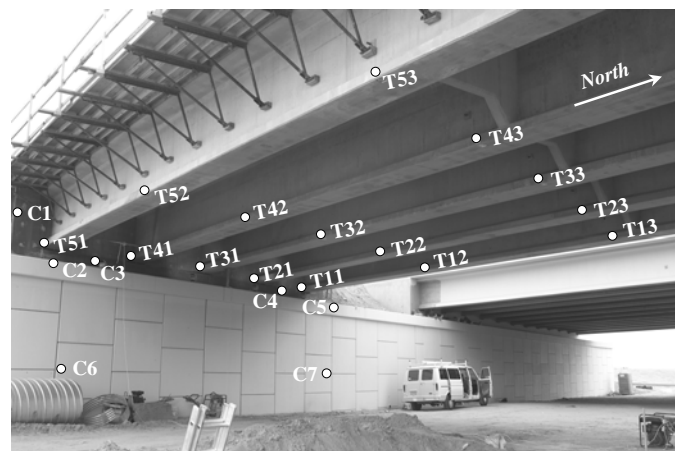
Figure 5. Locations of tie and control points on Las Alturas Bridge.

Photogrammetric targets were mounted on the east side of the bottom flange of each girder. The bullseye targets were installed at five points along the length of each girder: the ends, the quarter points, and mid-span for a total of 25 targets. These girder targets are hereafter referred to as tie points. A total of 15 control points were mounted on the abutments and retaining walls at both ends of the bridge. Figure 5 shows the locations of control points on the south end of the bridge along with some of the tie points on the girders.

Care was taken to distribute the control points throughout the entire area of the bridge at positions assumed to be rigid relative to the superstructure. Hence, any small displacements that may have occurred at these points were neglected. Control information was obtained by surveying the control points with a total station and prism. The measurement accuracy of the total station is approximately 1.5 mm (0.005 ft) with a 1-second resolution for angles. A

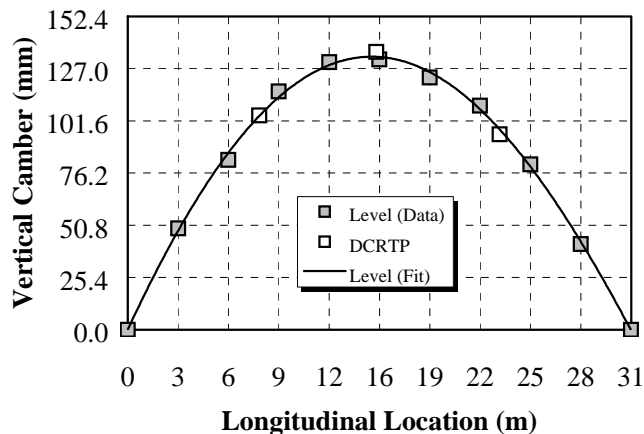
Figure 6. Typical comparison between photogrammetric measurements and level rod readings.

Photogrammetric measurements of the initial camber were compared to those obtained using a traditional surveying level. Level readings were taken at tenth points with a rod positioned on the girder top flanges. Variation of these measurements occurred due to the surface irregularities of the girder top flanges. Figure 6 shows a typical comparison between the photogrammetric measurements, labeled **DCRTP**, and level rod readings, labeled **Level (Data)**. On the horizontal axis, the longitudinal location ranges from 0.0 m (the north end) to 31.1 m (the south end) along the girder length. A curve fit analysis was performed on the level rod readings resulting in the solid line labeled **Level (Fit)**. Compared to the fitted curves, the photogrammetric measurements were within a standard deviation of  $\pm 8.5$  mm (0.33 in) for girder 1,  $\pm 2.4$  mm (0.10 in) for girder 2, and  $\pm 13.3$  mm (0.52 in) for girder 3, amounting to approximately 1 to 10 percent of the maximum measured girder camber.

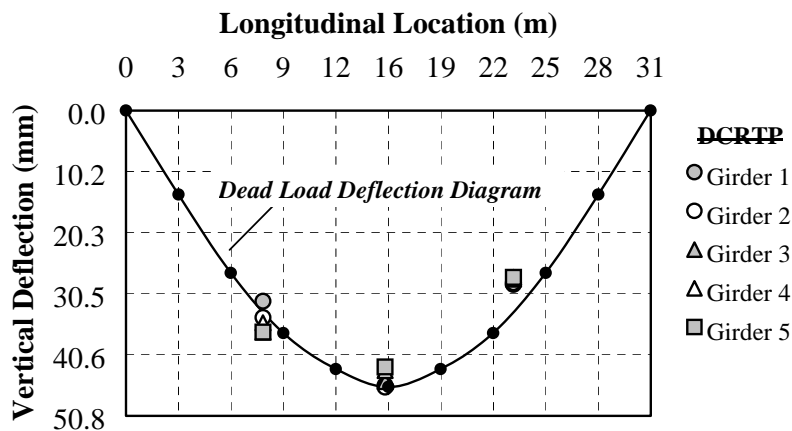
Figure 7. Comparison of photogrammetric measurements and dead load deflection diagram.

Dead load deflection measurements of the five girders using photogrammetry were evaluated by means of comparison with the dead load deflection (DLD) diagram specified in the design plans. The DLD diagram represents the expected dead load deflection of the bridge beams under the weight of the concrete deck and barriers and is used to set the rails for the screed to ensure that the deck is level after casting. The dead load deflections for the five girders are plotted in Figure 7 along with the DLD diagram. The standard deviation was approximately  $\pm 2.9$  mm (0.11 in) at the first quarter point,  $\pm 3.2$  mm (0.13 in) at mid-span, and  $\pm 5.4$  mm (0.21 in) at the third quarter point. Differences of this magnitude were expected since the DLD diagram is based on assumed material properties and a constant deck thickness. In addition, the boundary conditions are assumed to be simple supports and the contribution of the prestressing steel to the moment of inertia is ignored.

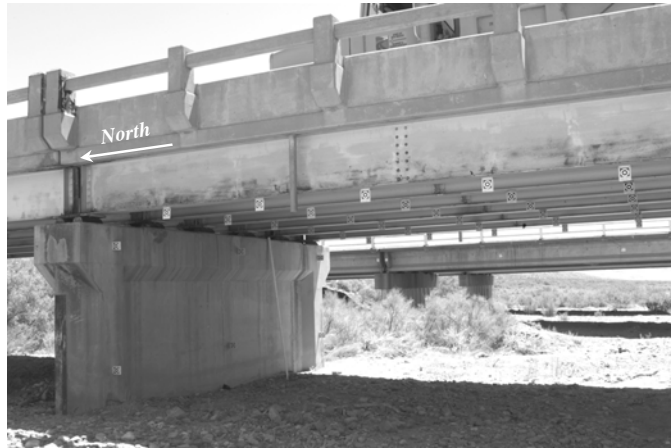
Figure 8. Target layout towards north end of Alamosa Canyon Bridge.

Based on previous laboratory test results (Jáuregui et al., 2003), it was shown that the use of double-sided targets improved the accuracy of the photogrammetric solution. As a result, steel frames were fabricated to hold double-sided laminated paper targets. Targets were mounted on the bottom flange at the  $1/10^{\text{th}}$  points of each of the six girders. These 54 targets served as tie points for the photogrammetric solution. Control targets were attached to three points near the top and bottom of the pier wall on the north and south ends of the span. Figure 8 shows the target layout towards the north end of the tested span of the Alamosa Canyon Bridge. All targets were labeled similar in format to that used in the Las Alturas Bridge study. In addition, the same equipment and procedures given previously in the Las Alturas Bridge study were used to survey the twelve control points and determine the control coordinates for use in the photogrammetry analysis.

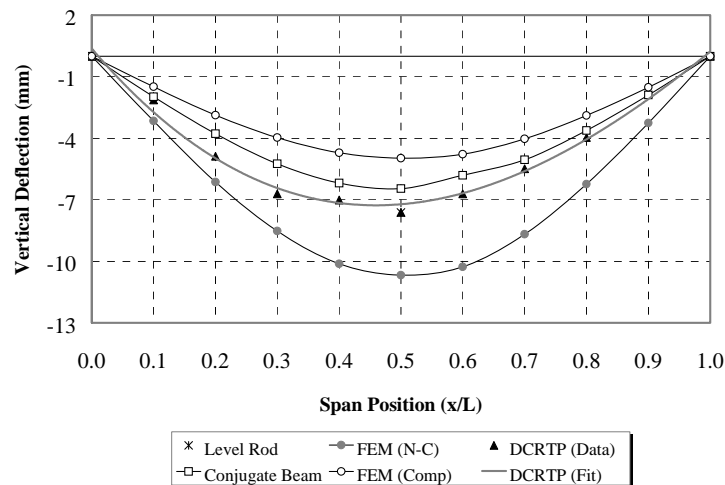
Figure 9. Vertical deflection under live loading versus span position for typical girder.

Typical results of the various analysis methods are shown in Figure 9. Elastic FEA results determined based on non-composite action (labeled as **FEM (N-C)**) are depicted with solid gray circles while results based on composite action (labeled as **FEM (Comp)**) are depicted by solid white circles. Photogrammetric results (labeled as **DCRTP (Data)**) are plotted as solid black triangles. A third-order polynomial regression was performed on the photogrammetry data, which resulted in the dashed line labeled **DCRTP (Fit)**. Curvature-based deflections (labeled as **Conjugate Beam**) are plotted using open square symbols while level rod measurements for each girder are labeled **Level Rod** and plotted as an asterisk.

Note that the composite and non-composite FEA results bracket the experimental results from the photogrammetric, conjugate beam, and level rod deflection values. At midspan, the photogrammetric and conjugate beam calculated deflections were within 1 mm (0.04 in) of one another, while photogrammetric and level rod readings were within 0.5 mm (0.02 in) of one another for all girders. Comparison of the midspan deflections of each girder from the photogrammetric analysis with the two FEA models gave an estimate of the level of composite action. The outer girders 1 and 6 were 92% and 87% composite by this criterion, falling to 71% for girder 2 and 68% for girder 5, and 54% and 58% for the central girders 3 and 4, respectively. The effects of friction and mechanical interlock between concrete and steel along with embedment of the top flange of the girders into the bottom of the deck are most likely the cause of the partial composite action (Jáuregui et al., 2002).

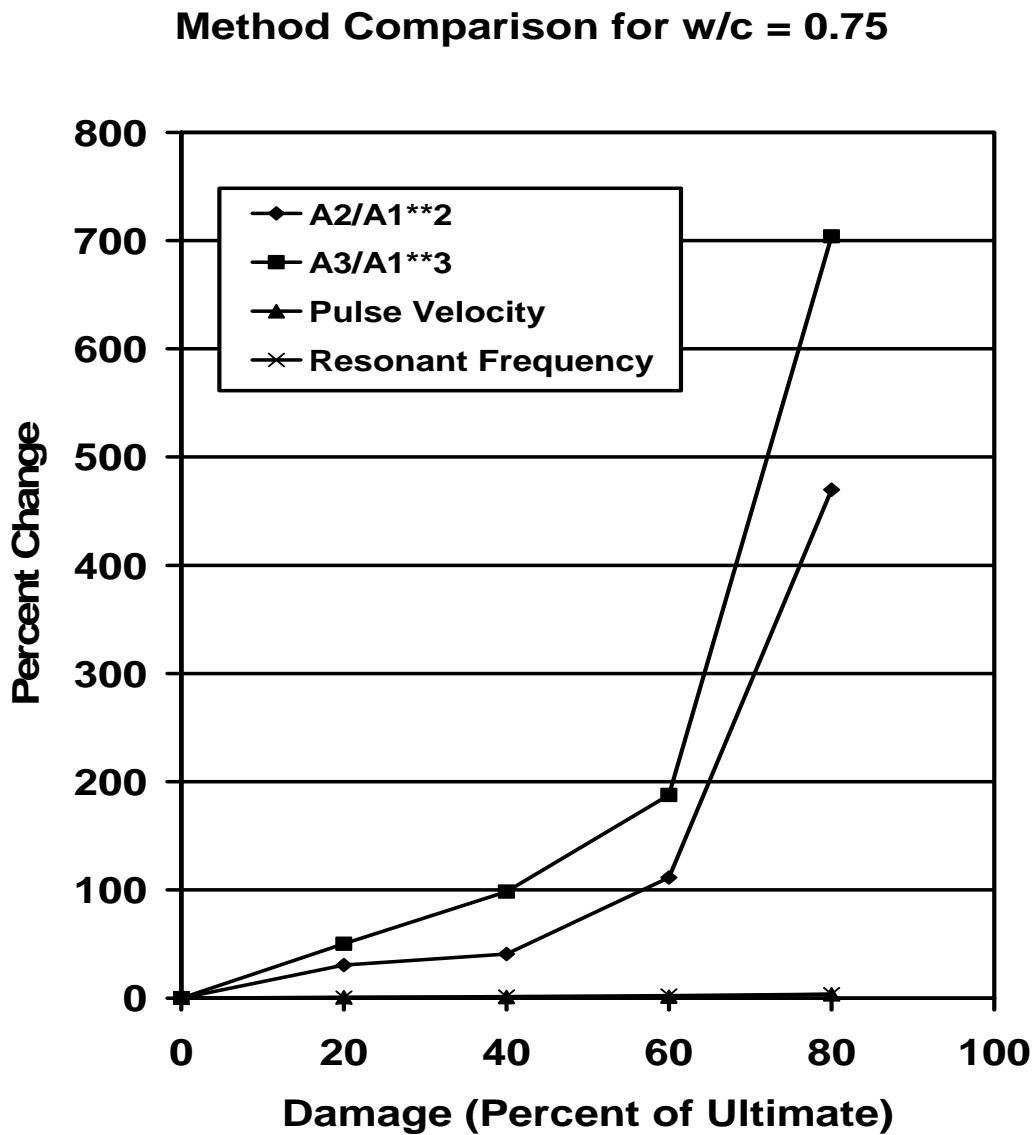
Figure 11. Damage Comparisons

Figure 11 show the results of the 0.75 water to cement ratio. The graph show a marked difference in sensitivity between the methods. Both harmonic ratios show increases over 10% at the 20% damage level. The second harmonic appears to drop off somewhat at the 40% damage level. Large increases are noted with the NLUT harmonic ratios at the 60% and 80% damage levels.

The results of the ASTM methods show a sharp contrast in sensitivity from the NLUT

20% damage level. The tests do show a steady increase from 0% to 80% damage levels with the largest percent change of 11% occurring with the resonant frequency method. Table 2 summarizes the comparison of percent changes in the methods as a result of damage.

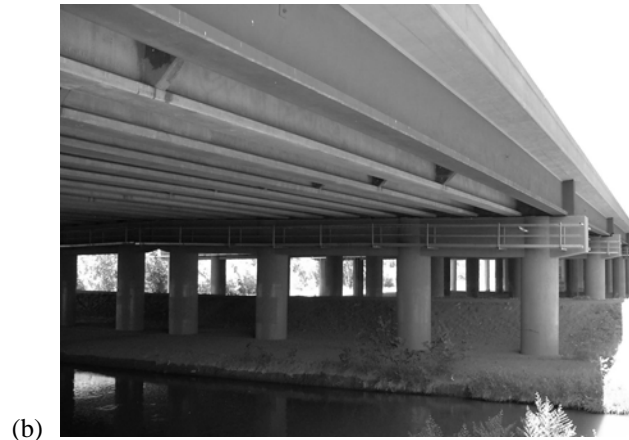
Figure 12. Longitudinal view of the I-40 Bridge: (a) design drawing and (b) photograph from underneath.

Figures 12 and 13 each show a design drawing and photograph (looking west) of the exterior 3-span continuous bridge unit located on the eastern end of the westbound structure. The three spans are supported by fixed (labeled F) and expansion (labeled E) bearings as shown in Figure 12(a). The cross-section of the I-40 Bridge consists of twelve bulb tee BT-1830 (BT-72) girders spaced 2.2 m (7 ft 3 in) apart as shown in Figure 12(a).

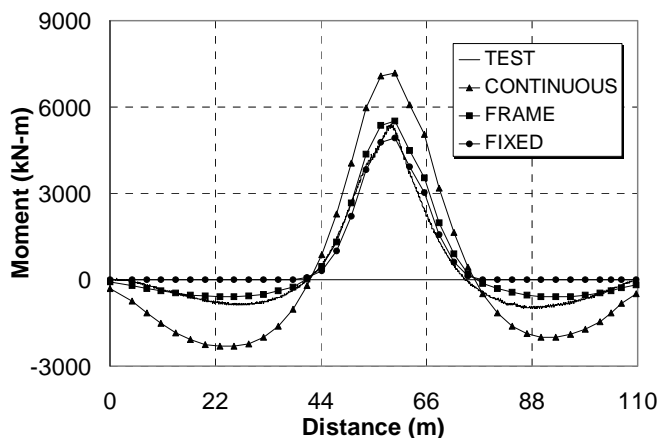
Figure 18. Measured vs. finite element moments at mid-span of exterior girder.

Figure 18 compares the positive mid-span moments for the exterior girder calculated from the measured strain values (labeled TEST) with those determined from the three finite-element models discussed earlier. The figure shows that the CONTINUOUS model overestimated the absolute value of the measured mid-span moment when the truck was on any of the three spans. The maximum positive moment from this model was about 34% larger than the mid-span moment measured from the live-load test. The FIXED model produced moments that were close to the measured moments when the truck was on the second span; however, since the girder deformations were restrained at the ends of the second span, the truck loading on the first or third span caused no bending moment at mid-span, which did not agree with the live-load test. This model was intended to provide an upper limit on the rotational stiffness at the pier and yielded mid-span moments that were nearly 8% smaller than the measured moments with the truck on the second span. The FRAME model provided a good correlation between the measured and predicted moment values when the truck was in all three spans. The mid-span moment from this model was slightly larger (by about 3%) than the measured moment. This strong correlation between the measured moment and those from the FRAME model was observed for each girder and for each load case. Although the interior piers were not designed to produce this type of restrained behavior, the pier stiffness contributed to measured moments about 25 percent smaller than those calculated based on design assumptions (i.e., pin and roller supports or zero pier stiffness).

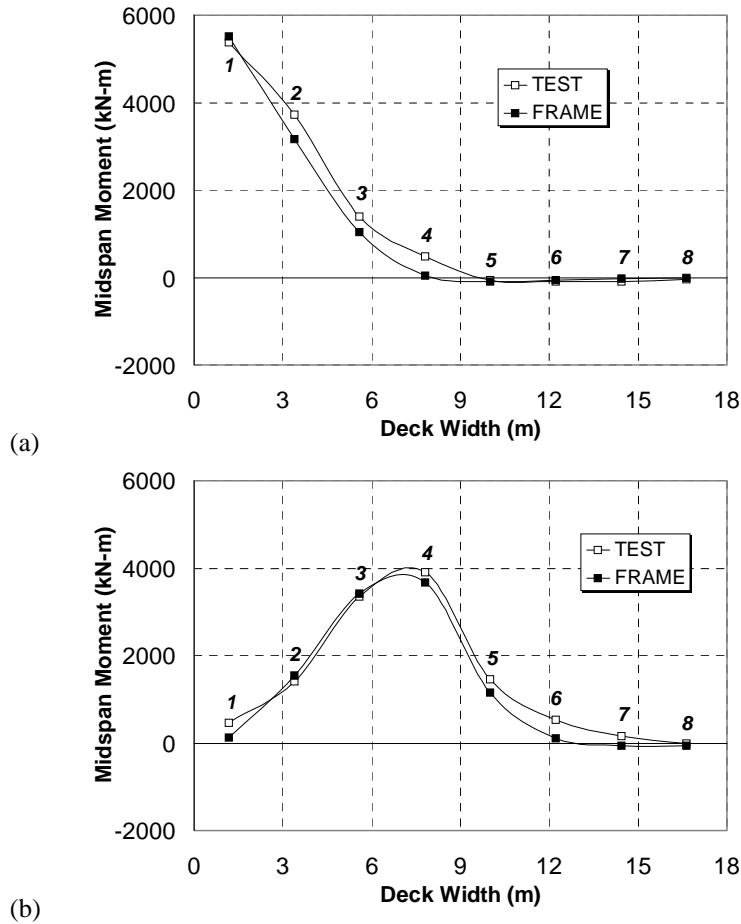
Figure 19. Measured vs. finite element moments at mid-span of the I-40 Bridge: (a) first path and (b) second path.

Figure 19 (a) shows a comparison of the mid-span moments for girders 1 through 8 with the truck positioned at the critical location for maximum positive moment along the first path. The finite-element moments plotted in the figure were calculated using the FRAME model. Figure 19(b) shows the same comparison as that given in Figure 20(a) with the truck positioned transversely in the second path. Similar to the first path, there was a close correlation (within 6%) between the finite element and the measured moments, which confirmed the accuracy of the FRAME model.
