Alternative Pavements for Snowmobile
Crossings

Final Report

Prepared by the New Hampshire Department of Transportation, in cooperation with the U.S. Department of Transportation, Federal Highway Administration

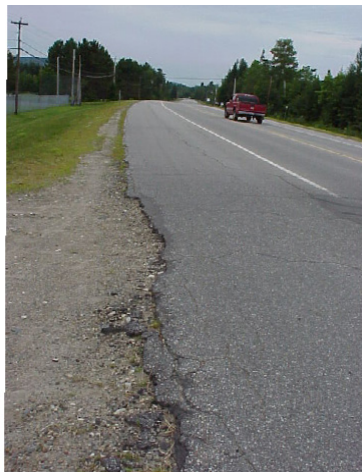
Fig. 1 -- Southbound shoulder edge is broken from stud damage during snowmobile acceleration to cross highway.

The project Technical Advisory Group (TAG) located three pairs of snowmobile crossings on or near the state highway system for testing. The sites were known for heavy snowmobile traffic and excessive pavement wear at the trail crossings. They are located on NH Route 26 in Errol, on US Route 3 and Brown Road in Groveton, and on Old Groton Road and Halls Brook Road along NH Route 25 in Rumney. The trail crossings in each test pair have similar snowmobile traffic and environmental conditions allowing for durability comparisons between the test products and the control pavement areas. A snowmobile counter was positioned along the trail at each trail-crossing pair to better compare the traffic level impacts on the tested materials. Examples of typical snowmobile damage are shown in Figures 1 and 2.

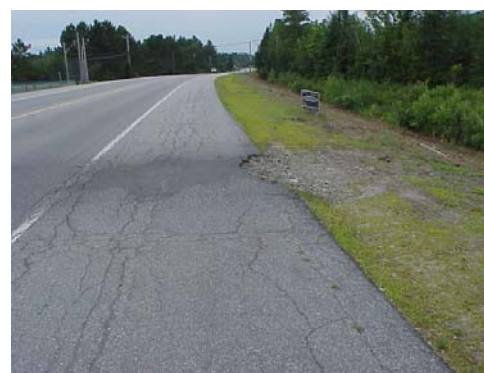
Fig. 2 – Northbound shoulder edge is broken and pavement surface is worn from snowmobile studs.

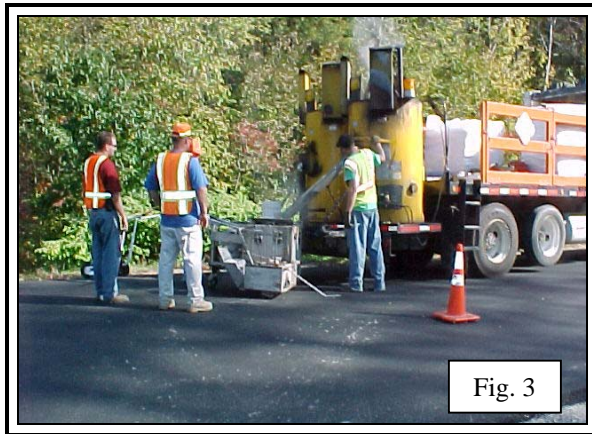
Fig. 3 – Truck mounted heater unit and applicator, Groveton

The Cleanosol installation process involved heating bags of Grade E-5 Norskilt brand thermoplastic material to 425° and 450° F in the kettle of a small self-contained heating unit carried by a small flatbed truck. The entire unopened bag is thrown into the kettle, since the bags are made of the same material as their contents. The heated thermoplastic is then transferred to a heated walk-behind applicator.

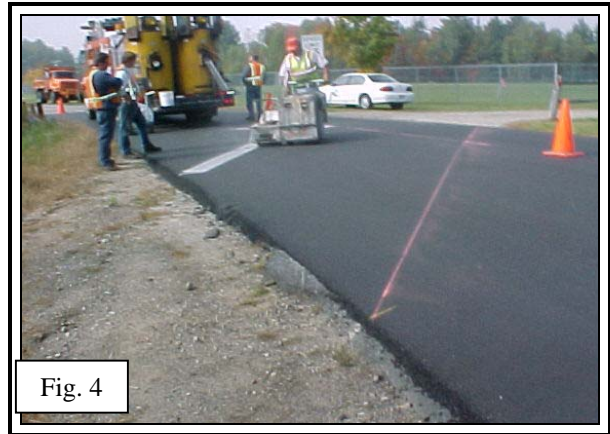
Fig. 4 – First strip applied, Groveton

A 10 – 12” wide strip of thermoplastic was laid down by the applicator at a constant thickness on the surface of the dry, clean, overlaid roadway. Fine silica sand was metered onto the freshly applied thermoplastic from a hopper mounted on the applicator. Additional sand was added by hand over each layer as it was being completed. The sand helps to reduce the stickiness of the hot surface and provides the material with better friction properties than thermoplastic alone. The strips were butted together to complete the first of three layers. The next layer was offset by one half of the strip width to cover the joints of the preceding layer and to create a ramped condition at the leading and trailing edges of the crossing for a smooth transition to the untreated pavement. The third layer was offset from the second. An additional pass was made across the ends of the strips to complete the installation. The entire process took a two-man crew approximately one hour to complete at each location.

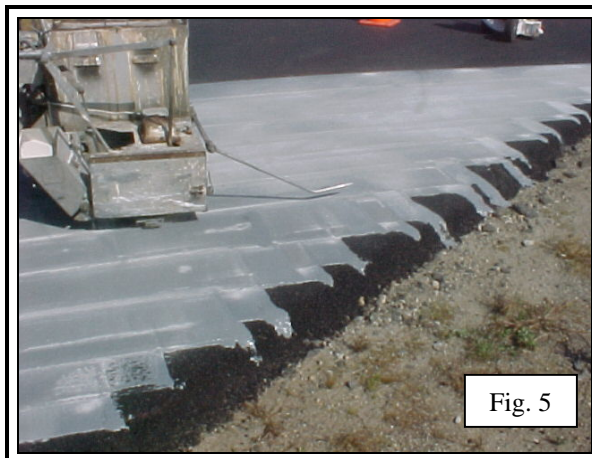
Fig. 5 – Third and final layer application, Groveton; note sand hopper at left of photo

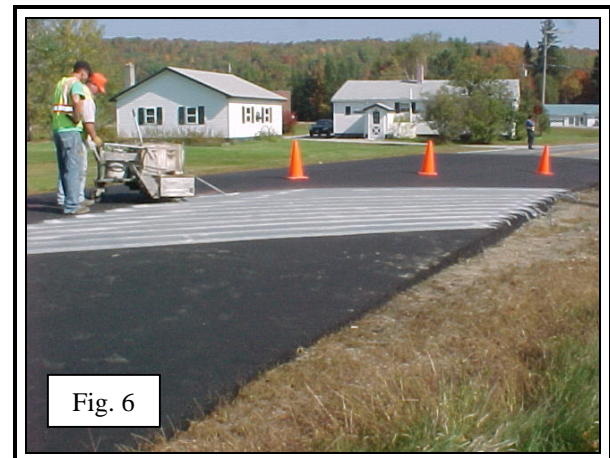
Fig. 6 – Edge strip covers ends, Groveton

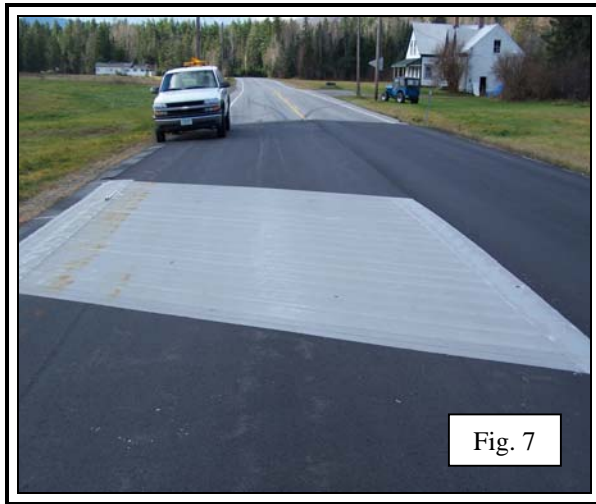
Fig. 7 – Completed panel, Errol

The Cleanosol installations were applied directly to the new overlay at a constant thickness. As a result, the new surface reflected whatever shape preceded it. For instance, a closer look at Figure 7 reveals longitudinal scuffmarks at the roadway crown, lane centerline and shoulder caused by early snow plowing on an irregular surface. These are indicators of the wheel rutting typical of the surrounding pavement, which exist in spite of the overlay. The panels are otherwise flat across the uppermost layer of material. The installations provide good ride quality in both high and low-speed environments. A high-speed crossing is little more noticeable than a good quality trench patch. Only cosmetic scrapes from snow plowing had been observed through the end of December. It should be noted that the snowmobile season was only several weeks old at the time of the observation.

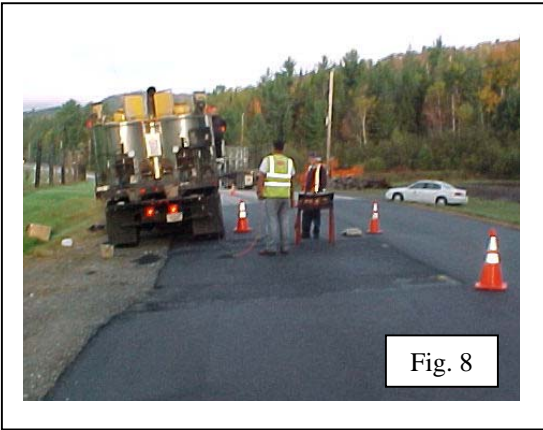
Fig. 8 – Blocked out area in overlay for Imprint inlay, Error

NHDOT had blocked out an area for the Imprint inlay when it placed the asphalt overlay surface preparation. This allowed Marino to apply the Imprint to the existing asphalt surface. The technique saved Marino from having to remove existing asphalt by softening it with infrared heat, Marino’s normal method. It also resulted in a cost savings to NHDOT.

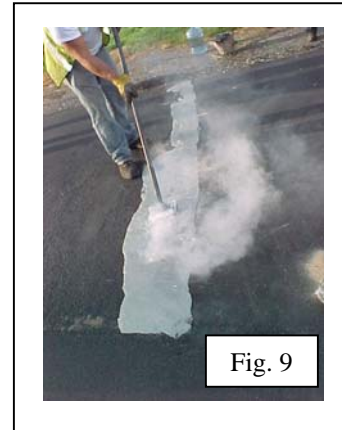
Fig. 9 – Application begins, Error

A truck-mounted heating unit similar to the Clark kettle blended pigment, resin pellets, fine aggregate and two types of reinforcing fibers at approximately 425 to 450 degrees F to prepare the product. The hot mixture was then placed and leveled by hand to match the finish grade of the surrounding asphalt pavement. A heated 6” x 6” iron was used to work the mix and smooth its surface. Play sand was broadcast over the surface before the placed material cooled and solidified.

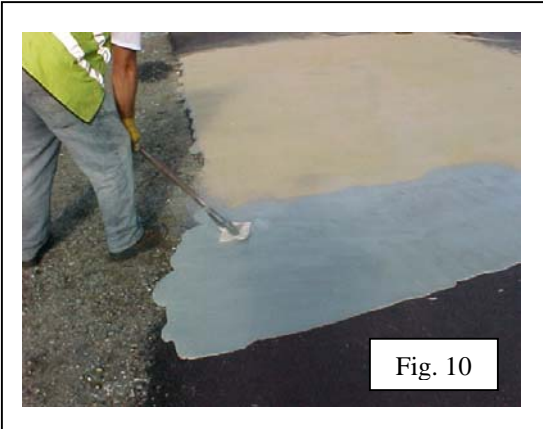
Fig. 10 – Final smoothing with tamper, play sand covers remainder, Error

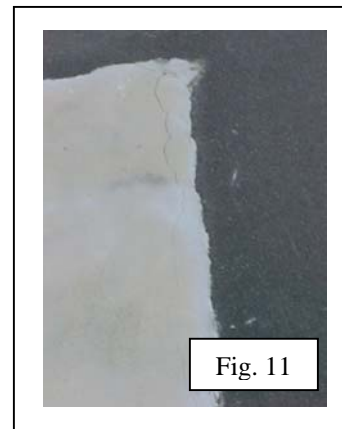
Fig. 11 – Shrinkage cracks appeared at edges, Error

Cracks developed immediately after installation in the Imprint panels. The butt joint between the Imprint and the HMA overlay contracted as well. Some edge cracking (Figure 11) can be attributed to installation at ambient temperatures just below the minimum requirement of 40 degrees F in Errol and just above 40 degrees F in Groveton. The existing pavement was pre-heated with propane torches, but perhaps not adequately to satisfy the needs of the hot-applied material. This matter raised questions regarding the quality of the bond between Imprint and the existing pavement. Additionally, cracks across the central panel areas and edge/joint chipping began to appear by the end of December (Figures 13 and 14). Had Marino heated the entire blocked out area with their infrared heaters prior to placing the Imprint, the greater depth of heating may have helped with bonding and slowed the contraction of the material. The torch method used for this specific installation may have heated the surface somewhat, but it was probably not enough to heat the large mass of the existing pavement layer in the cold environment on the installation date. While the Imprint was hot when applied, the thin layer (1/2" - 3/4") would have cooled rapidly from both the low air and ground temperatures. Stud damage had also been observed at the Errol site by the end of December.

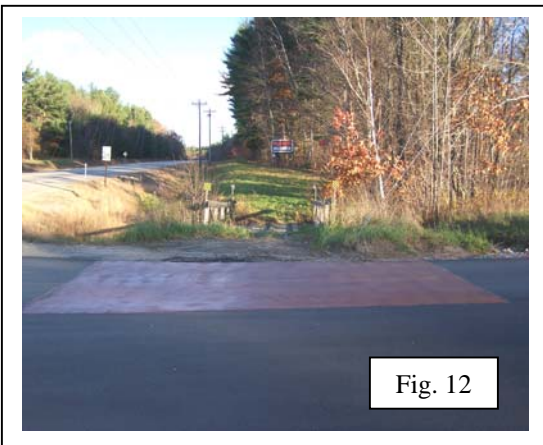
Fig. 12 – Completed panel with red pigment, Rumney

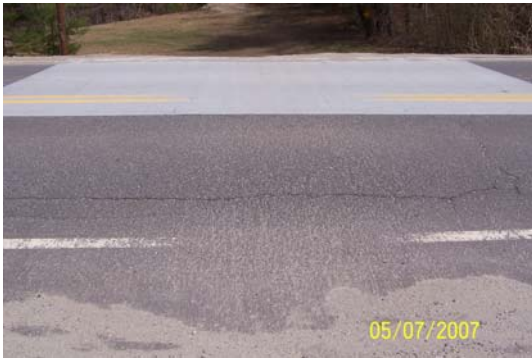
Center Wear Pattern

Two wear patterns were observed at the crossings. Where the trail width was constrained by forest or narrow trail, a wear trough developed in the center of the trail crossing, where most sleds traveled. In areas where the trail approach was broader, two-way traffic movement caused the heaviest wear to occur in a diagonal pattern across the trail. Heavy wear was observed in the first highway lane crossed, where quick acceleration took place. Lesser wear was noted on the second lane crossed.

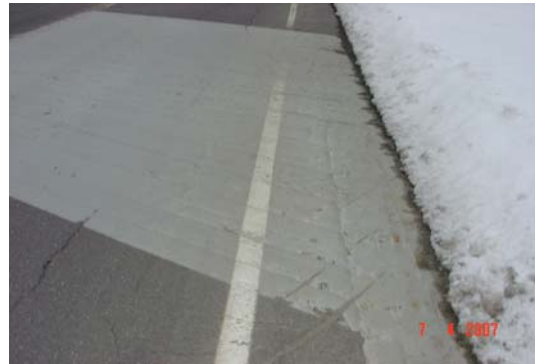
Two-Way Traffic Pattern

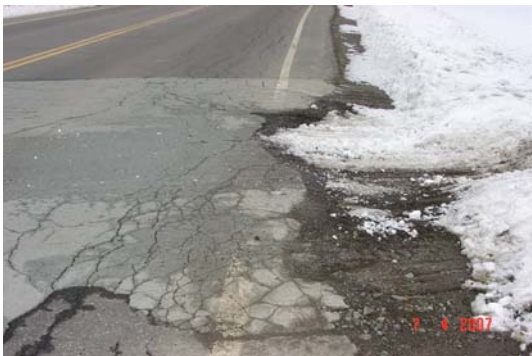
**NH Route 26 Shoulder
Erosion and Edge Chipping**

Severe erosion of the shoulder gravels and chipping of the pavement edge was observed on the NH Route 26 crossings. The poor shoulder drainage conditions contributed to the susceptibility to erosion. Shoulders with better drainage suffered less chipping damage. Conversely, the Groveton US Route 3 paved approach, described earlier, protected the highway shoulder from erosion and the pavement edge from chipping. The approach surface was heavily scratched. Less damage was noted at crossings located on the side roads, which were located near intersections with the numbered highways. This may be attributed to the safer traffic environment on the side roads. Traffic is both lighter, and slowing for a stop sign in each of these locations, rather than traveling at 50 MPH. The snowmobile drivers may not be stopping fully at the highway, and not accelerating as harshly to make the crossing.

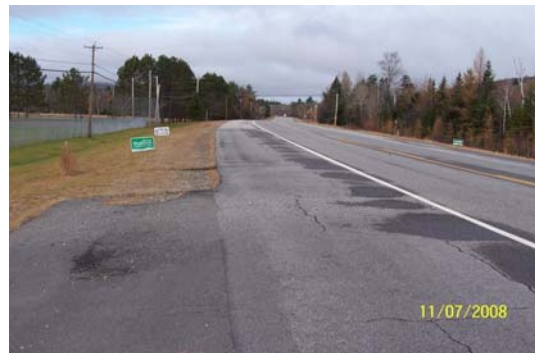
**US Route 3 Approach Apron
Surface Wear, Limited Loss of Edge**

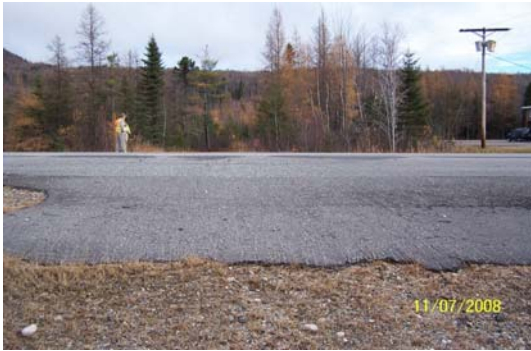
**US Route 3 Approach Apron
Surface Wear, Minor Loss of Edge**

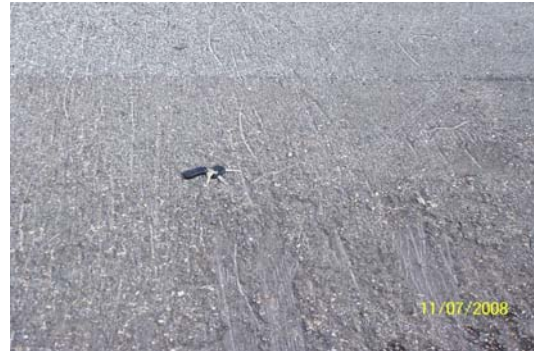
**US Route 3 Approach Apron
Surface Wear, No Loss of Edge**

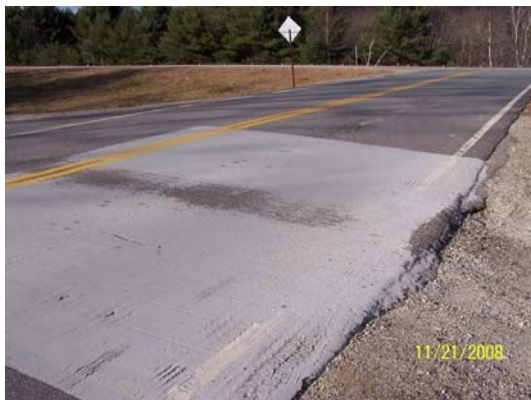
**Halls Brook Road, Rumney
Single-lane and Edge Wear
(Note Steep Slope Grade and
Erosion of Shoulder Materials)**

each other. The Rumney panels experienced single-lane traffic, effectively doubling the wear compared to wider, two-lane patterns. This traffic intensity wore completely through the surface treatment and exposed the underlying HMA layer.

Edge damage ranged from heavy surface treatment and control mix erosion (Rumney and Groveton) to pavement chipping and loss (Groveton and Errol) extending into the travel way (Errol). The broad range of edge damage can be mainly attributed to varying traffic levels. Shoulder grade and shoulder materials are also contributors.

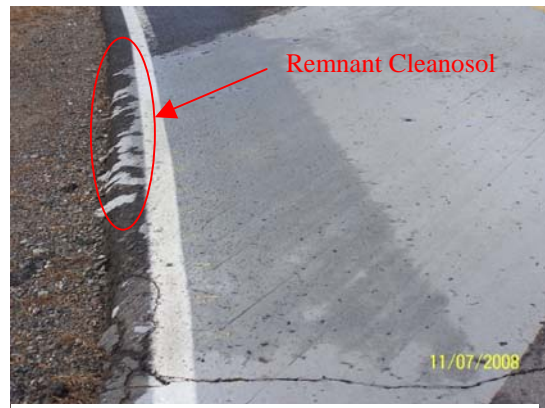
**Brown Road, Groveton
Edge Wear of Cleanosol
(End Strip is Worn Away Due
to Lack of Shoulder Material)**

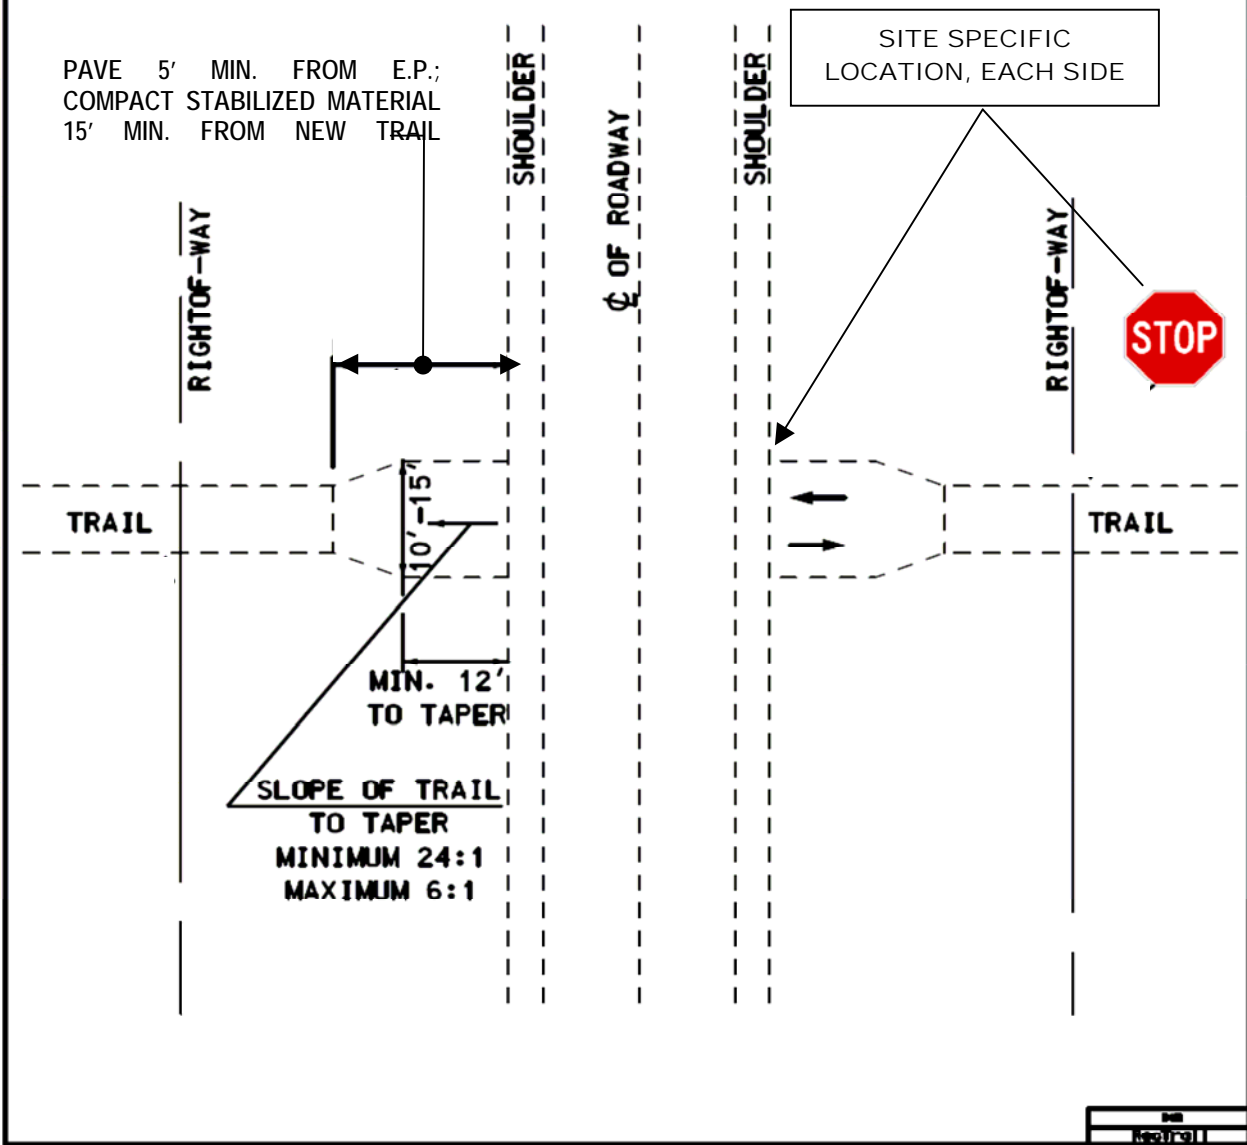
TYPICAL MOTORIZED RECREATIONAL VEHICLE TRAIL CROSSING

SITE SPECIFIC CONDITIONS MAY REQUIRE THAT THE FOLLOWING ITEMS BE ADDRESSED:

- PRESERVATION OF EXISTING DRAINAGE COURSES
- STABILIZATION OF THE TRAIL BEYOND THE PAVED APRON
- EMBANKMENT GRADING FOR THE TRAIL APPROACH

1. The Department should adopt Appendix A - Motorized Recreational Vehicle Trail Crossing detail for use in permitting new trail crossings. Its requirements are valid for wheeled vehicle trails as well as for snowmobiles.
