# Assessment of Alternatives in Vegetation Management at the Edge of Pavement

WA-RD 736.1

**RESEARCH REPORT**  
Internal WSDOT Study  
“Pavement Edge Vegetation Management”

Prepared for  
**Washington State Department of Transportation**  
and in cooperation with  
**U.S. Department of Transportation**  
Federal Highway Administration

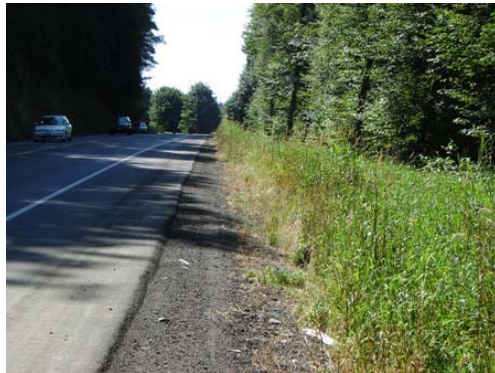
*An example of a roadside in Western Washington that meets all required objectives at the lowest annual maintenance cost is US 12 between Elma and Centralia. The pavement edge (Zone 1) is treated once a year with residual herbicides and the remainder of the operational area (Zone 2) is only mowed occasionally and typically only receives selective cutting or spraying to control unwanted weeds, trees and brush.*

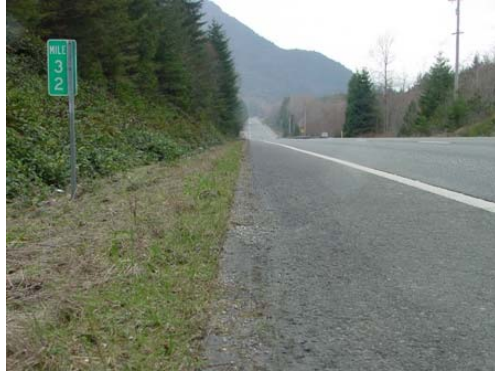
*In many cases the shoulder is mowed regardless of the presence of a vegetation-free zone. In these cases one of the main benefits of an added vegetation-free zone is prevention of edge build up. However, on the SR 2 corridor east of Gold Bar, the shoulder has been vegetated to the edge of pavement for the past 10 years and mowed two or more times each year. Edge build up in this area is routinely removed through winter plowing operations when operators run the edge of the plow blade along the edge of the pavement and the previous year's build up is broadcast away from the pavement toward the ditch.*

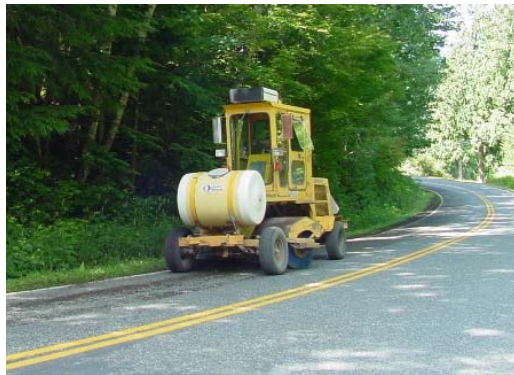
*Adjustments to maintenance practices such as sweeping and winter snow plowing help remove edge build up without adding cost. (isn't there a cost associated with sweeping?)*

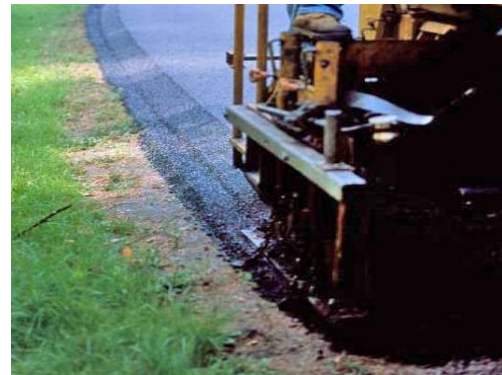
*Pavement edge design also can help manage edge build up and allow for stormwater surface drainage where grass is allowed to grow up to the edge of pavement*

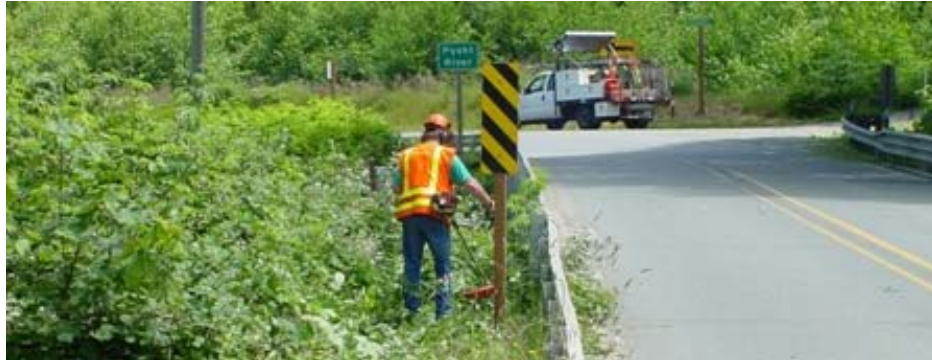
*Trimming vegetation around guardrails manually is time consuming and exposes maintenance workers to traffic and tripping hazards.*

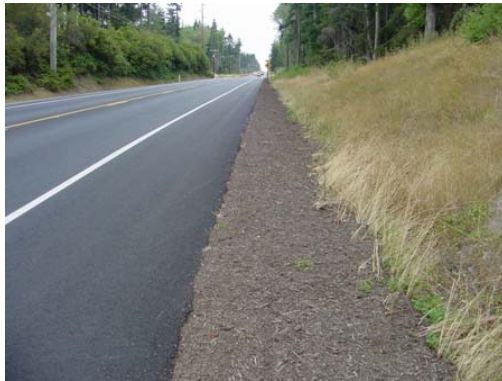
*A compost layer is less expensive than top course crushed rock and aids in stormwater management. Course grade material compacts for a drivable surface.*

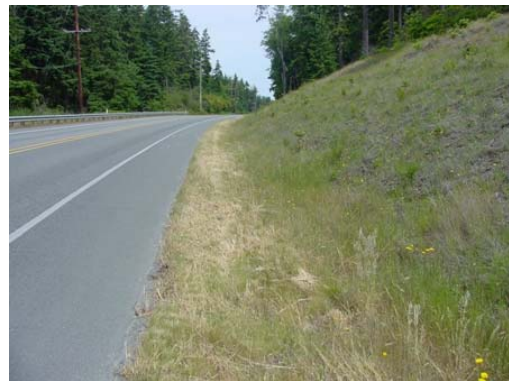
*5 years after construction this location has a well established grass stand and less edge buildup than other locations, shown here recently mowed with sickle bar.*

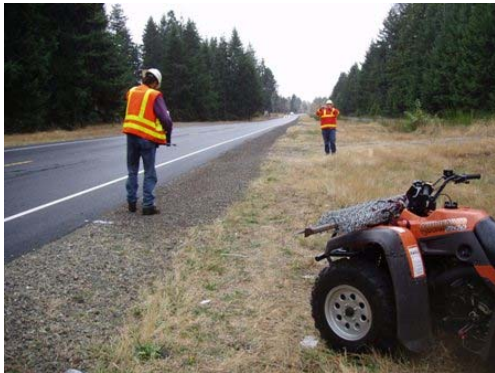
*Spreading seed by hand and raking in with an ATV and chain link proved effective and less expensive than hydro-seeding.*

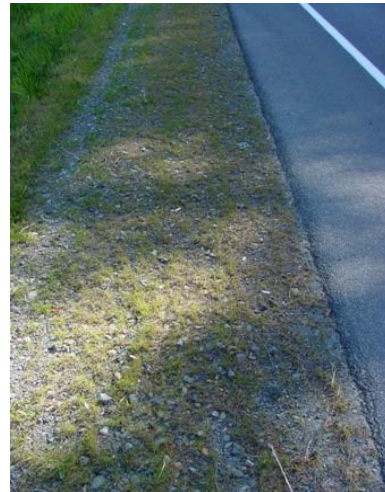
*This location has fairly sparse grass growth but no weeds. To date this site has required no maintenance whatsoever.*

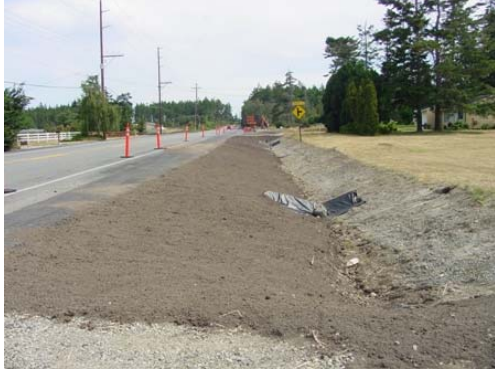
*Topsoil placed during construction was subject to erosion due to the fine particles in soil structure.*

**Recommendation:** This alternative should not be used due to the inability to compact the material. The resulting soft shoulder creates safety concerns if vehicles leave the pavement, and the potential for vehicles getting stuck. Where grass is intended to be established up to the edge of pavement through design/construction the recommended soil amendment should be a thin layer of course compost or a mixture of compost with sufficient crushed rock to provide support for errant vehicles.

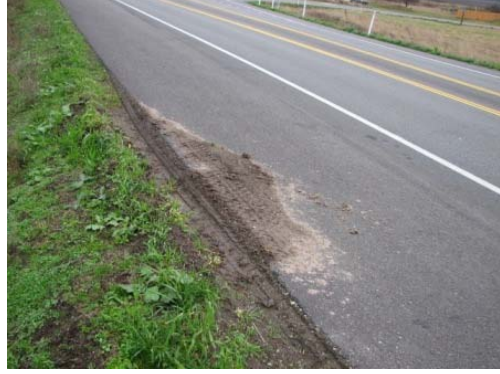
*Tires tend to sink into shoulder when vehicles drive off pavement and even got stuck in wet conditions.*

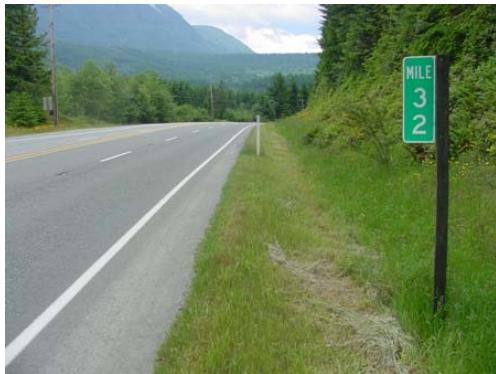
*Not only the pavement edge, but the entire right of way along this corridor is a model of consistent IVM application over time. The result is a high level of service at the lowest life-cycle cost.*

**Results:** This is perhaps the best example in Western Washington where maintenance has adapted and transitioned from a vegetation-free edge to a healthy grass stand. Shoulder buildup has not been an issue, being controlled incidental to winter plowing and sweeping operations. More frequent mowing also seems to contribute in minimizing edge buildup. Cost including two mowing cycles with the truck mounted boom mower is still only half the cost of other locations being mowed once annually using a tractor mounted drop-down side mower. Use of the truck mounted mower also allows the crew to do selective trimming as needed to control vegetation in Zone 2 beyond the pavement edge.

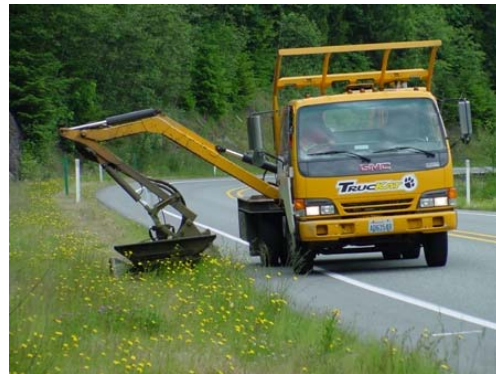
*Use of a truck mounted boom mower allows the crew to mow the edge at an average speed of 7 miles/hour and drive to mowing sites at highway speed. The mower is also used to selectively trim vegetation on the back slopes.*

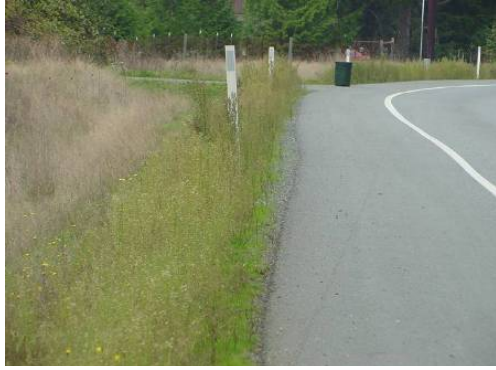
*In the first years after residual herbicide use was discontinued, a number of weed species established and spread along the pavement edge. Shown here is a heavy infestation of the annual weed *Conyza canadensis* or Horseweed.*

**Results:** Without any effort to manage the types of vegetation coming back in to what had been formerly maintained as bare-ground, weeds quickly became established in many areas. Depending on the surrounding area or traffic deposited seed source, tansy, knapweed, scotch broom and several other annual or perennial species of weeds have grown and spread along the shoulders. Scotch broom especially continues to persist and grow back even with repeated annual mowing.

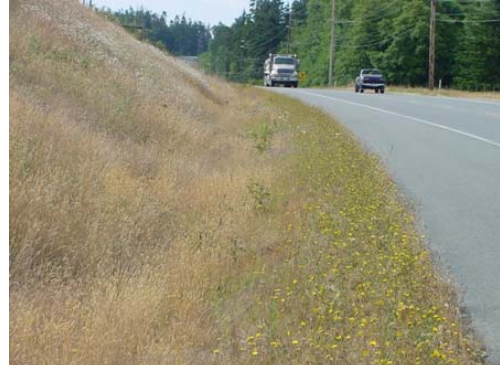
*Over 4 years most of the shoulders along SR525 have evolved into grasses and perennial nuisance weeds such as smooth catsear and occasional patches of scotch broom, tansy and knapweed.*

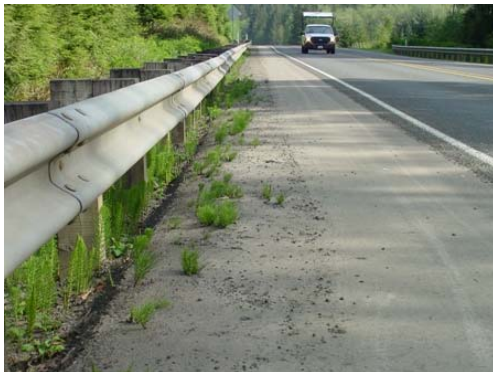
*Field horsetail grows in wet areas and if not controlled will come up through several inches of asphalt causing the pavement to deteriorate. The only way to manage horsetail is with selective herbicides.*

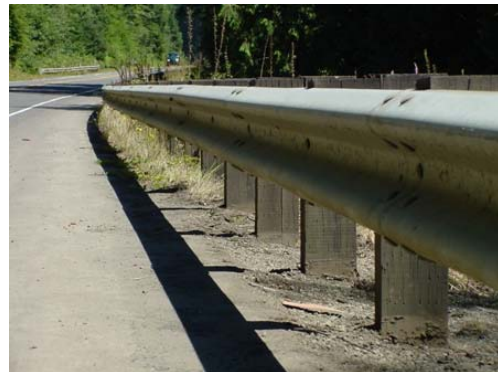
*Vegetation and buildup under guardrail has been removed manually on a three year cycle since herbicide use was discontinued in the early 1990's.*

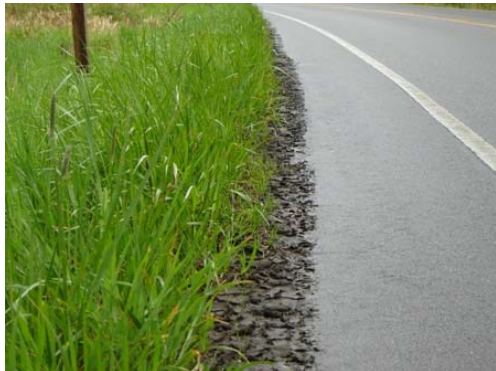
*Sediment buildup tends to accumulate along the edge of pavement more rapidly at low spots and insides of curves.*

- Ongoing Maintenance Costs – **\$186/mile/year**
  - Annual mowing w/ side mounted flail (Appendix B, Page 26)
  - Removal of shoulder buildup – Over the course of the study period edge buildup became more apparent, and as of today, five full growing seasons since the area discontinued maintenance of a vegetation-free Zone 1 there are locations where water may pond out into traffic lanes during storm events. Maintenance has been addressing these locations by grading out sections of shoulder or cutting out small channels through the buildup with shovels. This work was done incidental to other tasks and no cost estimates were developed.

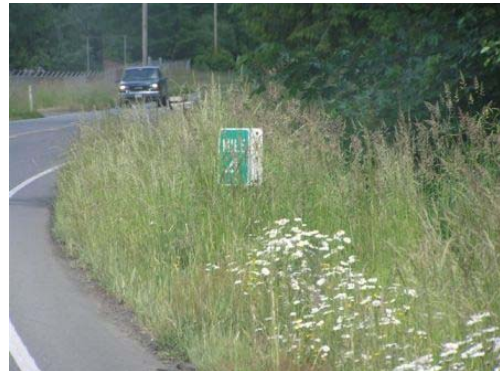
*Without multiple mowing passes in the spring and early summer, grass growth in places blocks sight distance and may impact traffic safety.*

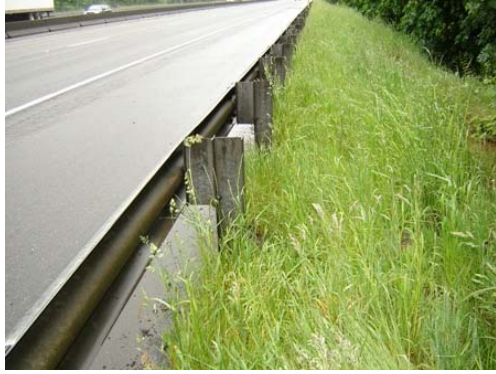
*Even in late June prior to mowing this roadside is completely functional.*

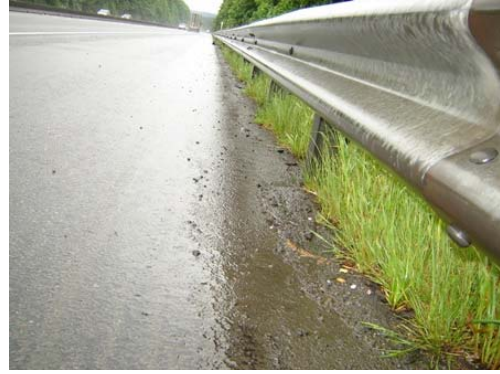
*Buildup under the rail has not been cleaned since construction and is still not causing any problems as of the end of the study period.*

**Recommendation:** This design configuration, running the pavement out to the face of the guardrail posts appears to offer a way to reduce the width if not eliminate the need to maintain a bare-ground strip. The area will continue to monitor this location for edge buildup. Mowing could be eliminated altogether in this location and selective herbicides used as need to further reduce cost/mile. Other locations throughout Western Washington with similar design configurations should be evaluated for treatment as conducted in this case.

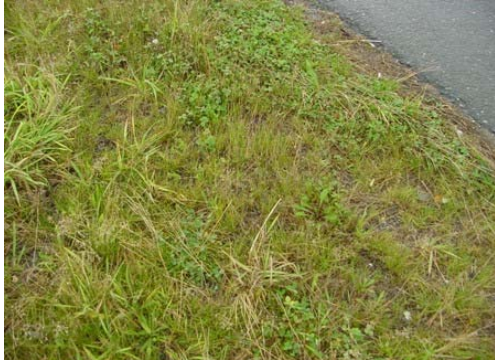
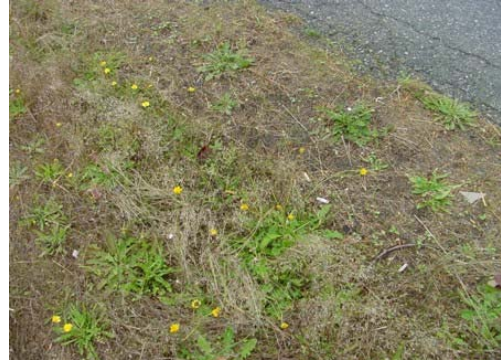
*These photos, taken in October of 2008, show the difference in vegetative composition between the between cases A10 and A11. Although A11, the planted SB shoulder (left) now contains a solid, desirable grass stand and relative few weeds, both sides exhibit similar results from a highway maintenance and operations standpoint.*

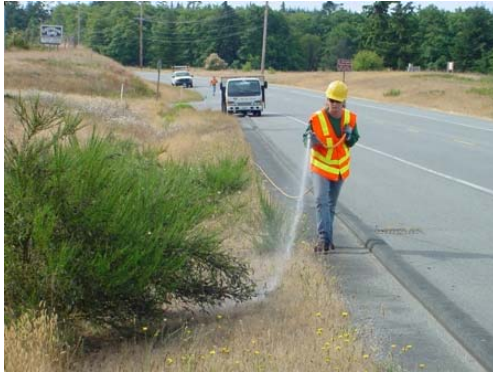
*A total of 12 soil drench treatments were applied to the two mile stretch over the three year study period.*

**Results:** The application of compost tea did not produce any noticeable or detectable enhancement of soil structure or vegetative growth.

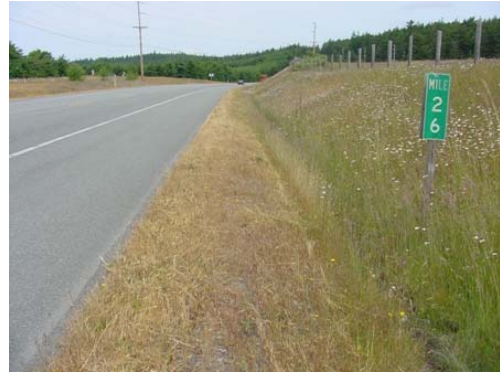
*No detectable difference resulted from the treatments, either in the scientific soil analysis or visually in vegetative top growth.*

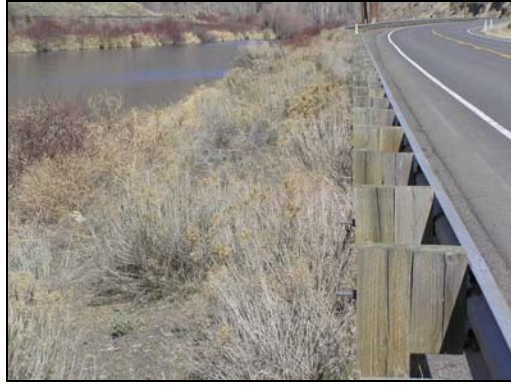
*SR 821 MP 21.10, 2004 two years after bare-ground treatments ceased*

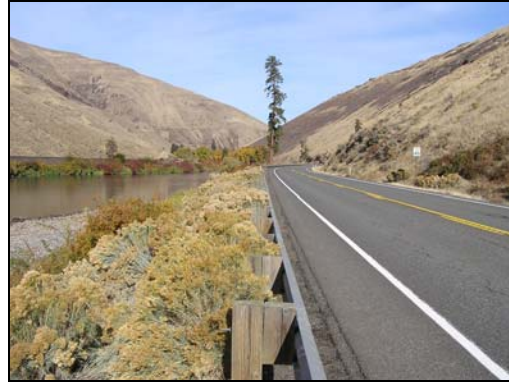
*SR 821 MP 21.10, fall of 2009, rabbit brush dominates the old bare-ground zone at the edge of pavement*

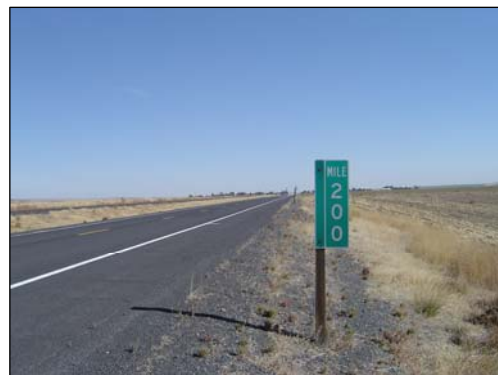
*US 2, MP 200 EB, 2009, three years after bare-ground applications ceased.*

Overall regeneration of desirable species has been slower than anticipated. This is most likely due to a number of factors including low organic matter in the roadside soil, low rain fall and slow degradation of residual chemicals. While establishment of desirable vegetation has been very slow, it does appear to be making steady gains. The full transition from bare-ground to established desirable vegetation at the edge of pavement will likely continue for at least another 2-3 years. This test plot indicates that in this situation the transition while slow can meet roadside maintenance needs at a cost that is lower than the traditional bare-ground treatment. As establishment of desirable vegetation continues vegetation maintenance costs, should continue to improve.

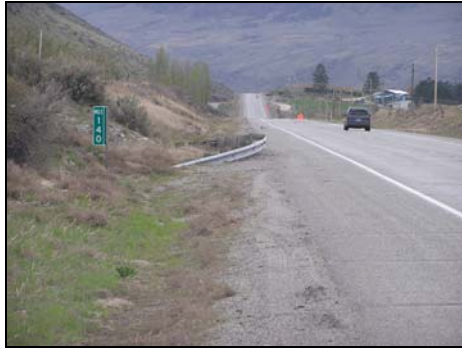
*SR 17 Northbound, annual maintenance with bare-ground chemicals.*

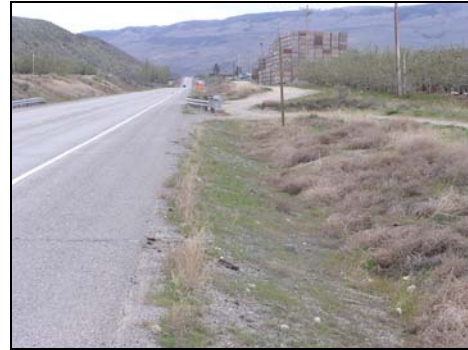
*SR 17 Southbound maintained with selective herbicides only. Native grasses have begun to establish along pavement edge.*

Cheat grass was one of the first species to migrate into the old bare-ground zone, while this isn't a desirable species it is better than many of the noxious weeds we expected. We believe that the cheat grass was at least helpful in reducing kochia, Russian thistle and other noxious weeds. Sand dropseed (*Sporobolus cryptandrus*) began to appear in 2007 as well, particularly at the edge of pavement. This species has continued to move out and is slowly filling in. Several other species have appeared in smaller quantities including Sandberg bluegrass (*Poa secunda*) as well as several wheatgrass species. It should be noted that while both sides of the roadway provided adequate weed control the Southbound side did look a little more unkempt when compared to the traditional bare-ground option. This appears to only be an aesthetic issue and did not cause any operational issues during the duration of this test.

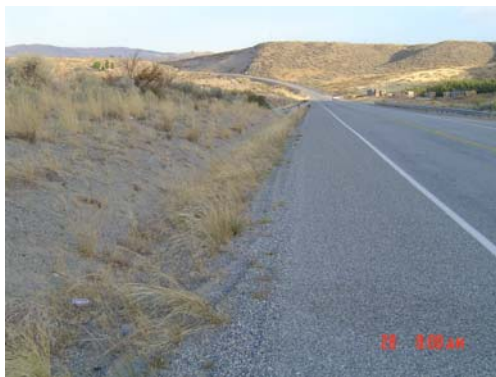
*SR 17 Southbound, MP 143, summer 2009 maintained with selective herbicides only.*

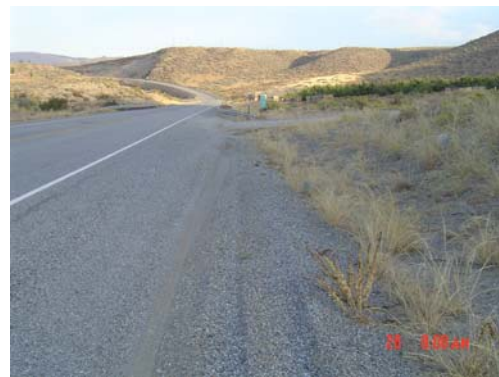
*SR 17 Northbound, MP 143, summer 2009, annually maintained with bareground chemical*

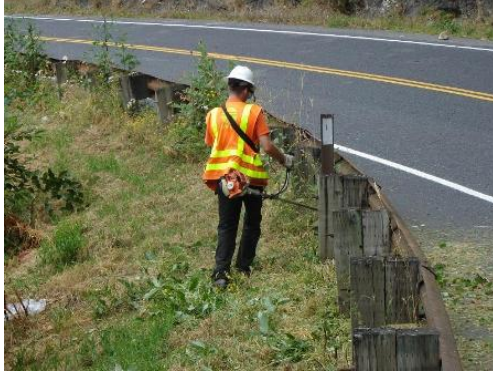
*Terrain behind the rail along this stretch of 101 and Lake Crescent is uneven and drops off steeply in places and is hazardous to operators.*

impeded roadway surface drainage. Although no injuries or accidents have been recorded at this site, the road is narrow and winding with sometimes heavy tourist traffic at the time mowing is required. Also there is uneven ground throughout on the back side of the rail and some areas that drop sharply into the lake.

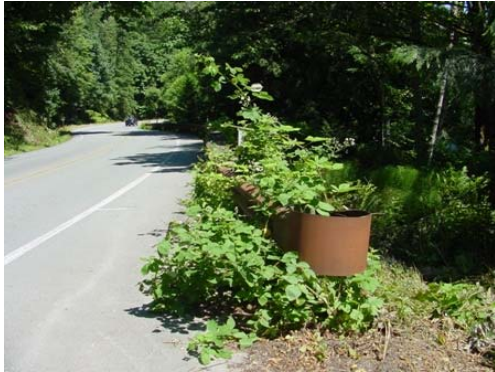
*Without the use of herbicides, vegetation re-growth completely covers the guardrail every year.*

**Results:** Several factors make this method of trimming a challenge in this area. The elevation tends to force vegetative growth later into the summer months and the plant community in the area favors a number of species of larger forbs and typically periodic rain throughout the summer results in abundant growth. The terrain around guardrail installations often drops sharply from the edge of the road making access difficult and hazardous. Use of corrections crews to do this work is cost effective and relatively efficient. However, corrections crews are not always available when needed, in which case the work must be done by WSDOT maintenance technicians.

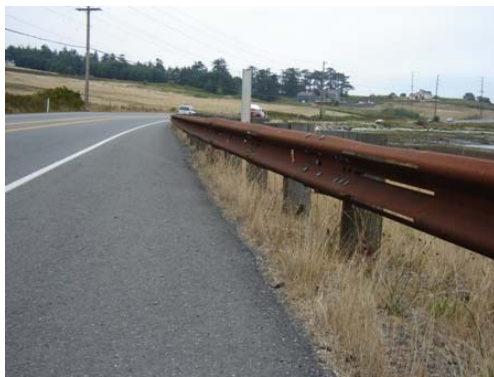
*Native grasses in this area are sparse and low growing, requiring virtually no maintenance.*

**Results:** This is a rare case in Western Washington where no vegetation maintenance is required around the base of guardrail other than occasional selective weed control. The presence of native low growing grasses in this location is due to the dry micro-climate and proximity to the saltwater beach. If it were possible to establish a stable grass stand with low growing grasses in locations such as this there may possibilities of doing this in other locations such as was tested in case 1.21.

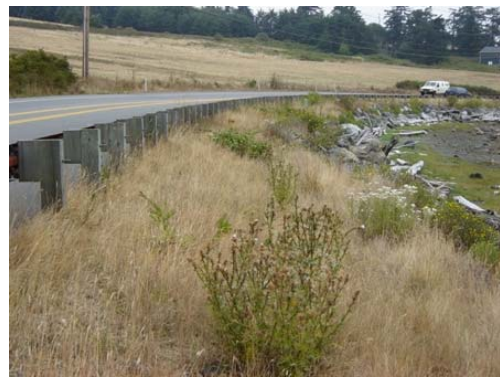
*The only roadside maintenance at this site is some selective control of unwanted vegetation is needed.*

**Recommendation:** If naturally occurring low growing grasses are present in an area or if they can be successfully established through seeding following construction or under guardrail cleaning, this is a viable option and the lowest overall under guardrail treatment. It would also be advantageous where low growing grasses can be established, to combine this type of treatment with an angled pavement edge design to help alleviate issues with edge buildup.

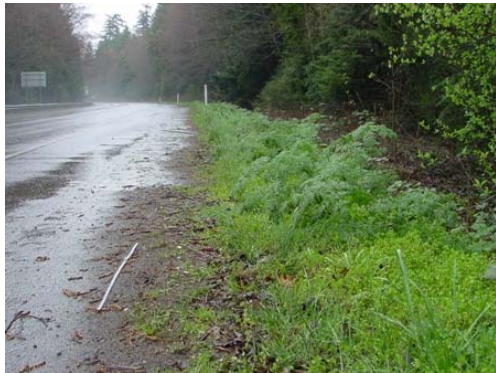
*Although this image does not show guardrail it does the amount of debris that accumulates on the shoulder and the amount of weed growth two years after shoulder reconstruction.*

**Results:** One of the greatest challenges on Bainbridge Island in this case was the fact that over the past 10 years a number of weed species have become established along the highway. This is mostly a result of insufficient resources to control the unwanted vegetation without the use of herbicides. When the new shoulders were constructed and seeded, weed seed from the adjacent roadside was deposited into the new shoulder soil with the grass seed and came up fairly thick in the years following construction. Treatment of these species required the use of broadleaf herbicides and after two years, some weeds are still persisting. Also, due to the high traffic volumes on this highway and large amounts of vegetative debris from surrounding trees, edge buildup began impeding surface drainage within two years after construction, particularly around the bases of guardrail.

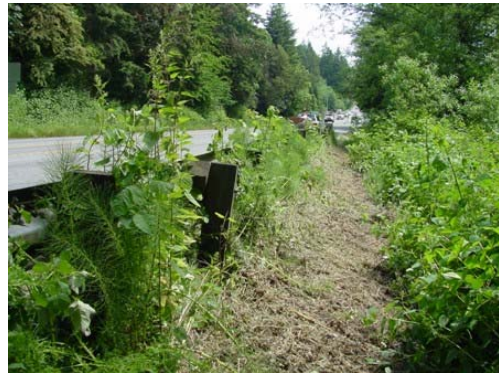
*Two years after reconstruction low growing grass seeded on the shoulders and under guardrail is overgrown by weeds and blackberry vines throughout most of the highway corridor on the island.*

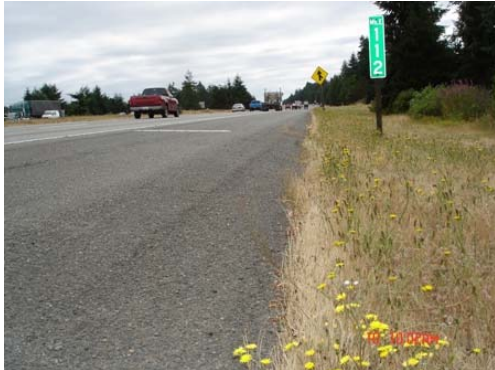
*A sloping pavement edge takes the place of a gravel strip in this case and requires no maintenance.*

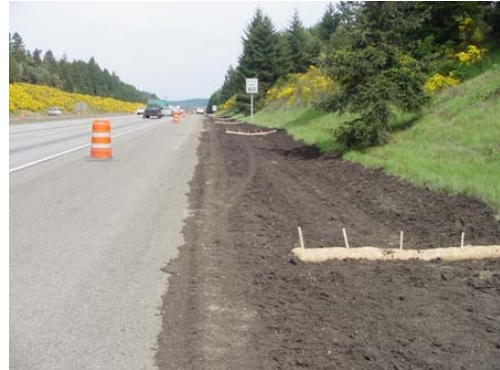
*A compost blanket was added to outside shoulders and median for enhanced stormwater management and pollution control along the section of freeway draining toward the Nisqually Delta.*

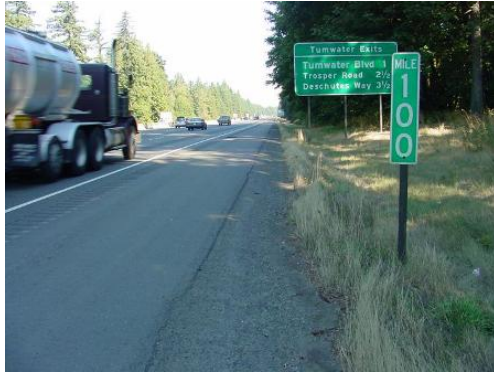
*Roughened edge within the study site, shown here four years after installation in 2004.*

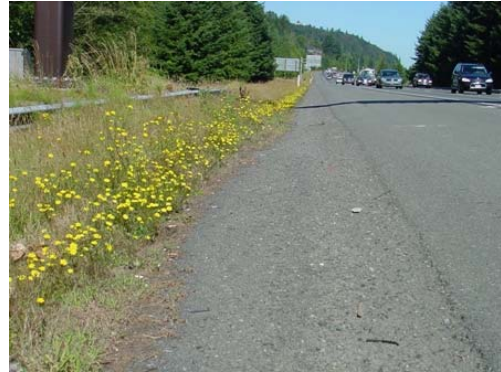
*Another example of a roughened, tapering edge, this one on I-90 near Lake Sammamish, constructed 1996, shown here in 2005.*

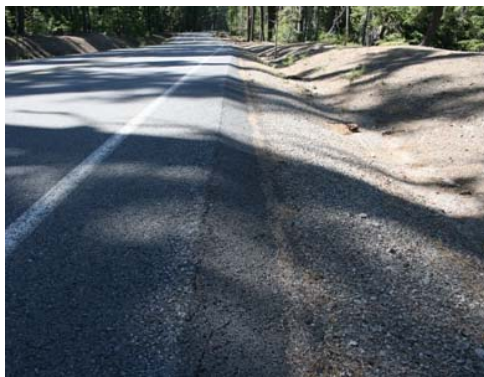
*On SR 62 in Oregon (Crater Lake Highway) a safety edge is used in combination with an adjacent shoulder free of vegetation.*

**Description:** The edge of asphalt pavement is finished with a 30 degree angle for the full depth of the paving layer. The term “safety edge” is used for this treatment because it allows vehicles to traverse off and back on the pavement at high speed without getting a wheel caught on a sharp edge drop. However, this treatment also allows for around 6 to 8 inches of sloping surface area for drainage before the non-paved and/or vegetated shoulder begins.

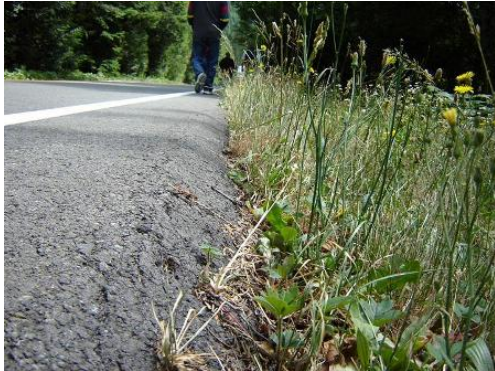
*In the study site on SR 410 in the Mt. Rainier National Park the safety edge is bordered by a grass shoulder. Shown here in the second year after construction.*

- Ongoing Maintenance Cost – **\$186/mile**
  - Mowing Secondary Highway with Side Mounted Flail – \$186/mile (Appendix B, Page 26) This cost could possibly be reduced by mowing with one of the other mowers in some cases, such as the truck mounted mower or the sickle bar.
  - Significant edge buildup is likely to occur at this location; at some point removal will be necessary unless winter plowing operation can be used to skim the buildup off on an annual basis.

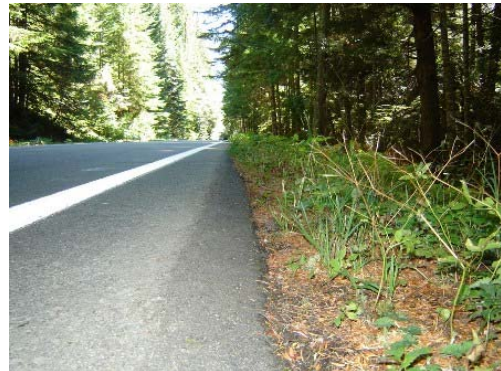
*During the three year study period, buildup occurred in some places, such as insides of curves, but much of the edge is still free draining five years after construction.*

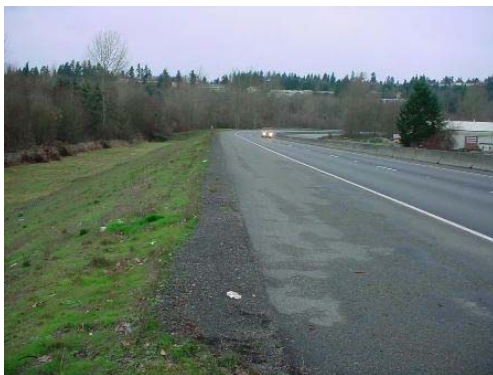
*This shows the site in the fall after the paving project was completed in the summer of 2002.*

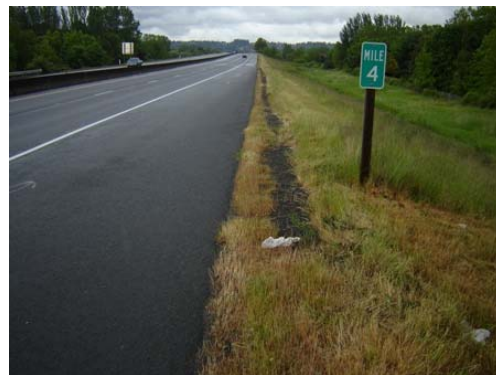
*By the end of the study period six years after construction, the strip of compacted grindings is over 50% grass cover. Grass establishment could be prevented with Glyphosate treatments on a 2 to 3 year or as needed basis.*

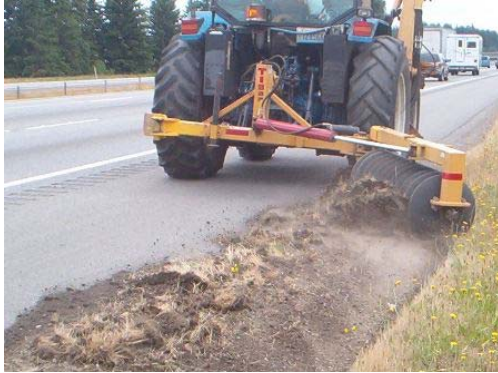
*Timing on the cultivation is important. Best results were when the work was done sometime in June when most of the vegetative growth was done but soils were still somewhat damp.*

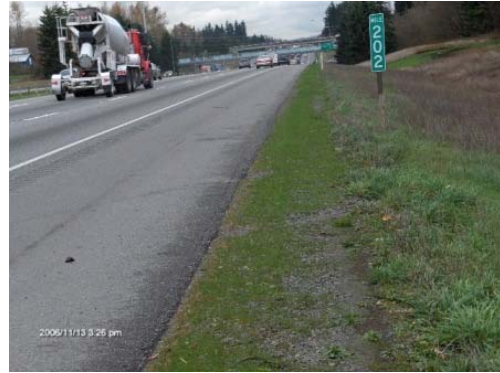
*By the fall a light grass stand begins to emerge in the cultivated area. As long as the area is cultivated annually this grass doesn't cause problems, but if it becomes well established will cause the cultivated soil to clump.*

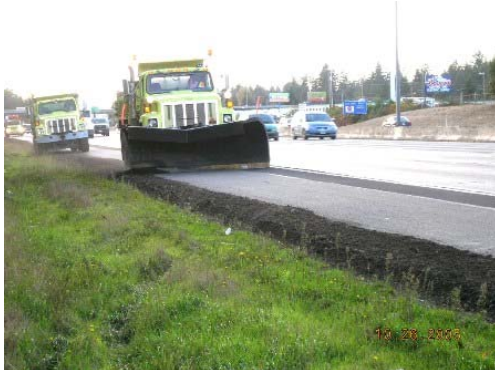
*This photo shows how the operation of cultivation works. A plow truck pushes the turned material back into place and the two buffer vehicles drive over the edge, packing it back into place.*

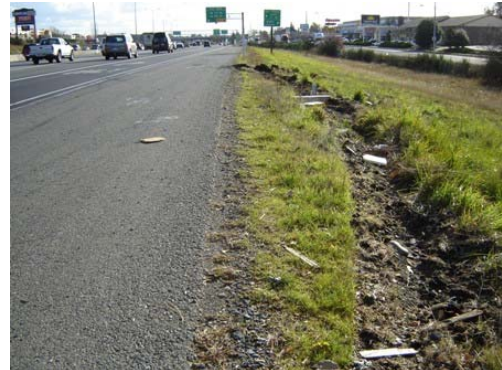
*At one point an errant vehicle left and returned to the road right at the location where the monthly documentation photos were taken, illustrating the importance of having a solid and even transition between paved and non-paved shoulder.*

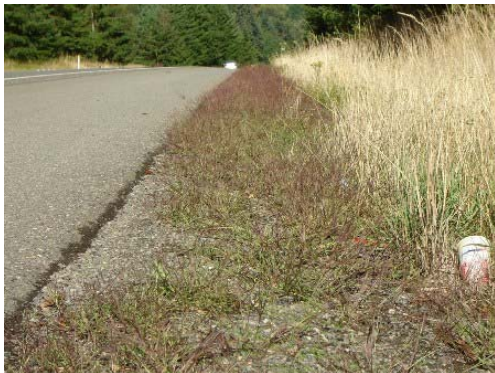
*In some locations annual grasses such as crab grass shown here emerged over the summer months. However in a case like this the growth does not impact highway operations or weed management objectives.*

**Results:** This corridor did not look as clean as the sections on I-5, due to the differing slopes off the shoulder and clumps from grass growth in the cultivated zone. Also, productivity was less than that achieved in Everett. However, the results in terms of even transition between paved and non-paved shoulder and eliminating any problems associated with edge buildup and drainage make this a viable alternative. In coming years the area will continue to evaluate condition

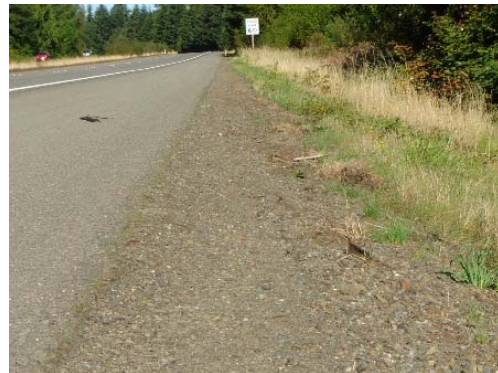
*In other locations the shoulder has remained vegetation free until the following fall when some re-growth typically occurs.*

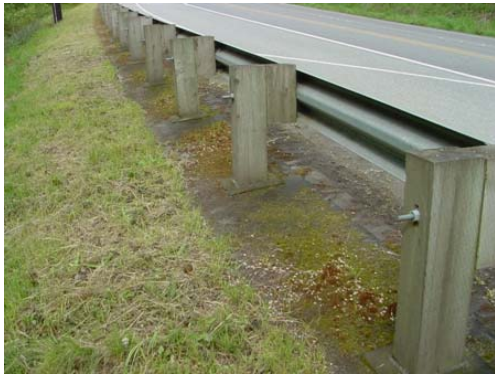
*At about 5 years after installation in this case, moss growth became a significant factor. Moss in combination with debris from falling leaves and cut grass and brush serves as a seed bed unless annual cleaning is done.*

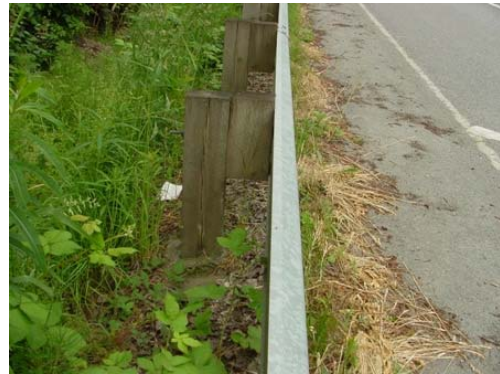
*Photo taken in June of 2009, seven years after installation and before annual cleaning is done.*

**Results:** In this location as in other Western Washington locations where there is ample moisture, heavy traffic, and overhanging trees, there are problems with

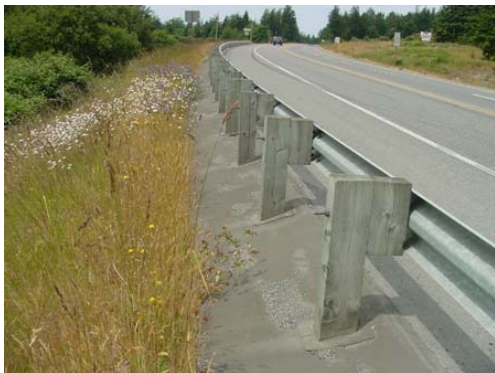
*On the north end of Whidbey Island the same product was installed by a contractor along with a new section of guardrail in 2006. At the time this photo was taken in June of 2009 it appears to be holding up well without maintenance attention.*

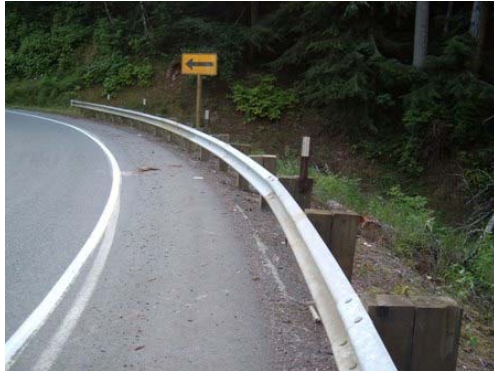
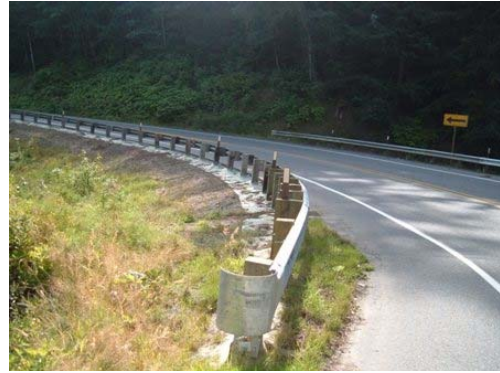
*These pictures, taken at the same time three years after installation show the difference in accumulation of debris between inside corner with curb on the edge of pavement and the outside corner.*

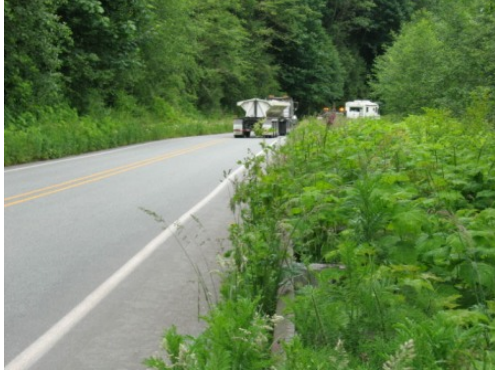
*Prior to installation of the fabric, vegetation completely covered the rail every year and had to be manually trimmed.*

**Results:** Although the surface of the soil was cut to the ground just prior to installation, the roots of the plants were well established and some of the more aggressive vegetation began coming up through cracks, around the base of posts, and along the edge between pavement and mat, despite all attempts to seal it off. As in the location on SR 112, this is a heavily forested area and the area applies sand at times during snow and ice events in the winter. These two factors resulted in the mat in this location becoming almost completely overgrown and buried within three years and requiring annual vegetation trimming with string trimmers.

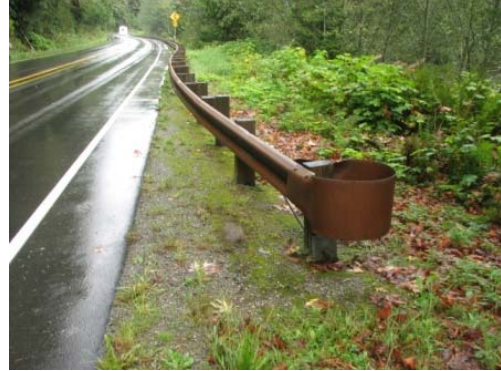
*Three years after installation the mat is buried in sand and debris. Vegetation is beginning to establish over the top of the mat but growth is inhibited.*

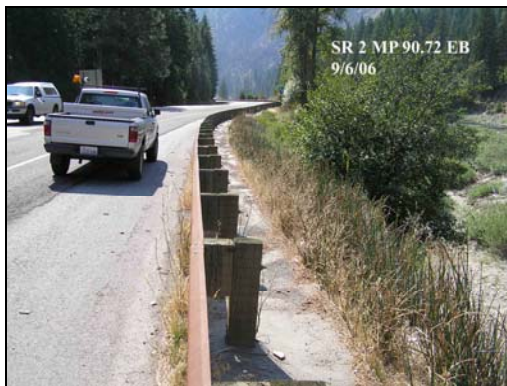
*US-2, 2006 two years after installation*

**Results:** WeedEnder Weed matting continues to function well on this test plot. This test plot location has subjected this product to a variety of weather conditions not encountered on other sites. These conditions include a substantial amount of snow and ice and related de-icing and snow removal. While no maintenance was required throughout the duration of this test plot, minor maintenance on several seams should occur within the next 12 months. Installation of the WeedEnder mats appeared to be more difficult to retrofit to existing guardrail than Traffic mats but have comparable overall performance in terms of weed control as well as some potential advantages including fire resistance the ability for water to filter through the material.

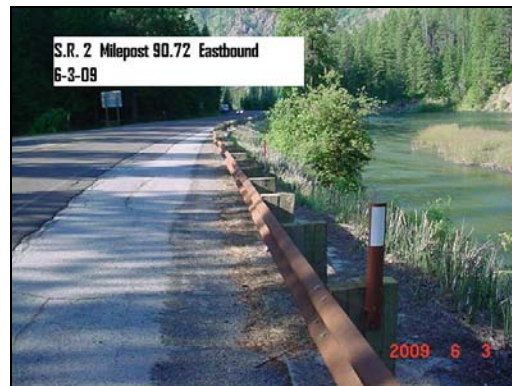
*US-2, 2009 five years after installation*

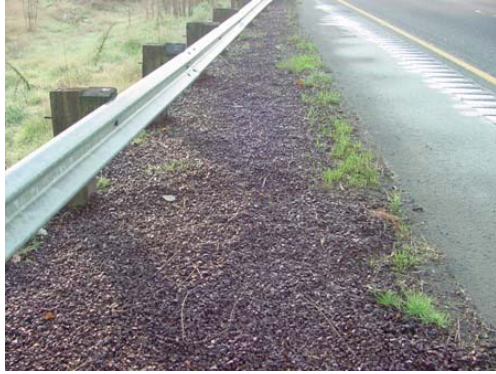
*In the first year following installation, grasses are already beginning to establish.*

**Results:** This material is permeable, but as dirt and debris generated by freeway traffic was deposited along the pavement edge and over the top, weeds and grass began to grow. As of today in the fall of 2009, five years after installation, the surface of the product is mostly covered with grass and weeds. Also, cars driving onto and over the surface of the material, tended to break the surface coating and dislodge the mulch. Concern was also expressed over the potential flammability of this product.

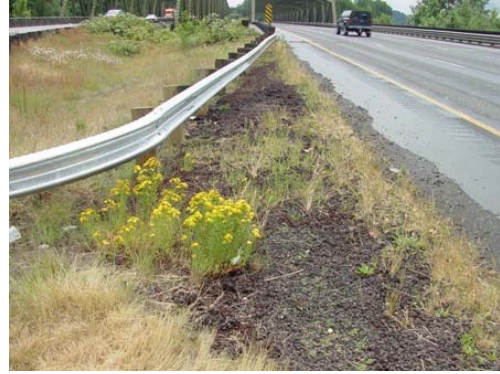
*By the fourth year after installation grasses and some weeds cover approximately half the surface of the treated area.*

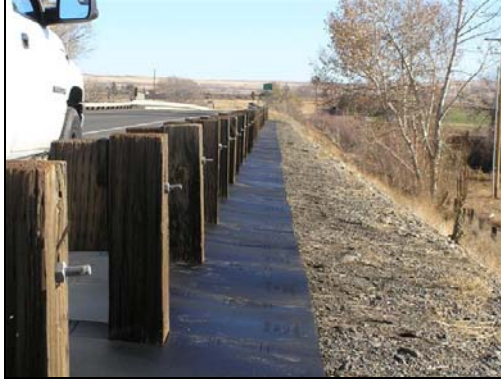
*Immediately following installation in 2006*

**Results:** Traffic Weed matting continues to function well on this test plot. The few times the mats have been hit or moved it's been relatively easy to reposition them. Retrofitting the guardrail with Traffic matting was easier than WeedEnder and Universal weed matting and has consistently out-performed Universal weed matting in terms of controlling weeds and durability.

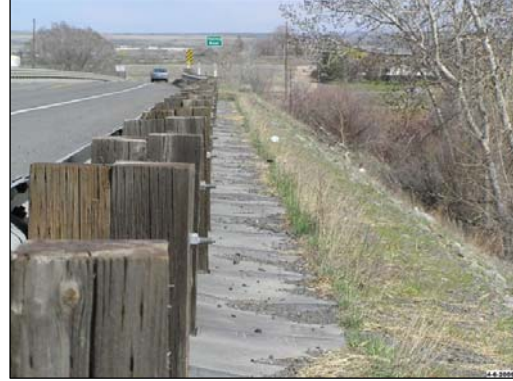
*Photo taken in 2009*

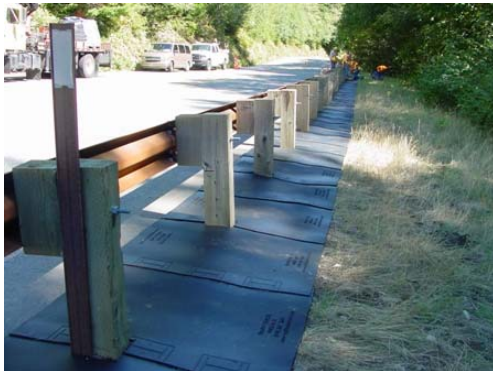
*The Traffix Weed Mat were the easiest of the under guardrail products to install. This is the product being installed in 2006.*

**Results:** This product is relatively heavy and at the time of installation was the most expensive of all under-guardrail weed barriers considered. However, possibly because of its weight and composition was the product that held up best over the three year duration of the study. The product is semi-permeable but due to its thickness tends to catch and channel water along the pavement edge. The expense of the material itself and extra cost in shipping is somewhat offset by the ease of installation. One thing learned after installation is that the overlapping edge of the mats at the seam should be with the direction of traffic. In this installation the overlapping edge faces toward traffic and tends to catch winter sand and debris at the seams.

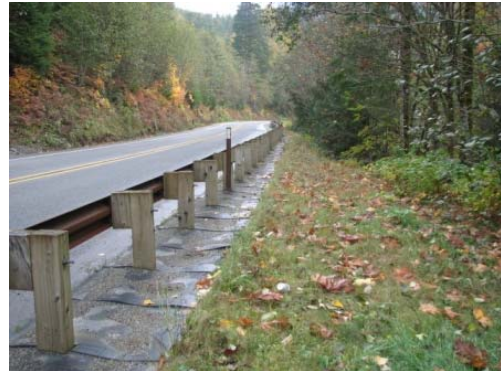
*This is the mat after three years. Some sand build-up, but it seems to blow or wash off over the course of each summer, no maintenance has been done at this location.*

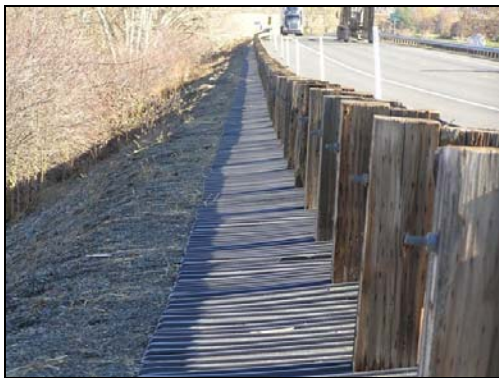
*SR 823, Installed in 2006*

**Results:** In general this product was difficult to install and generally did not perform particularly well. It did however provide some weed control through the life of the project, this level of suppression appears to be diminishing annually as the condition of the mats deteriorates. The material didn't hold up well to any type of impact from traffic or an inadvertent plow blade. Further it was more difficult to move or patch these mats when they did become damaged.

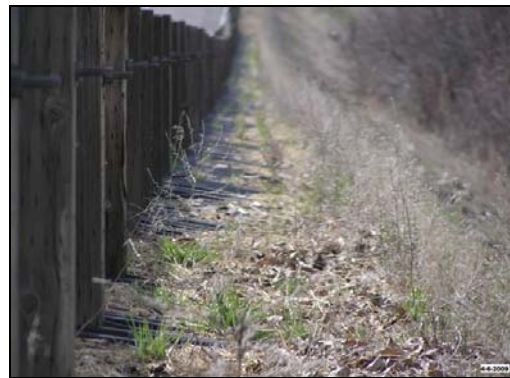
*SR 826, fall 2009- Cracked and damaged matting with vegetation growing up through the mats.*

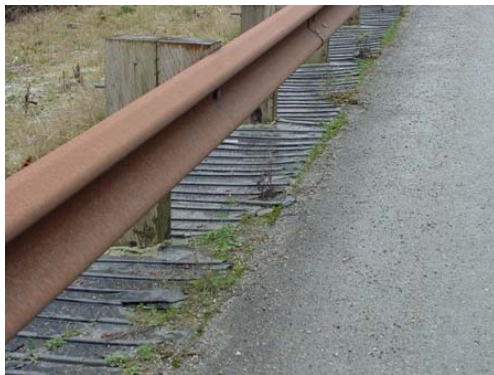
*Tiles were damaged by snow and ice thrown by passing plow trucks.*

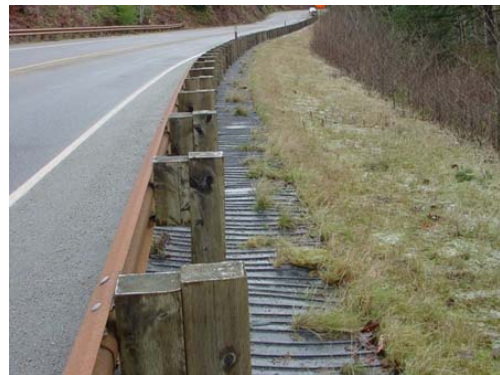
*Grass came through where the panels joined together and where the material cracked.*

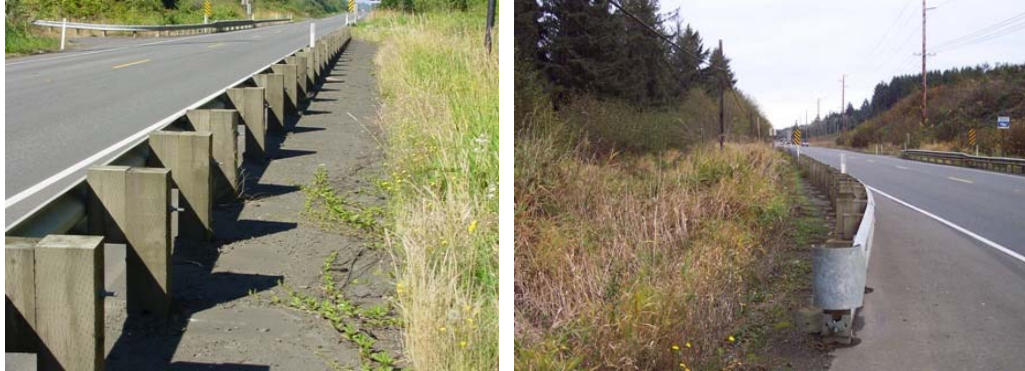
*New pavement and guardrail was installed in 2003. Photo on the left shows condition in 2005 after two years, photo on the right is from 2007 showing debris accumulation after four years. Rails along this section of SR 105 were cleaned in 2008.*

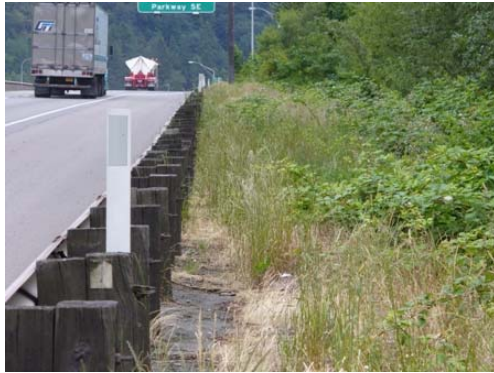
*Six years since the site was last cleaned, enough dirt and debris has deposited to support a grass stand over the pavement.*

**Results:** Due to the heavy traffic volume at this location, dirt and debris accumulate more rapidly in this location as compared to the SR 105 site. Surface of the pavement is angled down at the outside edge which helps direct debris out from under the rail, but significant accumulation still results in the entire paved area under and behind the rail being completely covered and growing vegetation within 5 years after cleaning.

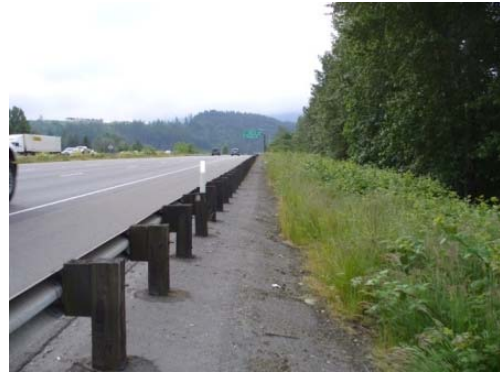
*Photo taken after the pavement was cleaned off in the spring of 2008.*

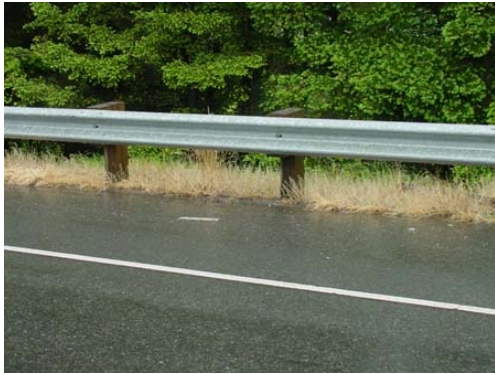
*Although non-selective, post emergent herbicides stop vegetation growth when applied in the spring, dead vegetation still remains in place and catches debris at the edge of pavement causing edge build over time and trapping water.*

**Results:** The use of a post emergent herbicide only controls vegetation that is green and growing. It does not control seed germination and sometimes does not kill the roots of existing vegetation. Therefore, this type of herbicide treatment essentially acts as a chemical mowing, with vegetation re-growth as soon as adequate precipitation occurs. However, this method worked well in keeping the rails from becoming overgrown. In some locations a follow-up treatment was required using selective herbicides to control horsetail and occasional patches of conifer seedlings. Because dead vegetation remains in place after treatment there is still accelerated edge buildup as compared to a vegetation free shoulder. Even dead material creates a barrier and catches debris, adds to buildup. For two to three weeks following treatment it is apparent that herbicide treatments were made, due to the color contrast of the dead vegetation.

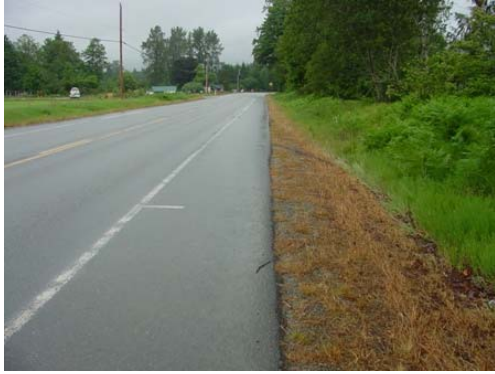
*Sparse and stunted re-growth occurs in areas annually treated with this mixture of herbicide. This cuts back on the amount of growth and subsequent edge buildup at the edge of pavement, however treated vegetation is visually apparent for several weeks following treatment, until surrounding vegetation begins to go dormant.*

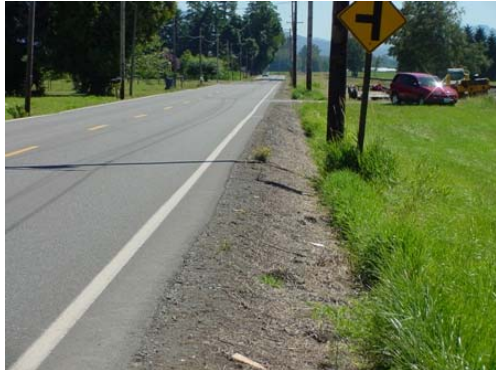
*Locations where accurately applied annual applications were made, Zone 1 remained vegetation-free.*

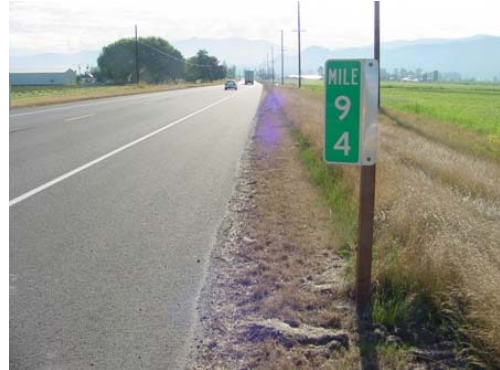
*Where annual applications were skipped in certain years and locations, grasses became established. The presence of vegetation, even if dead tended to make subsequent applications less effective, because herbicide was tied up in organic matter on the surface. Also, even dead vegetation at the pavement edge contributes to edge buildup.*
