# Assessment of Alternatives in Vegetation Management at the Edge of Pavement

WA-RD 736.1

**RESEARCH REPORT**  
Internal WSDOT Study  
“Pavement Edge Vegetation Management”

Prepared for  
**Washington State Department of Transportation**  
and in cooperation with  
**U.S. Department of Transportation**  
Federal Highway Administration

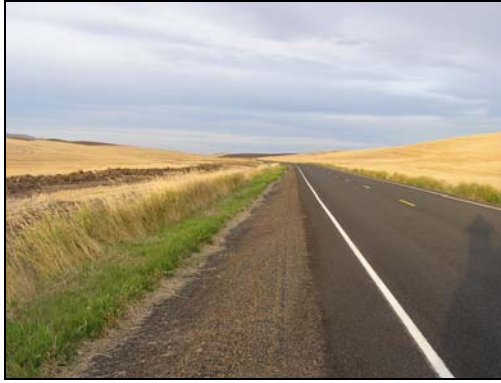
**Description:** Non-selective bare-ground chemicals were used in this location to maintain a 4-5' bare-ground zone. Two pre-emergent chemicals are used on this roadway; Portfolio (Sulfentrazone) at 4.6 oz and Landmark (Chlorsulfuron + Sulfometuron-methyl) at 12 oz. This mixture is applied in late March to early April with 50-60 gallons of carrier. This site receives approximately 20" of precipitation annually; the roadway ditches remain moist for the majority of the year.

**Results:** This application was very effective throughout the 16 shoulder miles. It held up very well with no measureable failures. In this case the bare-ground application eliminated 2 to 3 mowing passes per year.

*Bareground treatment on SR271, 2008.*

**Recommendation:** The bare-ground application has performed well in this situation. The combination of Landmark and Portfolio controlled all weeds and unwanted grasses throughout the growing season. The alternative, allowing vegetation to grow at pavement edge would require 2-3 mowing operations to control the 6' tall reed canarygrass (*Phalaris arundinacea*) as well as one selective spot application. Given the climate, shoulder width and site conditions this is an appropriate treatment and should be continued.

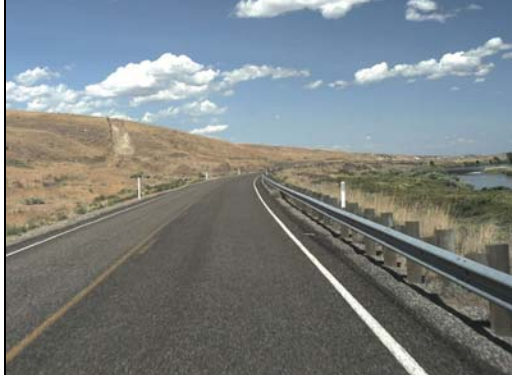
**Description:** Treat guardrail sections to maintain a 4-6' bare-ground condition under the rail. The bare-ground zone under guardrail is maintained in order to control noxious weeds, provide sight distance, reduce hand work, improve conditions for guardrail maintenance and to protect the posts from fire damage. Krovar (bromacil) was applied at a rate of 8 lbs per acre with 35 gallons of water during the spring, generally between mid March and early April. The site is located in one of the states most arid regions receiving approximately 6 inches of precipitation per year.

*Bareground treatment on SR225, 2008.*

**Results:** This application was very effective at controlling vegetation throughout this area. It held up very well with no significant breakthrough. Costs are substantially higher than standard bare-ground applications due to the amount of travel time between rail sections. For guardrail treatments in eastern Washington the average miles treated for a 4-6' band with was 14 miles. This low production quickly pushes up the cost per mile for this treatment.

**Recommendation:** The bare-ground application has worked well in this situation and continues to be the standard treatment for eastern Washington guardrail. It is recommended however that due to the high costs per mile, managers should evaluate the option of reducing or eliminating the use of bare-ground chemicals under guardrail. This should not be done unilaterally but with careful consideration of fire potential, vegetation type, height, shoulder width and sight distance.
