ALABAMA WARM MIX ASPHALT FIELD STUDY: FINAL REPORT

**National Center for
Asphalt Technology**
NCAT
at AUBURN UNIVERSITY

NCAT Report 10-XX

The Alabama Department of Transportation hosted a warm mix asphalt field demonstration in August 2007. The warm mix asphalt technology demonstrated was Evotherm Dispersed Asphalt Technology. The WMA and hot mix asphalt produced for the demonstration were sampled and evaluated in the laboratory. The construction of the WMA and HMA pavements were also documented along with the condition of the pavement sections up to one year. The results of the laboratory evaluation and field documentation are detailed in this report.

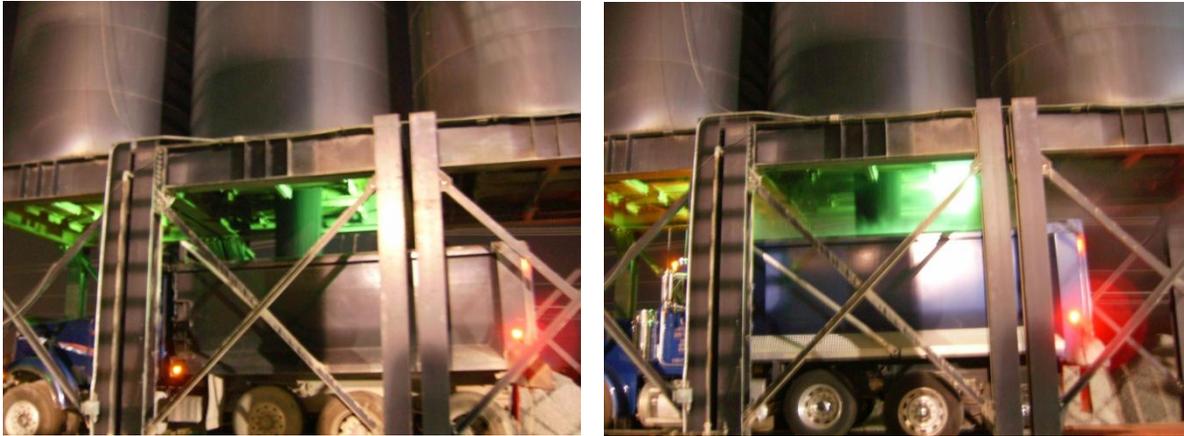
FIGURE 2 Mixture Being Loaded into Trucks -- WMA (Left) and HMA (Right)

On the second night of paving, August 27th, the WMA test strip mix was produced. The target mixing temperature was 121°C (325°F), which was lower than the temperature employed during the mix design verifications. Production was delayed due to an amperage issue concerning the slat chain. It was believed that the lower production temperatures were causing a strain on the slat conveyor, increasing the amperages needed to keep the slat moving. This increase eventually caused the emergency shut-off switch to activate, causing a slight delay until this could be resolved. When production started, approximately 500 tons of WMA were produced, with an average load-out temperature of 124°C (255°F).

On the third night of paving, August 28th, the WMA for the full night of paving was produced. Initially, the target mixing temperature was 121°C (325°F); however, the mixing temperature was reduced throughout the night. During production, the mix temperature at load-out began at 116°C (240°F), eventually decreasing to a temperature of 107°C (225°F) by the end of the night. One of the major observations made during the production of WMA was the lack of fumes as the mix was being loaded into the truck. This can be seen in FIGURE 2. Production of WMA averaged between 200-225 tons per hour.

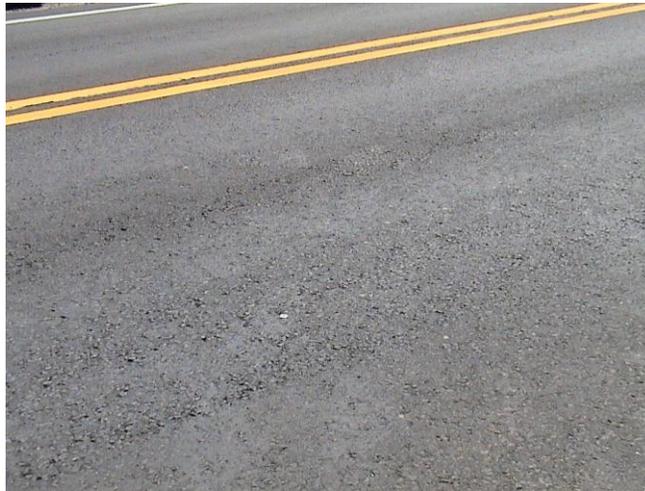
FIGURE 14 Mix Segregation in HMA

At the second site revisit distresses were observed and photographed. FIGURE 14 illustrates the mix segregation that was observed on the project. The picture is from the HMA test strip section; however, mix segregation was observed in all of the sections.

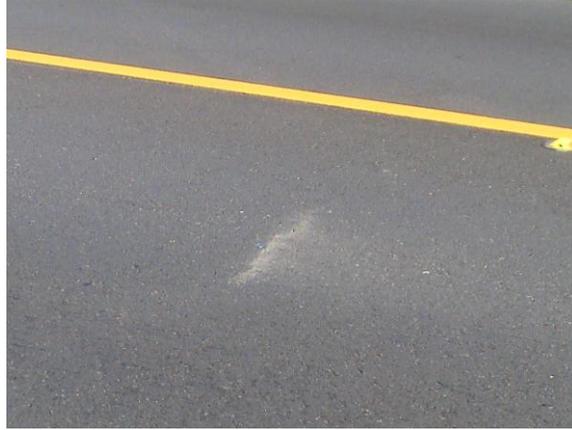
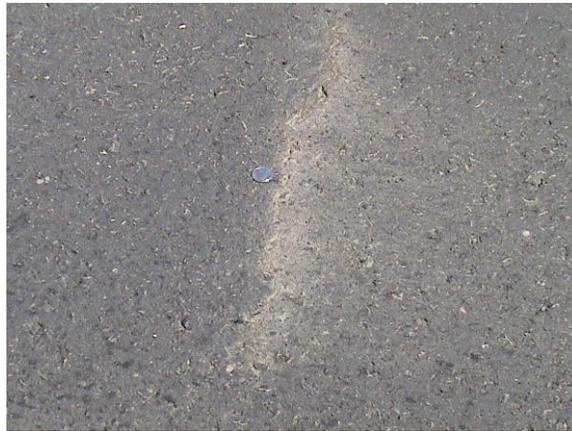
FIGURE 15 Crack in WMA Full Night of Paving Section

A crack was observed in the WMA full night of paving section. FIGURE 15 is a photograph of the crack observed. FIGURE 16 is a close up photograph of the crack. Soil was pumping up through the crack, suggesting that there may be a structural failure that caused the crack.

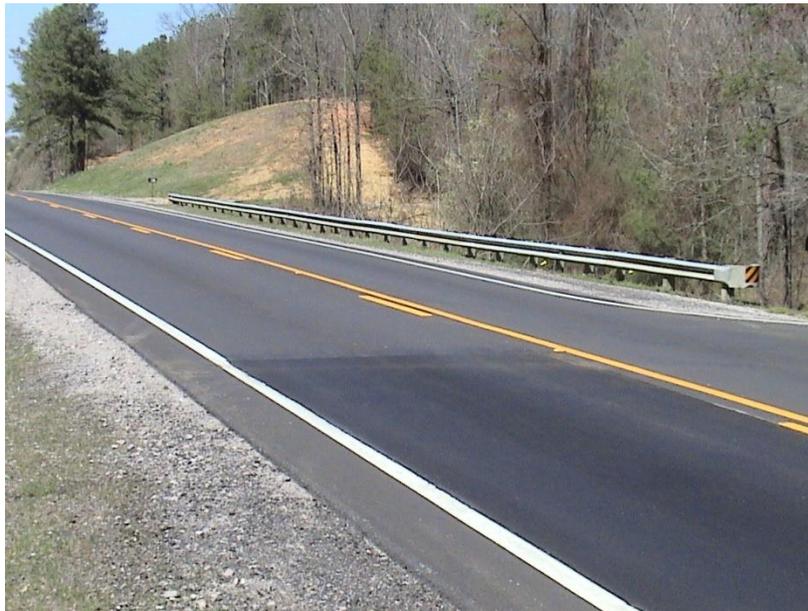
FIGURE 18 Patch in the HMA Full Night of Paving Section

A large patch was observed in the HMA full night of paving section. FIGURE 18 displays the patch. Efforts to identify the reason for the patch were unsuccessful.

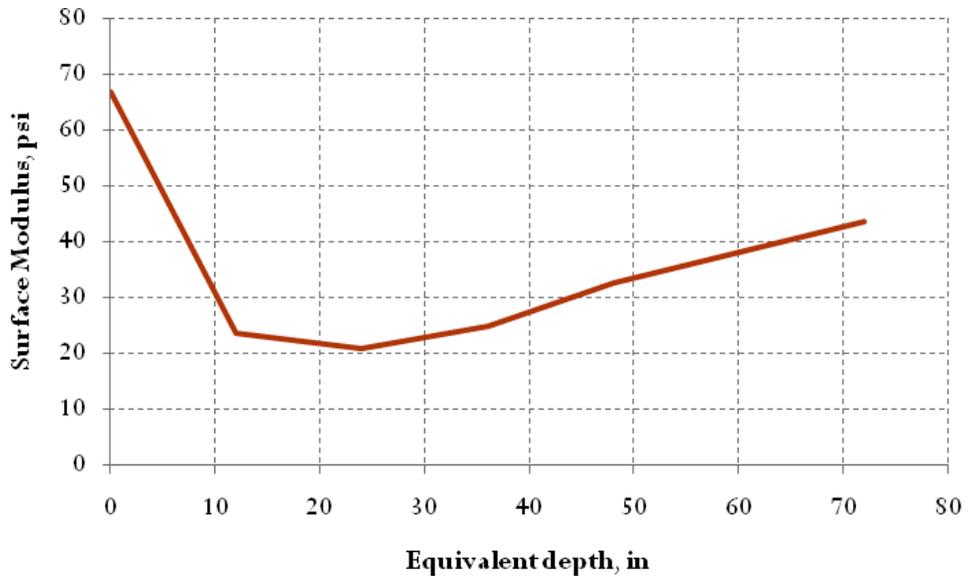
Equivalent depth, in
Figure 29. Surface Modulus Plot – Milepoint 14

the section range from 7,000 – 40,000 psi with an average and standard deviation of about 23,000 psi and 6,200, respectively. The FWD deflections were used as input for the back-calculation software MODCOMP 5, which employs linear elastic theory to iteratively vary layer moduli to match surface deflections. MODCOMP indicated the presence of a stiff layer in the lower subgrade at a depth of about 100 – 150 inches and estimated the subgrade moduli to be on average 25,000 psi. Using MODCOMP, the back-calculated moduli of the surface and base layers were on average in the order of 400,000 psi and 12,000 psi, respectively, with a modulus ratio (E_1/E_2) of about 33. The “stiffer” subgrade moduli relative to the base was also confirmed from surface modulus plots as shown in Appendix A Figure 29 that shows a stiffening of the pavement structure with depth. While this behavior may be attributed to a nonlinear stress-dependant response of the base and subgrade materials, the results do indicate a relatively weak base structure underlying a relatively stiff surface layer.
