USE OF SIMULATED HIGHWAY UNDERPASS CROSSING STRUCTURES BY FLAT-TAILED HORNED LIZARDS (*PHRYNOSOMA MCALLII*)

Final Report 594

May 2007

Arizona Department of Transportation
206 South 17th Avenue
Phoenix, Arizona 85007
In cooperation with
U.S. Department of Transportation
Federal Highway Administration

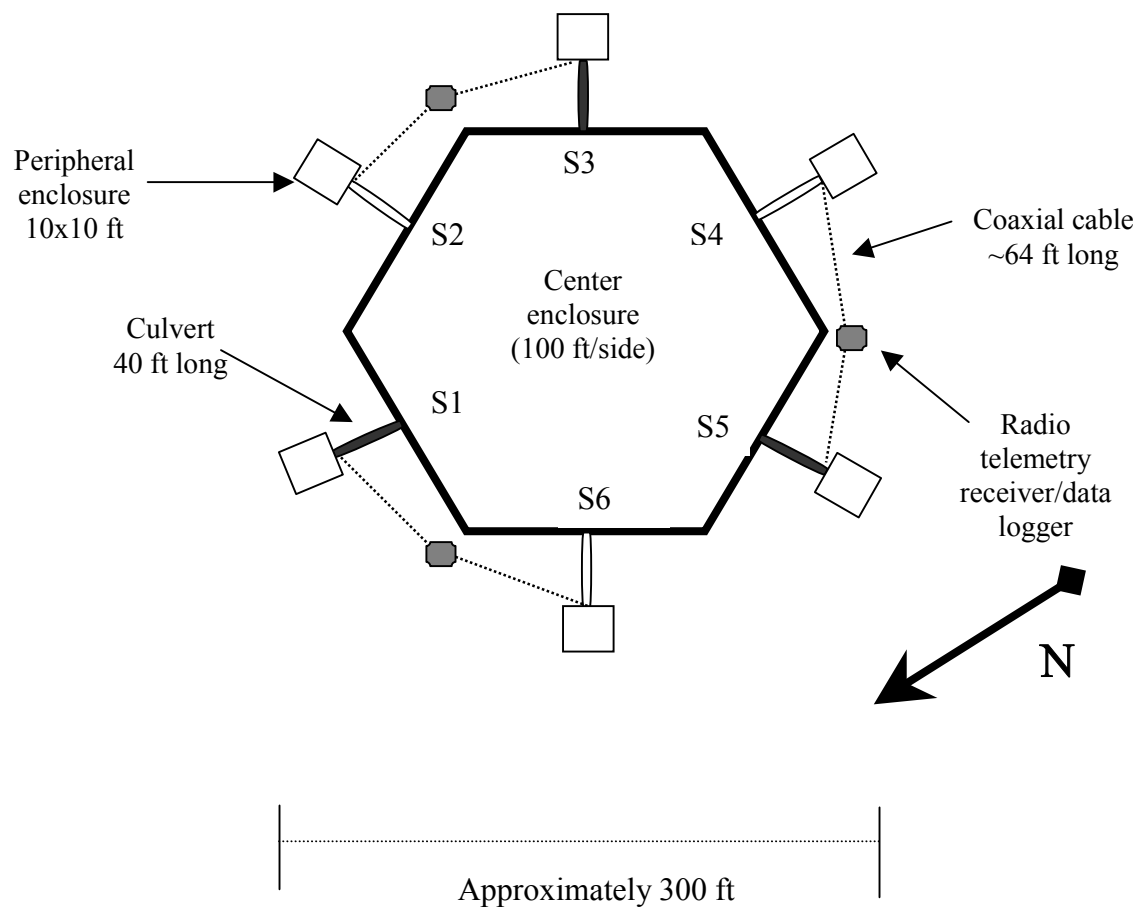
Figure 2. Layout of the testing facility (not to scale)

Notes: Total dimensions of the facility were approximately 300 feet by 300 feet. Each enclosure was constructed of 36-inch hardware cloth buried approximately 6 inches and held up by 1/4-inch rebar. The crossing structures (S1 –S6) were constructed as follows: S2 and S5 were 24-inch culvert piping; S3 and S6 were 36-inch culvert piping; and S1 and S4 were 4-foot tall by 8-foot wide simulated box culvert (constructed of 3/4-inch plywood). S2, S4, and S6 had skylights illuminating the crossing structures internally. All culverts had approximately 18-24 inches of soil or comparable insulation covering each structure. Three radio telemetry receiver-data loggers each operated two antennas of coaxial cable.

In 2005 the research team built a facility to test potential use of highway culverts currently used by ADOT to control water flow and erosion. The testing facility (Figure 2) was designed as a hexagon (100 feet/side, 6/10 acre) constructed with ¼-inch mesh hardware cloth 36 inches tall, buried 6 inches and held up by ¼-inch rebar. Midway on each side of the hexagon, we installed a 40-foot long culvert connected to a 10-foot by 10-foot hardware cloth peripheral enclosure. Ground inside the fenced area was not disturbed to preserve natural characteristics of the vegetation and soil. The length of culverts used in this study was similar to that of culverts used under typical two-lane roads. Four-lane roads typically have an open median between the opposing traffic directions. To maintain even substrate conditions throughout the testing facility, sand was distributed inside each culvert to thoroughly cover the floor 1-3 inches deep (Figure 3). The R-value (insulation coefficient) of a road (asphalt and gravel fill) was estimated to be approximately 22, so each culvert was covered with approximately 18-24 inches of soil and/or rigid foam insulation (R-Tech expanded polystyrene; Insulfoam, Tacoma, Washington, USA) to simulate thermal properties of an actual culvert under a road.

The testing facility included three types of culverts and two interior lighting options. Culvert types included 24-inch diameter galvanized steel culverts, 36-inch diameter galvanized steel culverts, and 4-foot tall by 8-foot wide box culverts. The steel culverts were the same as those in use by ADOT. The box culverts were constructed of ¾-inch plywood and framed with 2-inch by 4-inch wood posts (Figure 4). Box culverts were designed to mimic those made of concrete in use by ADOT. Each culvert received one of two lighting options: light or dark. The “light” culverts were lit inside with skylights; the “dark” culverts received only natural light from the ends. For the skylight option, at least one 12-inch tubular skylight was installed midway into one of each type of culvert. Because the 24-inch and 36-inch culverts were much darker than the box culverts, they were fitted with two additional skylights. In 2005, sunlight was directed into the mouth of these crossing structures with 22-inch flexible tubular skylights suspended from the top half of the culvert openings. These terminal skylights reduced the entrance diameter of these culverts by one-third to one-half. Interior lighting conditions were improved in 2006 by removing the terminal skylights, and installing two 10-inch tubular skylights, 10 feet away on either side of the midway skylight (Figure 5).

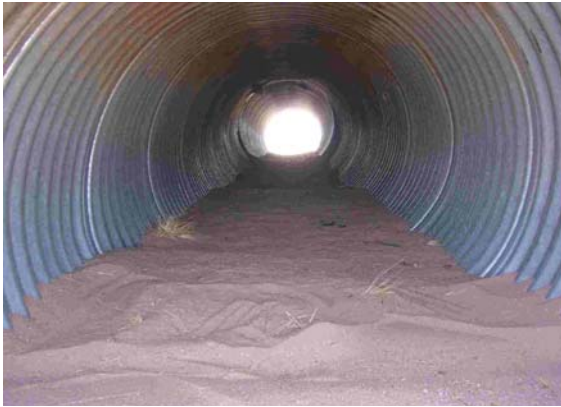
Figure 3. Soil from the site distributed through the 36-in diameter culvert without skylights.

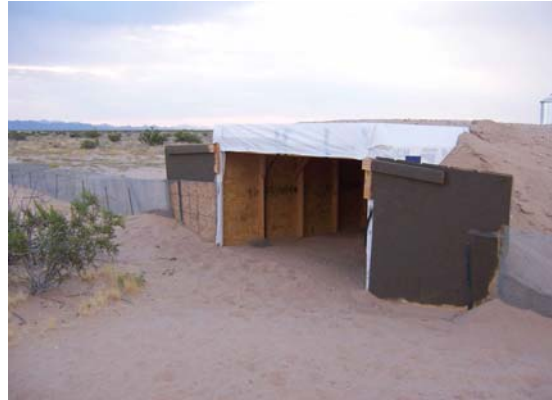
Figure 4. Entrance of the 4-ft by 8-ft box culvert with a skylight (upper right) and headwalls (dark brown).

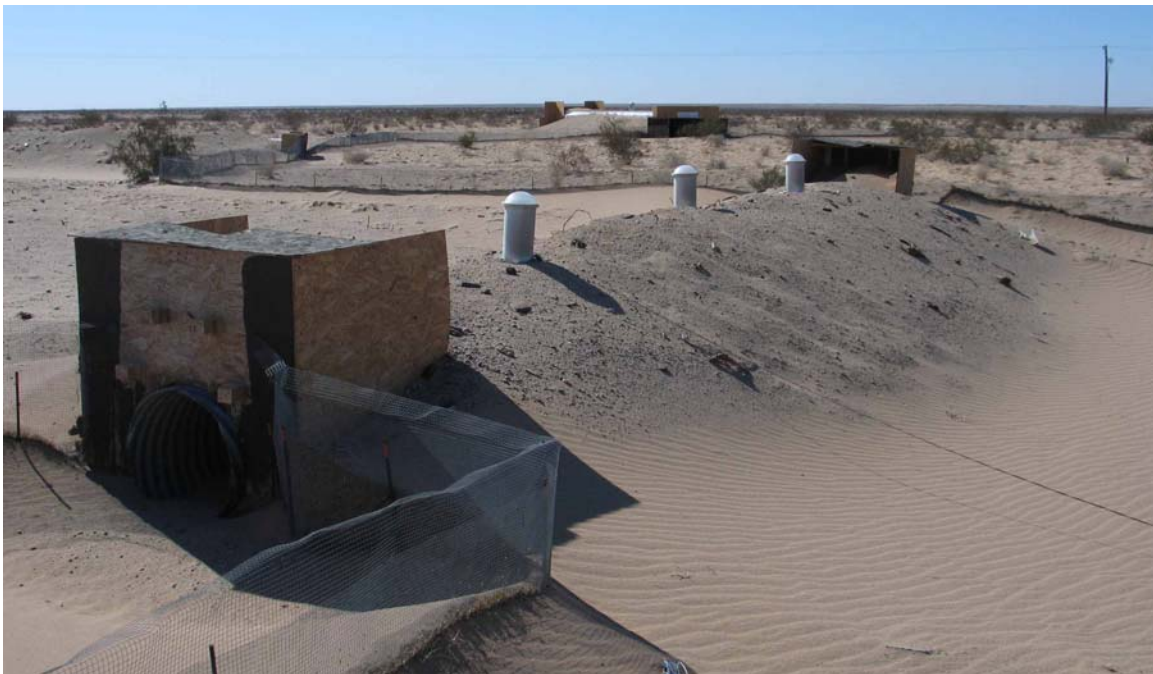
Figure 5. Skylights positioned on a 24-in diameter culvert.

Notes: In the background is the main enclosure. In the left foreground is the small peripheral pen that prevents flat-tailed horned lizards from escaping if they walk through the culvert. Plywood headwalls minimize sand loss at the ends.

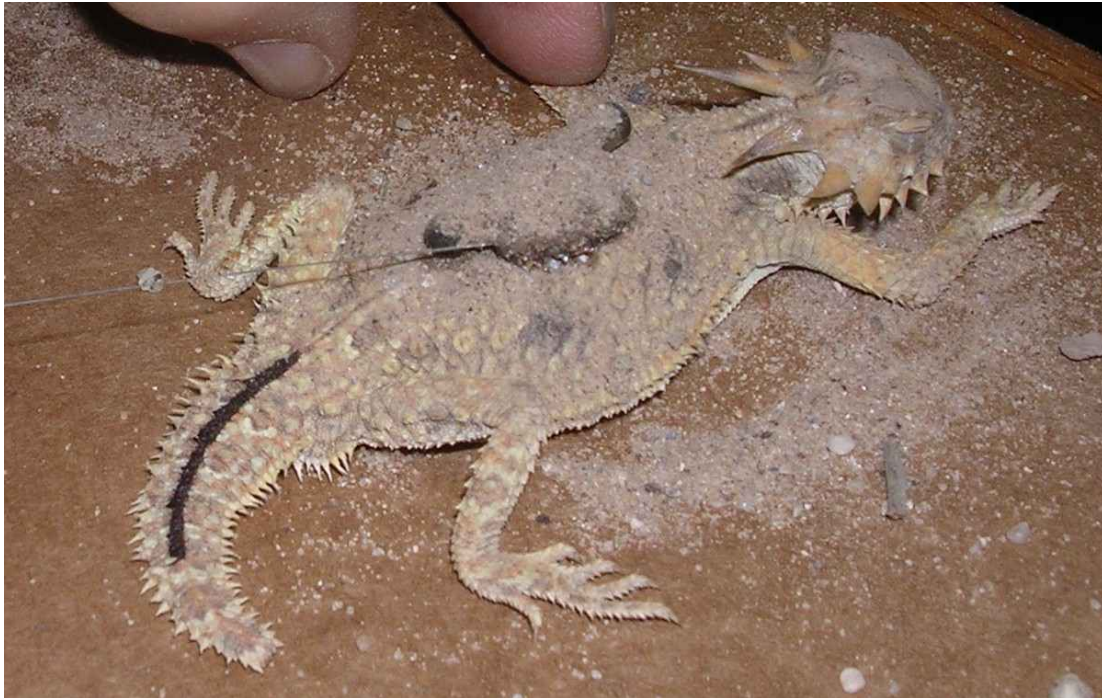
Figure 6. Flat-tailed horned lizard with a radio telemetry transmitter attached.

Notes: The larger rod on the left side of the lizard's back is a radio frequency identification transponder that we tested unsuccessfully in 2005. The traditional radio telemetry transmitter (Holohil model LB-2N) is on the right side of the lizards back, with the thin wire projecting posteriorly. Most lizards only carried the telemetry transmitter.

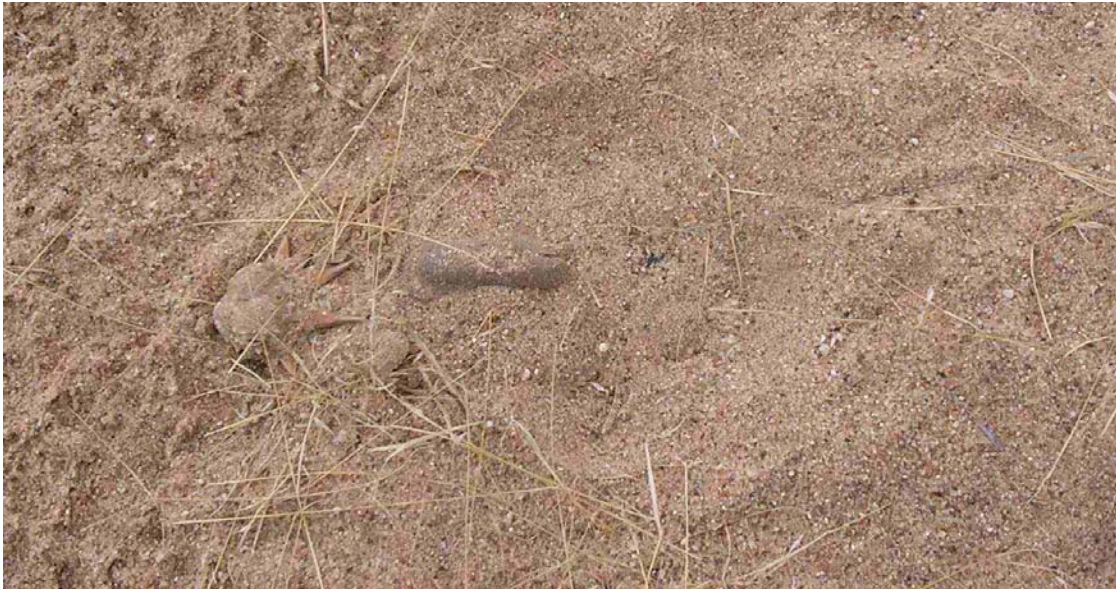
Figure 7. Flat-tailed horned lizard exhibiting typical hiding behavior while carrying a radio telemetry transmitter.

From September through October 2005 and June to September 2006, flat-tailed horned lizards were captured from approved locations on the Barry M. Goldwater Range and adjoining Bureau of Reclamation land. The research team recorded capture coordinates (UTM, NAD 1927), sex, and length (2005, total length; 2006 snout-to-vent length) for each individual. Only lizards ≥ 1 year old were used in the study. Either a 0.36-gram or a 0.77-gram radio transmitter (models LB-2N or BD-2, respectively; Holohil Systems Ltd., Carp, Ontario, Canada) was affixed on the back of each individual with Dap brand silicon aquarium sealant. After covering the tags with sealant, they were dusted with sand for camouflage. Each individual also received a unique identification mark on the belly and tail with black permanent marker. To ensure attachment and tag performance, tags were activated and affixed the night before releasing the flat-tailed horned lizards into the testing facility (Figures 6 and 7).

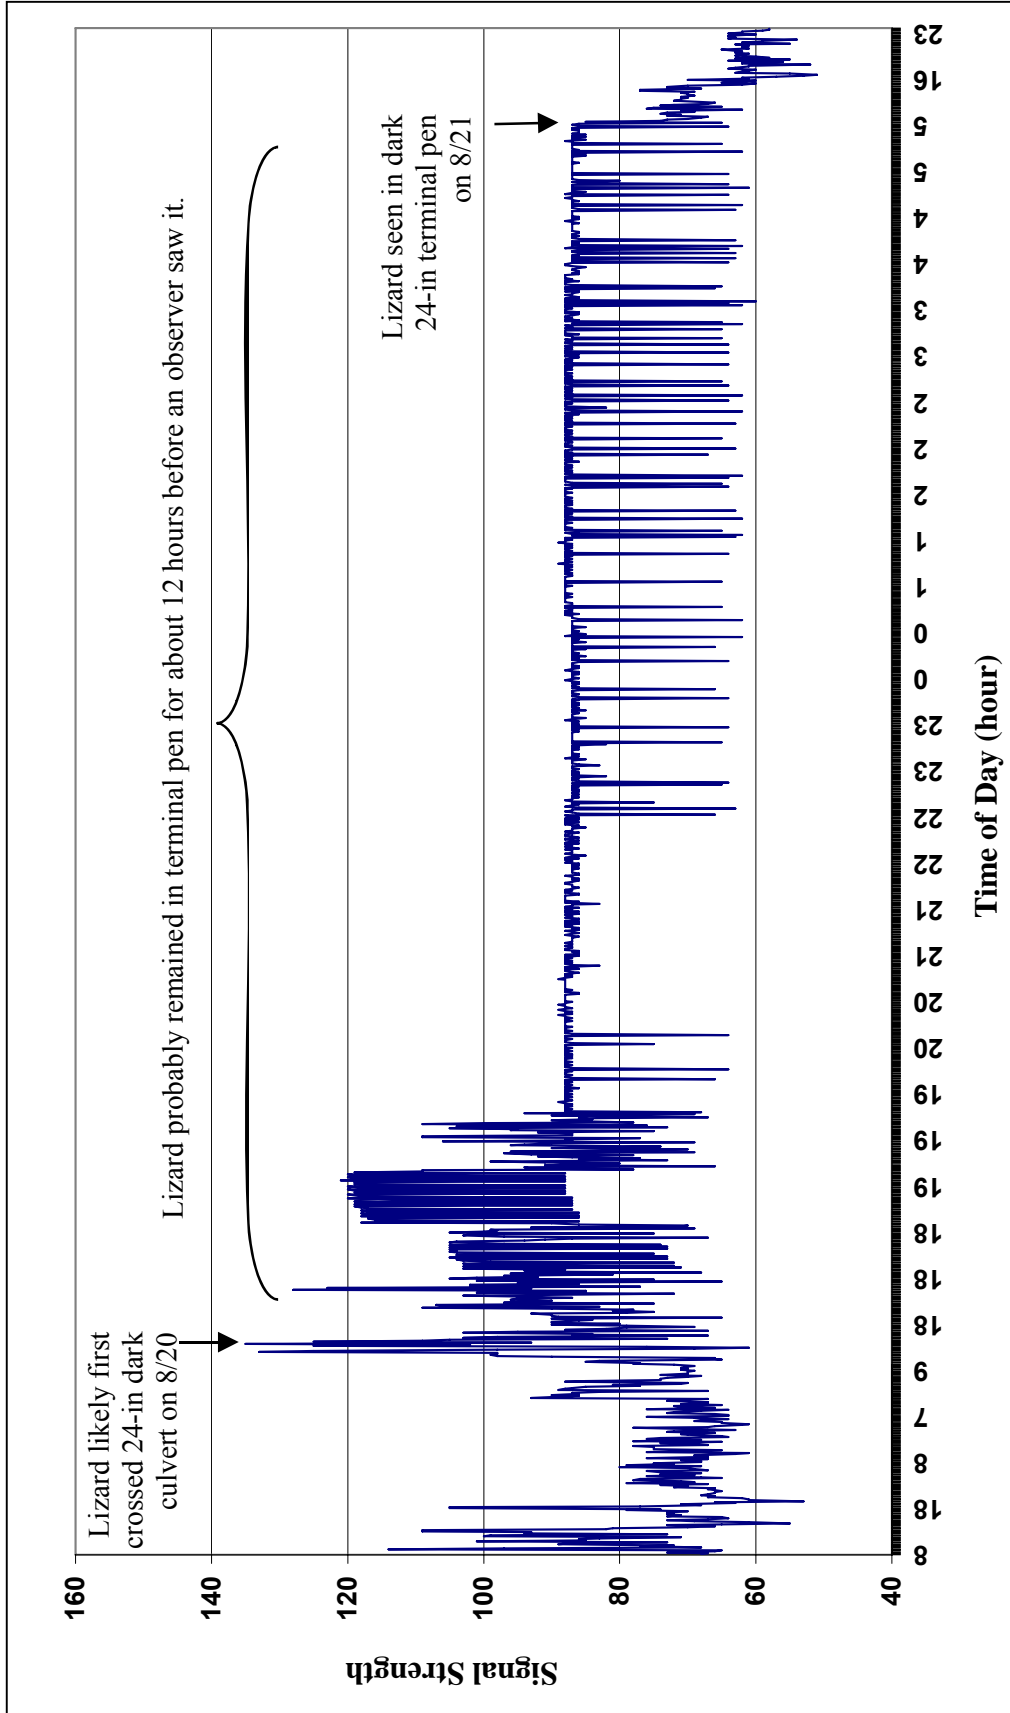
Appendix A (contd). Example of signal strength recorded by a remote telemetry receiver (Flat-tailed horned lizard Male MC44). This example includes all the detections of frequency 150.410-411 on receiver R2678, which monitored the dark 24-in diameter metal culvert and the lit 4-ft x 8-ft box culvert from 18-30 August 2006. The strong signals from the 24-in culvert dominate and cluster at the top of the line. After the lizard was seen in the terminal pen, he was moved back to the main pen, and the signal faded accordingly.

We established basic guidelines for interpreting remote telemetry data by evaluating the signal patterns recorded during visually confirmed crossing events. An example is presented on the next page. If a flat-tailed horned lizard successfully crossed through a culvert to the terminal pen, the following general patterns were usually (but not always) evident in the antenna and signal strength data:

- The data file had several hundred to a few thousand detections for a single frequency.
- The data file had many (e.g., > 40 or 50) detections at an identified antenna within a few minutes or hours. Detections without an identified antenna were not convincing.
- A dominant antenna was identified repeatedly in the section where lots of detections were recorded in a few minutes or hours. The dominant antenna was the one with a signal strength $\gg 100$, at the same time the subordinate antennas recorded a signal strength $\ll 100$ (if at all).
- The increase/decrease in signal strength was more or less steady over time as the lizard walked past the antenna. A convincing signal pattern would not jump instantly or repeatedly from a weak signal (e.g., 60-70) to a strong signal (e.g., >115).
