# Evaluation of Hot In-Place Recycle

WA-RD 738.1

**Post-Construction Report**  
Experimental Feature 09-01

**Contract 7648**  
**SR-542**  
**Britton Road to Coal Creek Bridge Vicinity**  
**MP 3.38 to MP 19.27**

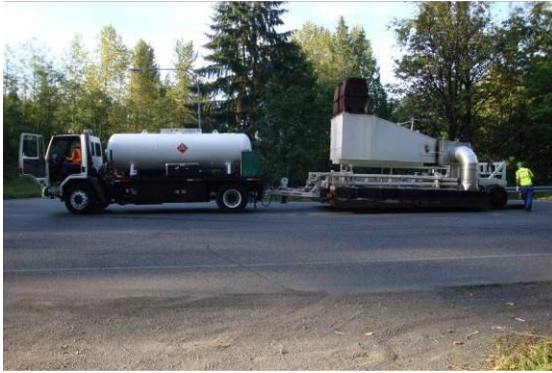
Figure 2. Preheater unit consisting of a propane truck and trailer with propane fired heaters.

The purpose of the preheaters is to remove moisture from the pavement and begin the heating process. The preheaters consist of a five ton truck pulling a trailer equipped with propane burners housed in an insulated steel enclosure. A 1,500 gallon tank on the truck

provides enough propane to operate the heater for an entire shift. Rubber tires on the rear of the trailer are removed and steel wheels support the trailer during operation.

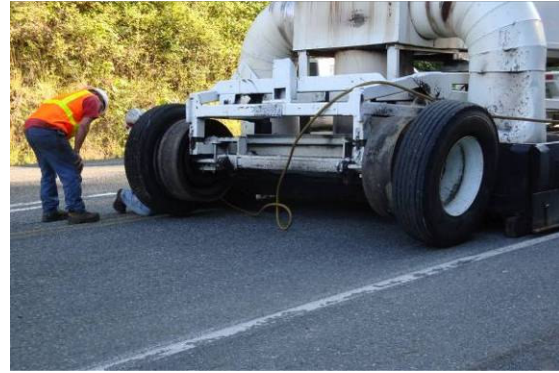
Figure 3. Removing rubber tires prior to paving.

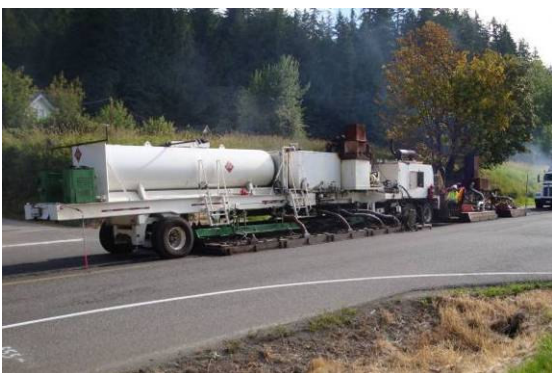
Figure 4. Front left side of Unit A.

The two heater scarifiers do not perform identical operations. To differentiate between the two heater scarifiers, Pyrotech labels the first as Unit A and the second Unit B. Unit A uses propane-fired infrared heaters mounted on the front of the unit to heat the pavement to a depth of 1 to 1 ¼ inches. Two five-foot-wide milling heads then mill the outside five feet on both sides of the lane to a depth of one inch leaving a two-foot un-milled strip down the center. After milling, Unit A places the hot millings in a windrow and adds recycling agent to the windrowed hot millings. A trailer with propane-fired heaters pulled by Unit A provided additional heat to the pavement.

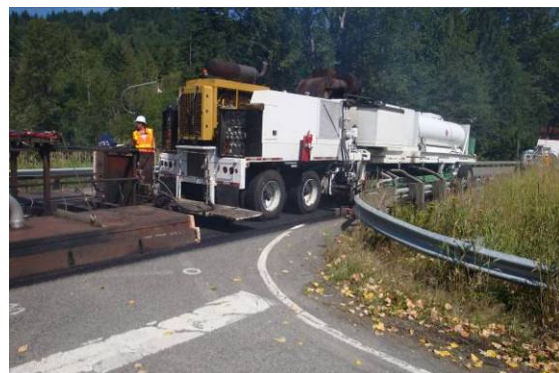
Figure 5. Right rear of unit A and towed trailer with heater.

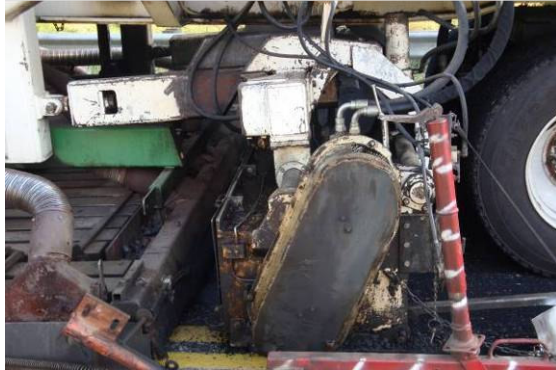
Figure 6. Milling head on left side of unit A removes a five-foot strip from the left side of the lane. An identical milling head removes the same amount from the right side.

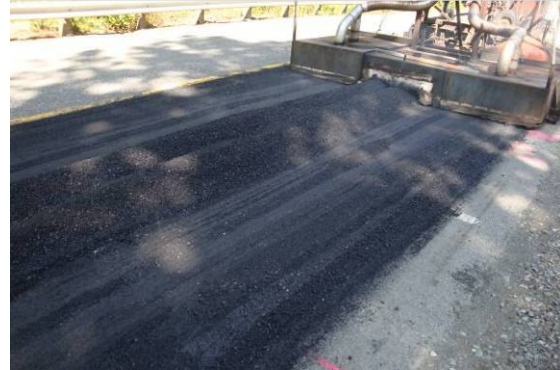
Figure 7. Milled HMA behind unit A is windrowed into the center of the lane.

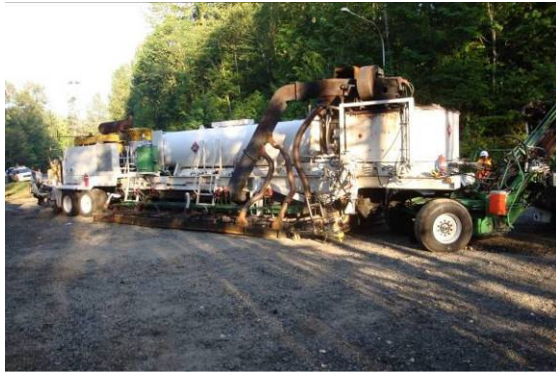
Figure 8. Left rear of unit B.

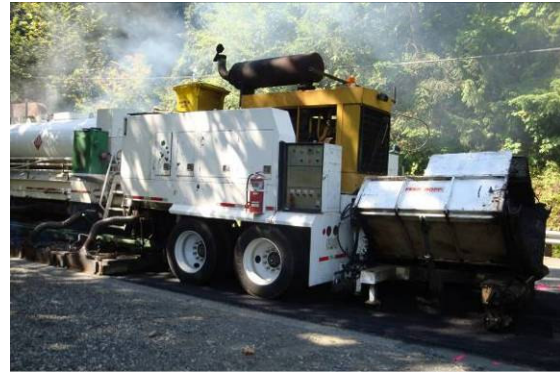
Figure 9. Right front of unit B showing hopper for admixture.

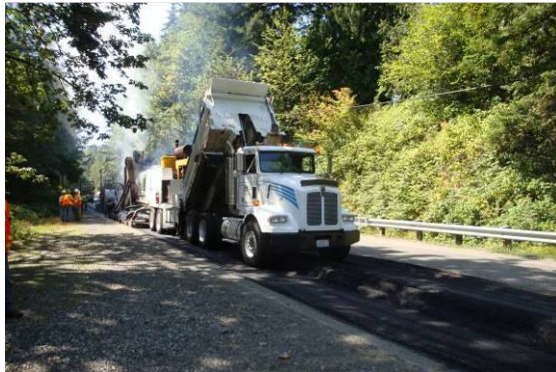
Figure 10. Truck dumping admixture into hopper of unit B.

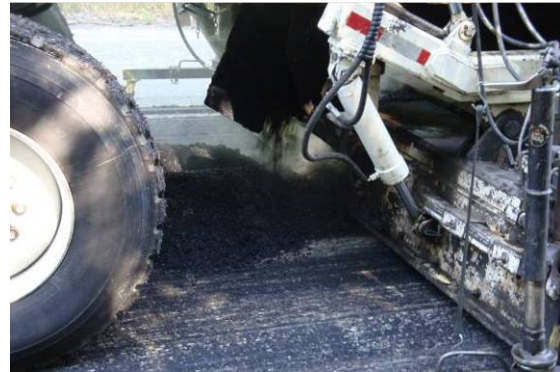
Figure 11. Millings from the full width milling head on unit B (right side of photo) are windrowed with millings from conveyer (top center).

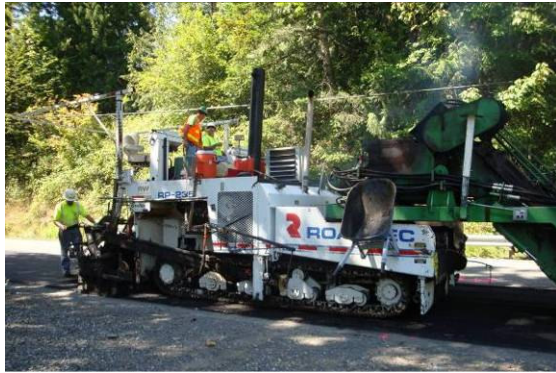
Figure 12. RoadTec RP 235 paving machine.

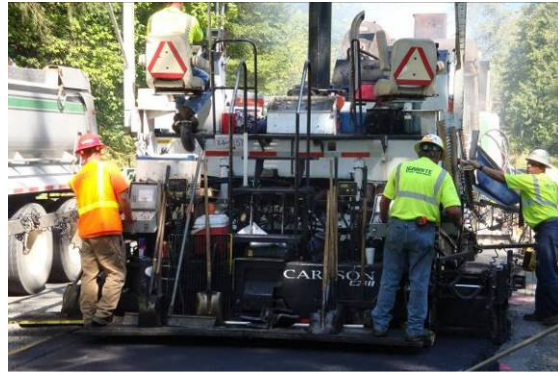
Figure 13. Rear view of RoadTec paving machine.

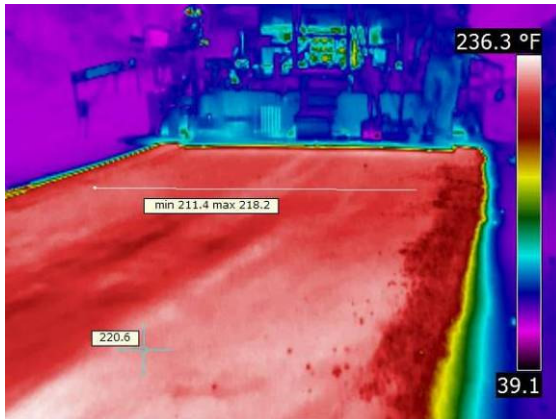
Figure 14. Thermal image showing uniform temperature across the mat.

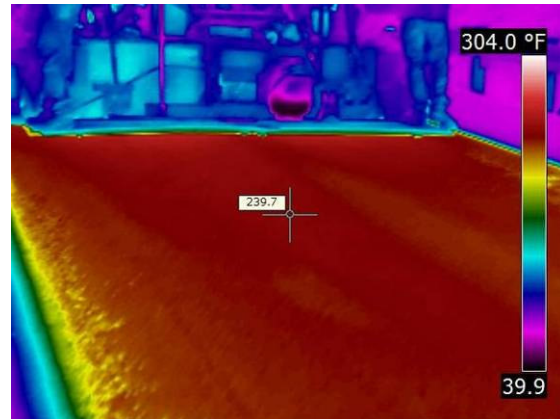
Figure 15. Maximum mat temperature was approximately 240°F.

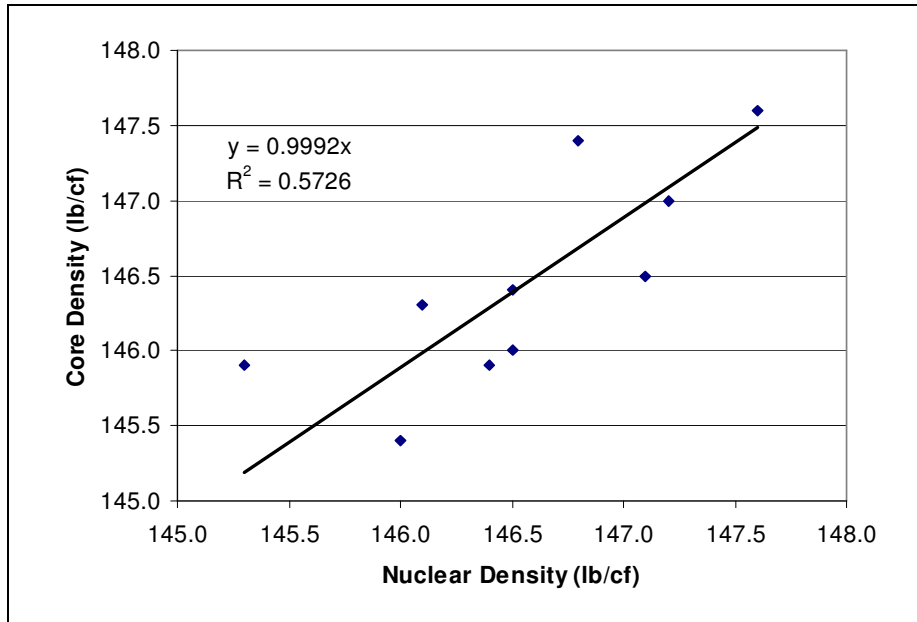
Figure 16. Plot of nuclear density gauge readings vs. core density results.

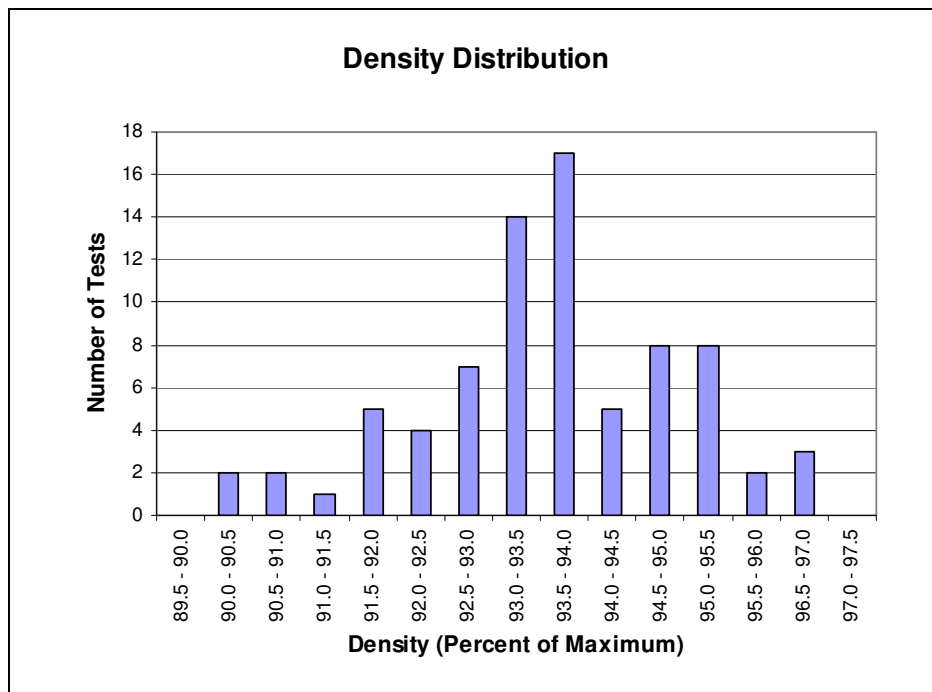
Figure 17. Distribution of corrected nuclear density test results for milepost 14.09 to 19.27.

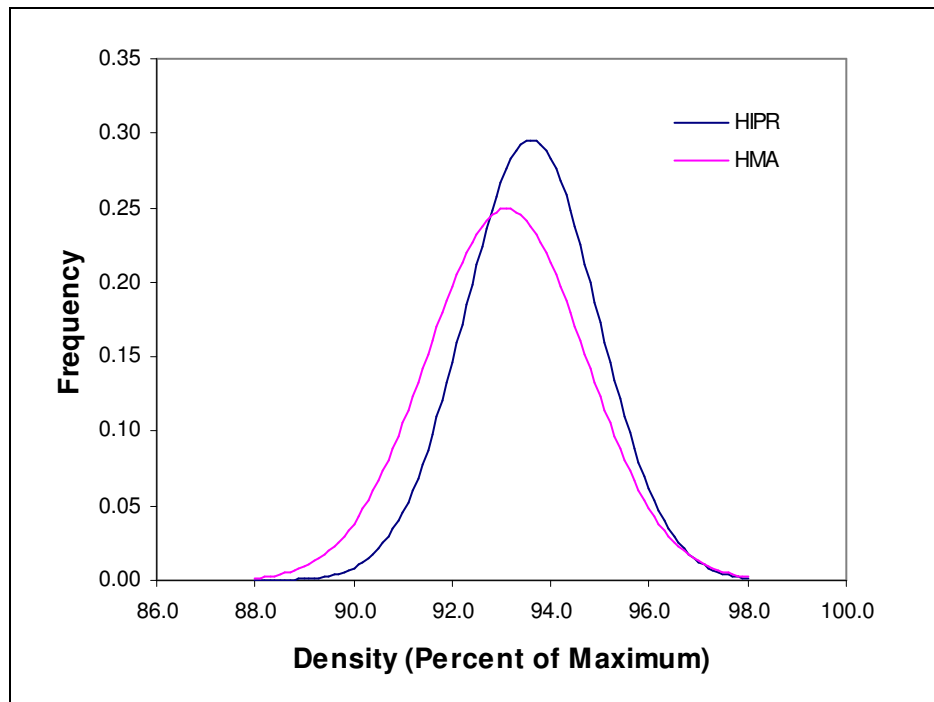
Figure 18. Comparison of normal distributions of HIPR density test results to WSDOT HMA density testing between 1990 and 2005.

Figure 18 compares the normal distribution of HIPR density tests between milepost 14.09 and 19.27 with that of WSDOT HMA density tests taken between 1990 and 2005. The similarity of the two distributions suggests that HIPR is capable of achieving in place densities comparable to HMA paved on WSDOT projects.

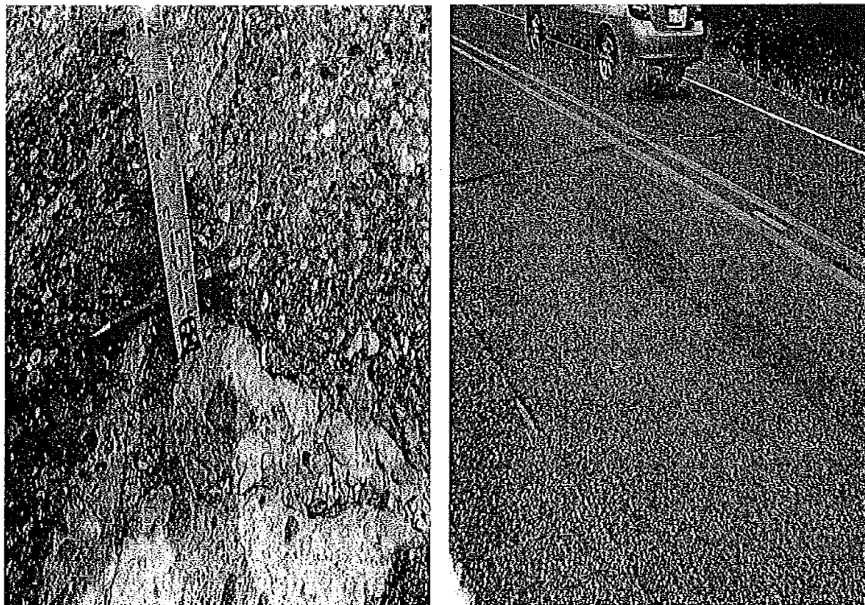
**Photos 1 & 2 (~MP 3.10):** ACP over the PCCP slabs has low to medium severity longitudinal and transverse cracking. The HMA layer thickness was measured ~.08’.

The pavement section from MP 2.98 to MP 3.38 has a thin HMA (~0.10') overlay over the PCCP panels (see Photos 1 & 2). We recommend this area to be overlaid and rehabilitated in the following manner:

1. At the beginning and end of the paving limits, grind transverse butt joints. The transverse butt joints should taper from 0.08' to 0.00' in a minimum length of 15'.
2. Crack seal cracks greater than ¼" in accordance with Section 5-04.3(5)C of the *Standard Specifications for Road, Bridge, and Municipal Construction*
3. Overlay the roadway including the shoulders with 0.15' HMA Class ½", PG 58-22.

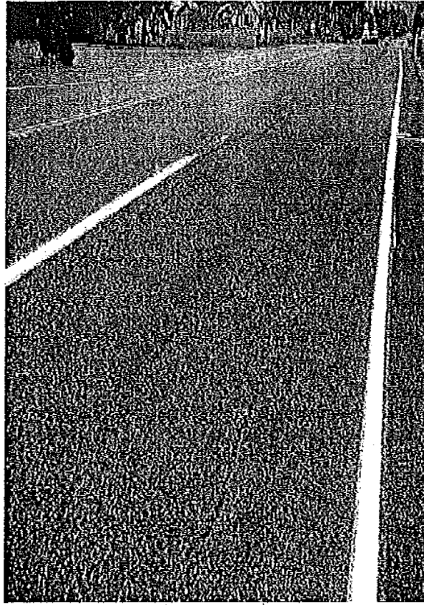
**Photo 3 (~MP 4.8):** Low to medium severity transverse & longitudinal reflective cracking.

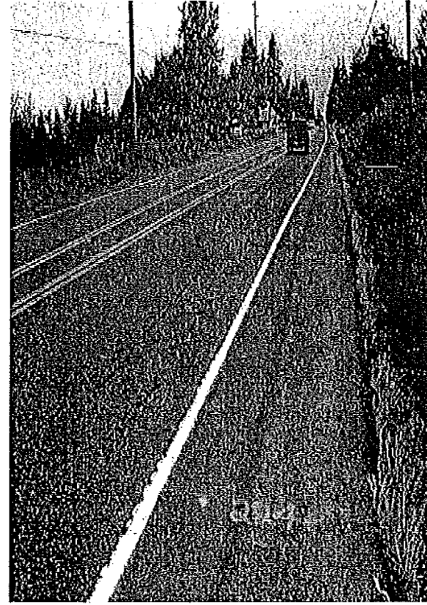
**Photo 4 (~MP 7.05):** Medium to high severity transverse and longitudinal cracking

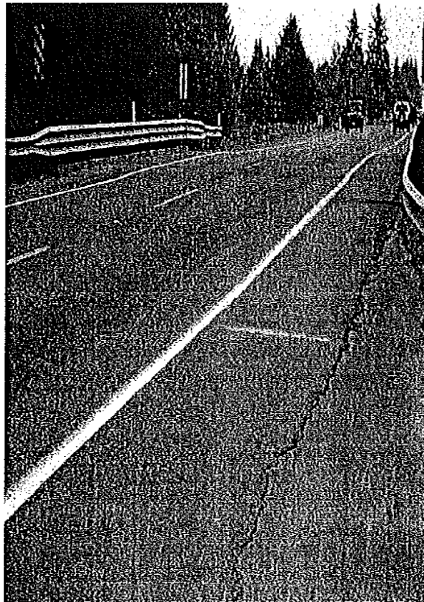
**Photo 5 (~MP 11.29):** Maintenance patching of HMA over the bridge deck # 542/016.

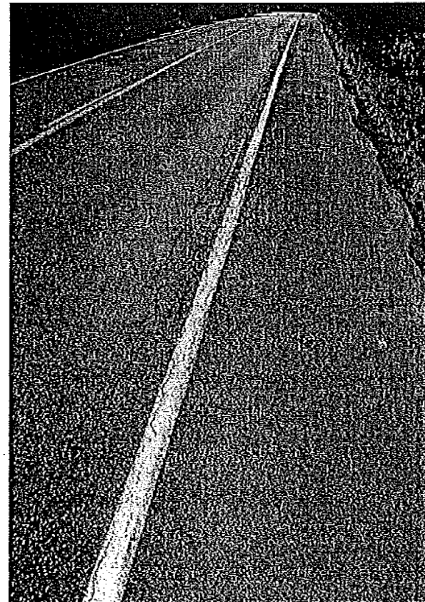
**Photo 6 (~MP 14.27):** Medium to high severity alligator cracking along the fog line and shoulder on WB lane.

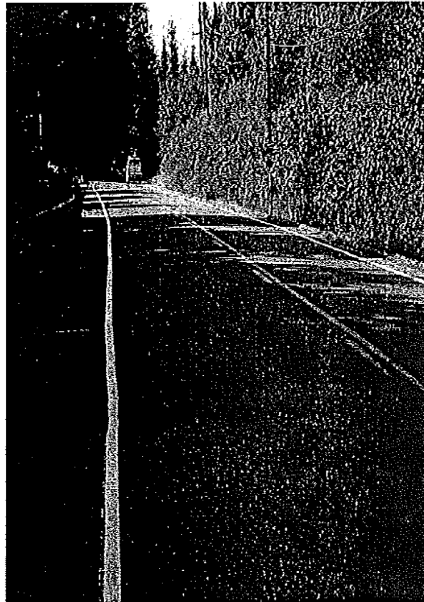
**Photo 7 (~MP 16.65):** Medium severity transverse and longitudinal cracking that was patched with HMA by maintenance crews.

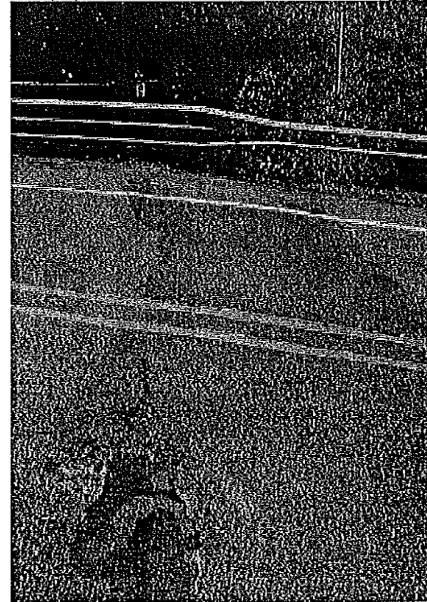
**Photo 8 (~MP 17.65):** High severity alligator cracking and settlement that was patched with HMA by maintenance at both ends of the bridge #542/21.

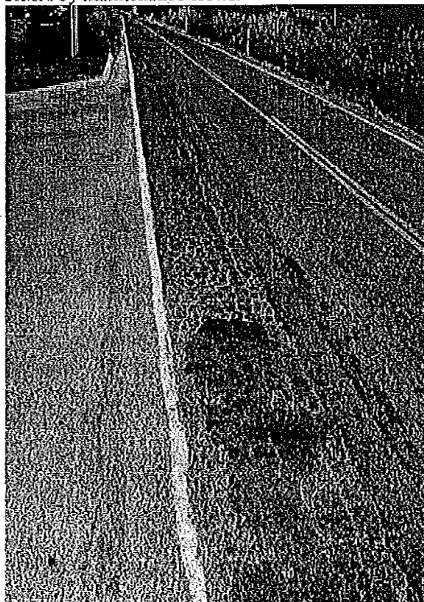
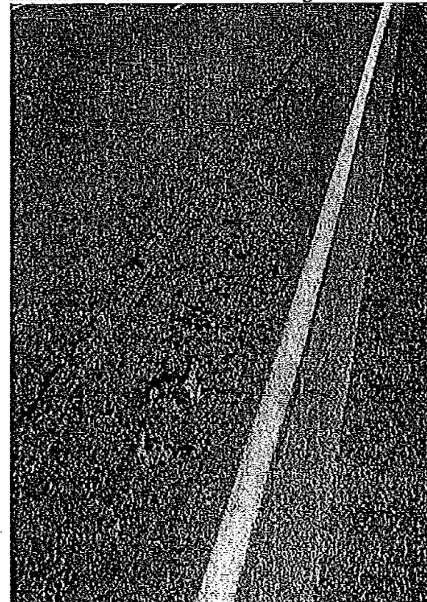
**Photos 9 & 10 (SR 9 at ~ MP 84.06):** Medium to high severity alligator cracking occurring in the wheel path between the edge of the PCCP panels and HMA pavement.

The HMA over the PCCP has low severity raveling, longitudinal and transverse reflective cracking, and medium to high severity alligator cracking (see Photos 9 & 10). Most of these alligator cracked areas extend outwards from edge of the narrow underlying PCCP panels.
