DYNAMIC EVALUATION OF NEW YORK STATE'S ALUMINUM PEDESTRIAN SIGNAL POLE SYSTEM

MIDWEST ROADSIDE SAFETY FACILITY

MwRSF Research Report No. TRP-03-223-09

December 22, 2009

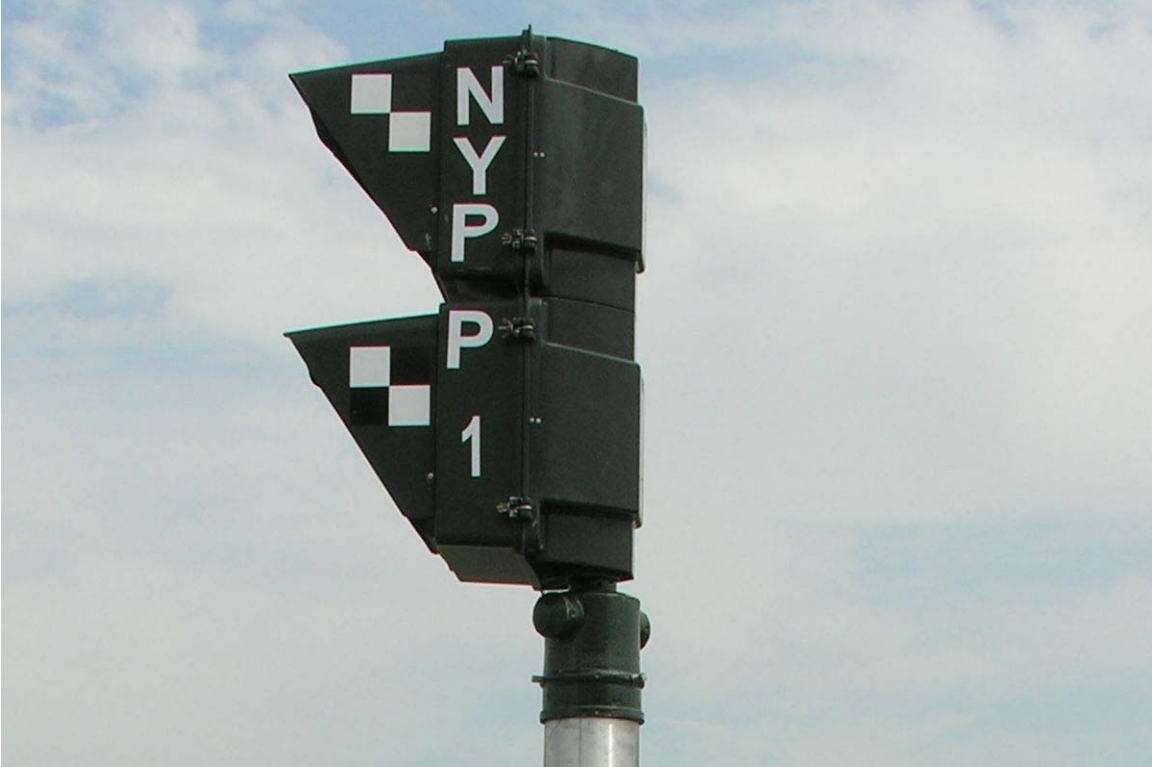
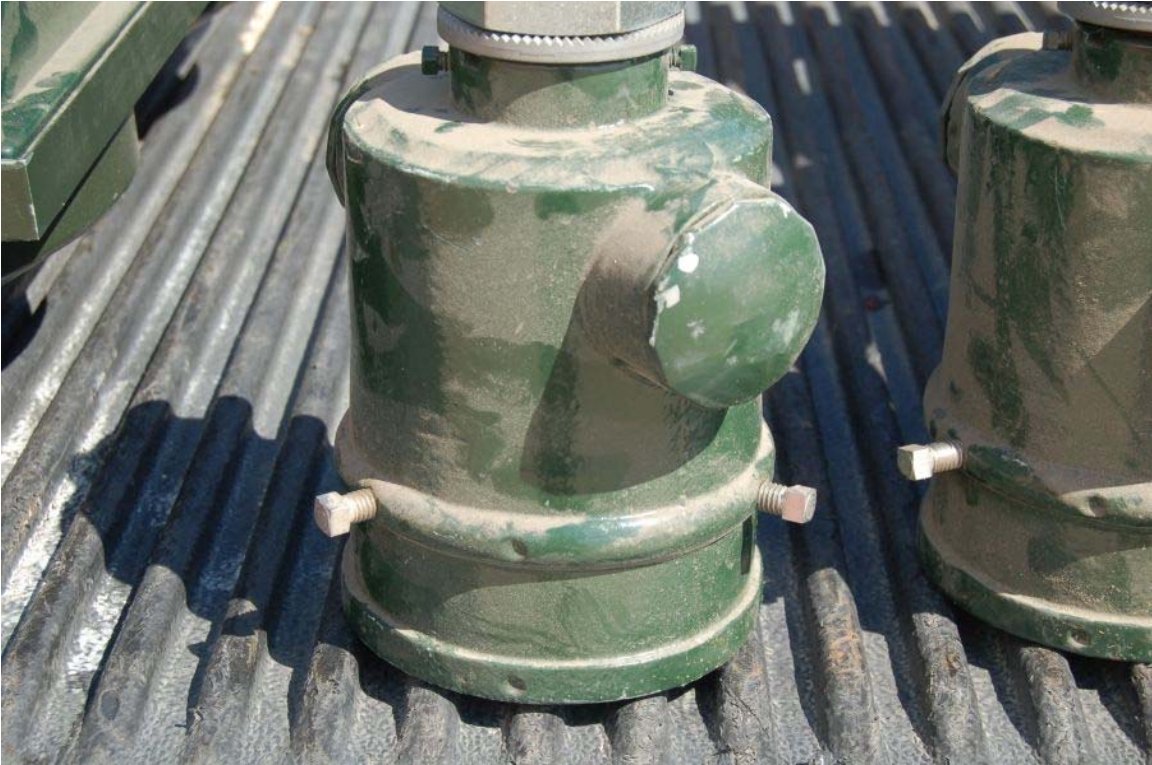
Figure 25. Pedestrian “Hand/Man” Signal and Attachment Bracket

The top of the adjusted pole had a larger diameter than the original 4½-in. (114-mm) outside diameter due to the 28-in. (711-mm) long segment being cut from the top of the tapered pole. As a result, the signal attachment bracket would not slide onto the top of the pole, and the inside of the bracket had to be lathed to increase the inside diameter of the bracket from 4⁵/₈ in. (117 mm) to 4⁷/₈ in. (124 mm), as shown in Figure 26. This reduction in bracket thickness was not believed to have a negative effect on the pendulum test since the bracket still had sufficient strength to secure the signal to the top of the pole and very little load would be transferred through the bracket. This bracket adjustment would not be necessary in real-world applications as long as the pole has the correct height and top diameter. The combined weight of the signal and the reduced thickness bracket was 26 lb (12 kg). After attachment to the pole, the total system weighed 59 lb (27 kg).

The test installation was comprised of an aluminum pole, a pedestrian “hand/man” signal, and a simulated rigid foundation, as shown in Figures 20 through 26. Each component is described separately in the following sections. The assembled test installation is shown in Figure 27. Material certifications are shown in Appendix A

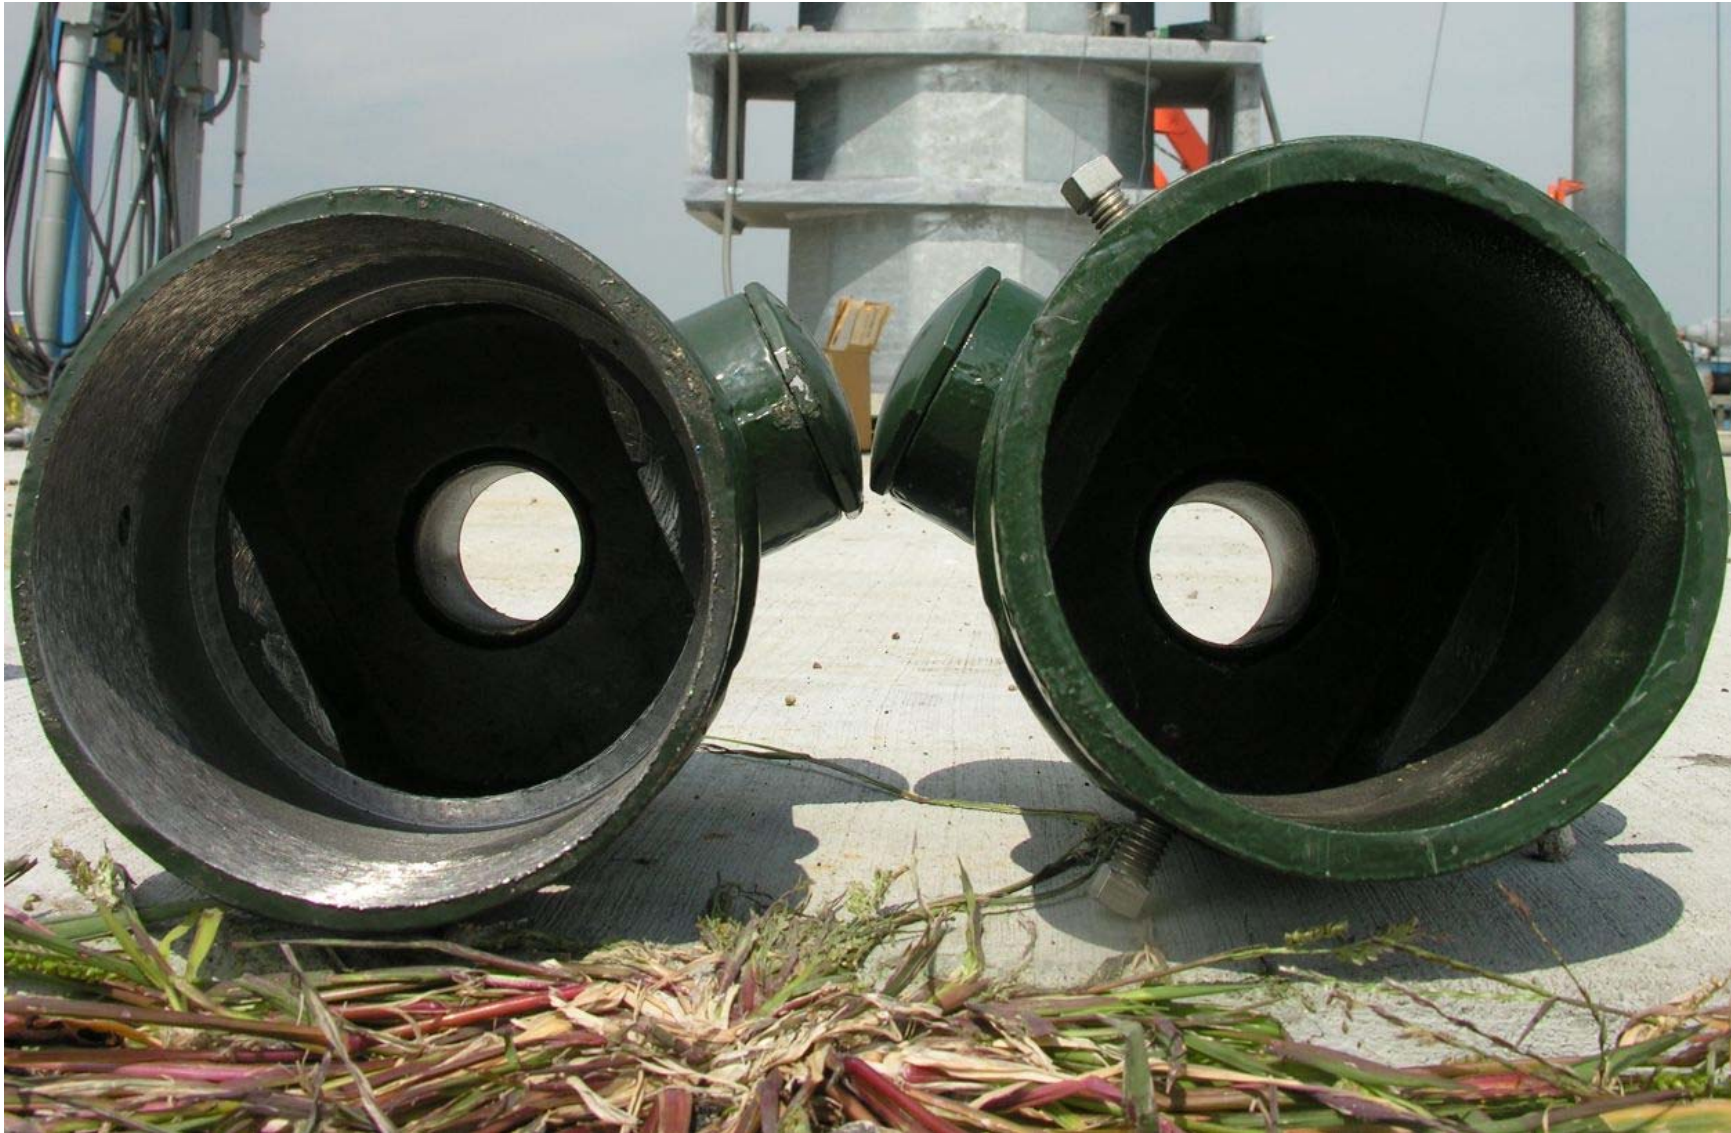
Figure 26. Left – Reduced Bracket Thickness, Right – Original Bracket Thickness

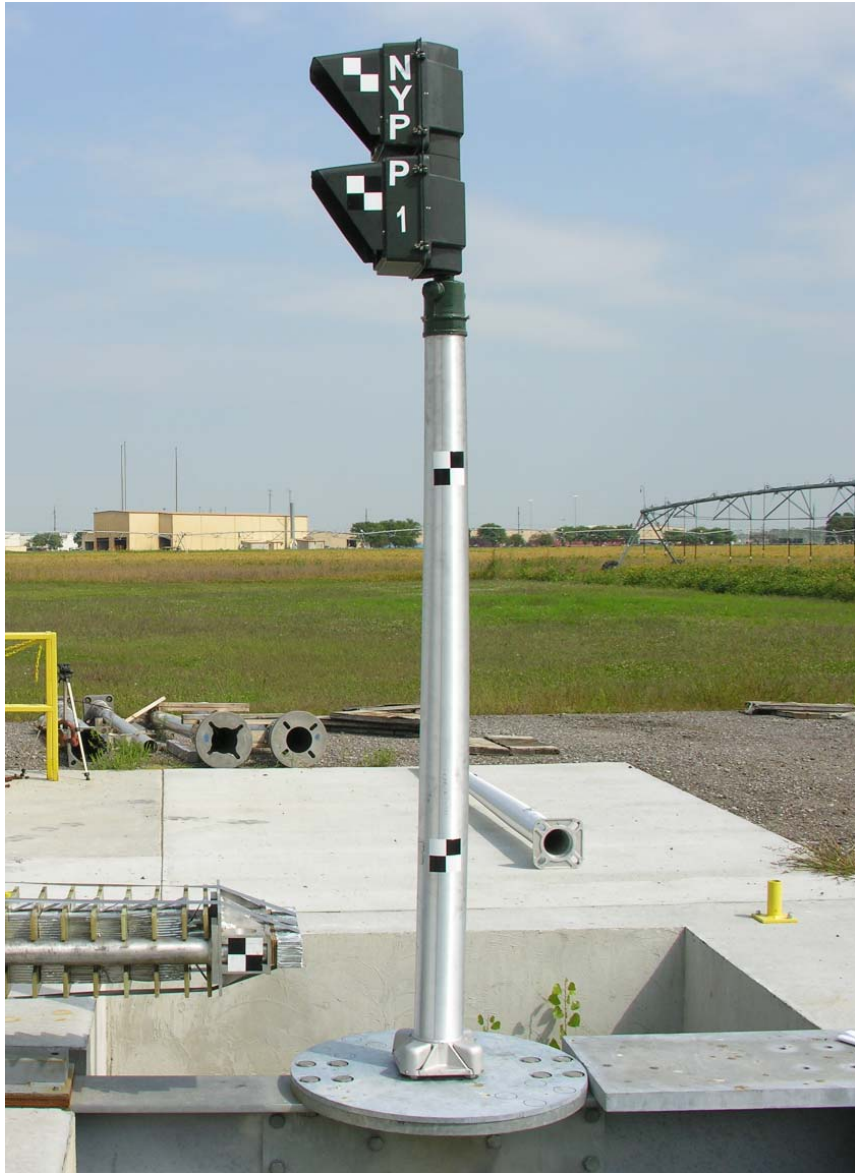
Figure 27. Assembled Pedestrian Signal Test Installation

The state of New York typically requires leveling nuts on all pole installations. Therefore, leveling nuts were placed between the adapter plate and the pole base plate. These leveling nuts and the assembled pole installation are shown in Figure 27. As a result, the bottom of the pole's base plate was 1 in. (25 mm) from the ground surface, while the top of the base plate and cylinder was 4½ in. (114 mm) above the ground. In addition, the top of the pedestrian "hand/man" signal was positioned 10 ft – 3 in. (3.1 m) above the ground surface.

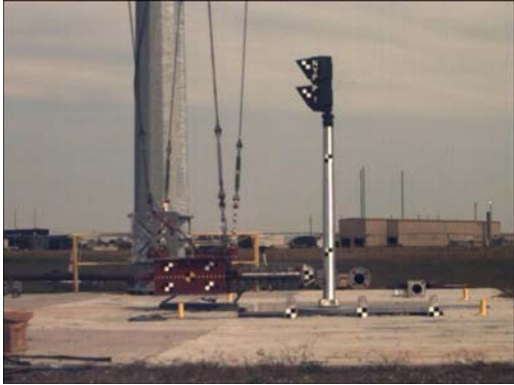
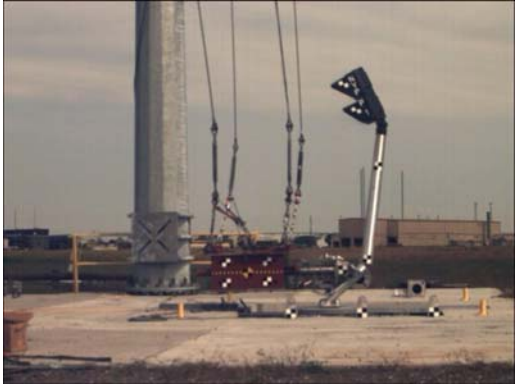
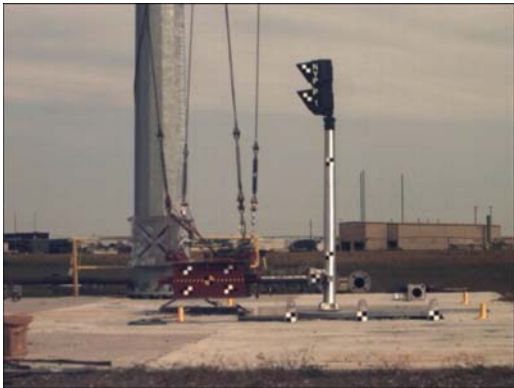
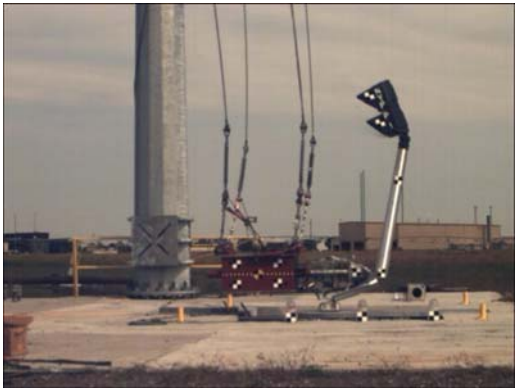
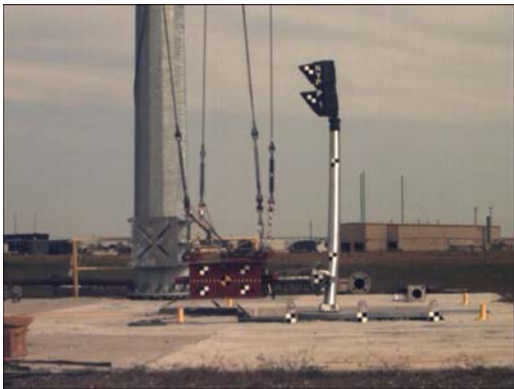
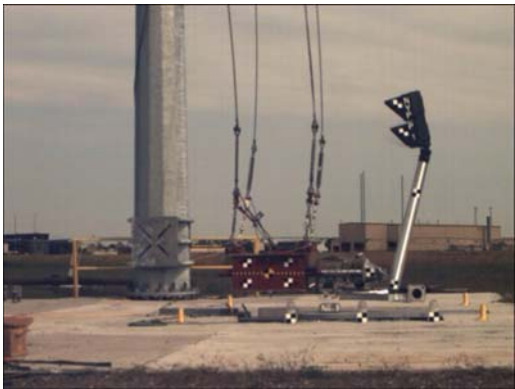
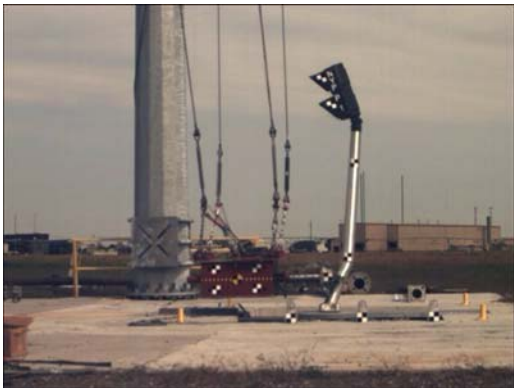
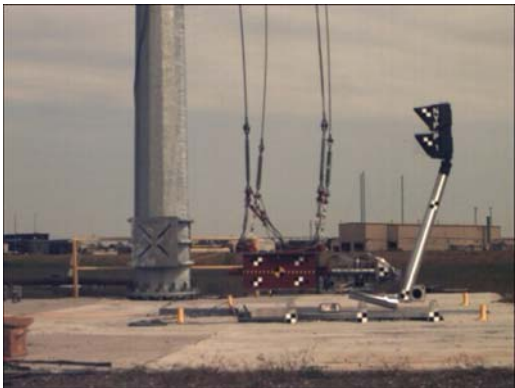
Figure 32. Sequential Photographs, Test No. NYPP-1

During test no. NYPP-1, the 1,898-lb (861-kg) pendulum with a crushable nose contacted the targeted impact point at a speed of 22.0 mph (35.4 km/h). The resulting impact events have been described in sequential order and are presented in Table 6. A summary of the test and analysis of the processed data is contained in Figure 30. Pre-test and post-test photographs of the test are shown in Figure 31, while sequential photographs are shown in Figures 32 and 33. Acceleration data plots from both the primary and the secondary units are shown in Appendix B.

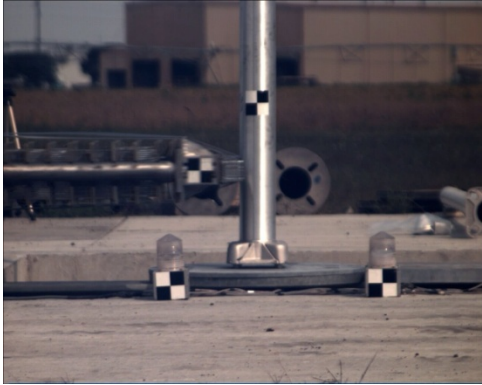
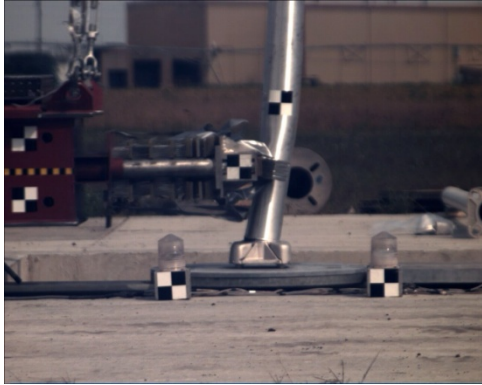
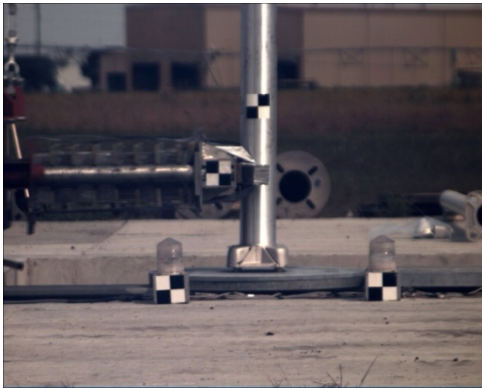
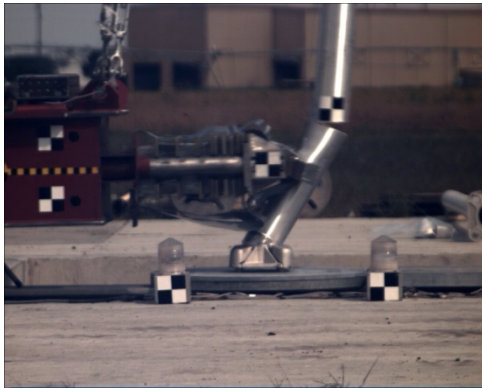
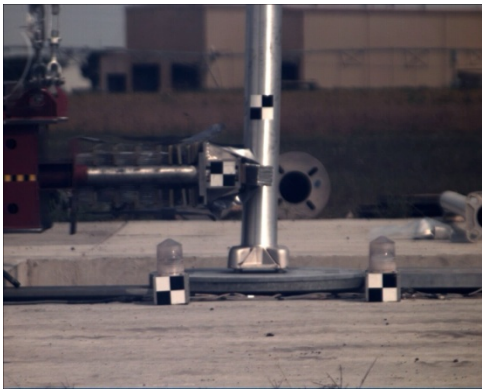
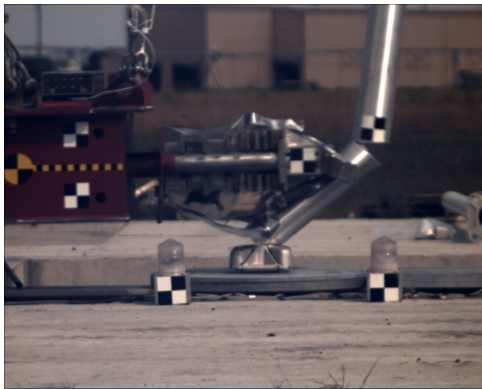
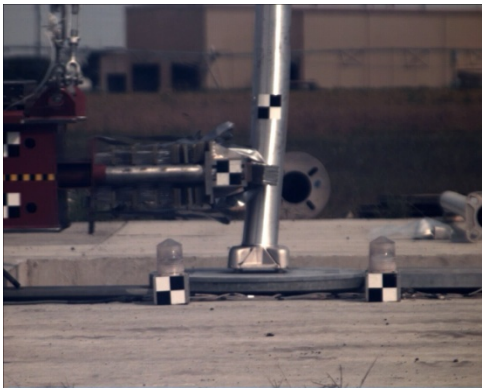
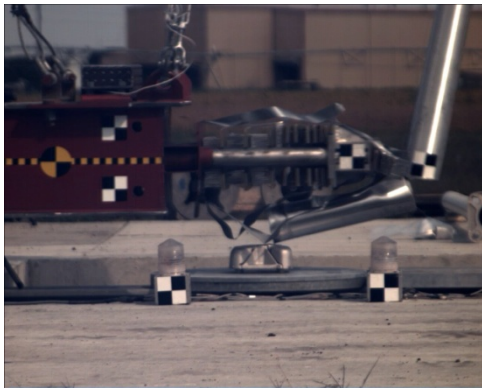
Figure 33. Sequential Photographs, Test No. NYPP-1

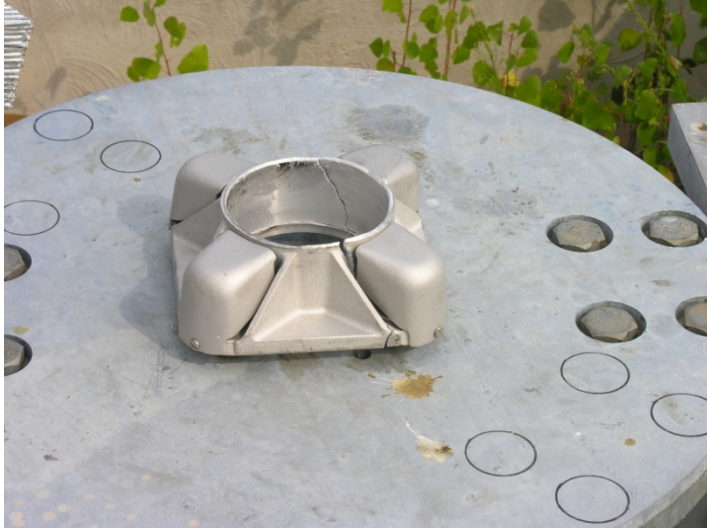
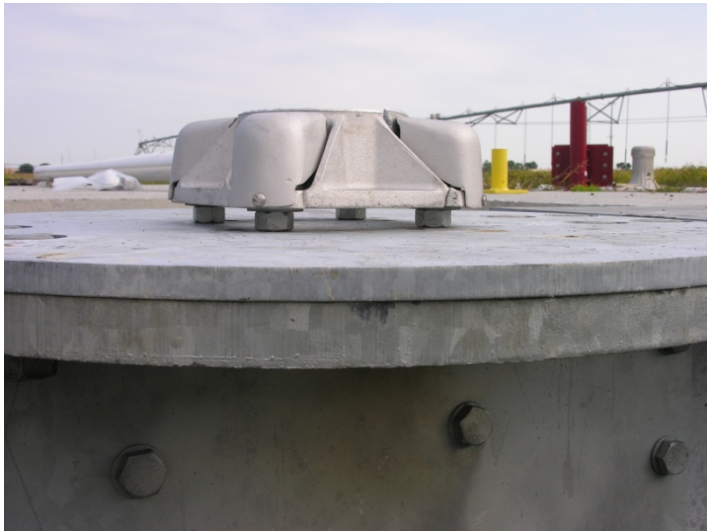
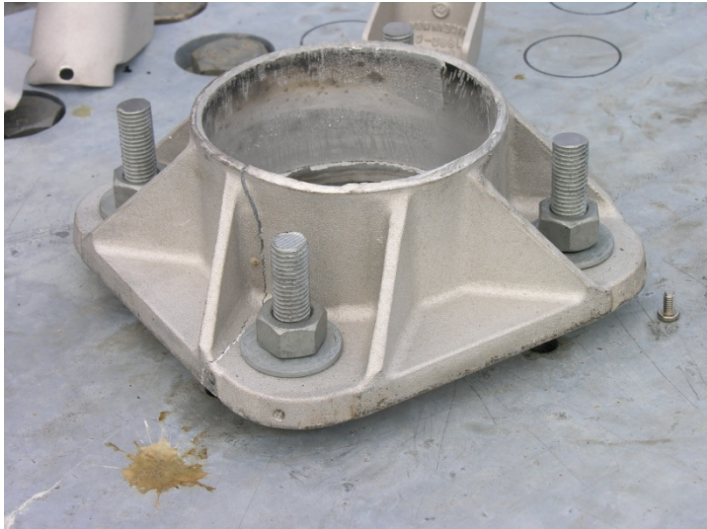
Figure 34. System Damage - Base Plate Cracks and Fractures, Test No. NYPP-1

As a result of the pendulum impact, the pedestrian signal pole system was broken into four separate pieces, as shown in Figure 31. The base plate assembly remained attached to the simulated rigid foundation and extended 4½ in. (114 mm) above the ground surface, as shown in Figure 34. Two cracks were found in the base plate assembly. The first crack was located on the

cylinder between the gussets surrounding the back-left anchor bolt and extended from the top of the cylinder to the base plate. The second crack began on the top of the cylinder between the gussets surrounding the back-right anchor bolt and continued through the base plate and out the back-right corner. The anchor bolts and nuts remained undamaged.

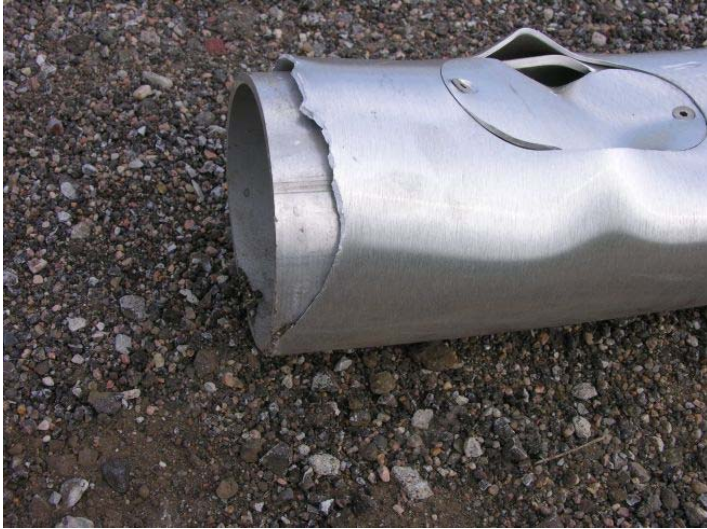
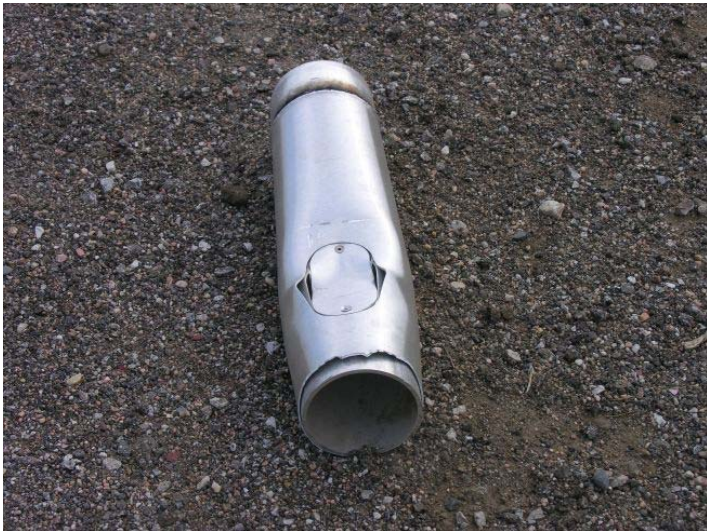
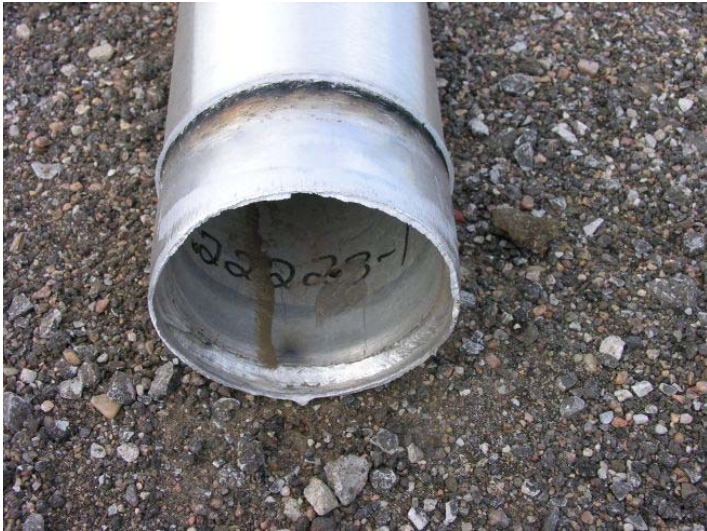
Figure 35. System Damage - Bottom Piece of Pole and Internal Sleeve, Test No. NYPP-1

The aluminum pole was detached from the base plate assembly and fractured into two pieces, as shown in Figures 35 and 36. The bottom piece came to rest 17 ft (5.2 m) behind the pole's original position. The bottom piece of the pole was 24 in. (610 mm) long and contained both the lower portion of the pole and the internal reinforcing sleeve. The bottom end of this segment contained the remains of the welds originally used to connect the pole to the base plate assembly. At the top of this segment, the pole was jagged along the fracture surface. The handhole cover was deformed and pushed inward from the impact, and local buckling of the pole was found on both sides of the handhole.

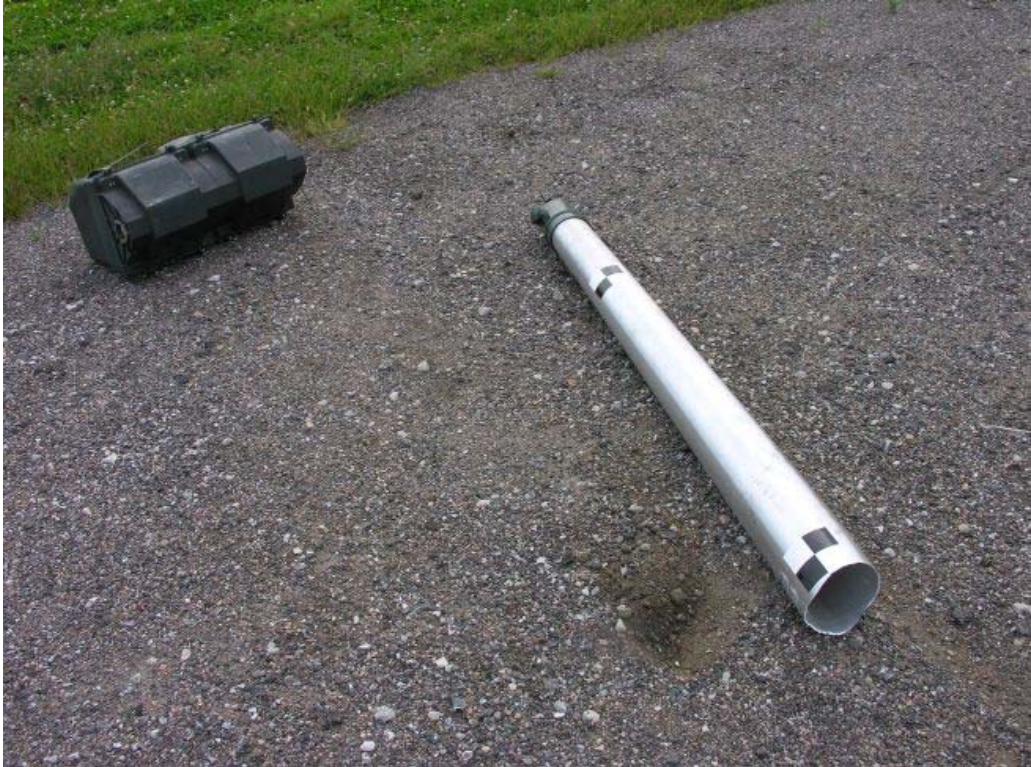
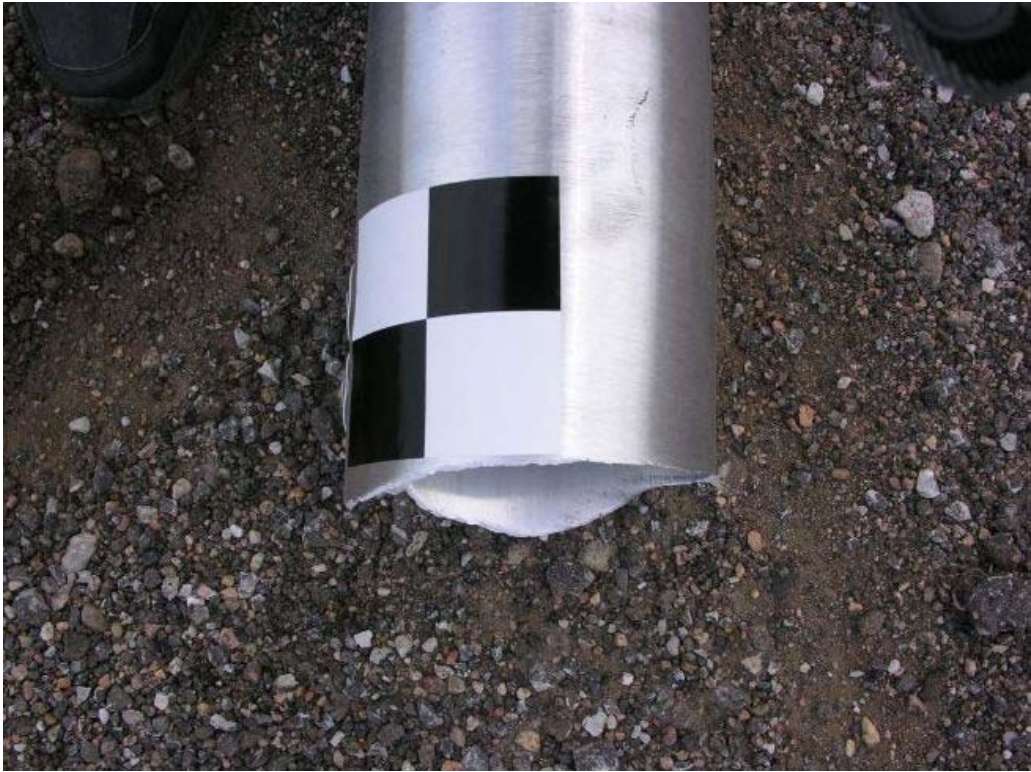
Figure 36. System Damage - Upper Portion of Pole, Test NYPP-1

The top portion of the pole remained largely undamaged and came to rest 34 ft (10.4 m) from the pole's original position. The only damage was the jagged fracture surface located at the bottom end of this segment.

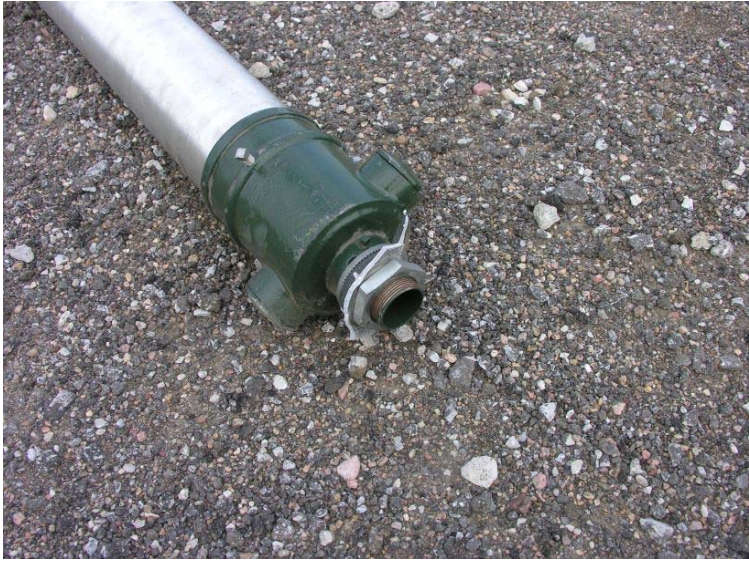
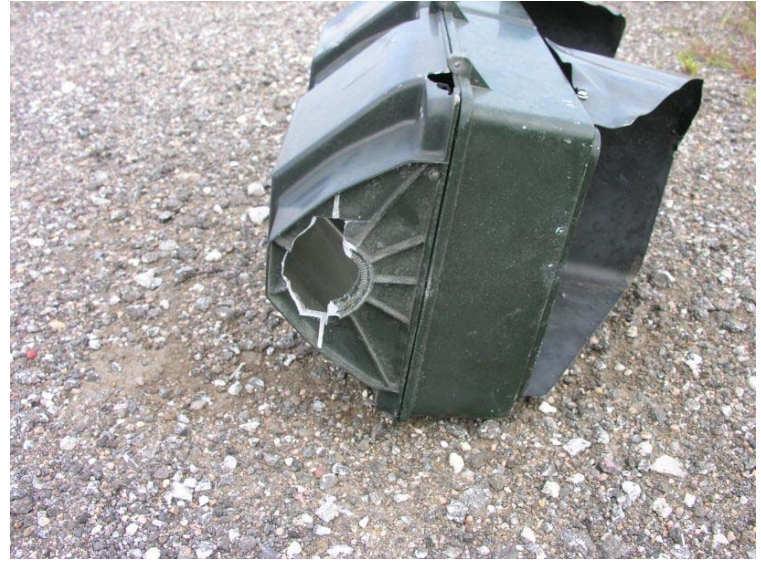
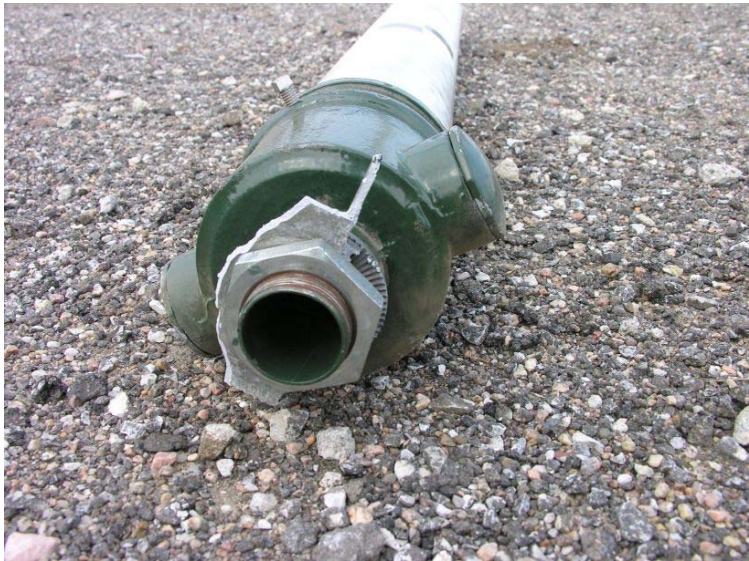
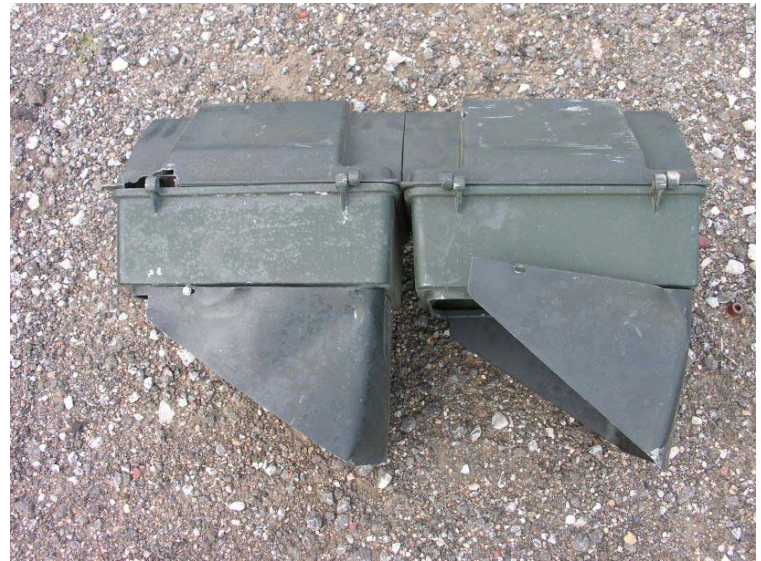
Figure 37. System Damage - Signal and Attachment Bracket, Test No. NYPP-1

The pedestrian signal was detached from the attachment bracket and came to rest 38 ft (11.6 m) behind the pole's initial position. A piece of the plastic surrounding the attachment bracket at the bottom of the signal had fractured off, as shown in Figure 37. This small piece remained wedged between the bracket and the attachment nut. The attachment bracket itself remained undamaged and fixed to the top end of the pole.
