# Inclinometer – Time Domain Reflectometry Comparative Study

**Final Report**  
**December 2004**

<b>1. Report No.</b> FHWA/OH-2004/010	<b>2. Government Accession No.</b>	<b>3. Recipient's Catalog No.</b>
<b>4. Title and Subtitle</b> Inclinometer – Time Domain Reflectometry Comparative Study	<b>5. Report Date</b> December 2004	<b>6. Performing Organization Code</b>
	<b>8. Performing Organization Report No.</b>	
<b>7. Author(s)</b> Shad M. Sargand, Lisa Sargent, Stephen P. Farrington	<b>10. Work Unit No. (TRAIS)</b>	
<b>9. Performing Organization Name and Address</b> Ohio Research Institute for Transportation and the Environment (ORITE) 114 Stocker Center Ohio University Athens OH 45701-2979	<b>11. Contract or Grant No.</b> State Job No. 14798(0)	
	<b>13. Type of Report and Period Covered</b> Final Technical Report	
<b>12. Sponsoring Agency Name and Address</b> Ohio Department of Transportation Office of Research and Development 1980 West Broad St. Columbus OH 43223	<b>14. Sponsoring Agency Code</b>

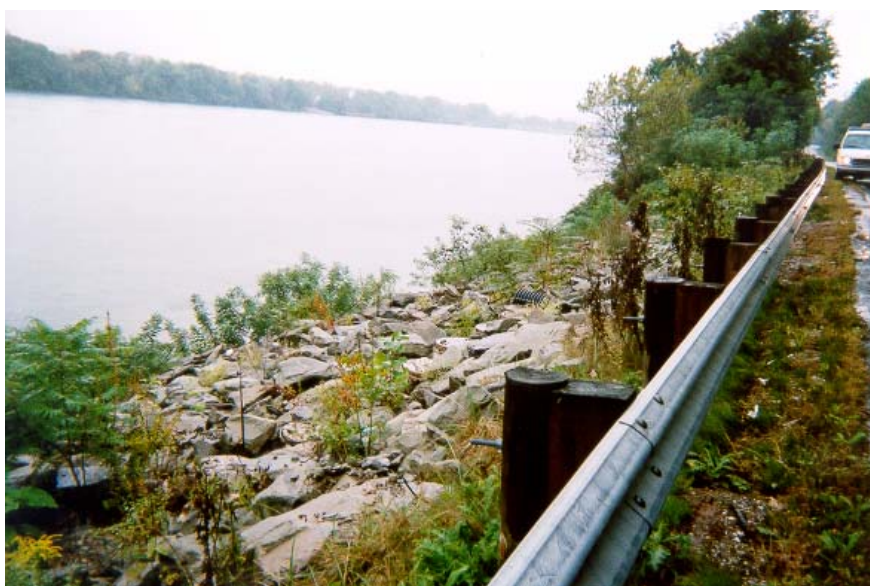
**Figure 3.2 - Stabilized Rock Embankment along MEG 338**

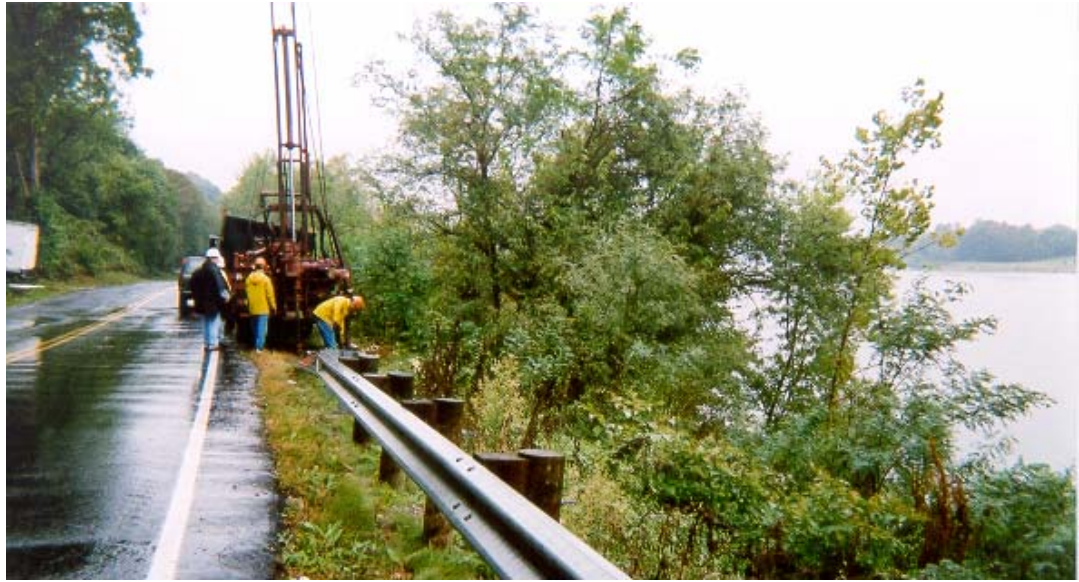
**Figure 3.4 - Installation of Instrumentation at MEG-338 Site**

Figure 3.4 shows the installation of instrumentation at the MEG-338 site. The picture shows the vicinity of the test site to the Ohio River.

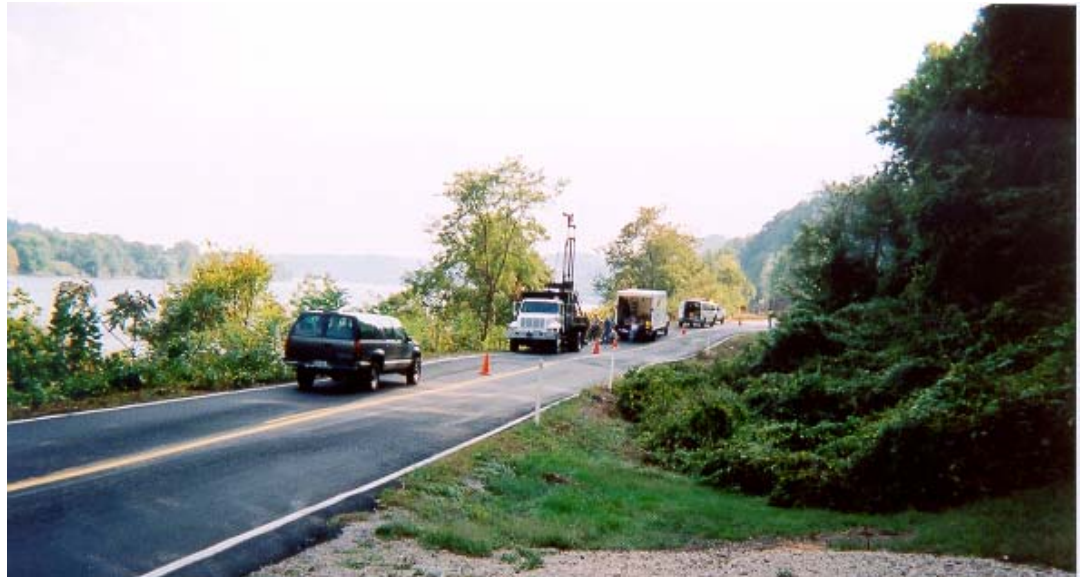
**Figure 3.5 - General View of MEG-124 Site**

Figure 3.5 shows an overall view of the MEG-124 site. The dip in the road is clearly evident. This location was experiencing lateral subsurface soil movement and road deterioration. The alignment of this section of road was originally straight, but it has shifted towards the river and sunk many feet over the years.

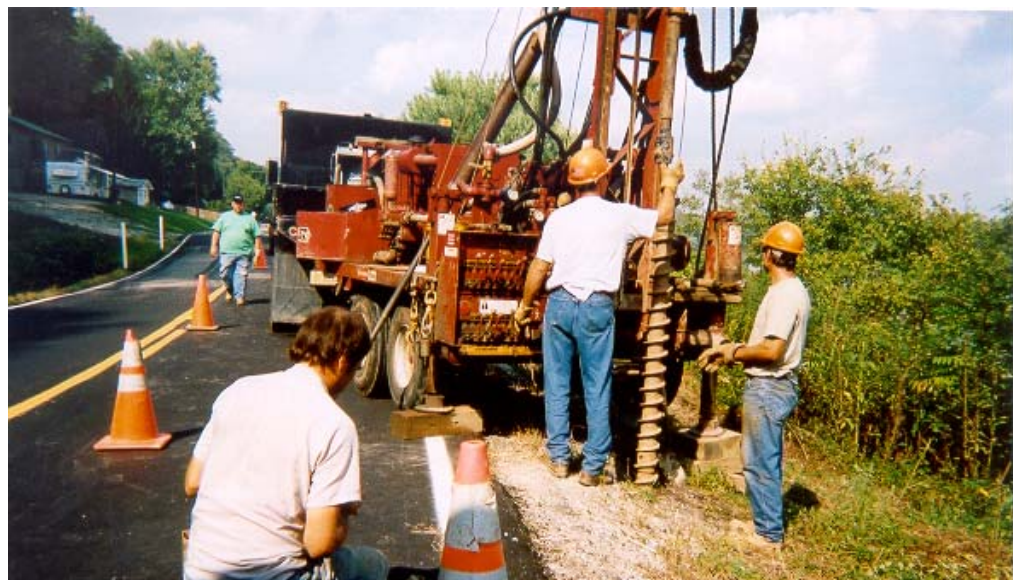
Figure 3.6 shows the installation of instrumentation at the MEG-124 site. At the time of installation, over ten nineteen of asphalt had been placed at this location to fill the dip and keep the road passable.

**Figure 3.6 - Installation of Instrumentation at MEG-124 Site**

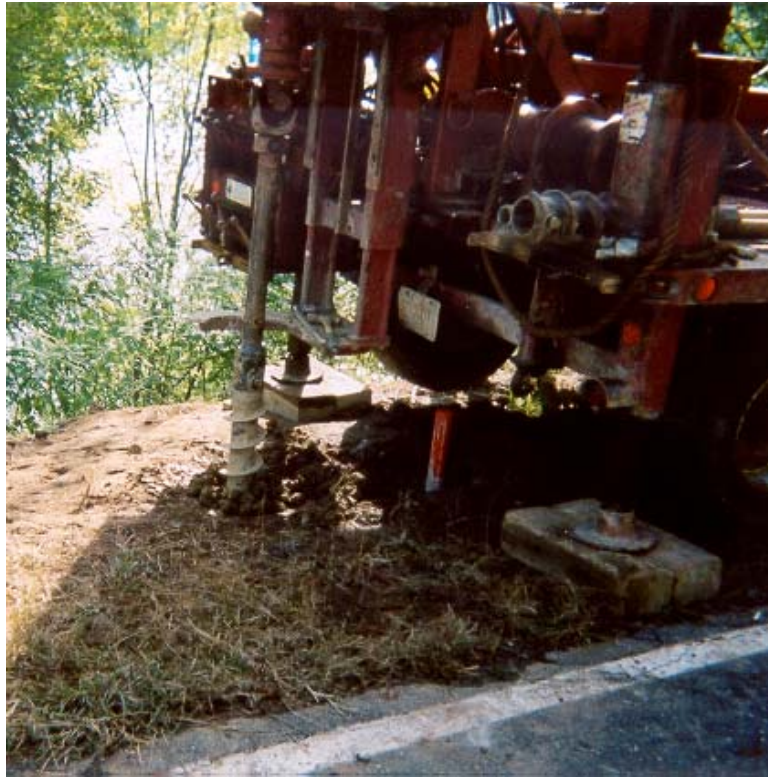
Figure 3.11 shows a photograph taken during the installation of a TDR cable after installation of an adjacent inclinometer casing at the MEG-338 site.

**Figure 3.11 - Drilling TDR Boring Adjacent to Inclinometer Installation at MEG-338 Site**

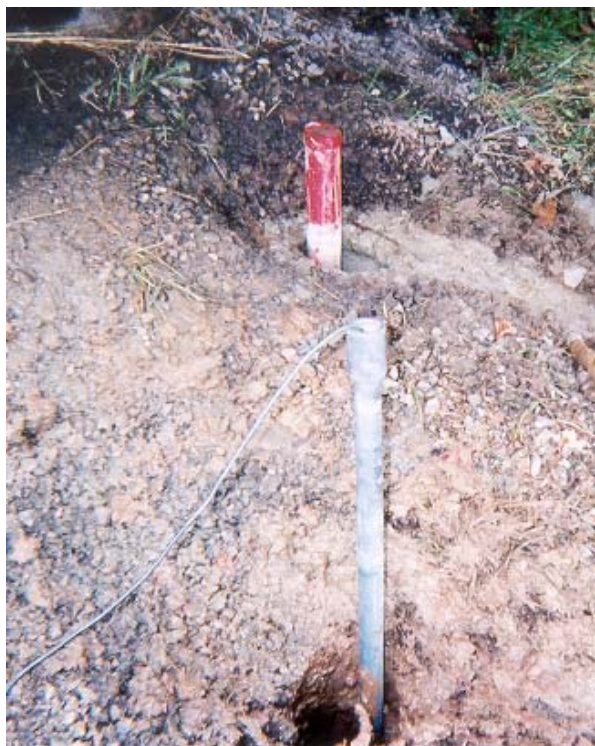
Figure 3.12 shows the installation of a TDR cables using the 1.5 in (3.8 cm) PVC pipe. Figure 3.13 shows the completed installation of an inclinometer and TDR cable. The protective PVC caps have been set in place with quick-setting cement.

**Figure 3.12 - Installation of TDR Cable Using 1.5 in (3.8 cm) Diameter PVC Pipe**

securely located in bedrock, the auger sections were carefully raised from around the cable and 1.5 in (3.8 cm) PVC pipe. Sections of the PVC tubing were then raised and unattached while the cable was held securely at the top of the boring. An additional twenty feet of cable above the boring was necessary to remove tubing sections and hold the cable. When all tubing sections were removed, the cable was centered in the boring and held taut while grout was pumped in to the boring. The same grout mixture was used for the Inclinerometers and the TDR Cables. After overnight setting of the grout, additional grout was added to the boring if needed. Once the grout stiffened, a 4 in (10 cm) diameter PVC tube with a screw cap was affixed over the cable and set with quick setting cement. The cable was cut with additional cable at the top of the ground surface. This allowed room to setup instrumentation for data acquisition. A BNC connector was then soldered to the cable end. Figure 3.10 shows a diagram of the TDR installation.

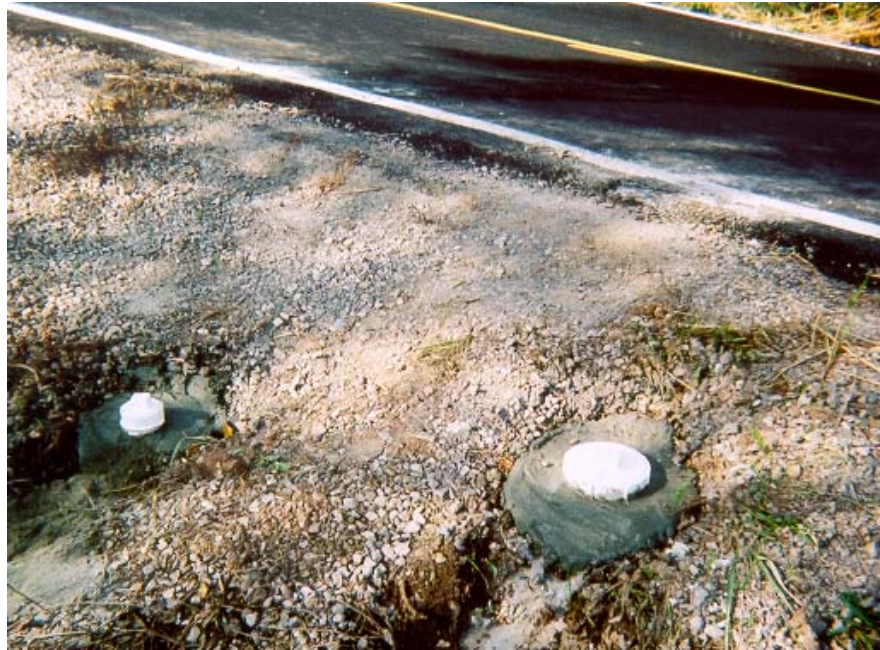
**Figure 3.13 - Completed Installation of Inclinometer and TDR Cable**

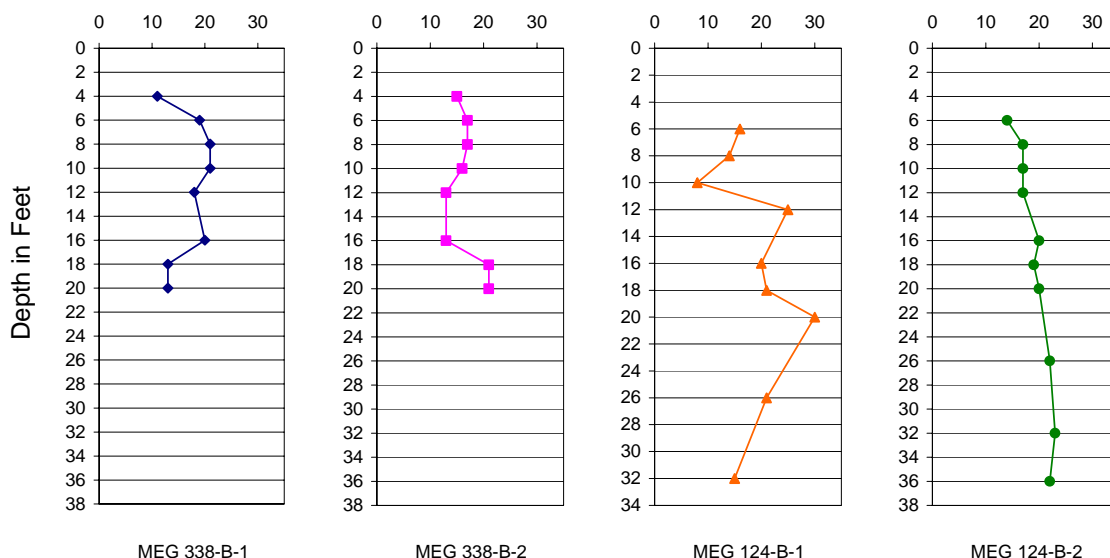
**Figure 3.14 – Gravimetric Soil Moisture Content from Soil Boring Laboratory Analysis (1 ft = 0.3048 m)**

Detailed soil profiles of the test sites were developed during drilling for the inclinometer casings by the ODOT Soils Laboratory. The boring logs and field data are attached in APPENDIX C – Boring Logs and APPENDIX D – Field Data. The soils encountered in the borings were sandy silt, silt and clay. The bedrock encountered was sedimentary rock; sandstone, siltstone and mudstone. Table 3.3 lists the depth to bedrock encountered at the test sites. Figure 3.14 shows the initial gravimetric soil moisture content with depth at the test sites.

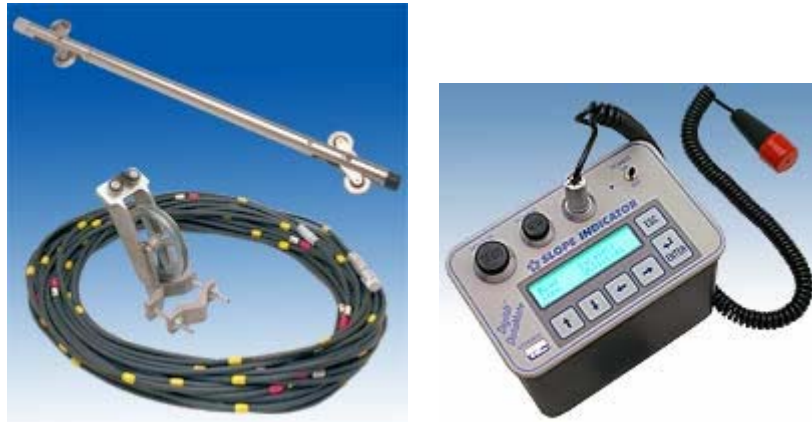
The Inclinometers were read by ODOT personnel using the Slope Indicator Company Digitilt® system. The system, shown in Figure 3.16, used a portable probe containing a gravity-sensing transducer, a portable readout unit for power supply and indication of probe inclination and a graduated electrical cable linking the probe to the readout unit. The probe read both the A axis and B axis simultaneously, but two readings, 180-degrees apart were taken and the readings were averaged for each axis. The traces of cumulative displacement were provided. The rate and depth of movement were also provided in monthly reports from the ODOT Office of Geotechnical Engineering. Figure 3.17 shows a photograph taken during an inclinometer reading by ODOT. The Inclinometer traces are located in APPENDIX A – Inclinometer Readings.

**Figure 3.16 – Slope Indicator Company Digitilt® System**

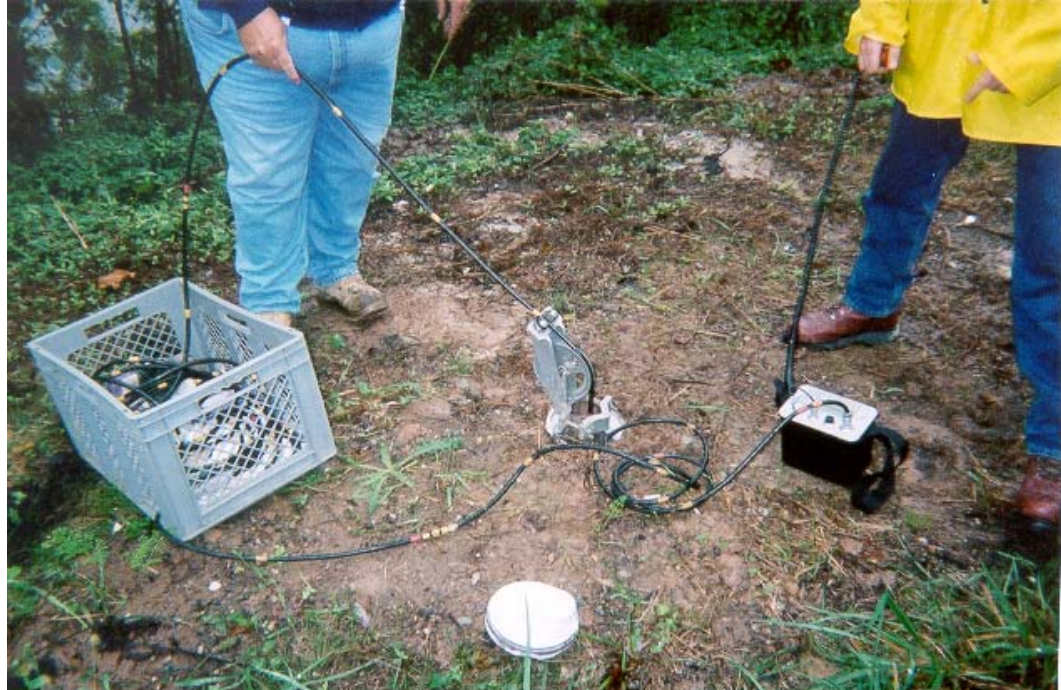
### **Figure 3.17 - Inclinator Reading by ODOT**

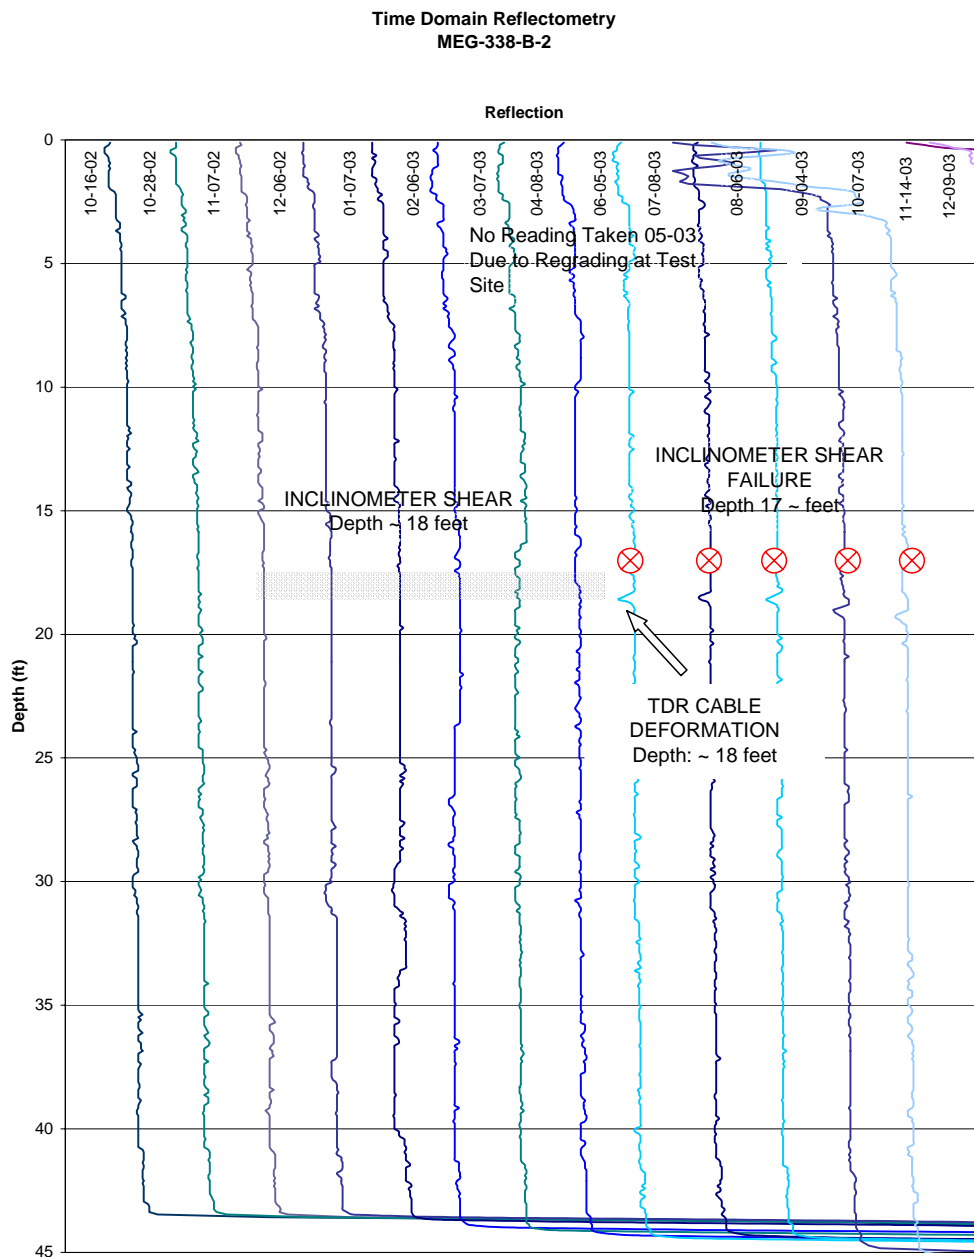
**Figure 4.6 - MEG 338-B-2 TDR Cable and Inclinometer Monthly Reading  
Results (1 ft = 0.3048 m)**

Figure 4.6 and Figure 4.7 show the monthly TDR cable readings and the last inclinometer reading for MEG 338-B-2. The MEG 338-B-2 cable experienced cable deformation at a depth of 18 ft (5.4 m). The cable connector at the top-end of the cable was damaged due to standing water in the PVC protective cap. The water damage is evident in the September through December traces. The inclinometer detected the shear plane at a depth of 18 ft (5.4 m) and the casing failed completely at a depth of 17 ft (5.2 m). The inclinometer casing at this site experienced an unusual negative cumulative displacement at the top end of the casing. The detected movement is in a red, gravelly sandy silt located at the interface between a medium stiff layer and a very stiff soil layer. The detected movement here is also along the interface of the two layers.

(⊗ Indicates inclinometer casing deformed beyond use)

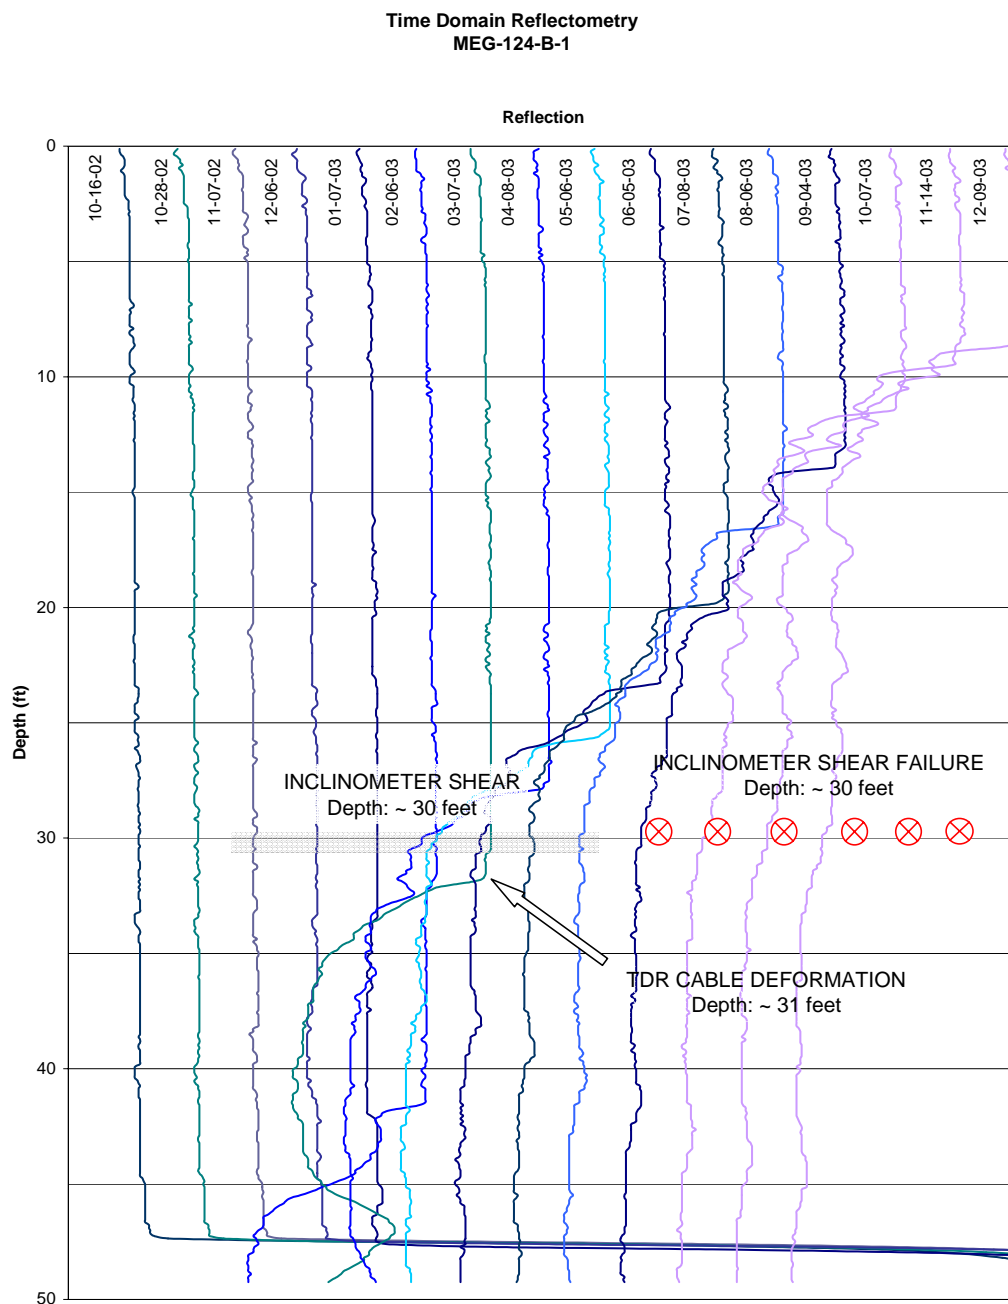
**Figure 4.8 - MEG 124-B-1 TDR Cable and Inclinator Monthly Reading  
Results (1 ft = 0.3048 m)**

Figure 4.8 and Figure 4.9 show the monthly TDR cable readings and the last inclinometer reading for MEG 124-B-1. The MEG 124-B-1 cable experienced cable shear at a depth of 31 ft (9.4 m). An initial deformation of the cable was detected at a depth of 42 ft (12.8 m), but the cable was sheared at the 31 ft (9.4 m) depth the following month so further monitoring of the 42 ft (12.8 m) depth shear plane was not possible. The damaged cable experienced water intrusion which can be seen in the monthly traces as an incrementally decreasing depth to the cable end. The inclinometer detected a shear plane and deformed beyond use at a depth of 30 ft (9.1 m). The movement at this depth is located within a red silt and clay layer. The stiff soil at this depth is underlain by a significantly harder layer. The detected movement is along the interface of the two layers, just above the bedrock.

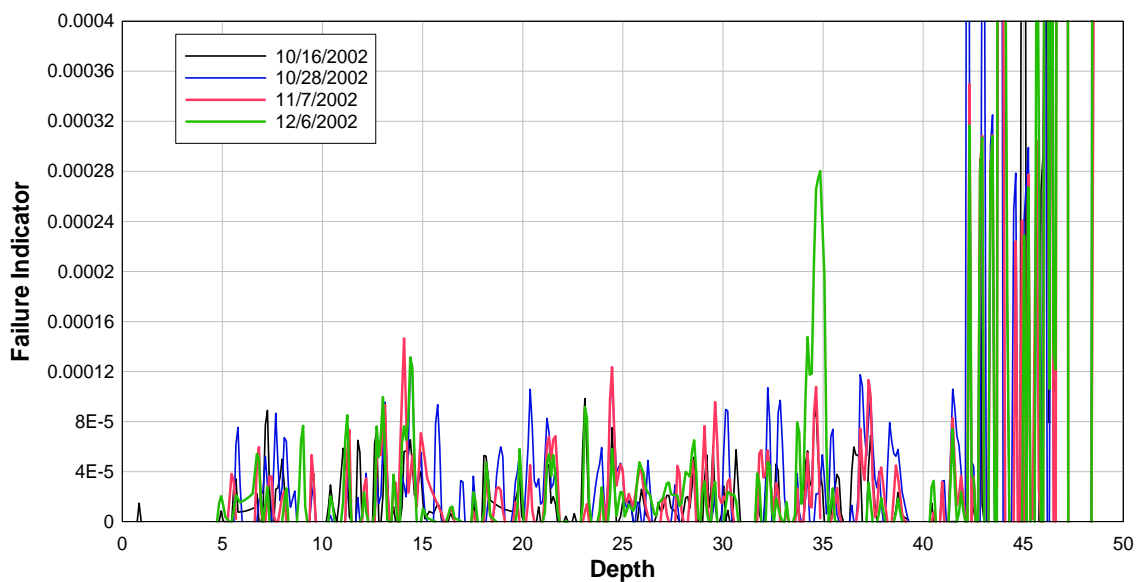
**Figure 4.15. Failure Indicator versus depth at installation A (338-B-1) through December 6, 2002, 81 days following baseline reading, showing movement at 35 ft (10.7 m) deep (1 ft = 0.3048 m).**

the strained region, so the depth at which the peaks occur does not representative the center of the movement. The center of movement, or shear plane, would be indicated by the zero crossing between positive and negative peaks in the temporal-spatial derivative of reflectance, as shown at a depth of 38 ft (11.6 m) in Figure 4.14. The Failure Indicator in this case will peak at 35 ft (10.7 m).
