Organizational Results Research Report

# **Coated Steel Rebar for Enhanced Concrete-Steel Bond Strength and Corrosion Resistance**

**Final Report**

September 2010

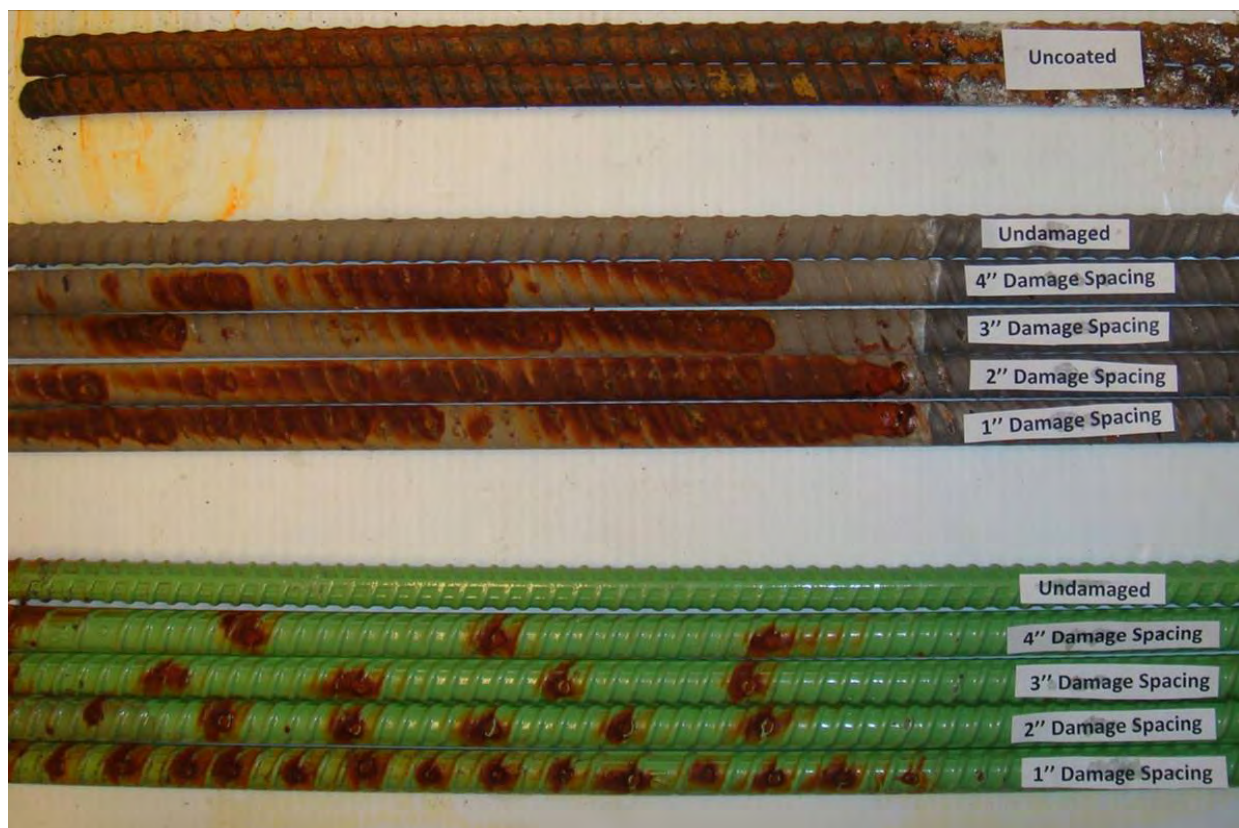
Figure 6.31 Surface conditions of all tested rebar after testing
