| 4. Title and Subtitle<br>THE TEXAS PERPETUAL PAVEMENTS: EXPERIENCE OVERVIEW AND THE WAY FORWARD | | | | 5. Report Date<br>October 2009<br>Resubmitted: April 2010<br>Published: July 2010 | |

**THE TEXAS PERPETUAL PAVEMENTS:  
EXPERIENCE OVERVIEW AND THE WAY FORWARD**

Report 0-4822-3

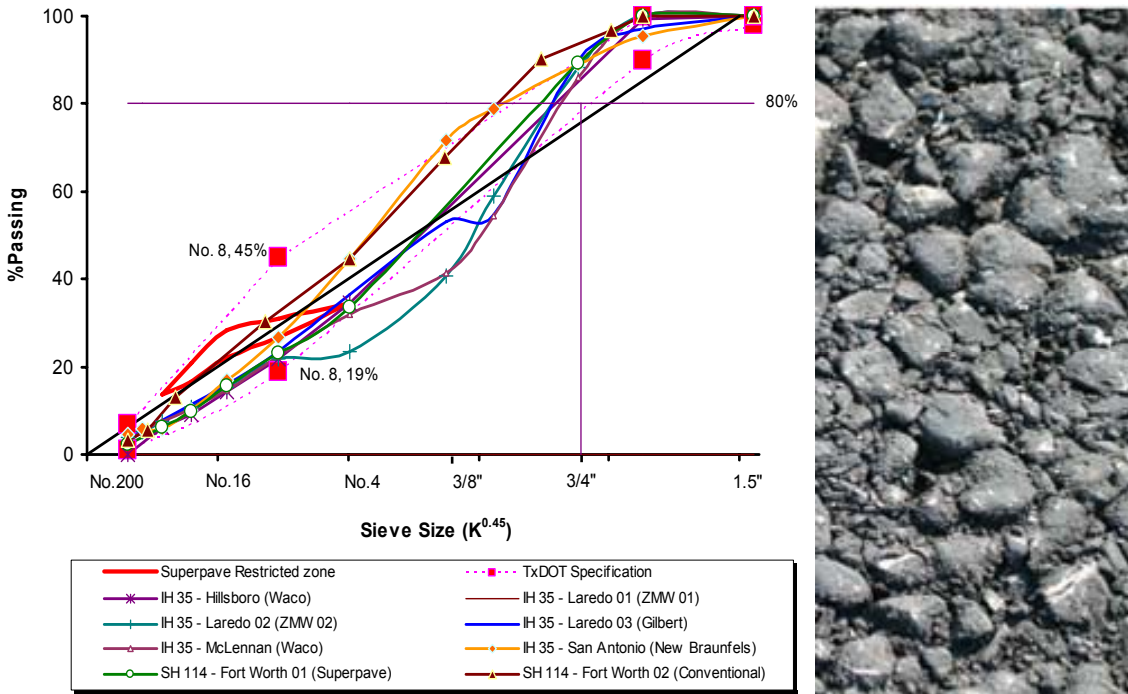
The aggregate blend proportions typically consist of a higher percentage of the coarser rock, an average of about 40 percent ( $\geq 3/4$ -inch NMAS rock), and a relatively lower percentage of the fine, an average of around 23 percent ( $\leq$  No. 4 NMAS mostly screenings or sand). On average, the combined aggregate gradation consists of about 13.3 percent retained on the number  $3/4$  inch sieve, with a design range of 10.0 percent to 20.0 percent.

**Figure 2-3. The 1-inch SF Coarse Aggregate Gradations and Coarse Surface Texture.**

As will be discussed in the subsequent chapters of this report, the 1-inch SFHMAC mix-design was found to be very problematic, associated with workability and constructability related-problems among others. Workability and compactability problems were also experienced in the laboratory with these mixes during sample fabrication. This was primarily attributed to the moderately low asphalt-binder content (about 4.2 percent) and coarser aggregate gradation with low fines content. Recommendations for mix-design improvements were made and are discussed subsequently in this report. Note that the 1 inch SFMAC was primarily designed as the main load bearing layer with an expected high resistance to rutting, and thus, the coarse aggregate gradation.

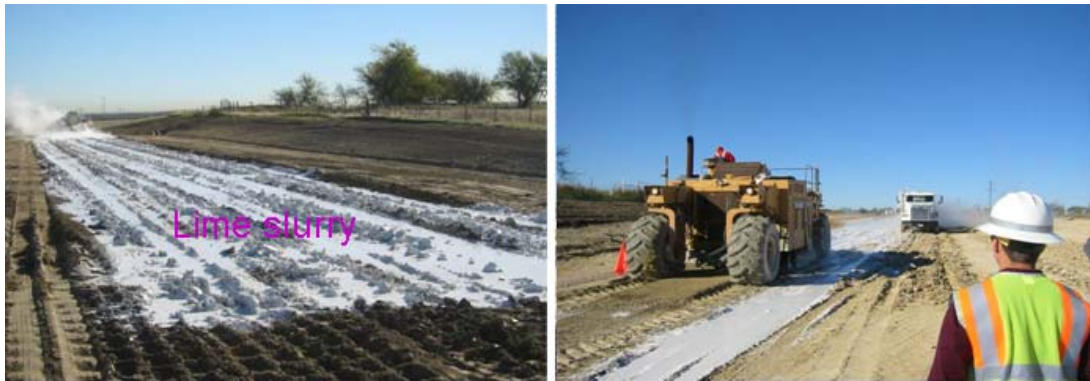
To date, satisfactory results have been obtained with both lime and cement stabilization yielding stiff non-moisture susceptible base layers. [Figure 3-1](#) shows an example of lime stabilization with a treatment depth of up to 8 inches on SH 114 ([Walubita and Scullion, 2007](#)). The lime dosage was 6 percent by dry weight, added in a liquid form as slurry, so as to optimize the stabilization process.

**Figure 3-1. Lime Treatment Process on SH 114.**

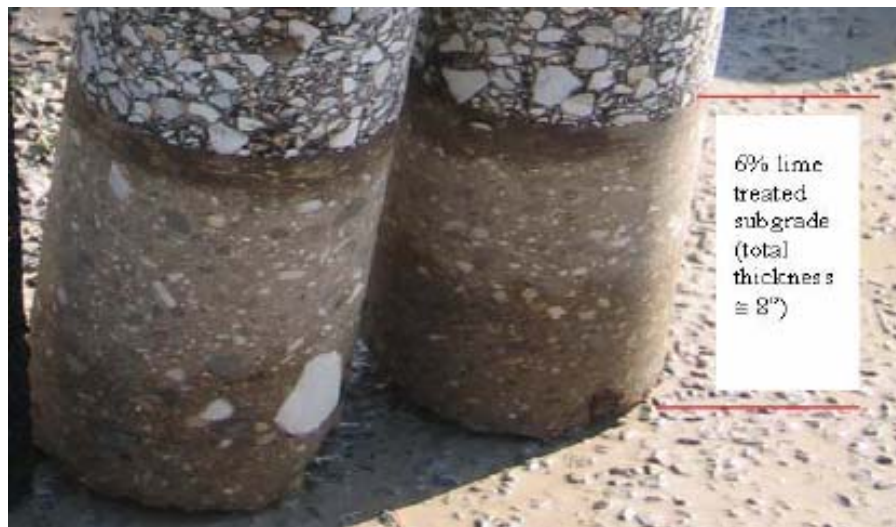
As shown in [Figure 3-2](#) (from subsequent field coring), the 6 percent lime treatment provided a highly bound stable foundation, i.e., stiff non-moisture susceptible layer. The stabilized subgrade material was cored in an intact state with no deterioration, which is unusual for a lime-treated layer ([Walubita and Scullion, 2007](#)).

**Figure 3-2. Field-Extracted Base Core from SH 114.**

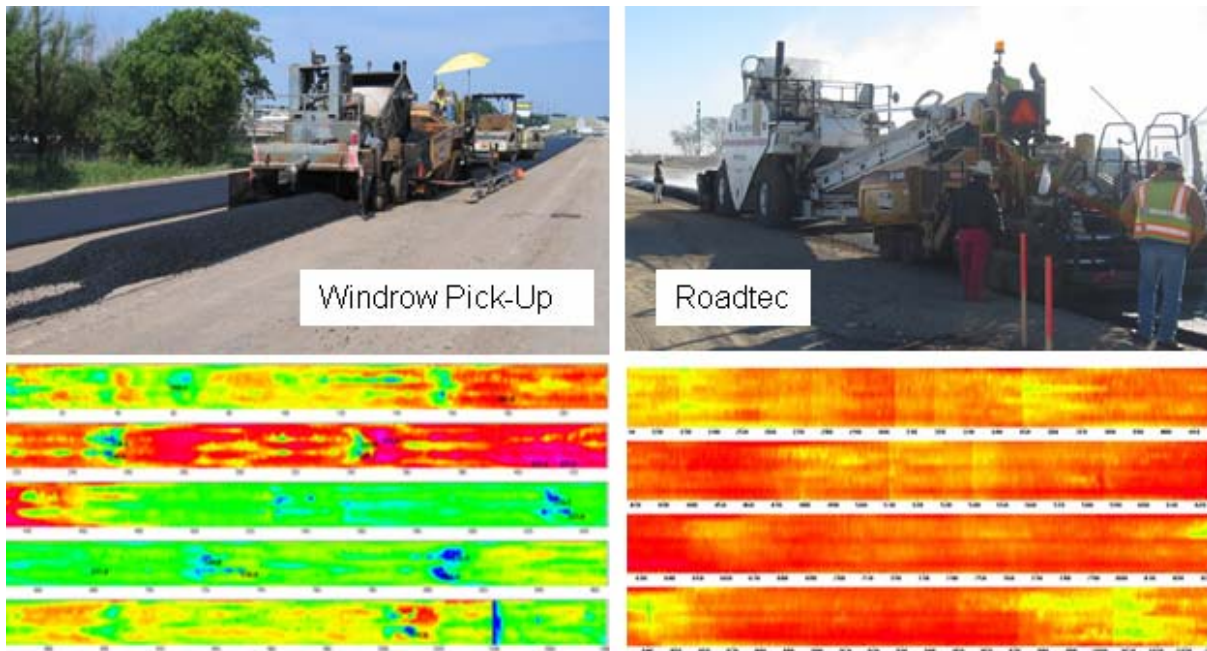
[Figure 3-3](#) shows the surface temperature profiles for the full lane width (12 ft) of new HMA mats. With respect to the thermal color coding scheme, red represents HMA mat temperatures near 300 °F, the target mat temperature; green represents mat temperatures between 235 and 270 °F, and blue represents mat temperatures less than 235 °F.

**Figure 3-3. Comparison of MTDs and HMA Mat Temperature Profiles on SH 114 (Red  $\cong$  300 °F [Good], 235 °F  $\leq$  Green  $\leq$  270 °F, Blue  $\cong$  220 °F [Thermal Segregation]).**

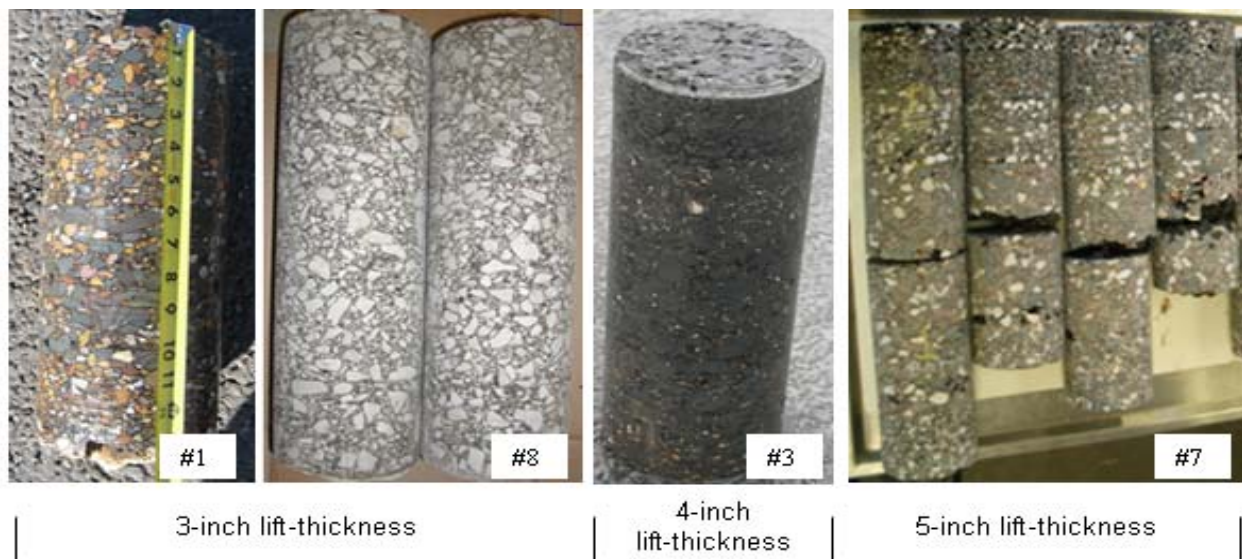
Compacting at the lower end of the allowable lift thickness range ( ~3 inches) was observed to yield a more constructible mix as gauged by attaining the target in-place density and layer interface bonding than using thicker lifts. Additionally, this also required less compactive effort in terms of the rolling pattern and number of passes. Compacting at a greater lift thickness tended to cause the mixes to segregate vertically, creating highly voided areas capable of detrimentally trapping moisture. [Figure 3-4](#) shows a comparative illustration of the compacted lift thickness for the 1-inch SFHMA layer.

**Figure 3-4. Effects of the Compacted Lift Thickness for the 1-inch SFHMA Layer.**

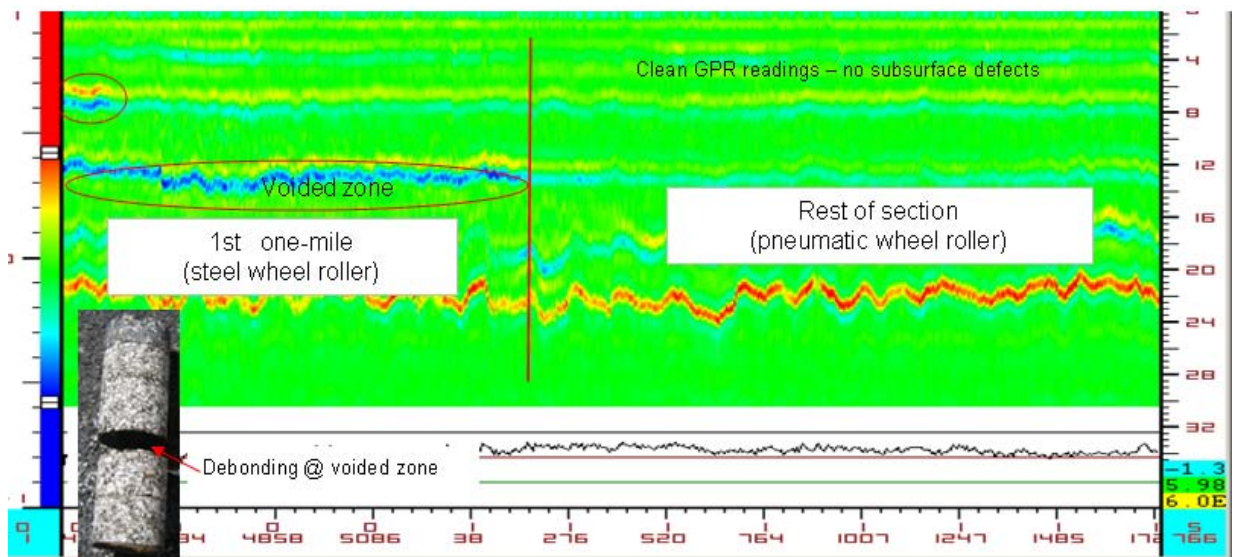
On most of the projects, the rolling pattern was as follows: (1) breakdown roller – two vibratory passes (steel wheel); (2) intermediate roller – three passes pneumatic rollers; and (3) one vibratory pass plus one static (steel wheel) pass. However, one project (Zamwalt01) also used the pneumatic as the breakdown roller with satisfactory results. From Figure 3-5, it is apparent that the pneumatic roller appears to have helped the 1-inch SFHMA compaction; the GPR readings after the first mile are clean with no indication of serious subsurface anomalies or density variations in the HMA layers.

**Figure 3-5. Steel Wheel versus Pneumatic Breakdown Roller (IH 35 – Laredo).**

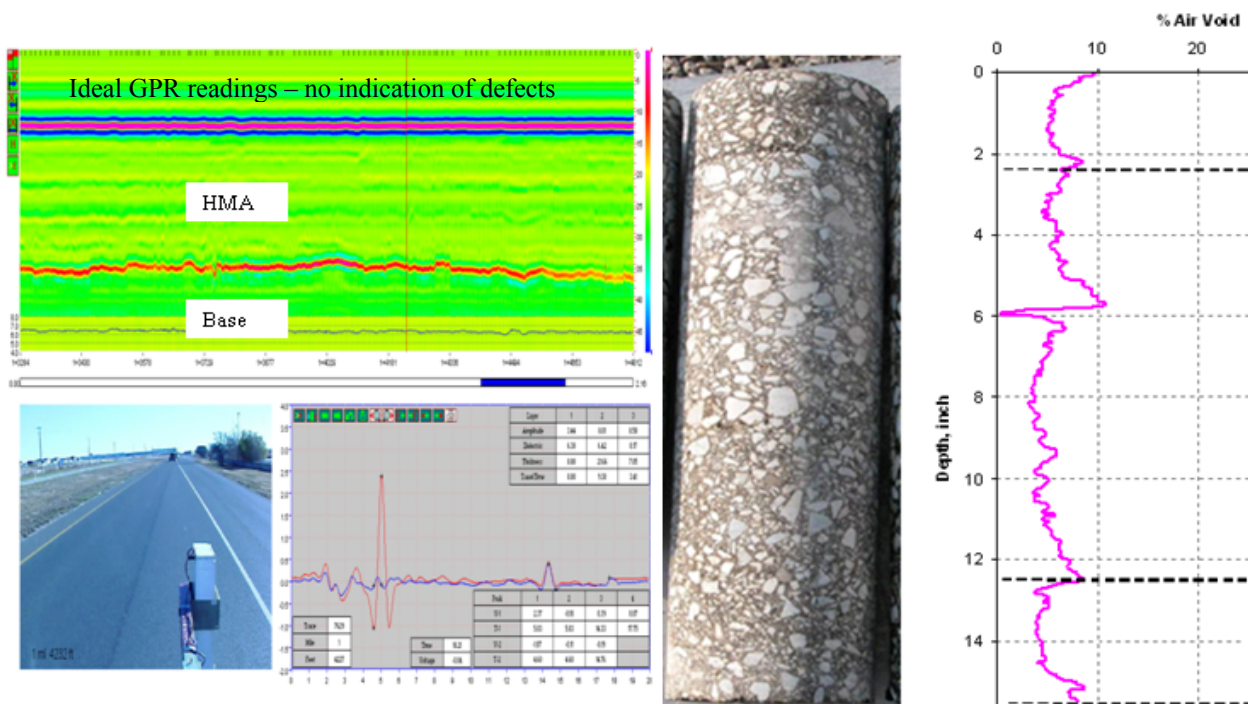
As would be expected, applying more rolling passes tended to improve the SFHMA compaction and uniform density attainment. Figure 3-6 shows an example of a core and AV distribution where the compaction pattern was as follows: five vibratory and two static passes for the breakdown roller, eight pneumatic passes for the intermediate roller, and one vibratory pass plus one static pass for the finishing roller. Overall, a total of 17 rolling passes were applied on this section. As can be seen in Figure 3-6, the core from this section is intact with no visible defects; the AV distribution based on X-ray CT scanning is also fairly uniform, averaging 7 percent and for the most part is below 10 percent. Also, the GPR readings are clean with no indication of subsurface anomalies.

Figure 3-6. SH 114 Conventional – 17 Total Compaction Rolling Passes.

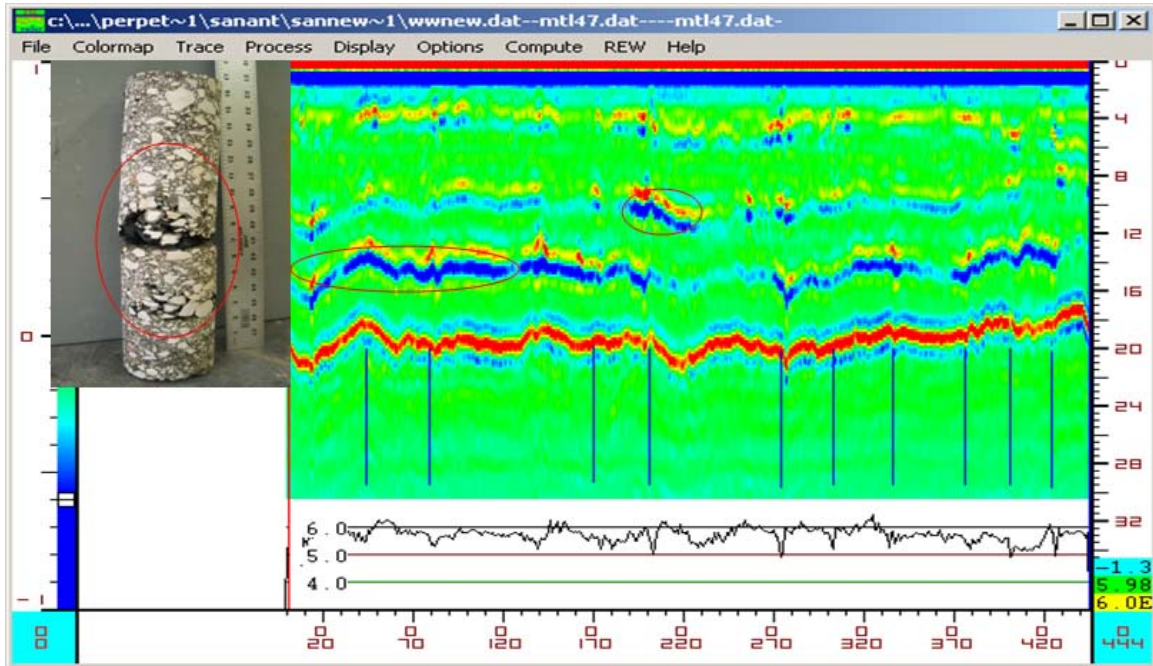
Figures 3-7 through 3-10 show some examples of non-ideal GPR measurements and substandard cores. These forensic defects are undesirable as they pose a potential problem for both the PP structural integrity and moisture damage.

Figure 3-7. GPR Density Variations and Forensic Defects in Core (IH 35 San Antonio).

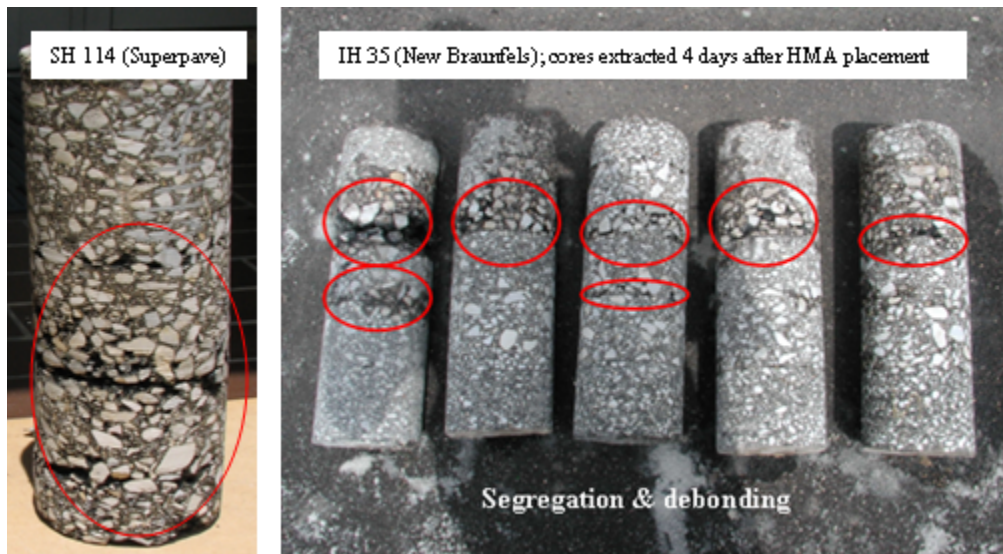
Figure 3-8. Substandard Cores from SH 114 and IH 35.

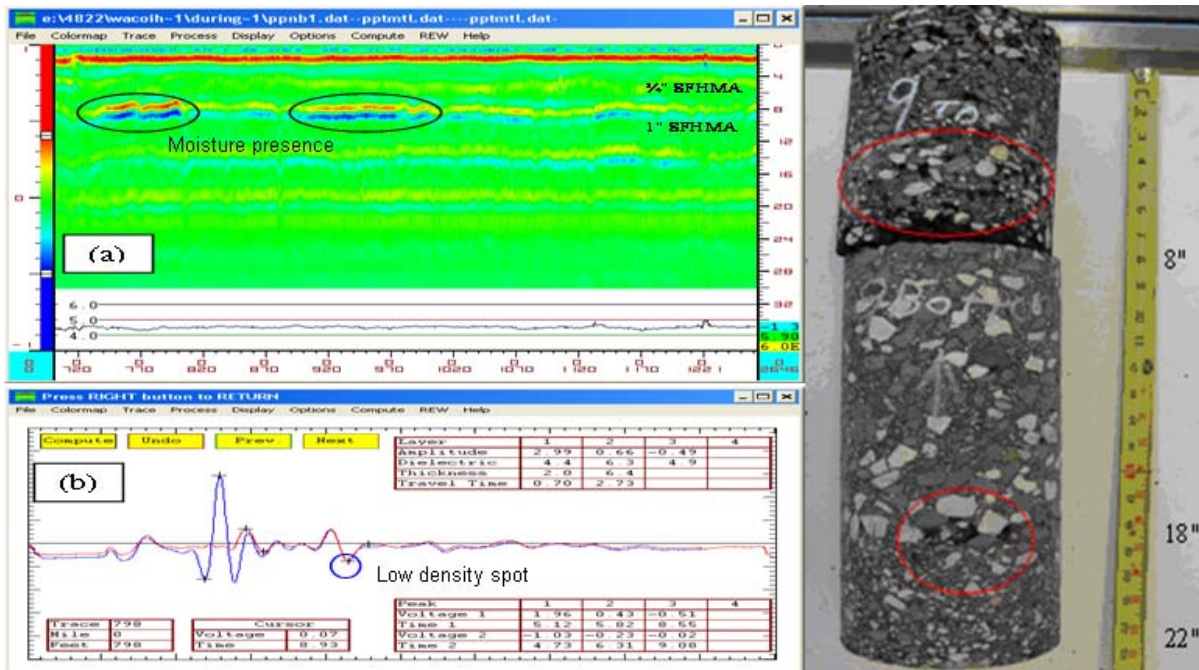
Figure 3-10. Evidence of Subsurface Defects/Moisture Presence on IH 35 (McLennan).

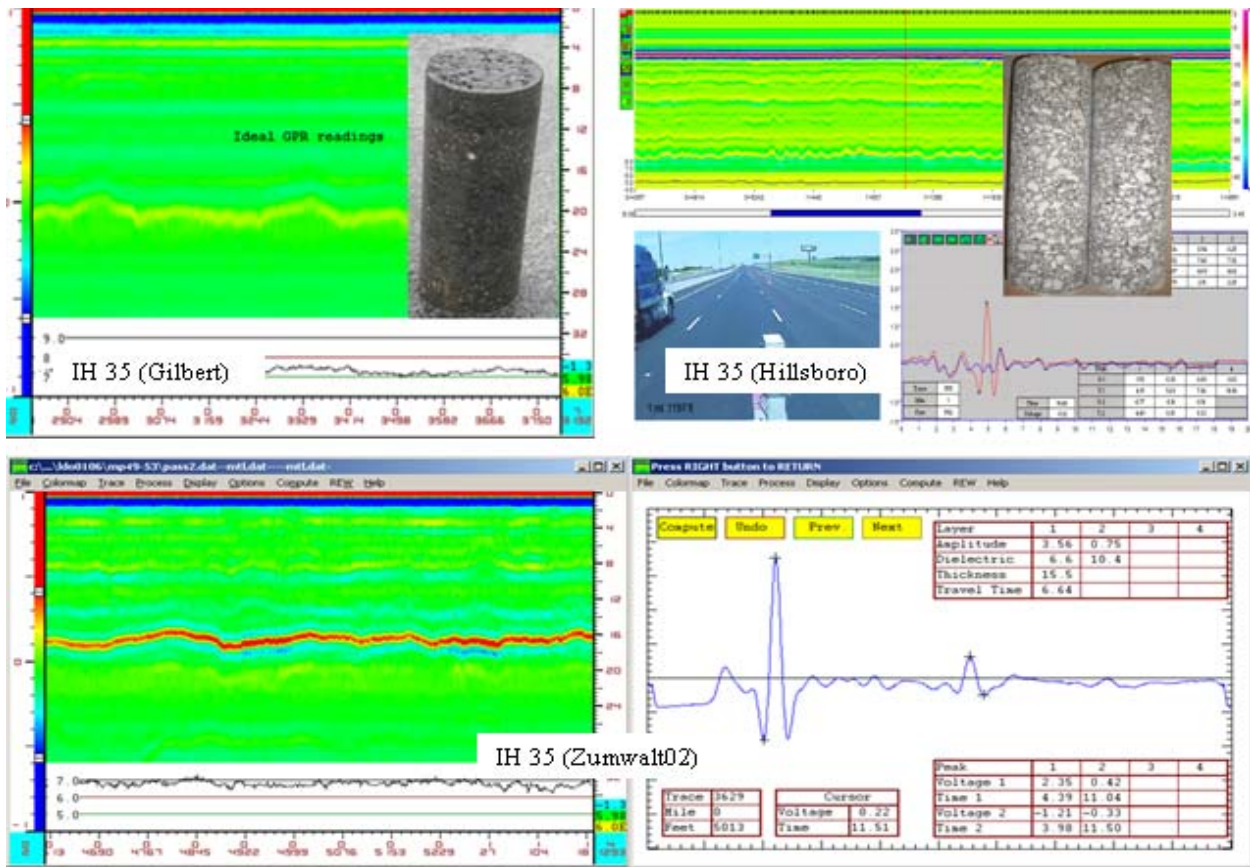
Despite the workability and compactability problems of the SFHMA mixes, construction quality was fairly satisfactory on some projects (or sections of the project), particularly those constructed at a later stage, such as the SH 114 (Conventional), IH 35 (Hillsboro), IH 35 (Zumwalt 01 and 02), IH 35 (Gilbert), and IH 35 (Price). Some examples of ideal GPR readings with no indication of subsurface defects are shown in [Figure 3-11](#).

**Figure 3-11. Examples of Ideal GPR Readings with No Subsurface Defects.**

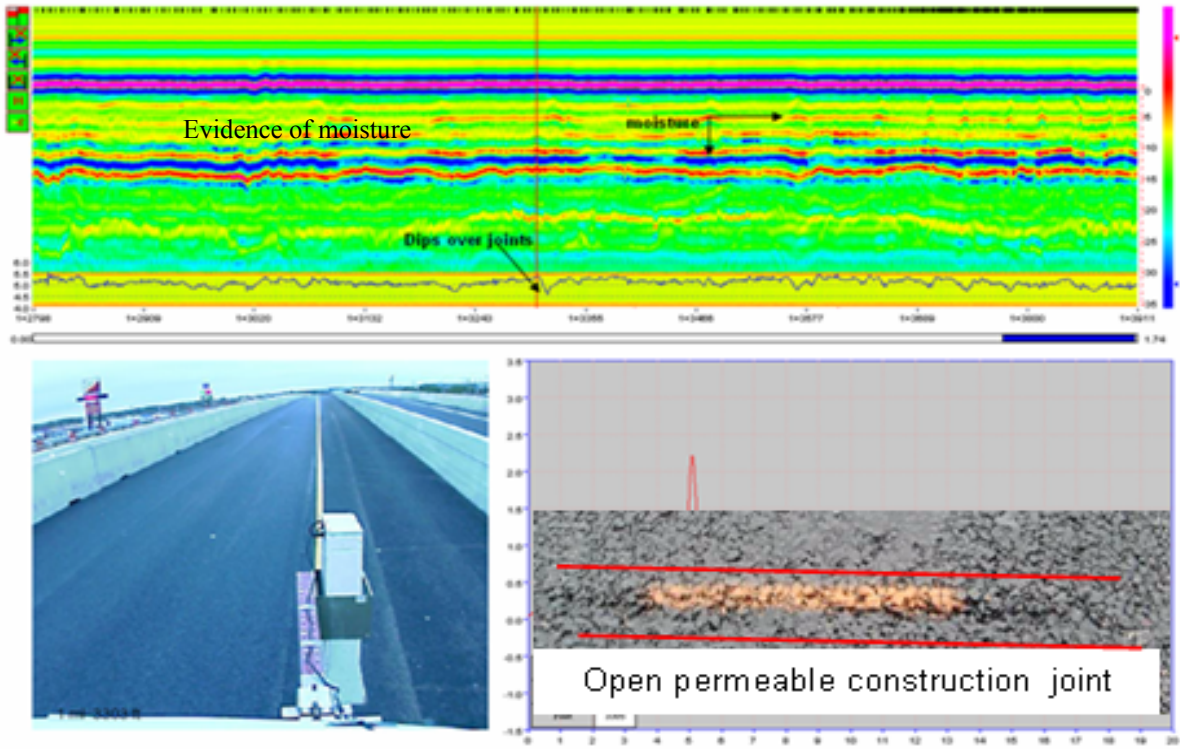
Construction joint problems were experienced on some projects due to poor joint staggering, effects of trench construction, low density, and poor joint compaction on part of the contractor. Trench construction is the process of removing, then rebuilding the existing structure one lane width at a time, allowing little latitude for joint staggering or proper density control along the mat free edge. Furthermore, particles from the wall of the adjacent structure, worked loose by construction equipment, are free to fall in the trench contaminating the new mat. These problems resulted in open permeable construction joints that detrimentally allow moisture to infiltrate into the PP structure. GPR measurements along and within the vicinity of the construction joints detected the presence of both low density spots and moisture entrapment. [Figure 3-12](#) shows these results for IH 35 Price (Laredo). Based on these GPR measurements, recommendations were subsequently made to strip seal all the open joints to limit moisture infiltration; see [Figure 3-13](#).

Figure 3-12a. Open Joint and Moisture Presence on IH 35 Price (Laredo, 2008).

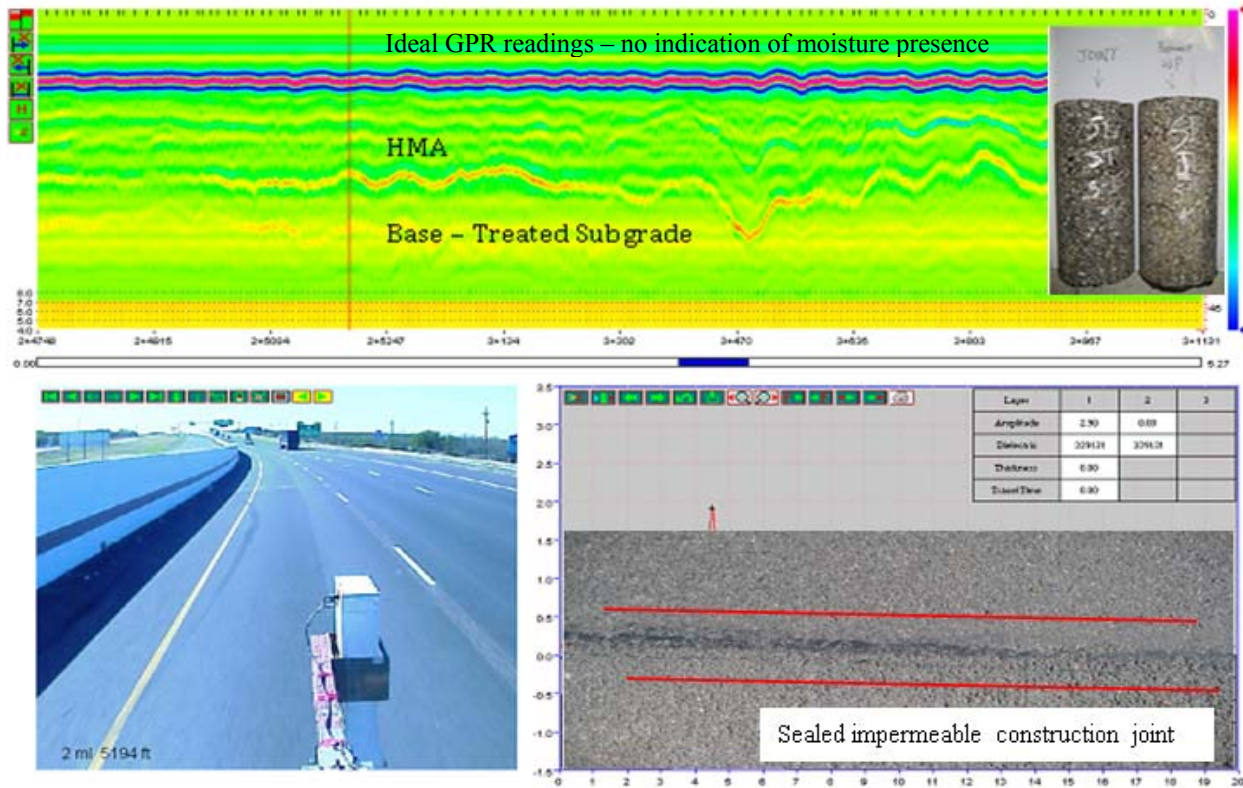
**Figure 3-13. Clean GPR Readings after Strip Sealing on IH 35 Price (Laredo, 2009).**

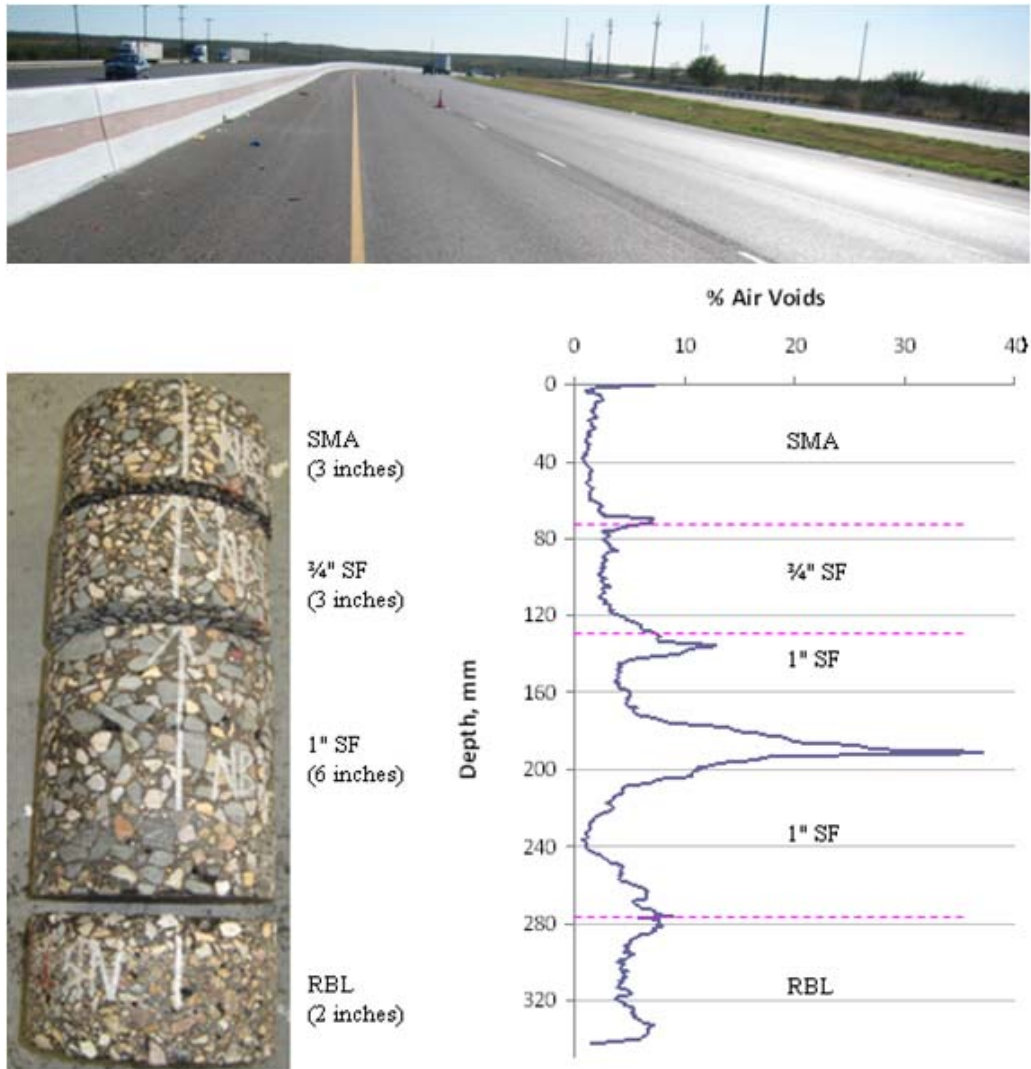
The AV content was generally found to be extremely high at the layer interfaces, thus explaining the rampant occurrence of interface layer debonding. Also, there was evidence of high non-uniform AV distribution for cores extracted from the construction joints. Figures 3-14 through 3-17 show some examples of the AV characterization for selected projects.

Figure 3-14. Core AV Distribution – IH 35 (NB, Price, Laredo).

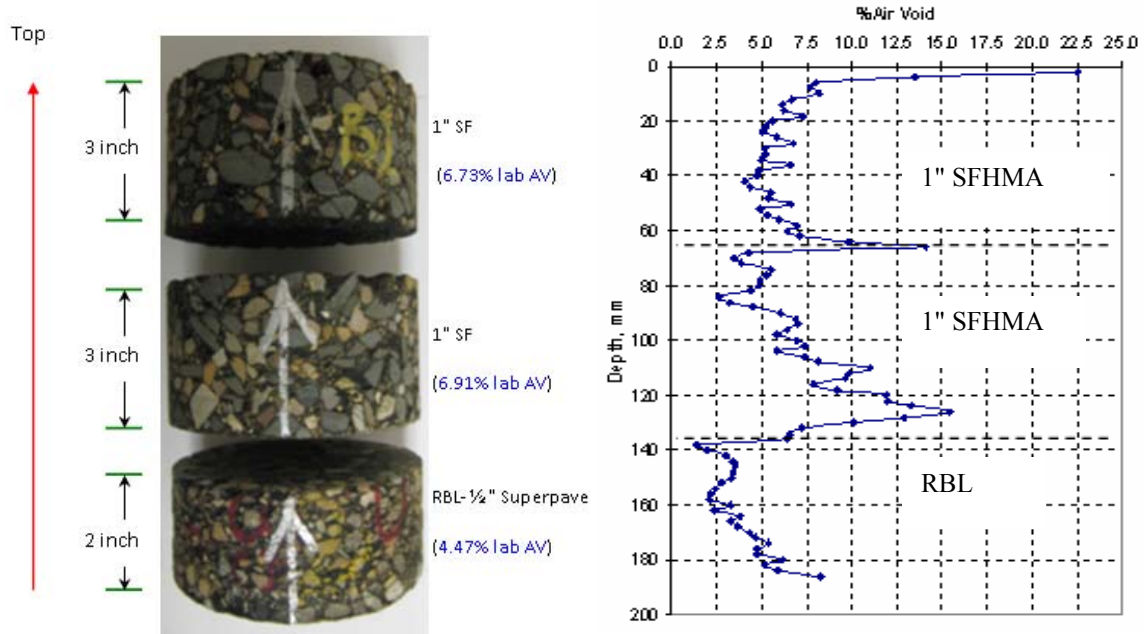
Figure 3-15. Core AV Distribution – IH 35 (SB, Price, Laredo).

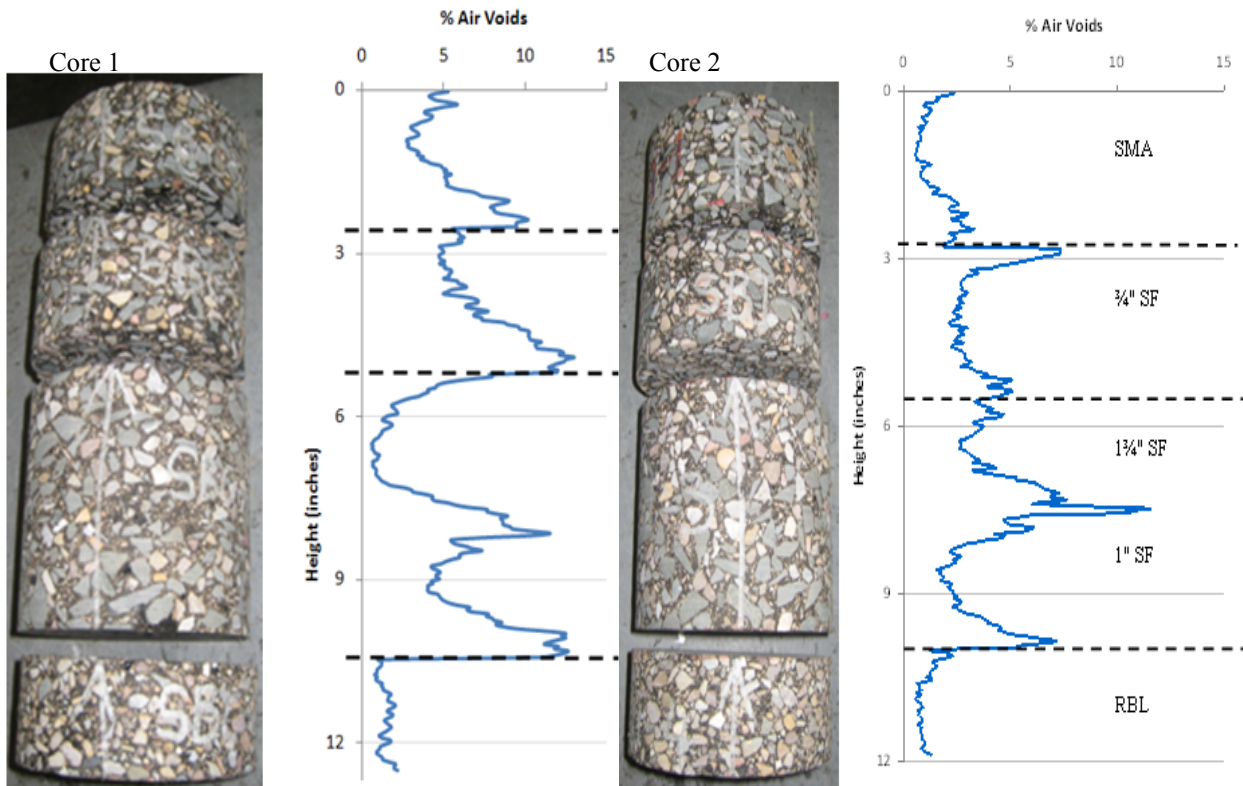
Figure 3-16. Coring and AV Distribution (Core 1 – along the construction joint; Core 2 – from inside lane) – IH 35 (SB Lane, Price, Laredo).

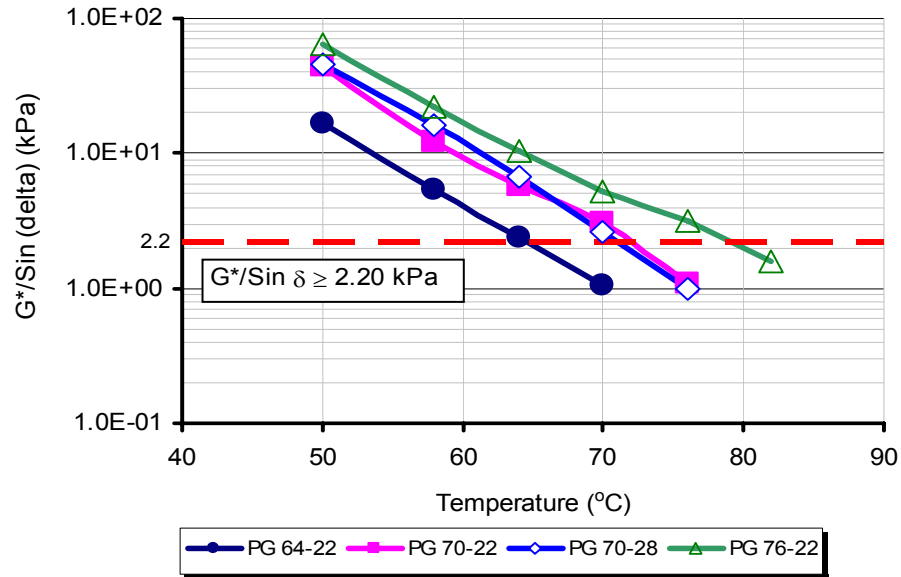
The majority of the asphalt binders used on the Texas PP projects was sourced from Valero and Wright asphalt in Texas. DSR test results for PG 64-22, PG 70-22, PG 70-28, and PG 76-22 asphalt binders (virgin) are shown in Figures 4-1 and 4-2. A detailed tabulation of these results ( $G^*$ ,  $\delta$ , and  $G^*/\text{Sin } \delta$ ) can be found in the Texas PP database (Walubita et al., 2009).

Figure 4-1. Binder  $G^*/\text{Sin } \delta$  (delta) versus Temperature.

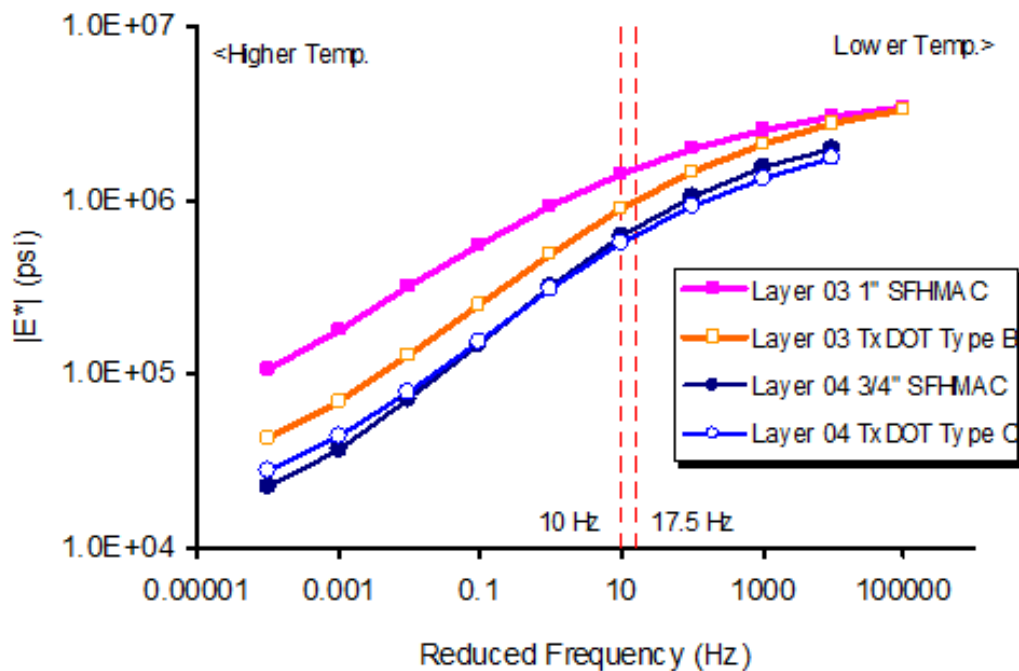
Where, |E\*| is the dynamic modulus (psi);  $\zeta$  is the reduced frequency (Hz);  $\delta$  is the minimum modulus value (psi); and  $\alpha$ ,  $\beta$ , and  $\gamma$  are the model shape parameters. Figure 4-3 shows a comparative plot of the |E\*| master-curves for the SFHMA, Type B, and RBL (Layer 04) mixes at a reference temperature of 70 °F.

Figure 4-3. |E\*| Master-Curves (Reference Temperature = 70 °F).

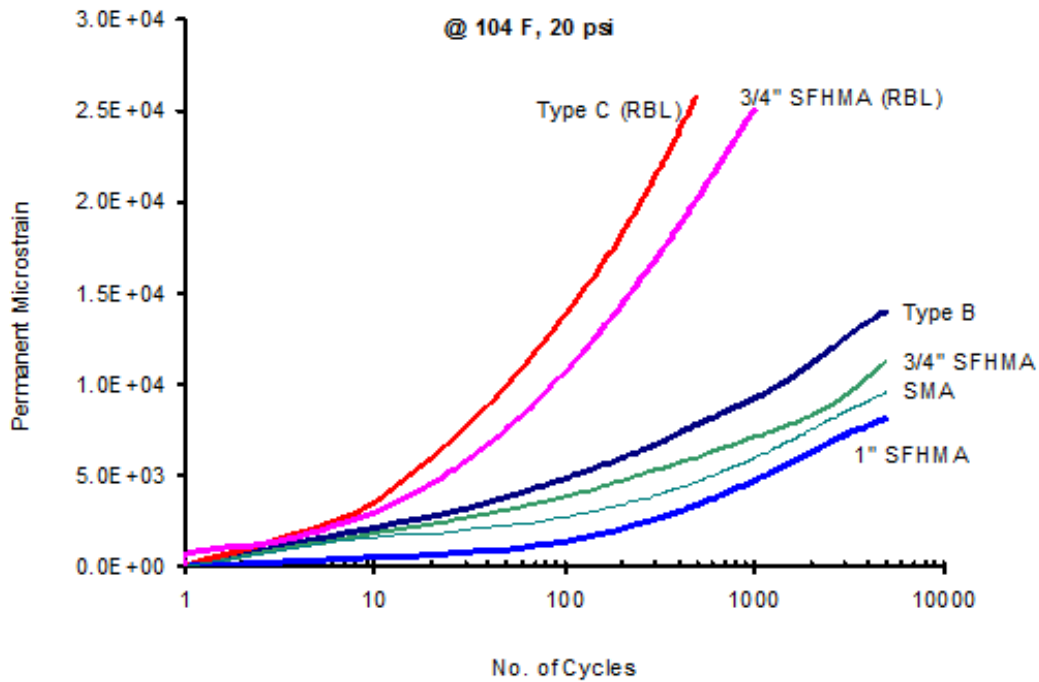
Though not very significantly different, the SMA performed better than the  $\frac{3}{4}$ -inch SFHMA and Type B mixes. While the SMA and  $\frac{3}{4}$ -inch SFHMA used higher PG asphalt-binder grades (PG 70-28 and PG 76-22, respectively), the Type B mix utilized a PG 64-22 asphalt-binder. At such a relatively high temperature (104 °F), the binder PG grade definitely played a significant role in the permanent deformation performance of the mixes, particularly for the Type B mix.

**Figure 4-4. Permanent Deformation Results.**

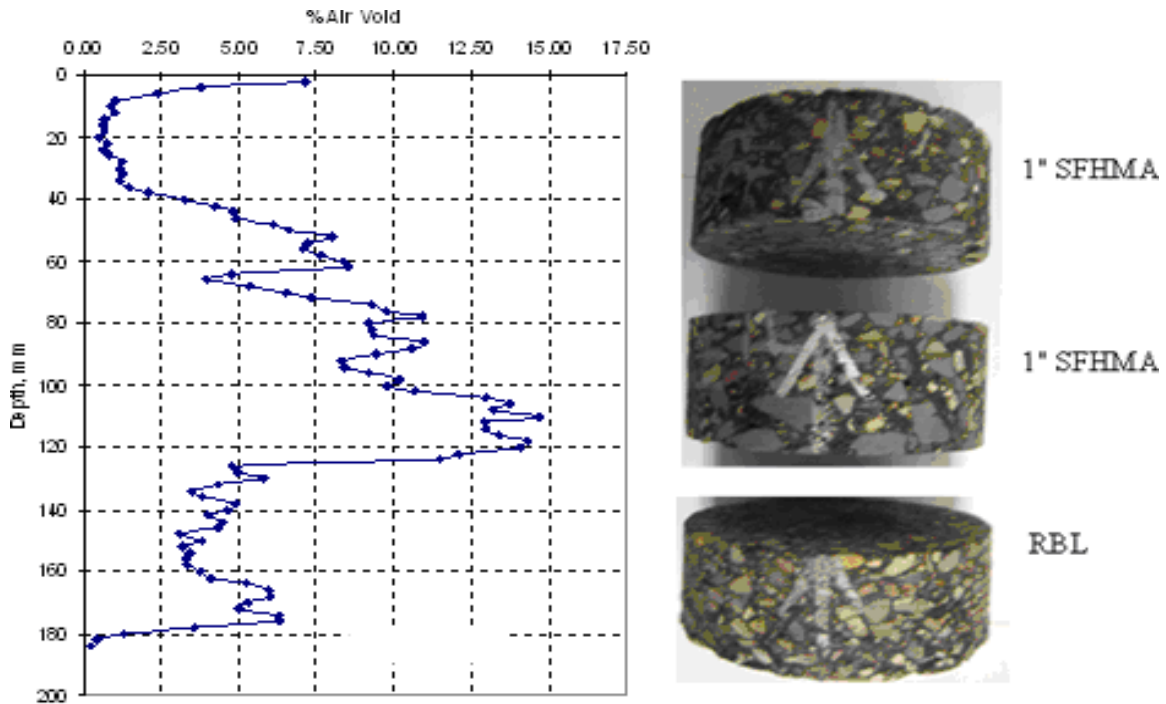
[Figure 4-5](#) shows an example of the AV distribution as a function of depth for the 1-inch SFHMA and RBL layers from the IH 35 Price job in Laredo. While the AV distribution in the RBL is fairly uniform at around 4.8 percent, it is not in the 1-inch SFHMA layers. The AV distribution is non-uniform and very high in magnitude, particularly at the bottom of the lower lift, with a peak of about 13.5 percent. If rain water infiltrates through, it will obviously be trapped within the bottom zone of the 1-inch SFHMA layer. This is undesirable and a reflection of the unfavorable mix workability and constructability problems of the SFHMA mixes.

**Figure 4-5. X-Ray CT Results for IH 35 Laredo Cores (Price).**

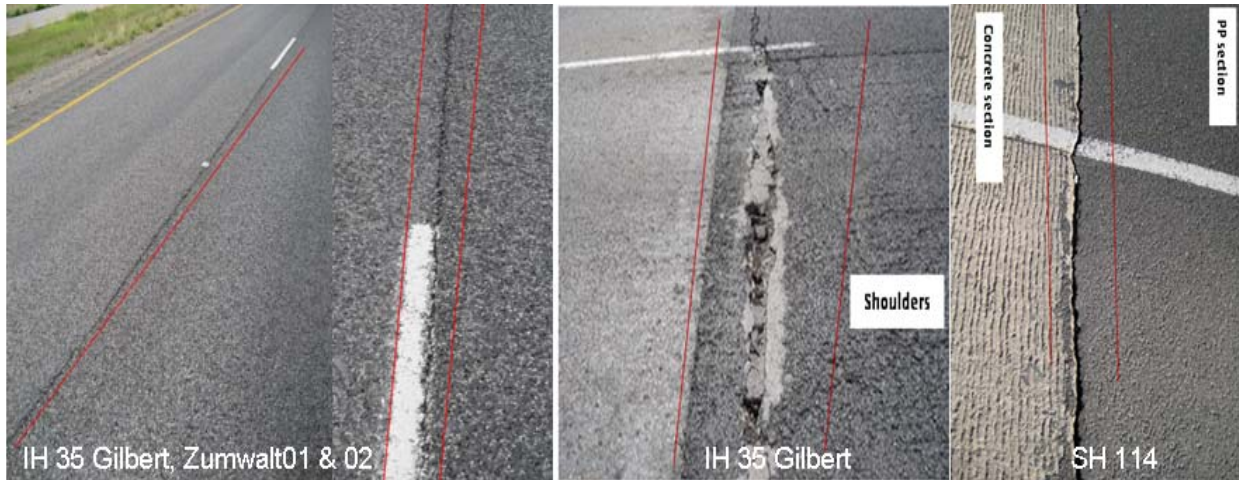
No visual surface defects were observed except for the poorly constructed open longitudinal and transverse construction joints on some projects, notably IH 35 (Gilbert, Zumwalt 01 and 02) and SH 114 (Superpave). Photos of some of these open construction joints are shown in [Figure 5-1](#). Conjecture is that poor joint compaction techniques are responsible for these deficiencies. Moisture ingress through the open construction joints, particularly during the rainy season, could eventually impact the PP structural performance. Based on these visual observations, recommendations were subsequently made to strip seal all the open construction joints. Recommendations were also made for future jobs to rigidly enforce the joint construction and compaction specifications, as well as the QC/QA evaluation protocols.

**Figure 5-1. Examples of Open Longitudinal and Transverse Construction Joints.**

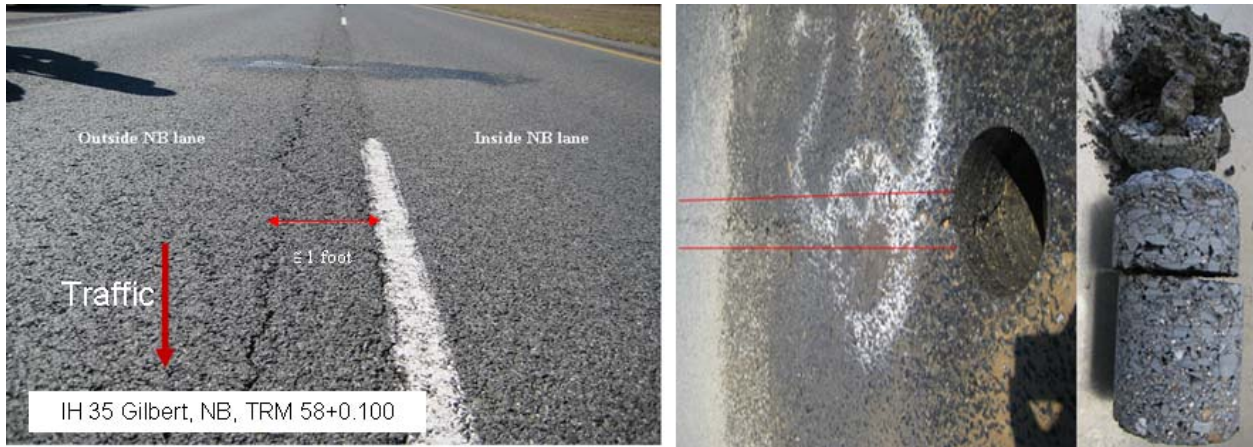
No fatigue-related cracking was observed; however, there are areas of construction-related longitudinal cracking on the IH 35 Gilbert project in the northbound lane between TRM 58+0.000 and 59+0.000. The cracking is believed to be surface initiated and is primarily related to the construction joint; it was apparent at this location that the joint was not adequately staggered with underlying mats. As shown in [Figure 5-2](#), the longitudinal cracking, which was about 400 ft long as of summer 2009, runs parallel to the construction joint at approximately 1 ft apart in the outside NB lane. From the core shown in [Figure 5-2](#), it is clear that the cracking initiated from the surface and is progressing downwards; the upper SMA and  $\frac{3}{4}$ -inch SFHMA layers disintegrated while the lower layers were relatively solid. In other areas however, the cracking had already progressed through the entire HMA including the RBL to the base; see the cores in [Figure 5-3](#).

**Figure 5-2. Longitudinal Cracking on IH 35 (Gilbert Job).**

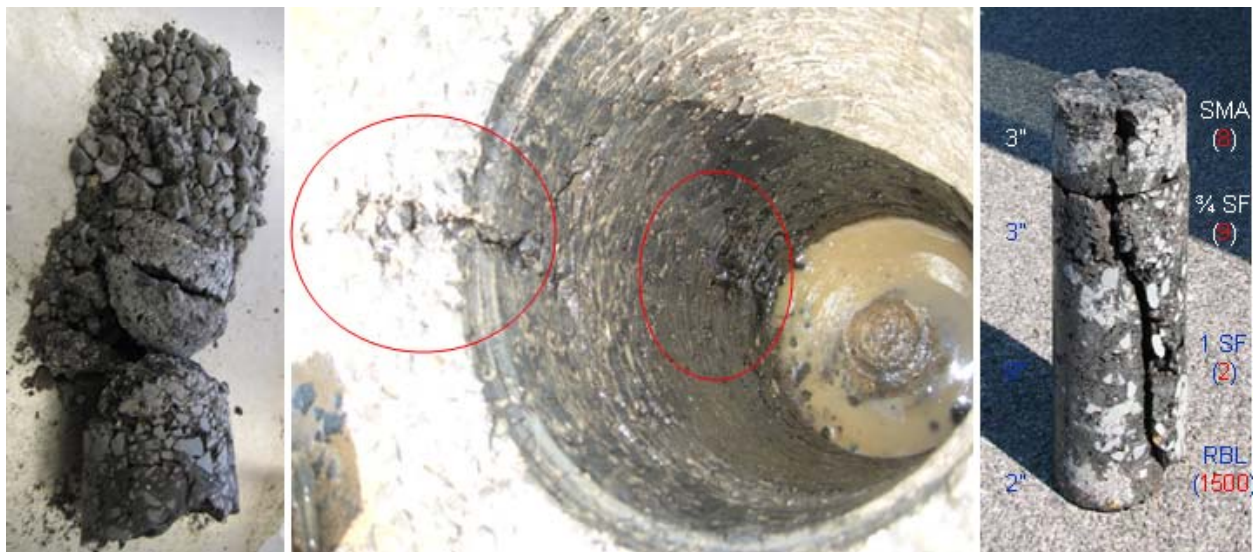
**Figure 5-3. Coring along the Longitudinal Crack on IH 35 (Gilbert Job).**

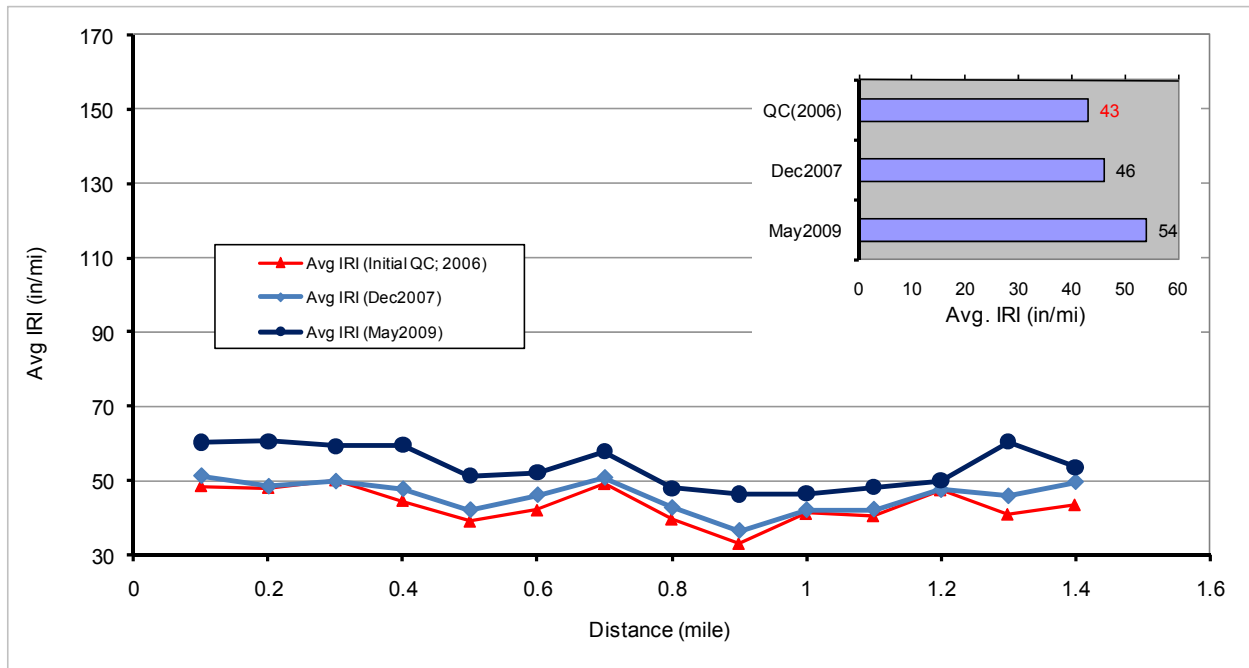
Figures 5-7 and 5-8 show some examples of the IRI plots for SH 114 (Superpave) and IH 35 (Hillsboro) as a function of longitudinal mile offsets and year of profile measurements. The numbers represent an average of the left and right wheel paths for the outside lanes that are heavily trafficked (as compared to the inside lane). Examples of detailed left and right wheel path IRI plots are included in Appendix C.

**Figure 5-7. Average IRI Plots for SH 114 (Superpave) – Outside EB Lane.**

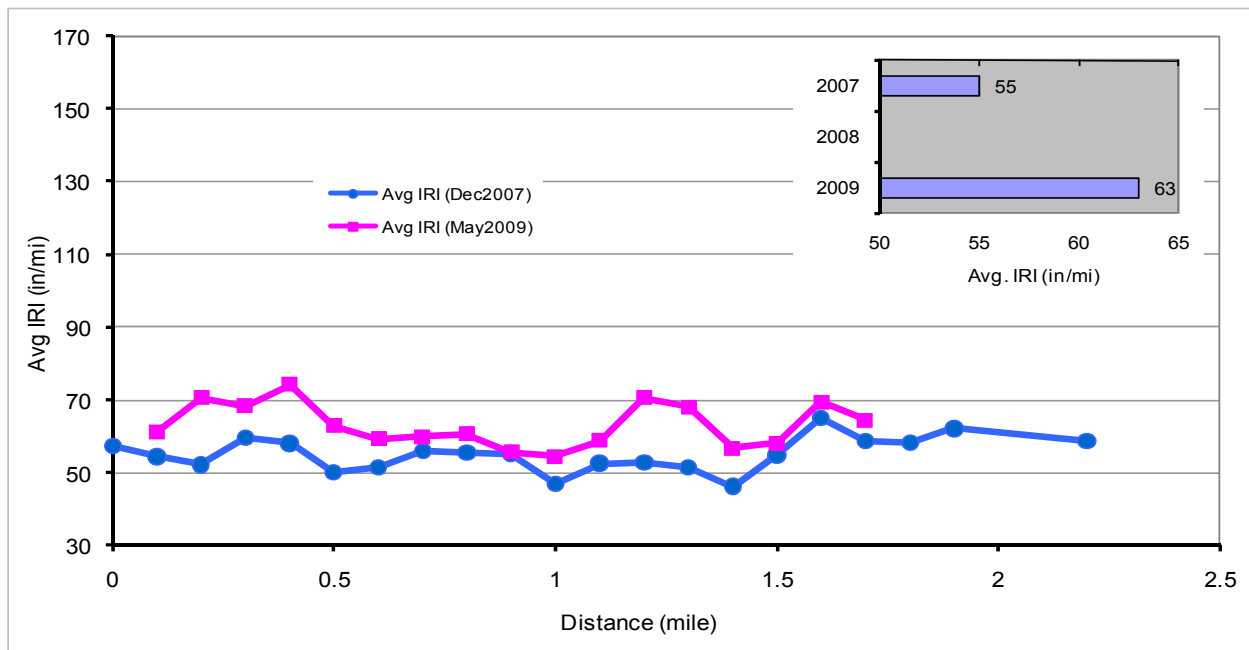
**Figure 5-8. Average IRI Plots for IH 35 (Hillsboro) – Outside NB Lane.**
