| 4. Title and Subtitle<br>THE TEXAS PERPETUAL PAVEMENTS: EXPERIENCE OVERVIEW AND THE WAY FORWARD | | | | 5. Report Date<br>October 2009<br>Resubmitted: April 2010<br>Published: July 2010 | |

**THE TEXAS PERPETUAL PAVEMENTS:  
EXPERIENCE OVERVIEW AND THE WAY FORWARD**

Report 0-4822-3

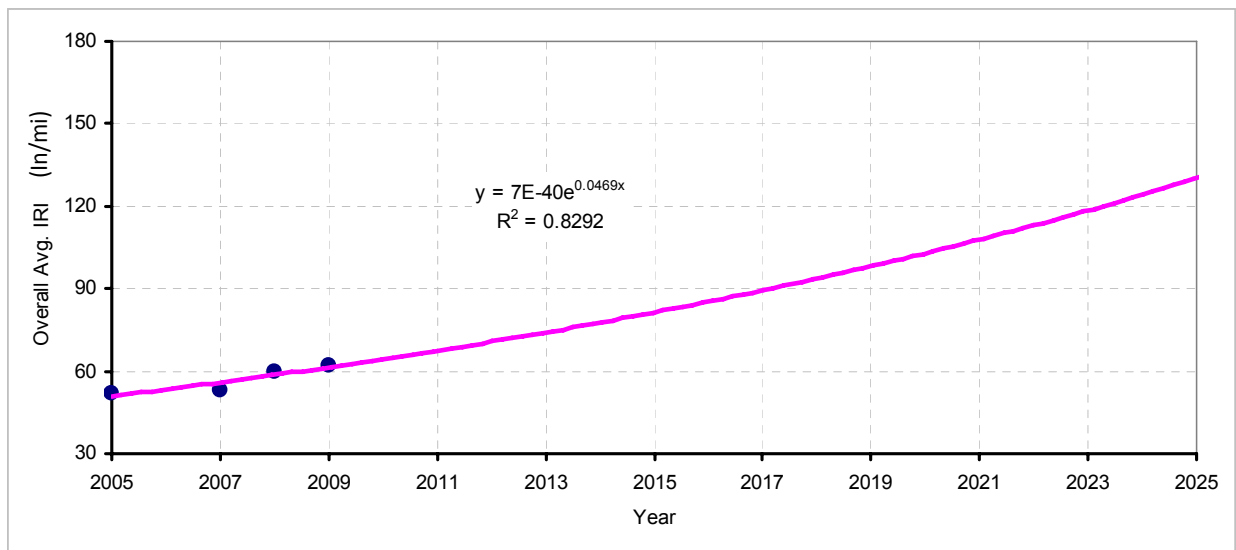
As evident in [Table 5-1](#), the IRI results indicate acceptable surface roughness with scores placing sections in the good-to-very good ride quality categories. Though there is a marginal progressive increase in surface roughness as would be typically expected, the overall average IRI for summer 2009 is still less than 70 in/mi (versus the threshold of 172 in/mi). Based on the overall average IRIs in [Table 5-1](#) and if an exponential surface deterioration rate is subjectively considered, the extrapolated overall average IRI in 2025 (after 20 years of service) would be only 123 in/mi, which is still less than the 172 in/mi threshold; about 40 percent less. [Figure 5-9](#) demonstrates this extrapolative plot.

**Figure 5-9. Extrapolative Plot of the Overall Average IRI.**

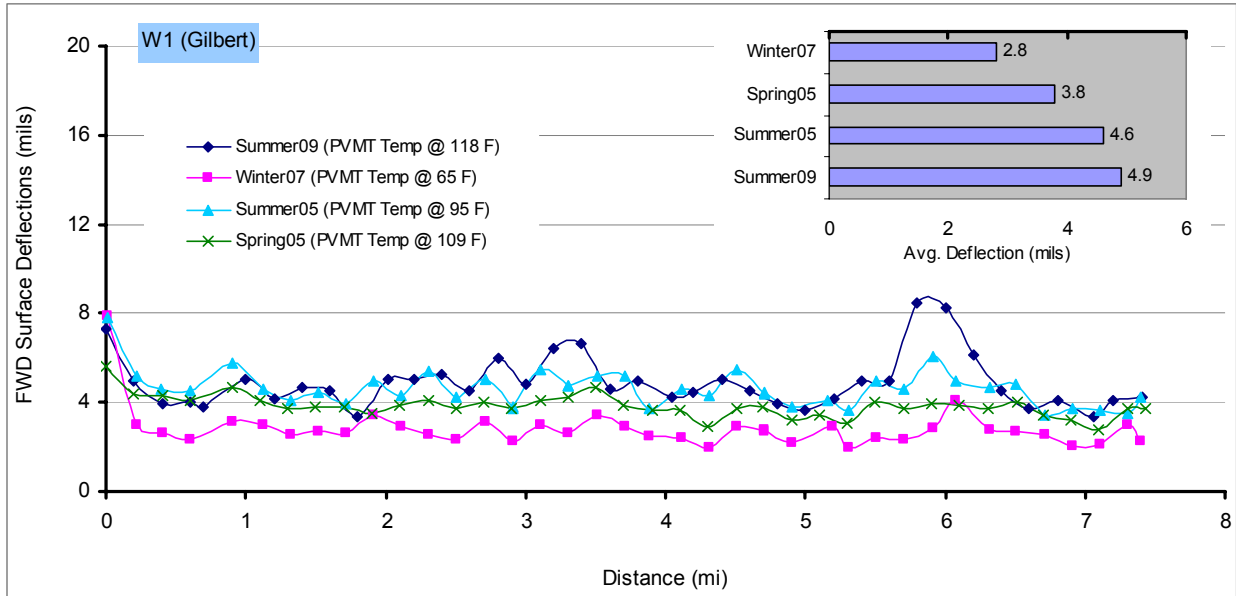
Even under summer pavement temperatures of over 100 °F, the surface deflections were less than 10 mils. In fact, the overall average for summer 2009 was only 5.0 mils. As expected, the deflections were least in winter, with an overall average of only 2.2 mils. Evidently, these results re-affirm the fact that the Texas PPs are very stiff and non-temperature susceptible structures, with high potential for rutting resistance. Some examples of the FWD deflection results are shown in [Figure 5-10](#) for IH 35 (Laredo), while [Figure 5-11](#) shows the overall average for both winter and summer seasons.

**Figure 5-10. Plot of FWD Deflections on IH 35 Gilbert (Laredo).**

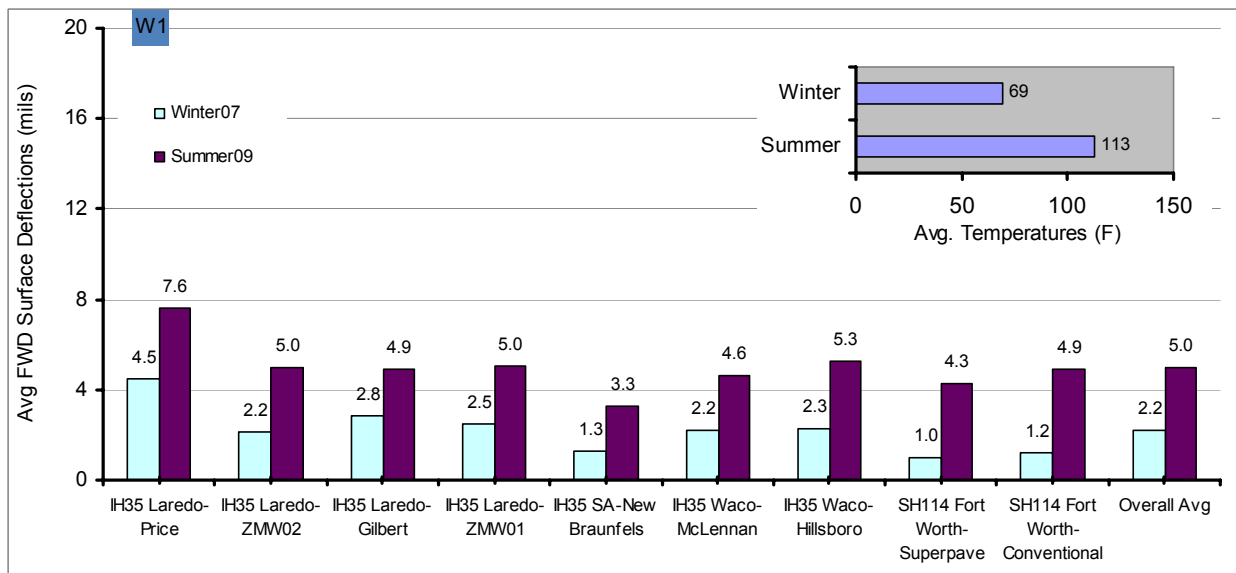
**Figure 5-11. Average FWD Surface Deflections (Winter and Summer).**

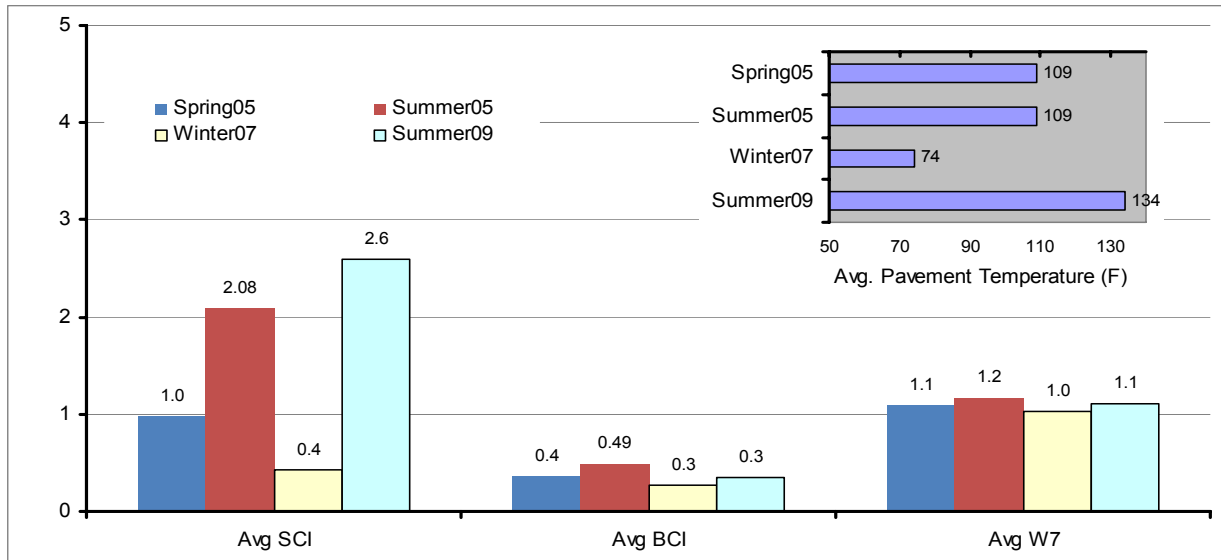
With the above considerations, both the SCI and BCI were therefore interpreted in the context of the HMA layers in this analysis; top ( $\approx 8$  inches) and lower ( $\approx 8$  to 16 inches) HMA layers, respectively. An example of the curvature index results is shown in [Figure 5-12](#) for IH 35 Zumwalt01 project. Detailed plots are included in [Appendix C](#).

**Figure 5-12. Summary Curvature Index Results for IH 35 Zumwalt 01 Project (Laredo).**

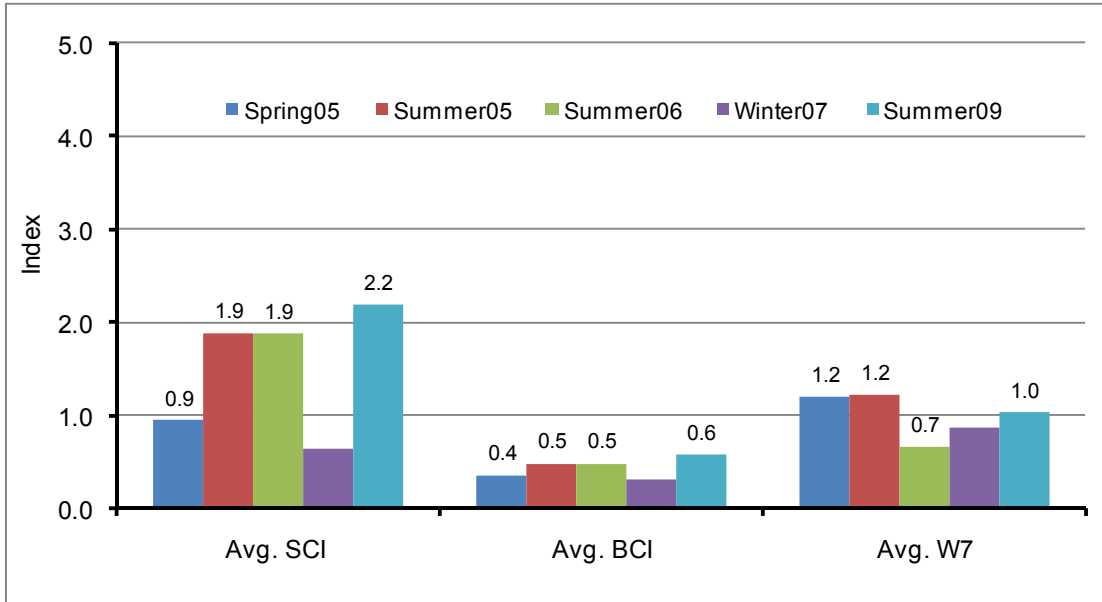
- Average SCI = 2.2                      Good condition and sufficient structural strength
- Average BCI = 0.6                    Good stable condition and sufficient structural strength
- Average  $W_7$  = 1.0                    Good stable condition and sufficient strength

**Figure 5-13. Average Curvature Indices for All the PP Projects.**

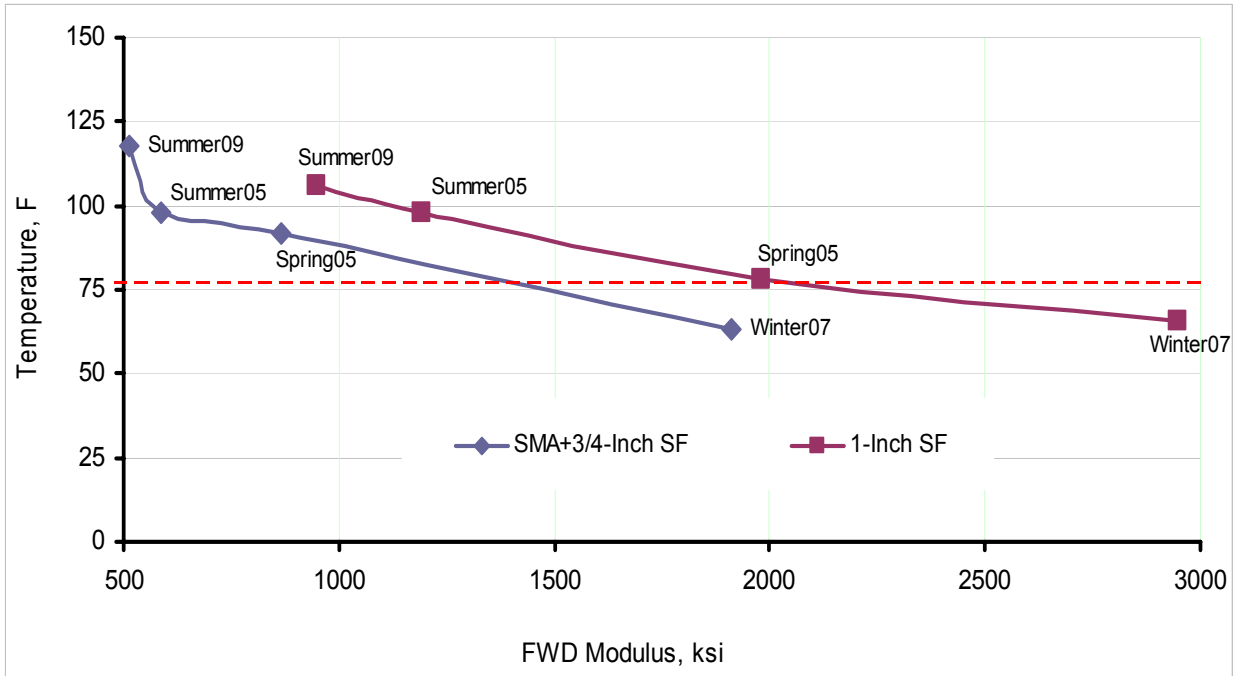
Figure 5-15. Example of FWD Moduli Plots (HMA Layers) for IH 35 Gilbert (Laredo).

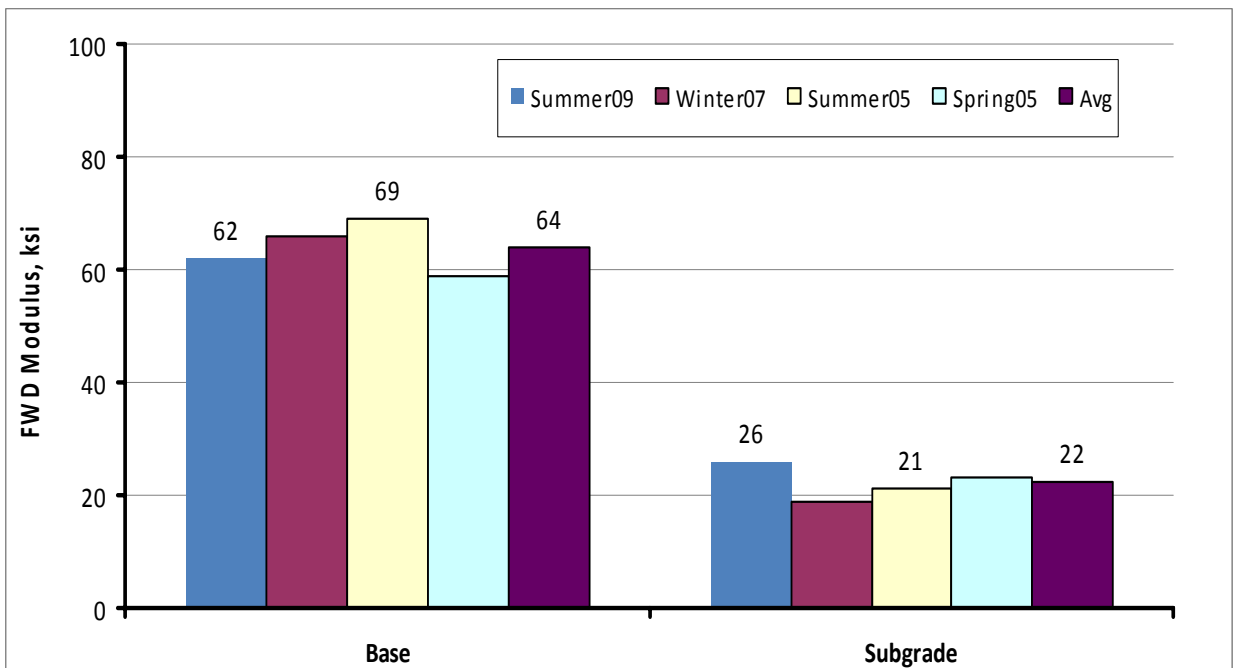
Figure 5-16. FWD Moduli Plots (Base and Subgrade) for IH 35 Gilbert (Laredo).

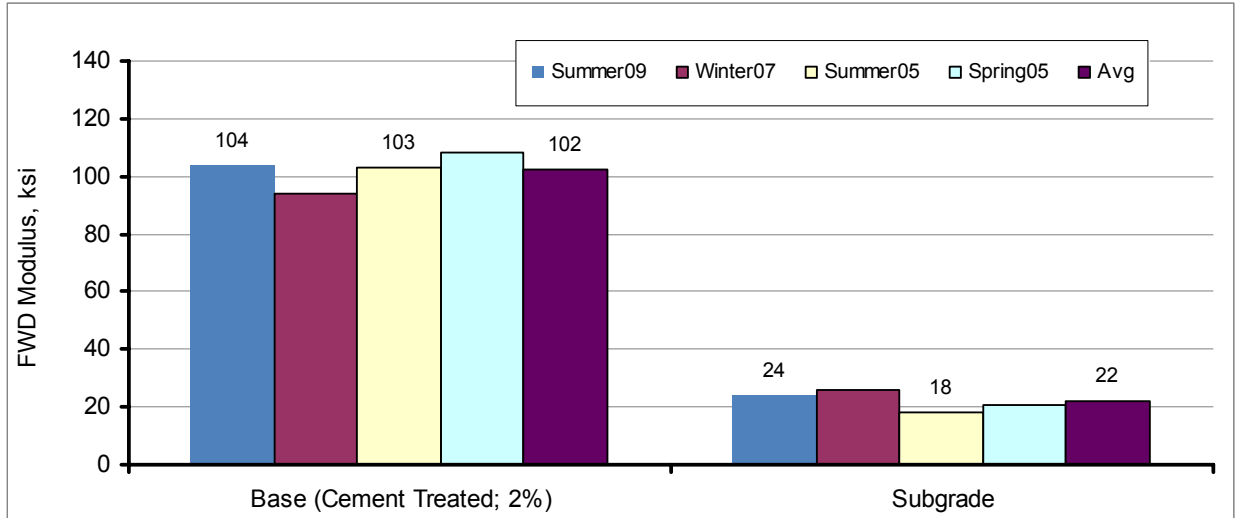
**Figure 5-17. Plot of Base and Subgrade FWD Moduli for IH 35 Zumwalt 02 (Laredo).**

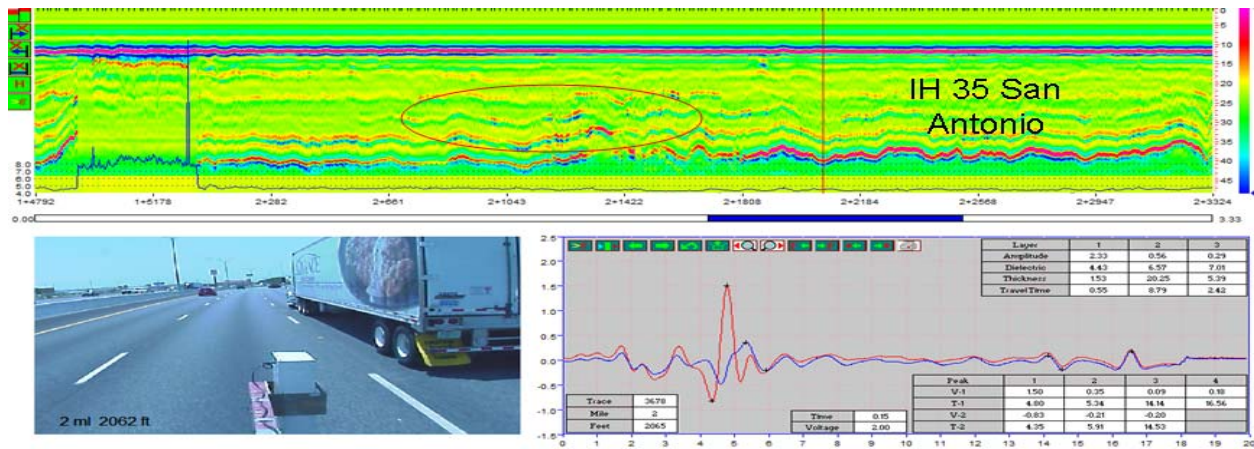
**Figure 5-18. Summer 2009 GPR Measurements on IH 35 (San Antonio).**

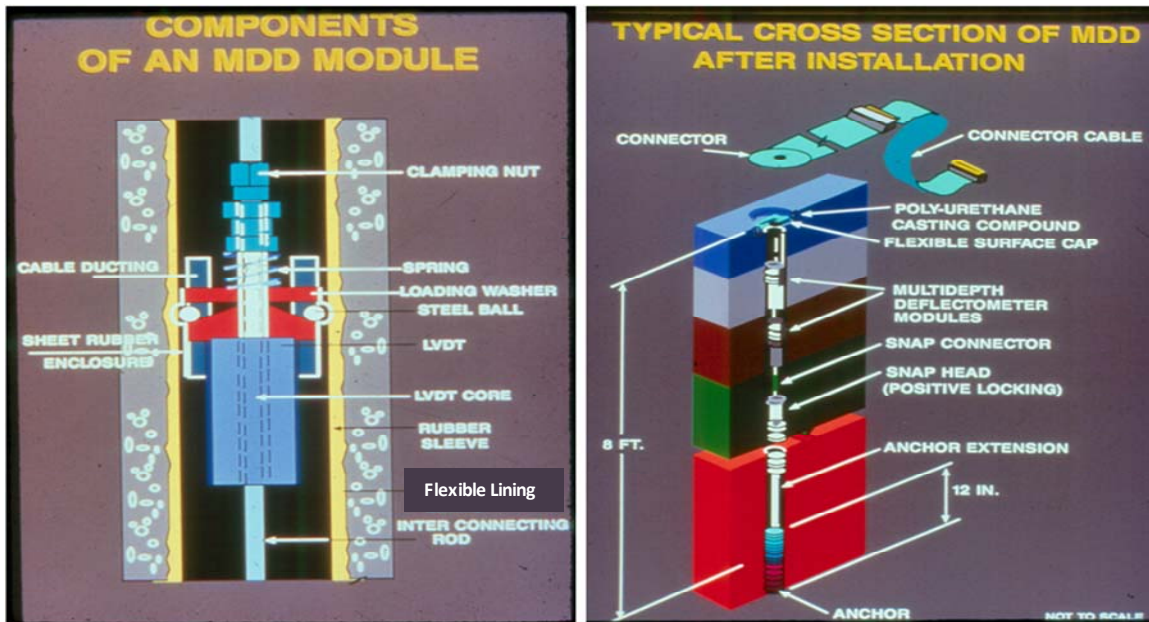
Figure 6-8a. MDD Instrumentation Set Up.

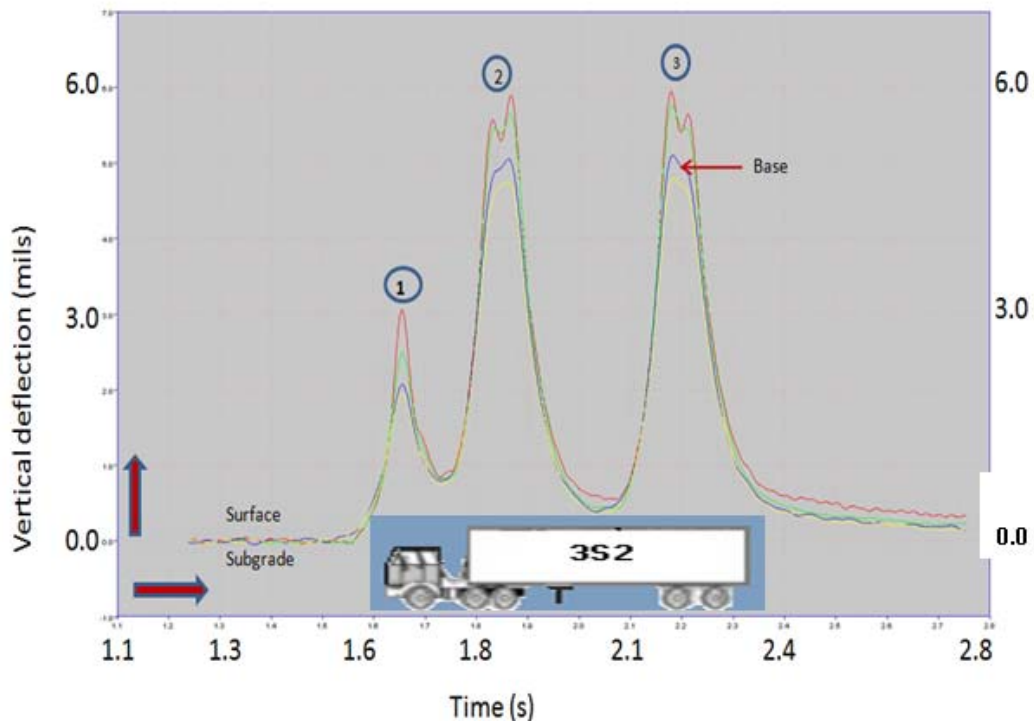
**Figure 6-10. Typical 18 Wheeler-Truck MDD Deflection Response with Time Passage.**

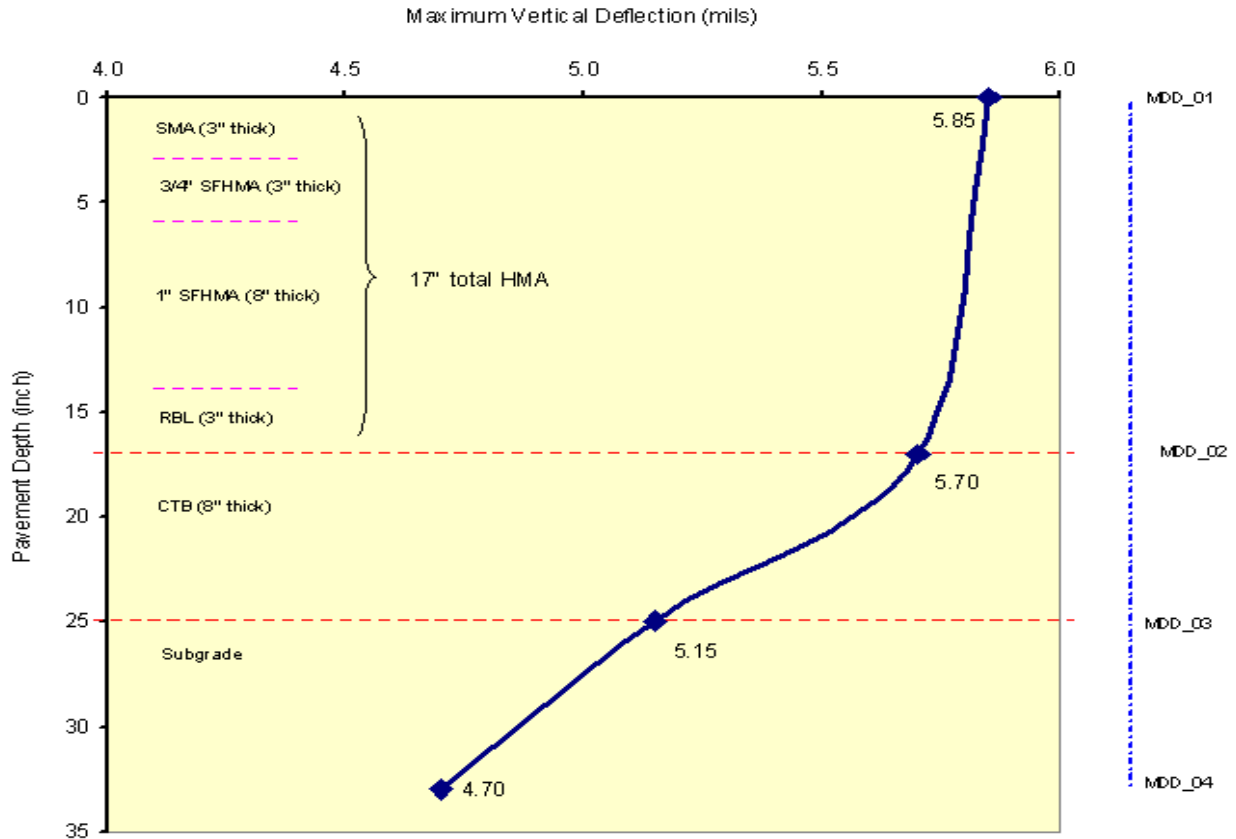
**Figure 6-11. Example MDD Deflection Measurements as a Function of Pavement Depth.**

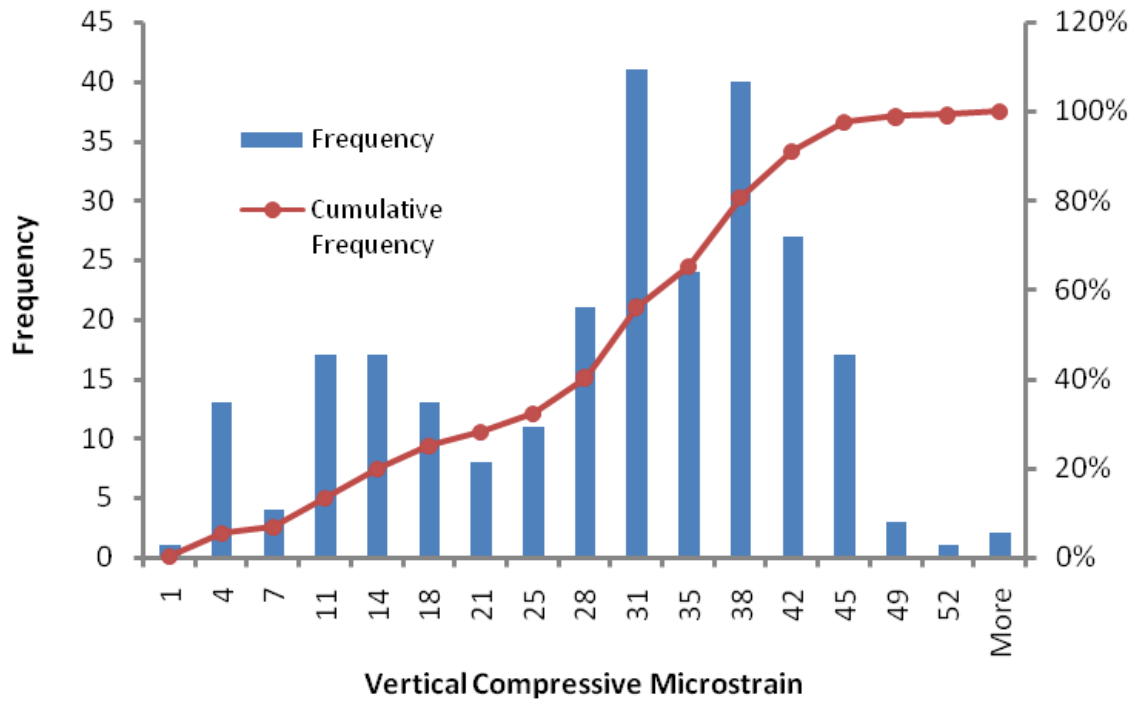
Figure 6-12a. Vertical Strain Plot for the HMA Layers.

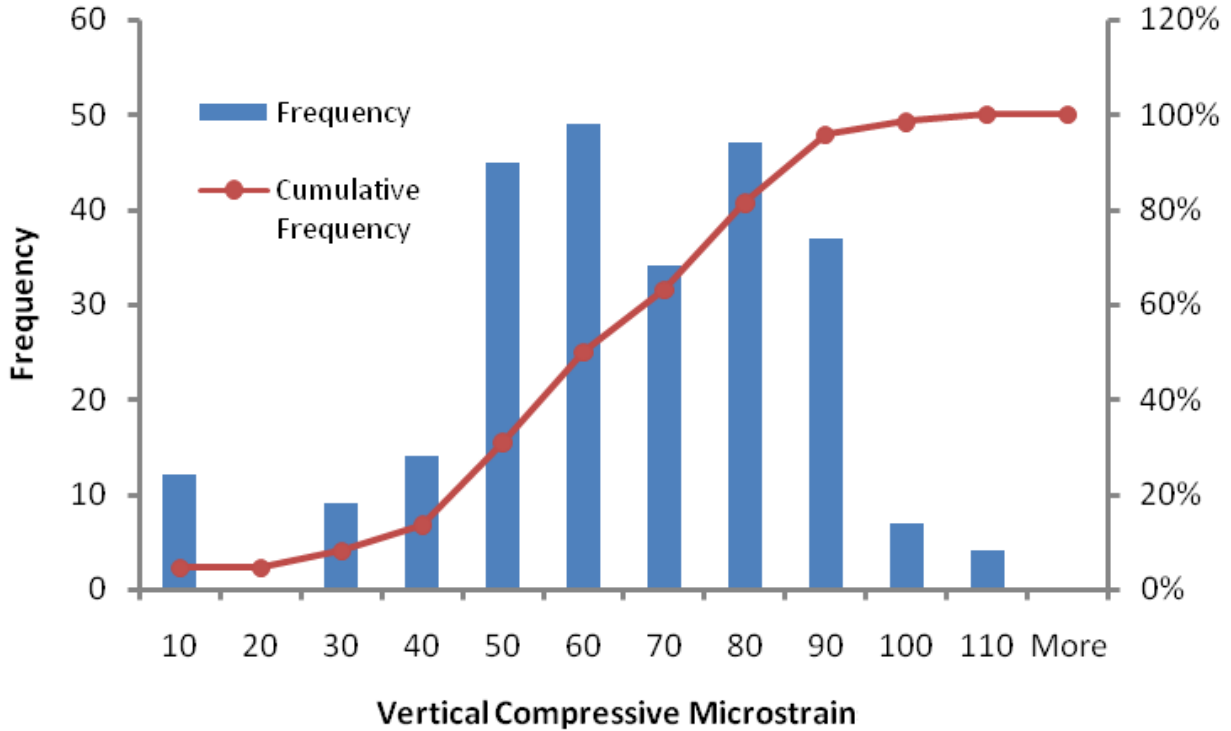
Figure 6-12b. Vertical Strain Plot for the Base.

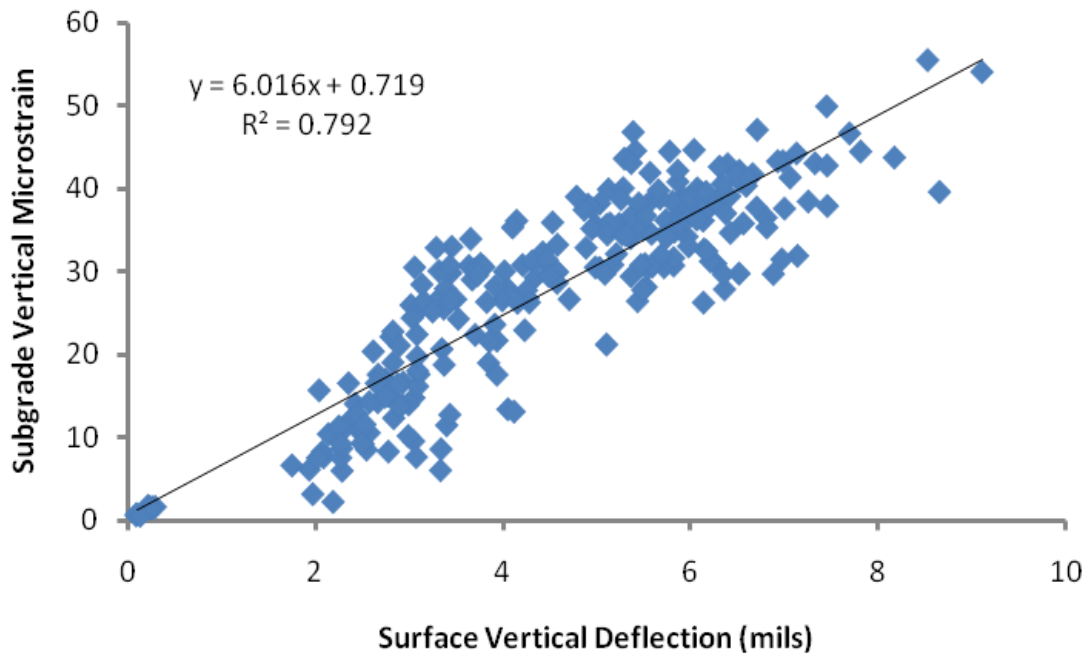
**Figure 6-13. Surface Deflection versus Subgrade Microstrains in the Top 8 inches.**

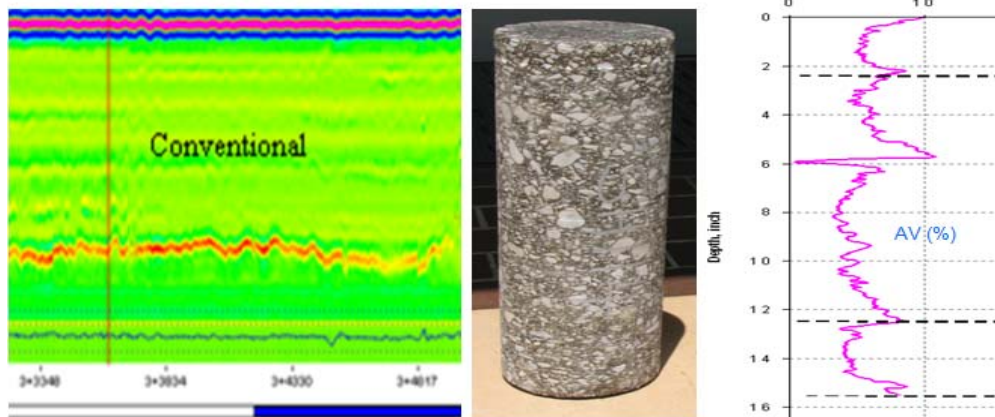
**Figure 8-4. Ideal GPR Readings, Non-Defective Intact Core, and Uniform AV Core Distribution from SH 114 Conventional.**

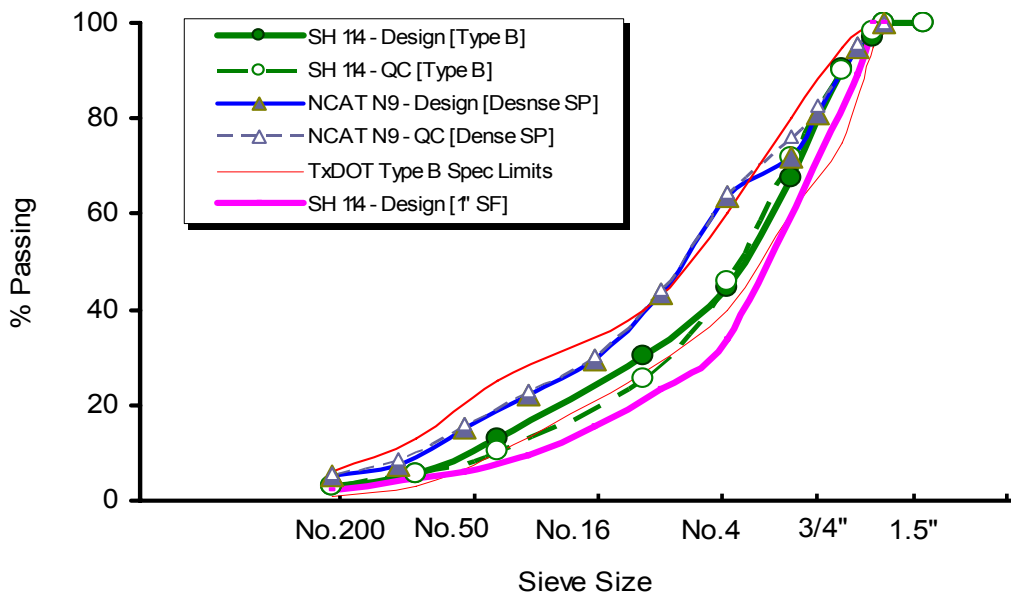
**Figure 8-6. Aggregate Gradation Comparisons.**

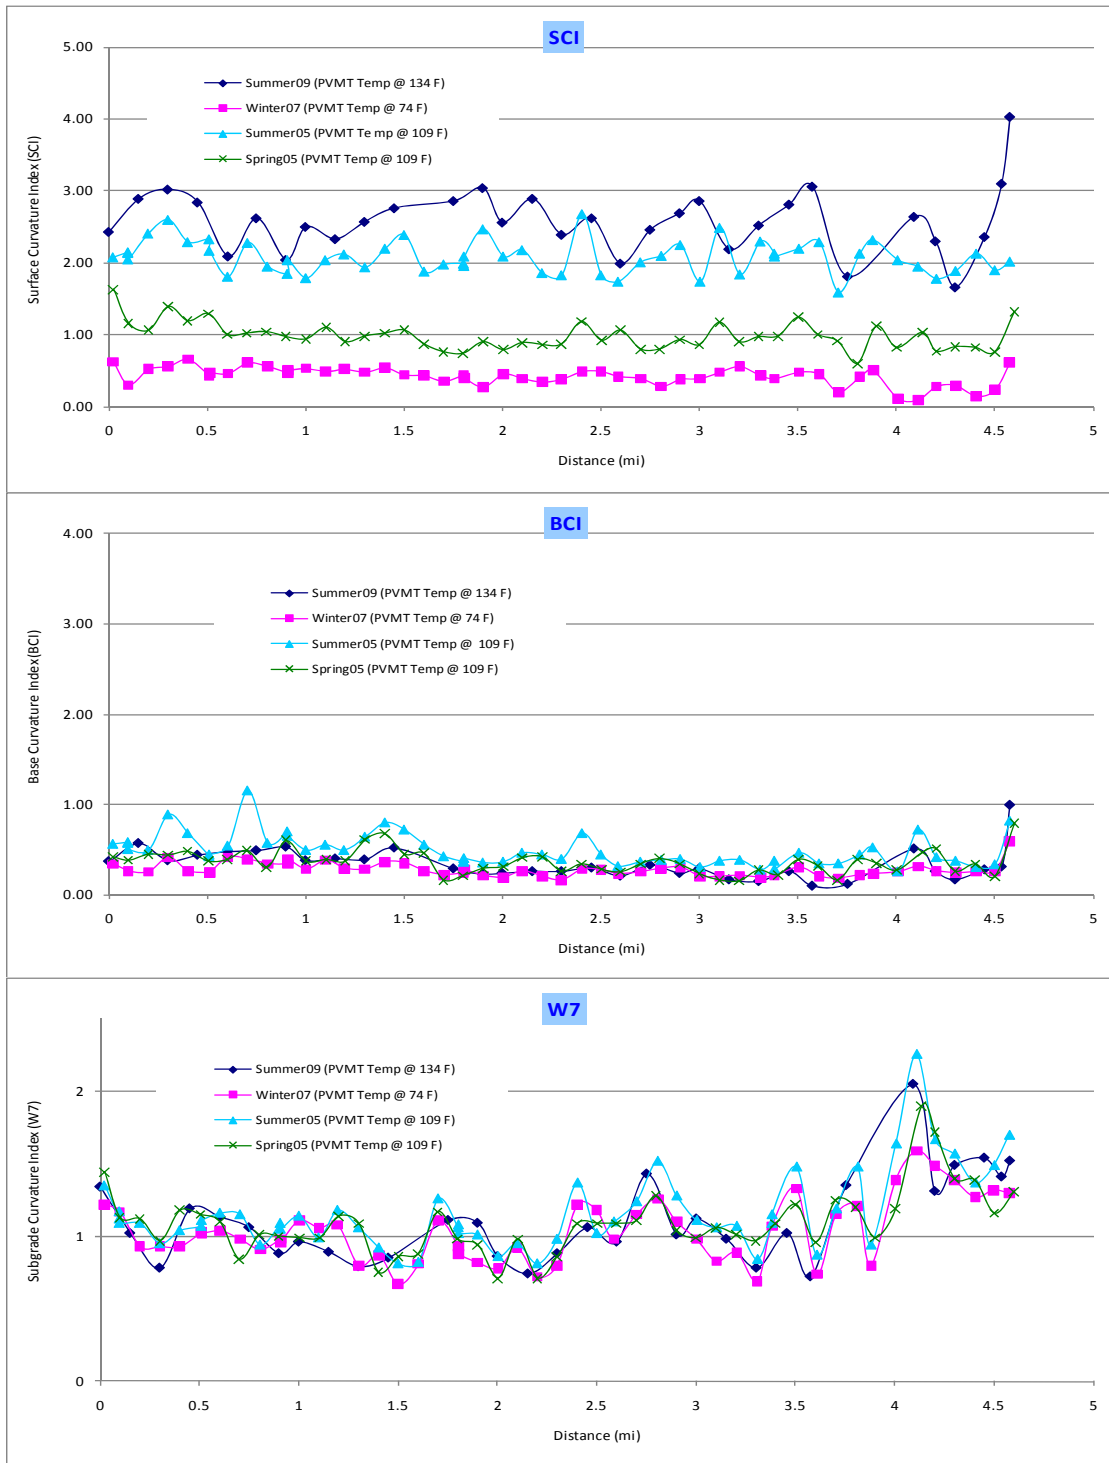
**Figure C-4. Example Curvature Index Plots for IH 35 Laredo – ZMW01.**

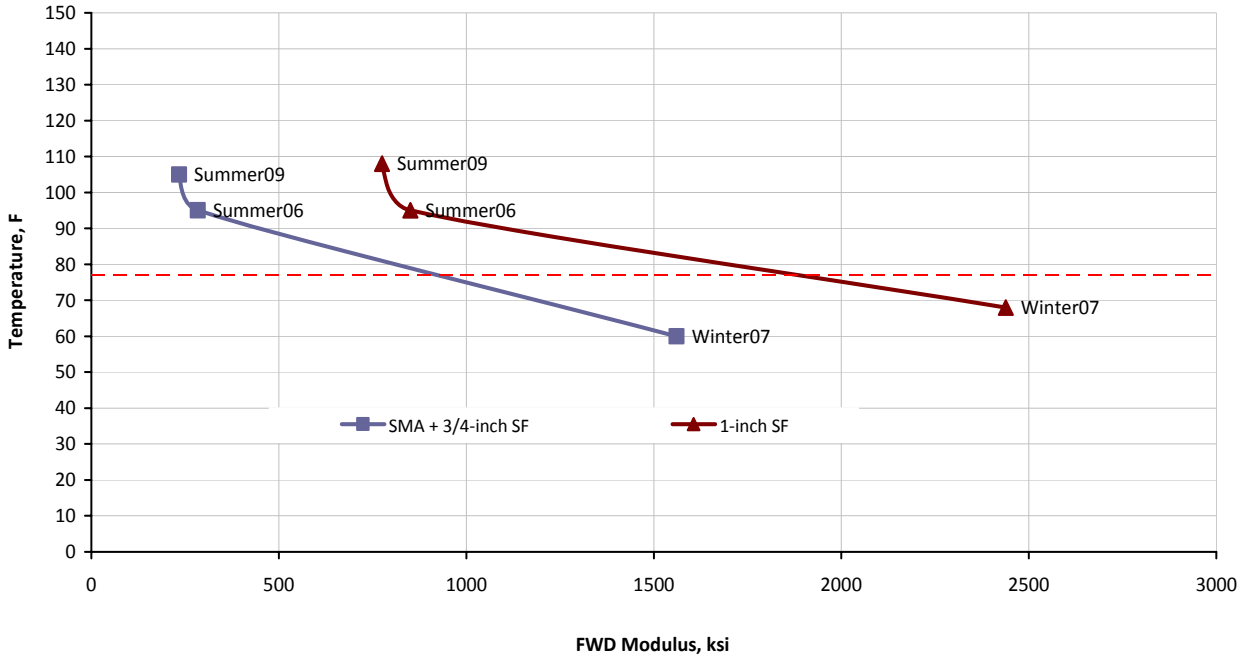
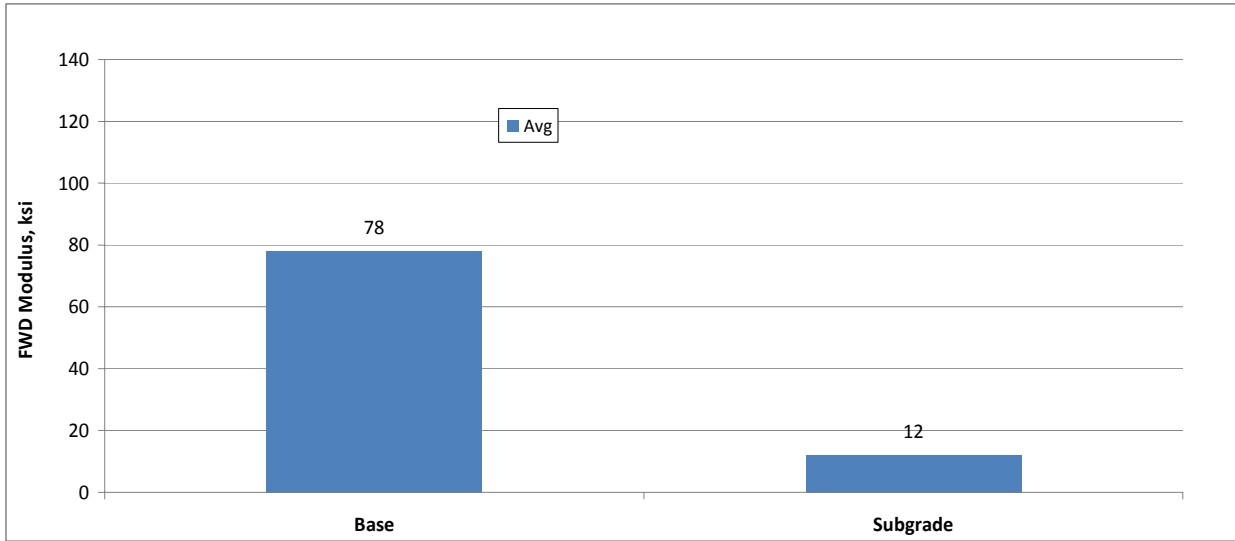
**Figure C-5. Example Moduli Plots for SH 114 – Superpave.**

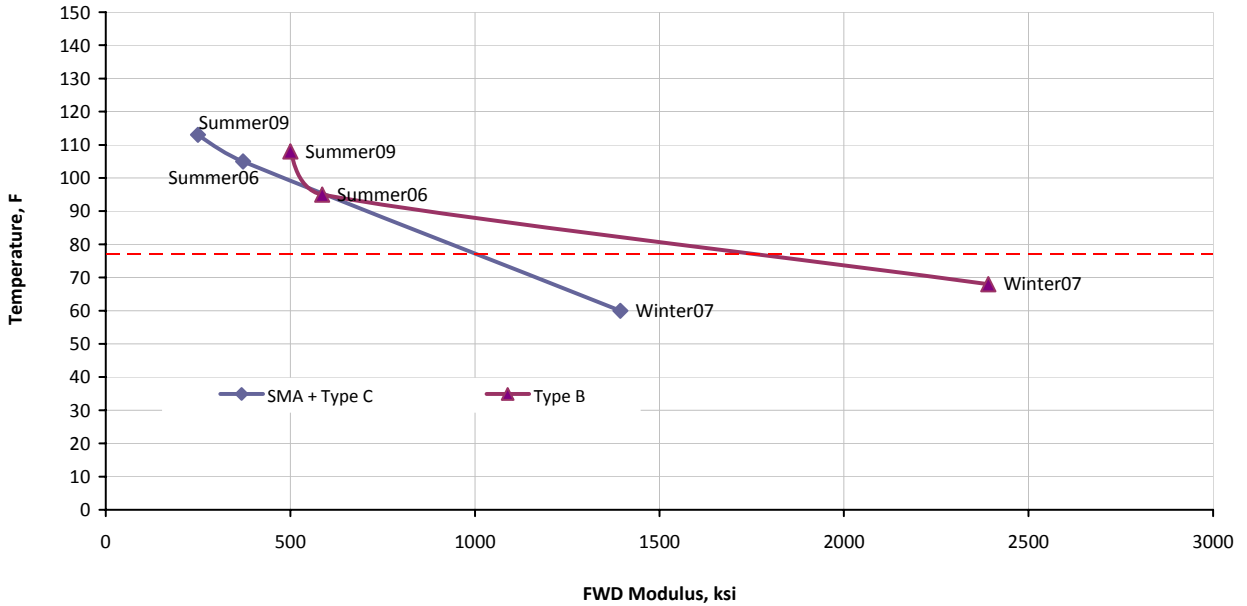
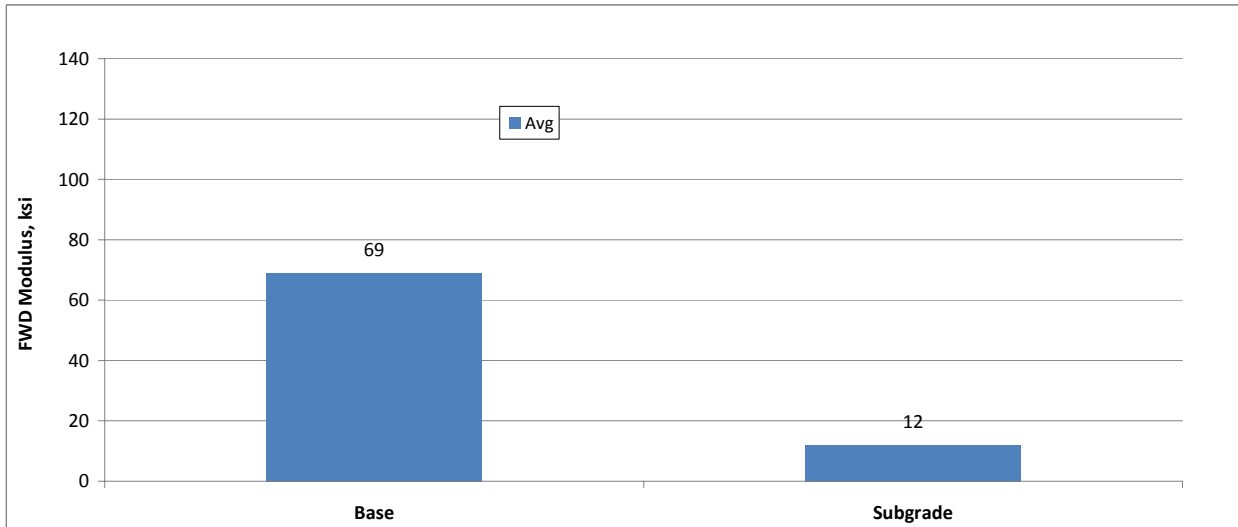
**Figure C-6. Example Moduli Plots for SH 114 – Conventional.**

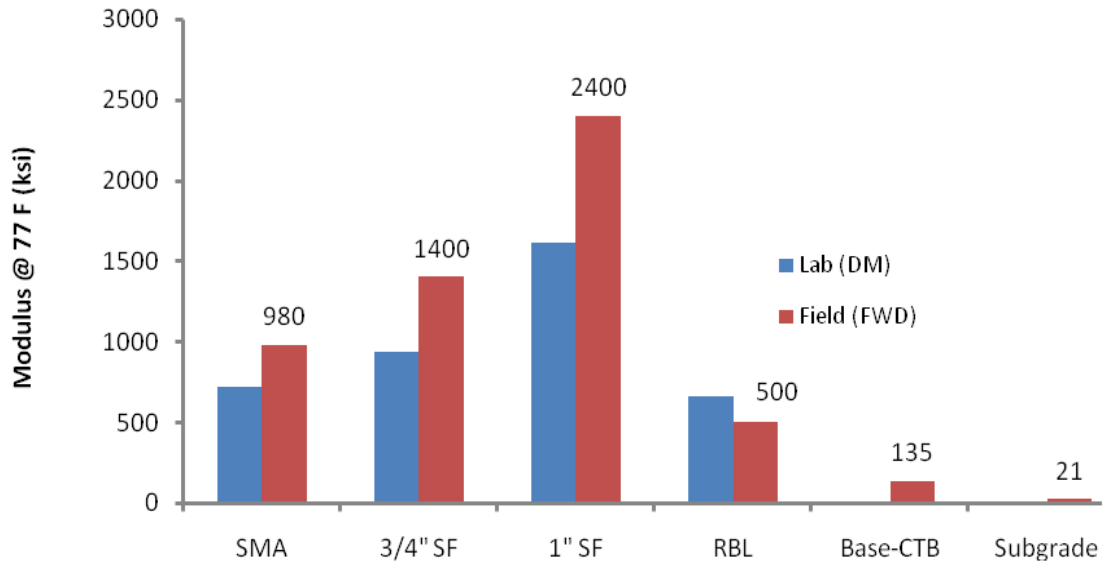
**Figure C-7. Example FWD Layer Moduli Values for IH 35 – ZUMW02.**

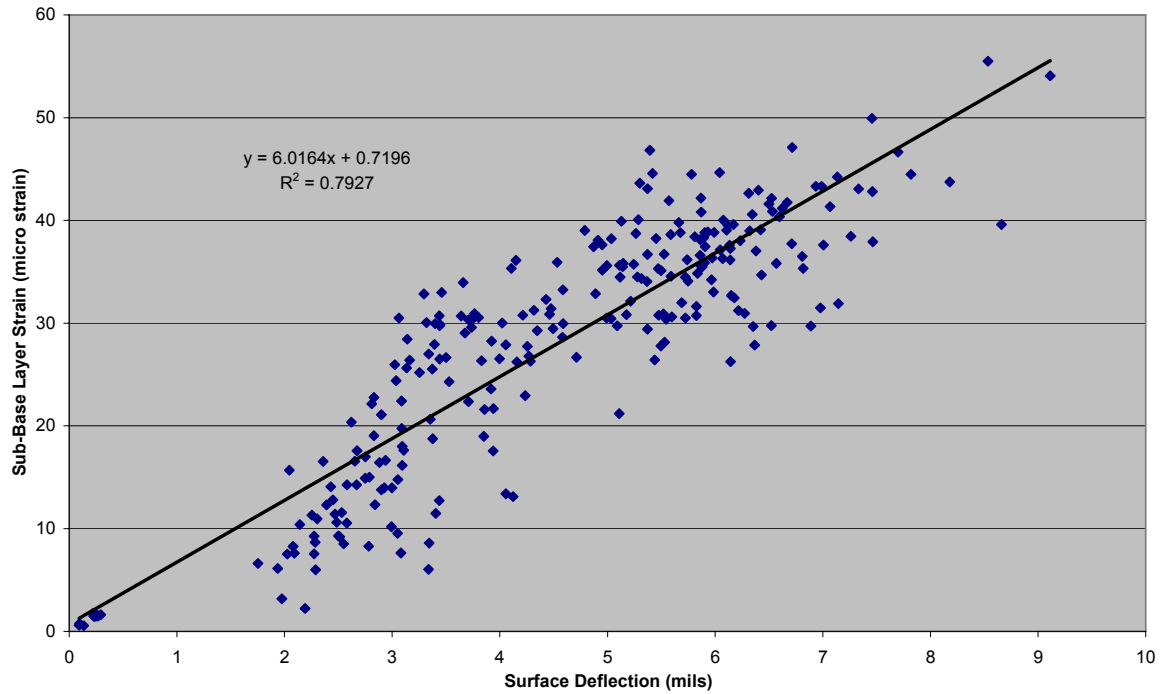
**Figure D-1. Surface Deflection vs. Subbase Vertical Strain – IH 35 ZMW02.**

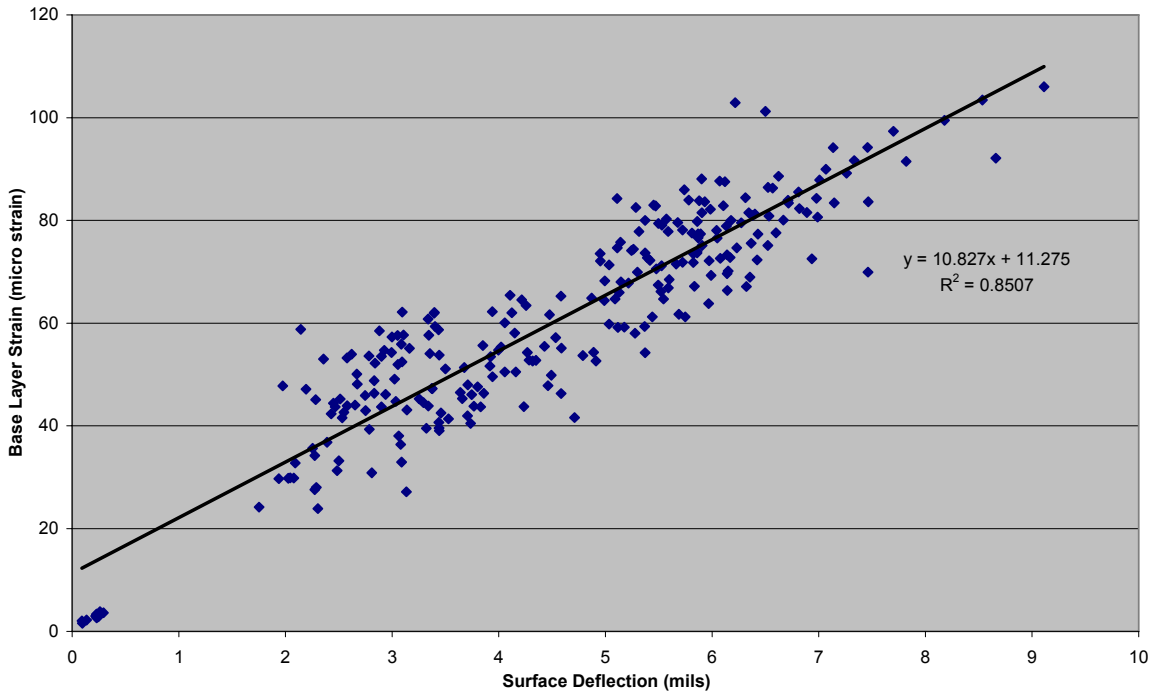
**Figure D-2. Surface Deflection vs. Base Layer Vertical Strain – IH 35 ZMW02.**

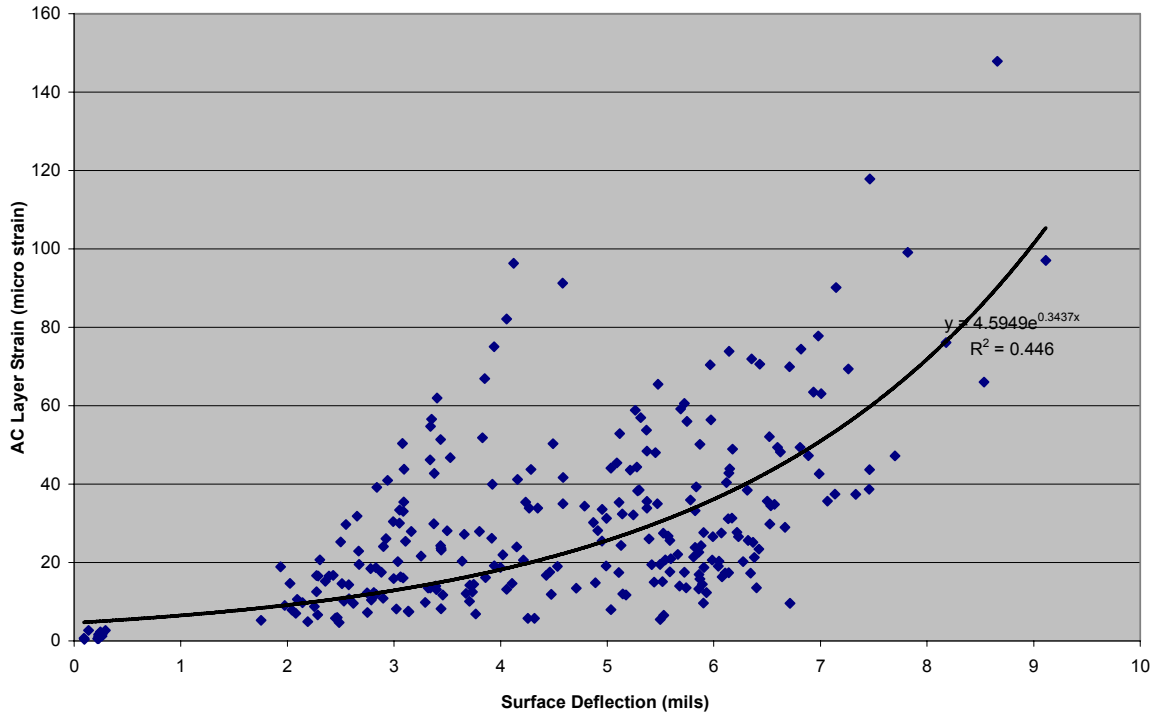
**Figure D-3. Surface Deflection vs. Surface Layer Vertical Strain – IH 35 ZMW02.**
