Structural Health Monitoring and Condition Assessment of Chulitna River Bridge: Sensor Selection and Field Installation Report

December 2012

INE/AUTC 12.30

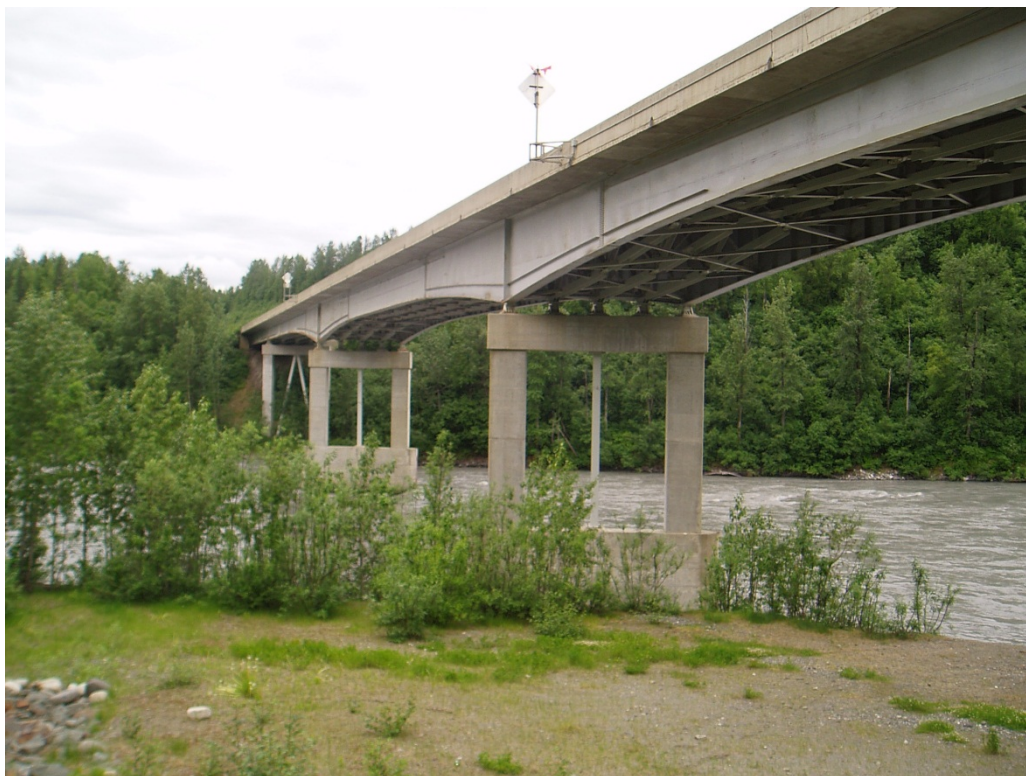
Figure 1. Current Picture of the Chulitna River Bridge

The Chulitna River Bridge, built in 1970, is located at Historic Mile Post 132.7 on the Parks Highway between Fairbanks and Anchorage, Alaska. The Parks Highway is the most direct route connecting Anchorage with Fairbanks and Prudhoe Bay. Heavy, overload vehicles, up to 410,000 pounds, regularly travel the route. The original 1970 bridge was a 790-foot long, 5 span, continuous bridge with two exterior steel plate girders and three sub-stringers. It had a cast-in-place concrete deck 34 feet wide. In 1993, the bridge deck width was increased to 42 feet 2 inches by replacing the original cast-in-place deck with precast concrete deck panels. To accommodate the increased loads, the two original exterior plate girders were strengthened, three new longitudinal steel trusses were installed utilizing the original stringers as top chords, and steel bracing was added to the piers (Figure 1).

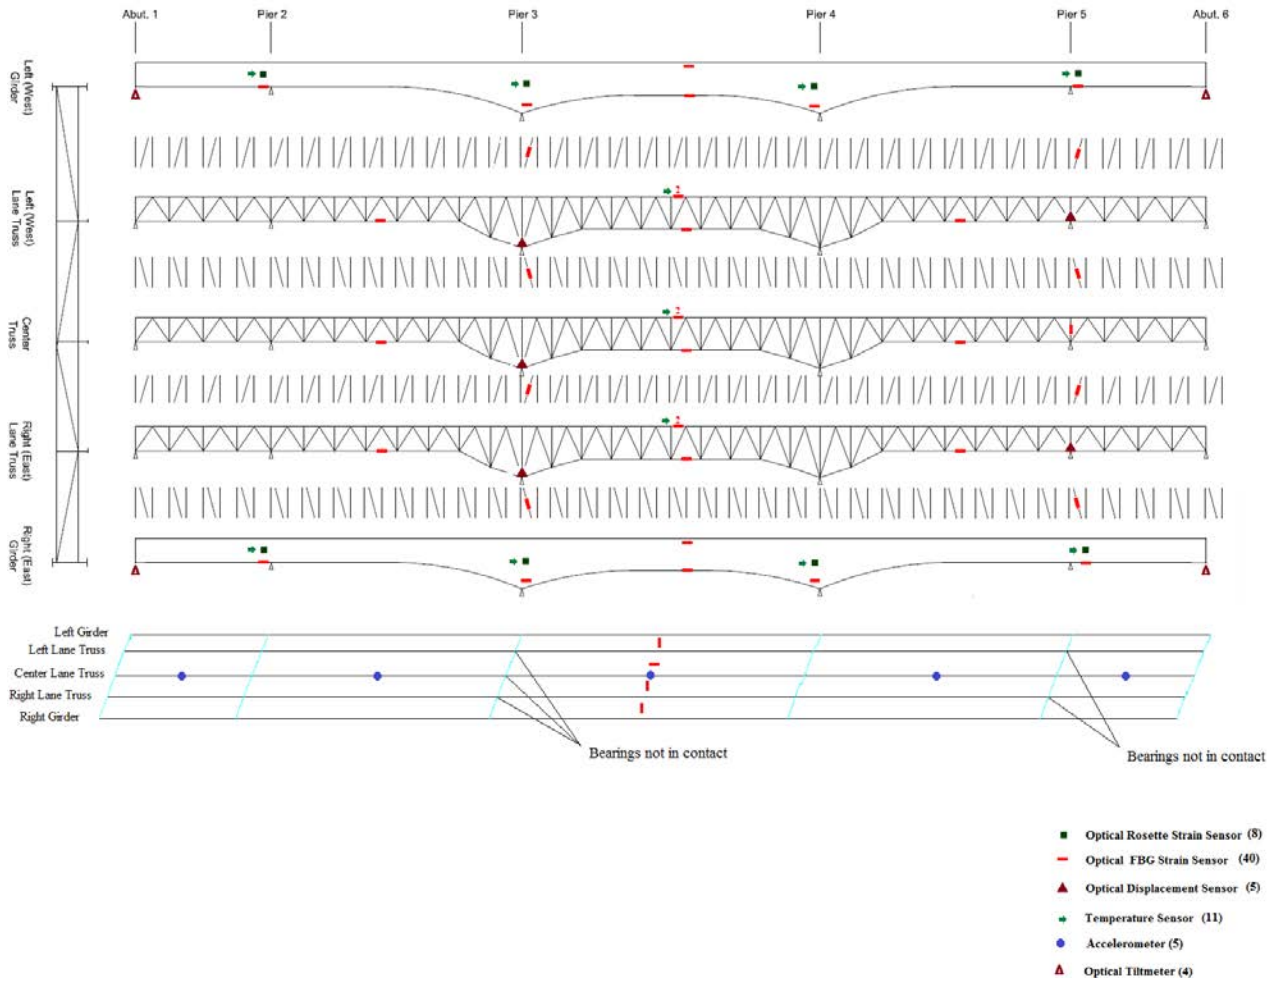
Figure 4. Sensor Layout

AKDOT&PF and Chandler Monitoring Systems, Inc. a total of 73 sensors were selected to be installed to monitor the behavior of this bridge. The sensor arrangement (Figure 4) was selected to best provide information about changes in the load distribution in girders and trusses. Most of the sensors are located in places that have the lower load rating factors and others are used to observe load distribution throughout bridge.

We attempted to measure the Shear force effects by placing eight optic fiber Bragg grating (FBG) rosette strain sensors near the piers. We are attempting to measure flexural strain caused by moments near mid-span are to be monitored by twelve optic FBG strain sensors placed near mid-spans of the girders. To monitor the bending and the axial forces in the trusses, fifteen optic FBG strain sensors are located within the composite trusses. The live load distribution in the girders and the trusses can be calculated by comparing the force between the girders and the trusses. For monitoring the load transfer through the cross frames and the concrete deck, twelve optic FBG sensors are placed on the cross frames’ diagonal trusses and the concrete deck. Other optic FBG sensors are located on members that are considered to have the lower load ratings. Five accelerometers are used to monitor changing of stiffness’s in the trusses and girders. The supports are monitored for rotation with tilt meters. If all supports are not free to rotate as they should the bridge may exhibit a twisting condition. This accounts for an additional four sensors. Five displacement sensors are used to monitor the displacement of the truss bearings. The following table is a brief summary of sensor quantities.

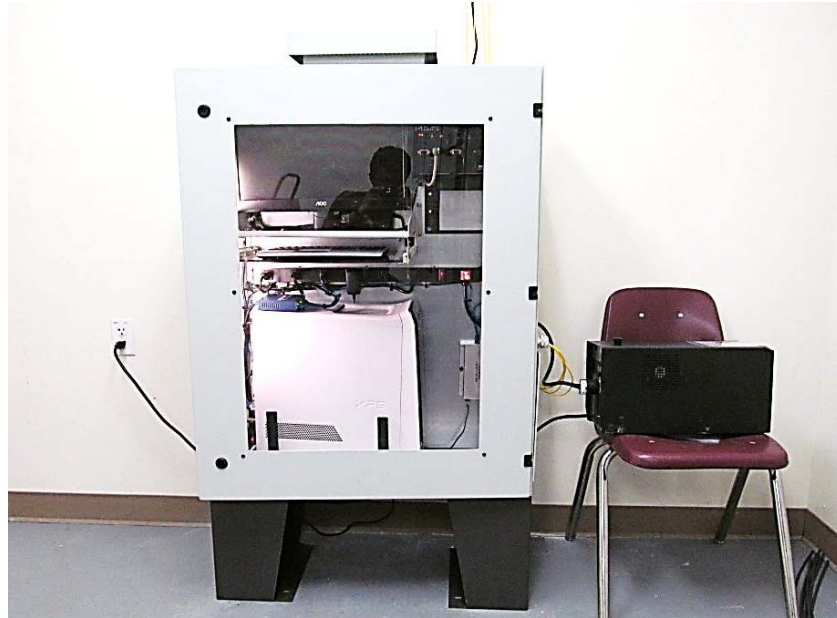
Figure 9. Control Panel at the Princess Hotel

TASK A: Place the control panel in the communications room of the Princess Hotel, confirm panel area placement, make cable connections needed, and bolt panel to the floor (Figure 9).

OBSTACLE 3: Connector problems: CMS was unable to connect the control panel to the fiber-optic lines ran by MTA. CMS had inadvertently brought the wrong type jumpers needed to connect the interrogator to the main fiber optic lines. CMS quickly realized their mistake and ordered the correct jumpers. Due to the semi-remote location of the installation, the replacement jumpers took over a week to arrive. Upon arrival the CMS installers realized that the replacement jumpers were also incorrect. A second order of replacement jumpers was ordered. Because of these delays, CMS was forced to temporarily place the interrogator at the bridge site to test sensor arrays during the installation. This temporary configuration allowed CMS to

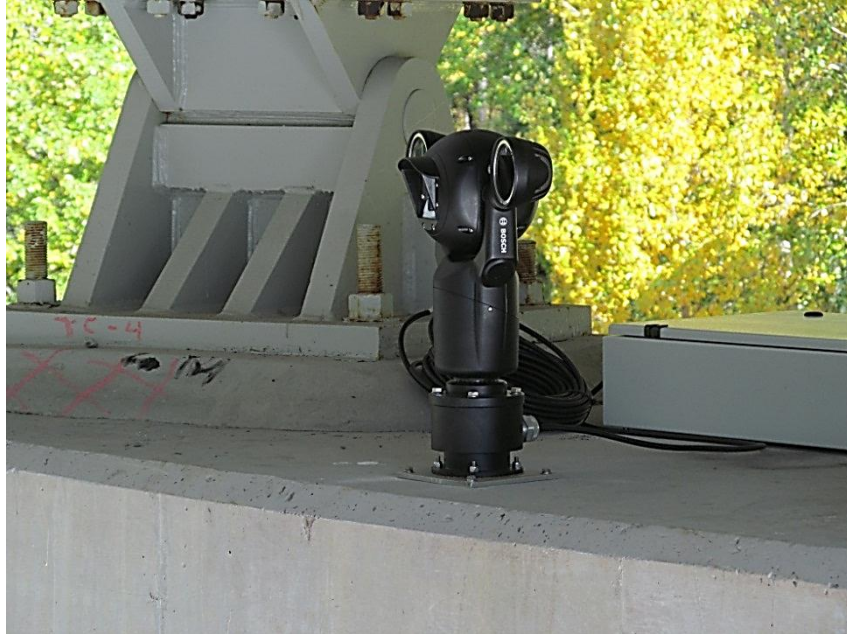
Figure 10. Camera and Camera Control Panel

TASK B: Install power for camera. Install camera and camera control panel (Figure 10).

OBSTACLES: Camera communications problems: Both the installation of the required 110 V. power source and subsequent electronics and hardware went smoothly. Ongoing communication issues with the camera control panel have prevented successful operation of the camera.

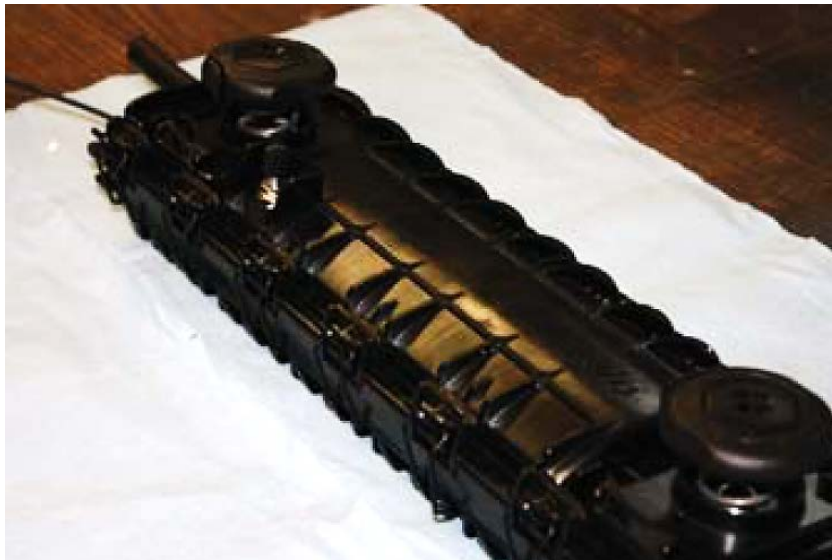
Figure 11. Splitter Box

TASK C: Install the main fiber optic trunk line. Secure the trunk line in place using epoxy, cable clips and industrial cable ties. Install splitter boxes along trunk line (Figure 11).

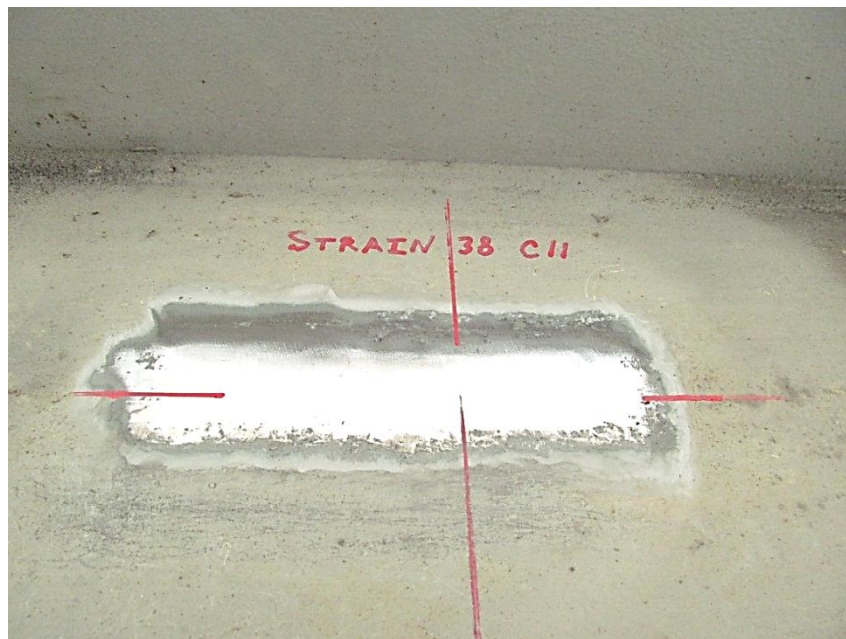
Figure 13. Metal Preparation: Grind and Mark the Sensor Location

TASK E: Grind and prepare sensor locations for the installation (Figure 13). Cover with the temporary protective covering (Figure 14).

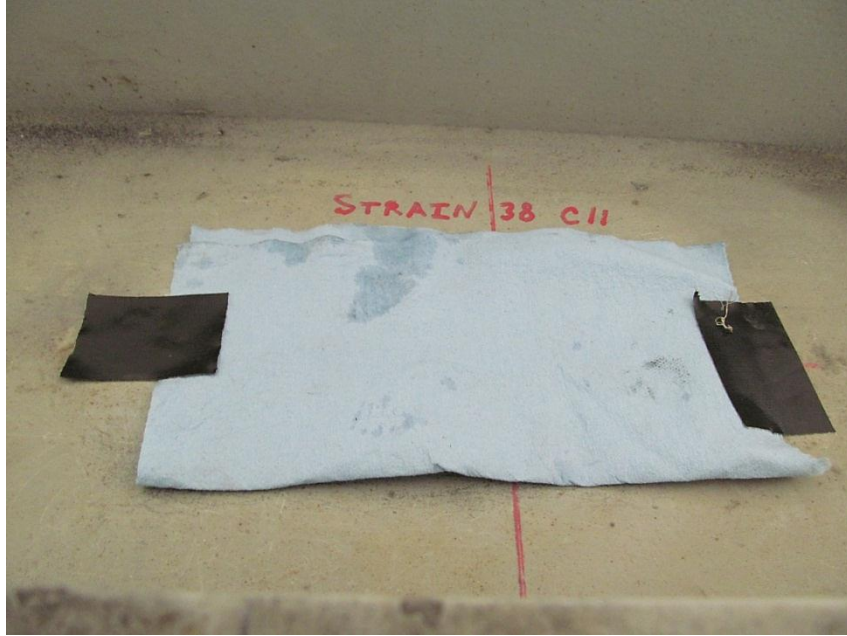
Figure 14. Rust Prevention: Used a Temporary Protective Covering

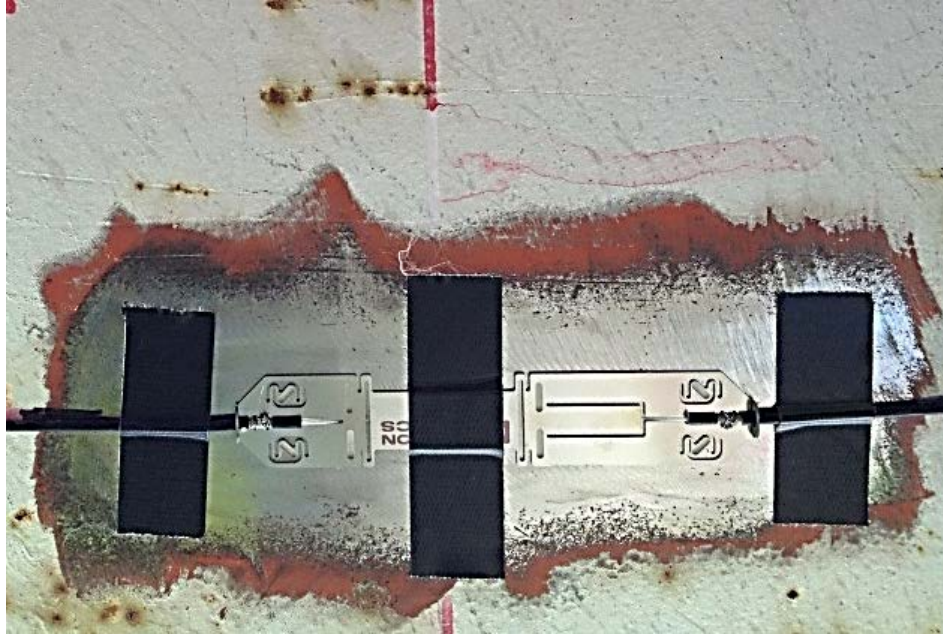
Figure 16. Spot Weld Strain Sensor

TASK A: Install sensor arrays (Figure 15). Arrays contain in part and/or in combination of the following sensors: steel strain sensors (Figure 16, Figure 17), concrete strain sensors (Figure 18, Figure 9 and Figure 20), rosettes (Figure 21, Figure 22), tilt meters (Figure 23), temperature sensors (Figure 24), displacement sensors (Figure 25), accelerometers.

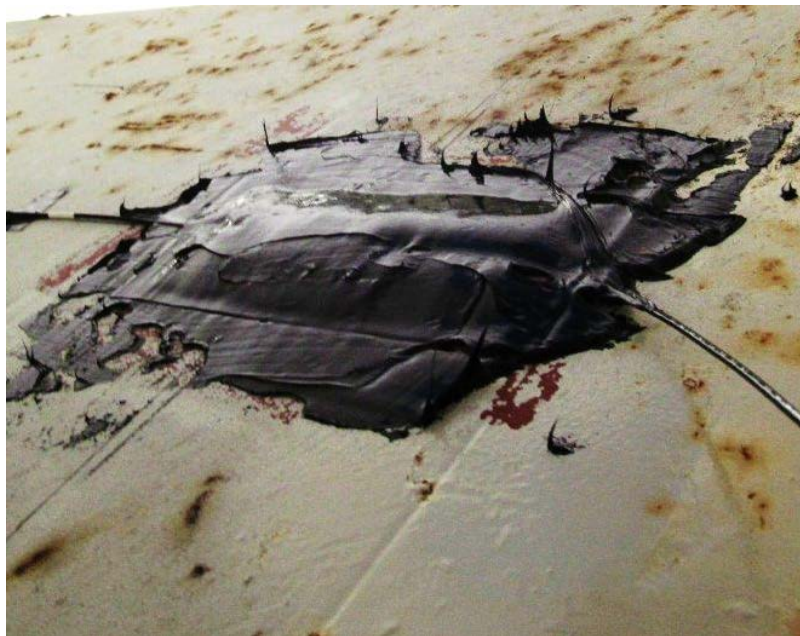
Figure 17. Strain Sensor Cover with the Protection Coating

AUTC recommended the following protection system: 1) A 1/32” rubberized silicone sheet was to be placed directly over the sensor, providing a protective envelope that encapsulated the sensor. 2) A layer of Sulpruf SCS2000 silicone paste was then to be placed over the silicone sheet extending beyond the sheet in all directions. This silicone paste acts to seal the perimeter of the silicone sheet, cover any exposed base metal, and to add an extra layer of protection to the sensor. See Figures 16 to 22 illustrating the sensor protection process.

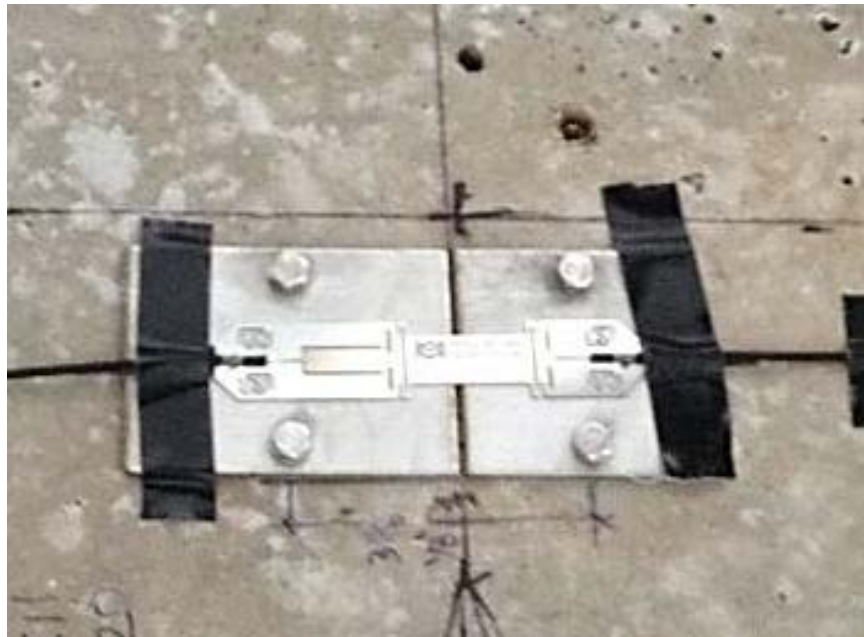
Figure 19. Spot Welded Strain Sensor on Steel Plate

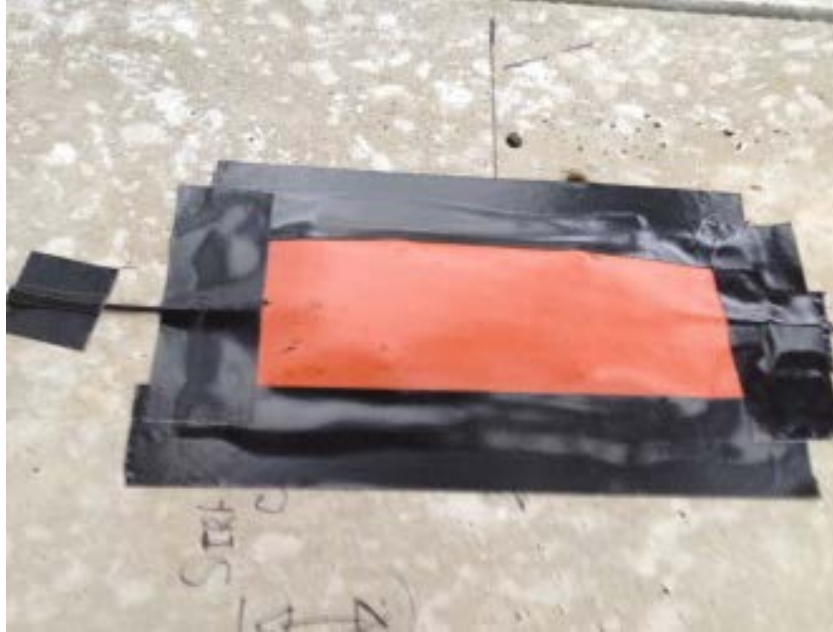
Figure 20. Strain Sensor with Protective Cover

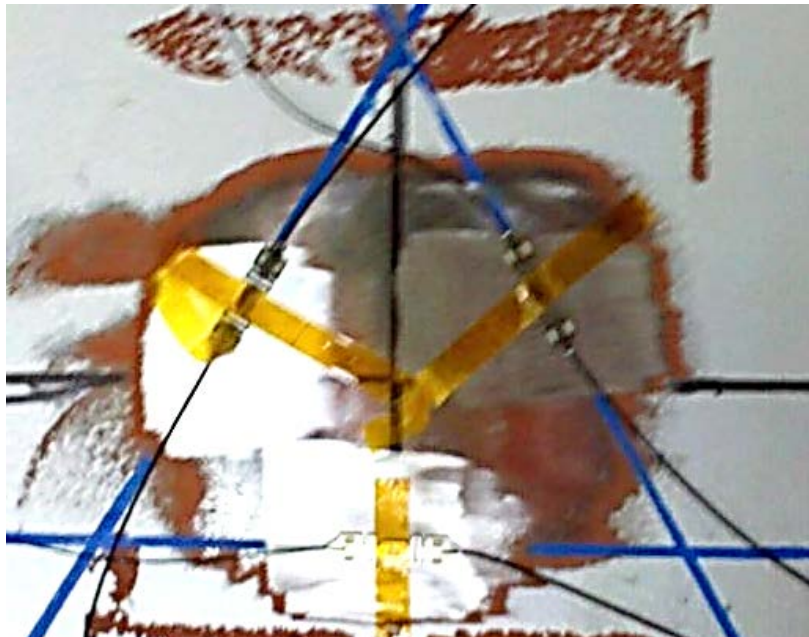
Figure 21. Spot Welded Rosette to Girder

OBSTACLE 1: Rosette sensors, specially ordered from Germany for this project, proved to be problematic. Unknown to the CMS installers, these rosettes were constructed with five micron fibers, not nine micron fiber that the system required. The issue was not discovered until CMS was on-site trying to splice them in. Ultimately the rosette sensors were not used. Alternative configurations of three small strain gauges were used in place of one rosette sensor.

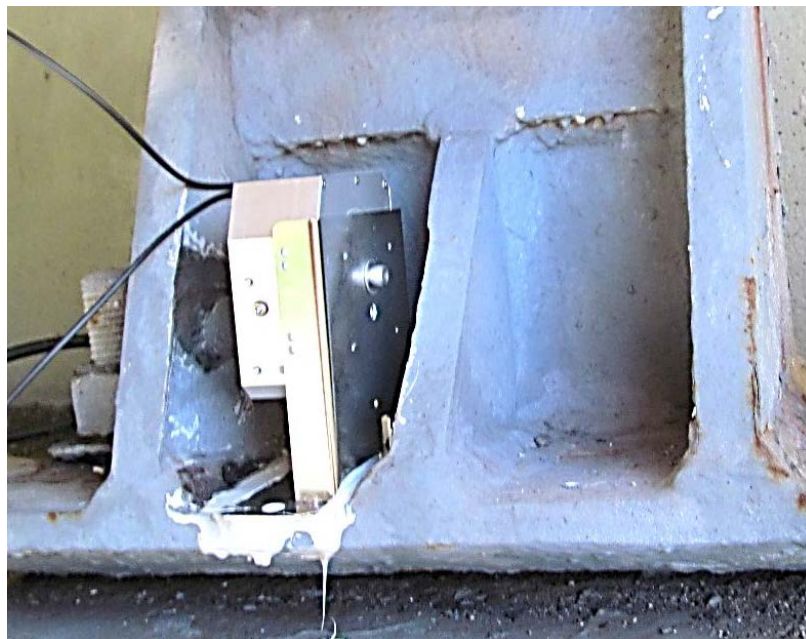
Figure 23. Tilt Meter at a Roller Support

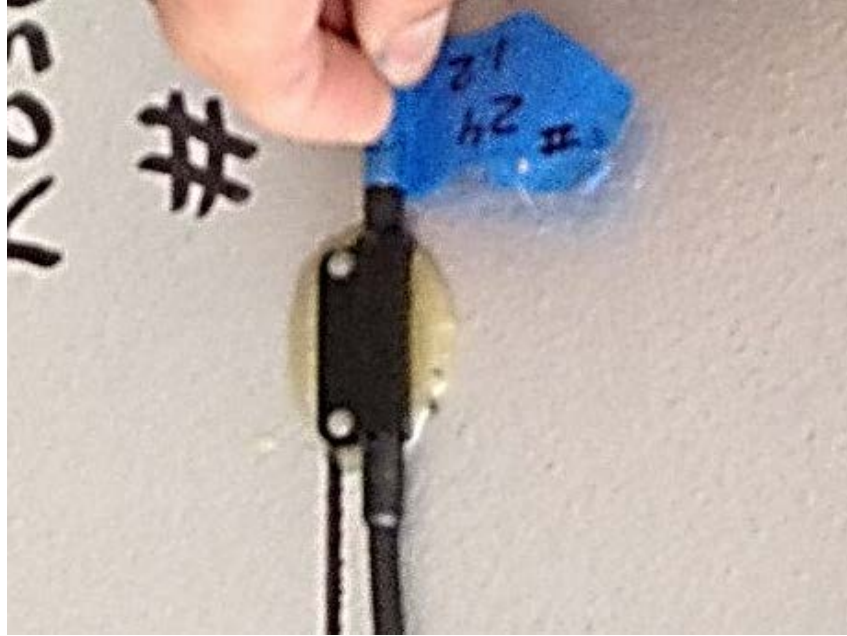
Figure 24. Using Epoxy to mount Temperature Sensor

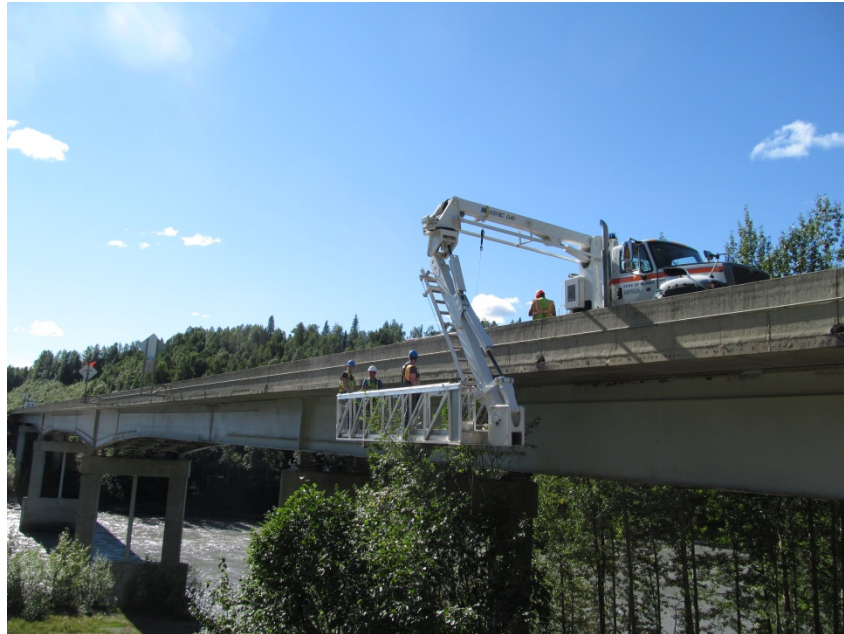
Figure 27. A-30 Truck Mounted Safety Equipment

Truck mounted work platforms and the operators were provided by AKDOT&PF. CMS and AUTC personnel were safety trained and were required to wear the proper safety gear (harnesses, safety glasses, ear plugs and hard hat. During installation, CMS and AUTC personnel with the assistance of AKDOT&PF operators used an A-30 and UB-50 truck (Figures 27 and 28) to access structural members, prepare and install sensors. The A-30 has large platform and it is convenient for a worker for accessing equipment and to walk on the platform, however, it has limited extension and it couldn't reach some parts of the bridge. The UB-50 has a small platform,

but it can extend longer than A-30 and it makes up for the shortness where the A-30 couldn't reach.

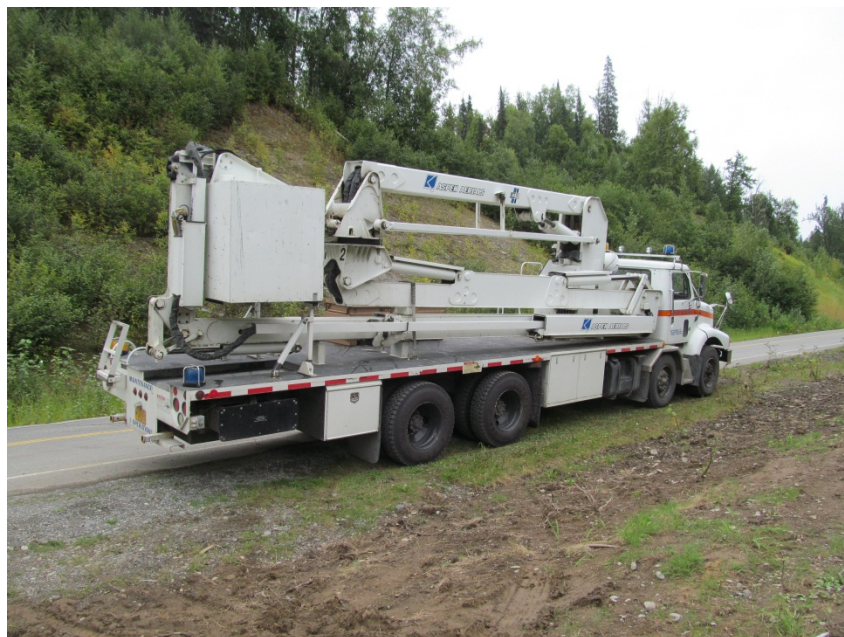
Figure 28. Truck Mounted UB-50 Safety Equipment.
