**Report No. CDOT-2010-3
Final Report**

Evaluation of the Performance, Cost- Effectiveness, and Timing of Various Pavement Preservation Treatments

Scott Shuler, Ph. D., P. E.

**COLORADO DEPARTMENT OF TRANSPORTATION
DTD APPLIED RESEARCH AND INNOVATION BRANCH**

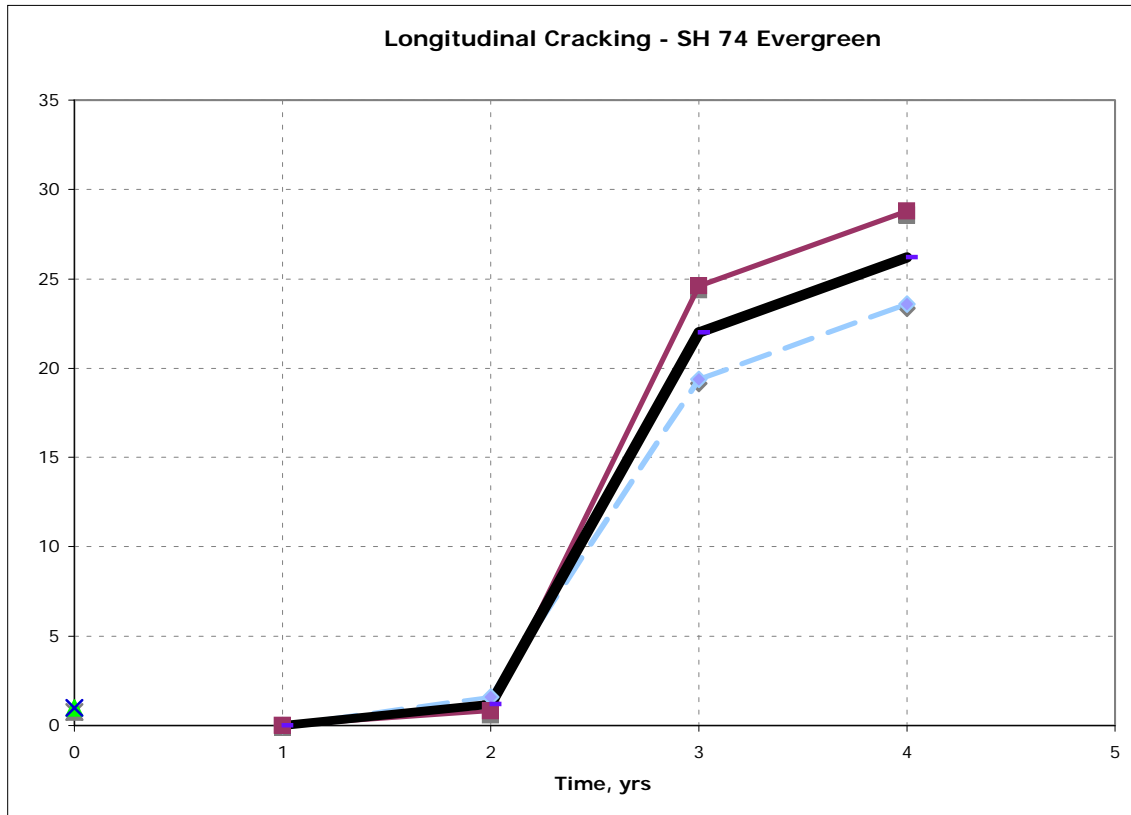
Construction of the SMA on SH 74 occurred one year prior to the beginning of this research. However, the project was included in this study to provide some indication of thin SMA performance. Pavement condition data collection began one year after construction as shown on Figures 23 and 24 for the longitudinal and transverse cracking that began appearing after one year. Results shown in Figures 23 and 24 indicate each of two test sections (solid and dashed lines) and the average (bold solid).

Figure 23. Longitudinal Cracking/500 ft Section for Thin SMA on SH 74, Evergreen

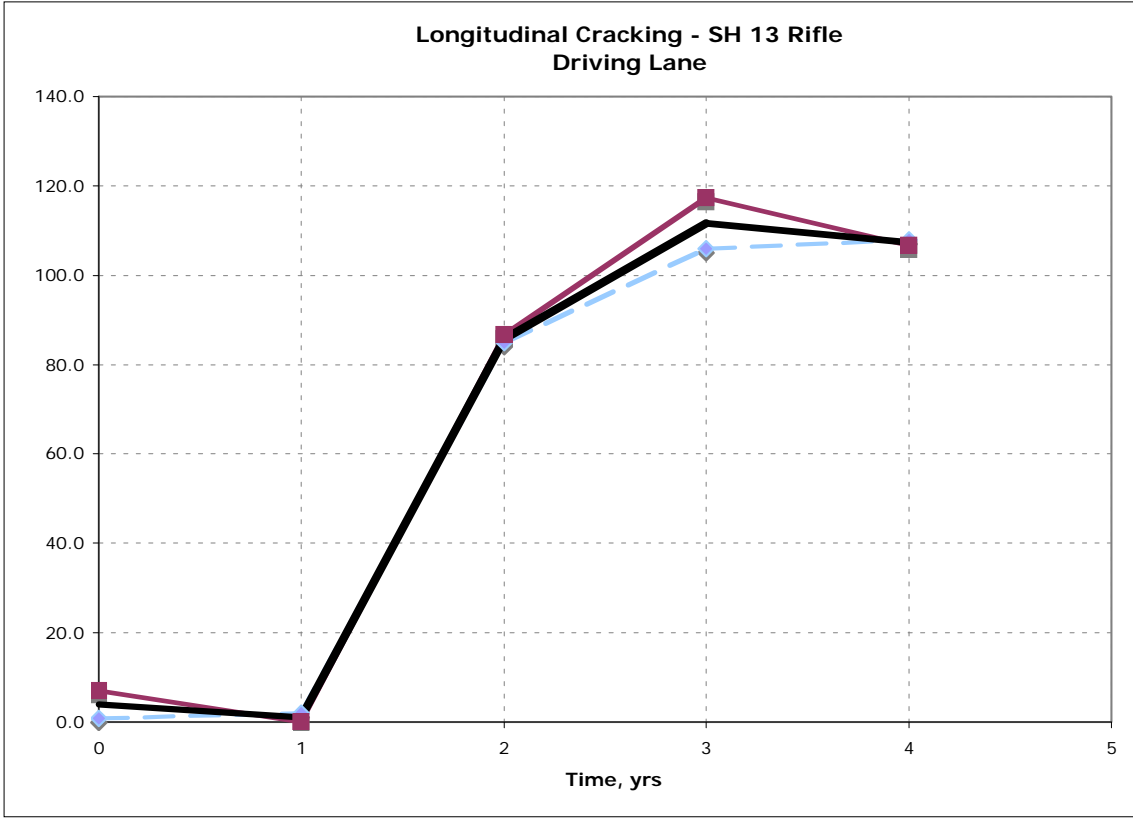
The Rifle test sections include driving and passing lanes of the northbound SH 13 by-pass. Two evaluation sections for each lane were monitored and the results are shown on Figures 25 through 28. Average condition is shown as the solid bold line on each figure.

Figure 25. Longitudinal Cracking /500 ft Section for Thin SMA on SH 13, Rifle

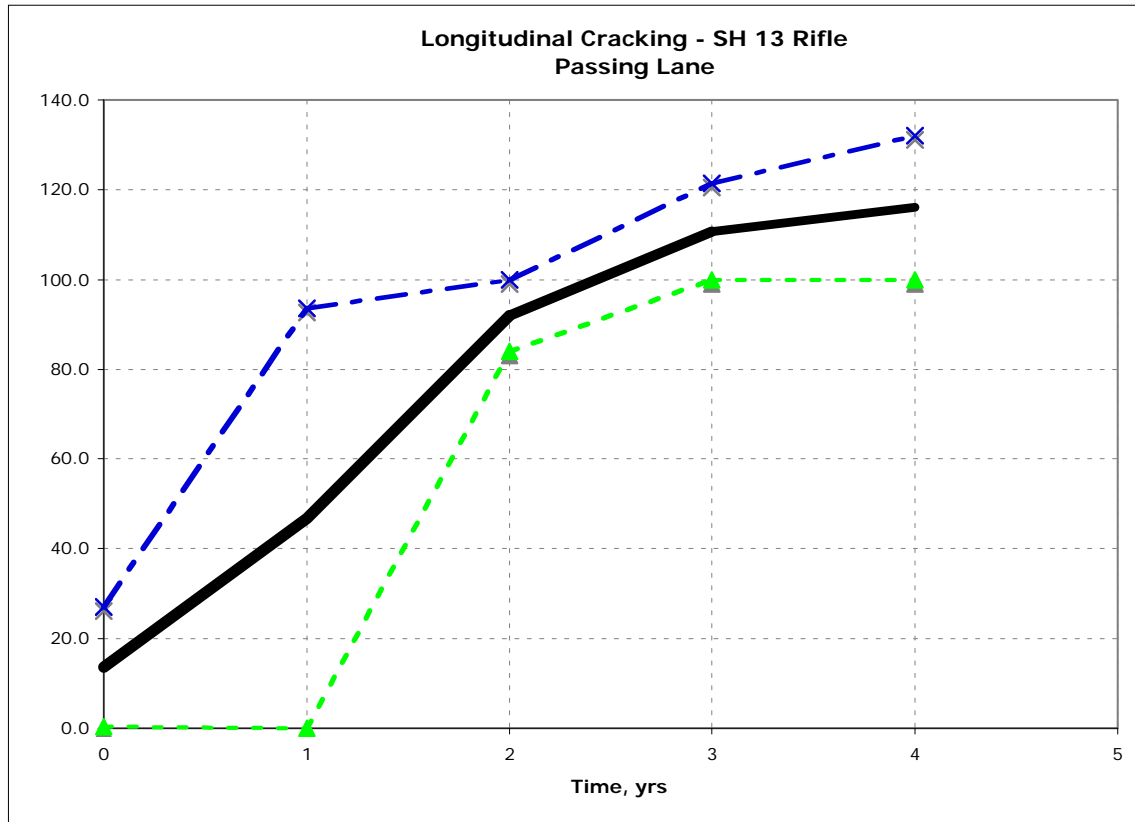
Figure 26. Longitudinal Cracking /500 ft Section for Thin SMA on SH 13, Rifle

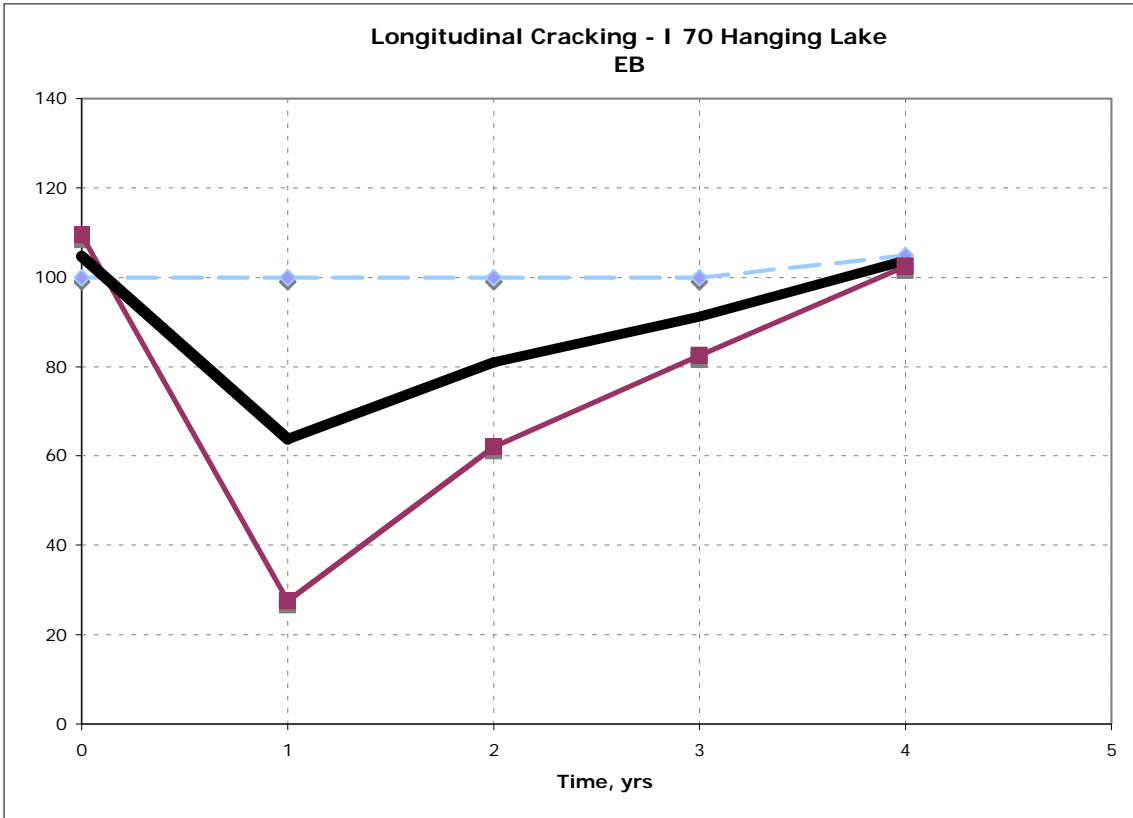
The Hanging Lake test sections include the driving lanes of eastbound and westbound I-70. Two evaluation sections for each direction were monitored and the results are shown on Figures 29 through 32. Average condition is shown as the solid bold line on each figure.

Figure 29. Longitudinal Cracking /500 ft Section for Thin SMA on I-70, Hanging Lake

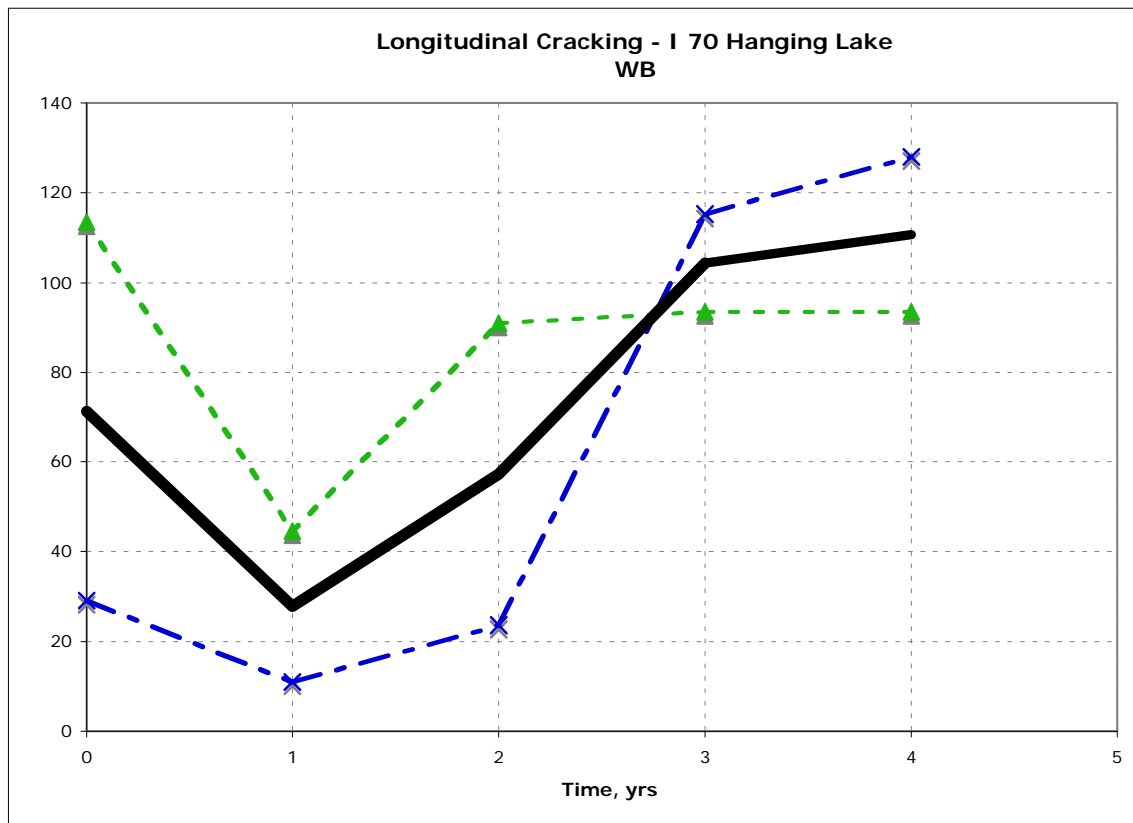
Figure 31. Longitudinal Cracking /500 ft Section for Thin SMA on I-70, Hanging Lake

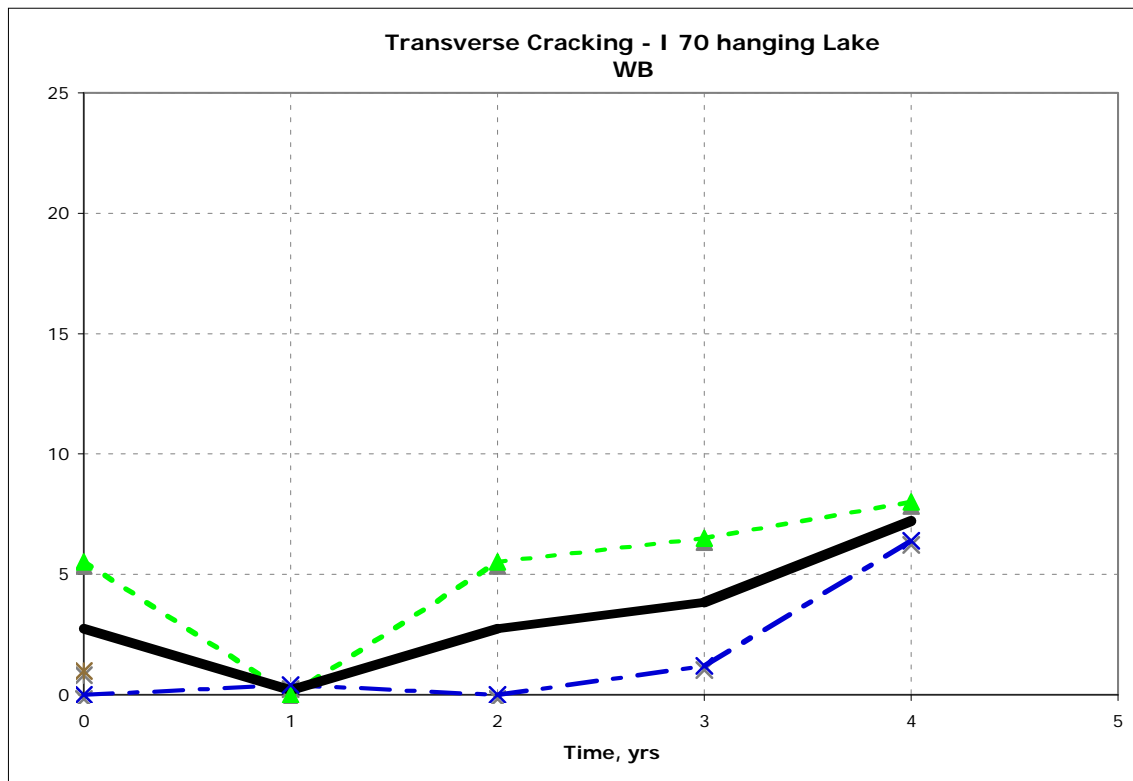
Figure 32. Transverse Cracking /500 ft Section for Thin SMA on I-70, Hanging Lake

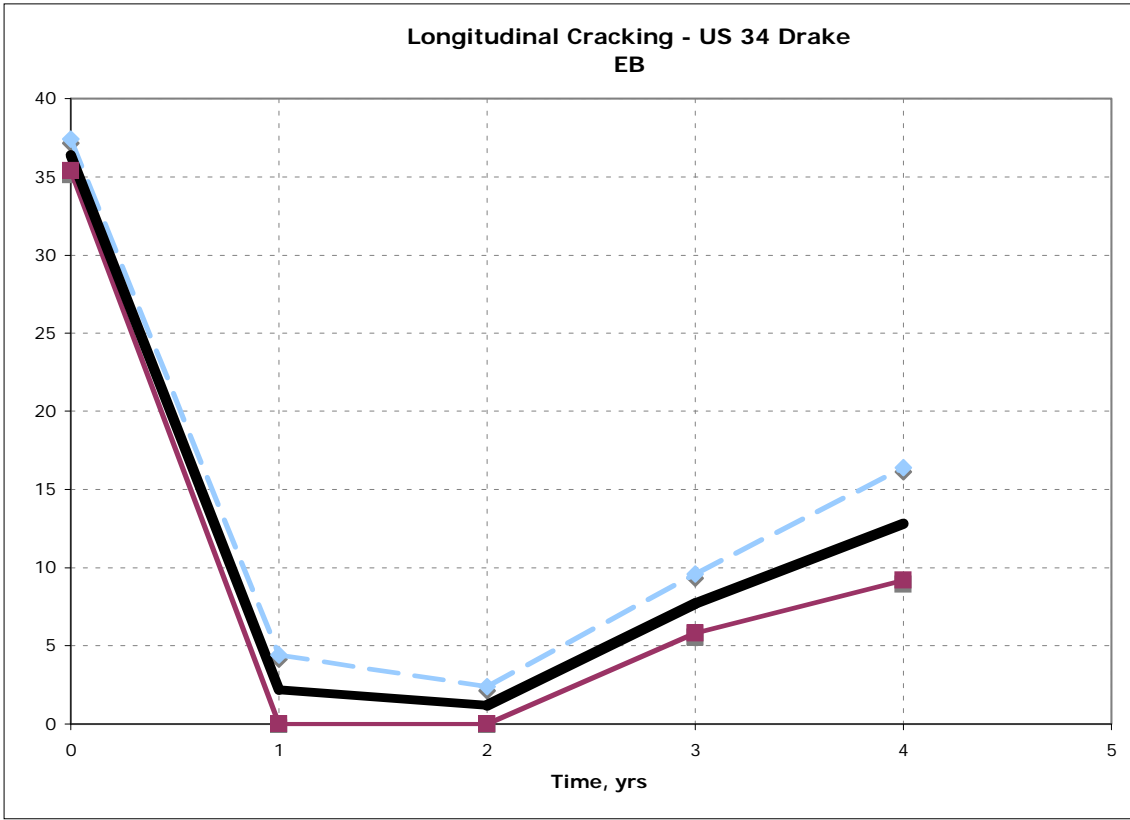
The test sections on US 34 at Drake include two evaluation sections in the eastbound and two sections in the westbound direction. Results of condition surveys are shown on Figures 33 through 36. Average condition is shown as the solid bold line on each figure.

Figure 33. Longitudinal Cracking /500 ft Section for US 34, Drake

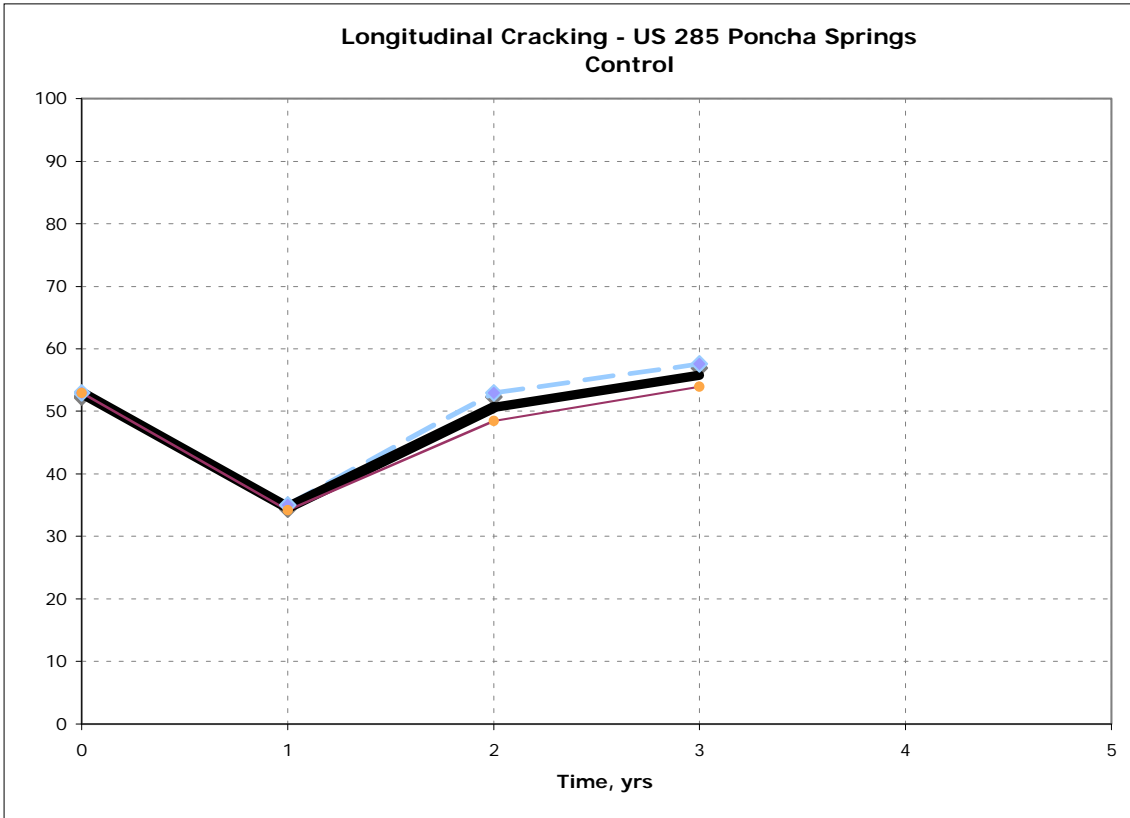
The test sections on US 285 near Poncha Springs and on Poncha Pass include a total of twenty evaluation sections. Performance of these will be presented with respect to the three types of treatments evaluated. These treatments are a control section with no chip seal, a chip seal with no fog seal applied, and a chip seal with a fog seal applied. These treatments were applied at the top of Poncha Pass and below the pass at the Arkansas River near Poncha Springs. Performance for these test sections is presented separately for the “Pass” and the “Springs” because of the potential differences in performance. Average values shown in the figures are for each of two control sections, two no fog seal sections and six fog sealed sections. Results of these condition surveys are shown on Figures 39 through 50. Average condition is shown as the solid bold line on each figure.

Figure 39. Longitudinal Cracking /500 ft Section for Control Sections on US 285, Poncha Springs

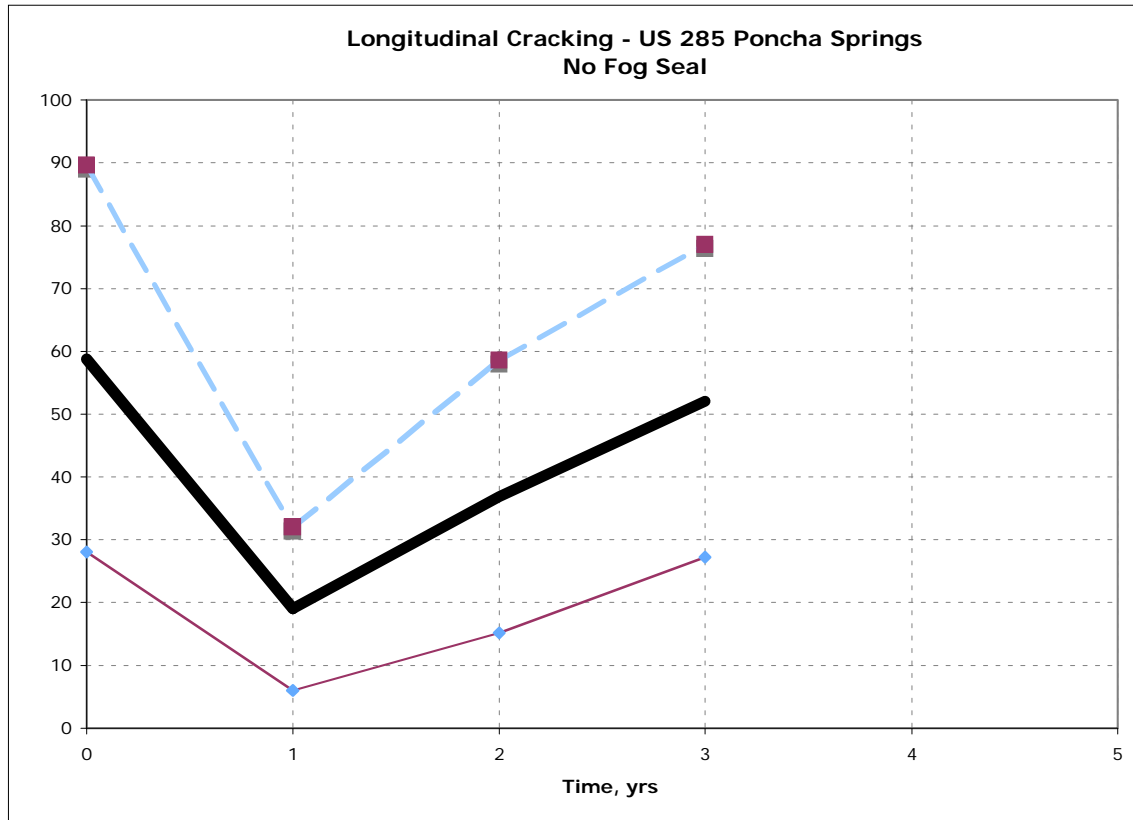
Figure 41. Longitudinal Cracking /500 ft Section for No Fog Sections on US 285, Poncha Springs

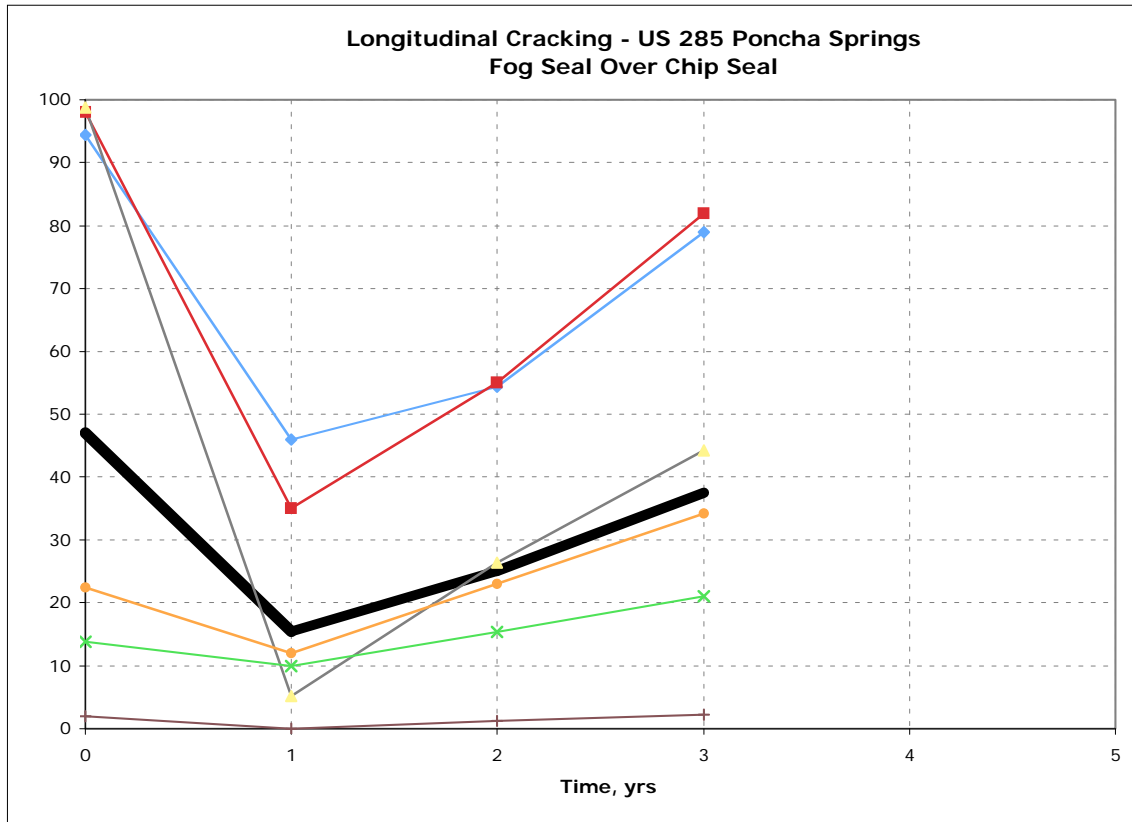
Figure 43. Longitudinal Cracking /500 ft Section for Fog Seal Sections on US 285, Poncha Springs

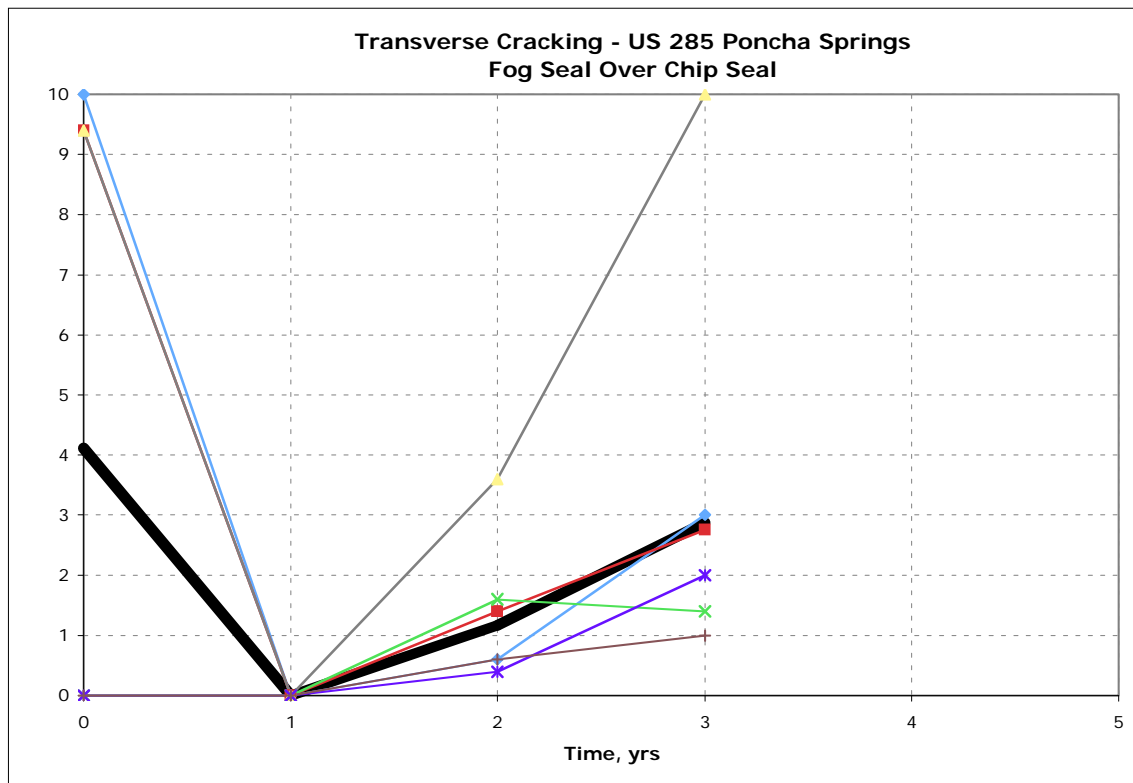
Figure 44. Transverse Cracking /500 ft Section for Fog Seal Sections on US 285, Poncha Springs

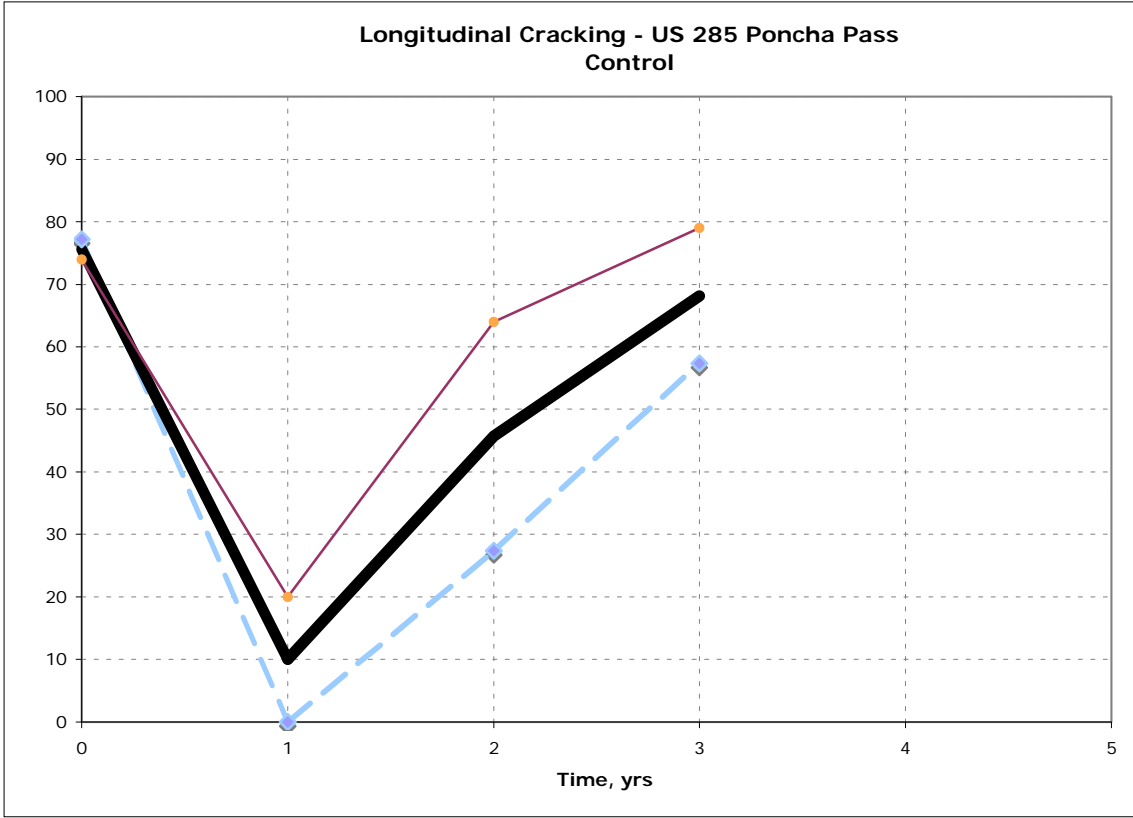
Figure 45. Longitudinal Cracking /500 ft Section for Control Sections on US 285, Poncha Pass

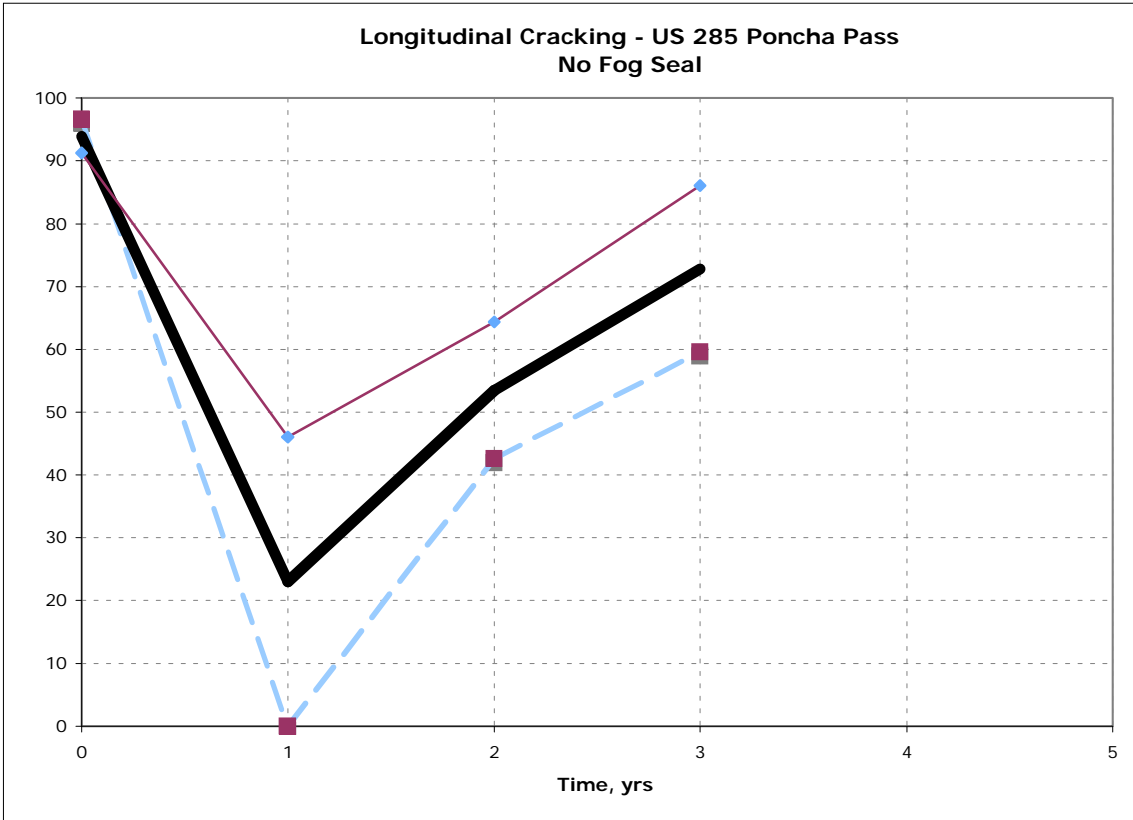
Figure 47. Longitudinal Cracking /500 ft Section for No Fog Seal Sections on US 285, Poncha Pass

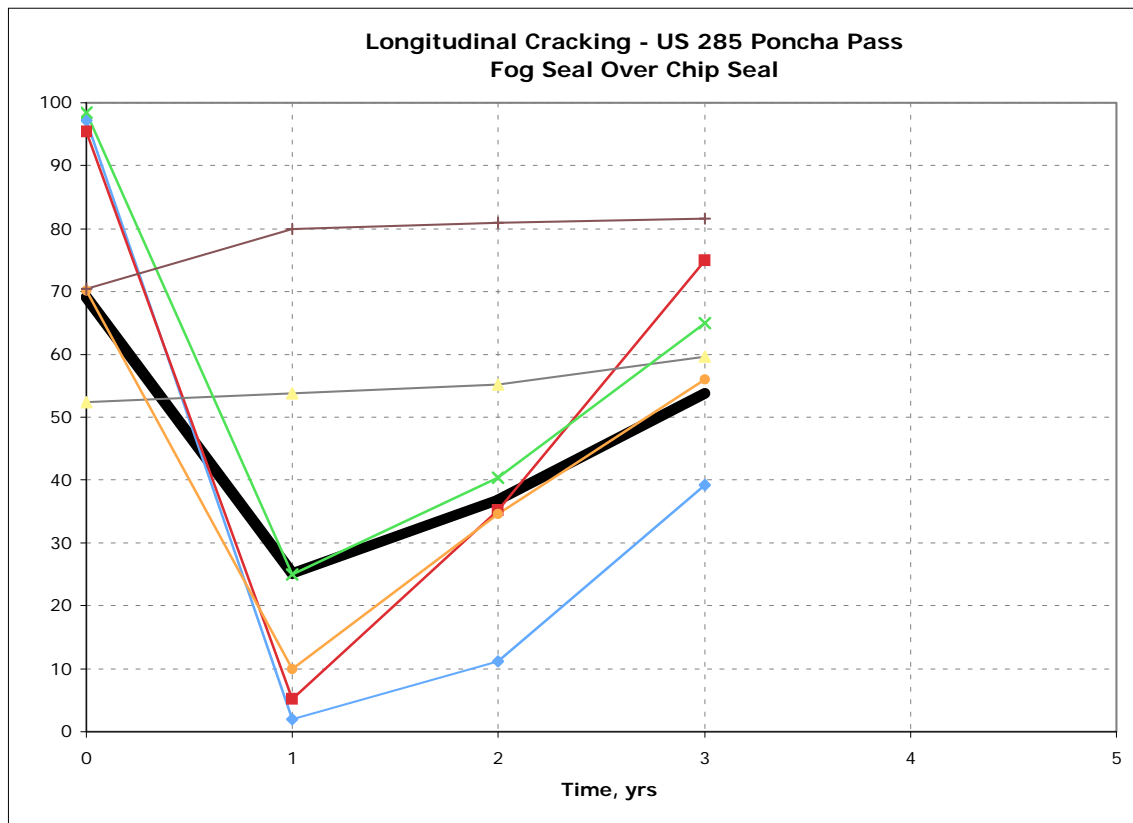
Figure 49. Longitudinal Cracking /500 ft Section for Fog Sealed Sections on US 285, Poncha Pass

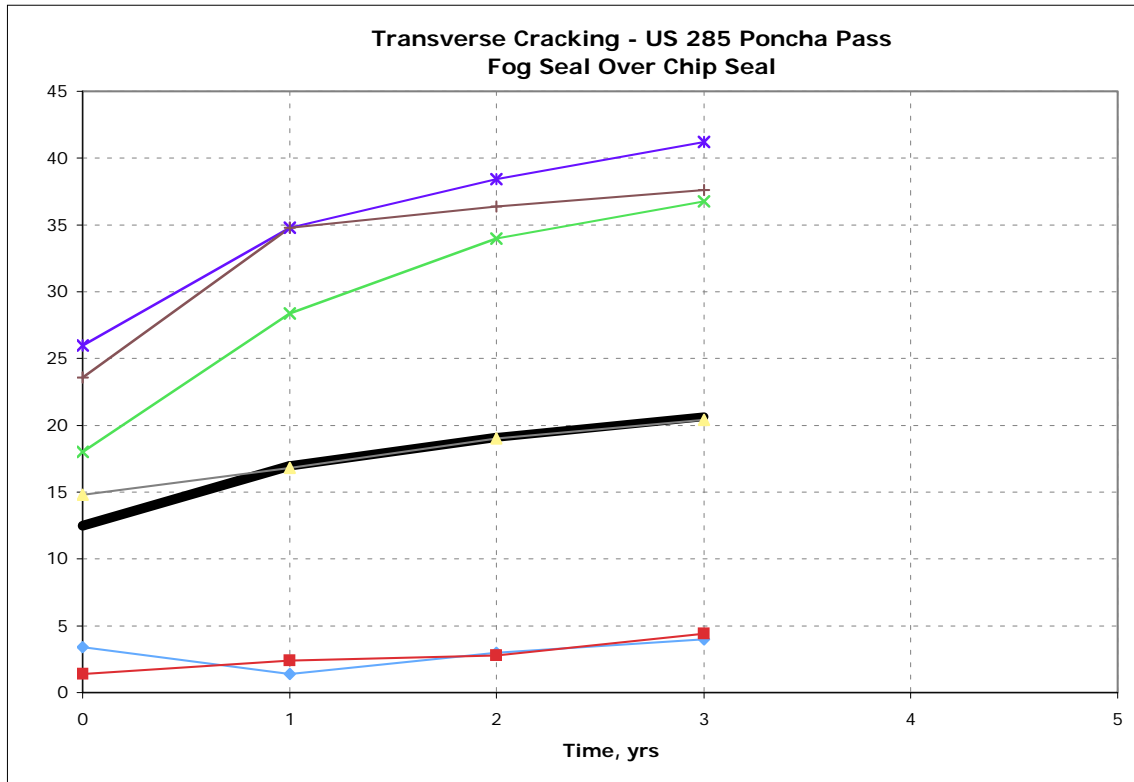
Figure 50. Transverse Cracking /500 ft Section for Fog Sealed Sections on US 285, Poncha Pass

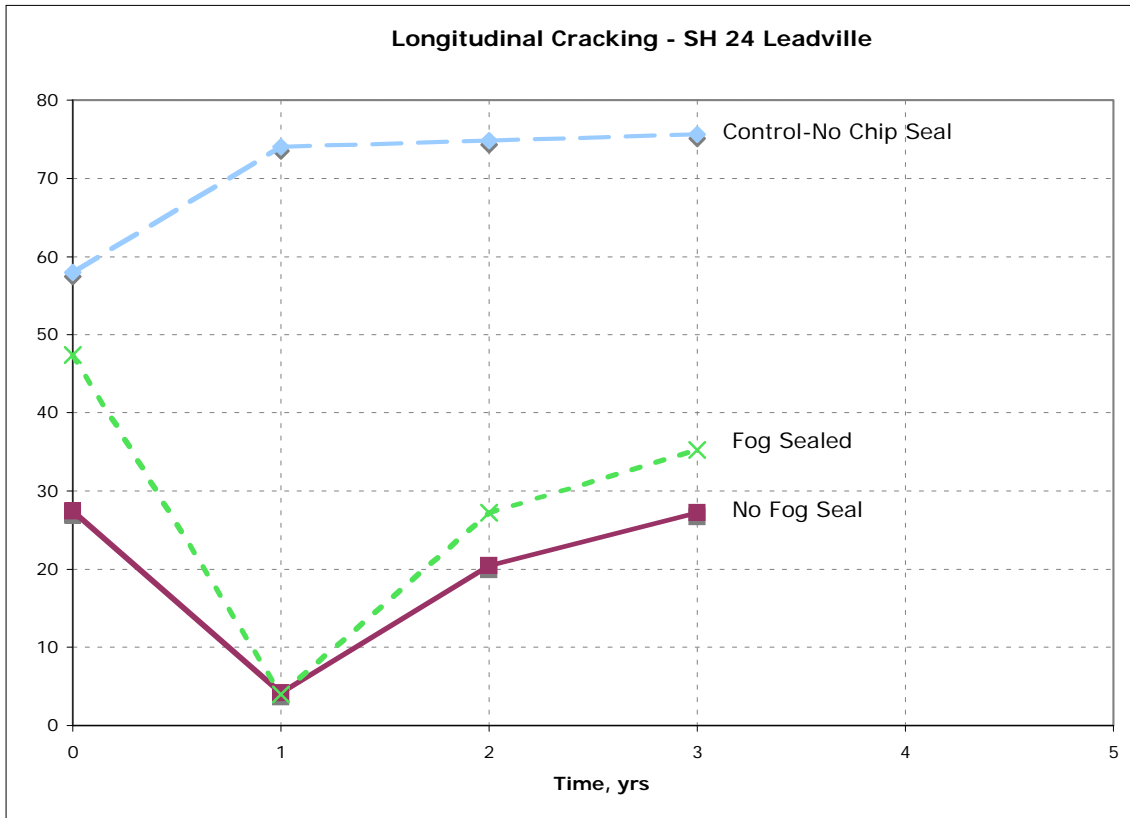
Figure 51. Longitudinal Cracking /500 ft Section for Test Sections on SH 24, Leadville

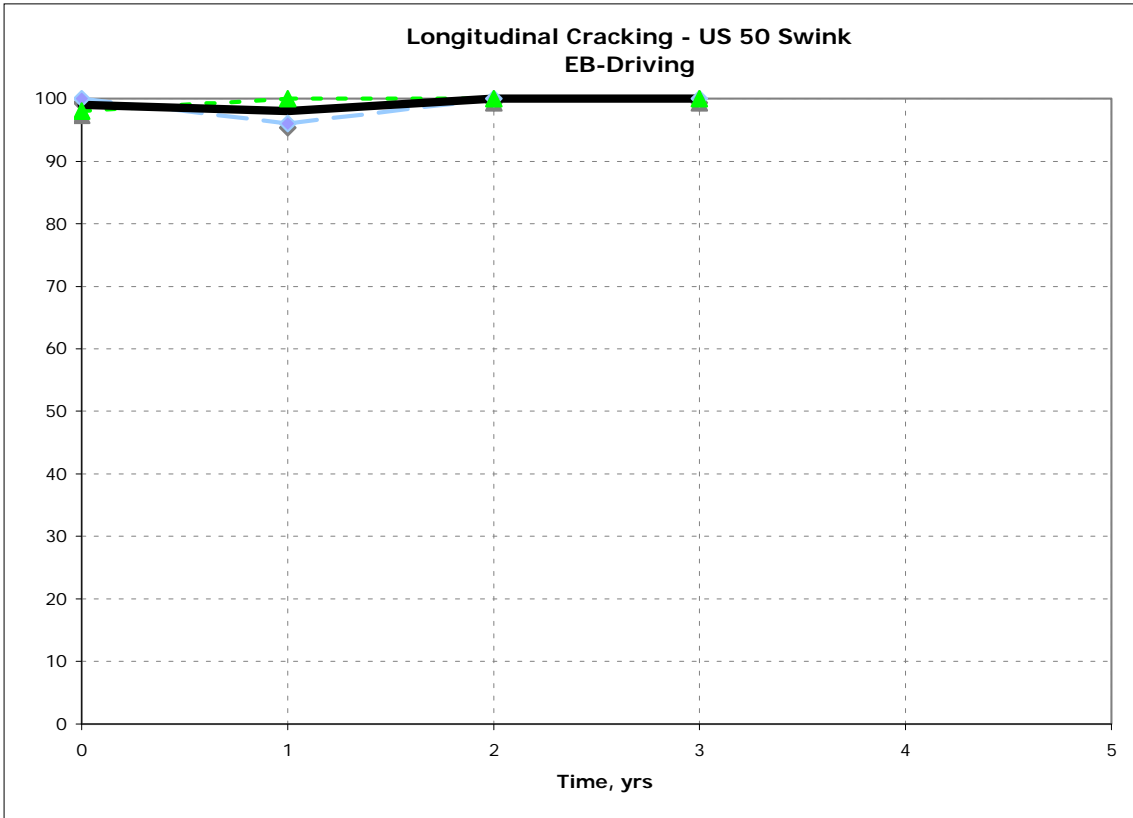
There are eight evaluation sections on US 50 near Swink, two each in the eastbound and westbound driving lanes and two each in the east and westbound passing lanes. Results of performance evaluations are shown in Figures 53 through 60 for each section. Average condition is shown as the solid bold line on each figure.

Figure 53. Longitudinal Cracking /500 ft Section for EB Driving Lane-US 50, Swink

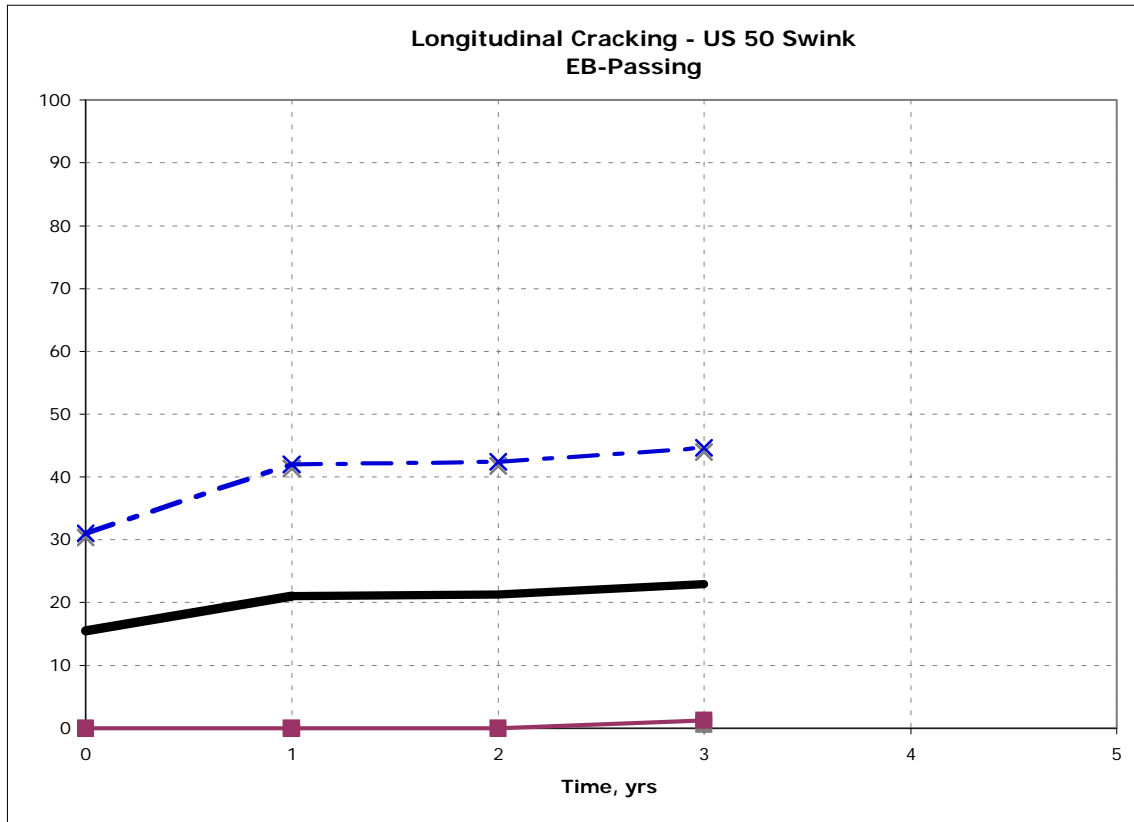
Figure 55. Longitudinal Cracking /500 ft Section for EB Passing Lane-US 50, Swink

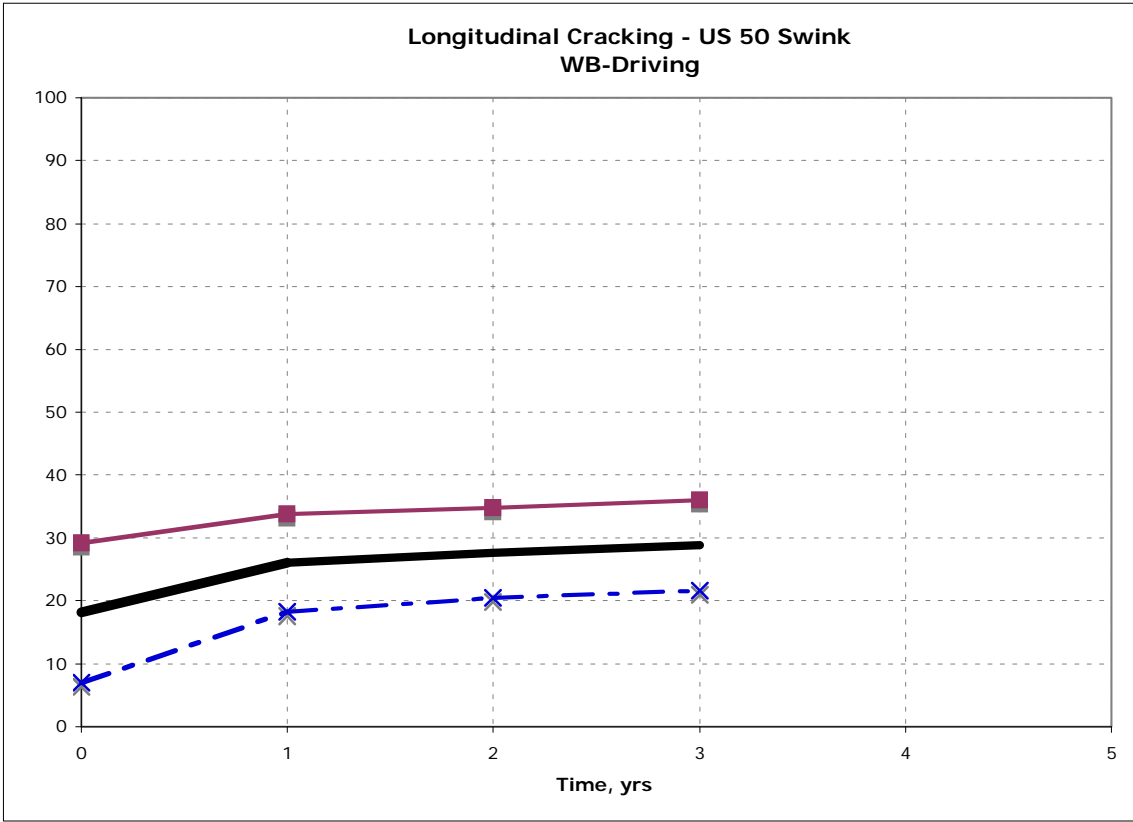
Figure 57. Longitudinal Cracking /500 ft Section for WB Driving Lane-US 50, Swink

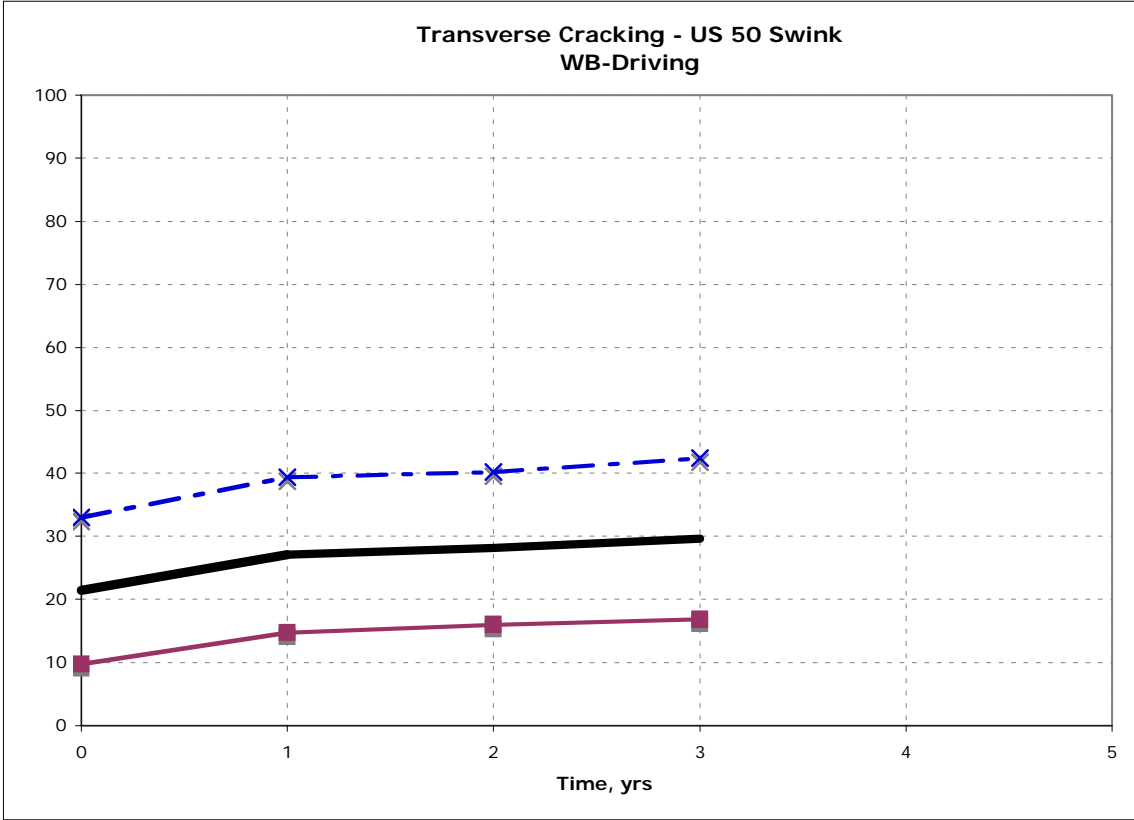
Figure 58. Transverse Cracking /500 ft Section for WB Driving Lane-US 50, Swink

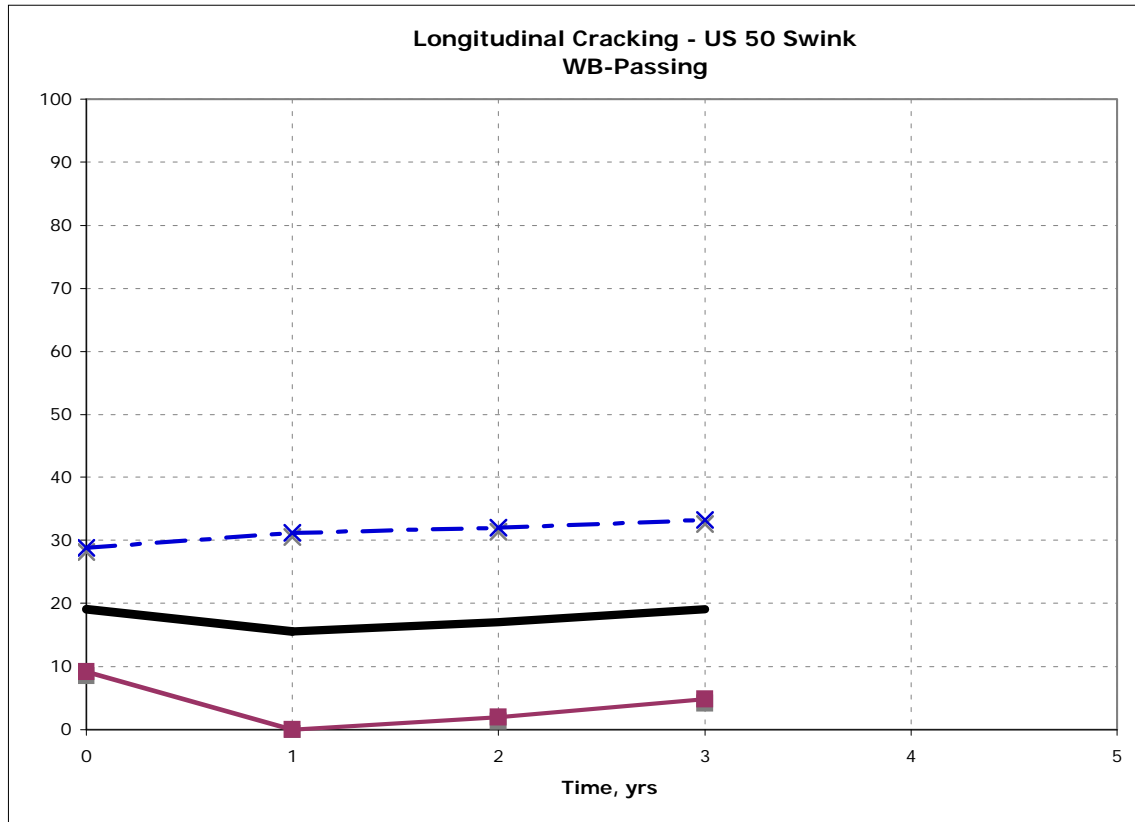
Figure 59. Longitudinal Cracking /500 ft Section for WB Passing Lane-US 50, Swink

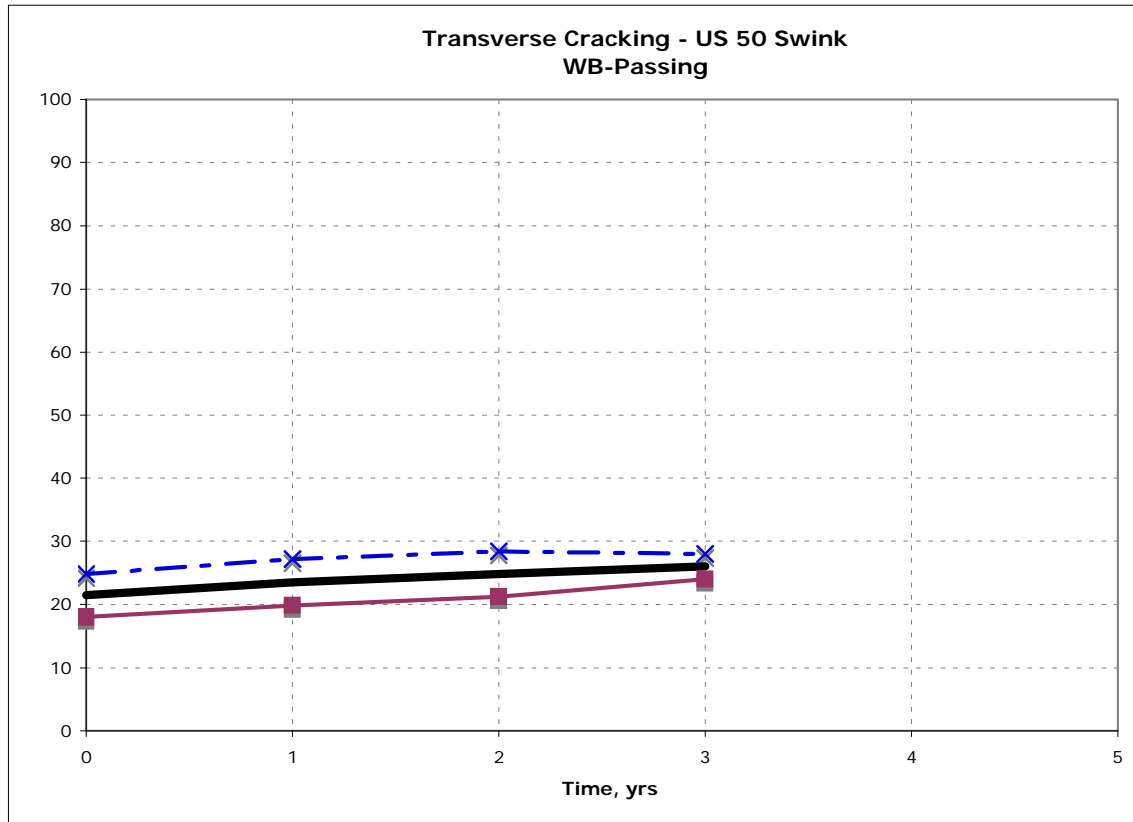
Figure 60. Transverse Cracking /500 ft Section for WB Passing Lane-US 50, Swink

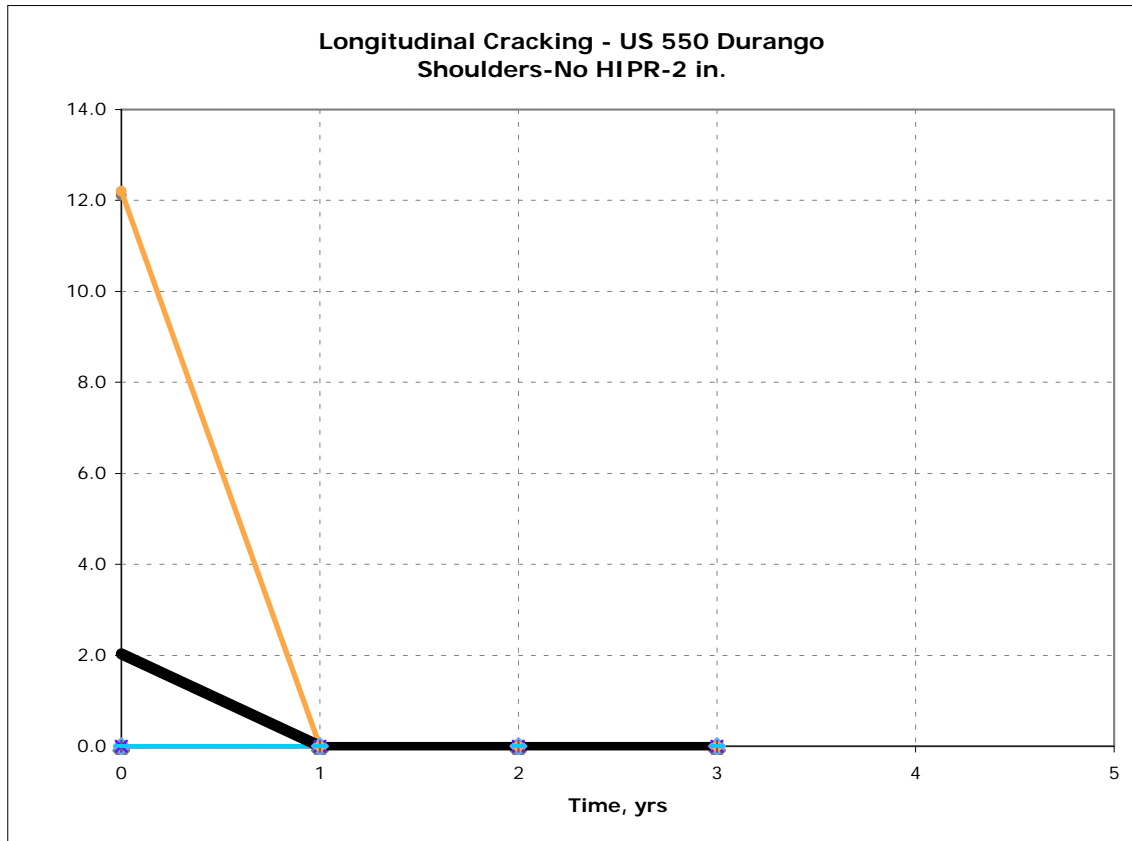
Figure 66. Longitudinal Cracking/500 ft Section for US 550, Durango – Shoulders, No HIPR, 2 in.
