**Report No. CDOT-2010-3
Final Report**

Evaluation of the Performance, Cost- Effectiveness, and Timing of Various Pavement Preservation Treatments

Scott Shuler, Ph. D., P. E.

**COLORADO DEPARTMENT OF TRANSPORTATION
DTD APPLIED RESEARCH AND INNOVATION BRANCH**

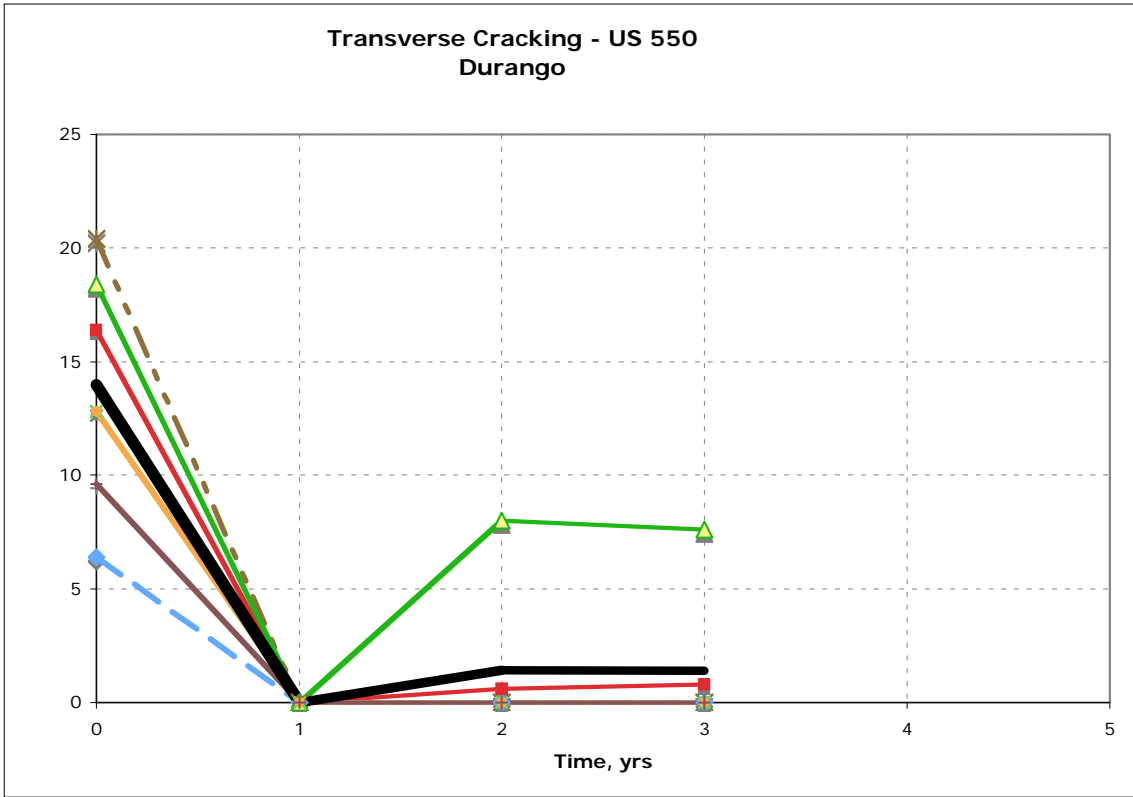
Figure 67. Transverse Cracking/500 ft Section for US 550, Durango – Shoulders, No HIPR, 2 in.

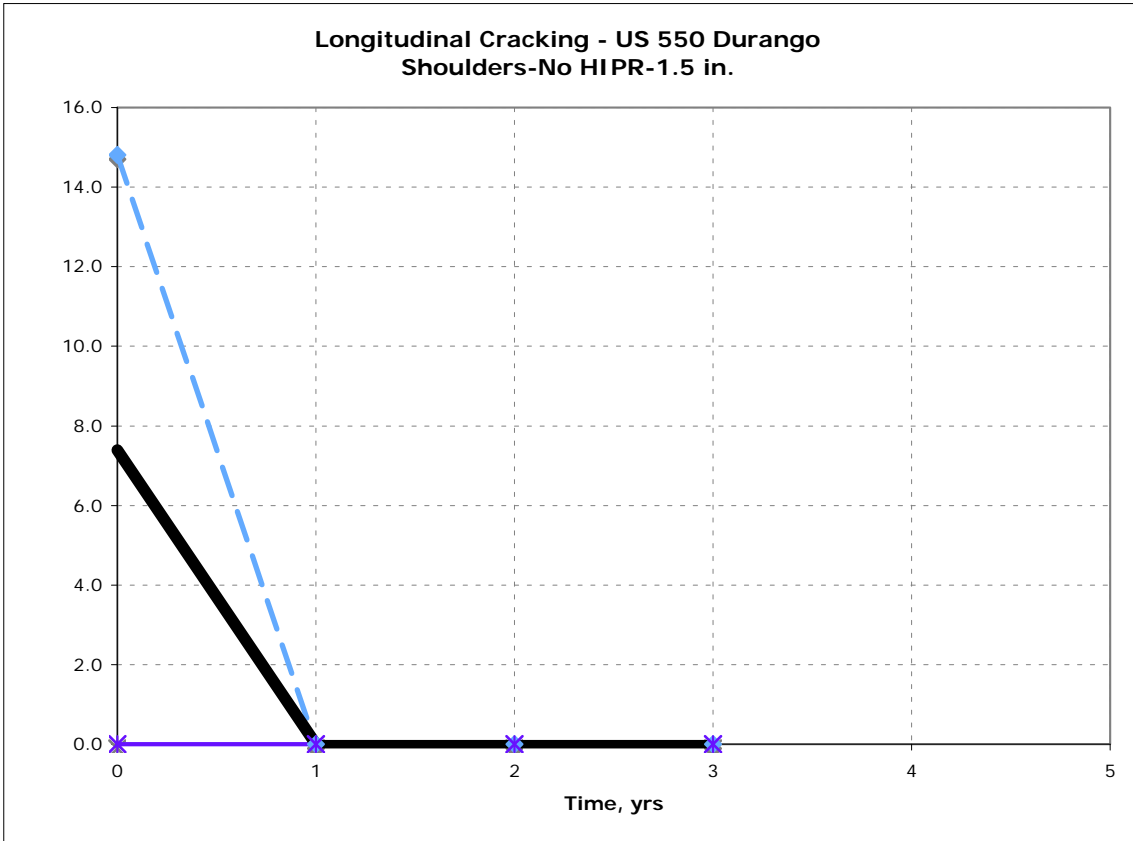
Figure 69. Longitudinal Cracking/500 ft Section for US 550, Durango – Shoulders, No HIPR, 1.5 in.

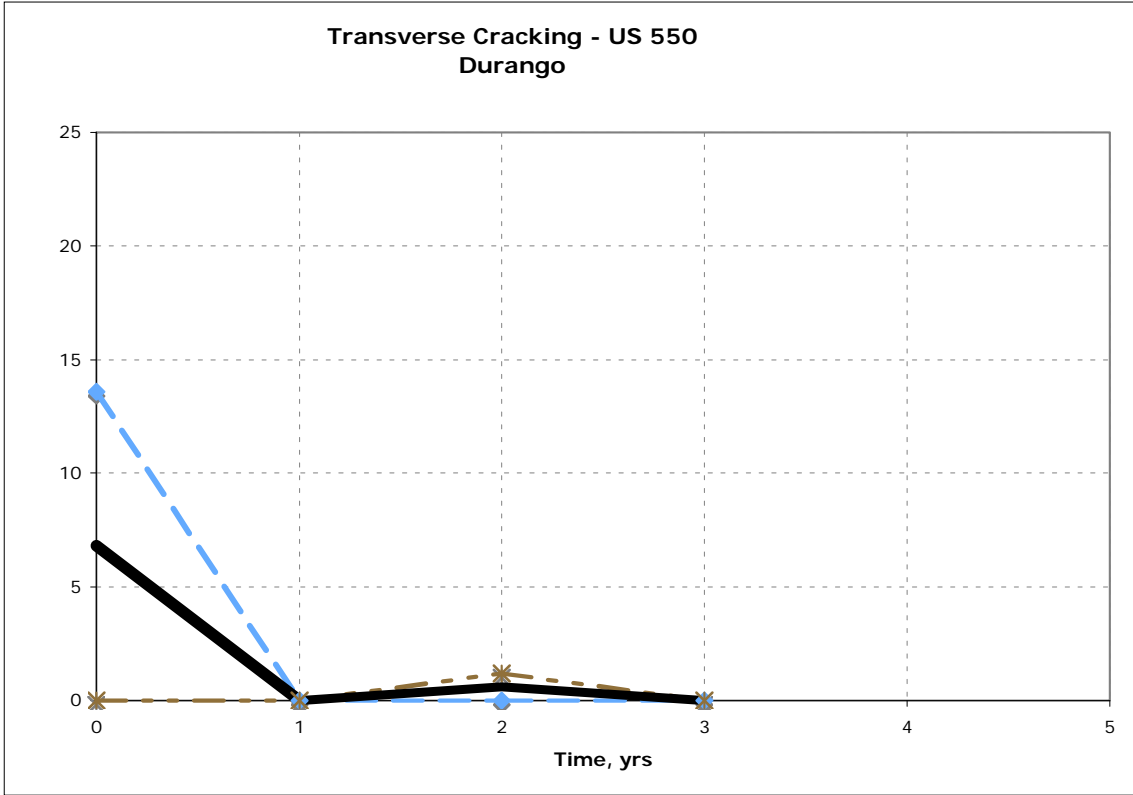
Figure 70. Transverse Cracking/500 ft Section for US 550, Durango – Shoulders, No HIPR, 1.5 in.

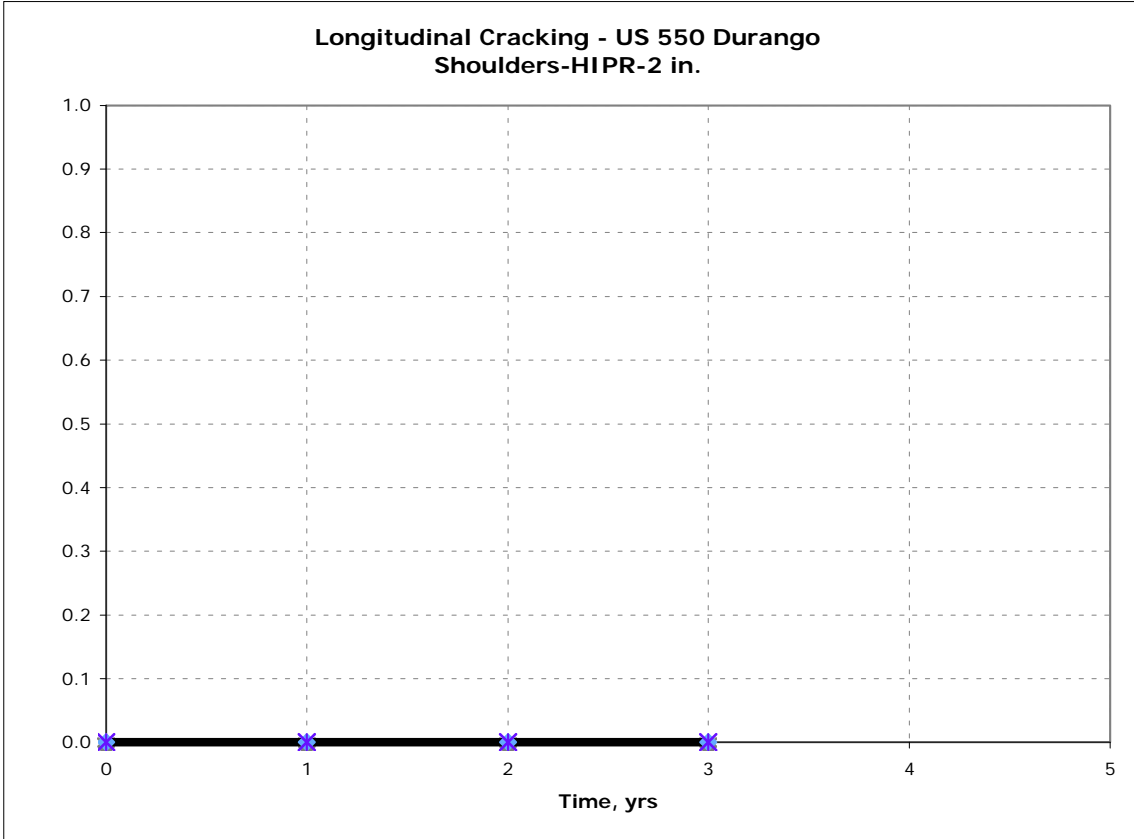
Figure 71. Longitudinal Cracking/500 ft Section for US 550, Durango – Shoulders, HIPR, 2 in.

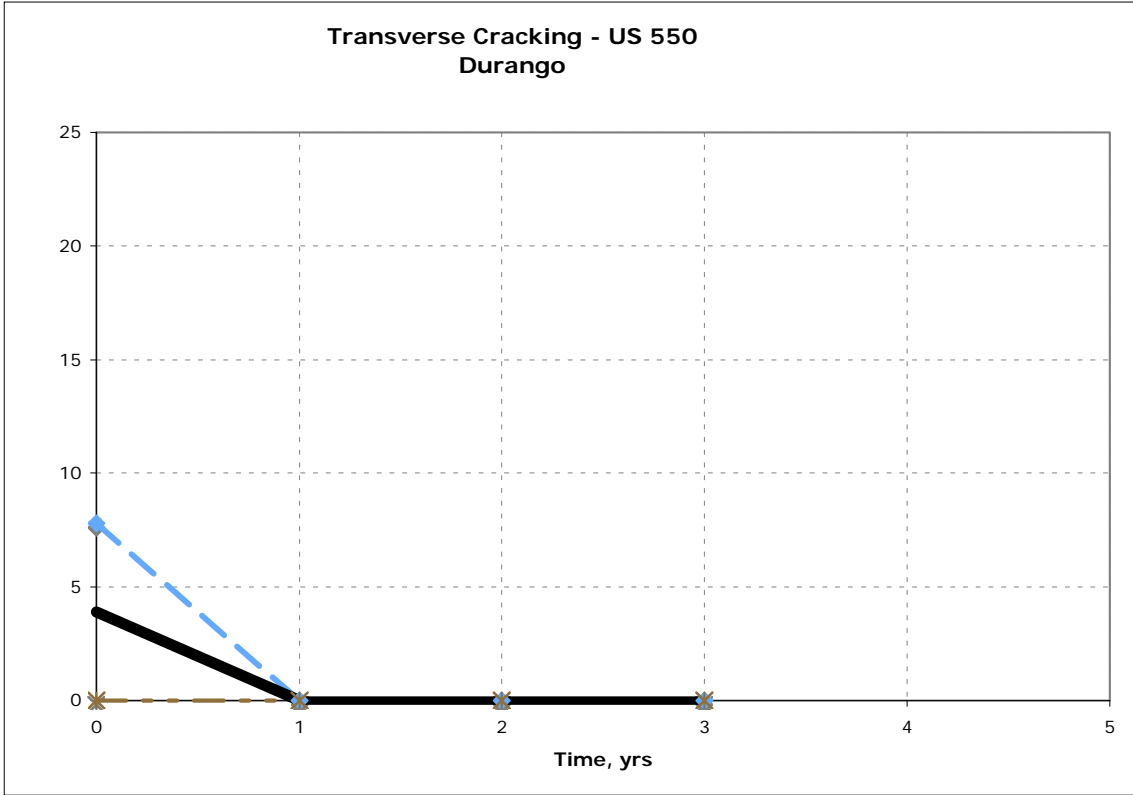
Figure 72. Transverse Cracking/500 ft Section for US 550, Durango – Shoulders, HIPR, 2 in.

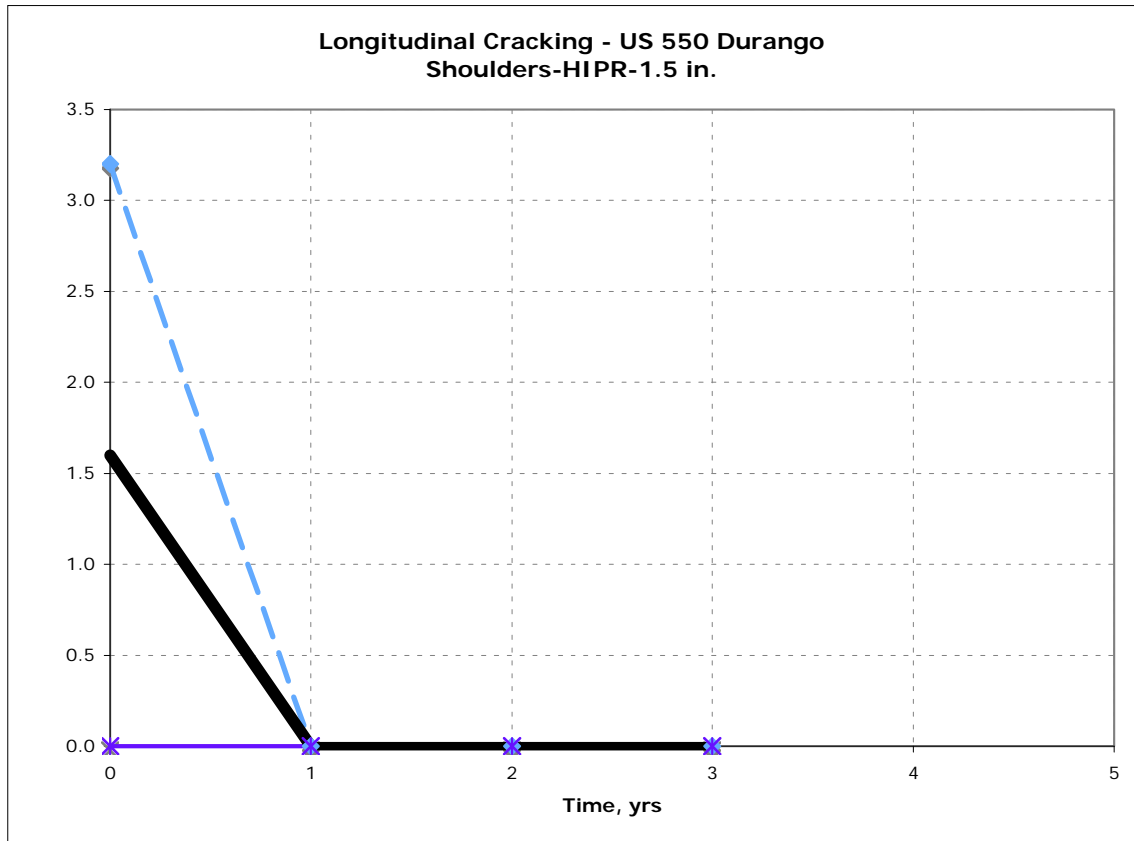
Figure 73. Longitudinal Cracking/500 ft Section for US 550, Durango – Shoulders, HIPR, 1.5 in.

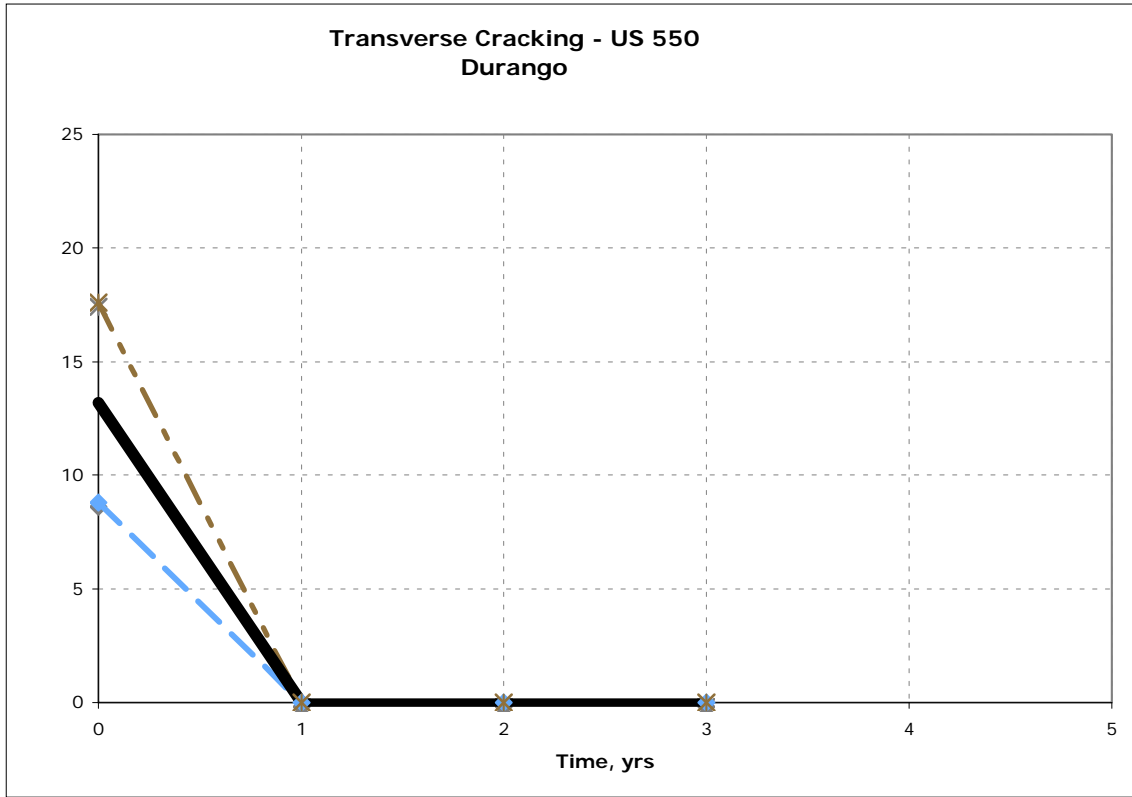
Figure 74. Transverse Cracking/500 ft Section for US 550, Durango – Shoulders, HIPR, 1.5 in.

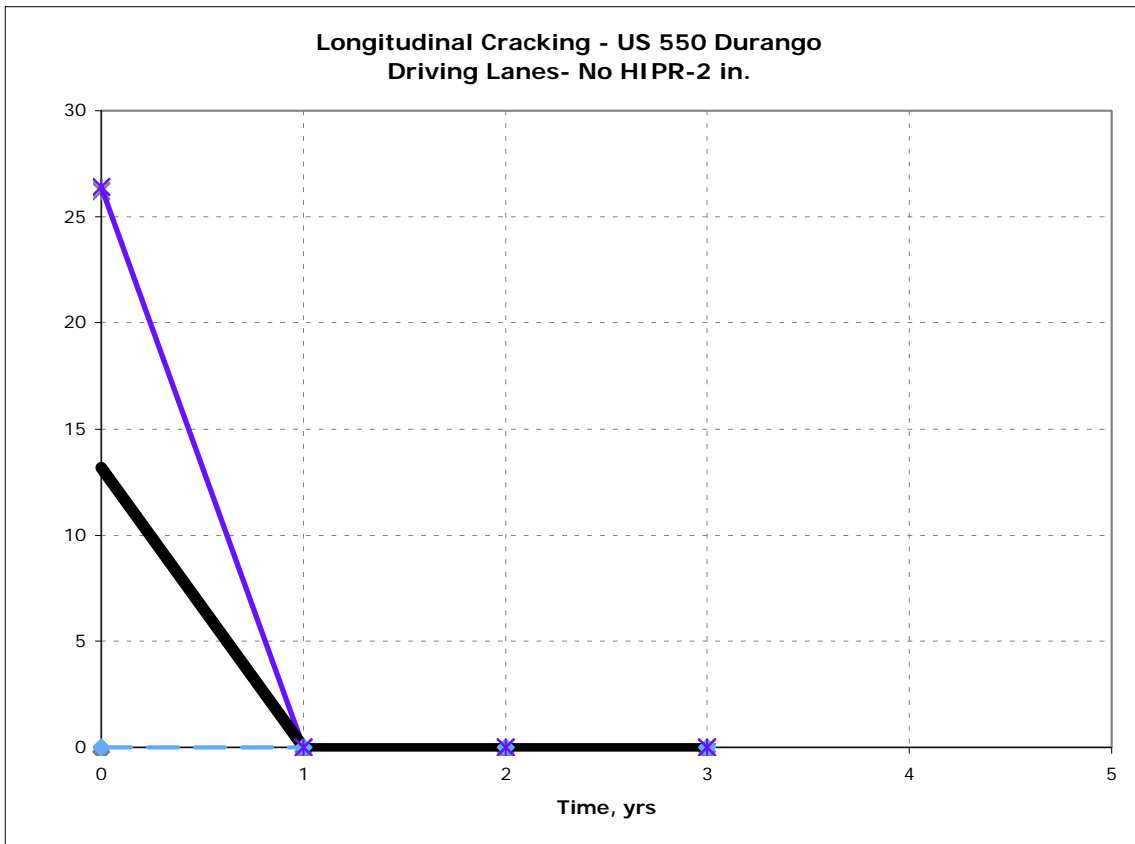
Figure 75. Longitudinal Cracking/500 ft Section for US 550, Durango – Driving Lanes, No HIPR, 2 in.

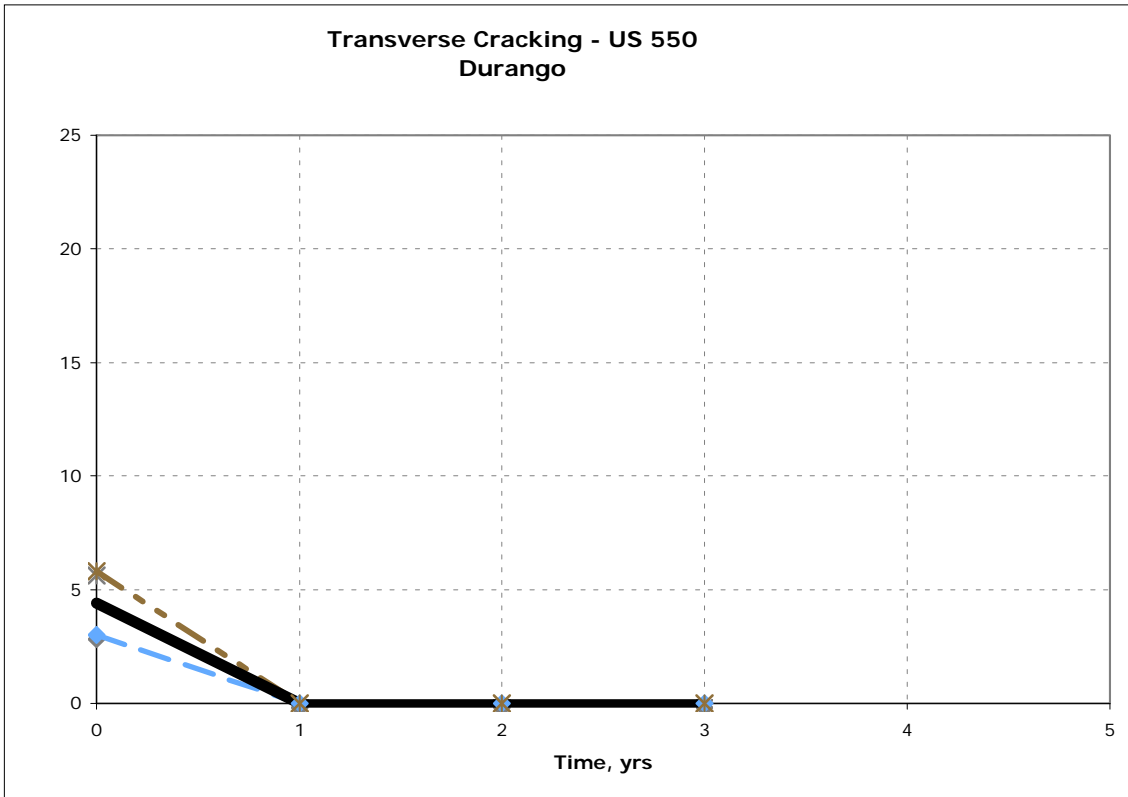
Figure 76. Transverse Cracking/500 ft Section for US 550, Durango – Driving Lanes, No HIPR, 2 in.

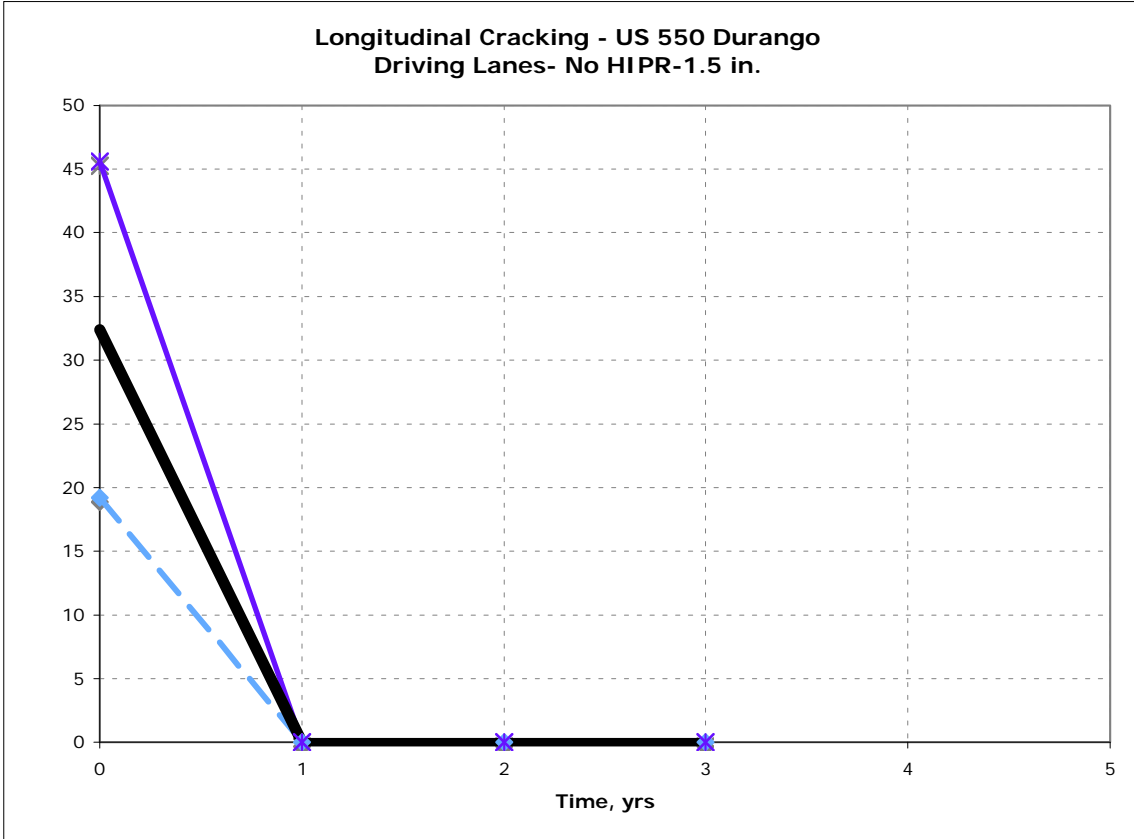
Figure 77. Longitudinal Cracking/500 ft Section for US 550, Durango – Driving Lanes, No HIPR, 1.5 in.

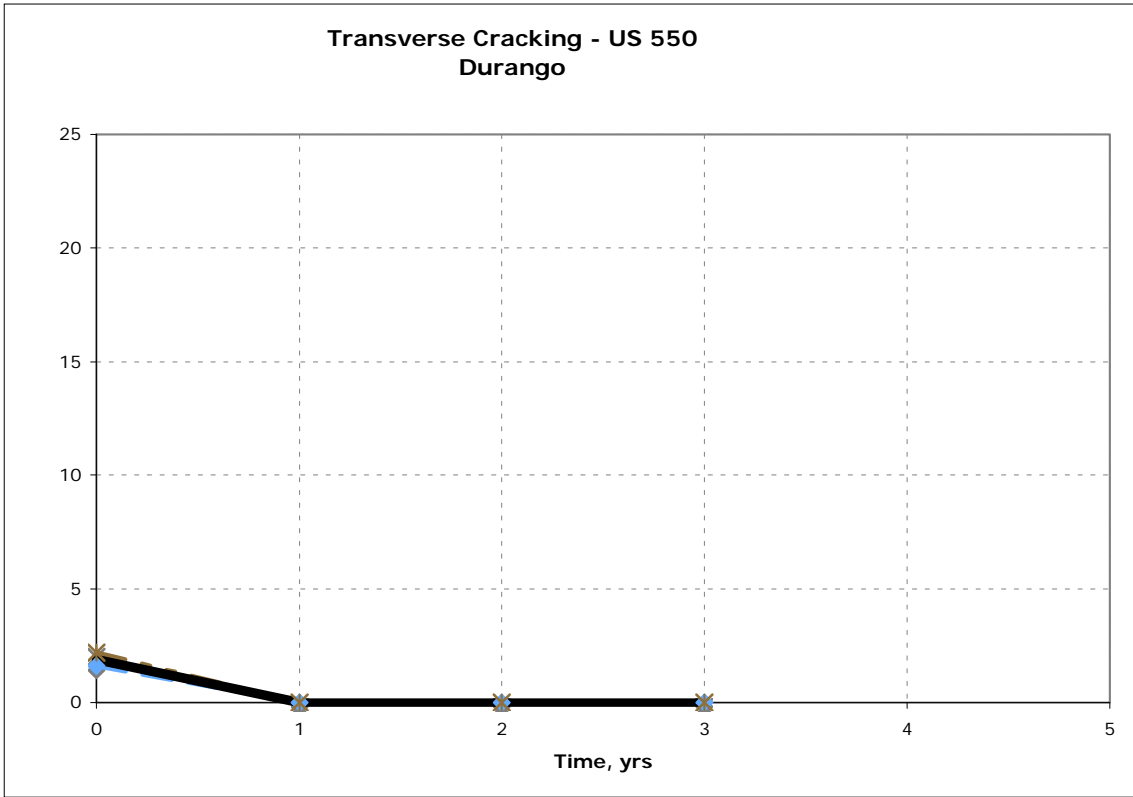
Figure 78. Transverse Cracking/500 ft Section for US 550, Durango – Driving Lanes, No HIPR, 1.5 in.

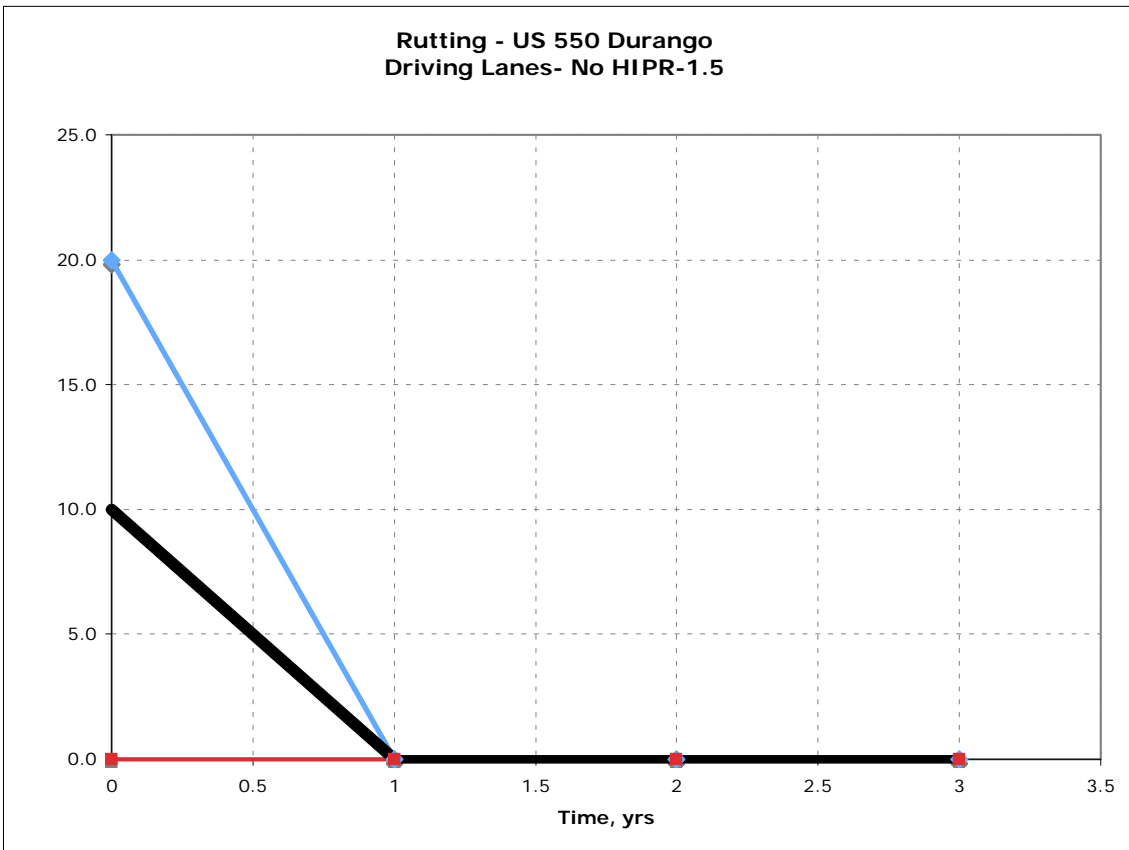
Figure 79. Rutting/500 ft Section for US 550, Durango – Driving Lanes, No HIPR, 1.5 in.

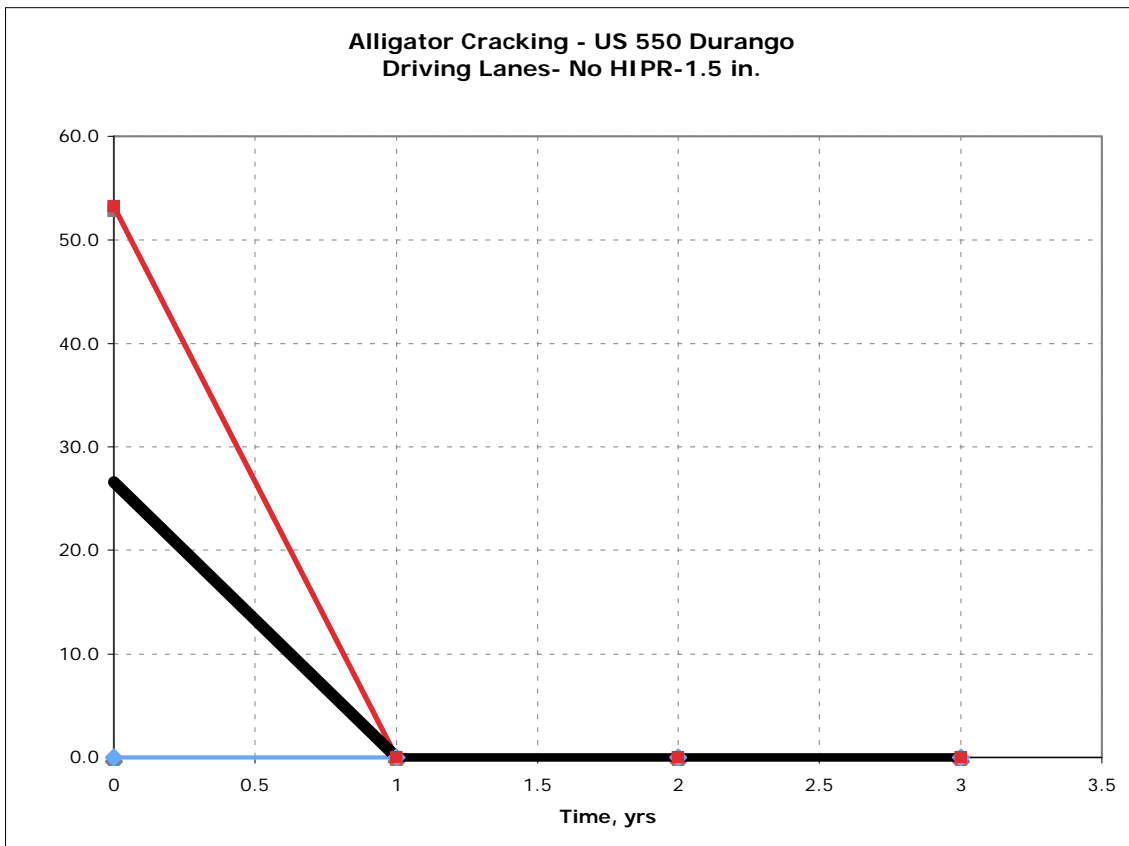
Figure 80. Alligator Cracking/500 ft Section for US 550, Durango – Driving Lanes, No HIPR, 1.5 in.

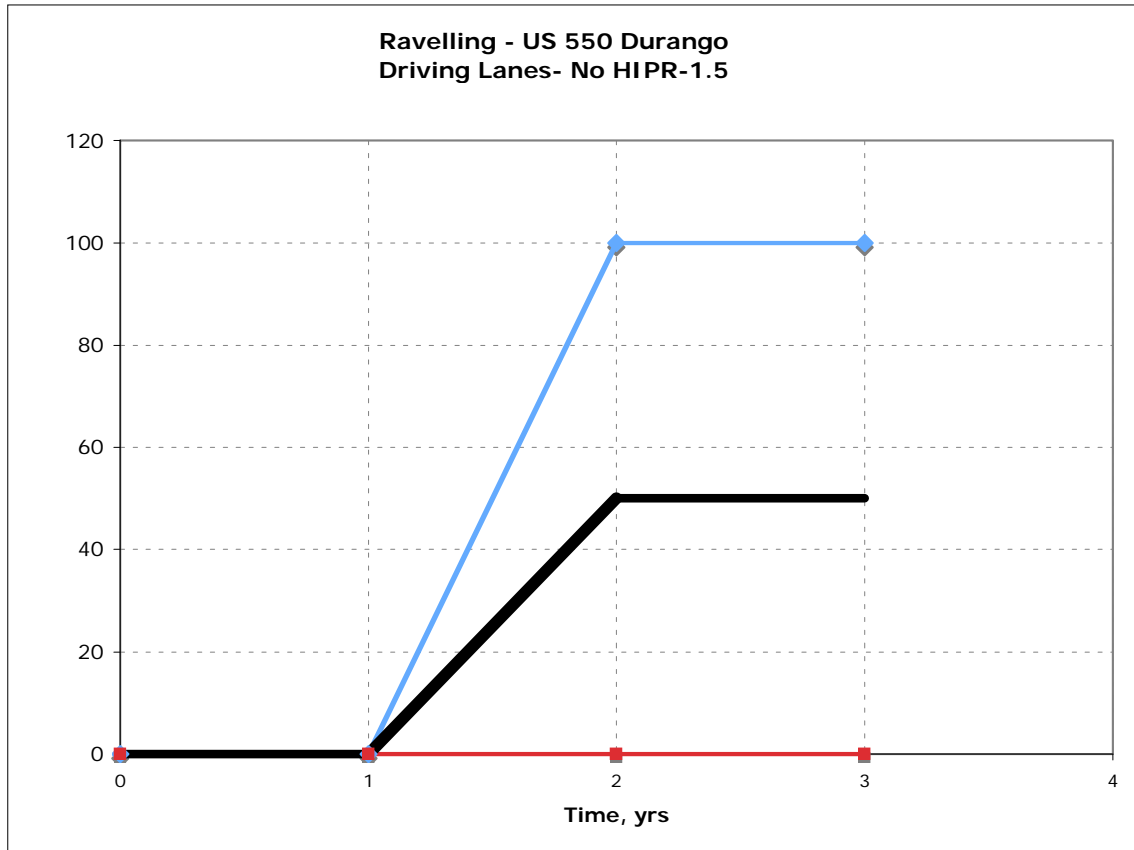
Figure 81. Ravelling/500 ft Section for US 550, Durango – Driving Lanes, No HIPR, 1.5 in.

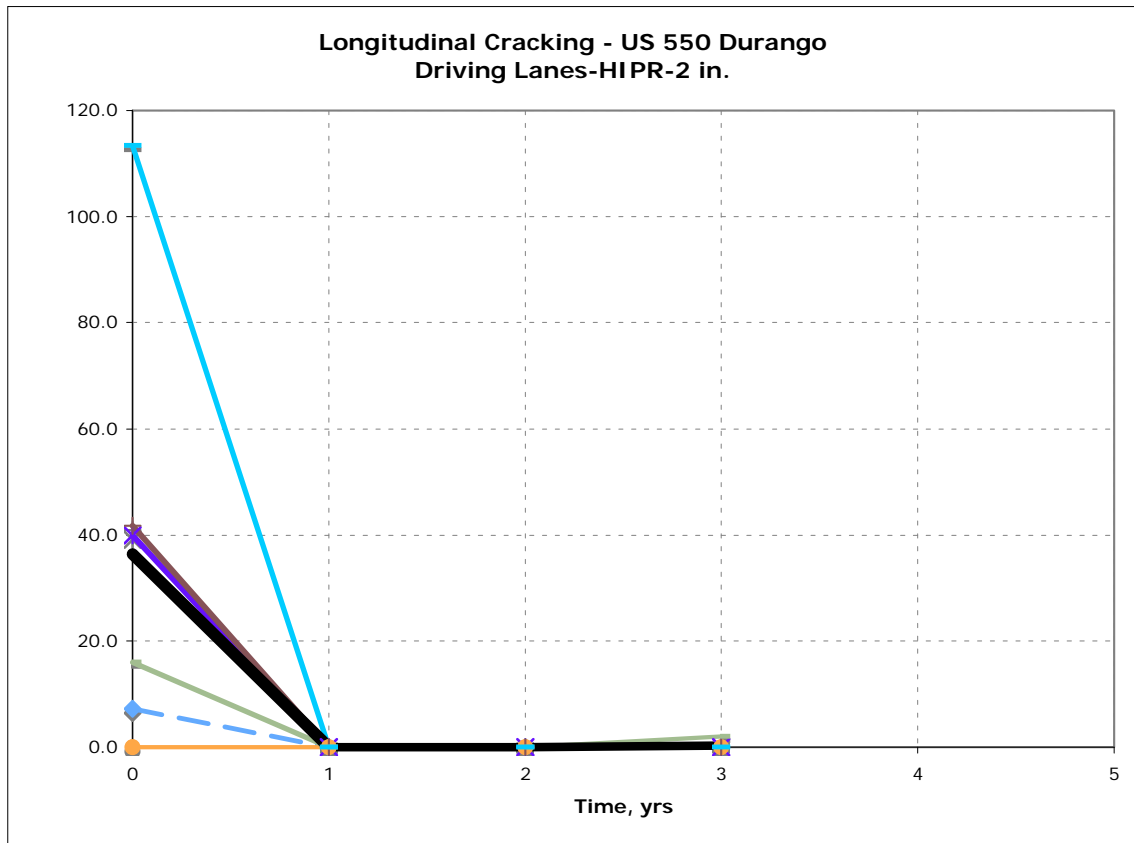
Figure 82. Longitudinal Cracking/500 ft Section for US 550, Durango – Driving Lanes, HIPR, 2 in.

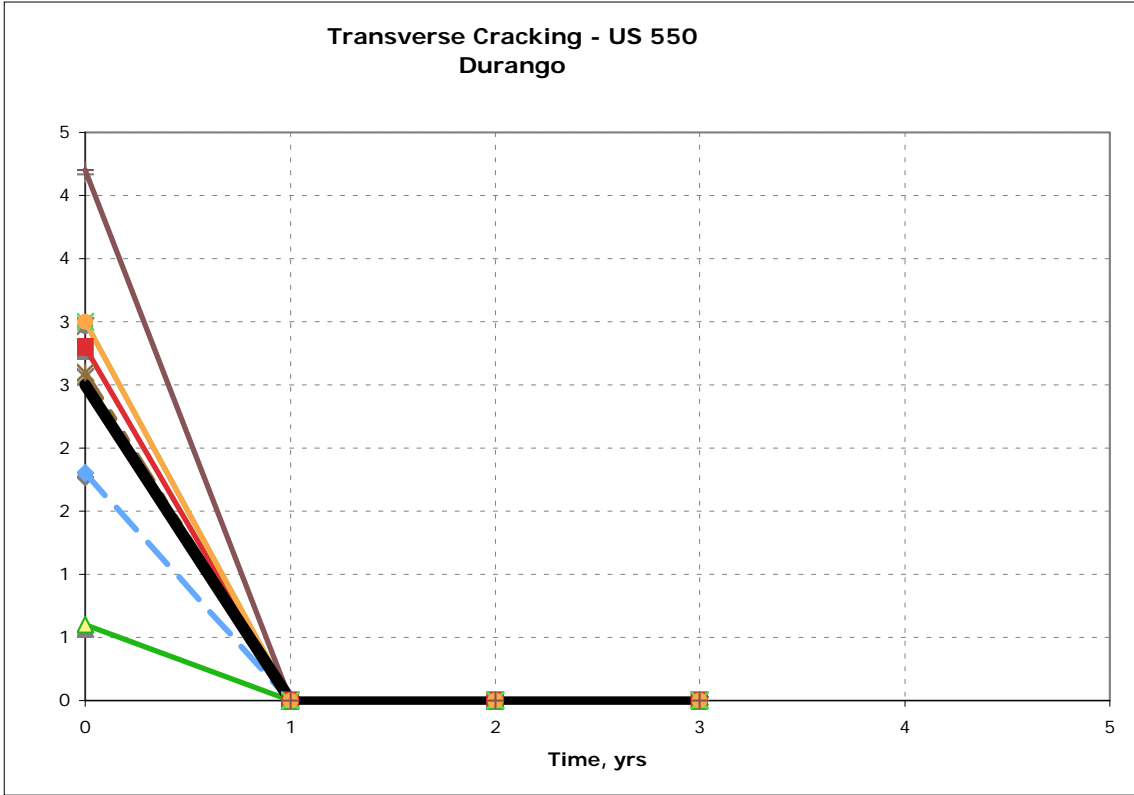
Figure 83. Transverse Cracking/500 ft Section for US 550, Durango – Driving Lanes, HIPR, 2 in.

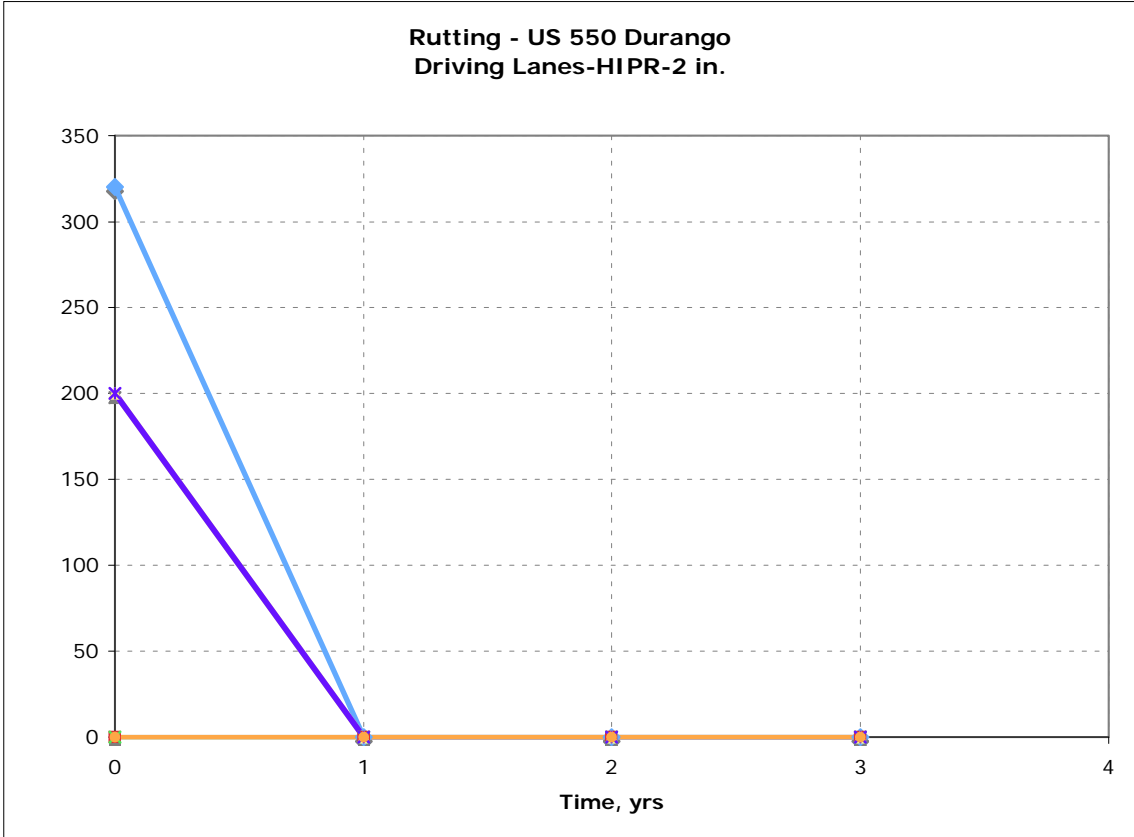
Figure 84. Rutting/500 ft Section for US 550, Durango – Driving Lanes, HPR, 2 in.

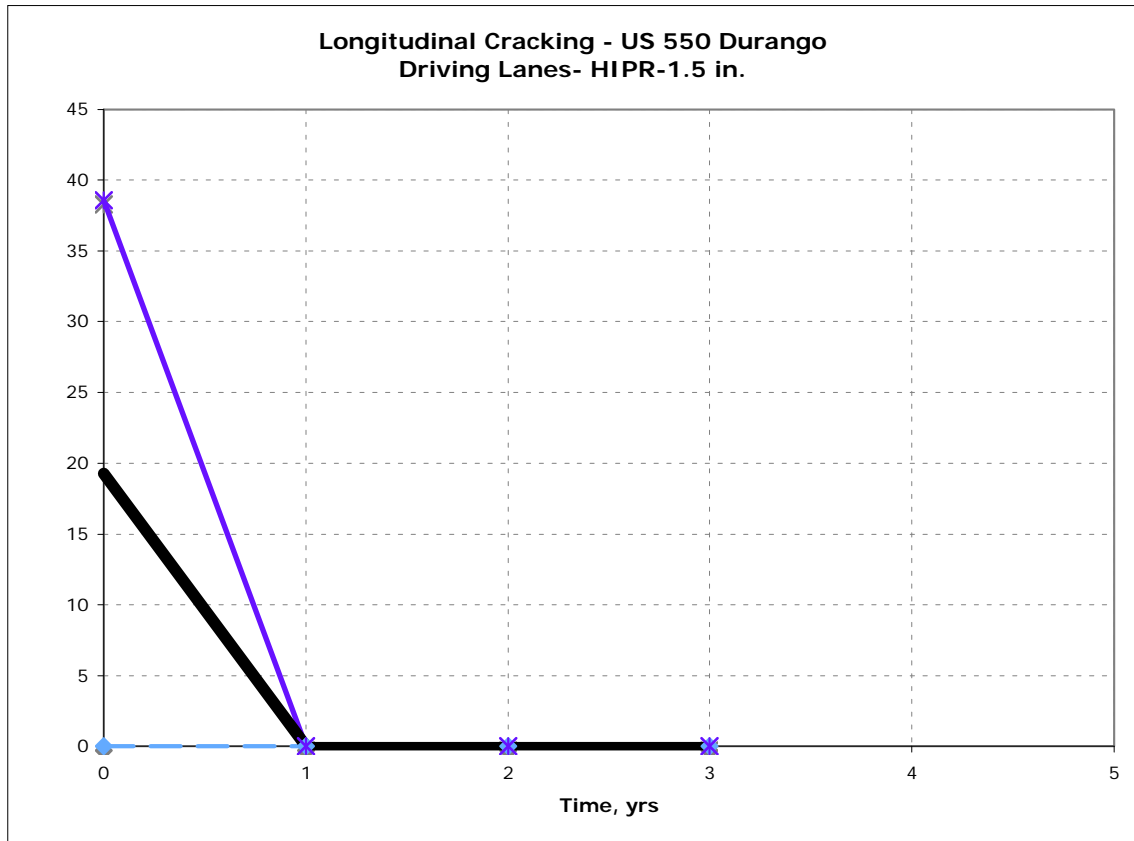
Figure 85. Longitudinal Cracking/500 ft Section for US 550, Durango – Driving Lanes, HIPR, 1.5 in.

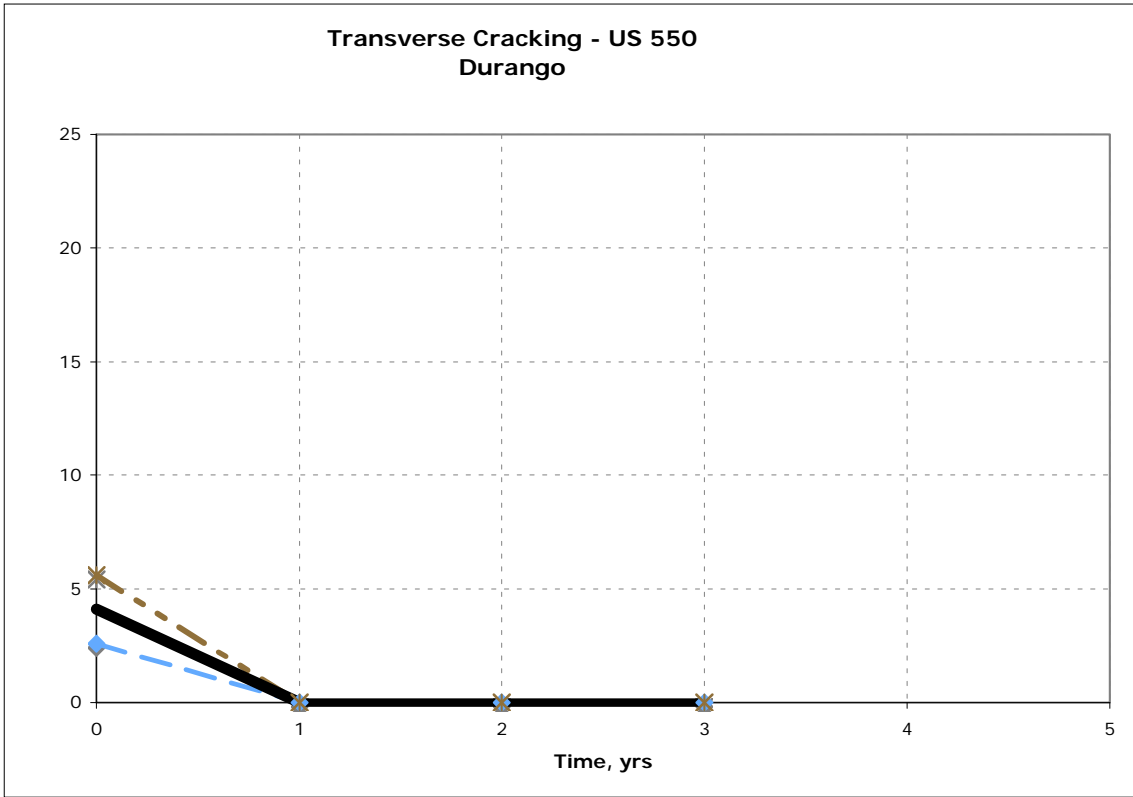
Figure 86. Transverse Cracking/500 ft Section for US 550, Durango – Driving Lanes, HIPR, 1.5 in.

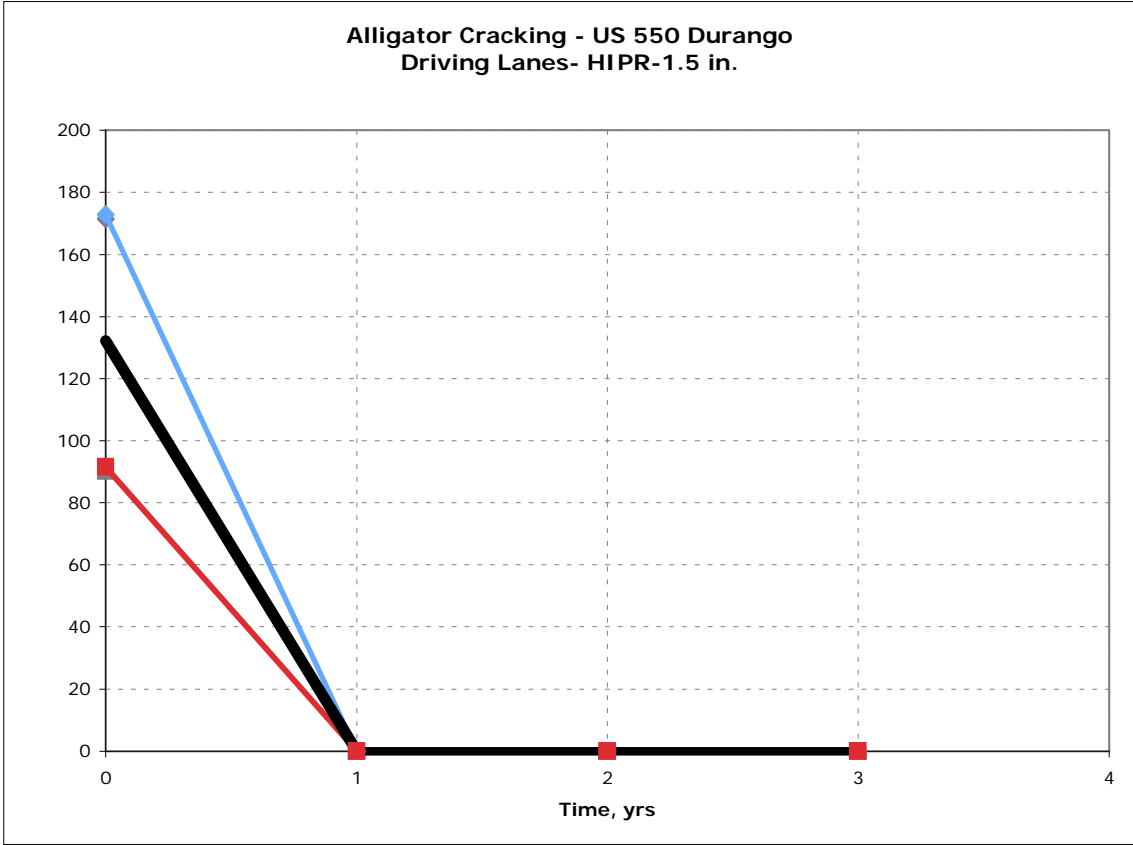
Figure 87. Alligator Cracking/500 ft Section for US 550, Durango – Driving Lanes, HIPR, 1.5 in.

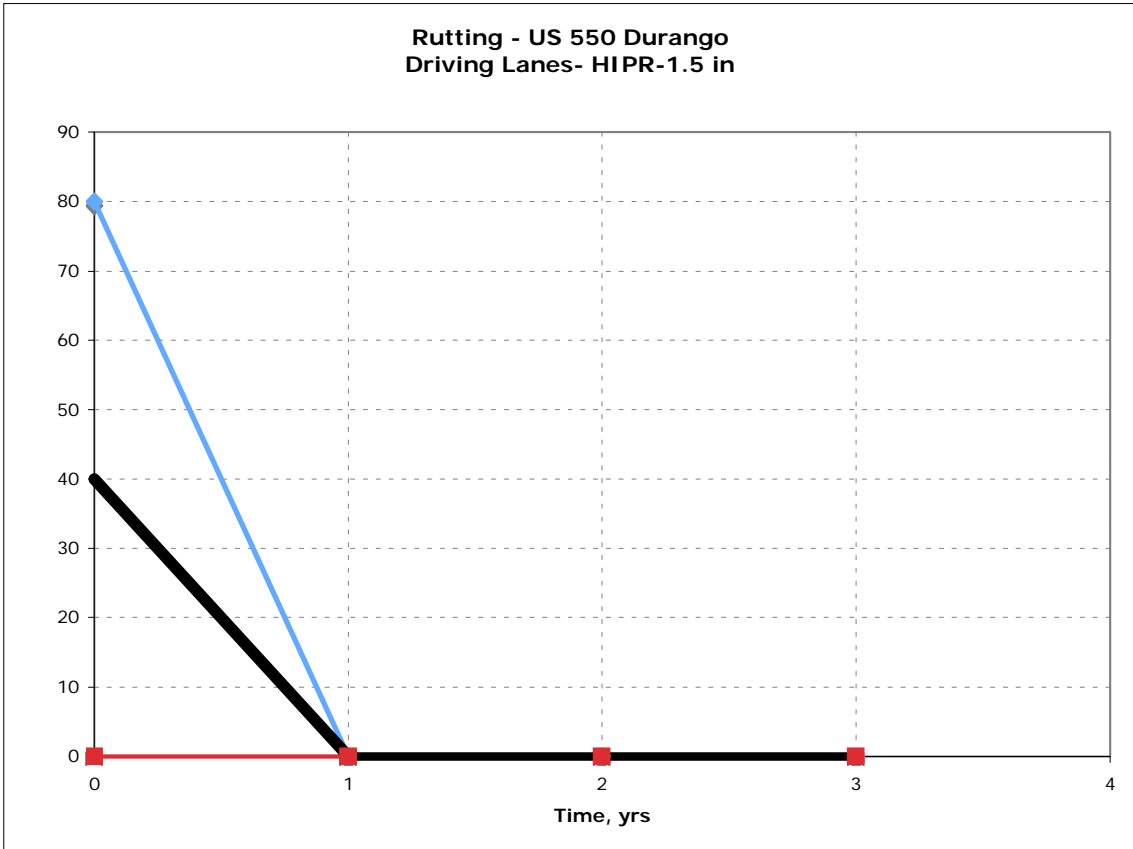
Figure 88. Rutting/500 ft Section for US 550, Durango – Driving Lanes, HIPR, 1.5 in.

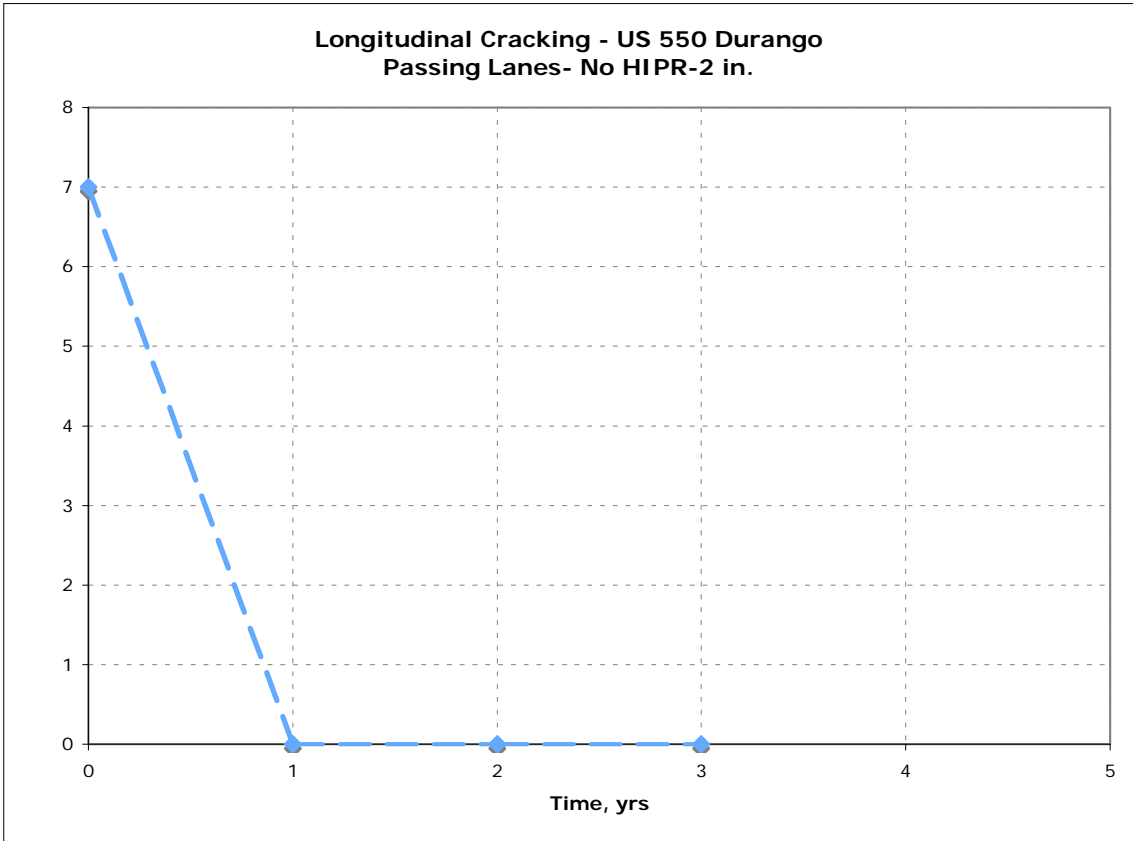
Figure 89. Longitudinal Cracking/500 ft Section for US 550, Durango – Passing Lane, No HIPR, 2 in.

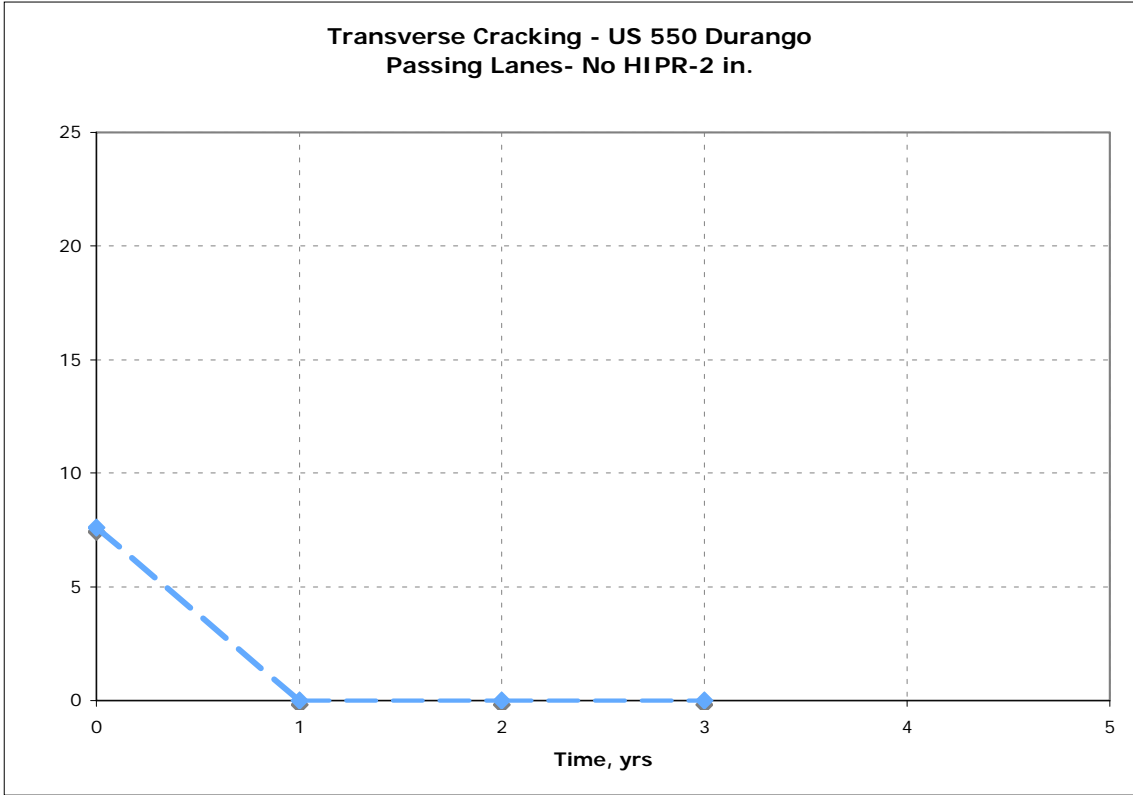
Figure 90. Transverse Cracking/500 ft Section for US 550, Durango – Passing Lane, No HIPR, 2 in.

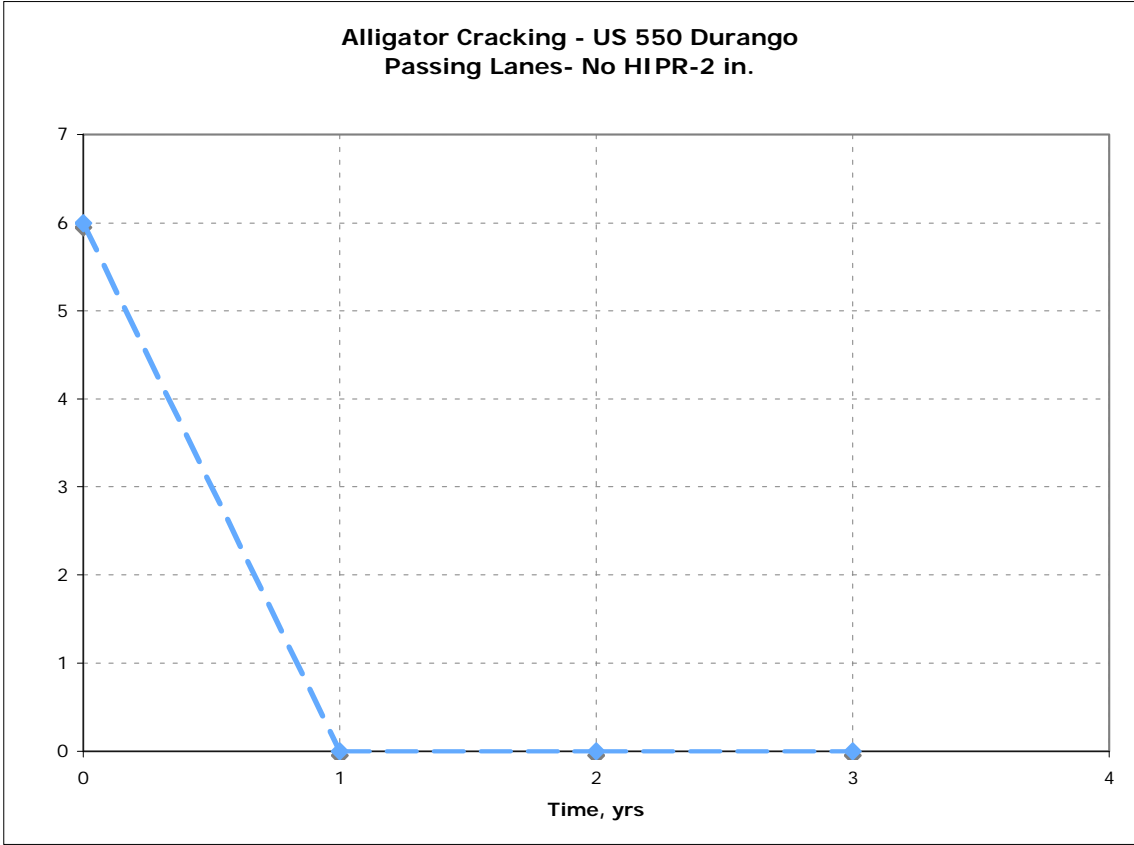
Figure 91. Alligator Cracking/500 ft Section for US 550, Durango – Passing Lane, No HIPR, 2 in.
