**Report No. CDOT-2010-3
Final Report**

Evaluation of the Performance, Cost- Effectiveness, and Timing of Various Pavement Preservation Treatments

Scott Shuler, Ph. D., P. E.

**COLORADO DEPARTMENT OF TRANSPORTATION
DTD APPLIED RESEARCH AND INNOVATION BRANCH**

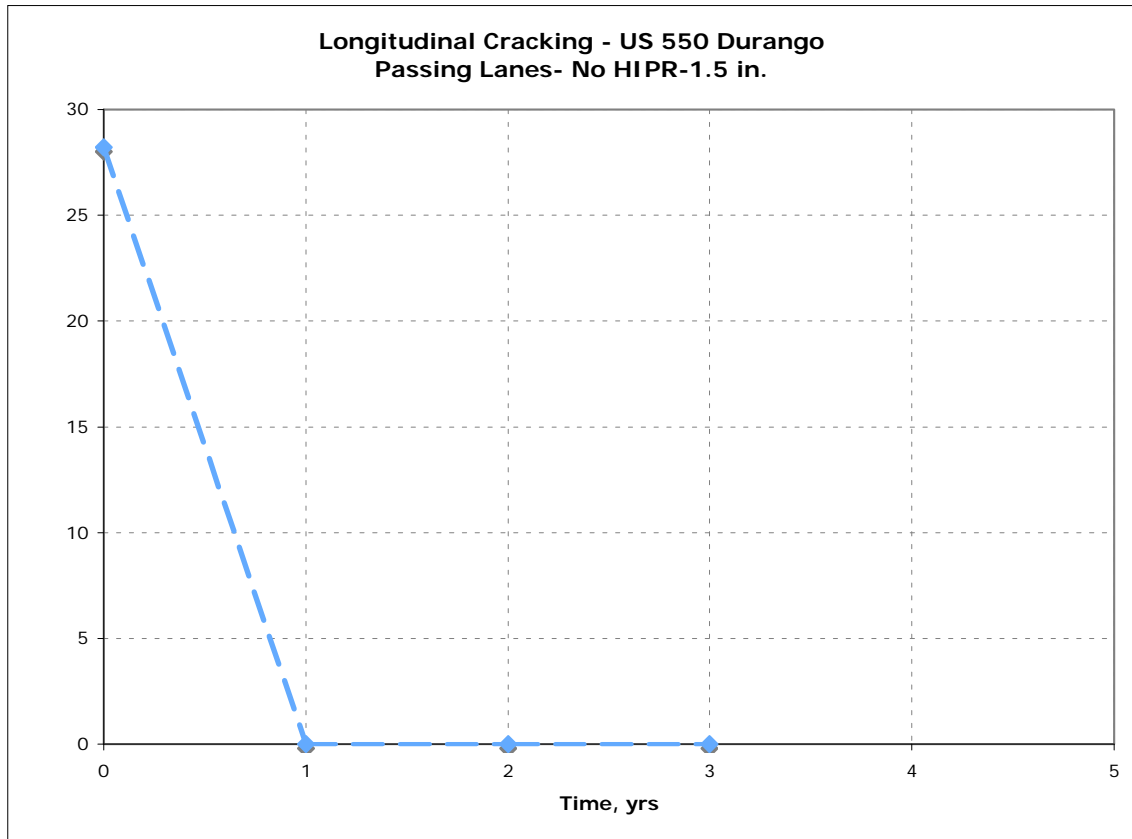
Figure 92. Longitudinal Cracking/500 ft Section for US 550, Durango – Passing Lane, No HIPR, 1.5 in.

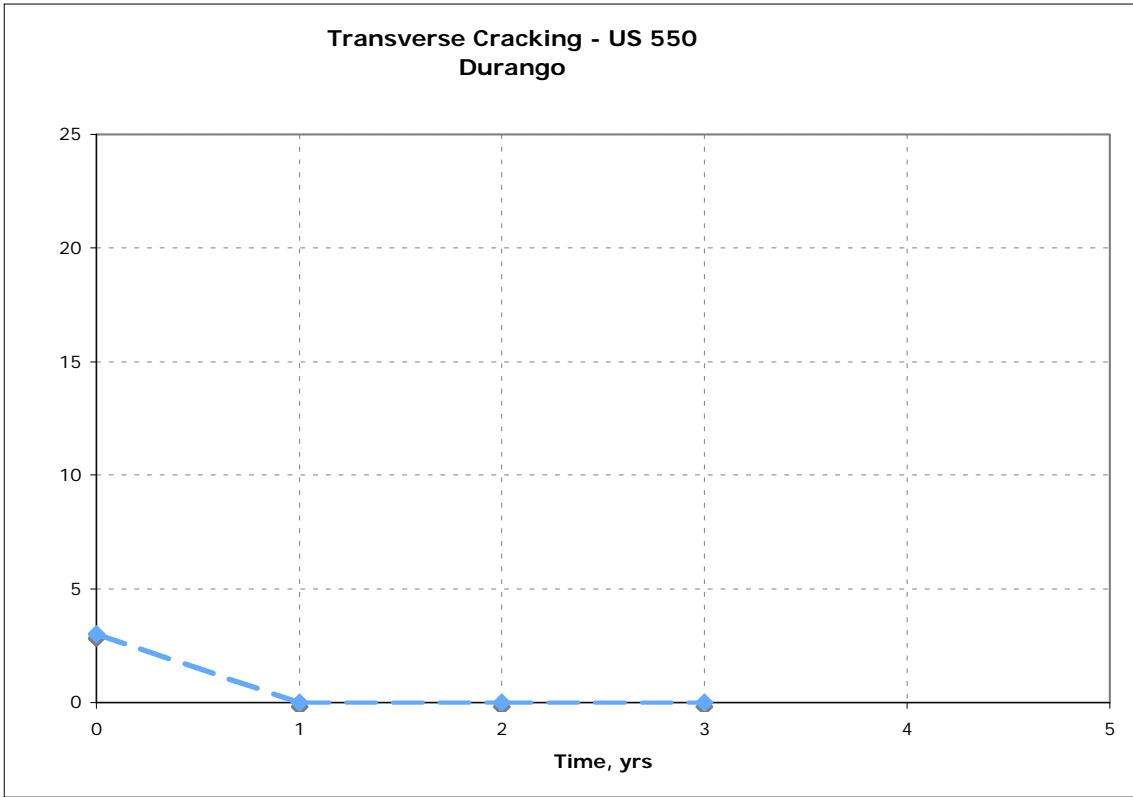
Figure 93. Transverse Cracking/500 ft Section for US 550, Durango – Passing Lane, No HIPR, 1.5 in.

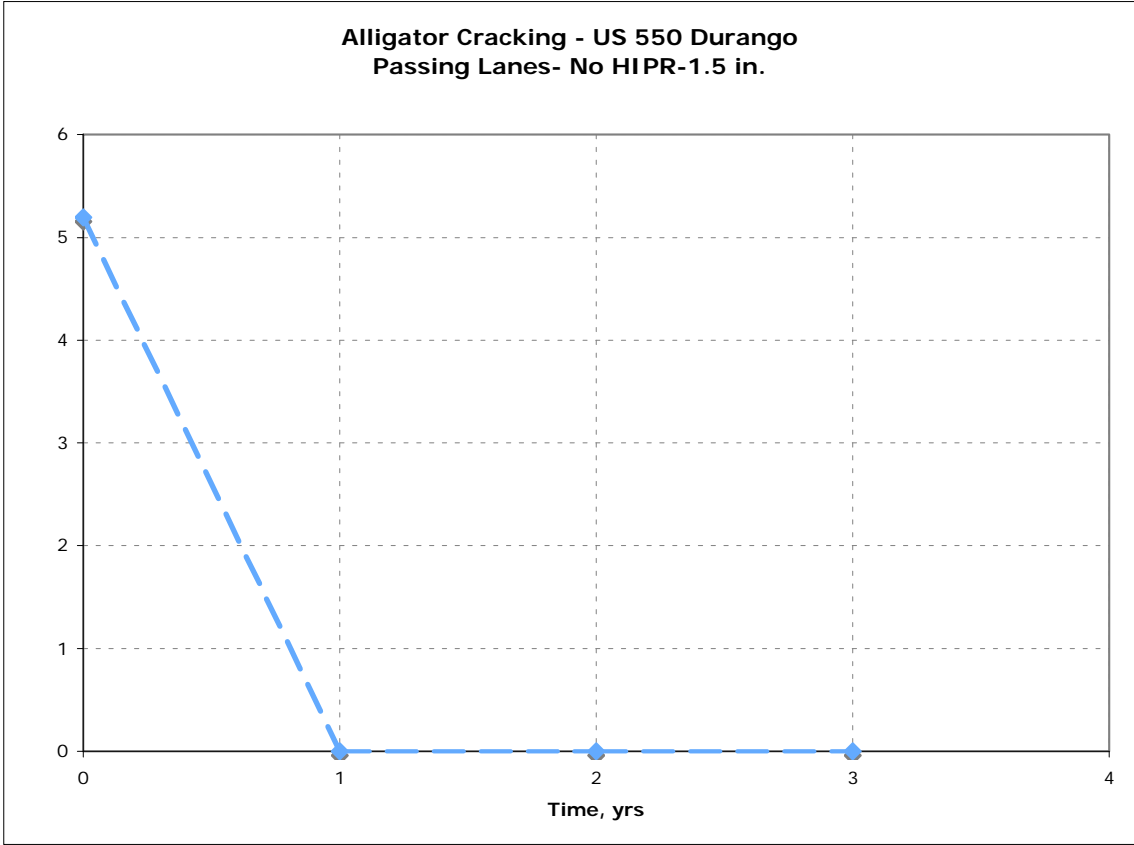
Figure 94. Alligator Cracking/500 ft Section for US 550, Durango – Passing Lane, No HIPR, 1.5 in.

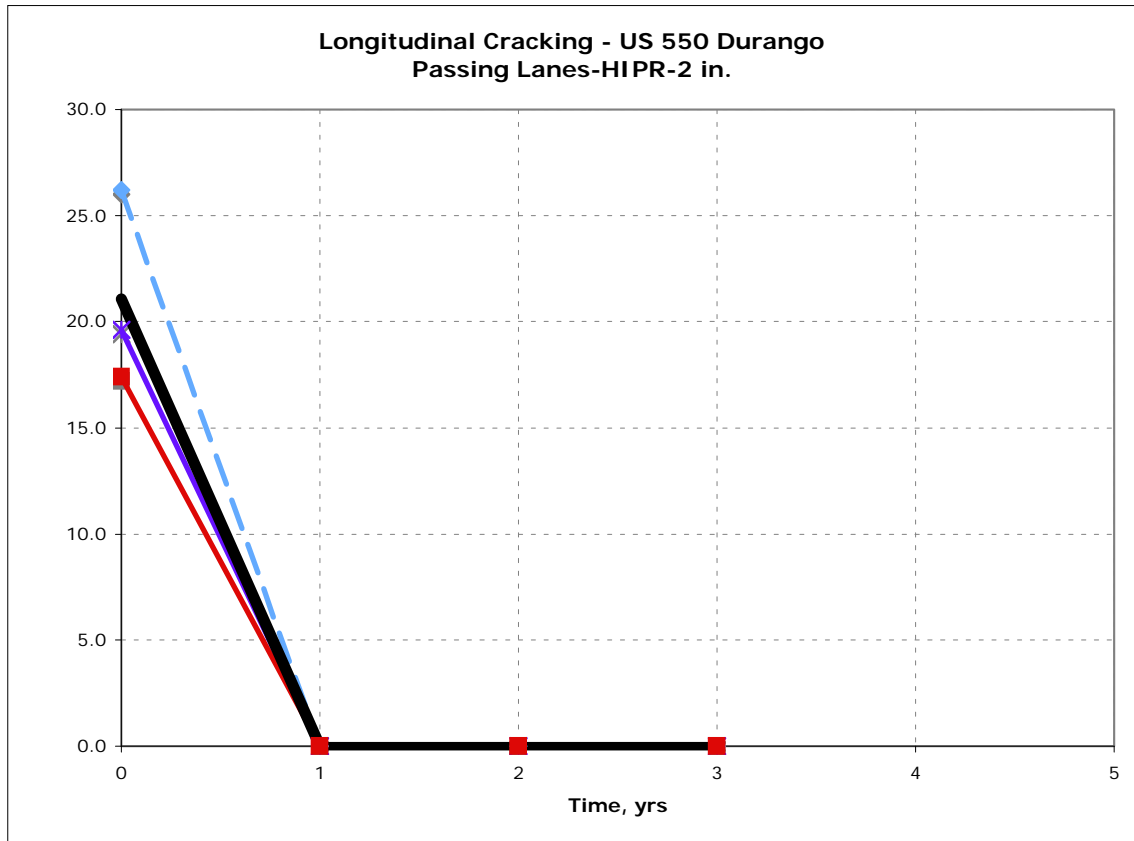
Figure 95. Longitudinal Cracking/500 ft Section for US 550, Durango – Passing Lane, HIPR, 2 in.

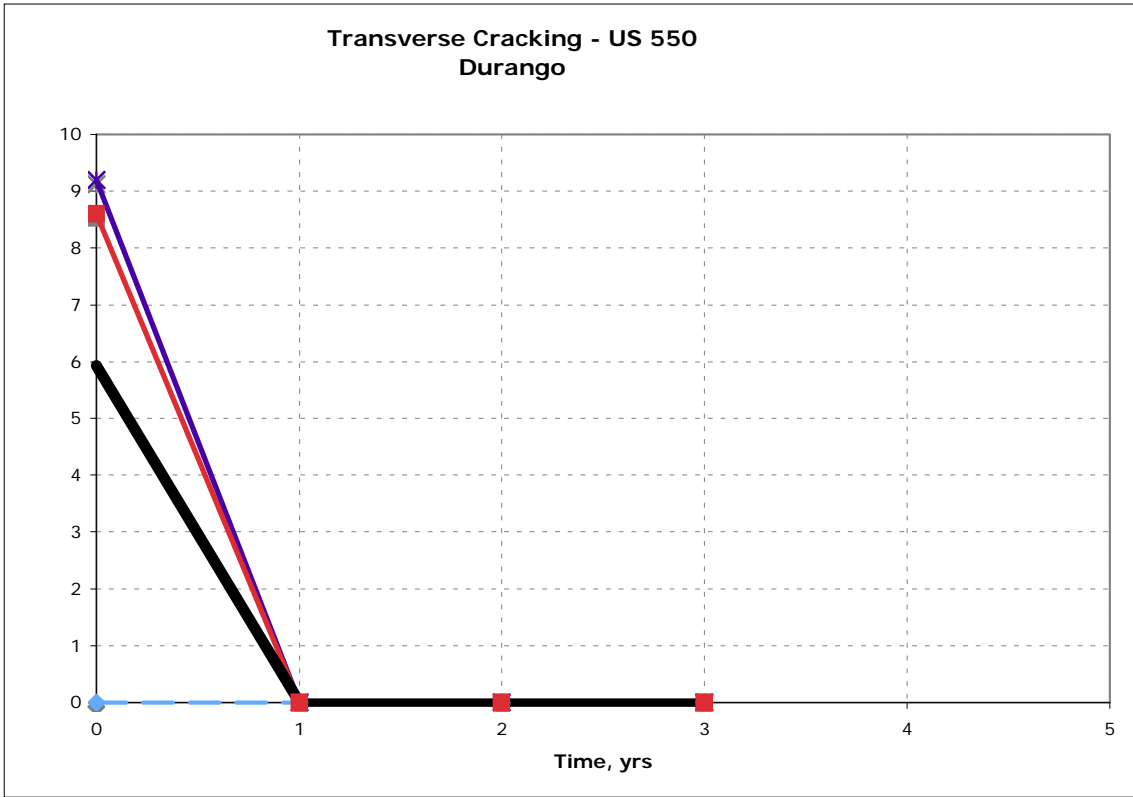
Figure 96. Transverse Cracking/500 ft Section for US 550, Durango – Passing Lane, HIPR, 2 in.

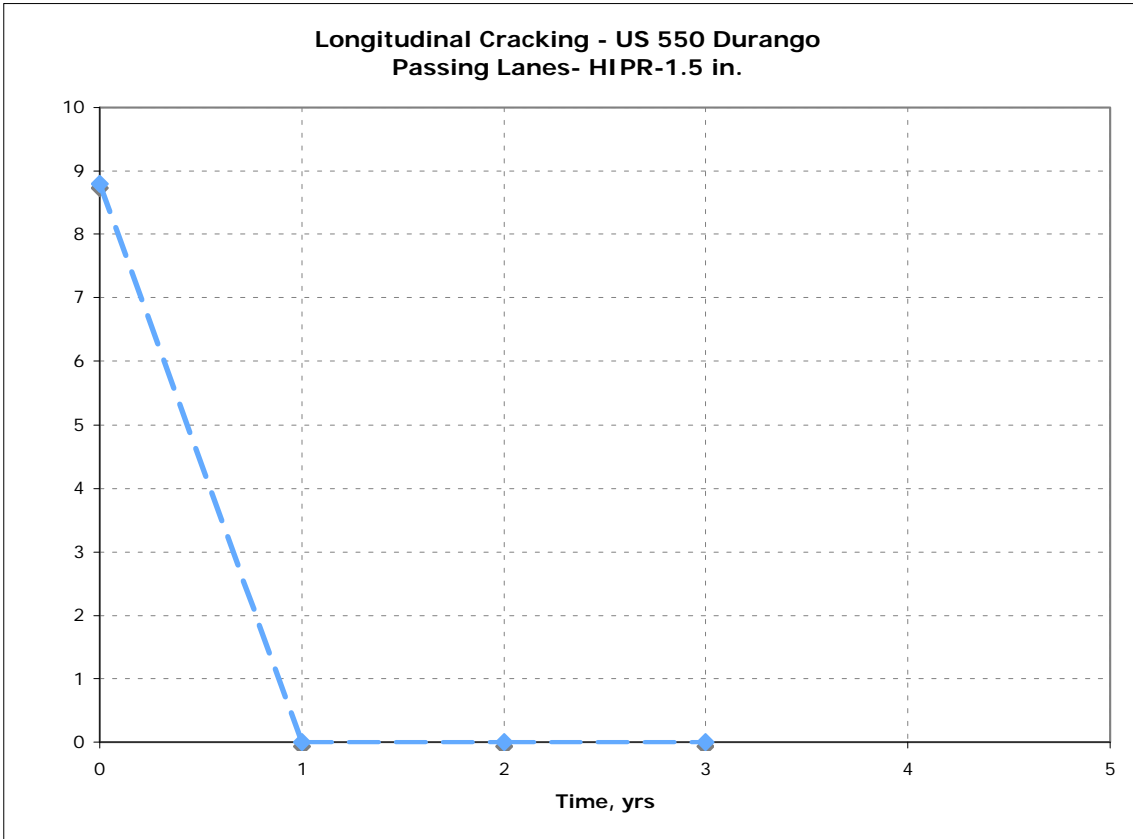
Figure 98. Longitudinal Cracking/500 ft Section for US 550, Durango – Passing Lane, HIPR, 1.5 in.

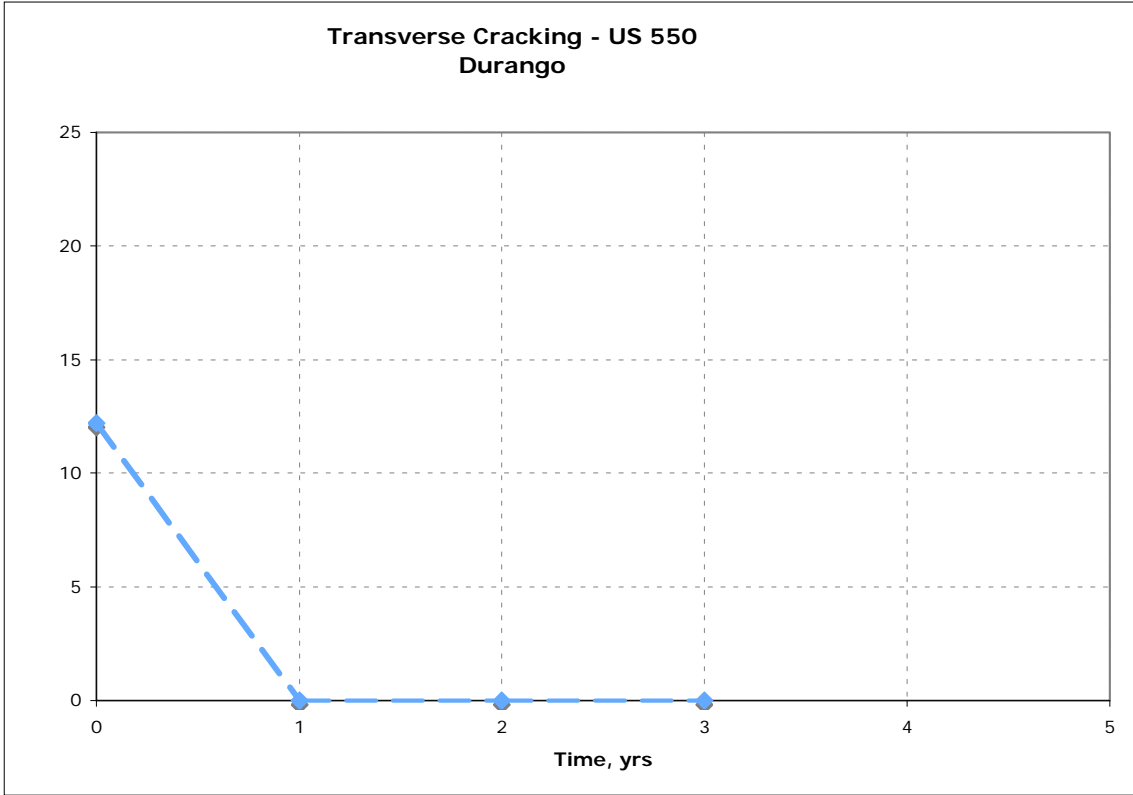
Figure 99. Transverse Cracking/500 ft Section for US 550, Durango – Passing Lane, HIPR, 1.5 in.

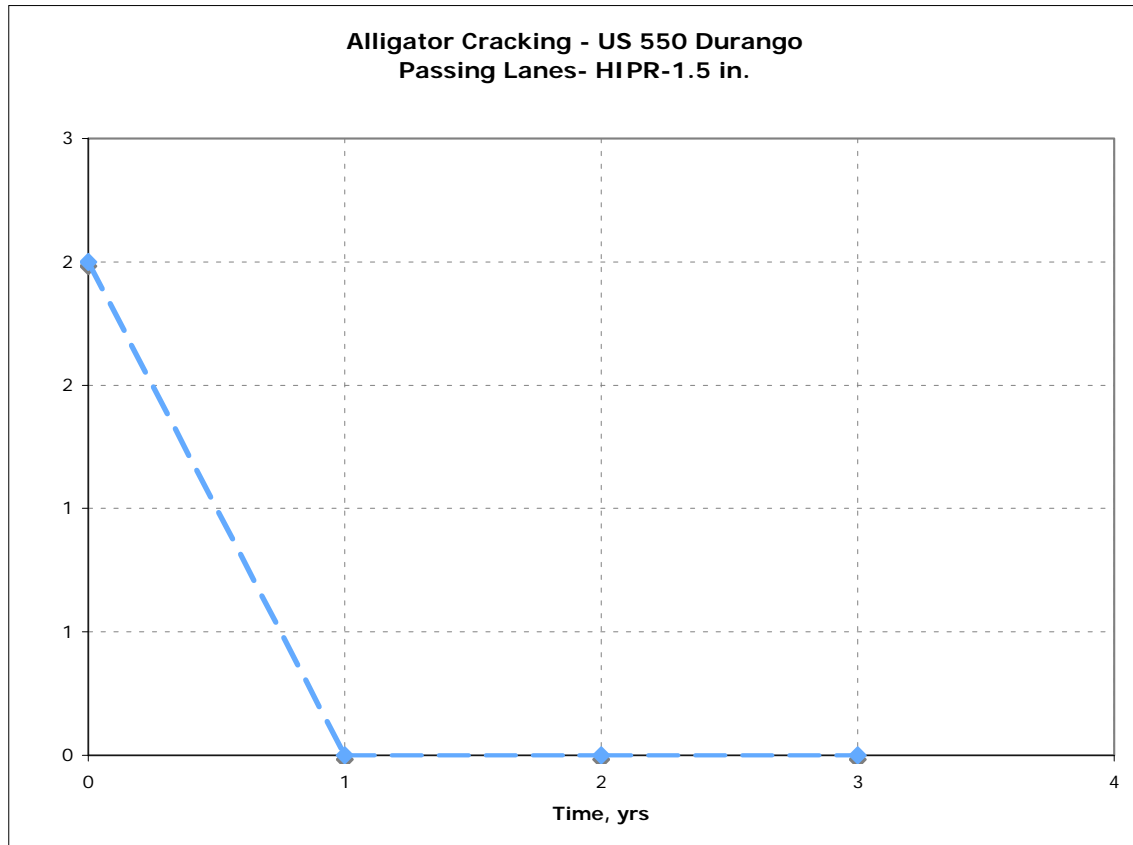
Figure 100. Alligator Cracking/500 ft Section for US 550, Durango – Passing Lane, HIPR, 1.5 in.

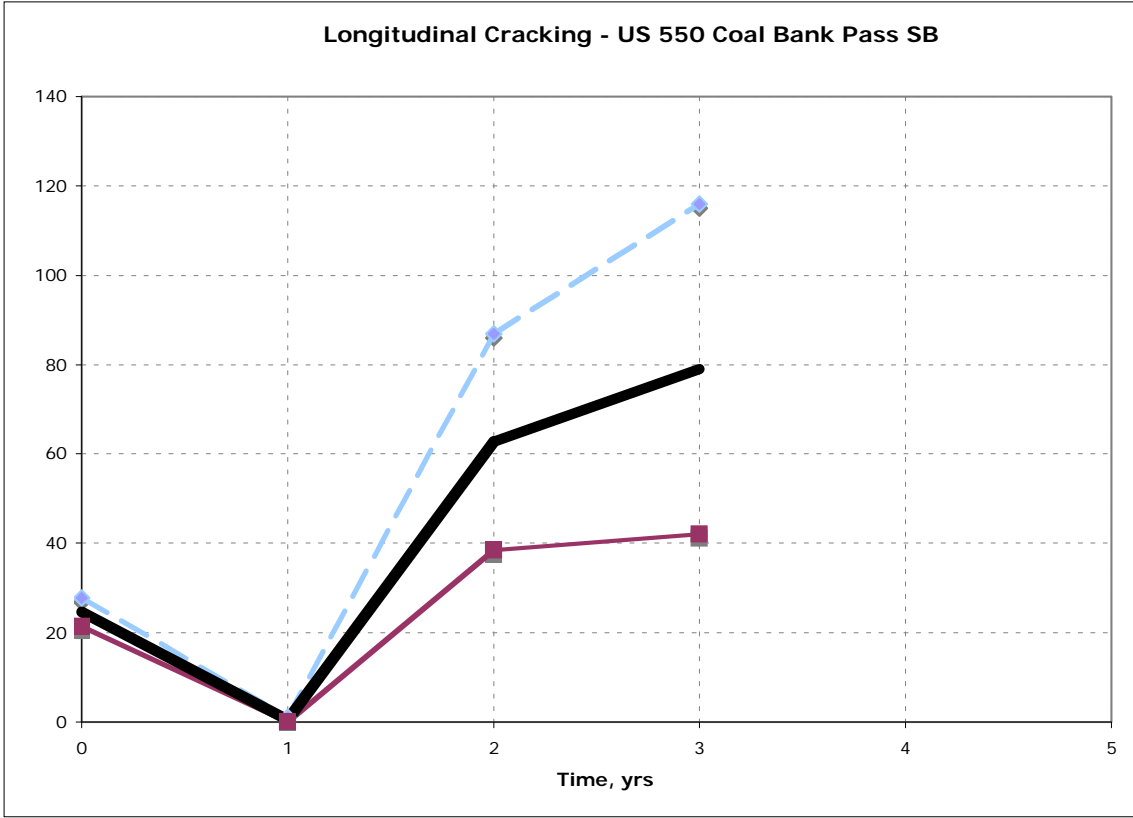
Four evaluation sections were established on US 550 south of Coal Bank Pass, two in the southbound lane and two sections were monitored in the northbound lane. The results of three years of performance data on these sections and the average are shown in Figures 101 through 107.

Figure 101. Longitudinal Cracking/500 ft Section for US 550, Coal Bank Pass Southbound

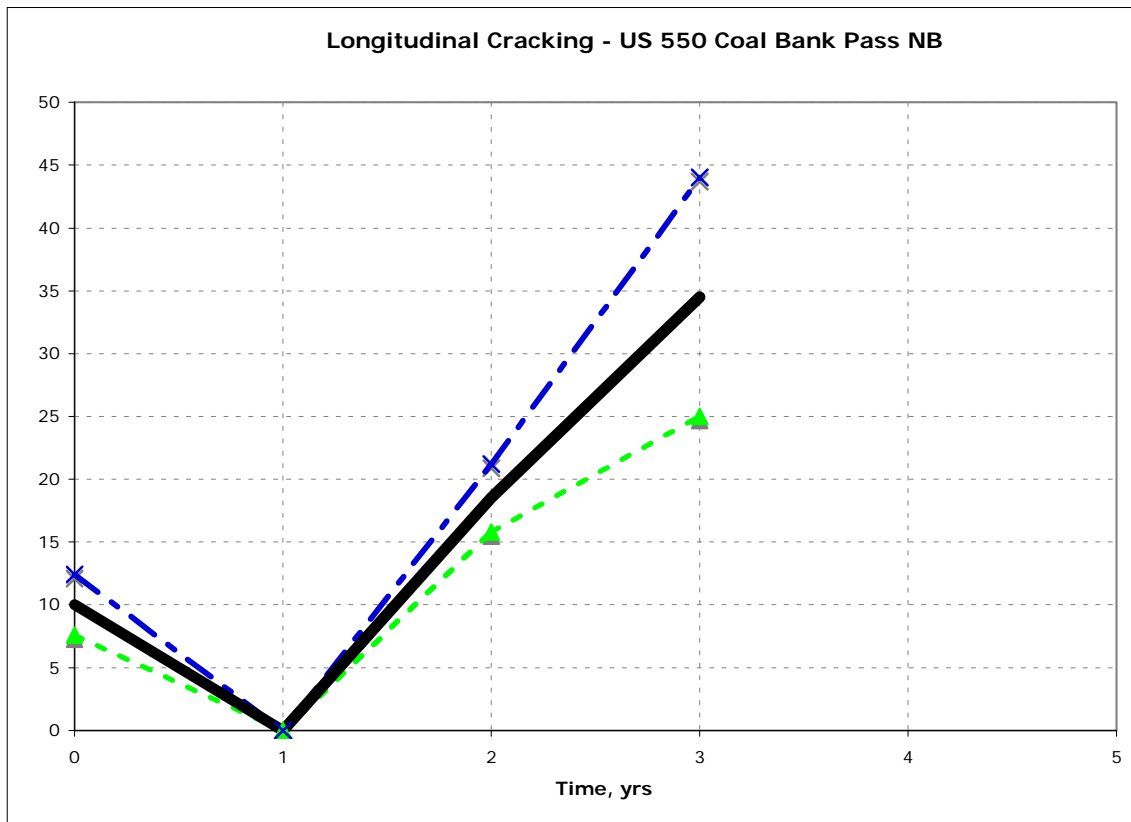
Figure 104. Longitudinal Cracking/500 ft Section for US 550, Coal Bank Pass Northbound

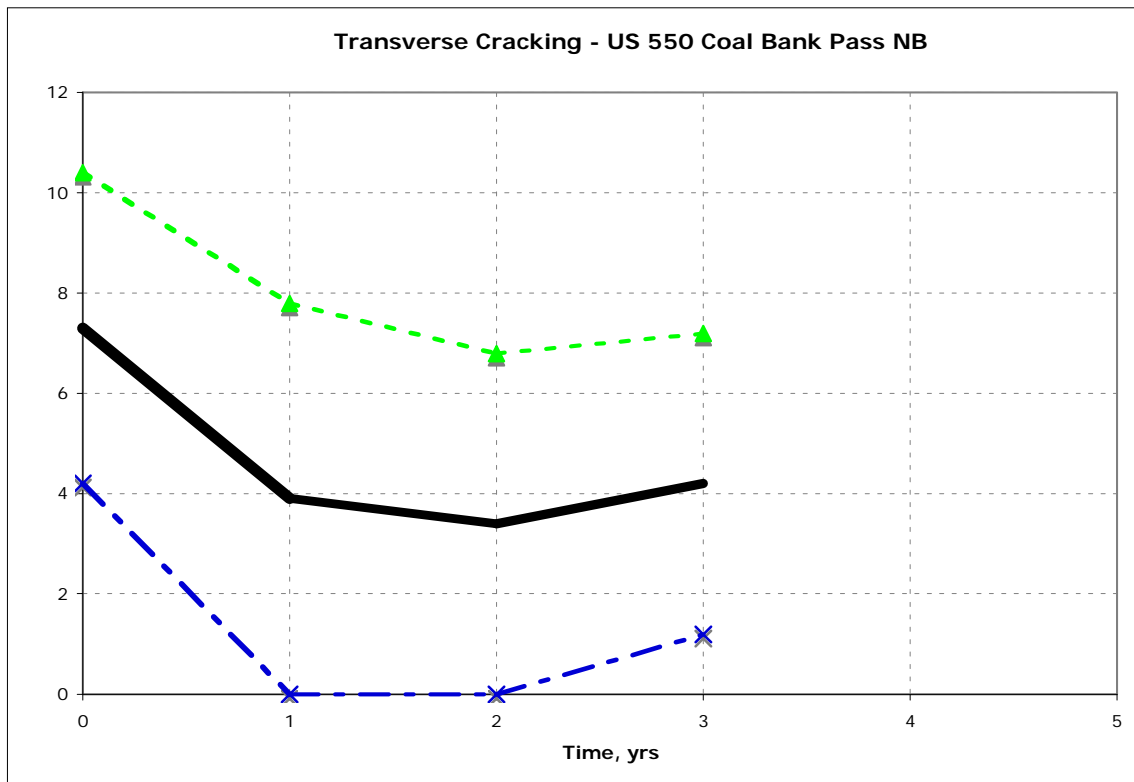
Figure 105. Transverse Cracking/500 ft Section for US 550, Coal Bank Pass Northbound

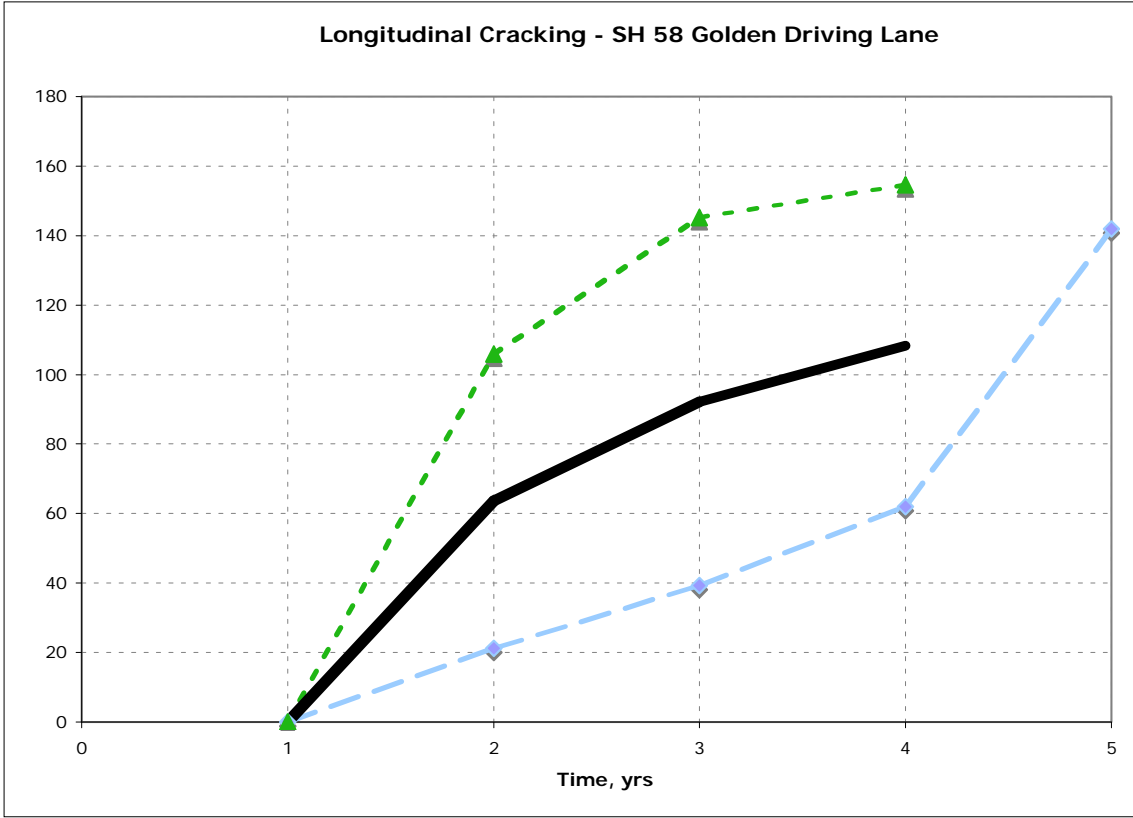
Figure 111. Longitudinal Cracking/500 ft Section for SH 58, Golden – Driving Lane

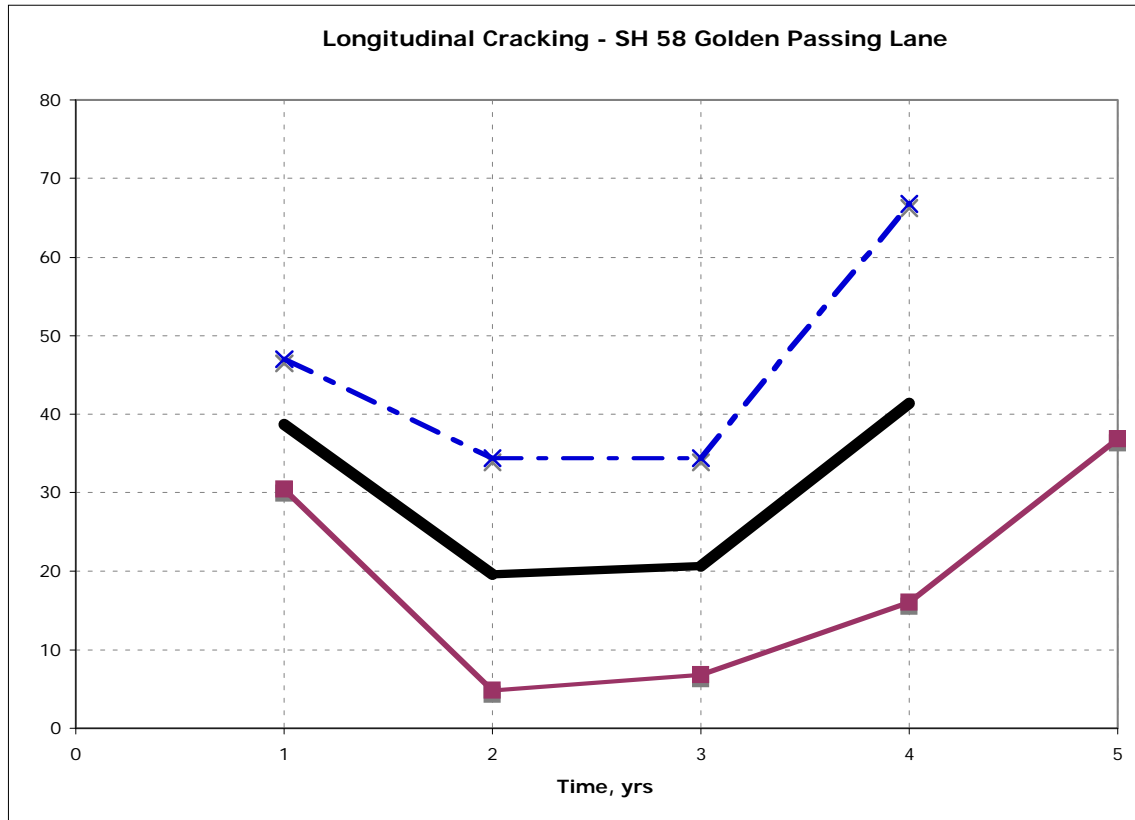
Figure 113. Longitudinal Cracking/500 ft Section for SH 58, Golden – Passing Lane

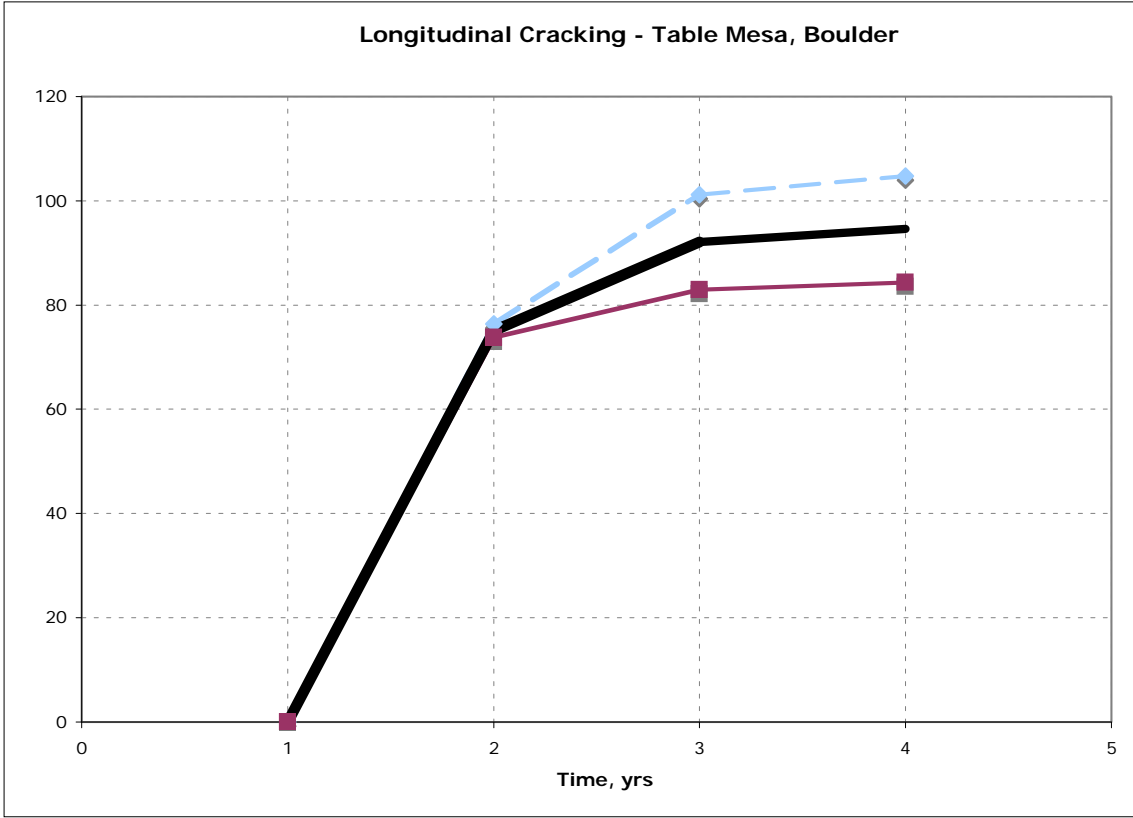
Two evaluation sections were established on Table Mesa Drive in Boulder in the eastbound driving lanes one year after construction of the ultra thin bonded wearing course. Results of four years of performance data on these sections and the average are shown in Figures 115 and 116.

Figure 115. Longitudinal Cracking/500 ft Section for Table Mesa, Boulder

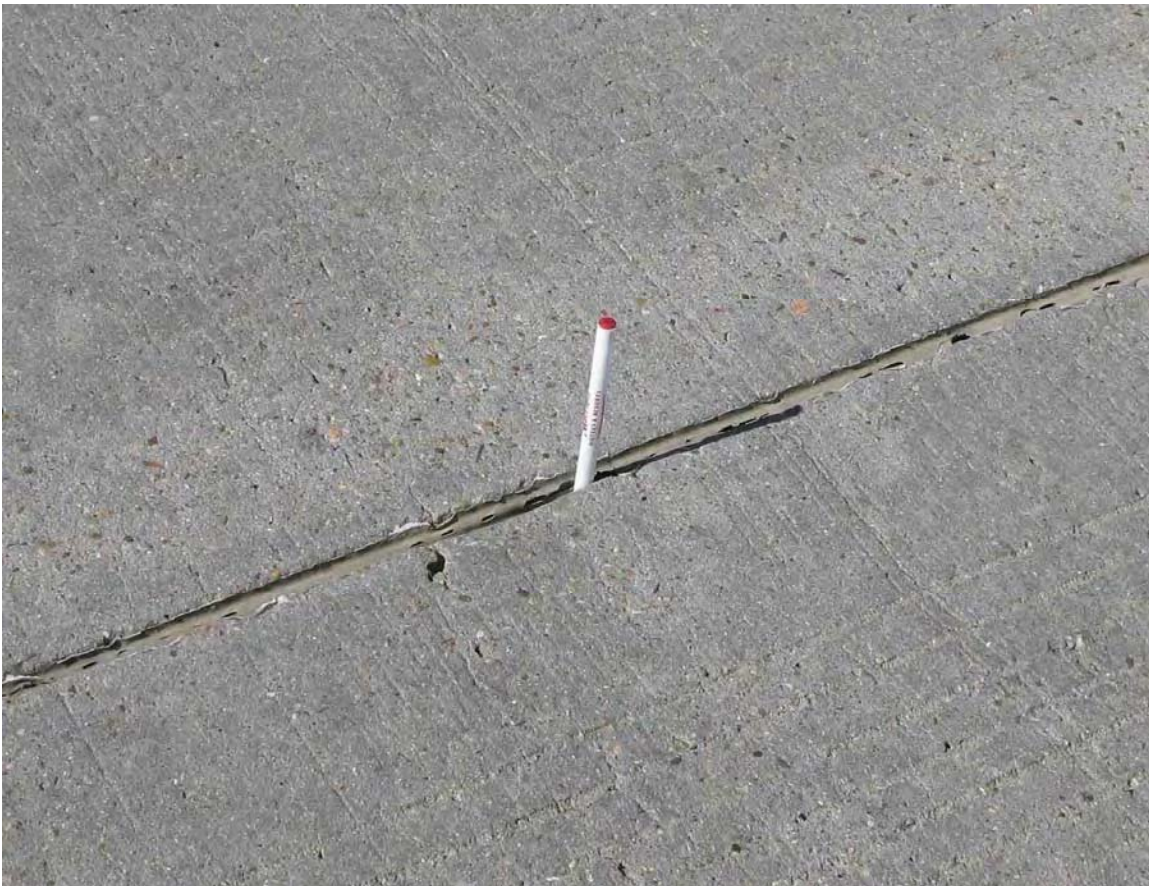
The joints that had been resealed in 2006 remained sealed through 2007 and then began to fail in 2008 with approximately 5 percent of the joints separating from the sealant and approximately 10 percent of the sealant failing within the sealant. This failure increased in 2009 to approximately 30 percent of the sealant failing within the sealant revealing a void beneath as shown in Figure 120. This photo was taken immediately south of the southern test section at approximately MP 2.8. The control sections that had been established in 2006 had been sealed before the 2009 survey.

Figure 120. Sealant Failure on US 287, Campo

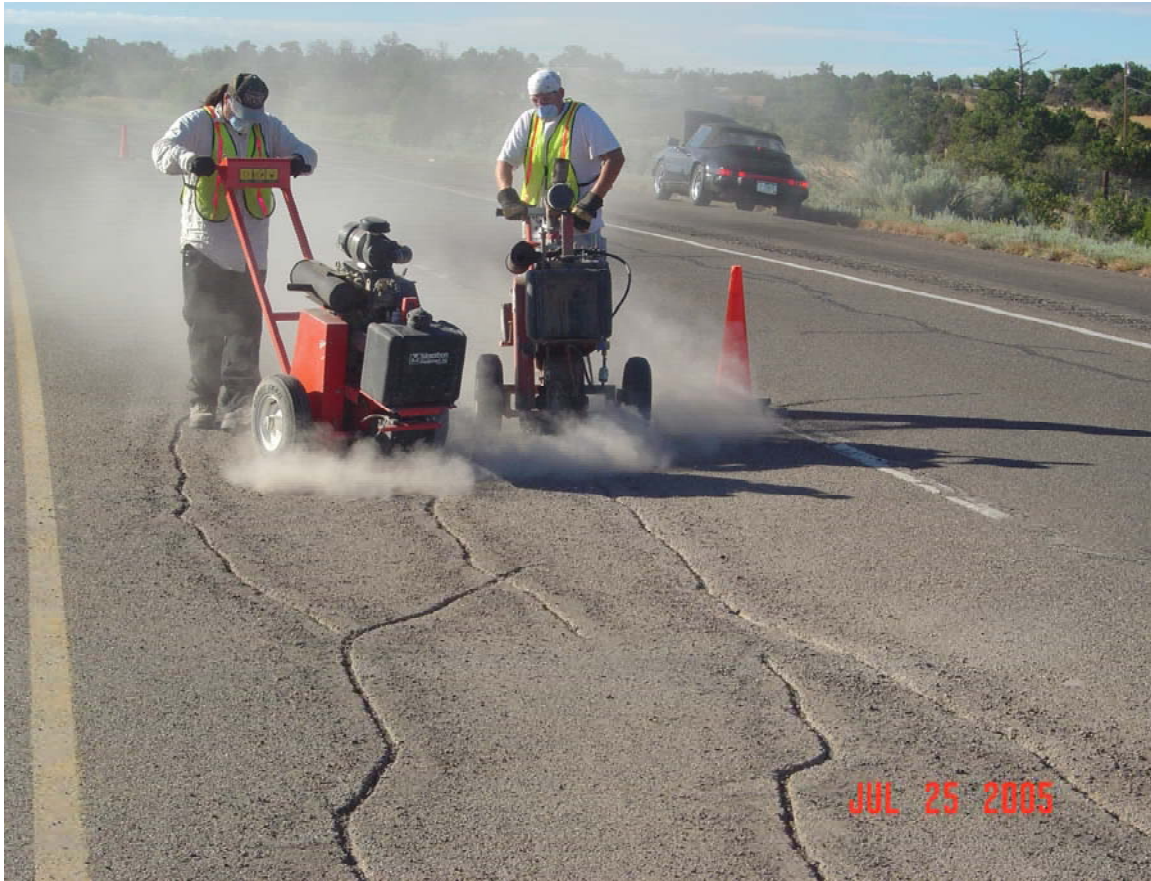
Routing cracks prior to filling with crack sealer is currently not practiced in Colorado. In fact, it has been advised against because of potential damage that could result (2) and the belief that it is uneconomical. However, recent observations in a neighboring state (6) shown in Figure 1 indicates that routing is being practiced prior to crack filling and may be economical when done under specific circumstances.

Figure A1 – Routing Cracks Prior to Crack Sealer Installation on I-25, NM

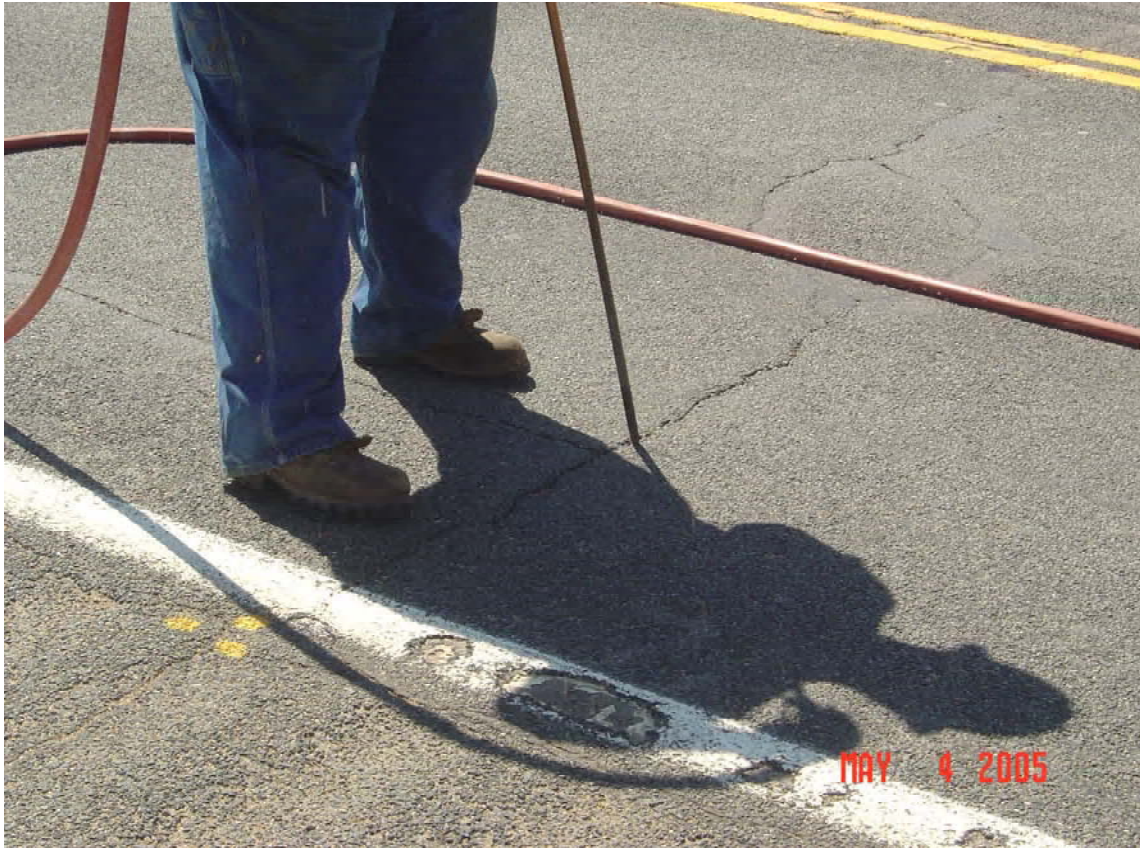
The first step in crack filling is cleaning any debris from inside the crack. This is done using compressed air. Air pressure should not exceed 100 psi to assure damage does not result to crack faces. Figure 4 shows an operator cleaning a crack with compressed air.

Figure A4 – Cleaning Crack with Compressed Air

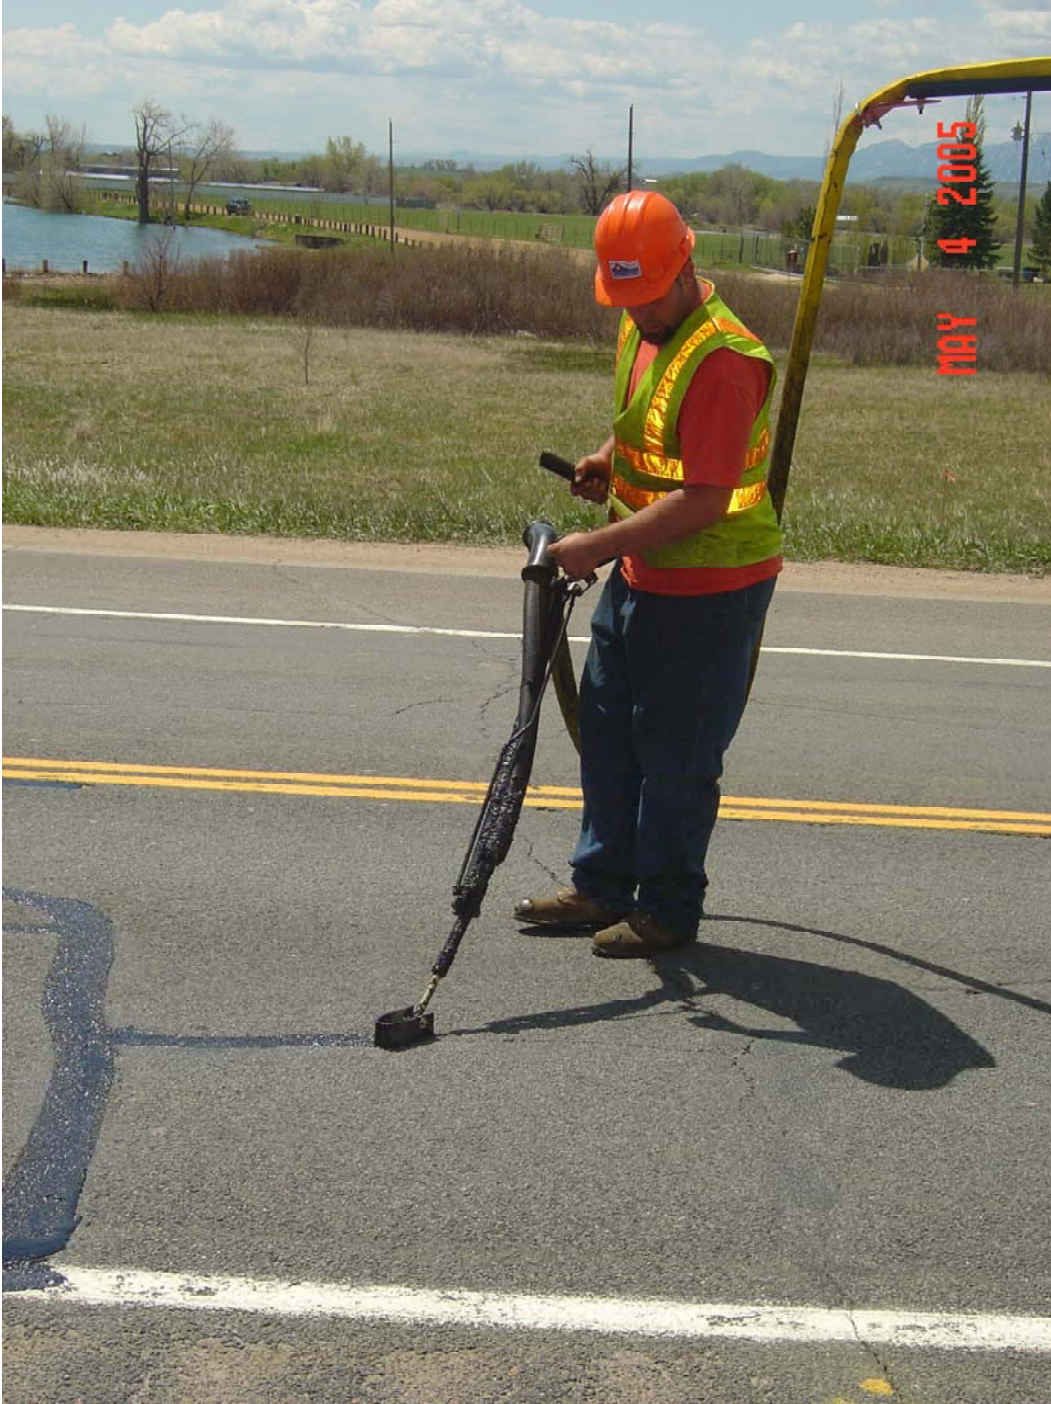
Figure A6 – Pressure Distributor for Crack Sealing

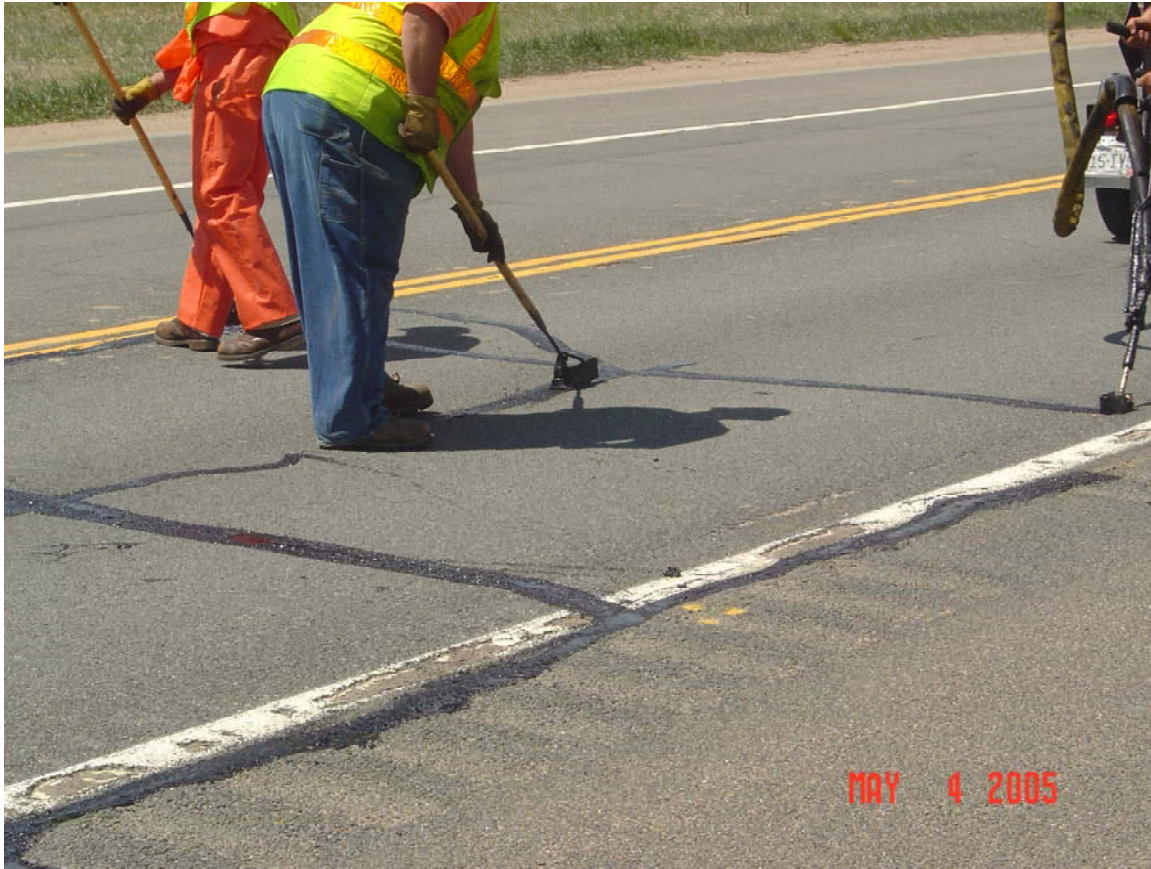
Figure A7 – Squeegee Application After Crack Pouring

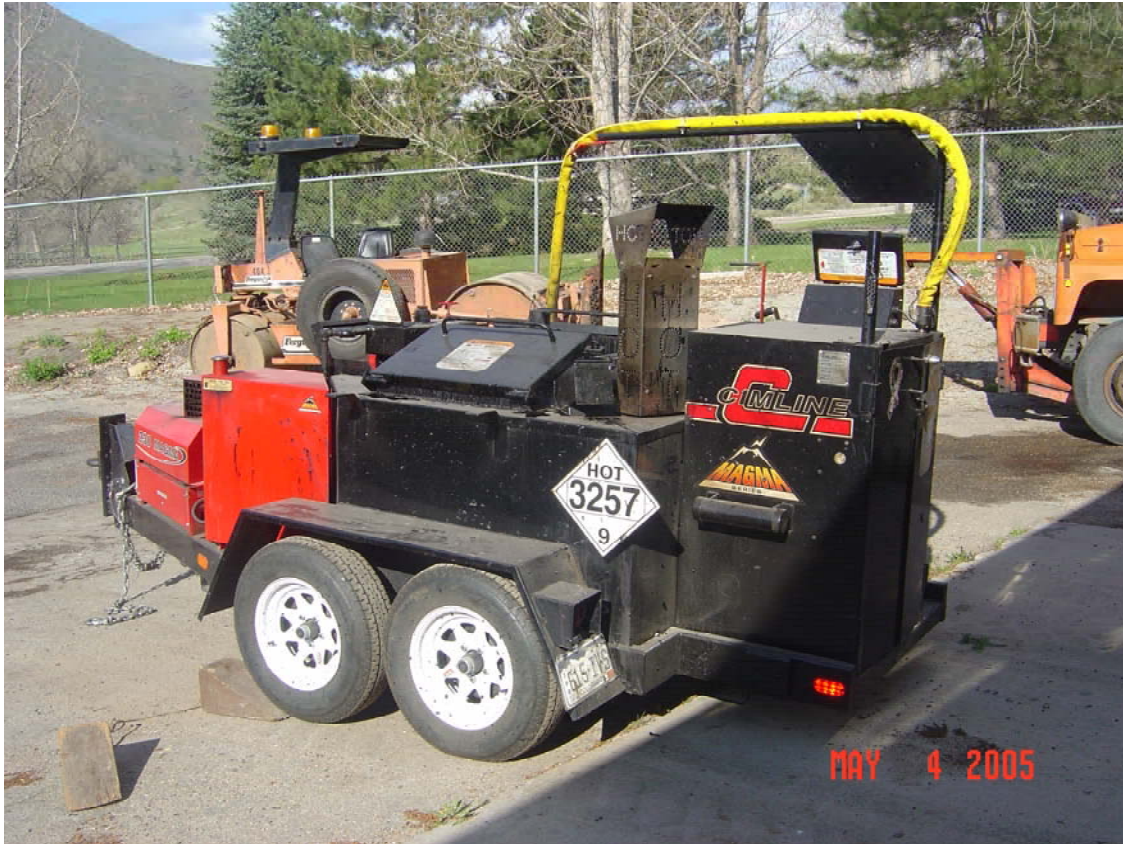
Before being poured, crack sealant should be melted in a double-jacketed reservoir. Hot oil circulates in the jacket, preventing the direct heating of the sealant. This reduces sealant degradation. The melter is also equipped with a central agitator that must allow for efficient heat transfer throughout the sealant and for preventing hot spots. Gauges measure oil and sealant temperatures. The gauges must be calibrated every spring. It is highly recommended that supervisors and inspectors carry a hand-held thermometer to verify that the sealant gauge is indeed calibrated. An infrared thermometer can also be used to monitor temperature, but it becomes unreliable when the sealant emits fumes. Figure 8 shows one sealant melter that conforms to these requirements.

Figure A8 – Crack Seal Melter

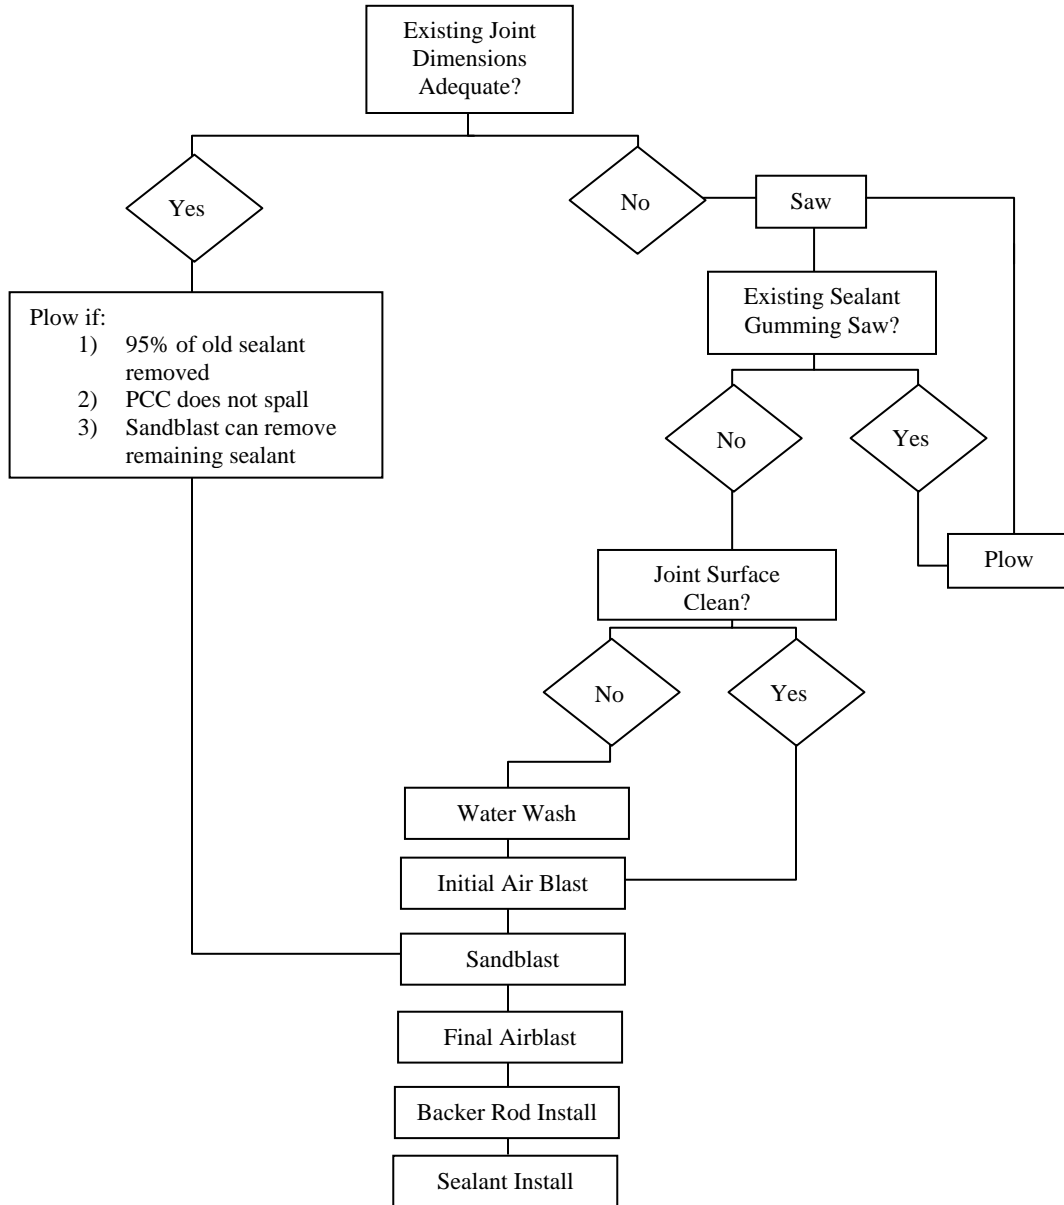
Figure A14 – Decision Process for Joint Resealing
