FATIGUE PERFORMANCE OF VARIABLE MESSAGE SIGN & LUMINAIRE SUPPORT STRUCTURES

Volume II – Fatigue Testing and Failure Analysis of Aluminum Luminaire Support Structures

FINAL REPORT
May 1998

FATIGUE TESTING AND FAILURE ANALYSIS OF ALUMINUM LUMINAIRE SUPPORT STRUCTURES

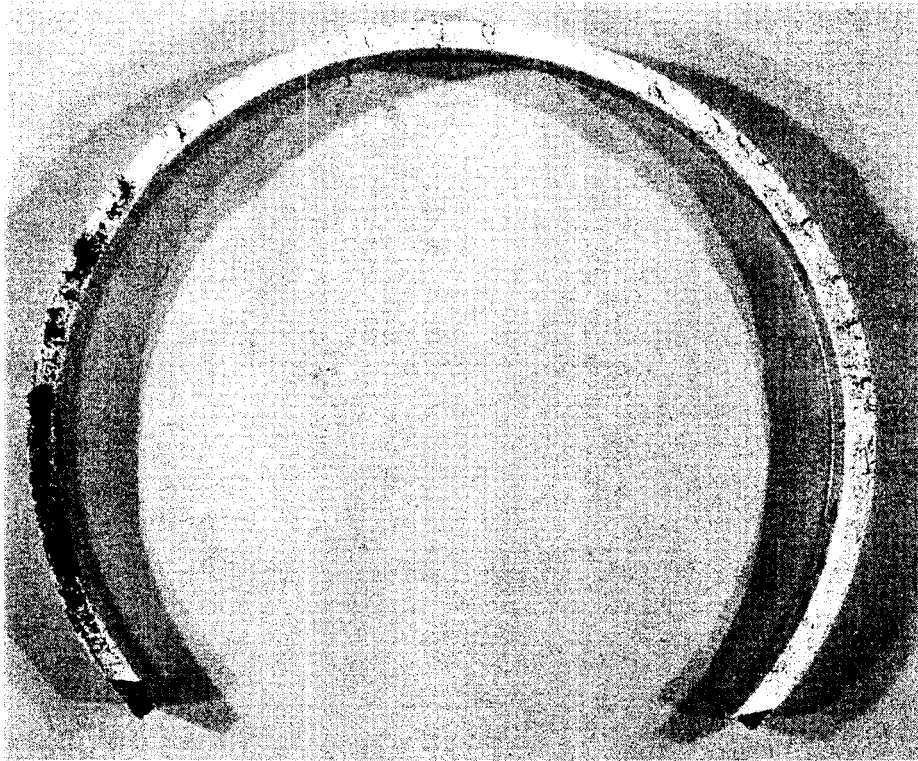
Figure 3-18 Typical Through-Thickness Weld Toe Crack.

As can be seen in Table 3-1 four of the seven cracks in the poles formed as a semi-elliptical weld toe crack that propagated through the pole and then continued on around the circumference. Figure 3-18 shows a typical fatigue crack that formed and propagated in this manner. The cracks that formed at the weld toe and propagated through the pole are plotted separately from those that cracked behind the weld toe. This is because the crack that formed behind the weld toe is primarily caused by a shear stress on the effective area of that weld leg and should consequently be compared to a Category F type detail.

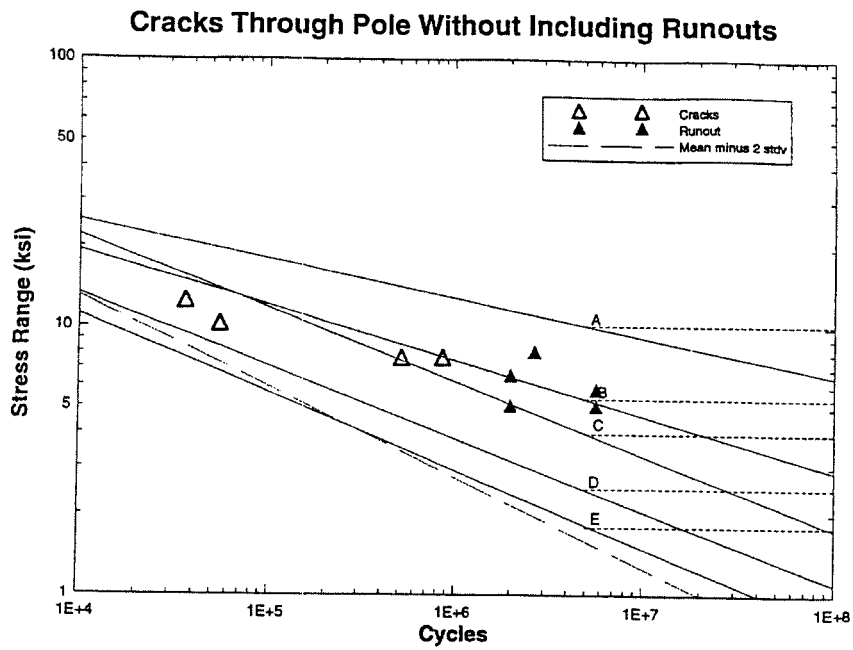
Figure 3-19 S-N Curve for Through-Thickness Cracks Not Including the Runouts.

There are two methods for plotting crack data on an S-N curve. One is to include the runouts in the mean minus two standard deviations calculations and the other is to leave them out. Different researchers prefer one to the other and it is not clear which is more "correct". The thing that is clear is that not including the runouts in the computation results in more conservative values for the mean minus two standard deviations calculation. Both methods are presented here for comparison of the impact on the final decision of the detail category. Figure 3-19 and Figure 3-20 show an S-N plot of the through-thickness fatigue crack data not including the runouts and including them in the mean minus two standard deviations calculation, respectively. As can be seen from comparing the two plots the mean minus two standard deviation is more conservative when the runouts are not included, however in this data set the fatigue strength of the detail is equal to Category E regardless of whether the runouts are included or not.
