LATERALLY LOADED PILE CAP CONNECTIONS

Utah Department of Transportation Research
Division

Brigham Young University
Department of Civil & Environmental
Engineering

August 2010

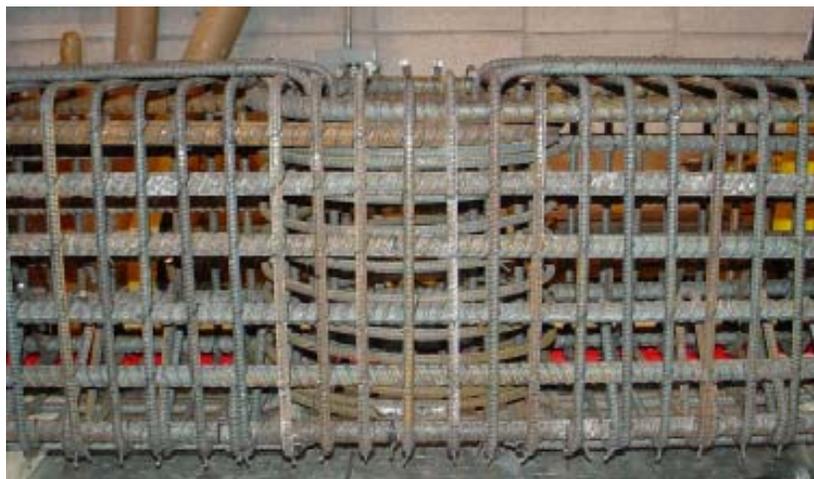
Figure 2-4 Reinforcing cage for pile cap Model 4 Montana State University (Stephens and McKittrick, 2005).

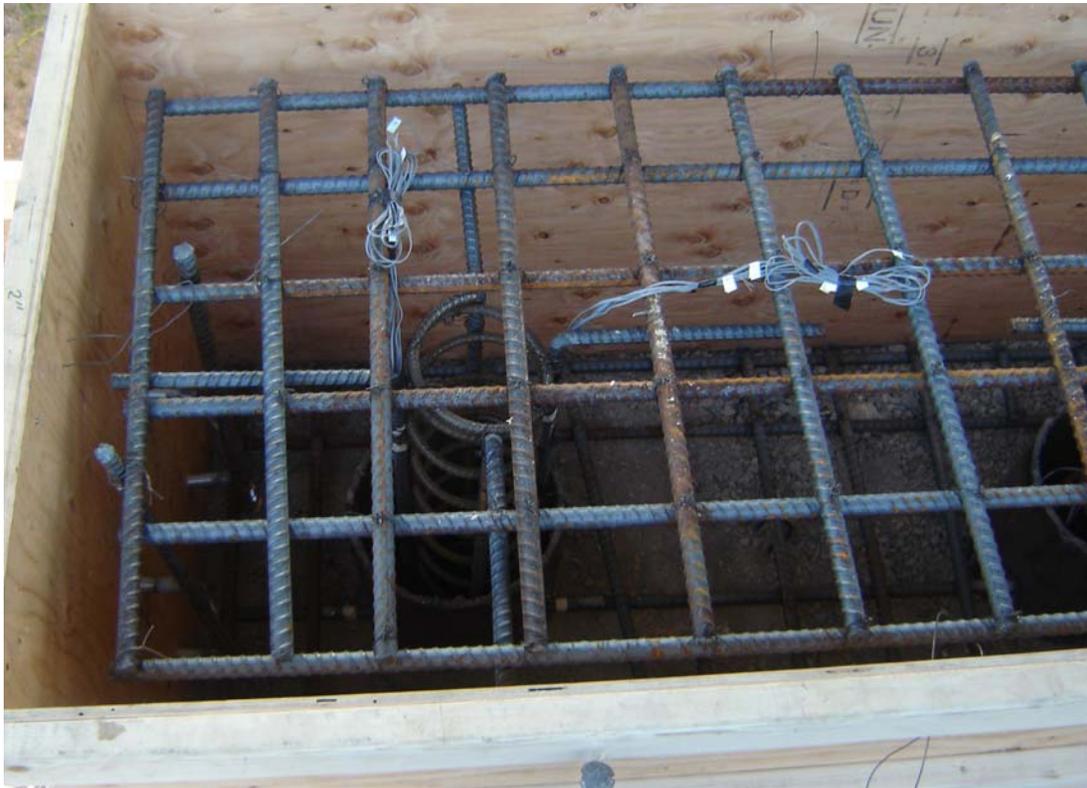
Figure 3-14 Photograph of Pile Cap 1 reinforcing.

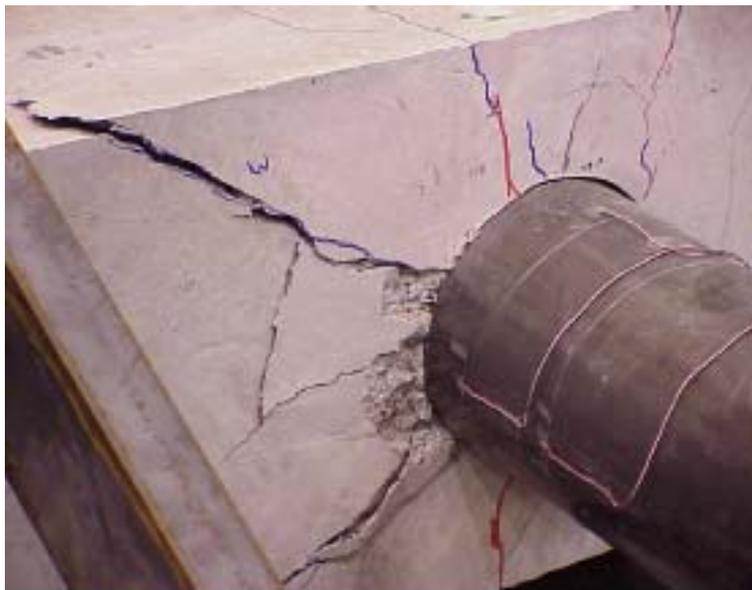
Figure 4-2 Failure of pile caps tested at Montana State University.

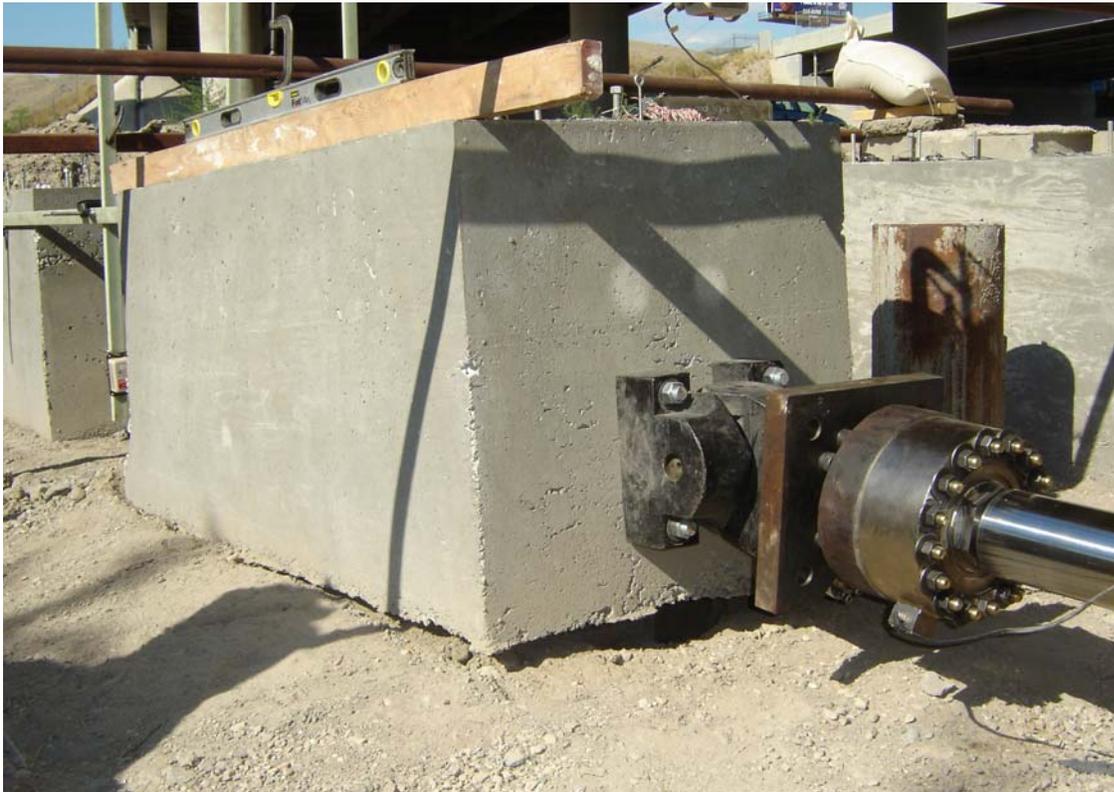
Figure 5-7 Photograph of Pile Cap 1 at failure showing uplift of the back pile.

the pile cap failure was considered to fall under the category of excessive deflection under load. This was due to the piles pulling out of the ground as shown in the photograph in Figure 5-7.

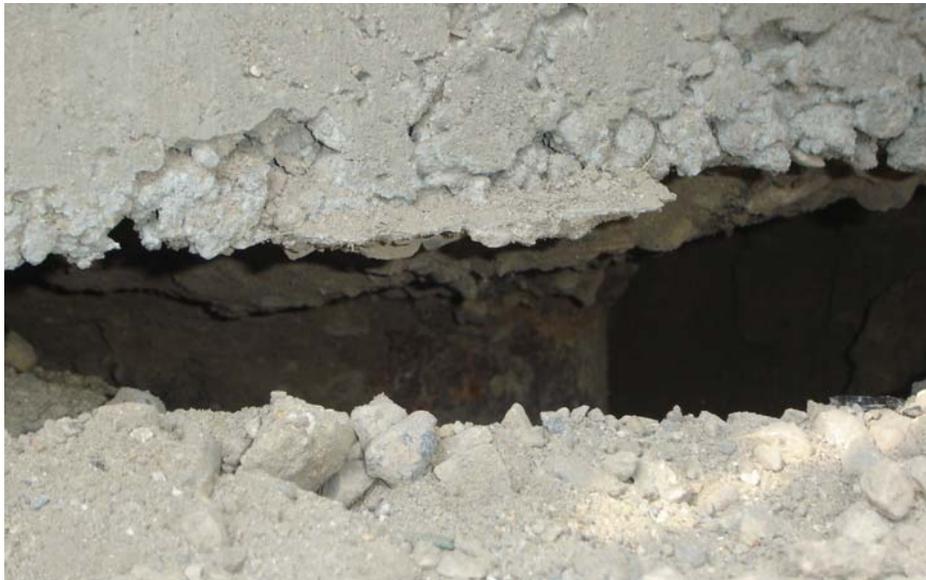
Figure 5-11 Pile Cap 2 failure in pullout.

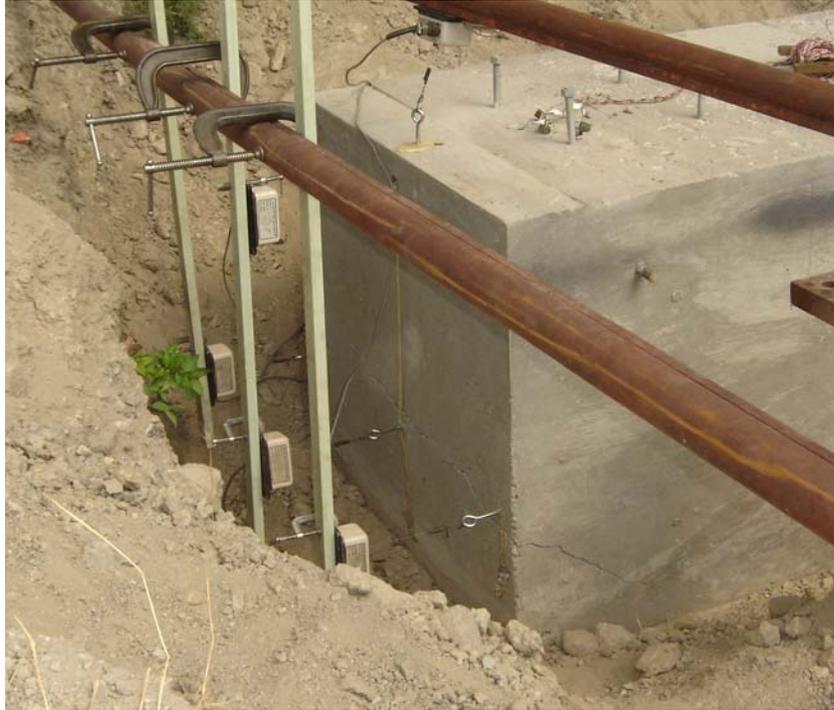
Figure 5-12 Initial cracking on the front face and side of Pile Cap

surprisingly similar to that for the other tests. With the excessive amount of cracking it appeared that the back pile did little in resisting deflection, yet either the front pile compensated or the remaining concrete was sufficient to transfer load between the two piles. The cracking occurred at the location

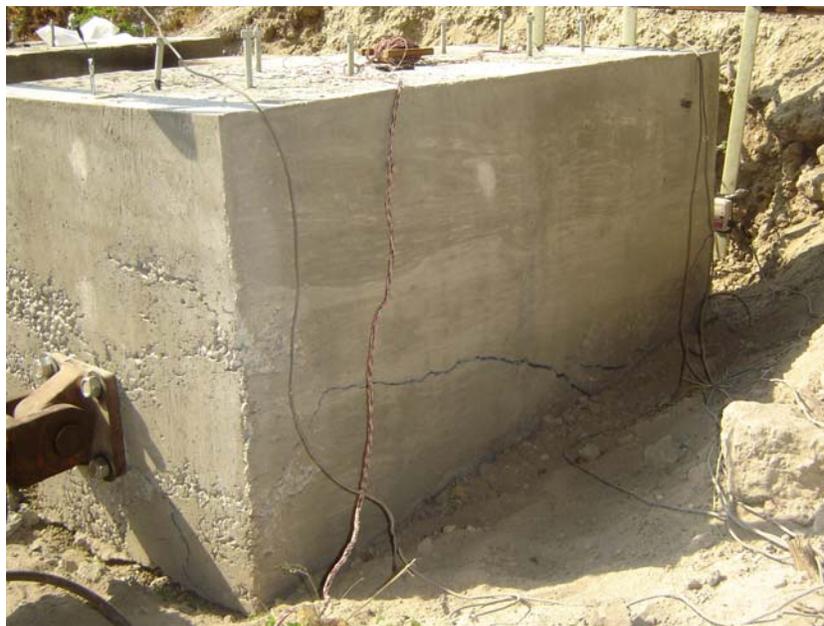
Figure 5-13 Cracking at a 90 kip load on the back and side of Pile Cap 3.

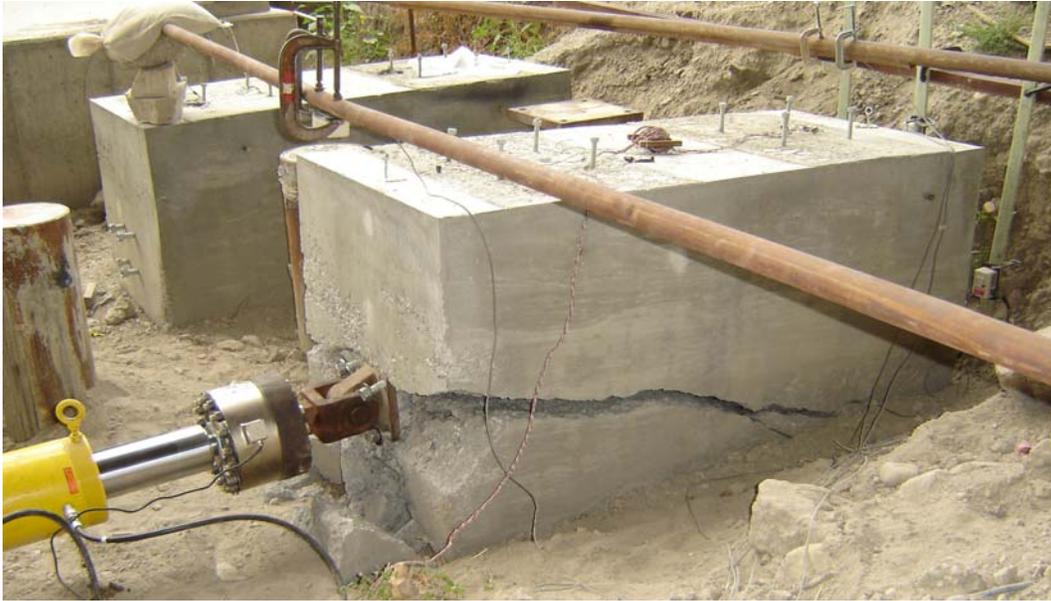
Figure 5-14 Shear crack in Pile Cap 3 at failure.

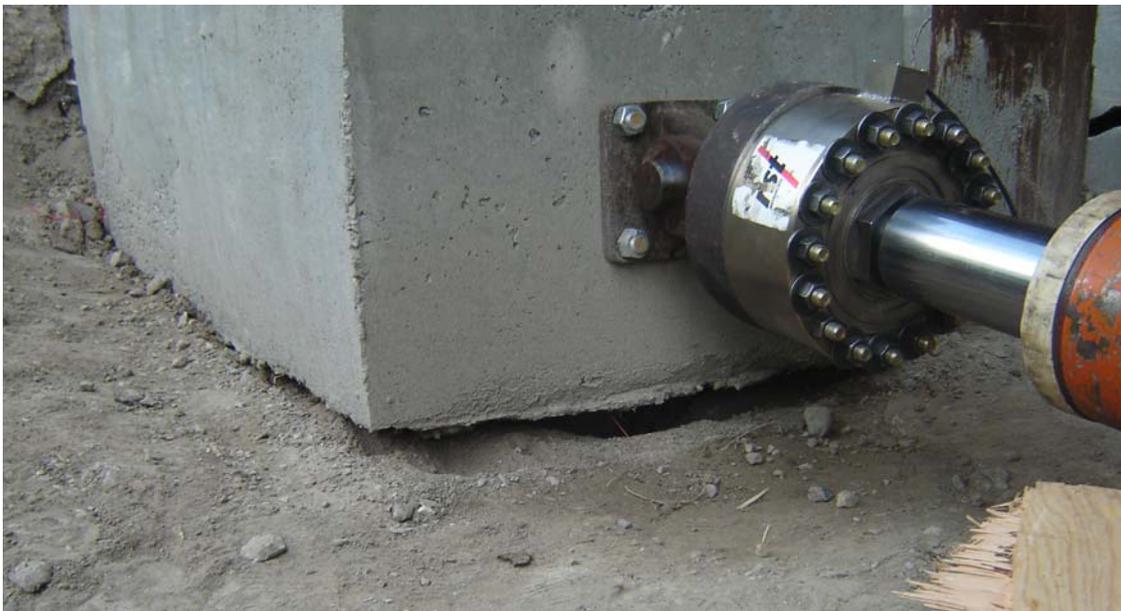
Figure 5-18 Photograph of Pile Cap 4 after pullout failure.
