1. Report No. FHWA/TX-11/0-6103-1		2. Government Accession No.		3. Recipient's Catalog No.	
4. Title and Subtitle STUDIES TO DETERMINE THE EFFECTIVENESS OF LONGITUDINAL CHANNELIZING DEVICES IN WORK ZONES				5. Report Date October 2010 Published: January 2011

STUDIES TO DETERMINE THE EFFECTIVENESS OF LONGITUDINAL CHANNELIZING DEVICES IN WORK ZONES

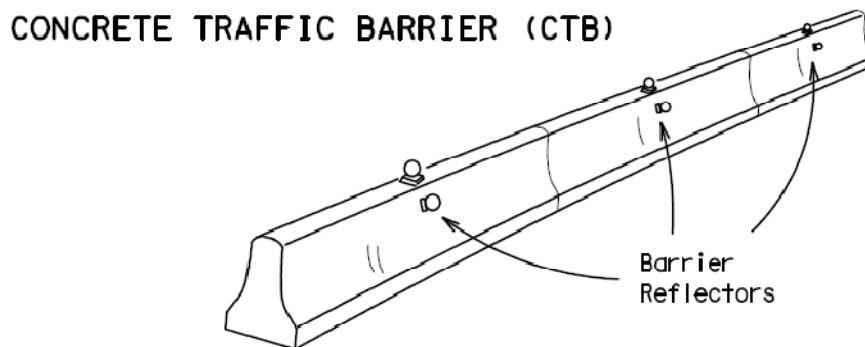
Figure 3. Barrier Reflectors (10).

Texas Transportation Institute (TTI) researchers are also concerned that LCDs are currently delineated the same as barriers. Although continuous line applications of LCDs may appear to form a solid wall, they do not meet the vehicle redirection requirements for temporary traffic barriers. Thus while LCDs must be “crashworthy,” they do not provide positive protection for obstacles, pedestrians, or workers. However, since LCDs look very similar to water-filled barriers, the two devices are often confused with each other. Delineating LCDs the same as barriers may exacerbate the confusion and lead to a false sense of security for both motorists and workers and misapplication of LCDs in work zones.

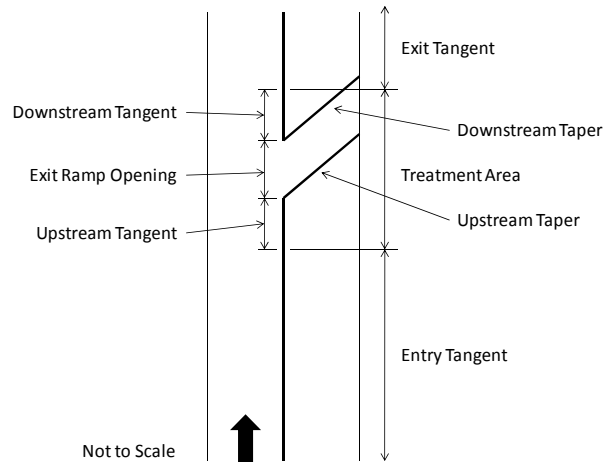
Figure 4. Simulated Work Zone Layout.

than the channelizing device spacing, researchers initially used an exit ramp opening equal to the channelizing device spacing (i.e., 120 ft). Researchers also felt that this smaller exit ramp opening was indicative of the spacing used during shorter-term maintenance activities.

One alternative to improve exit ramp delineation might be as simple as expanding the exit ramp opening. Based on discussions with TxDOT personnel and a review of some urban freeway work zone plans, it was clear that gaps much larger than 120 ft were typically used on longer-term construction projects, even when no deceleration lane was provided. Thus, researchers decided to enlarge the exit ramp opening in the third phase of the study. Although researchers anticipated using a 500 ft gap for the exit ramp opening, it was quickly determined that a gap this large could be clearly seen beyond the limits of the closed-course study. Therefore, researchers chose to simply double the length of the previous exit ramp opening (i.e., 240 ft).

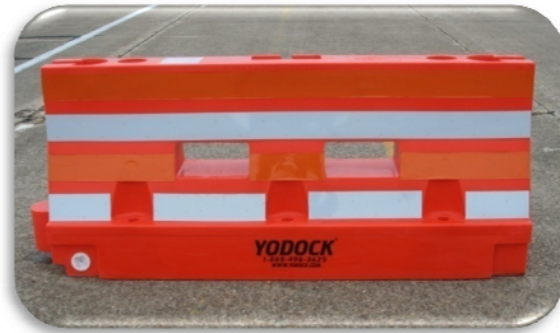
Figure 5. Example of Devices Studied.

Two types of devices were used during this study. The first was conventional channelizing drums, while the other was LCDs placed in a continuous alignment. Both devices are shown in Figure 5.

(a) Standard Drum

(b) LCD

Table 6 contains the dimensions of the devices studied. During a demonstration, TxDOT personnel and TTI researchers determined that taller LCDs (46 inches) blocked the view of the exit ramp opening when used in the upstream tangent and taper, which may cause confusion due to a lack of positive guidance. In addition, TxDOT personnel and researchers were concerned that the taller LCDs might block the view of a stalled passenger car on the exit ramp. Thus, researchers decided to use the 32-inch tall LCDs in this study.

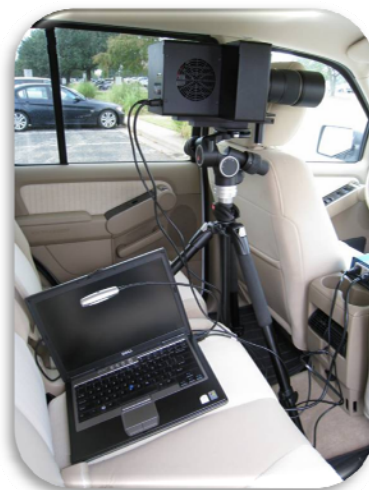
Figure 7. Photometric Analysis Equipment.

All of the photometric measurements were taken at night on the runway network of the Texas A&M University Riverside Campus. Researchers obtained all of the photometric measurements from a 2009 Ford Explorer using a Radiant Imaging ProMetric 16-bit Charge-Couple Device (CCD) Photometer (see Figure 7). The CCD measurements were captured from the driver's perspective. Researchers set the headlights in the low-beam configuration and placed the vehicle in the center of the travel lane adjacent to the closed lane. The elevation of the center of the headlights was 36 inches from the pavement surface, and the CCD elevation was 60 inches from the pavement surface.

measurements from a 2009 Ford Explorer using a Radiant Imaging ProMetric 16-bit CCD Photometer (see Figure 7). As discussed previously in Chapter 3, the CCD measurements were captured from the driver's perspective. Researchers set the headlights in the low-beam configuration and placed the vehicle in the center of the travel lane adjacent to the closed lane. The elevation of the center of the headlights was 36 inches from the pavement surface, and the CCD elevation was 60 inches from the pavement surface. For each treatment, researchers took photometric measurements 100 ft upstream of the beginning of the lane closure. Researchers also measured the illuminance to ensure that the ambient lighting conditions were similar for each treatment during each phase and between phases.

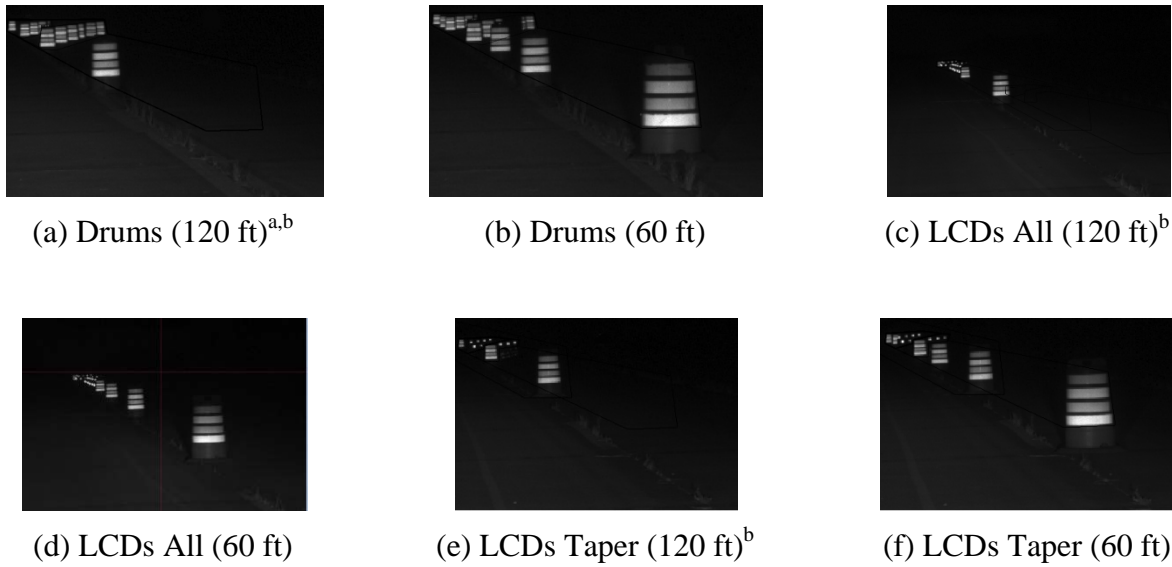
Figure 8. View from the Beginning of the Treatment.

Figure 8 shows the view from the beginning of the six treatments. From this location, the visual field is mainly comprised of the drums on the upstream tangent, and in all but one case (Figure 8a), the exit ramp tapers are not readily apparent. While the closer drum spacing on the upstream tangent (i.e., 60 ft) tended to block the view of the drum taper (Figure 8b), in person the closer drum spacing made the exit ramp opening appear larger. In addition, as shown in Figure 9, the closer drum spacing increased the luminance of the whole array from 1.8 to 5.9 cd/m². Thus, the amount of light reflected back to driver was three times more with the closer drum spacing. Also, the luminance of the exit ramp itself only decreased 0.7 cd/m².

^a Distance in parentheses is the drum spacing on the tangents.
^b Maximum drum spacing on the tangents for a 60 mph posted speed limit (9).

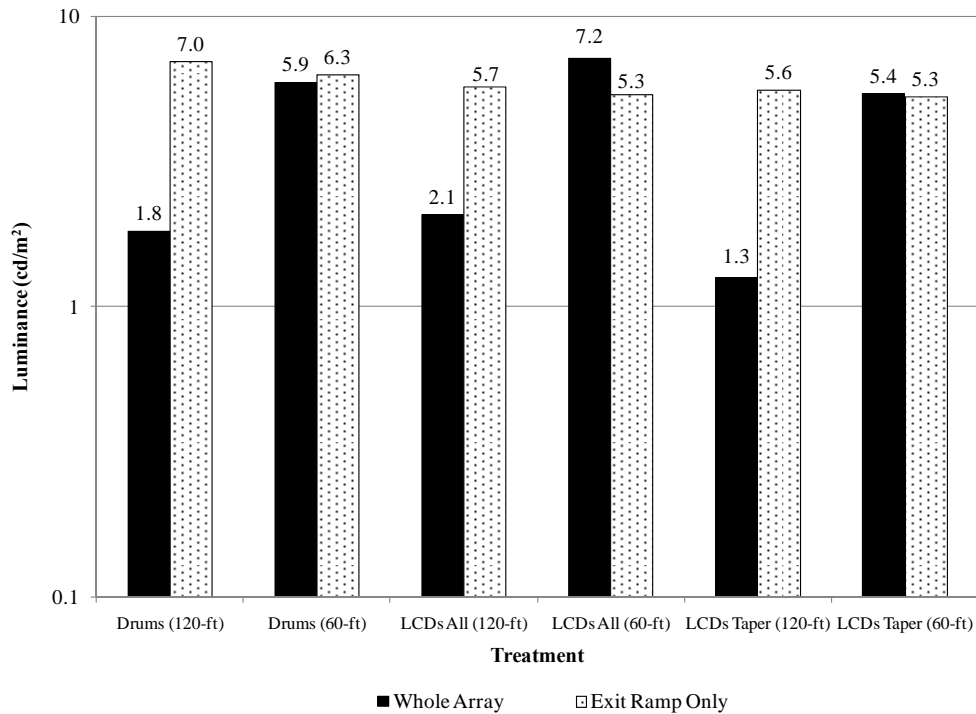
Figure 9. Luminance Data at the Beginning of the Treatment.

As shown in Figure 9, the LCD treatments with the closer drum spacing also increased the luminance of the whole array. In addition, all of the LCD treatments had comparable luminance values of the exit ramp itself (5.3 to 5.7 cd/m^2), and these values were only 1.0 to 1.3 cd/m^2 less than the luminance of the exit ramp itself with all drums.

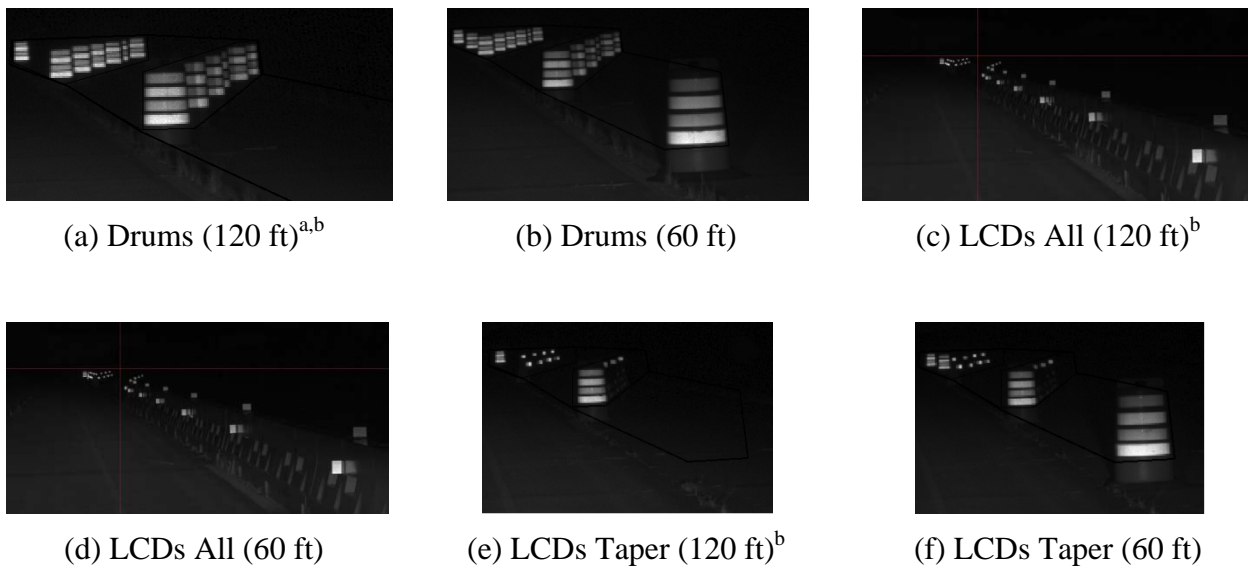
As shown in Figure 10, at 120 ft upstream of the exit ramp, the exit ramp itself comprises a larger portion of the visual field. Figure 11 shows the whole array and exit only luminance values for the treatments 120 ft upstream of the exit ramp. Again, the closer drum spacing increased the whole array luminance for those treatments with drums on the tangent within 120 ft of the exit ramp. Also, the all LCD treatment produced whole array luminance values (1.2 and 1.1 cd/m^2) similar to the other two treatments with drums spaced every 120 ft (1.9 and 0.9 cd/m^2).

^a Distance in parentheses is the drum spacing on the tangents.

^b Maximum drum spacing on the tangents for a 60 mph posted speed limit (9).

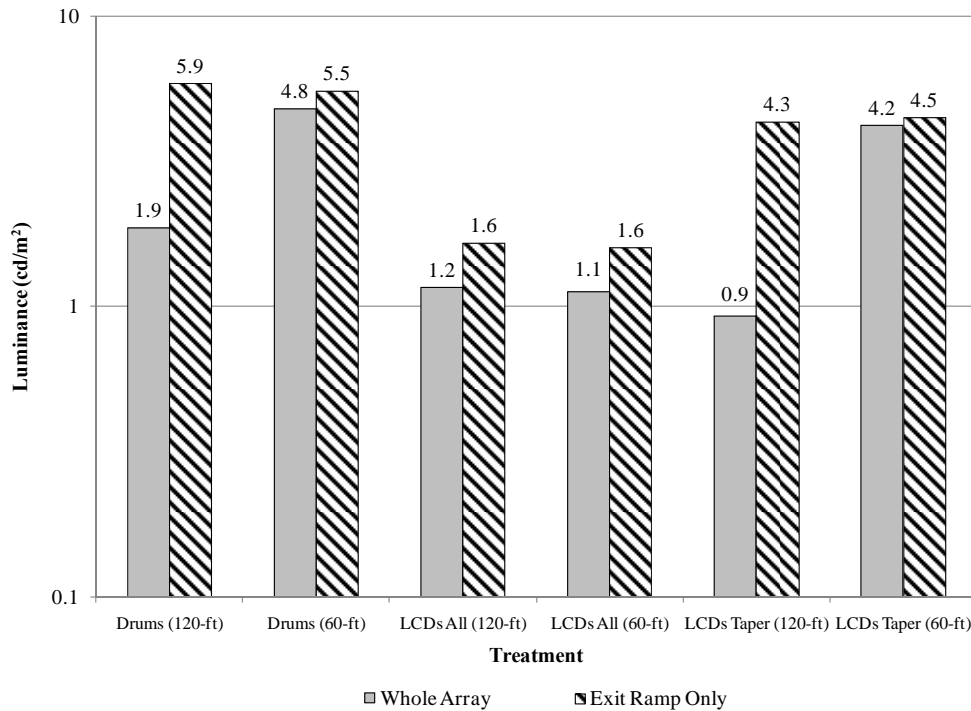
Figure 11. Luminance Data at 120-ft Upstream of the Exit Ramp.

exit ramp luminance because no drums were located in the immediate vicinity of the exit ramp, and the retroreflective surface area was significantly less. However, during the demonstration, the panel observed that the barrier reflectors on the LCDs in the tangent did form a line of delineation that when stopped indicated a gap in the devices through which a driver could exit.

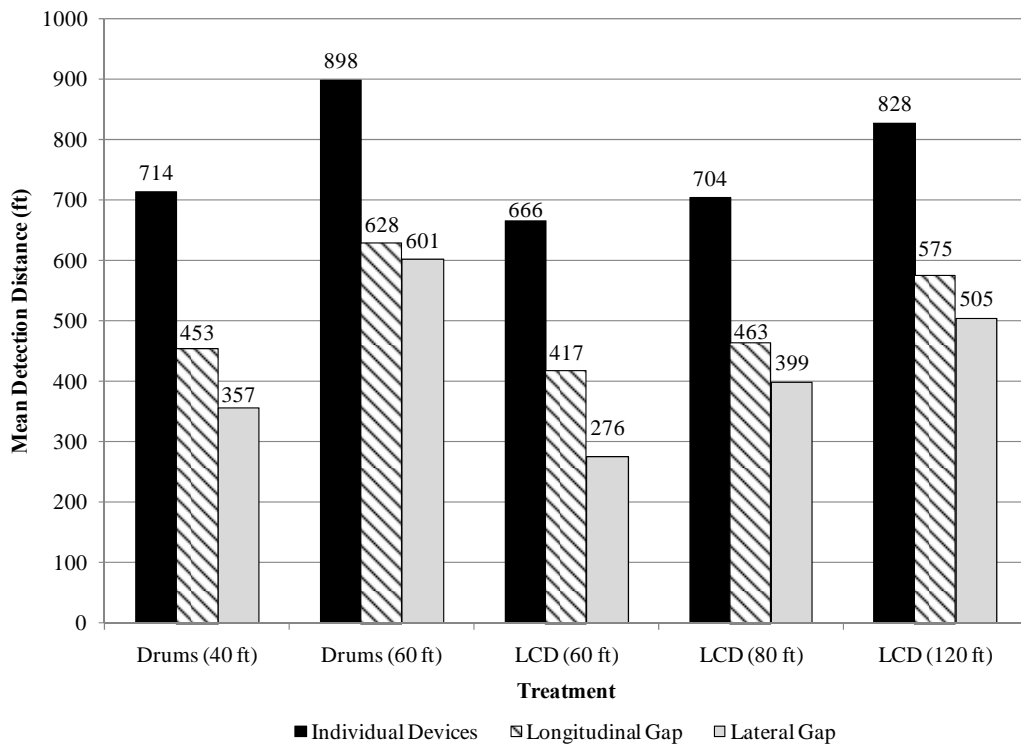
Figure 15. Detection Distance Evaluation Results.

Figure 15 shows the results of the detection distance study. The treatment with drums spaced every 60 ft had the longest mean detection distances for all three measures of effectiveness (898 ft, 628 ft, and 601 ft for individual devices, longitudinal gap, and lateral gap, respectively). In contrast, the treatment with LCDs spaced every 60 ft had the shortest mean detection distances for all three measures of effectiveness (666 ft, 417 ft, and 276 ft, respectively). The significantly shorter detection distances mean that the taper appeared to look like a solid wall of devices until the researcher was closer to the treatment.

The treatment with the closer drum spacing (40 ft) also appeared to look like a solid wall until closer to the treatment (statistically different from the standard drum spacing) and all but one of the mean detection distances for the treatment with the closer drum spacing were determined not to be significantly different from the treatment with LCDs spaced 60 ft (p value = 0.678, 0.626, and 0.023, respectively). Thus, simply reducing the drum spacing also appears to be an effective way to form the illusion of a wall of channelizing devices.

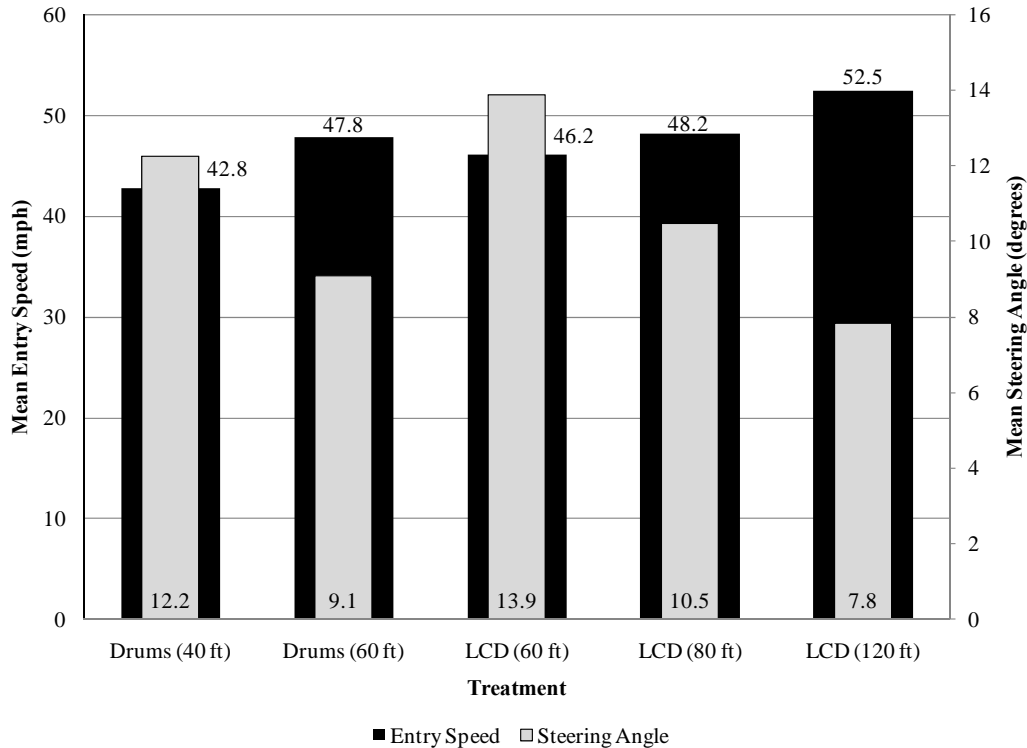
Figure 16. Turning Movement Evaluation Results.

conventional channelizing drums. So, at the same spacing, a much larger steering angle is required to execute the turning movement without striking the channelizing devices.

However, the mean entry speed and mean steering angle for the treatment with drums spaced every 40 ft (42.8 mph and 12.2 degrees) were both significantly different from the treatment with drums spaced every 60 ft. In addition, researchers determined that both measures of effectiveness for the treatment with drums spaced every 40 ft were not significantly different from those for the treatment with LCDs spaced every 60 ft. Thus, simply reducing the drum spacing appears to result in similar turning movement characteristics as using LCDs spaced every 60 ft.

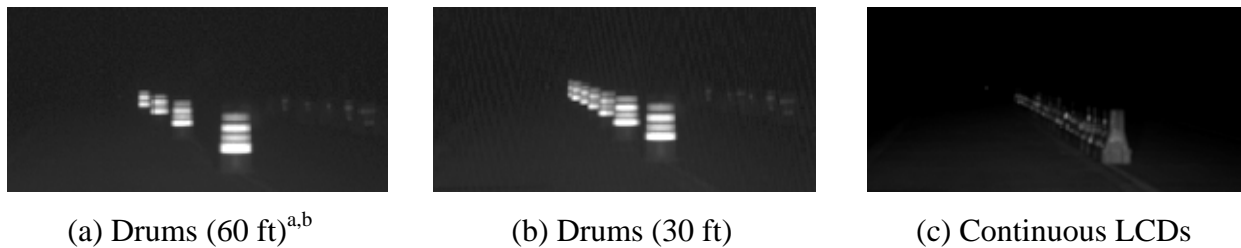
Figure 18 and Figure 19 show the view of the Phase I tangent and taper treatments, respectively. The whole array luminance data for these treatments are shown in Figure 20 and Figure 21, respectively. As expected, the whole array luminance measurements for the drum treatments with half the standard device spacing (28.2 and 18.1 cd/m^2 , respectively) were slightly higher than the drum treatments with the standard device spacing (21.0 and 11.6 cd/m^2 , respectively) since more retroreflective surface was available. It is also apparent from Figure 18 and Figure 19 that the drum treatments with half the standard device spacing look more like a wall of a devices at night (i.e., the gap between drums is less noticeable).

^a Distance in parentheses is the drum spacing.

^b Maximum drum spacing on a tangent for a 30 mph posted speed limit (9).

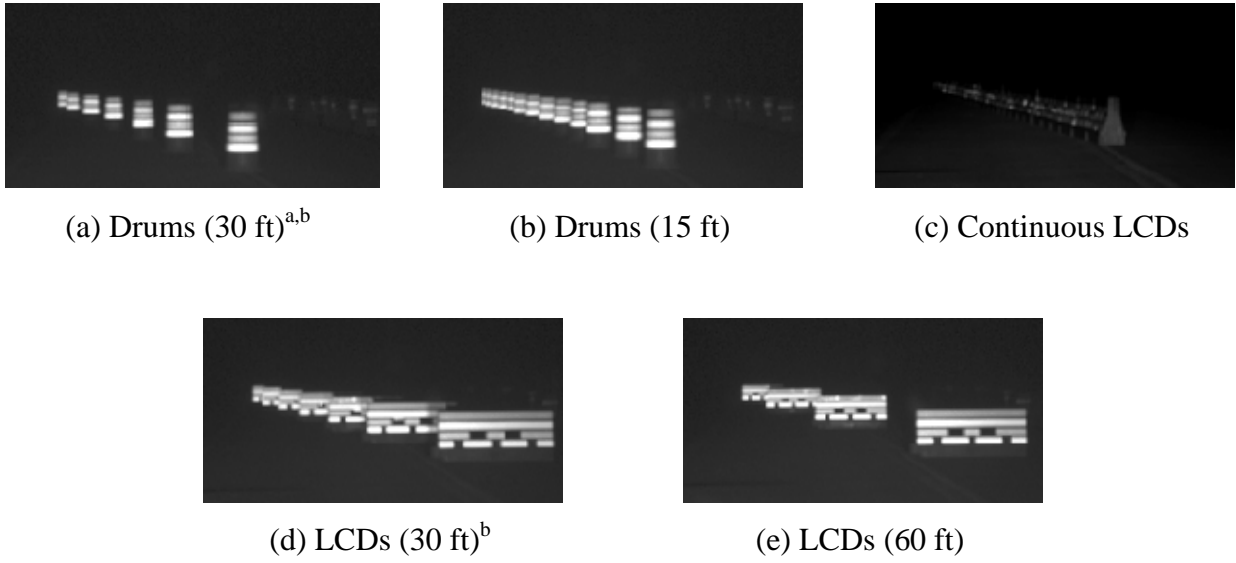
Figure 19. Phase I Taper Treatments.

^a Distance in () is the channelizing device spacing.

^b Maximum channelizing device spacing on a taper for a 30 mph posted speed limit (9).

The continuous LCD treatment with retroreflective sheeting applied in a similar fashion to drums had considerably lower luminance values for both tangents and tapers (0.7 and 0.4 cd/m^2 , respectively) and thus is not readily apparent to drivers at night. These findings are not surprising given that retroreflective sheeting is not designed for the steep entrance angles produced when LCDs are used continuously in a lane closure (e.g., 82 degrees at 100 ft upstream of the merging taper). The retroreflective sheeting on the LCDs was only effective when placed as a barricade, perpendicular to the traffic flow (30.3 and 25.0 cd/m^2 , respectively). However, as shown in Figure 19, the longer LCD spacing (60 ft) resulted in less overlap of the devices, and the gap between the first two devices was readily apparent. Thus, the array of LCDs looked less like a wall of devices compared to the 30 ft LCD spacing.

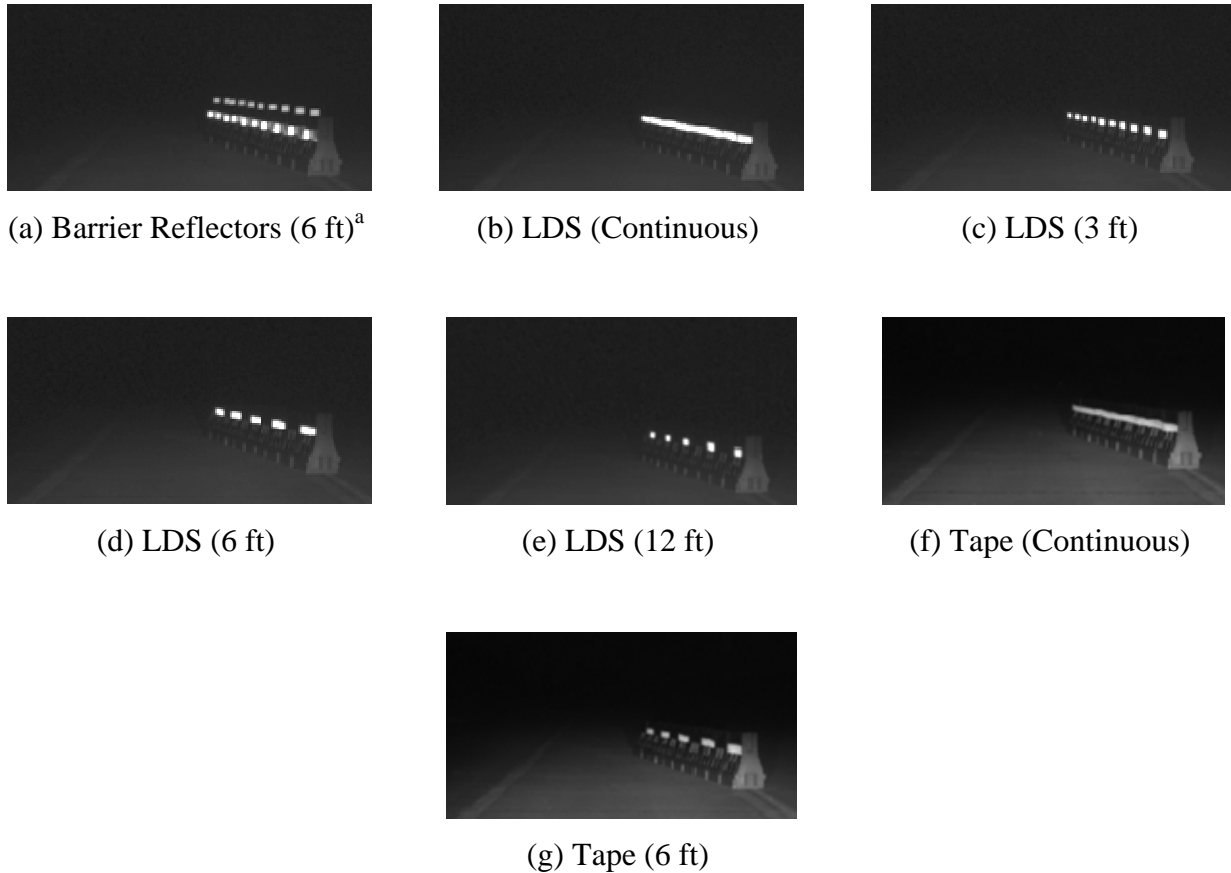
Figure 22. Phase II Taper Treatments.

Figure 22 shows the view of the Phase II taper treatments, and Figure 23 shows the whole array luminance data for these treatments. The LDS panels in a continuous application produced the highest whole array luminance value (5.5 cd/m^2), followed by the barrier reflectors spaced every 6 ft (4.4 cd/m^2). The LDS panels spaced every 6 ft produced a slightly higher whole array luminance value (2.9 cd/m^2) than the LDS panels spaced every 3 ft (2.5 cd/m^2). This may be due to the use of two panels in the middle of every other LCD to form the 6-ft spacing versus one panel in the middle of each LCD to form the 3-ft spacing. The standard temporary pavement marking tape produced the least amount of whole array luminance (0.7 and 0.5 cd/m^2 , respectively).

^a Distance in parentheses is the barrier reflector spacing.

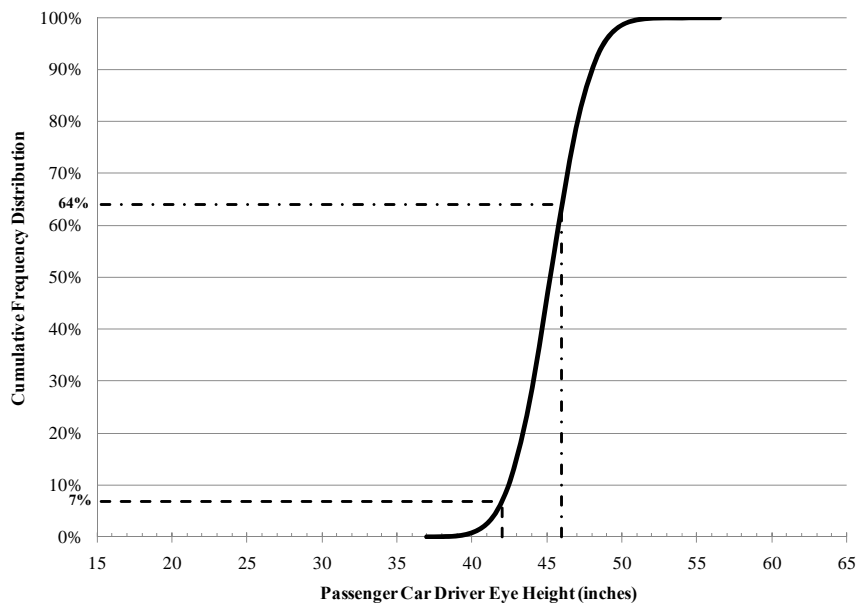
Figure 27. Comparison of Passenger Car Driver Eye Height Distribution to LCD Heights.

A passenger car driver’s ability to see over obstructing objects, such as LCDs, is a function of driver eye height and the height of the LCDs. As previously discussed, LCDs range in height from 18 to 46 inches; however, all but one type of LCD is 32 inches tall or higher. Using the descriptive statistics for driver eye height in Table 25, researchers computed the cumulative distribution function for driver eye height shown in Figure 27. It is apparent from the graph that almost all drivers would be able to see over LCDs that are less than 37 inches tall (five products). However, a significant percentage (64 percent) of the passenger car drivers would not be able to see over the tallest LCDs (46 inches).

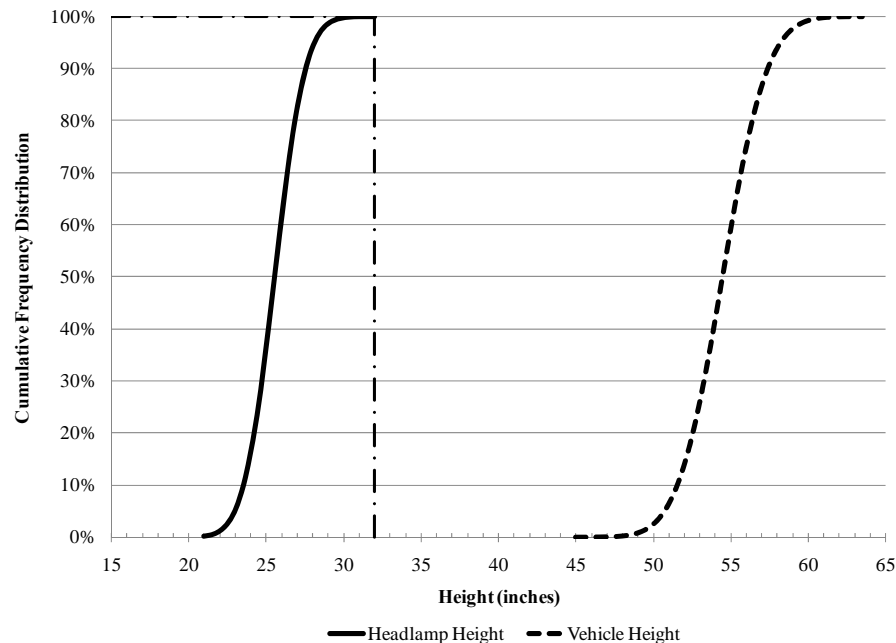
Figure 28. Comparison of Critical Object Height Distributions to LCD Heights.

A passenger car driver's ability to see a critical object located beyond obstructing objects, such as LCDs, is also a function of the critical object height and the height of the LCDs. Figure 28 shows the cumulative distribution functions of two critical object heights (18). During daylight hours, the critical object height is assumed to be the height of vehicles approaching on the major road. It is apparent from the graph that almost all passenger car vehicle heights are higher than the tallest LCDs (46 inches) and thus could likely be seen during daylight conditions. However during a panel demonstration, researchers and TxDOT personnel noted that it was more difficult to distinguish a passenger car from the 46-inch tall LCDs than the 32-inch tall LCDs, especially when the two objects were similar in color (e.g., a red car and orange LCD).

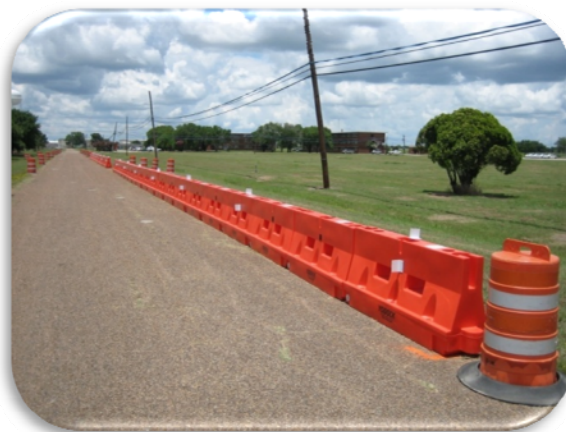
Again, all LCDs must be crashworthy; however, the test level for which each device is approved varies. Also, some LCDs can be used with and without ballast (i.e., water or sand), and some LCDs have been approved with or without the use of other traffic control devices (e.g., warning lights, delineators, and signs). As shown in Figure 32, in the exit ramp and driveway scenarios studied, the blunt end of the continuous LCD sections was either exposed or shielded with a drum. Additional crash testing may be needed to determine the necessity for end treatments if there is a potential for instability when an end-on collision occurs.

(a) Exposed Ends of the Downstream Taper and Tangent – Exit Ramp Scenario.

(b) Drum in Front of Upstream End of Continuous LCDs – Driveway Scenario.
