**September 2010**

WHRP 10-12

**MONITORING AND LOAD DISTRIBUTION STUDY FOR THE LAND BRIDGE**

# **Final Report**

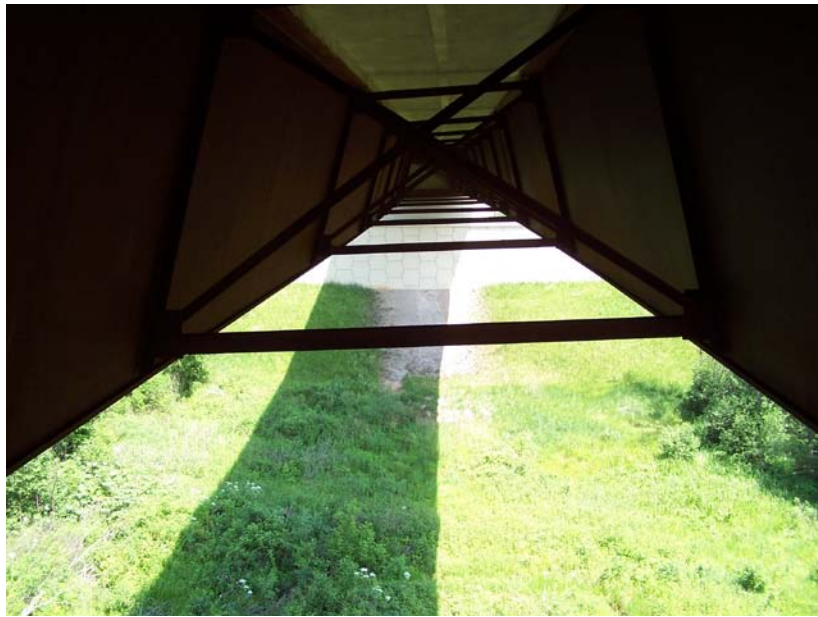
**Figure 3.3: View Between Bridge Girders**

Every 4.25 meters (14 ft), connection angles are bolted to the outside of the web to support bridging angles between the two side-by-side girders (see Figure 3.3). Site topography and highway layout also required a slight sweep in the bridge from west to east as shown in Figure 3.4.

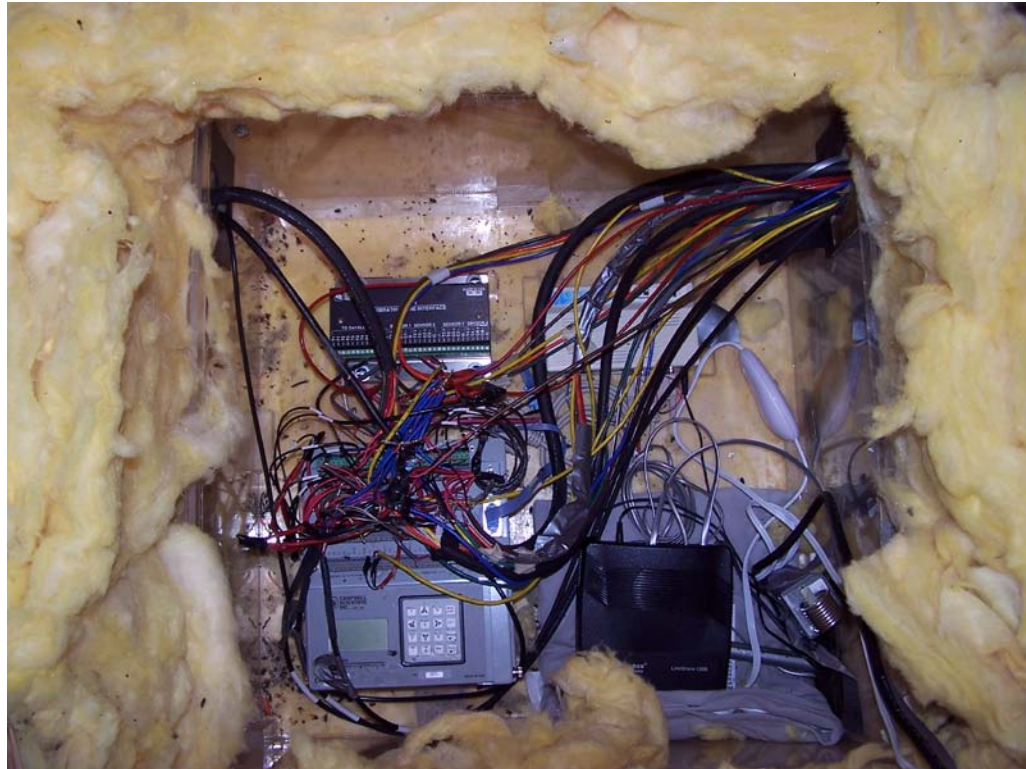
results of some of the data and it was determined through laboratory experimentation that this drift was due to thermal fluctuations of the datalogger itself. Further experimentation showed that maintaining a consistent temperature within the control center helped to minimize this effect. Figure 3.5 shows the command center in the east girder.

**Figure 3.5: Data Acquisition Command Center**

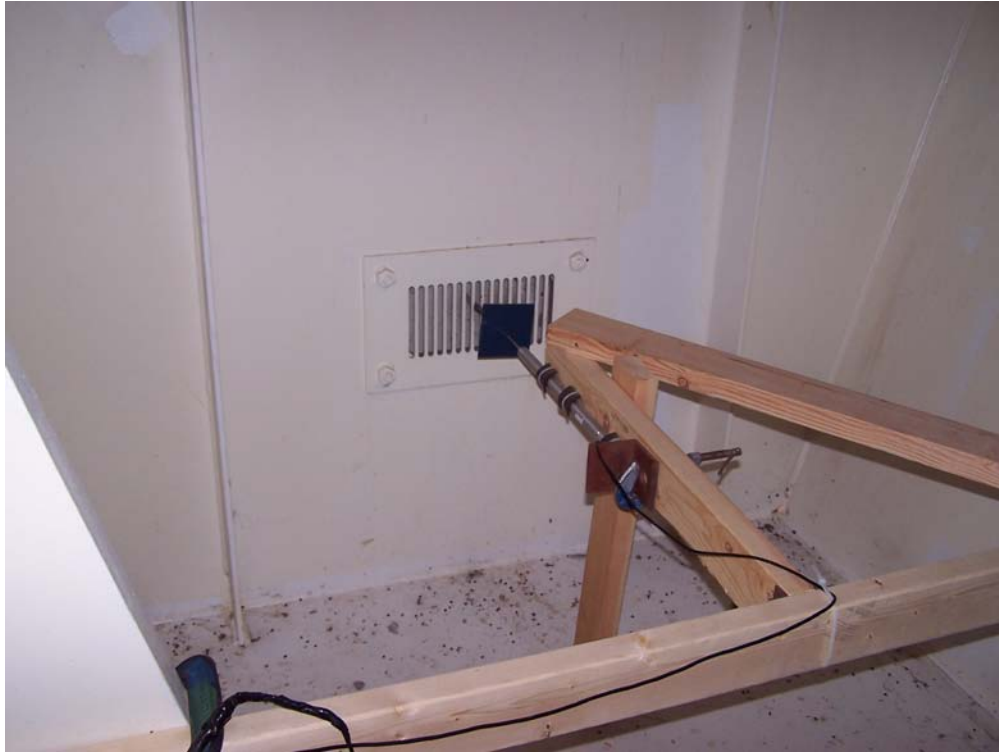
determine the expansion or contraction of each of the bridge girders due to thermal cycles.

**Figure 3.7: Longitudinal Expansion/Contraction LVDT**

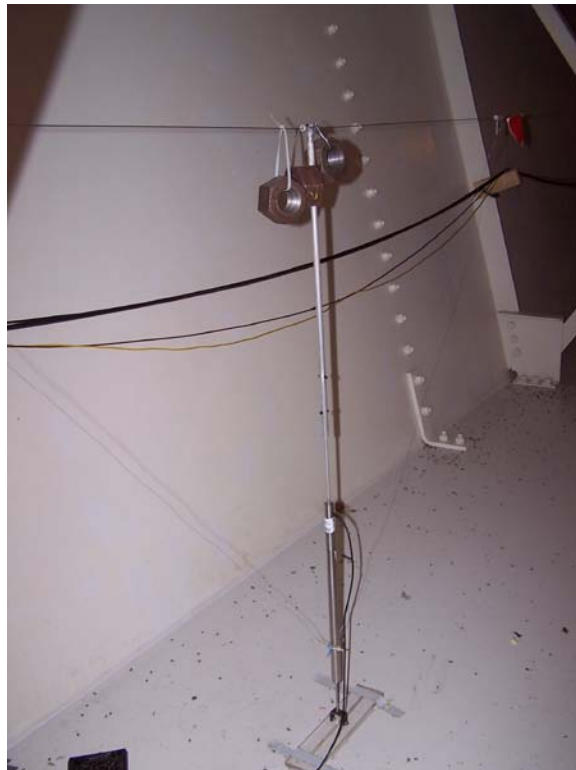
the bridge girder. Since the bridge girder will also be experiencing longitudinal expansion and contraction, it became necessary for the mid-span deflection LVDT to be able to accommodate this movement (in the longitudinal direction, parallel to the girder span). In order to do this, the custom-fabricated track had a slot which accepted a roller that was attached to the core of the LVDT, allowing movement of the LVDT with bridge expansion and contraction while guiding the core of the LVDT and not allowing any lateral movement (perpendicular to the girder span).

**Figure 3.8: Mid-Span Deflection LVDT**

Since this was the first time the research team employed this method, great care was taken to ensure that it would provide meaningful and reliable results. A scaled-down, trial run of this setup was created in the Structural Laboratory at UWM. With this setup the research team was able to ensure that the LVDT would truly function in a frictionless manner, not causing the stainless steel cable to move up and down with the

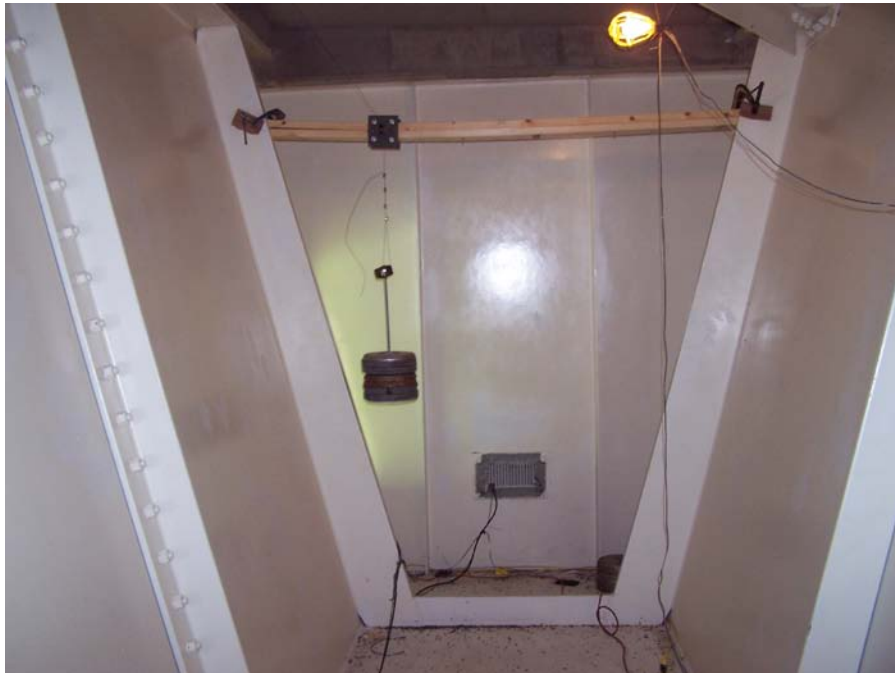
**Figure 3.9: South End of Bridge Girder**

At each end of the trapezoidal box girders, bearing stiffener plates of Grade 345W (Grade 50W,  $f_y = 50$  ksi) steel are welded to the inside of the webs using fillet welds, and to the bottom flange using a double-bevel weld (see Figure 3.9). Connection plates are welded to the inside of the web approximately every 4.25 meters (14 ft) along the length of the bridge using fillet welds and have cross-bracing angles connected to them (see Figure 3.2). T-sections are bolted to connection plates inside the girder, at the top of the web, and run diagonally in the horizontal direction along the length of the bridge to provide lateral support to the top flanges.

The research team employed a system which recognizes the fact that at the ends, or supports, of each girder, there is no vertical deflection occurring; so the mid-span deflection needs to be taken with respect to these end points. A system was employed (see Figures 3.8 and 3.9) in which a thin, stainless steel cable was attached near the top of the end stiffeners on the north end of each girder. This cable was then extended continuously to the south end of the bridge. Here, the cable is run through a pulley system that is again attached to the end stiffeners and dead weight is attached to this free end of the cable (see Figure 3.9). This produces a system in which there is always a constant tension on the cable. As the bridge expands and contracts, since the cable has a constant tension, the elevation of the cable at mid-span is not changing since it is supported at each end by the stationary abutments. As the girder deflects vertically due to live loading or due to thermal effects, the elevation of the steel cable does not vary. Since a stationary reference point now exists at mid-span, a vertical deflection may be taken as the difference between the bottom of the deflecting girder and the stationary steel cable. In order to measure this vertical deflection, a LVDT was hung from the steel cable, with the core of the LVDT bearing on a custom-fabricated track fastened to the top surface of the bottom flange of the bridge girder (see Figure 3.8). In contrast to the LVDT employed for measuring longitudinal expansion or contraction, the core (the inner, moving element) of this LVDT is freely moving and frictionless, which provides no resistance to movement. The core bears on the bottom flange of the girder due to gravity only. For this application, this is an important property so that the LVDT does not push back up on the steel cable, since this is our fixed datum point. The body of the LVDT now is stationary while the core is able to freely move up and down with the bottom of

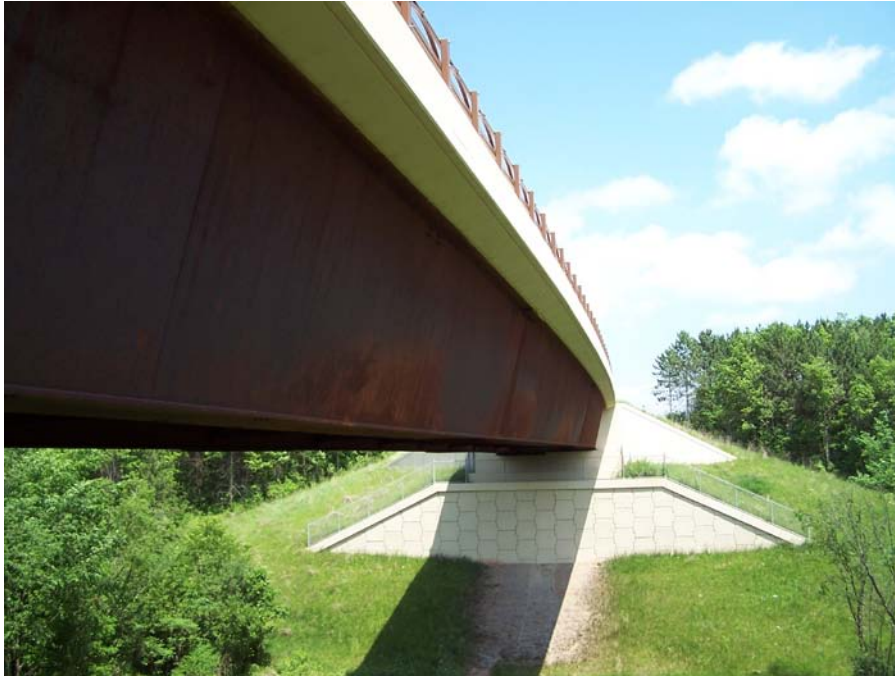
concrete deck. As seen in Figure 3.10, the bridge overhang casts a shadow on a portion of the face of the bridge girder for much of the day, depending on season and time of day. The research team considered this effect when placing the thermistors on the bridge steel to obtain steel temperature. A total of five thermistors were placed on the bridge to provide these measurements. The thermistors were placed on the interior surface of the bridge girder at mid-span, at approximately one-third of the height up from the bottom of the girder. This location was chosen so as to experience the maximum effects of the sunlight and to avoid experiencing any shadows due to the bridge overhang, while also distancing the thermistor from the “cold” bottom flange of the girder, which does not receive any sunlight. Thermistors were placed on both the east and west walls of each girder, to allow for a comparison of the temperature differential experienced due to sunlight exposure. One thermistor was also hung outside of the girder at mid-span, between the two girders. This was accomplished by hanging the thermistor out of a joint at a splice point of the girder. This thermistor would not experience any effects due to sunlight as it is hung between the two girders and does not experience any sunlight. The purpose of this thermistor is to get information regarding outdoor ambient air temperature to evaluate bridge movements due to average daily and seasonal temperature changes.

**Figure 3.10: East Face of Bridge**

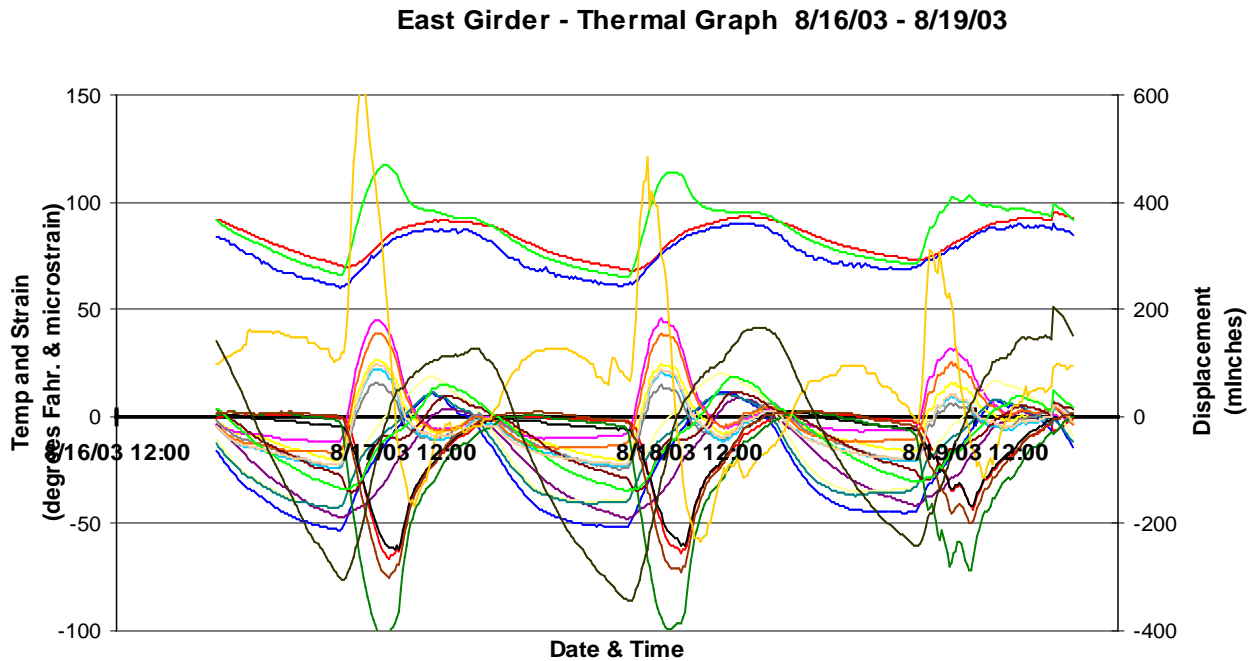
trials is shown in Figure 3.12. As a result of this data, the research team was able to recognize that outdoor ambient air temperature was not so much the principle cause of the strains observed at various gages; rather, it was the presence of sunlight on the exterior surfaces of the bridge.

**Figure 3.12: East Girder- Thermal Trial Results**

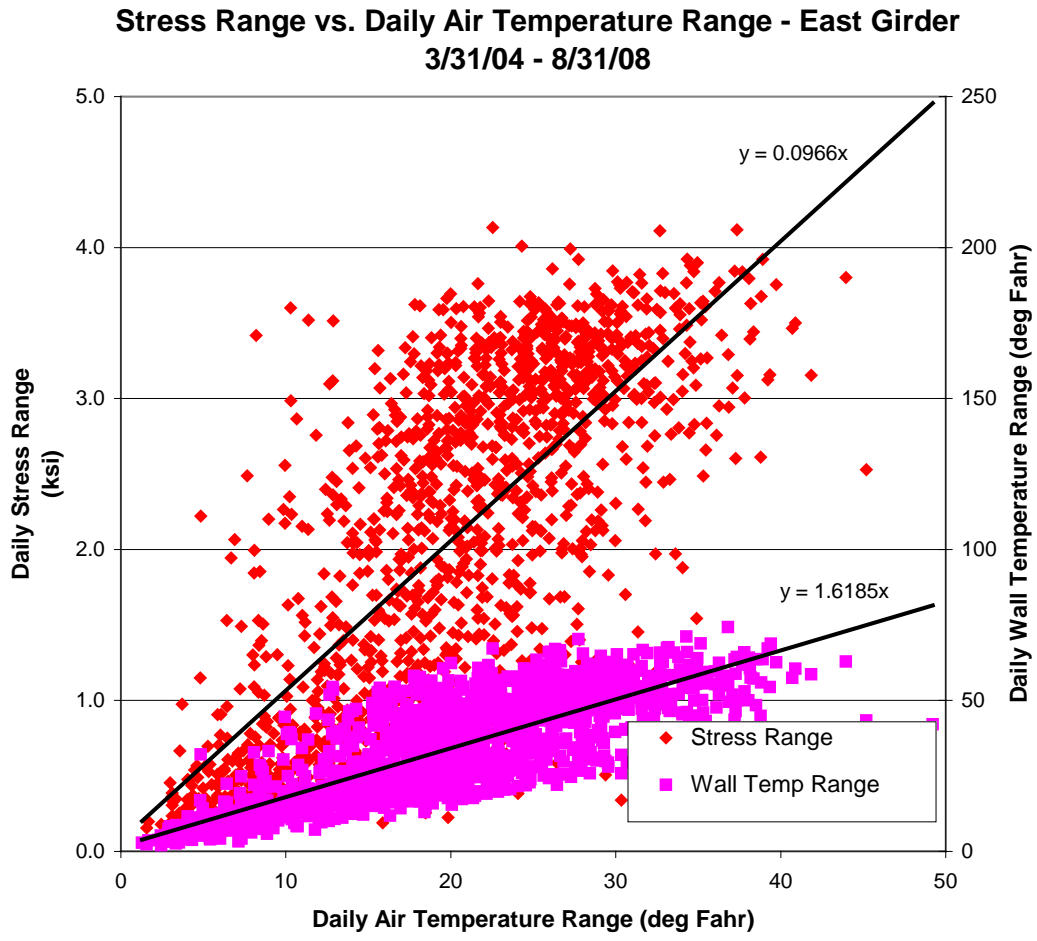
Figures 5.9 and 5.10 present a simple way to evaluate what magnitude of stress ranges and wall temperature ranges can be expected in the Land Bridge on any given day based on the air temperature range that is anticipated.

Figure 5.9: Observed Daily Thermal Effects vs. Daily Air Temp. Range- East Girder

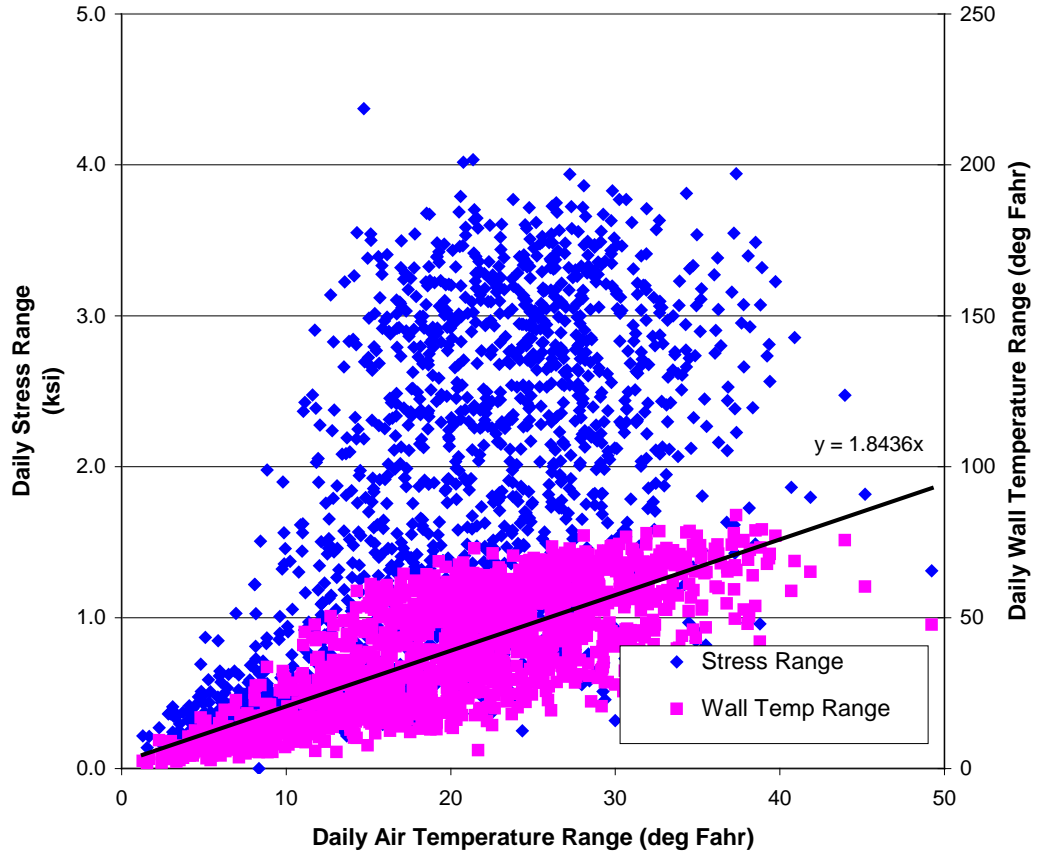
Figure 5.10: Observed Daily Thermal Effects vs. Daily Air Temp. Range- West Girder

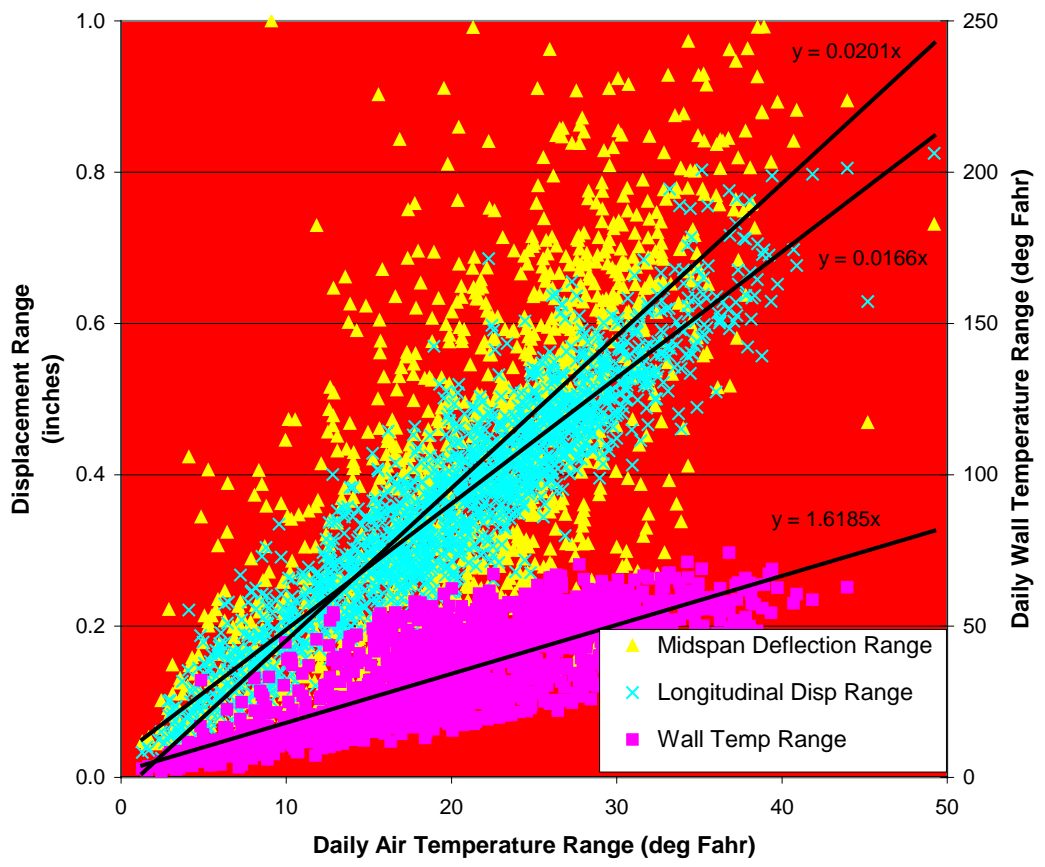
Figure 5.11: Thermal Movements vs. Daily Air Temp. Range- East Girder
