Research Report for ALDOT Project 930-645

# EVALUATION OF CRACKING OF THE US 331 BRIDGE DECK

The Alabama Department of Transportation

AUGUST 2010

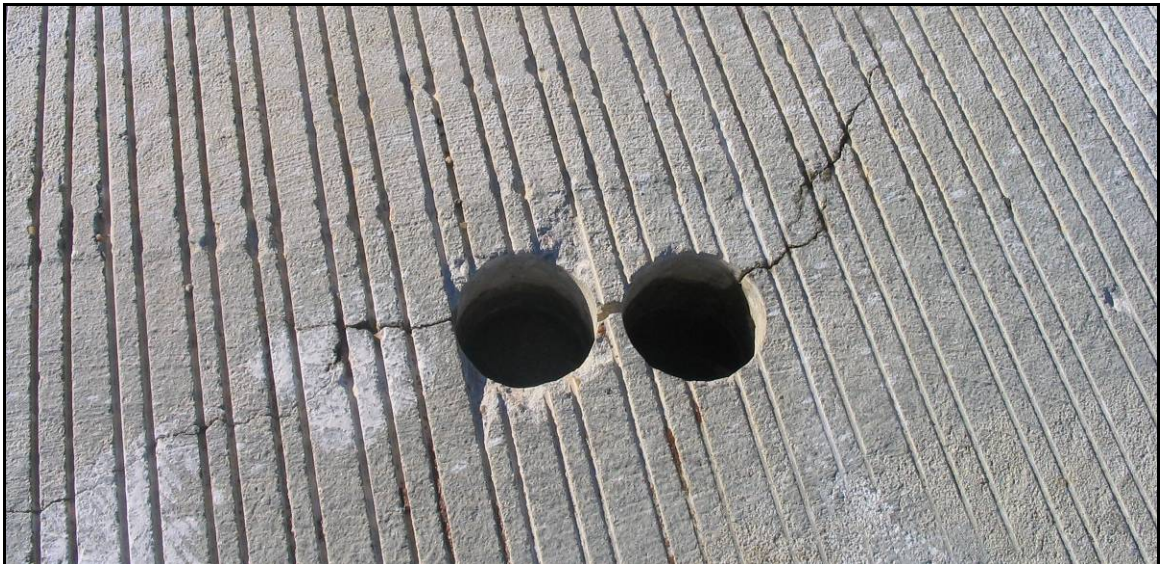
Figure 1-1: Core holes through cracks in the US 331 bridge deck

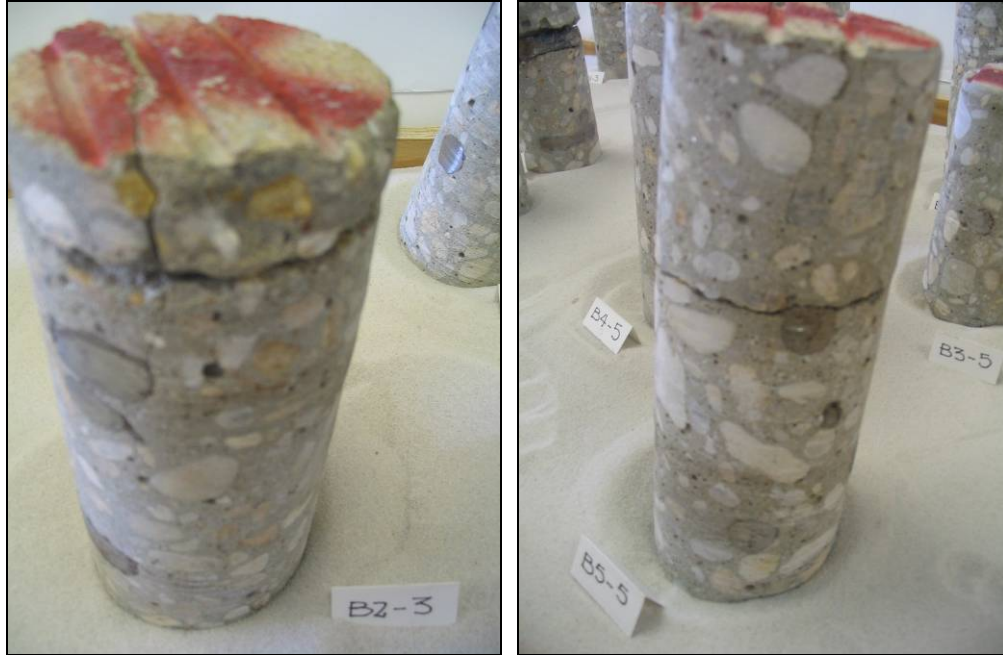
**Figure 1-4:** Cores from the US 331 deck with vertical and horizontal cracks

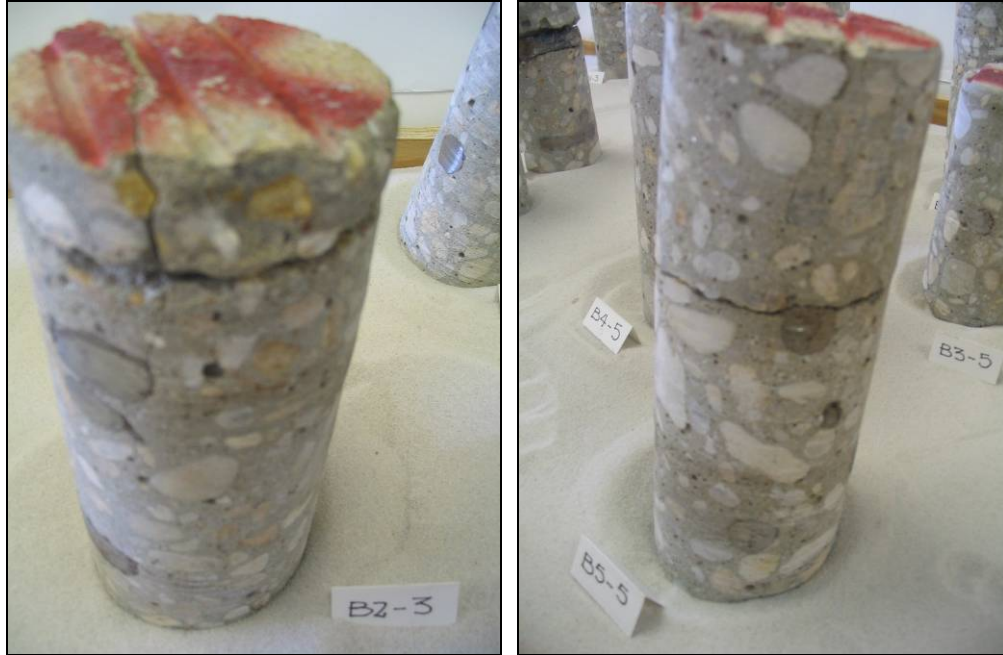
**Figure 3-6:** Cores from the US 331 deck with vertical and horizontal cracks

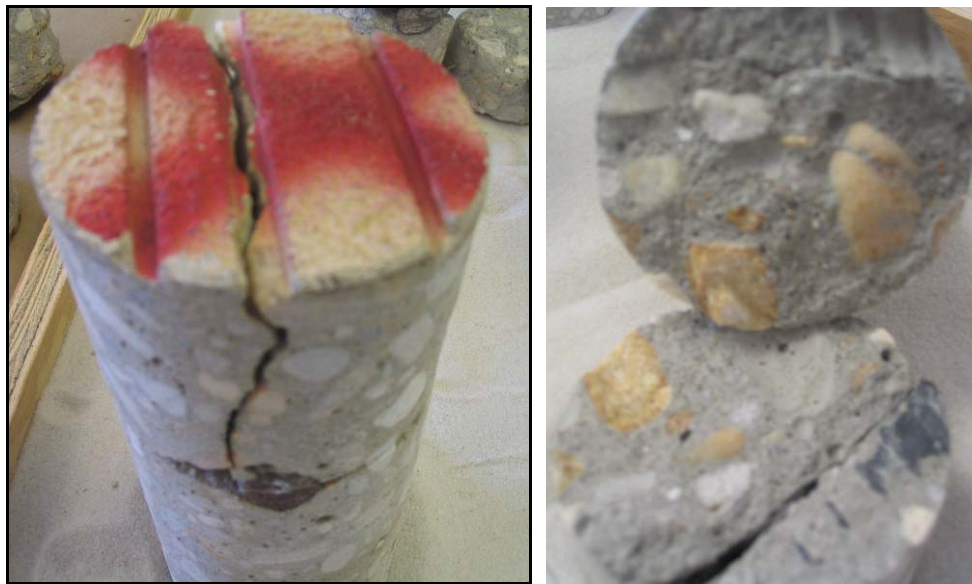
**Figure 3-7:** Cores from the US 331 deck with vertical and horizontal cracks

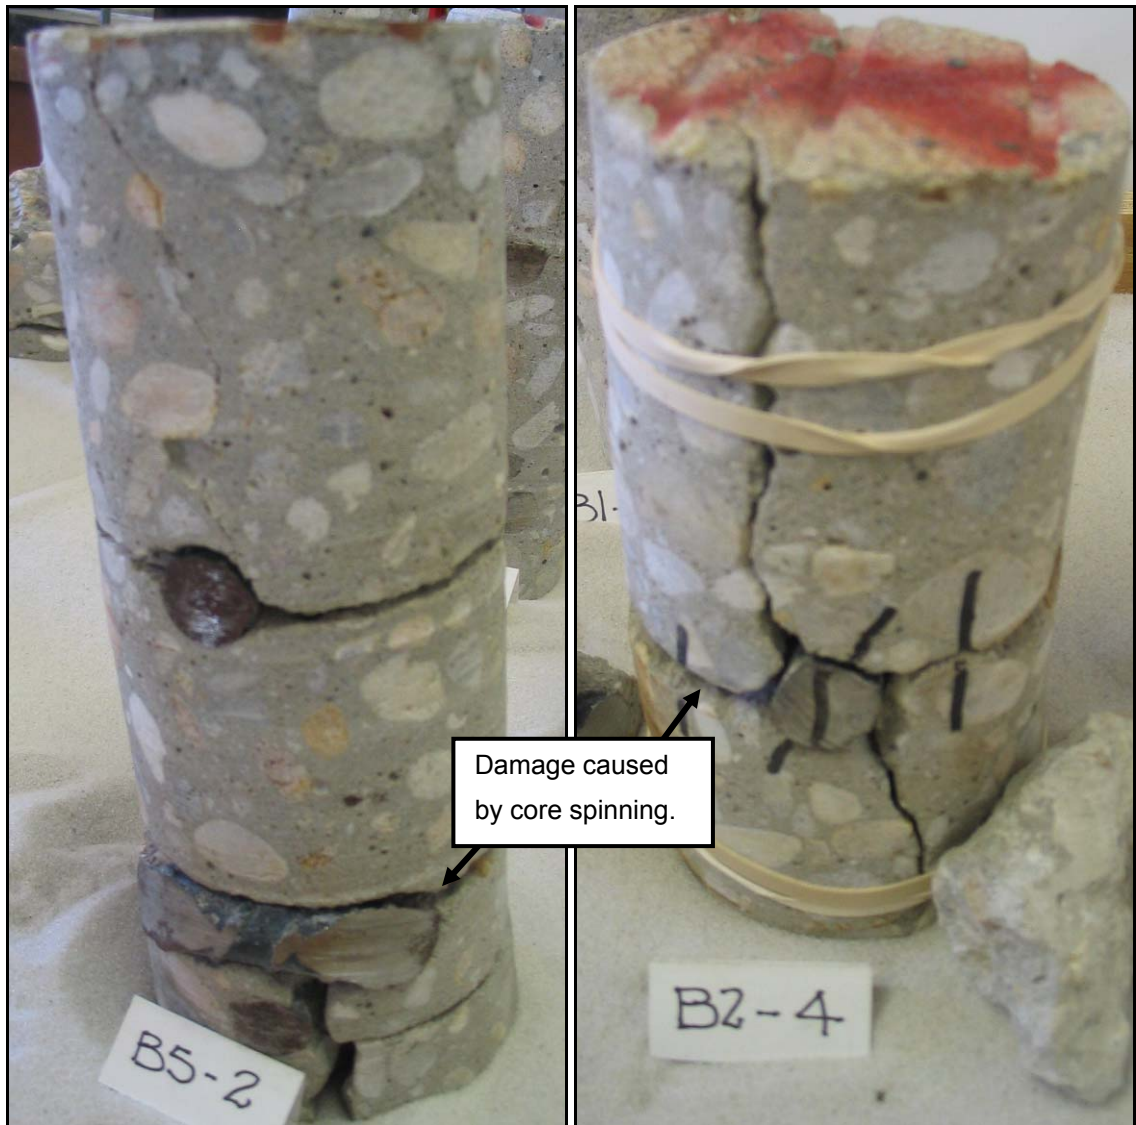
**Figure 3-8:** Cores from the US 331 deck with vertical and horizontal cracks

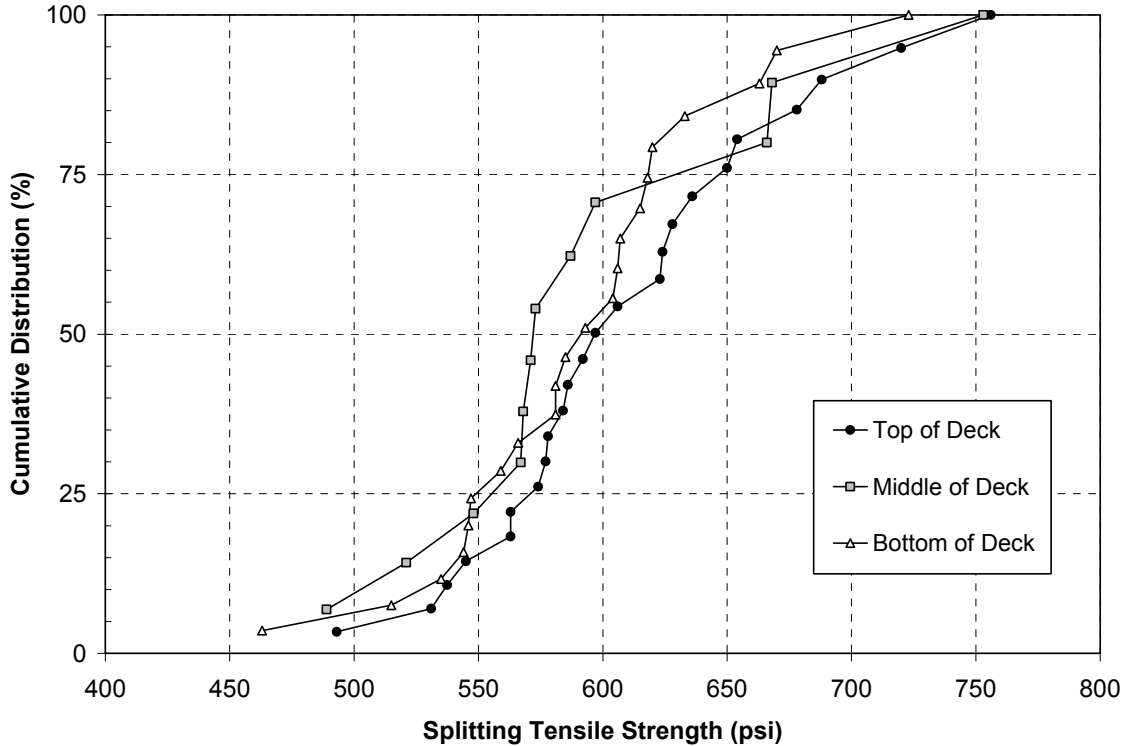
The cumulative distribution of splitting tensile strength at the top, middle, and bottom of the deck is shown in Figure 3-13. The distribution of tensile strengths at the top, middle, and bottom of the deck are very similar. The average strength at the top of the deck is slightly greater than at any of the other locations. The data reveals no apparent loss of splitting tensile strength at the top of the deck, and the average measured splitting tensile strength exceeds the value estimated from the average in-place compressive strength obtained. These results indicate that the cracking on the US 331 bridge deck is probably not attributable to inadequate curing.

**Figure 3-13:** Splitting tensile strength distribution of Pour C and D of the US 331 deck

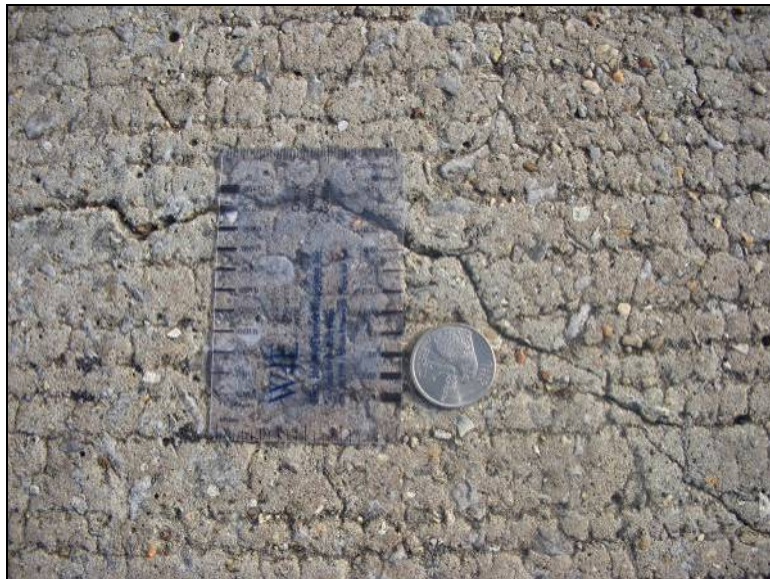
**Figure 3-22:** Picture of the wide surface cracks on the bridge deck on the Courtland Bypass

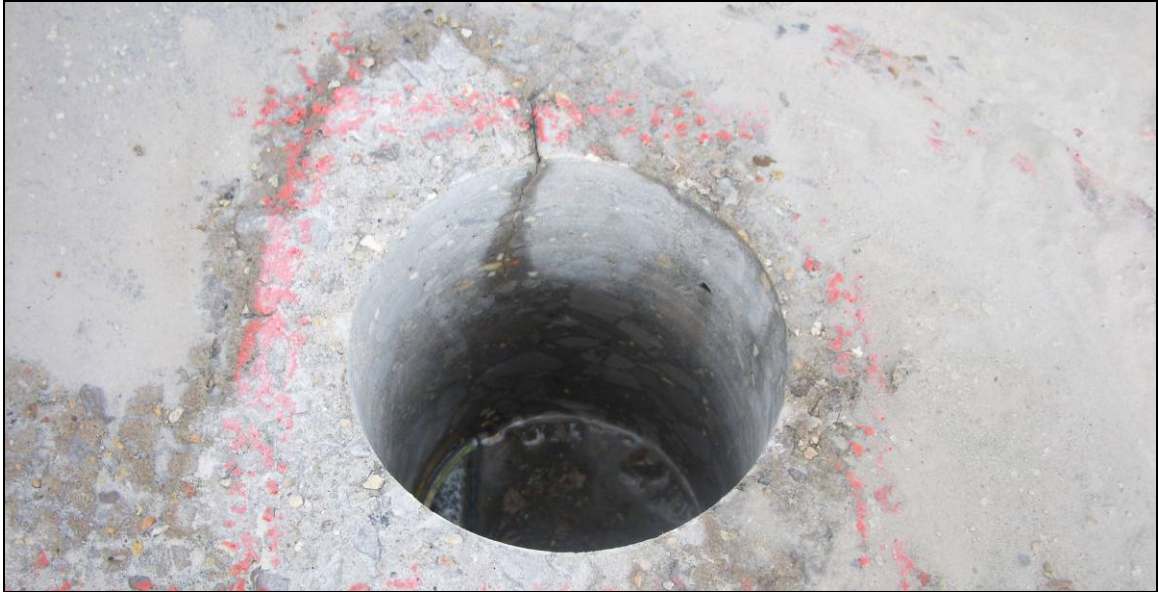
**Figure 3-23:** Pictures of the core hole on the bridge deck on the Courtland Bypass

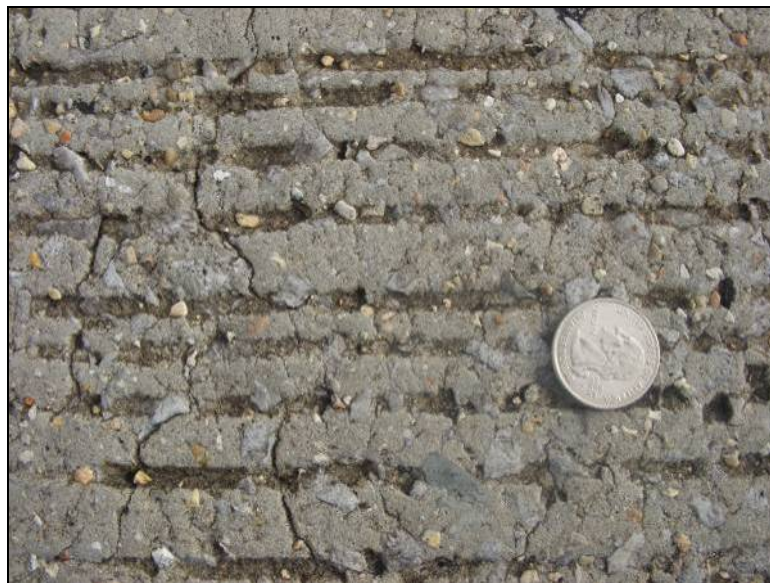
**Figure 3-25:** Picture of some surface cracks on the bridge deck on SR 216 over L&N RR

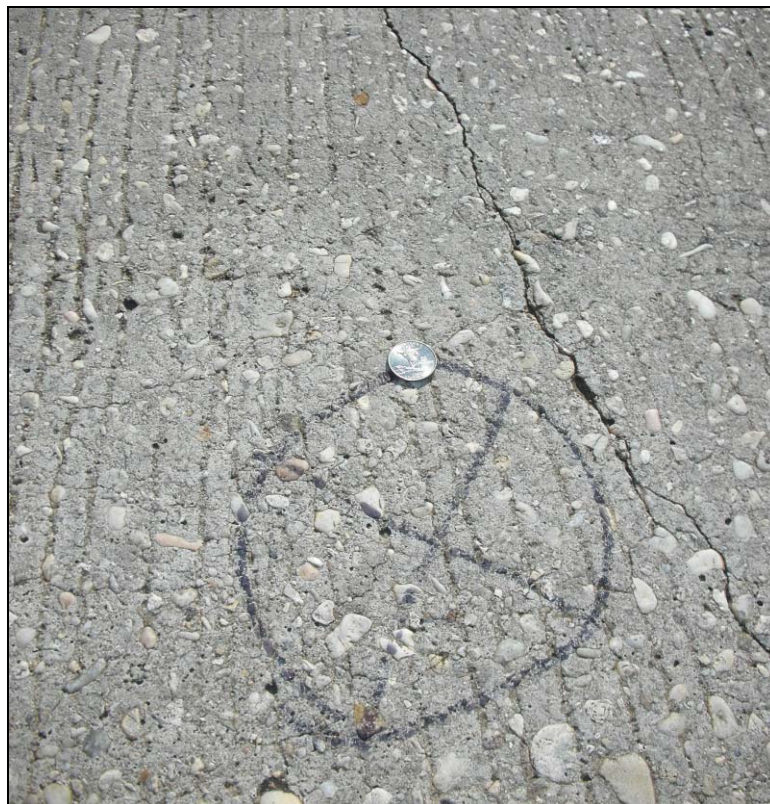
**Figure 3-27:** Picture of a wide surface crack on the SR 21 bridge deck at Tunnel Springs

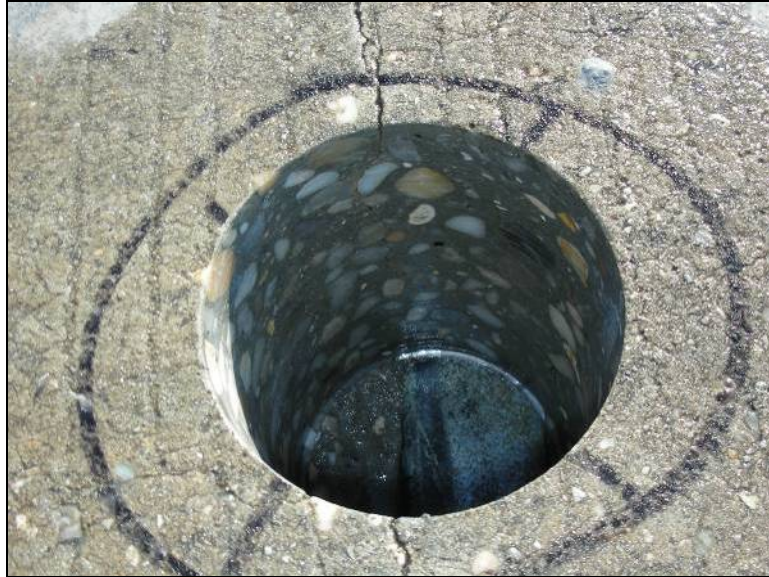
shown in Figure 3-28. Cores were extracted adjacent to transverse cracks; however, no horizontal cracks were present in the cores. The coefficient of thermal expansion of the cores was determined in accordance with AASHTO TP 60 (2004) to be  $6.95 \times 10^{-6} / ^\circ\text{F}$ .

**Figure 3-28:** Picture of the core hole on the bridge deck on SR 21 at Tunnel Springs

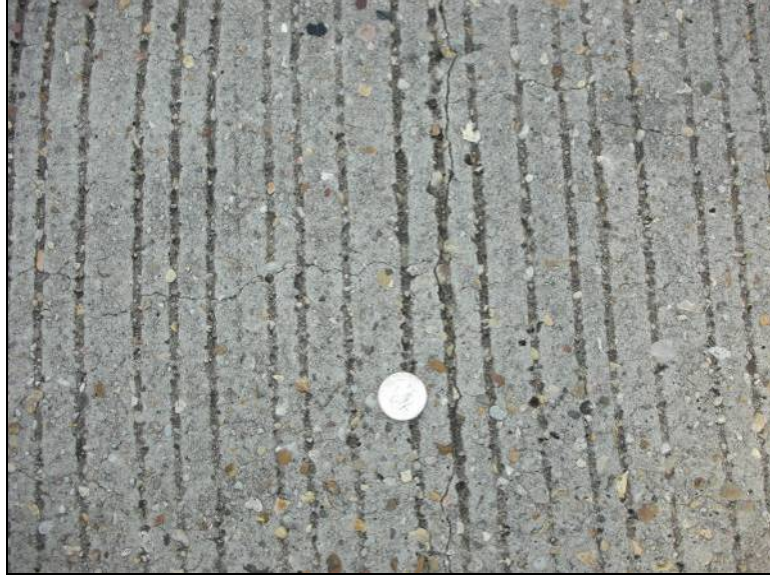
**Figure 3-30:** Picture of the surface cracking on the US 98 bridge deck
