## **MASH Test 3-11 of the TxDOT Portable Type 2 PCTB with Sign Support Assembly**

### **Research/Test Report 0-6143-1**

Project Title: Standards for Mounting Traffic Control Signs  
and Devices on Concrete Traffic Barrier (CTB) in Construction Work Zones

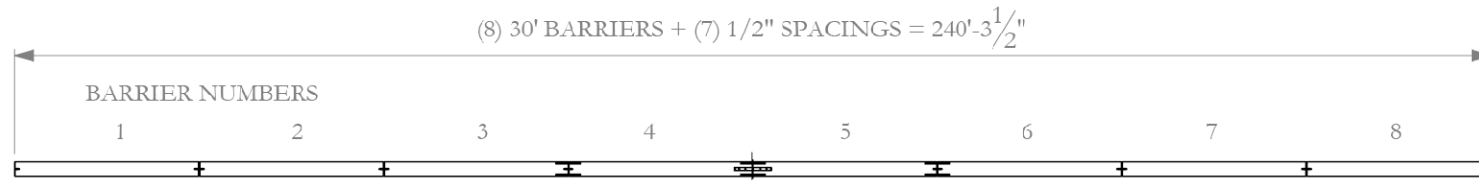
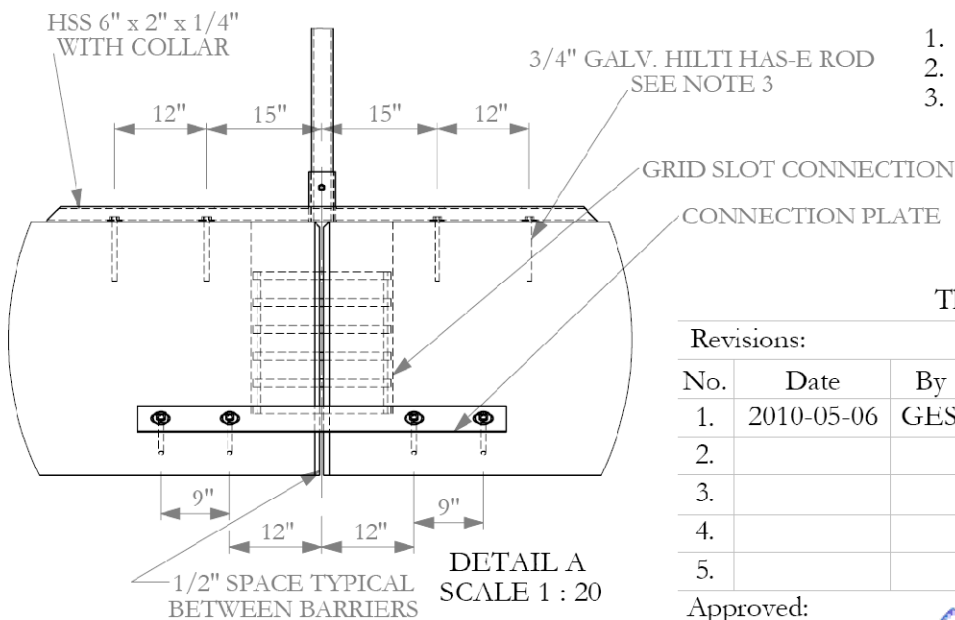
Figure 1. Details of the TxDOT PCTB Sign Support Assembly.

1. Grid Slot Connections at each joint.
2. Connection Plates at joints C, D, and E, both sides.
3. Embedded min. 8", anchored with Hilti HIT Hy 150 adhesive system (typical).

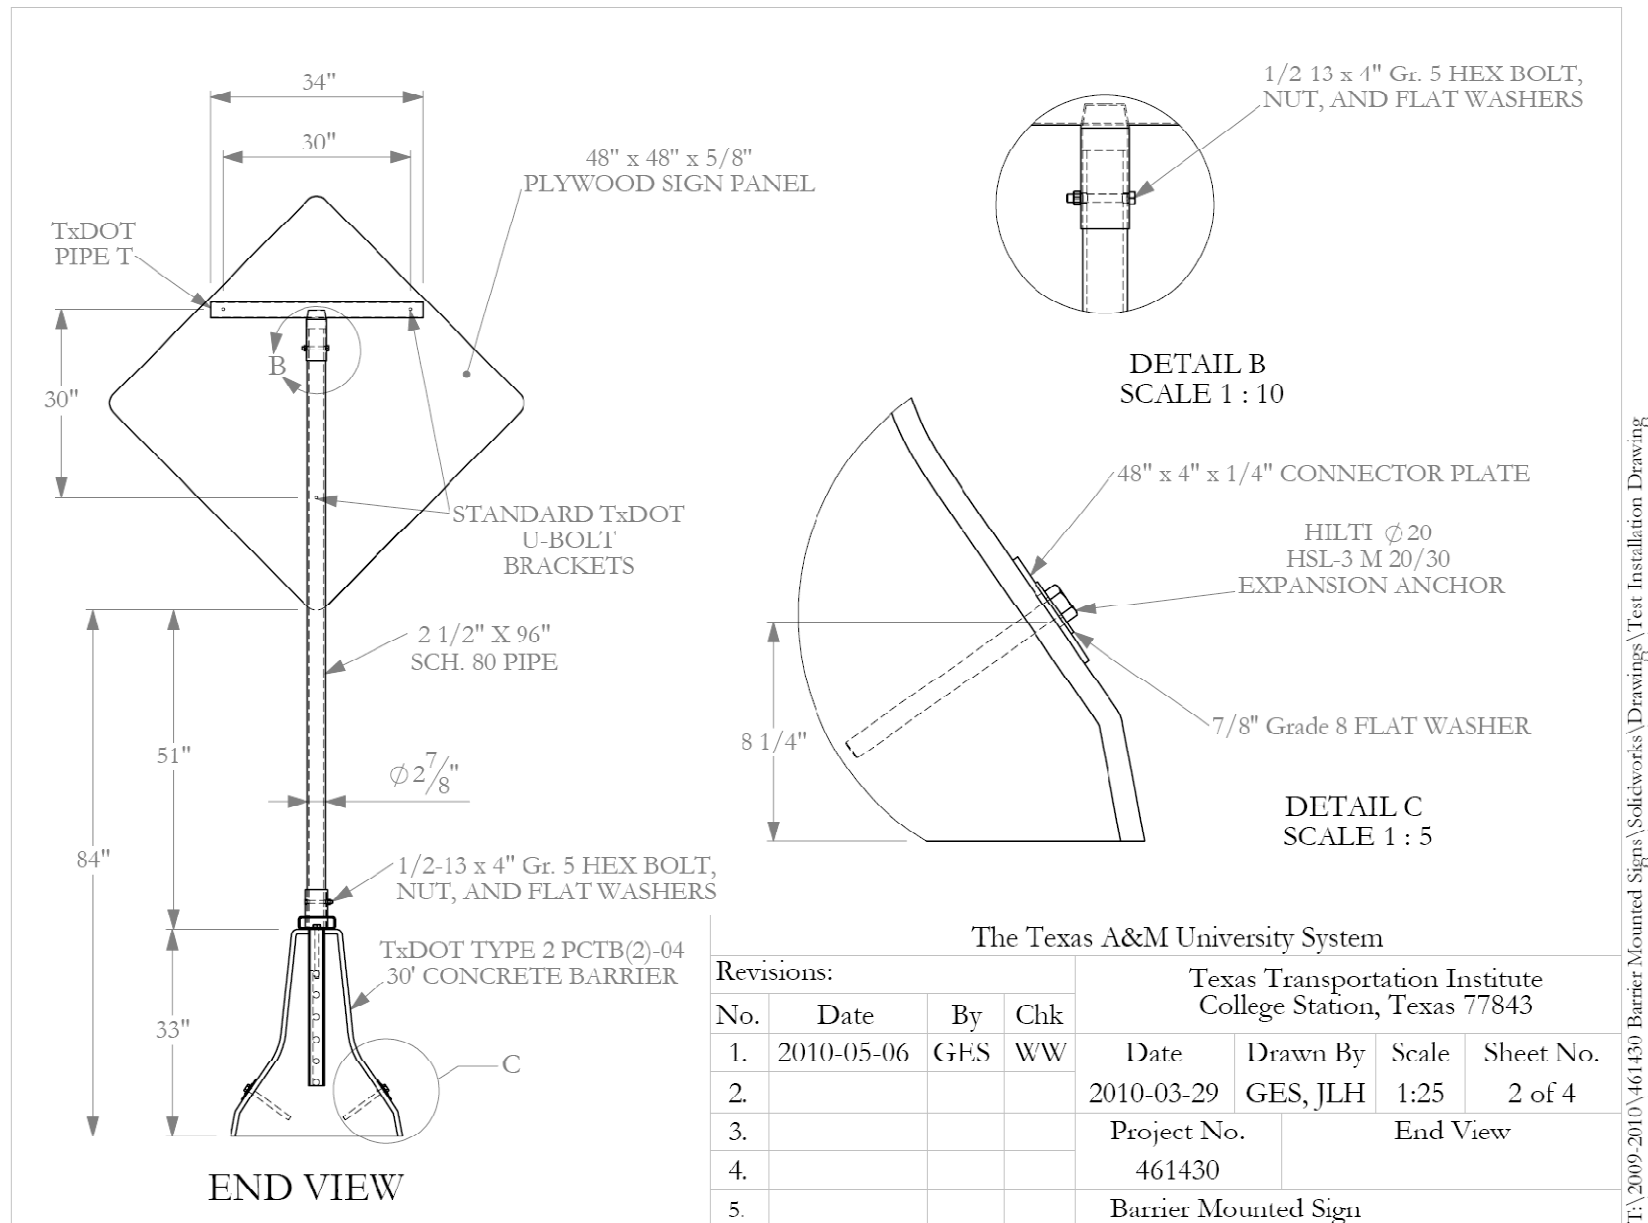
**Figure 2. Details of the TxDOT Type 2 PCTB Sign Support Assembly.**

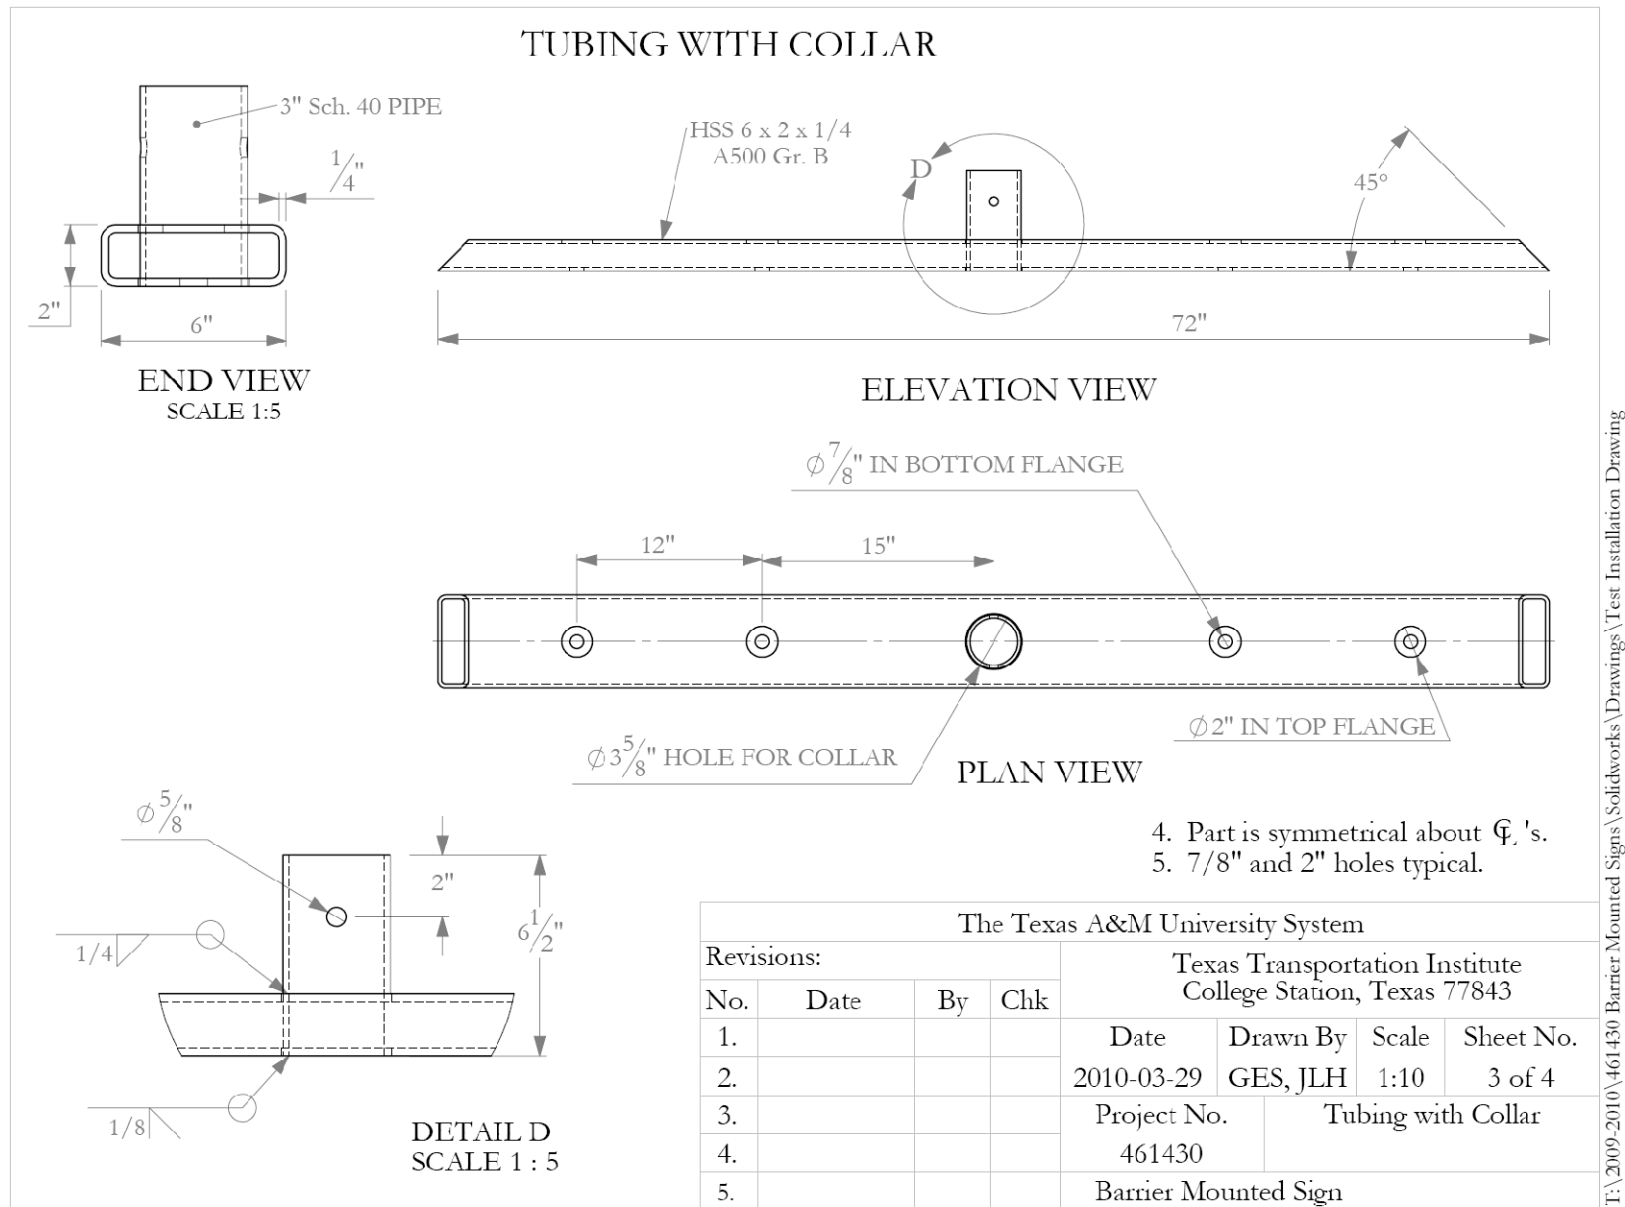
**Figure 3. Details of the TxDOT Type 2 PCTB Sign Support Connection.**

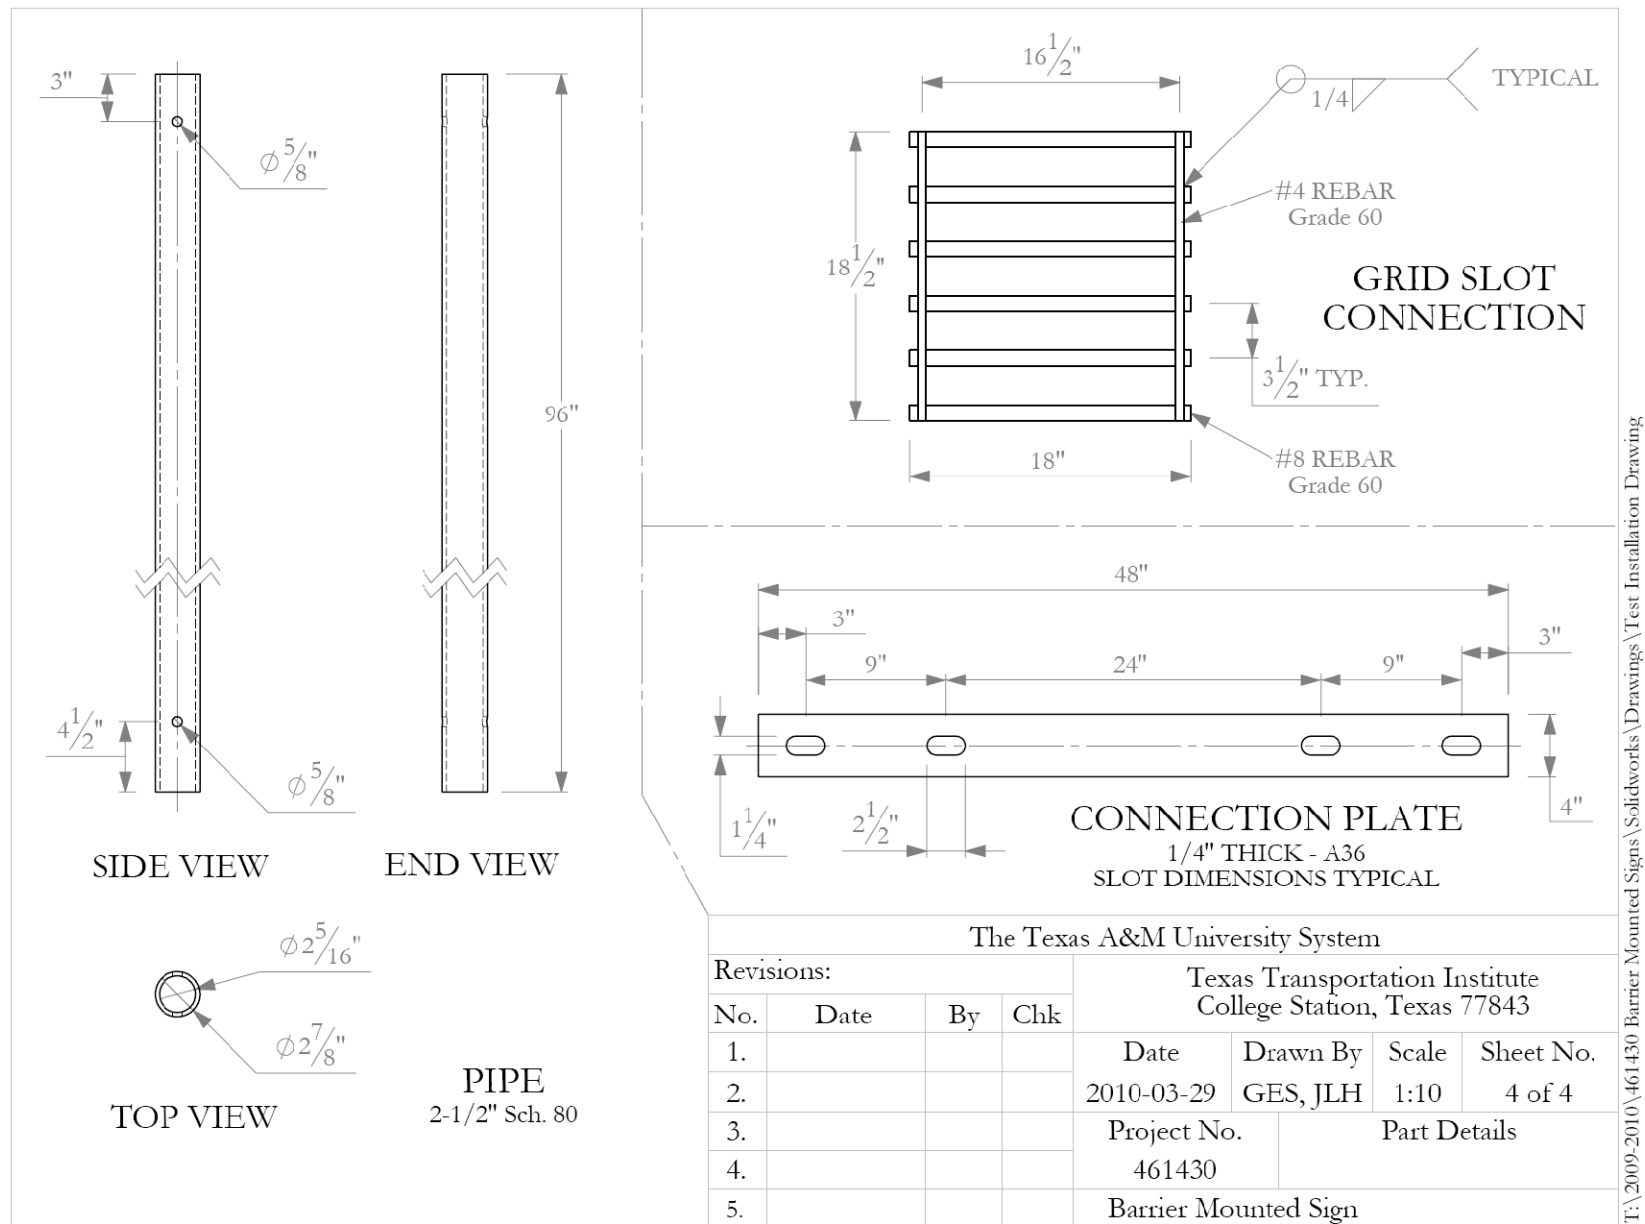
**Figure 4. Details of the Grid Slot and Connection Plate.**

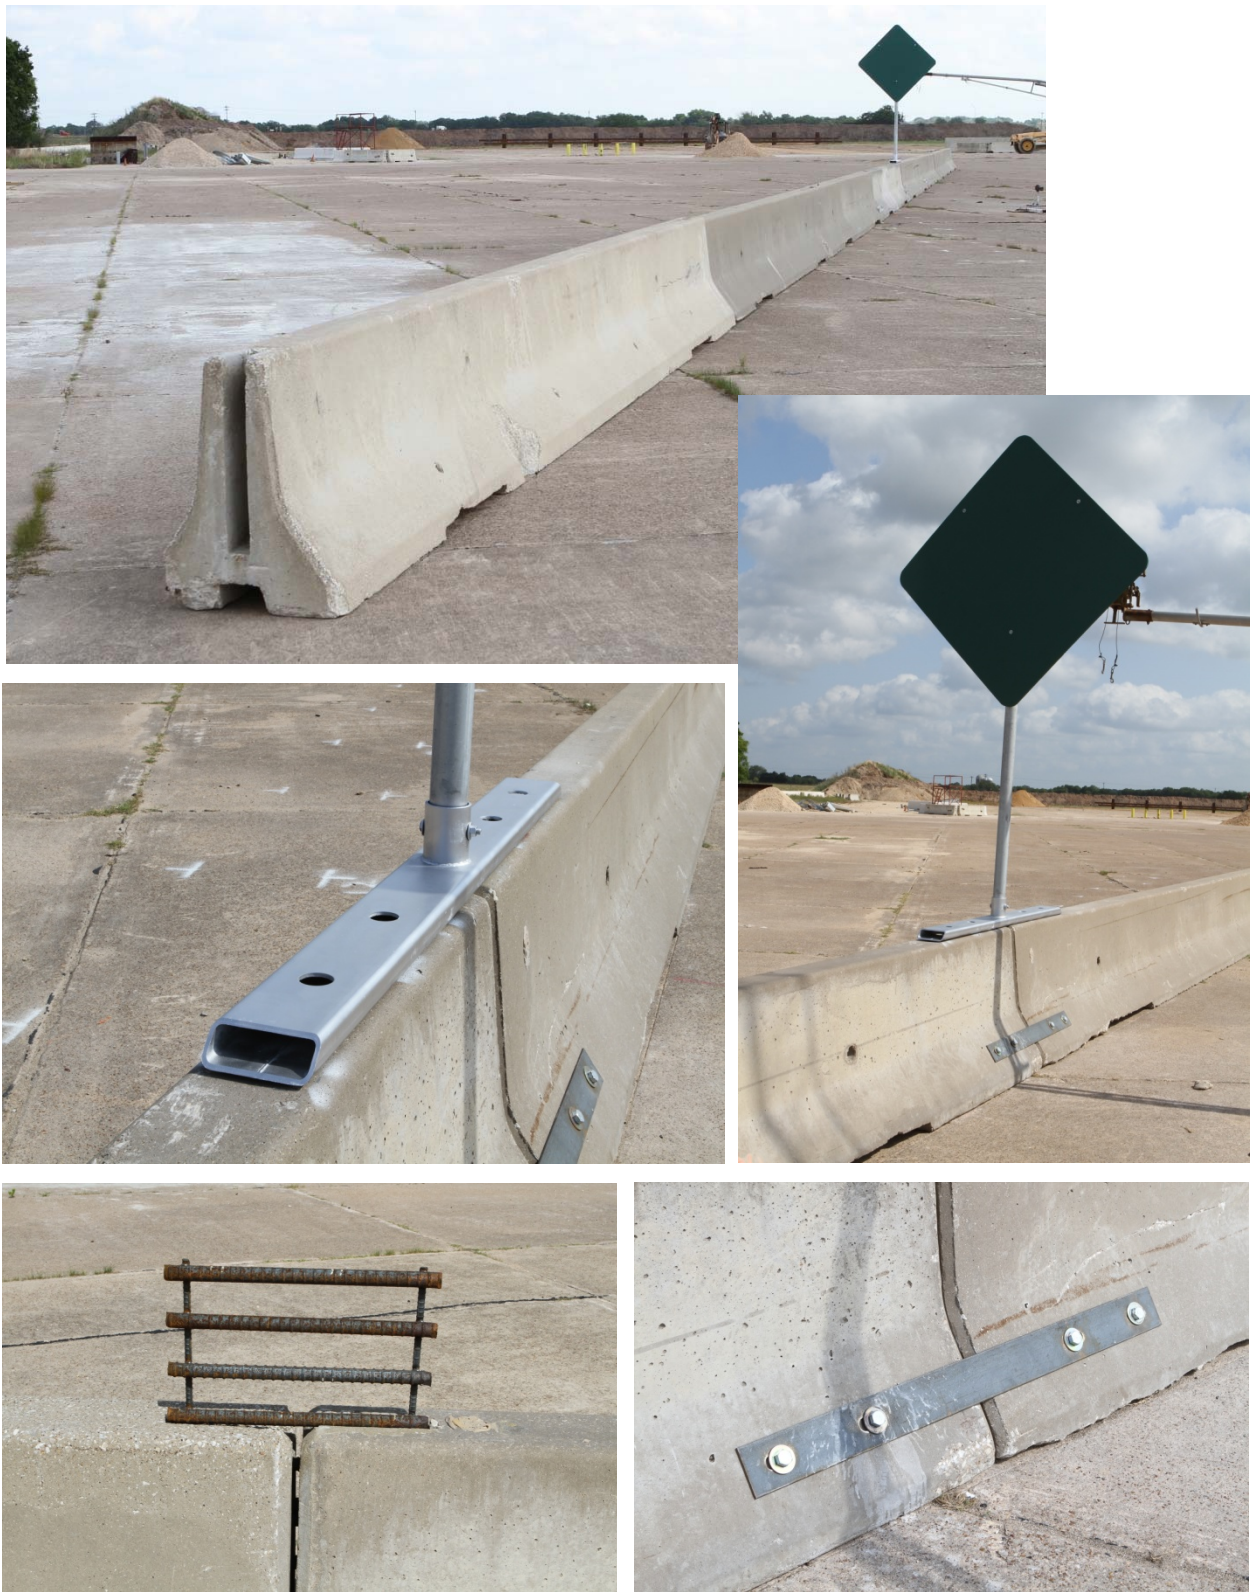
**Figure 5. TxDOT PCTB with Sign Support Assembly and Steel Strap Connections before Test No. 461430-1.**

The modified Texas grid-slot PCTB with the plate connector straps and rebar grid tested under TxDOT Project 0-6162 was utilized for the barrier tested for this project. Since the connector strap was ruptured in the crash test performed under TxDOT project 0-4162, the thickness of this strap was increased to ¼-inch thickness to improve the performance barrier when used in conjunction with the sign support connection. The sign support connection designed for this project served to provide support for the sign post and sign, as well as provide additional stiffness of the joint in the immediate impact area of the barrier. Minimizing the roll angle of the vehicle and minimizing intrusion of the vehicle over the barrier immediately after impact was deemed necessary for the successful performance of the sign support connection tested on top of the TxDOT Type 2 PCTB. The sign support connection developed for this project was designed to improve the stiffness of the barrier joint by the added bending strength of the connection tube and the four adhesive anchors used in the connection (two each side of the joint). Therefore, TTI researchers recommend using the sign support connection developed for this project at a joint in the TxDOT PCTB barrier system in conjunction with the ¼-inch thick plate connector straps at the joint and at adjacent joints (two) in the installation.

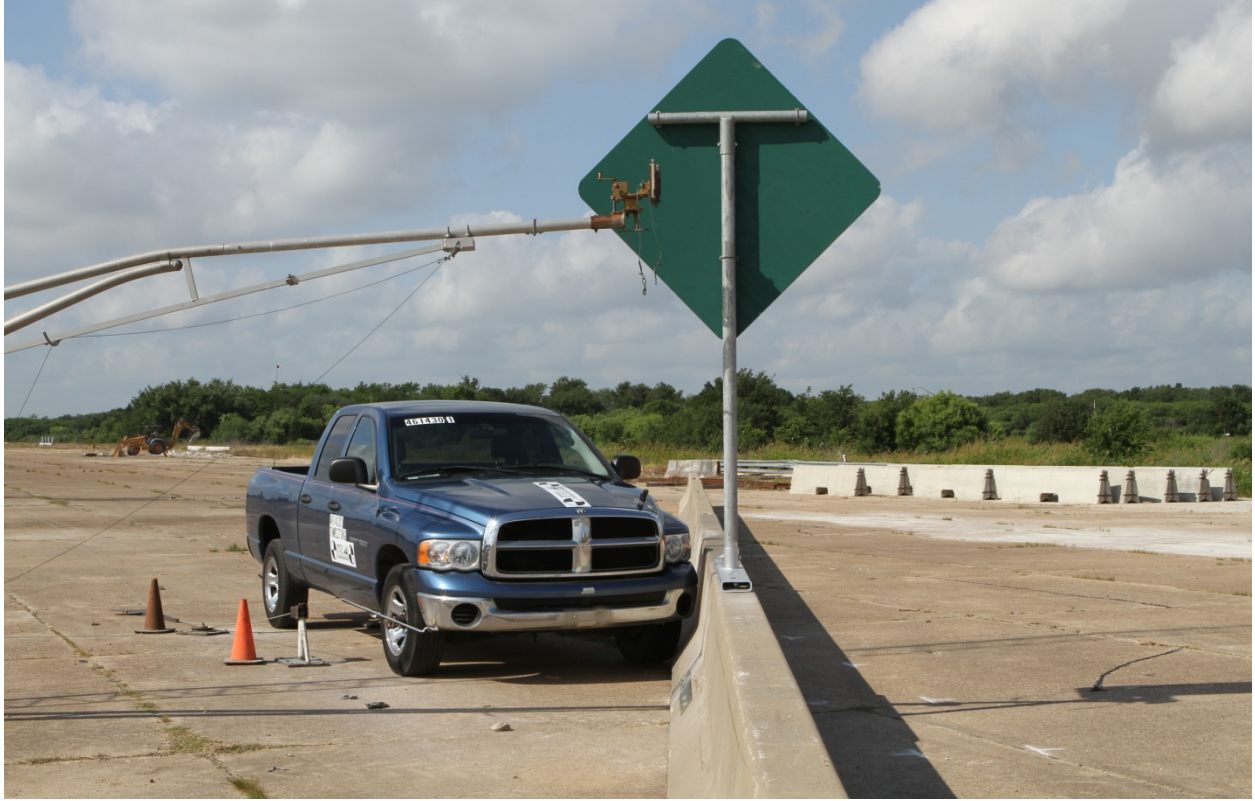
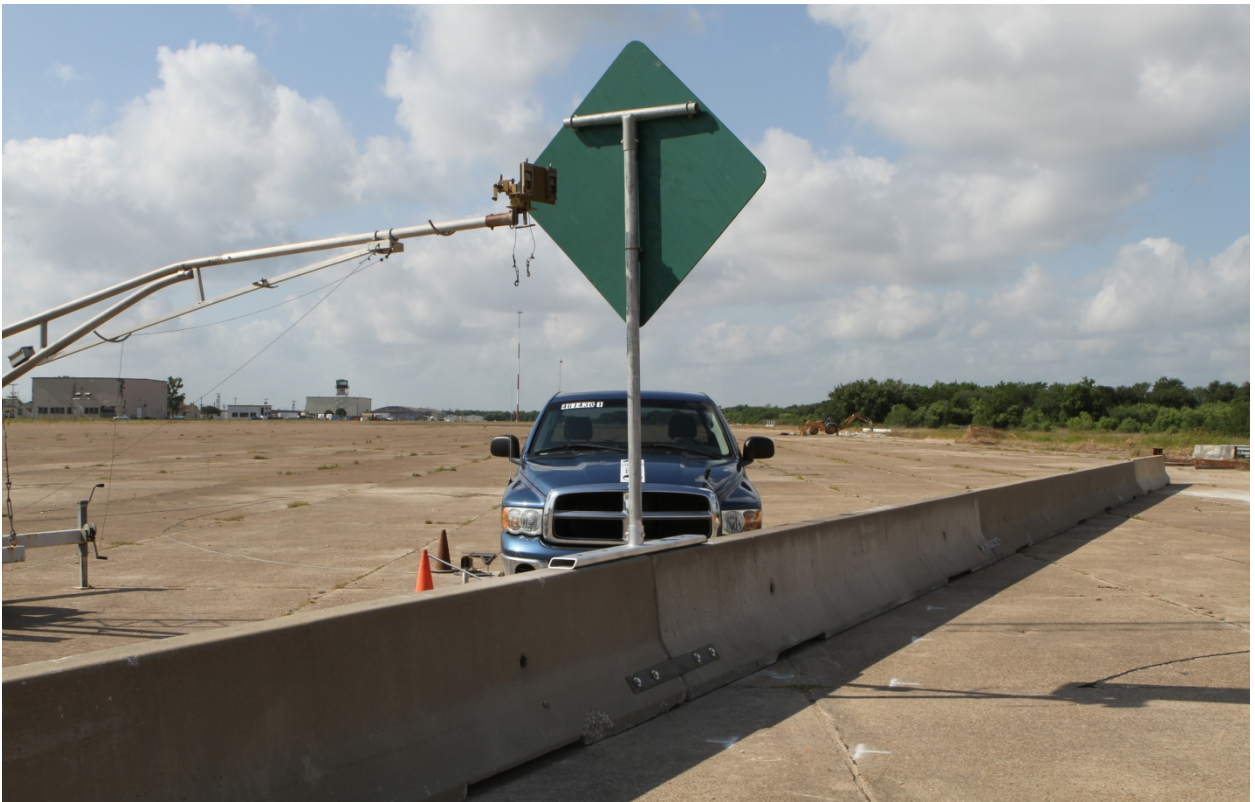
The 2005 Dodge Ram 1500 pickup truck, traveling at an impact speed of 63.5 mi/h, impacted the TxDOT CTB 10.0 ft upstream of the joint between sections 4 and 5 at an impact angle of 24.6 degrees. At approximately 0.016 s, the vehicle began to redirect, and at 0.020 s, the top of PCTB section 4 began to deflect toward the field side. A crack on the field side of PCTB section 4 began to form at 0.038 s, and PCTB section 5 began to deflect toward the field side at 0.040 s. At 0.082 s, the vehicle contacted the base of the PCTB mounted sign support and PCTB section 5. As the vehicle continued forward, the left front exterior fender panel of the vehicle caught on the sign support and the fender pulled away from the vehicle. The vehicle then began to ride along the top of the PCTB. At 0.210 s, the vehicle lost contact with the barrier and was traveling at an exit speed of 54.6 mi/h and 6.9 degrees. At 0.310 s, the bed of the truck lost contact with the sign support. Brakes on the vehicle were applied at 2.4 seconds after impact, and the vehicle subsequently came to rest facing the PCTBs 223 ft downstream of impact and 33 ft toward the field side of the PCTBs. Figures 14 and 15 in Appendix C show sequential photographs of the test period.

**Figure 6. Vehicle and Installation Geometrics for Test No. 461430-1.**

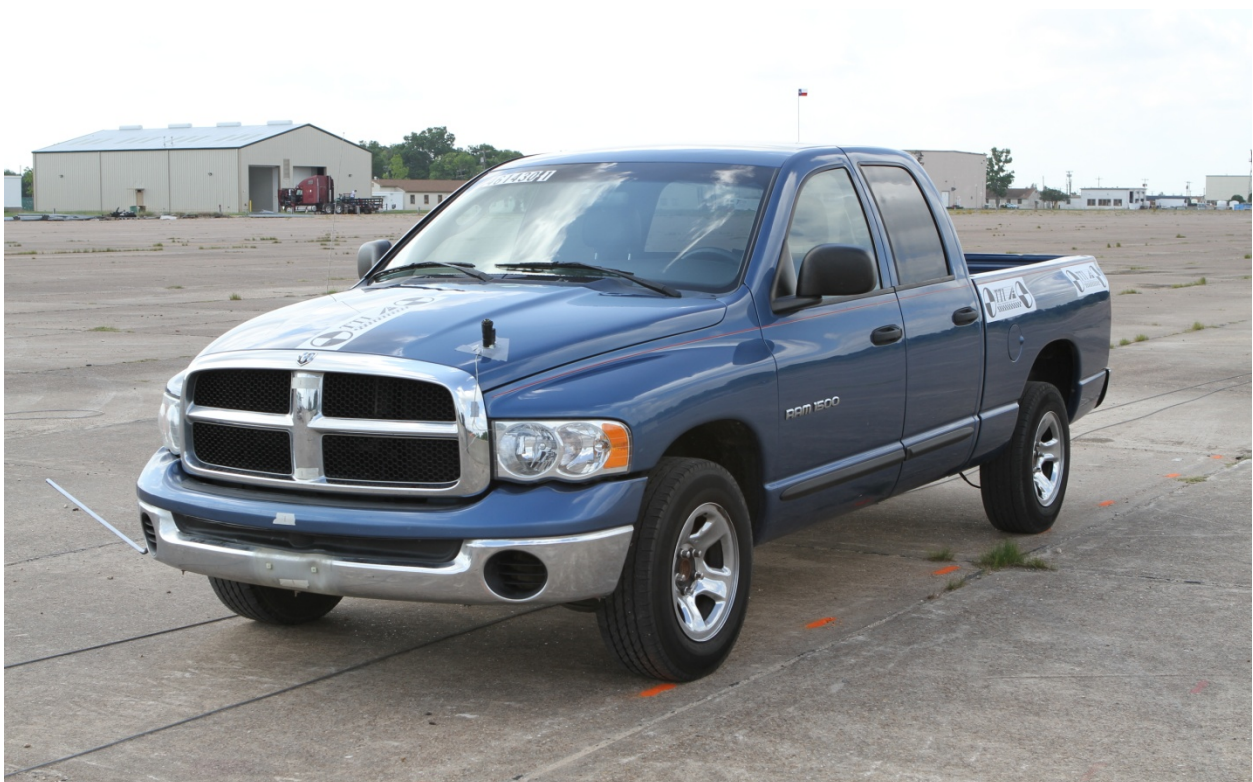
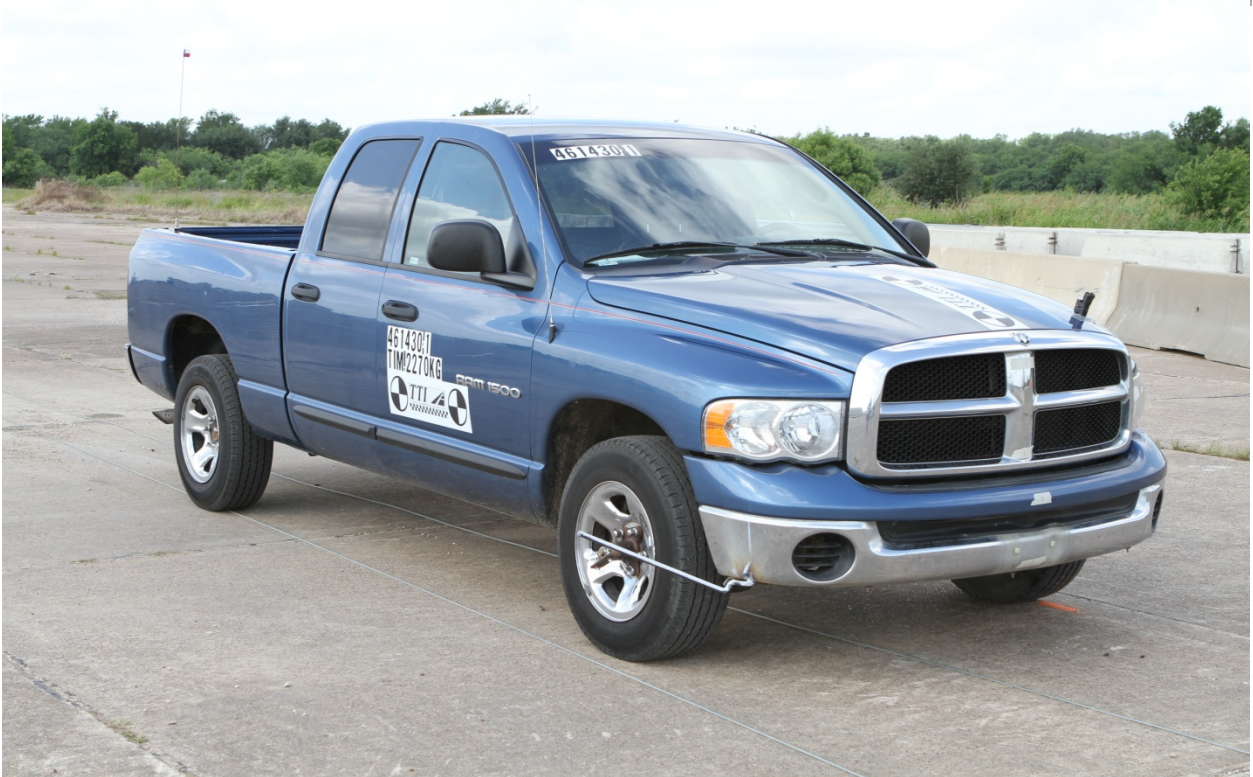
**Figure 7. Vehicle before Test No. 461430-1.**

A 2005 Dodge Ram 1500 pickup truck, shown in Figures 6 and 7, was used for the crash test. Test inertia weight of the vehicle was 5000 lb, and its gross static weight was 5000 lb. The height to the lower edge of the vehicle bumper was 13.5 inches, and it was 16.0 inches to the upper edge of the bumper. Height to the vehicle center of gravity was 28.5 inches. Figure 13 and Table 2 in Appendix B give additional dimensions and information on the vehicle. The vehicle was directed into the installation using the cable reverse tow and guidance system and was released to be free-wheeling and unrestrained just prior to impact.

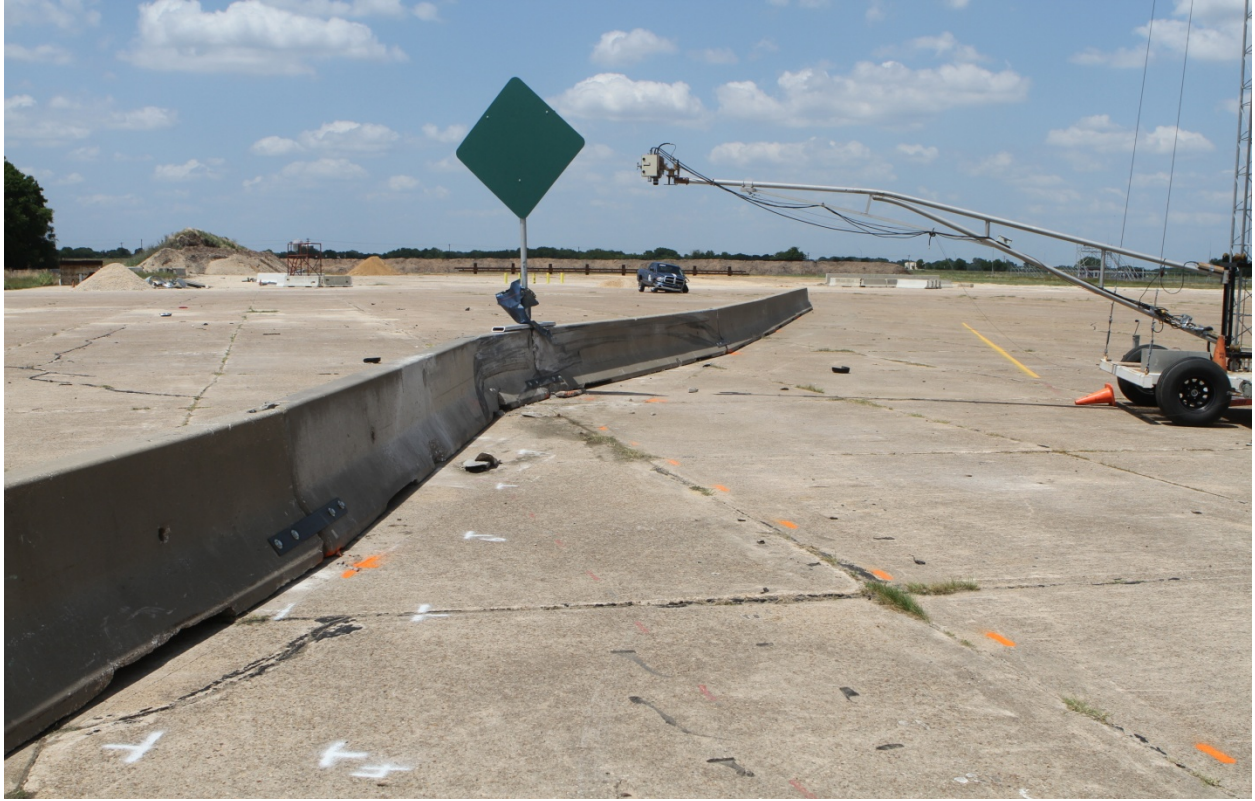
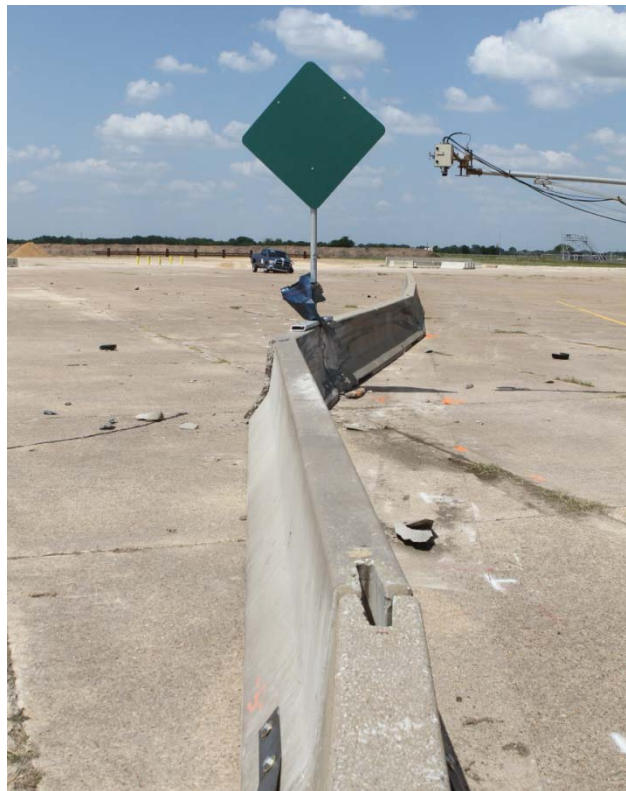
Figures 8 and 9 show damage to the PCTB mounted sign assembly after the test. PCTB section 4 ruptured through the concrete and all but the lower two longitudinal rebar 78 inches upstream of the joint between sections 4 and 5. Length of contact of the vehicle with the barrier was 43.2 ft. Working width with the vehicle and the PCTB only was 5.8 ft. Working width with the vehicle and the PCTB mounted sign support was 10.2 ft (due to lean of the top of the sign support). Maximum dynamic deflection of the barrier during the test was 3.9 ft, and maximum dynamic deflection of the PCTB mounted sign support was 4.3 ft.

**Figure 8. After Impact Vehicle Position for Test No. 461430-1.**

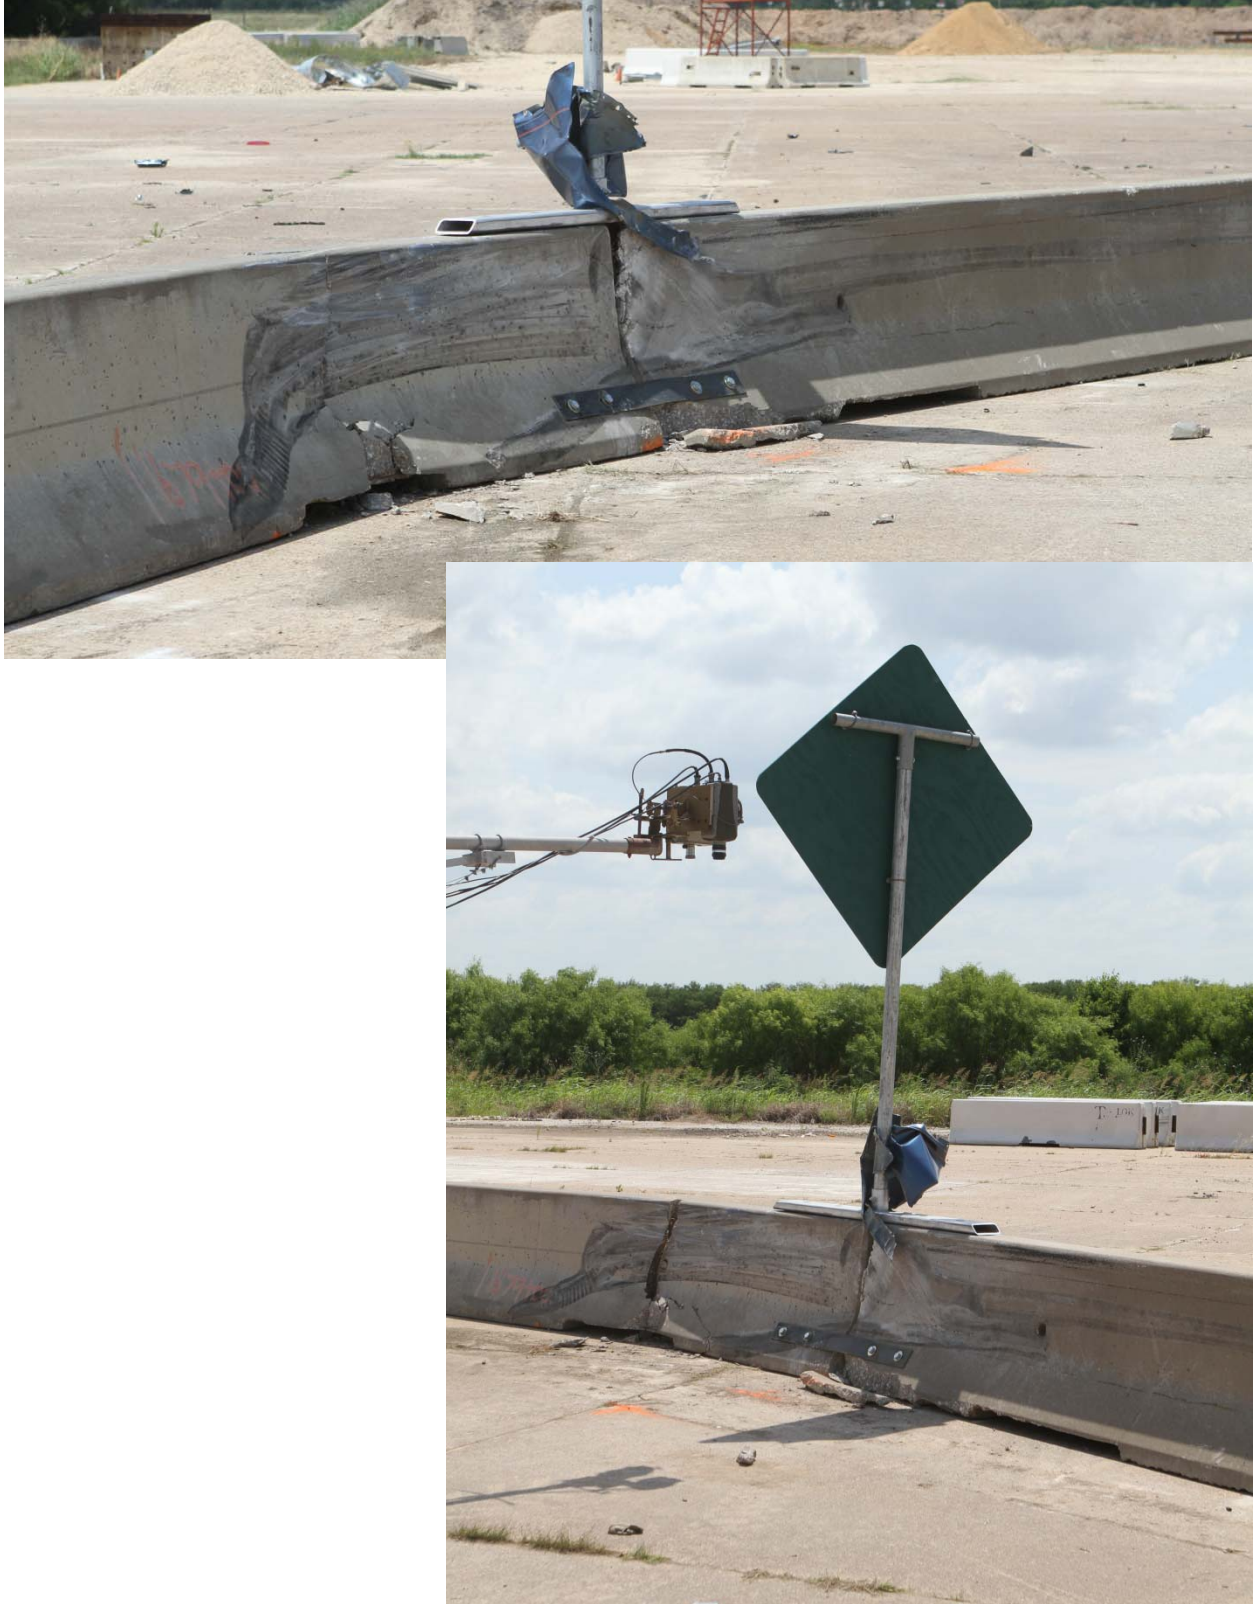
**Figure 9. Installation after Test No. 461430-1.**

Result: PCTB section 4 fractured but remained partially connected with the installation. No penetration or potential for penetration occurred, and this did not present undue hazard for others in the area. (PASS)  
Maximum occupant compartment deformation was 4.0 inches in the driver side firewall area near the toe pan. (PASS)

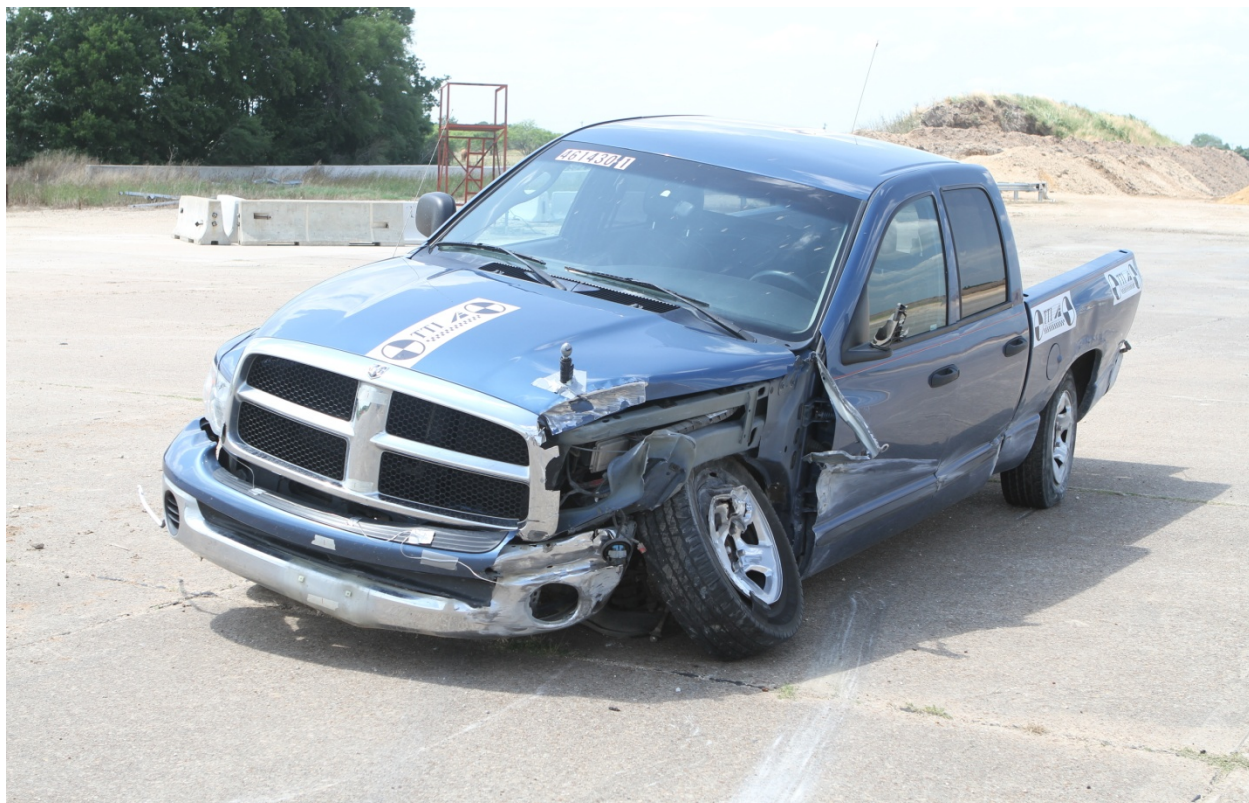
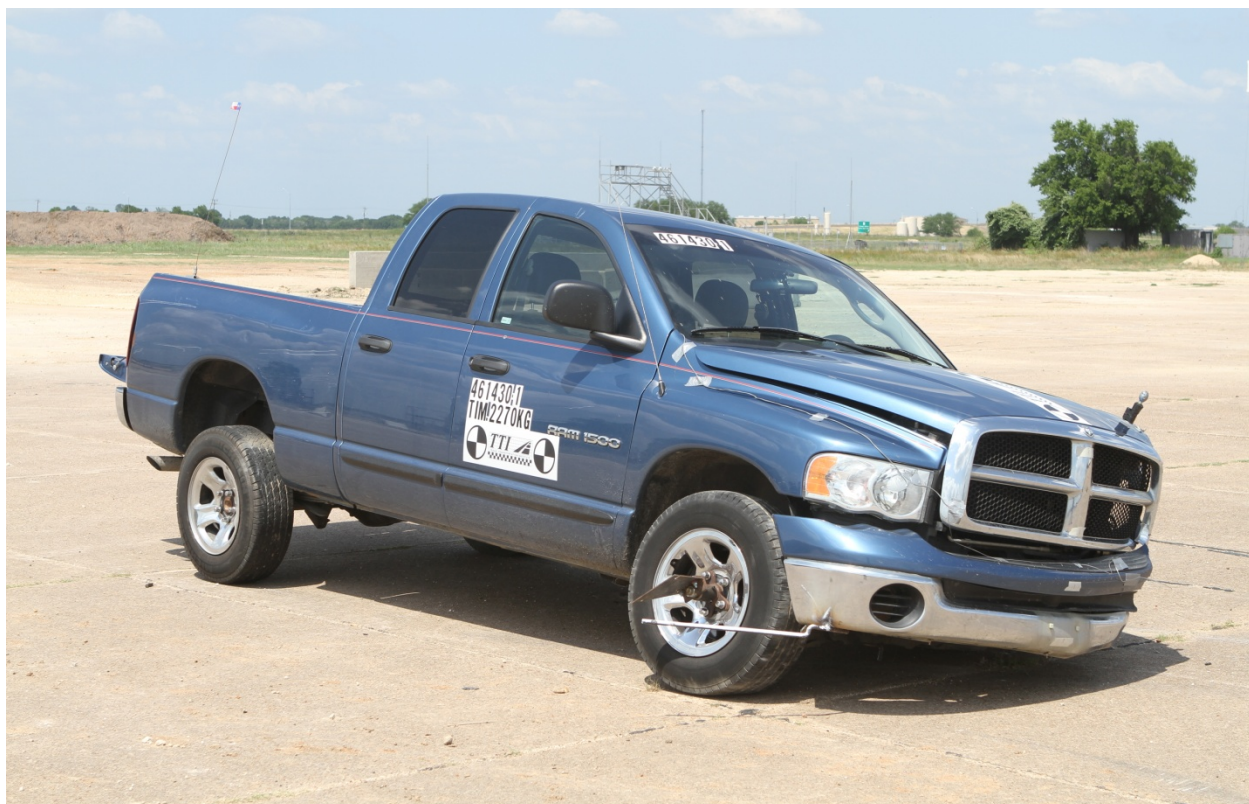
Damage to the 2270P vehicle is shown in Figure 10. The left upper and lower ball joints of the front suspension were broken and the tie rod was deformed. Also damaged were the front bumper hood, grill, left front fender, left front and rear doors, left exterior bed, and rear bumper. The left front wheel rim was deformed and the tire deflated. The left rear wheel rim was also deformed, however, the tire remained inflated. Maximum exterior crush to the vehicle was 13.0 inches in the frontal plane at the left front corner at bumper height. Maximum occupant compartment deformation was 4.0 inches in the left firewall area near the toe pan. Photographs of the interior of the vehicle are shown in Figure 11. Exterior vehicle crush and occupant compartment measurements are shown in Appendix B, Tables 3 and 4.

**Figure 10. Vehicle after Test No. 461430-1.**

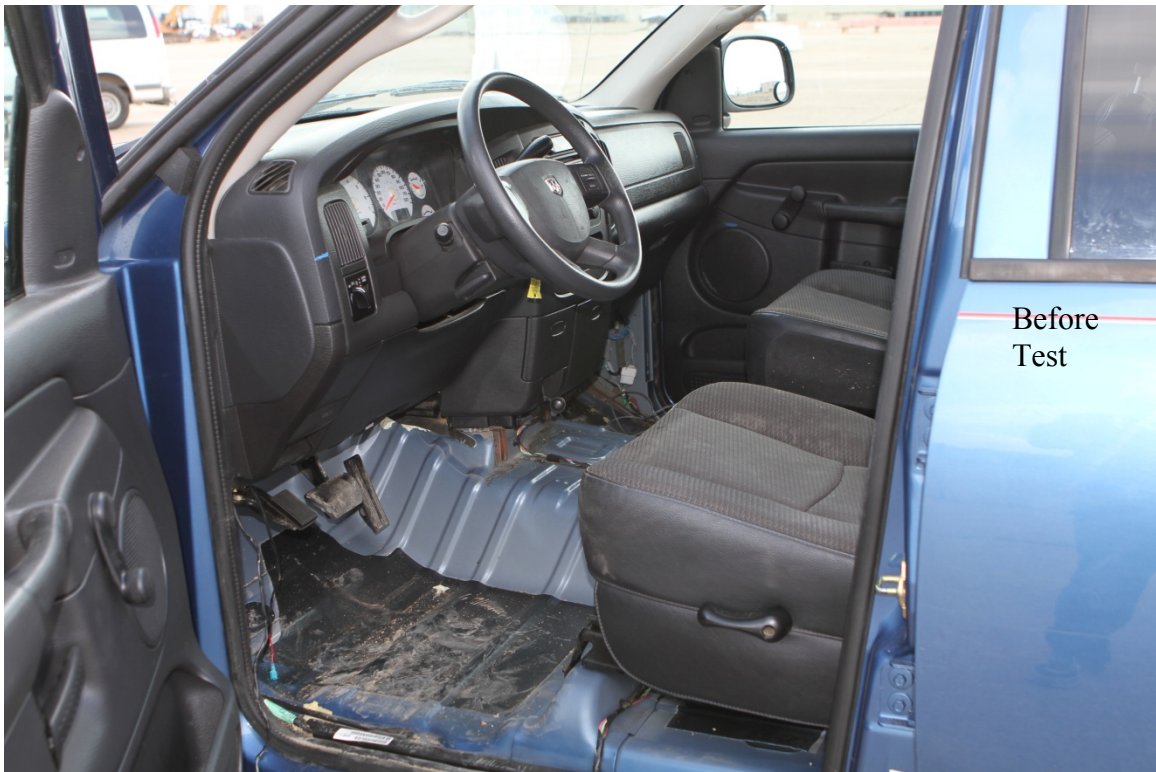
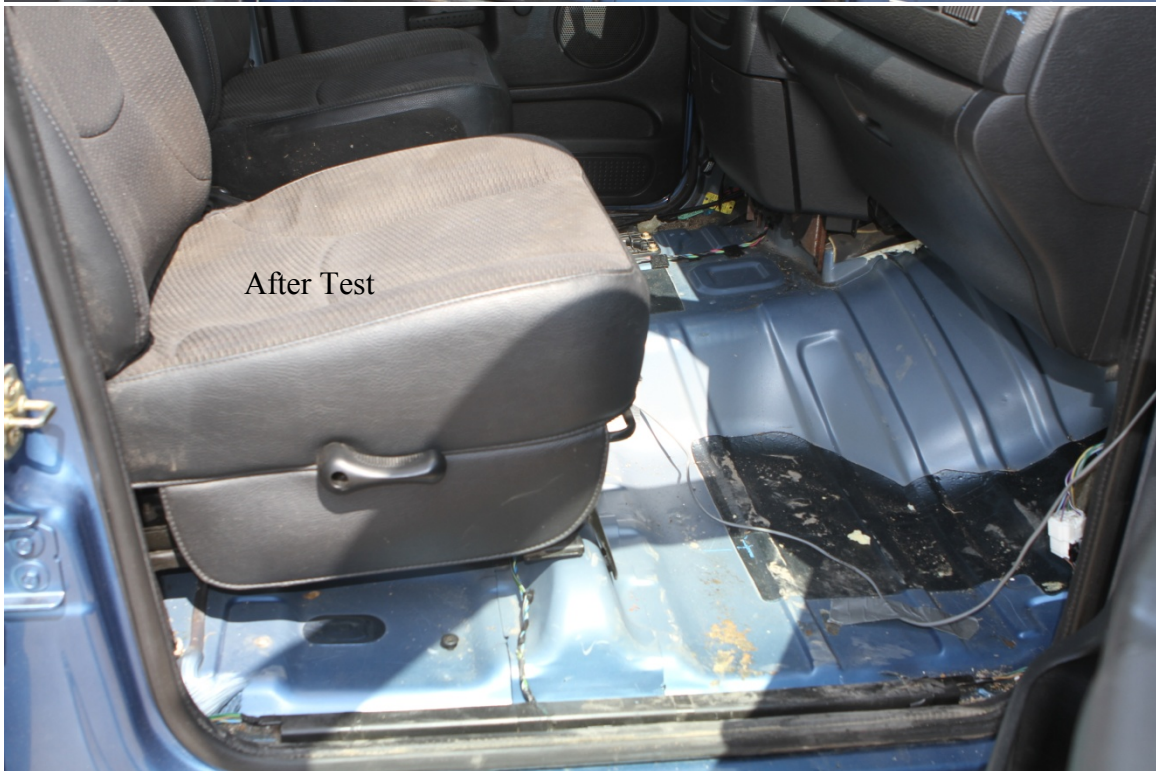
**Figure 11. Interior of Vehicle for Test No. 461430-1.**

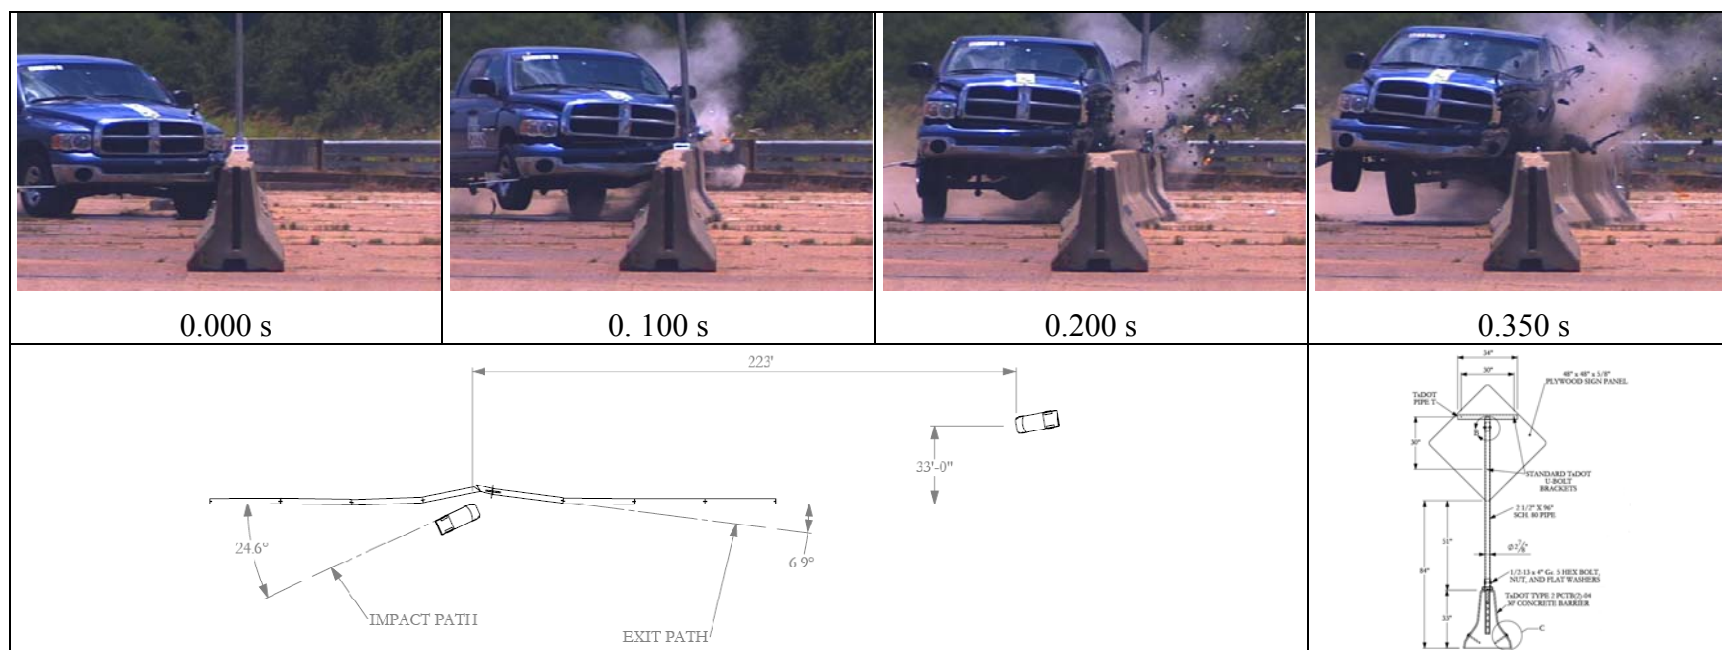
Test Agency..... Texas Transportation Institute  
 Test Agency Test No. .... 461430-1  
 Test Standard Test No. .... MASH 3-11  
 Date ..... 2010-05-24
