## **MASH Test 3-11 of the TxDOT Portable Type 2 PCTB with Sign Support Assembly**

### **Research/Test Report 0-6143-1**

Project Title: Standards for Mounting Traffic Control Signs  
and Devices on Concrete Traffic Barrier (CTB) in Construction Work Zones

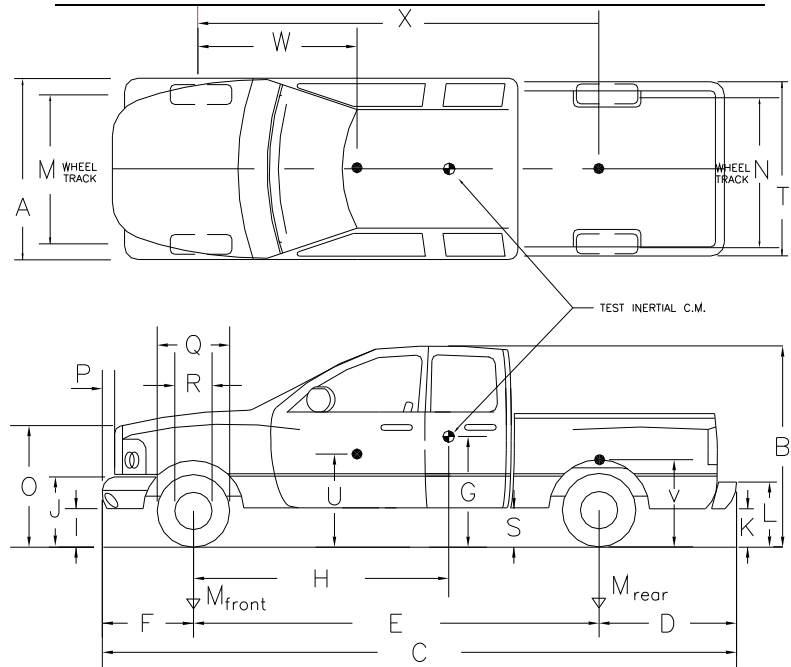
**Geometry:** inches

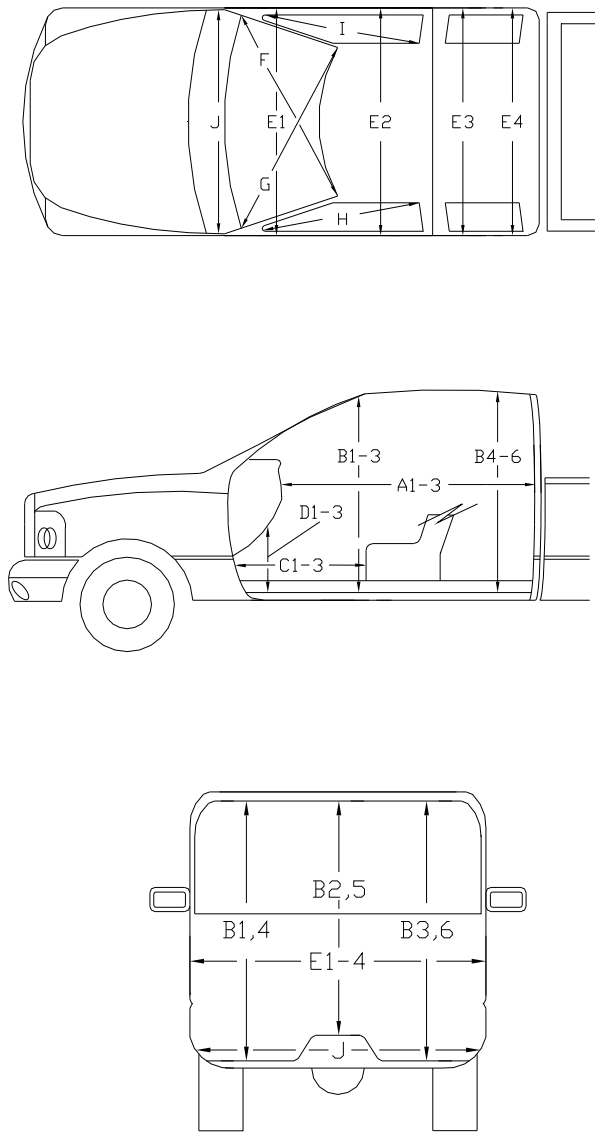
**Table 4. Occupant Compartment Measurements for Test No. 461430-1.**

**OCCUPANT COMPARTMENT  
DEFORMATION MEASUREMENT**

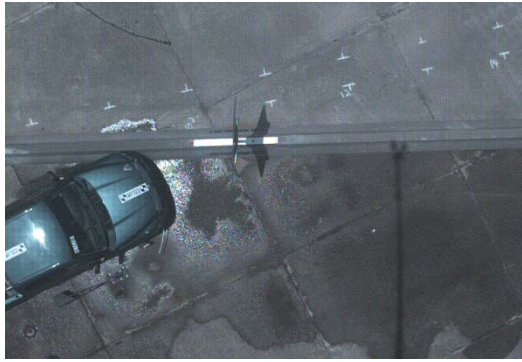
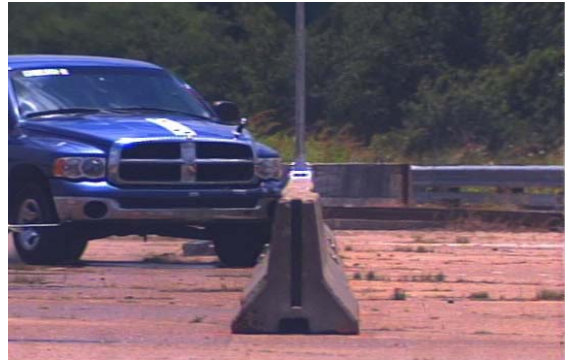
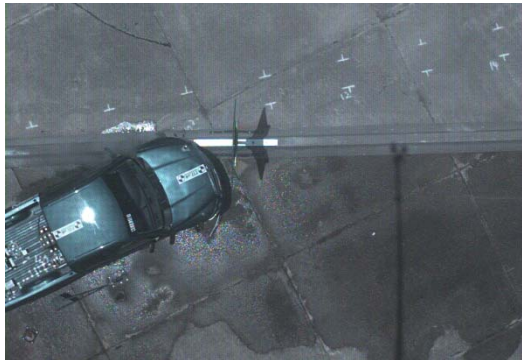
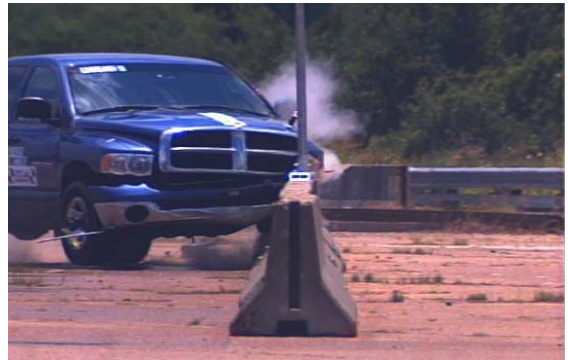
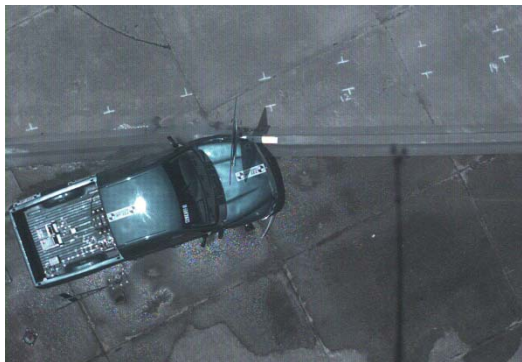
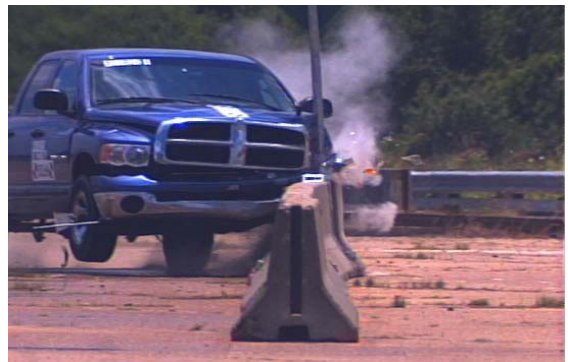
**Figure 14. Sequential Photographs for Test No. 461430-1  
(Overhead and Frontal Views).**

The 2005 Dodge Ram 1500 pickup truck, traveling at an impact speed of 63.5 mi/h, impacted the TxDOT CTB 10.0 ft upstream of the joint between sections 4 and 5 at an impact angle of 24.6 degrees. At approximately 0.016 s, the vehicle began to redirect, and at 0.020 s, the top of PCTB section 4 began to deflect toward the field side. A crack on the field side of PCTB section 4 began to form at 0.038 s, and PCTB section 5 began to deflect toward the field side at 0.040 s. At 0.082 s, the vehicle contacted the base of the PCTB mounted sign support and PCTB section 5. As the vehicle continued forward, the left front exterior fender panel of the vehicle caught on the sign support and the fender pulled away from the vehicle. The vehicle then began to ride along the top of the PCTB. At 0.210 s, the vehicle lost contact with the barrier and was traveling at an exit speed of 54.6 mi/h and 6.9 degrees. At 0.310 s, the bed of the truck lost contact with the sign support. Brakes on the vehicle were applied at 2.4 seconds after impact, and the vehicle subsequently came to rest facing the PCTBs 223 ft downstream of impact and 33 ft toward the field side of the PCTBs. Figures 14 and 15 in Appendix C show sequential photographs of the test period.

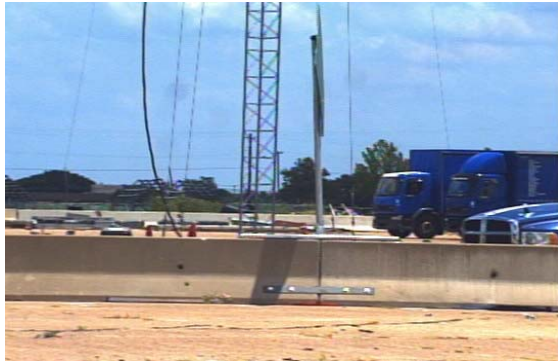
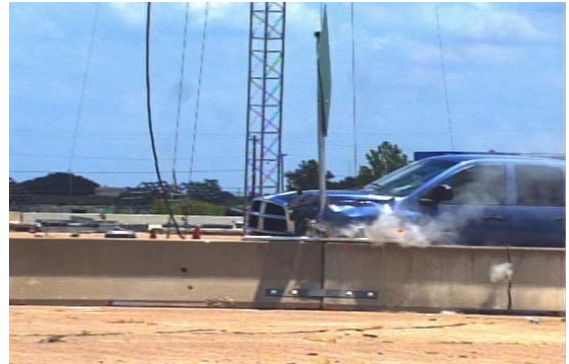
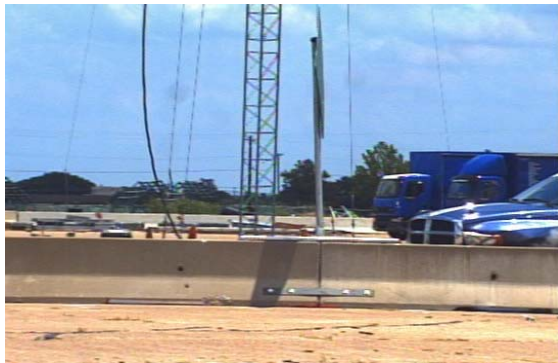
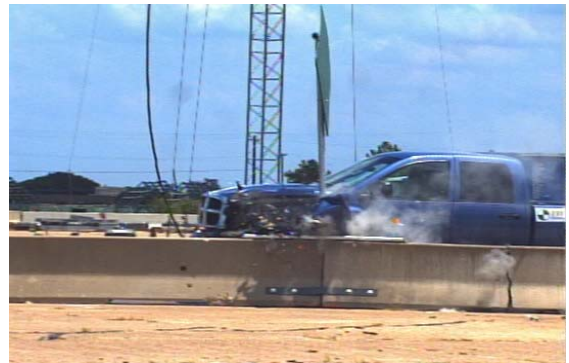
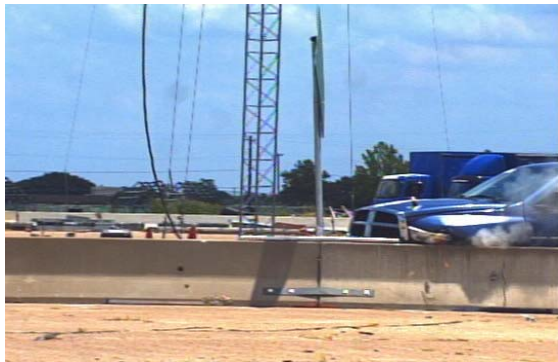
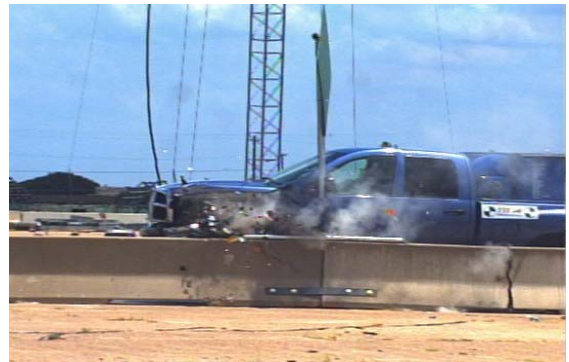
**Figure 15. Sequential Photographs for Test No. 461430-1  
(Rear of Barrier View).**

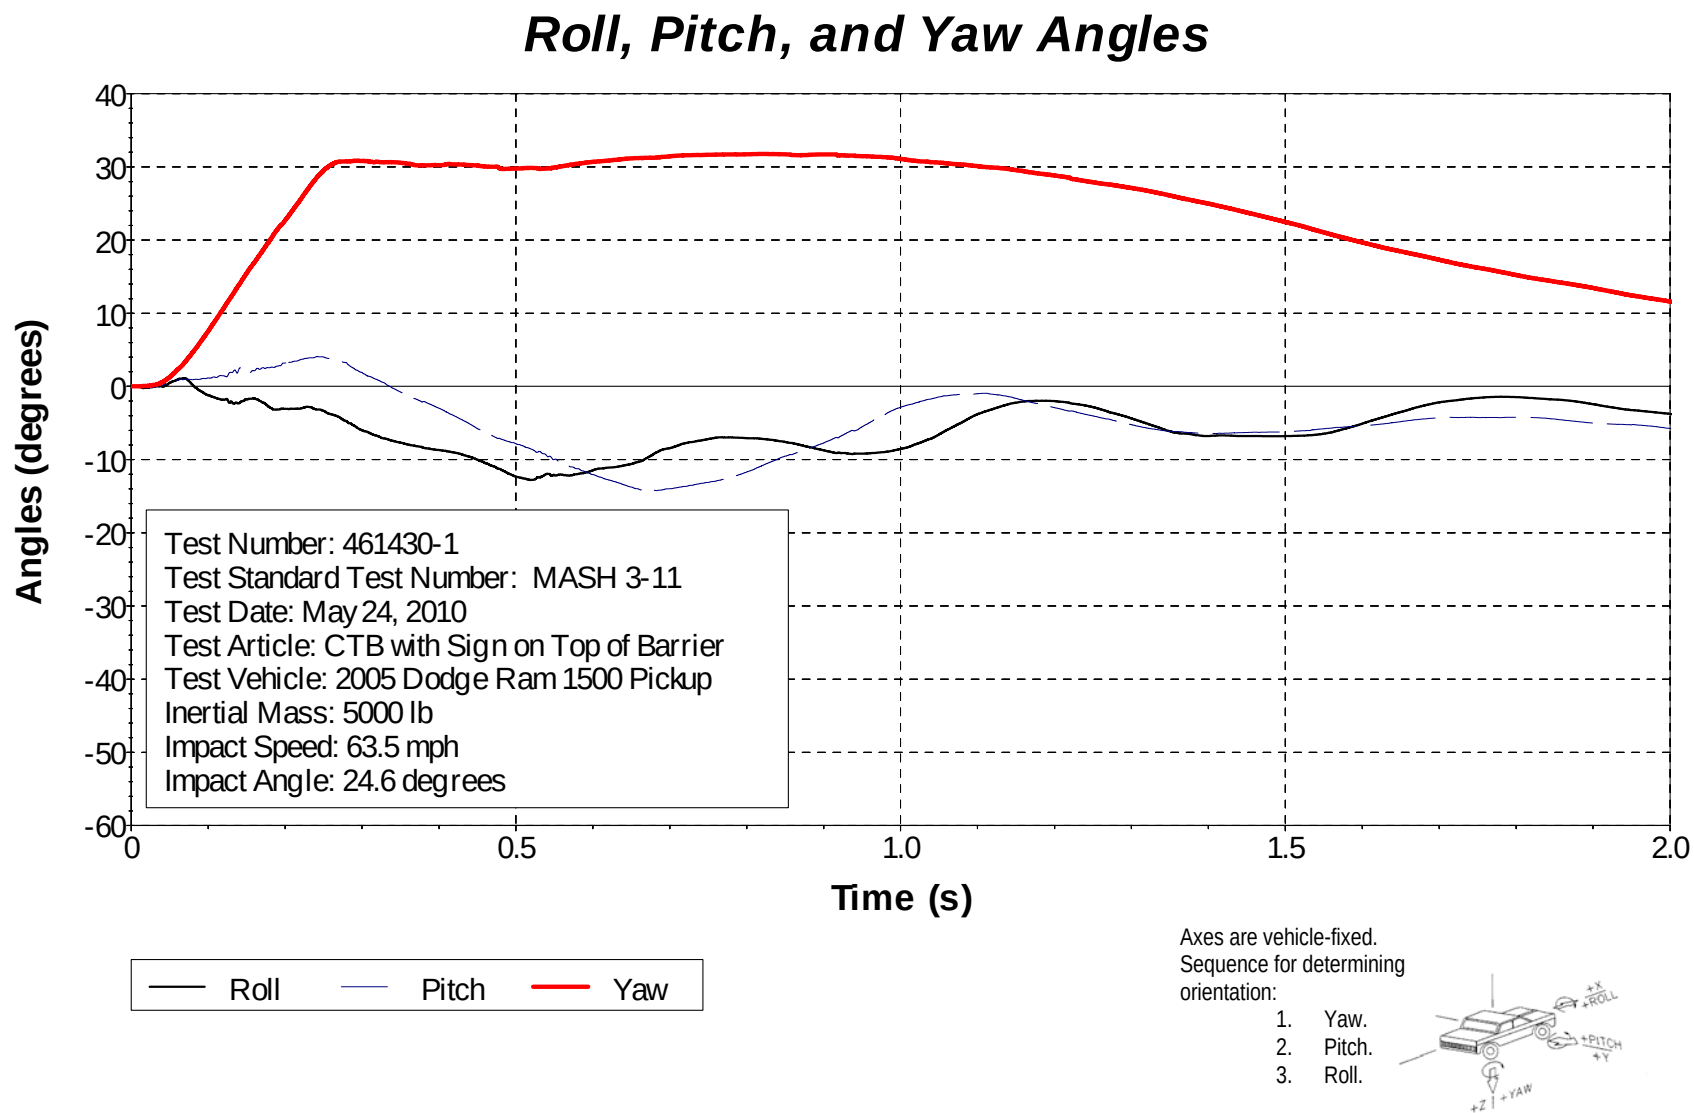
Figure 16. Vehicle Angular Displacements for Test No. 461430-1.

Data from the accelerometer, located at the vehicle center of gravity, were digitized for evaluation of occupant risk. In the longitudinal direction, the occupant impact velocity was 13.8 ft/s at 0.101 s, the highest 0.010-s occupant ridedown acceleration was  $-10.3$  Gs from 0.117 to 0.127 s, and the maximum 0.050-s average acceleration was  $-5.5$  Gs between 0.019 and 0.069 s. In the lateral direction, the occupant impact velocity was 21.3 ft/s at 0.101 s, the highest 0.010-s occupant ridedown acceleration was 9.8 Gs from 0.232 to 0.242 s, and the maximum 0.050-s average was 11.1 Gs between 0.034 and 0.084 s. Theoretical Head Impact Velocity (THIV) was 27.8 km/h or 7.7 m/s at 0.098s; Post-Impact Head Decelerations (PHD) was 10.3 Gs between 0.118 and 0.128 s; and Acceleration Severity Index (ASI) was 1.27 between 0.034 and 0.084 s. These data and other pertinent information from the test are summarized in Figure 12. Vehicle angular displacements and accelerations versus time traces are presented in Appendix D Figures 16 through 22.

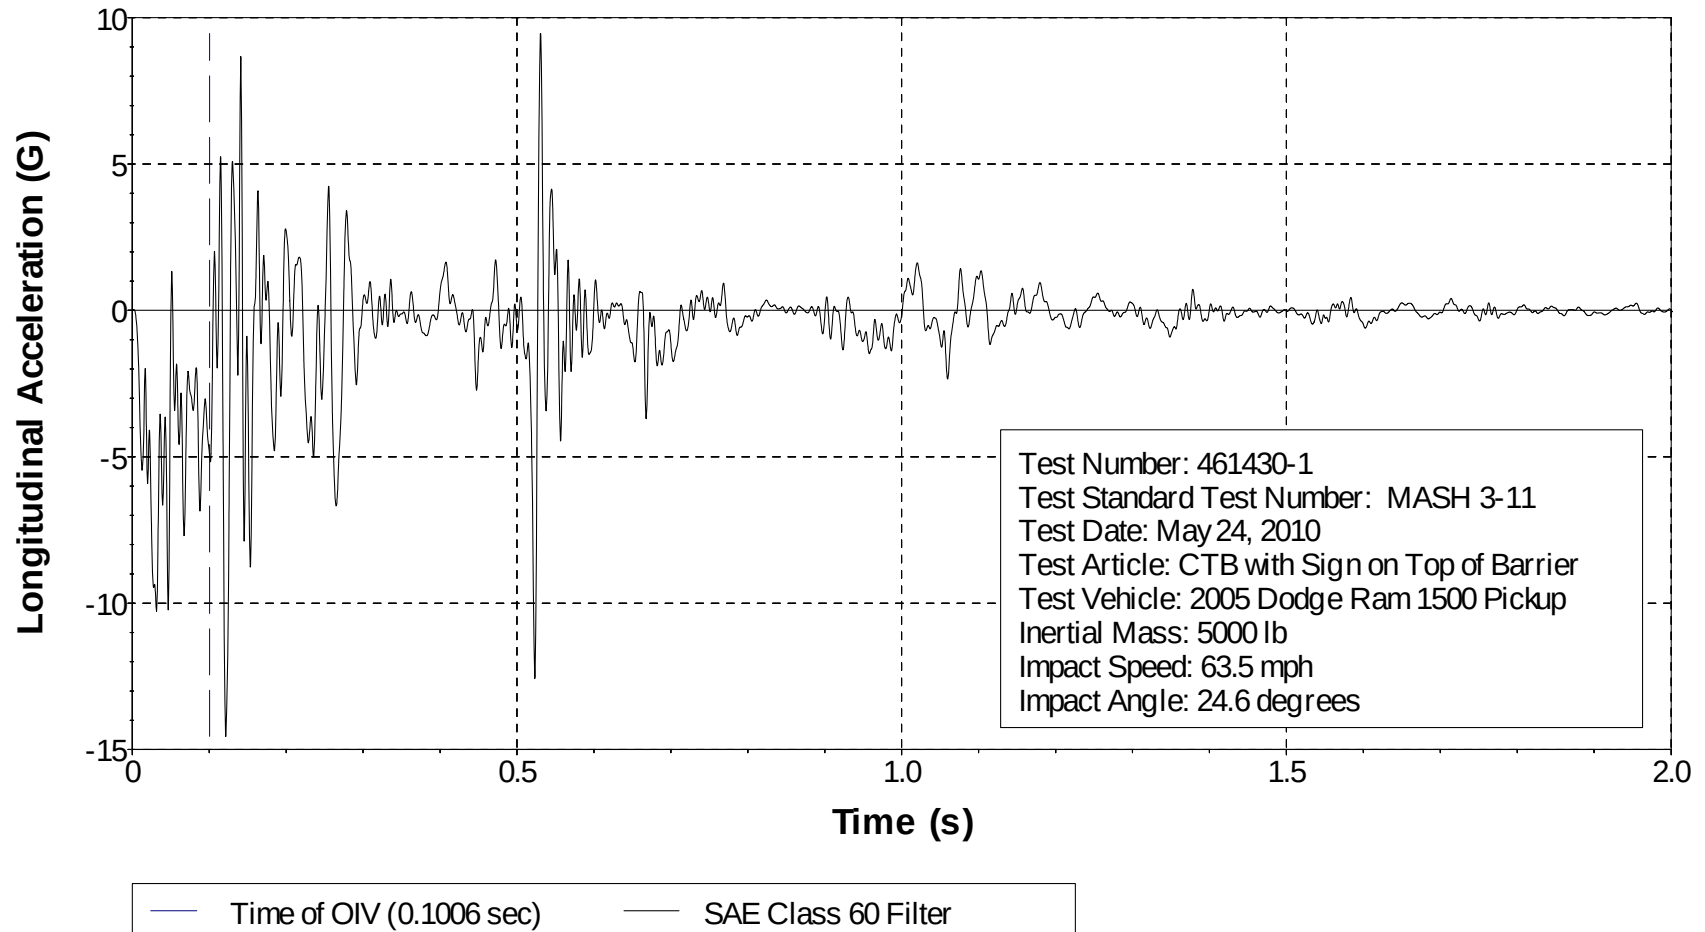
**Figure 17. Vehicle Longitudinal Accelerometer Trace for Test No. 461430-1  
(Accelerometer Located at Center of Gravity).**

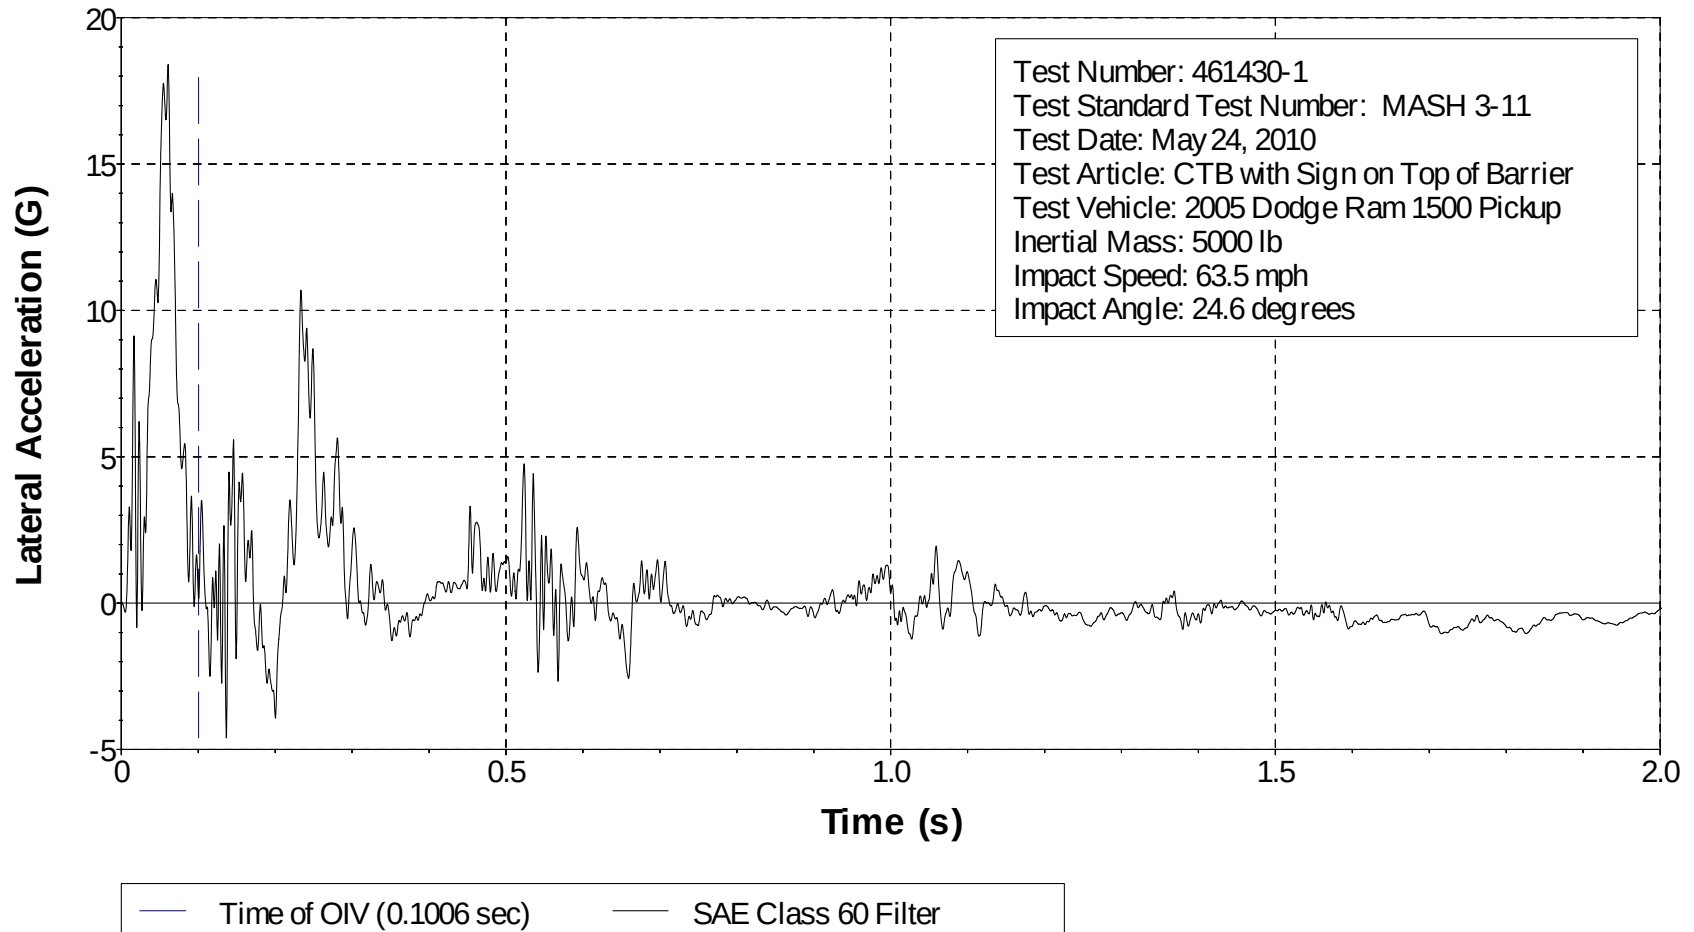
**Figure 18. Vehicle Lateral Accelerometer Trace for Test No. 461430-1  
(Accelerometer Located at Center of Gravity).**

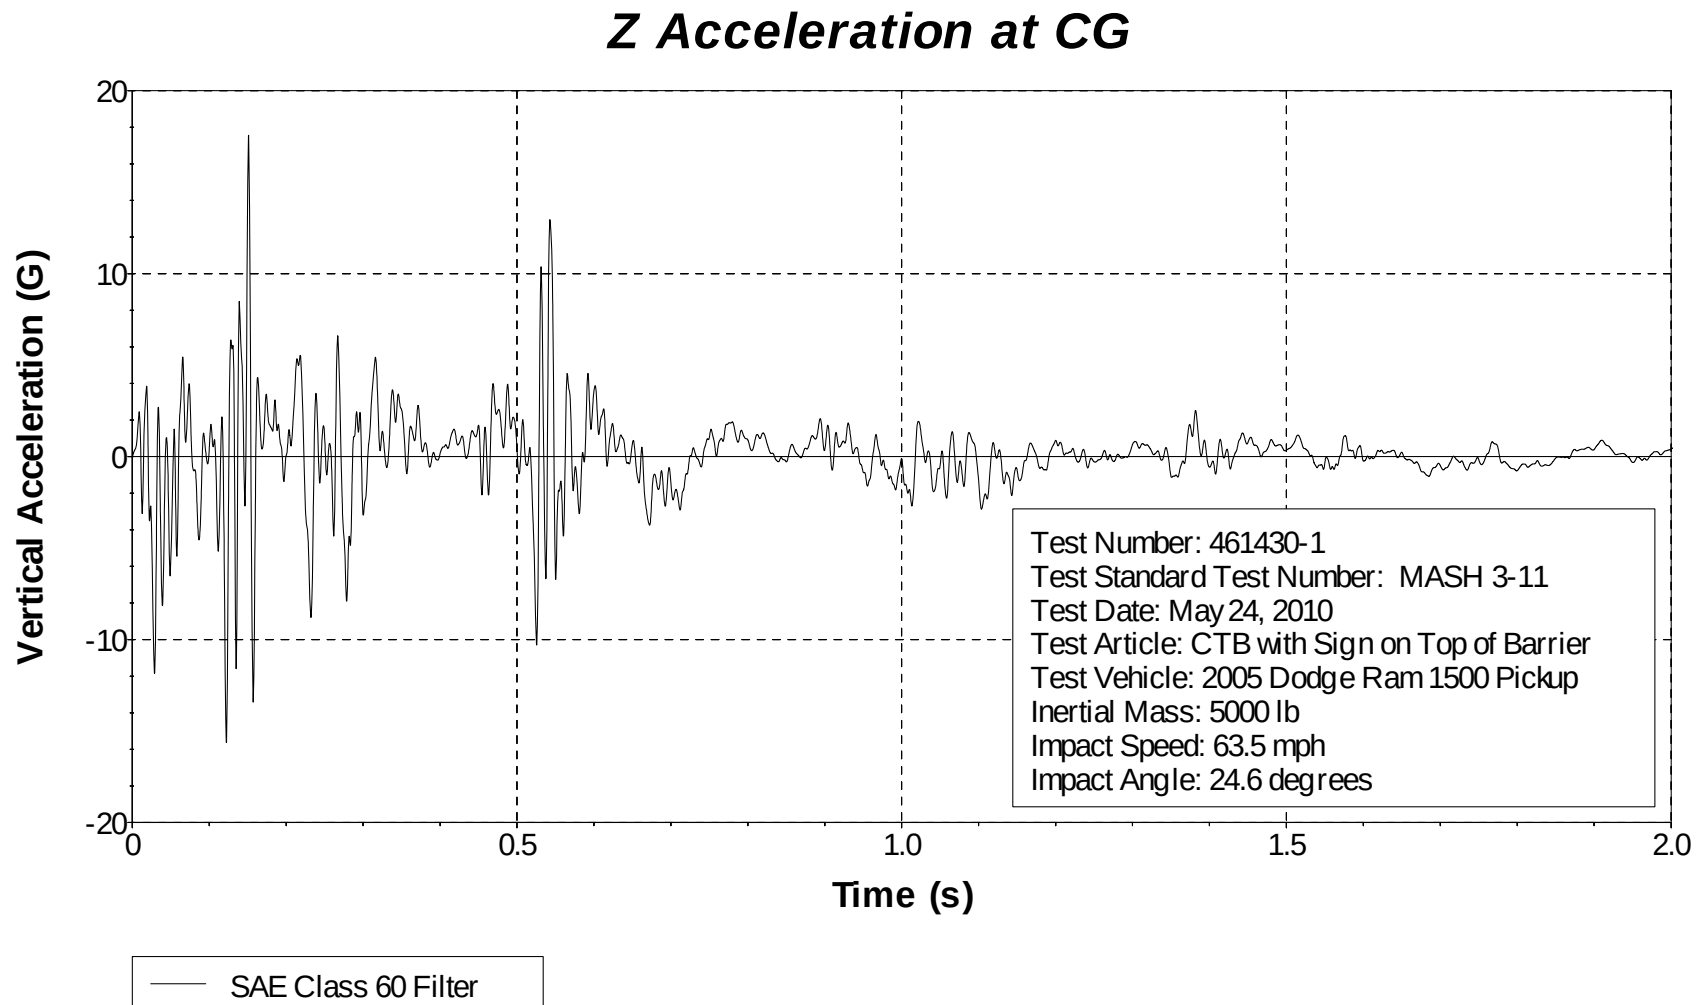
**Figure 19. Vehicle Vertical Accelerometer Trace for Test No. 461430-1  
(Accelerometer Located at Center of Gravity).**

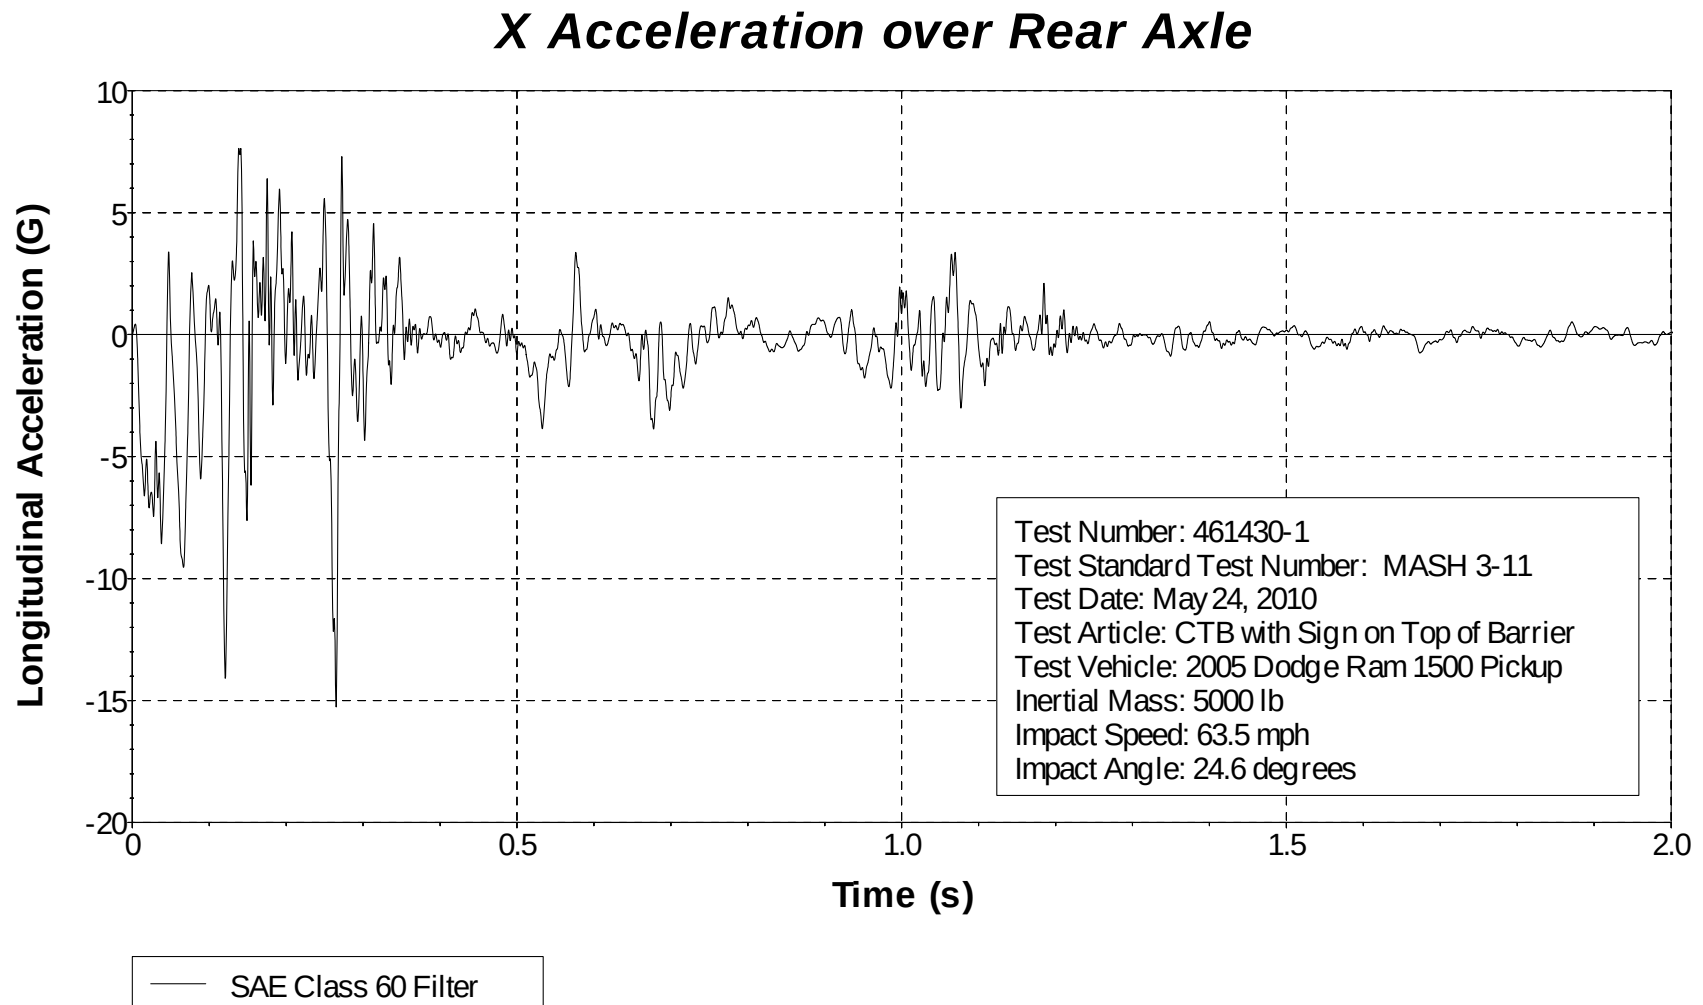
**Figure 20. Vehicle Longitudinal Accelerometer Trace for Test No. 461430-1  
(Accelerometer Located over Rear Axle).**

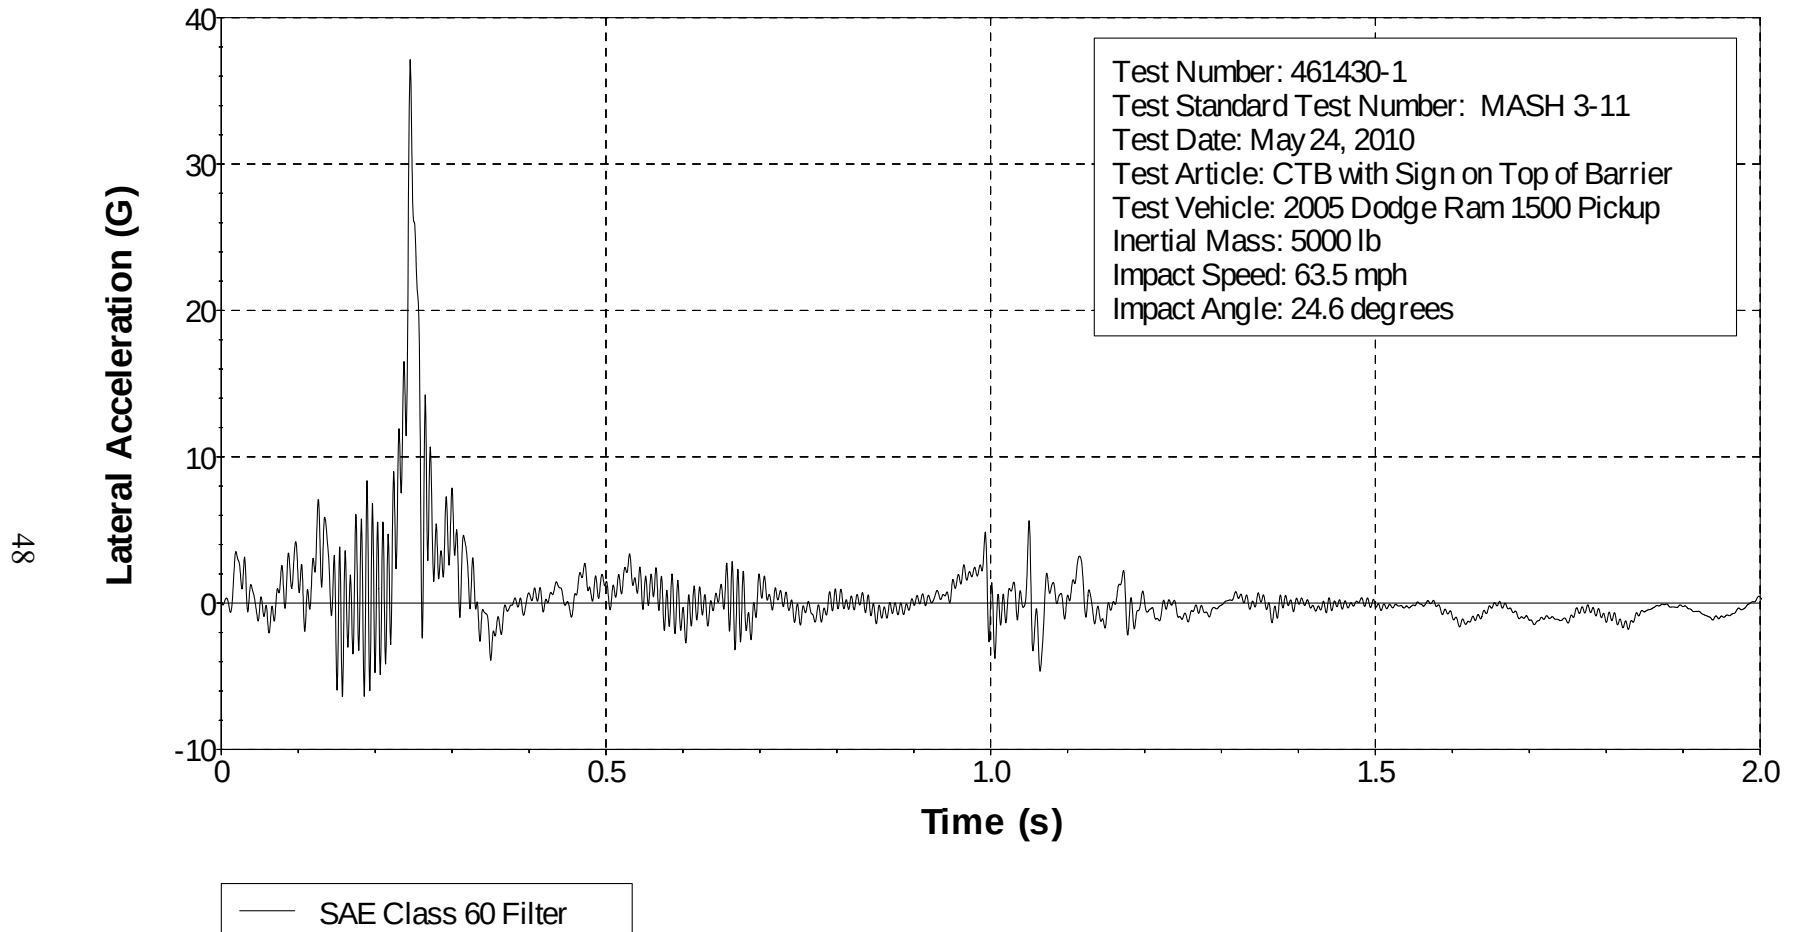
**Figure 21. Vehicle Lateral Accelerometer Trace for Test No. 461430-1  
(Accelerometer Located over Rear Axle).**

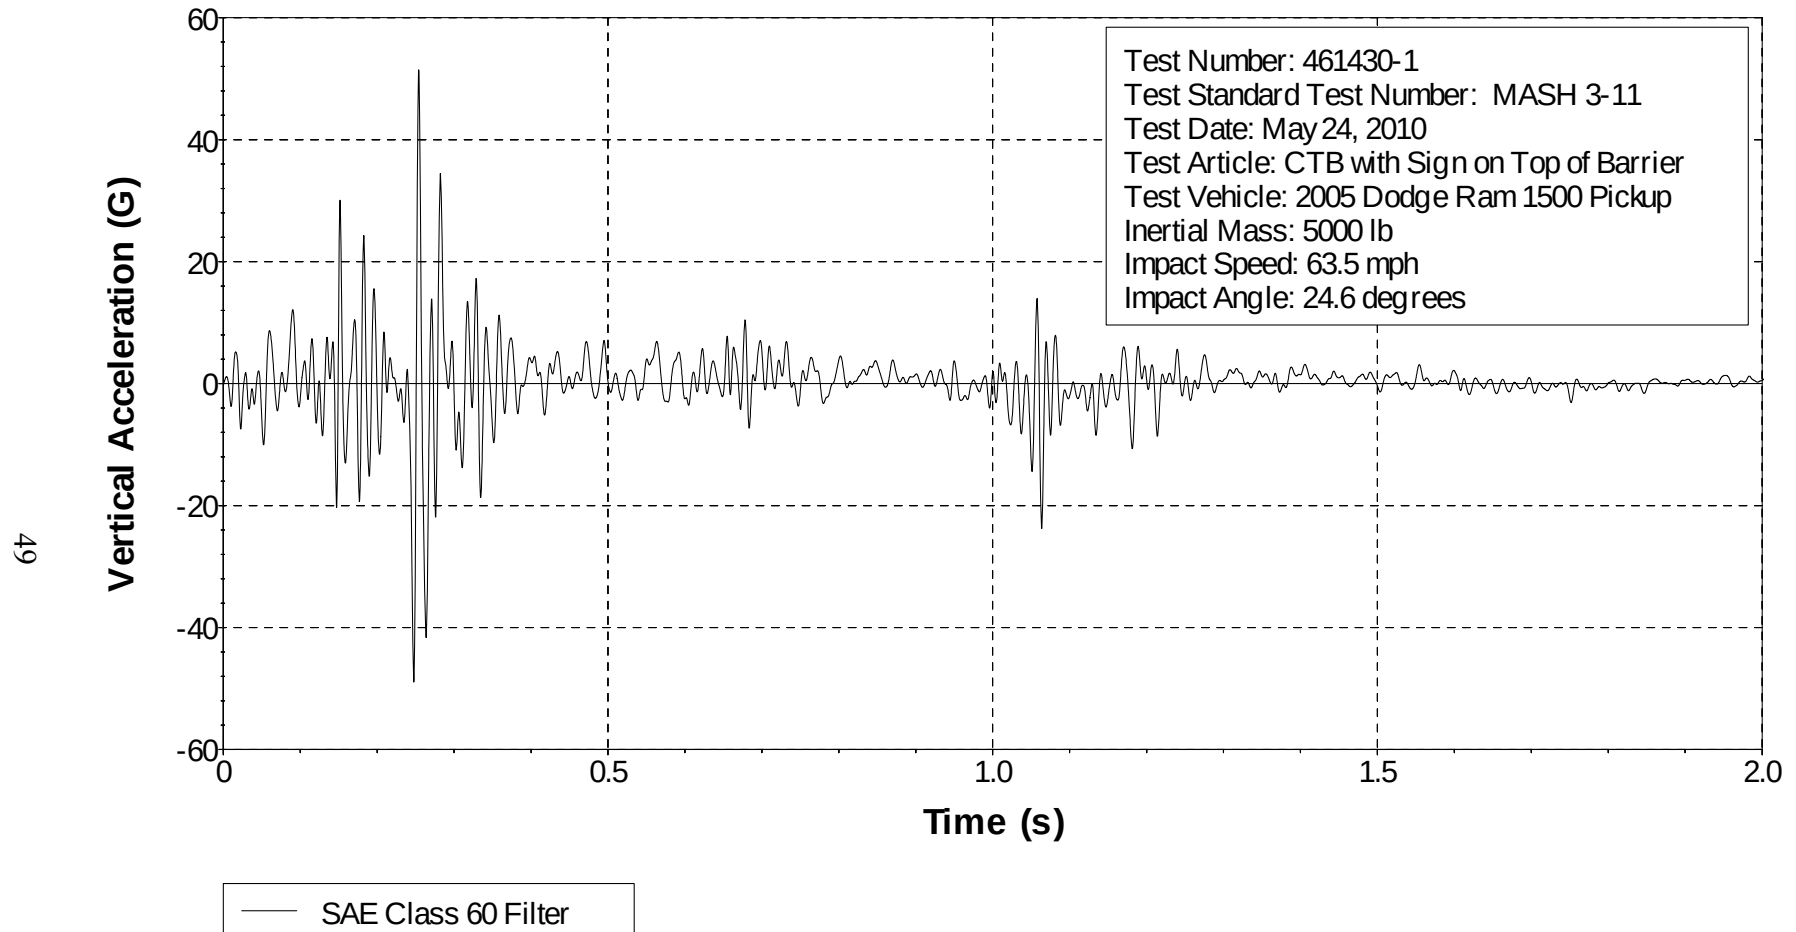
**Figure 22. Vehicle Vertical Accelerometer Trace for Test No. 461430-1  
(Accelerometer Located over Rear Axle).**
