A STUDY OF ACCIDENTS INVOLVING HIGHWAY BRIDGES

Virginia Highway Research Council  
(A Cooperative Organization Sponsored Jointly by the Virginia  
Department of Highways and the University of Virginia)

March 1971  
VHRC 70-R34

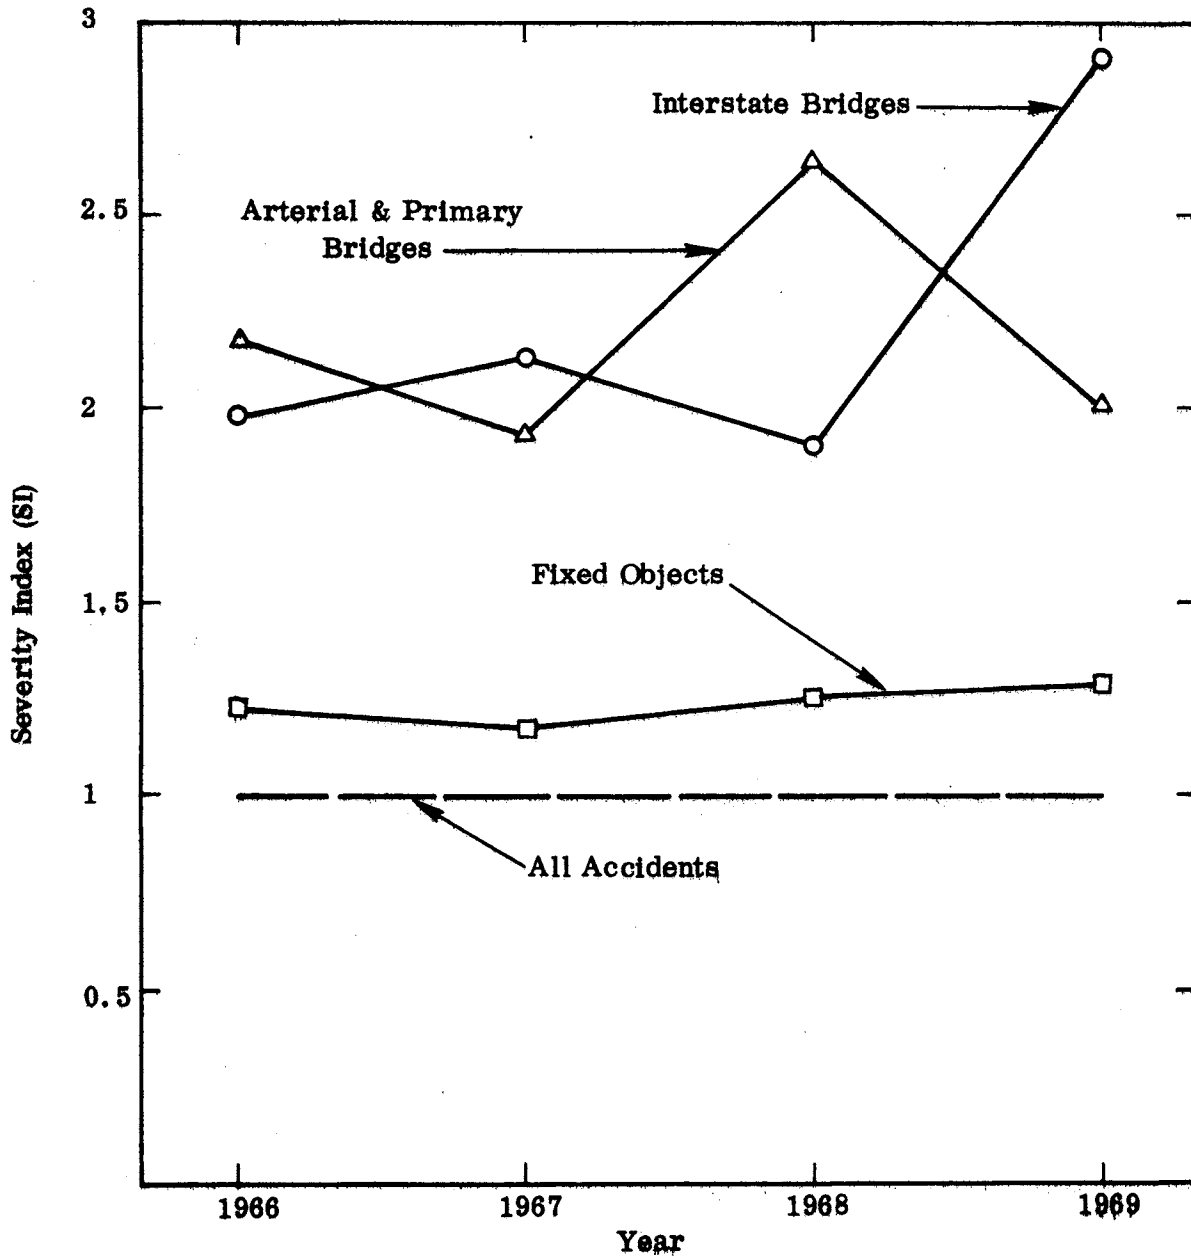
Figure 1. Relative severity of accidents involving bridge structures and fixed objects.

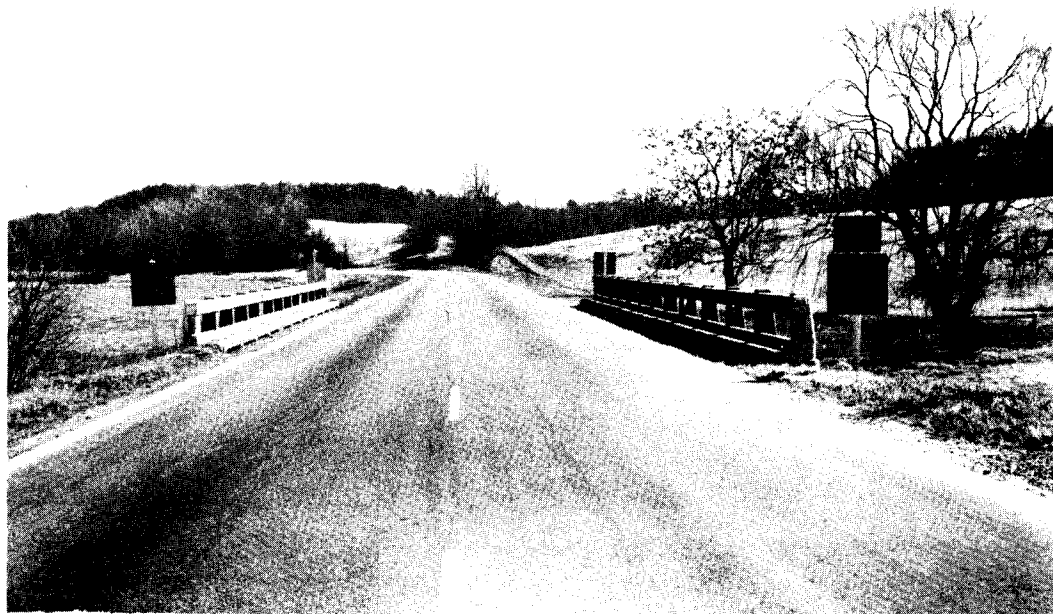
Figure 2. View of bridge #3 in Table IV showing excellent alignment and sight distance characteristics but the restricted roadway width and exposed ends of the rigid concrete railing constitute a potential hazard.

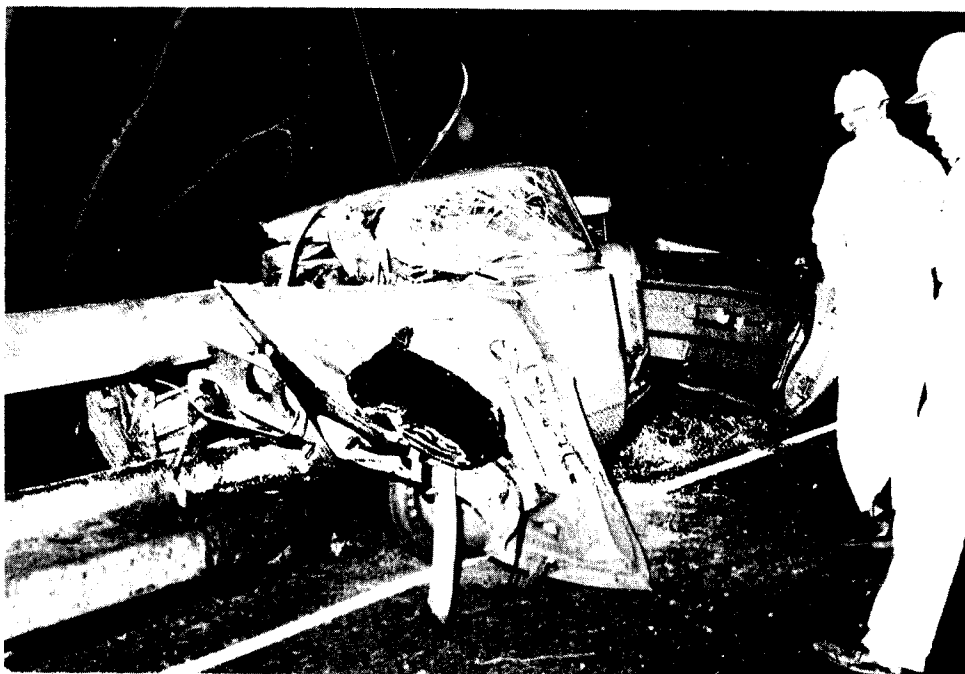
Figure 3. The results of a head-on collision with the right hand end post of the bridge shown in Figure 2.

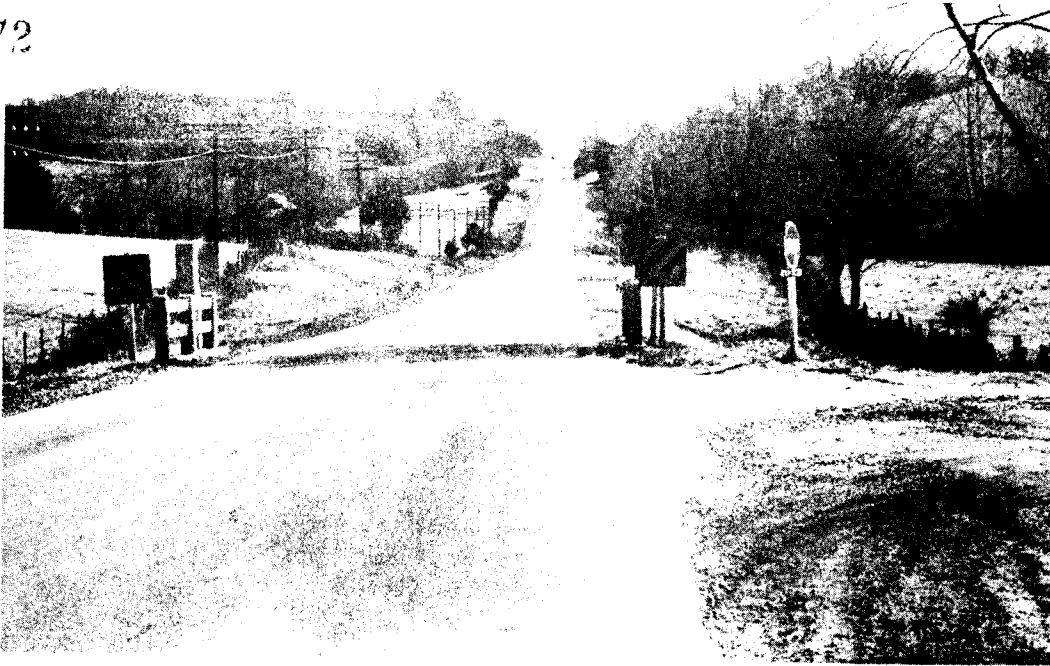
The first case study bridge has had a history of accidents — one fatal — and was recently involved in a sequence of collisions. When a narrow roadway width bridge is located within a passing opportunity section of a two lane highway such as that shown in Figure 4, collisions involving the bridge railings appear to occur more frequently than when this situation does not exist. This 22 ft. long, 23 ft. clear roadway bridge was involved in a passing type accident in August 1969 when a westbound vehicle met an eastbound vehicle passing another eastbound vehicle. The westbound vehicle went into a skid to avoid the eastbound vehicles, crossed to the opposite side of the road, knocked out the east end of the bridge railing (Figure 5), and went over the edge of the structure. The railing was rebuilt but in March 1970 an eastbound vehicle, forced over by a passing vehicle, knocked out the west end of the same railing (Figure 6). Subsequently, the rail was rebuilt, but in May 1970 an eastbound tractor-trailer, after being forced off the edge of the approach roadway, struck the same rail knocking it out entirely (Figure 7).

Figure 4. A narrow roadway with bridge located within a passing opportunity section of a two lane highway. An intersection is located to the right adjacent to the structures. (Bridge #1 of Table IV.)

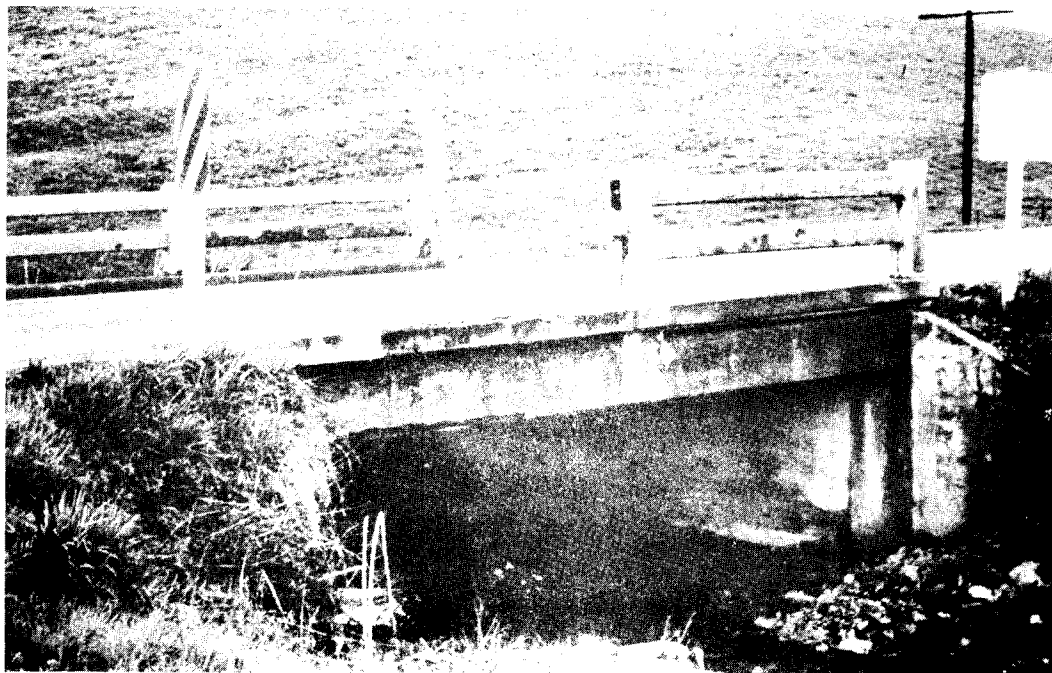
Figure 6. The same structure as shown in Figures 4 and 5. The east end of the concrete rail has been replaced and the west end subsequently knocked out. (Date of accident — March 1970.)

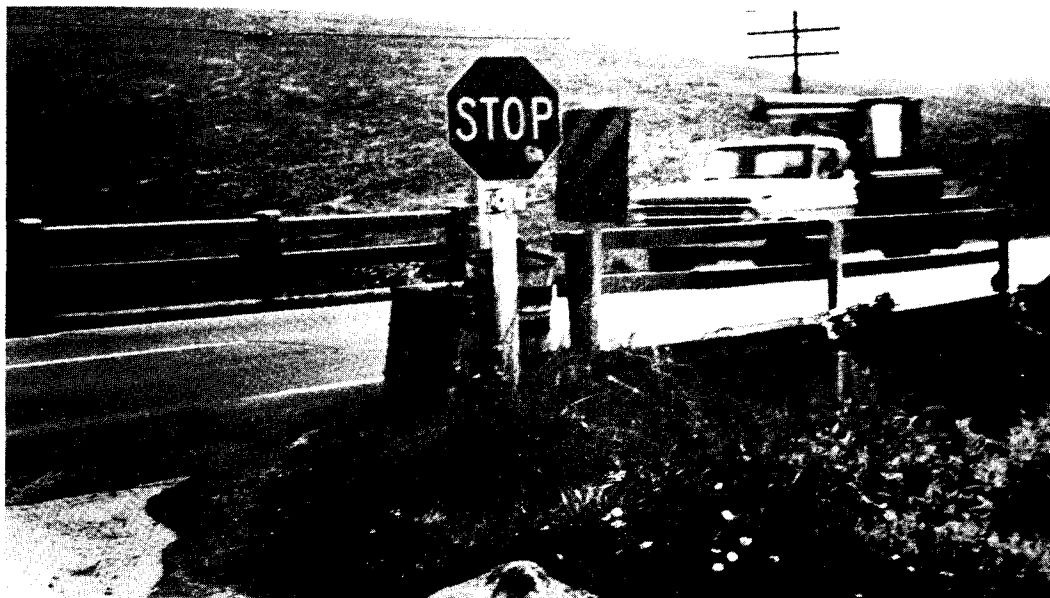
Figure 7. The same structure as shown in Figures 4, 5, and 6. Subsequent to March 1970 the concrete rail was rebuilt but later knocked out entirely and a temporary wooden rail again installed. (Date of accident — May 1970.)

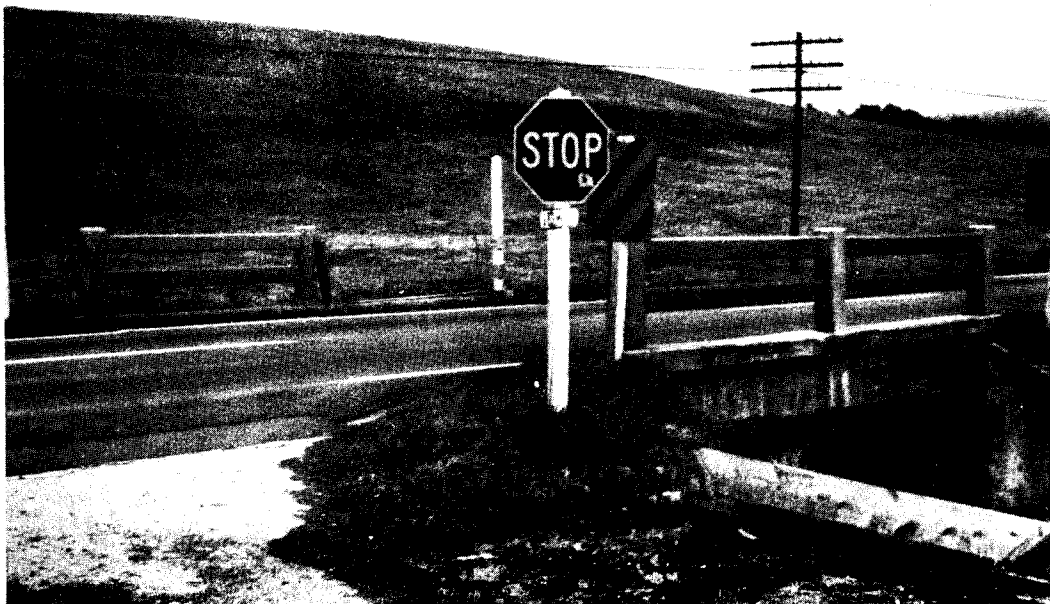
The rail was again rebuilt and in November 1970 the east end of the railing on the opposite side of the road was knocked out (Figure 8) by an out of control eastbound vehicle. The last two accidents were single vehicle property damage types and no reports were filed. (Details of the two accidents were obtained from a resident living adjacent to the bridge site.) In each of the two accidents, the steep slope off the edge of the main roadway pavement to the adjacent intersection may have been a contributing factor (See Figure 4). The truck driver, for example, was unable to get the rear wheels of his trailer back onto the pavement to avoid hitting the bridge railing. Still another vehicle lost control by running off the pavement in the same area. Note also that the pavement edge striping is discontinued across the intersection. Under certain circumstances this could be a contributing factor and is discussed further in a later case study.

Figure 8. The same structure as shown in Figures 4 through 7. Here the south rail has been rebuilt; the east end of the north rail knocked out. (Date of accident — November 1970.)

It is difficult to determine the total economic losses from the series of accidents described since property damages are only estimated by the reporter, some damages are not reported at all, and medical expenses are unknown. A reasonable estimate of the property damages, which occurred during a 15-month period, can be made as follows:

Personal property damages on two reported accidents	\$3,000
Personal property damages on two unreported accidents	1,000
Four repairs of handrail at average cost of \$432* each	<u>1,728</u>
Total	\$5,728

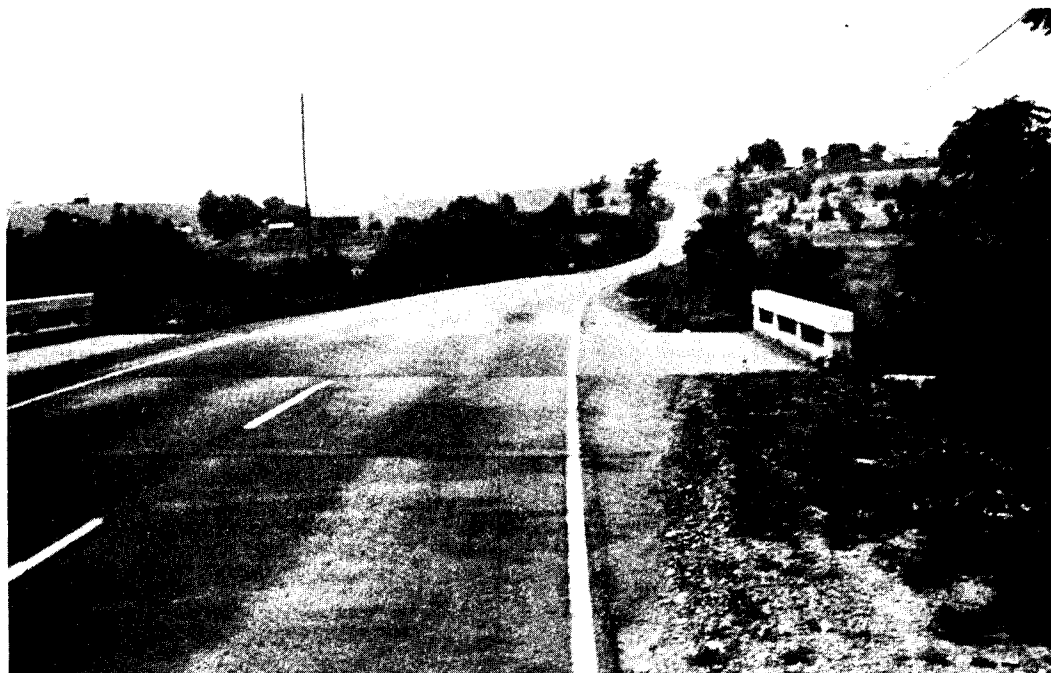
Figure 9. A 32 ft. span, 40 ft. roadway bridge which was widened from a 23 ft. roadway. As a secondary measure, an approach guardrail anchored to the bridge rail would further enhance this safety improvement.

- (3) That for short span length narrow roadway width bridges (typical of those shown in Figures 5 and 9 of the report) with accident histories, it is recommended that widening these structures to equal the full approach roadway shoulder width be considered the best alternative in the program outlined in paragraphs 1 and 2.

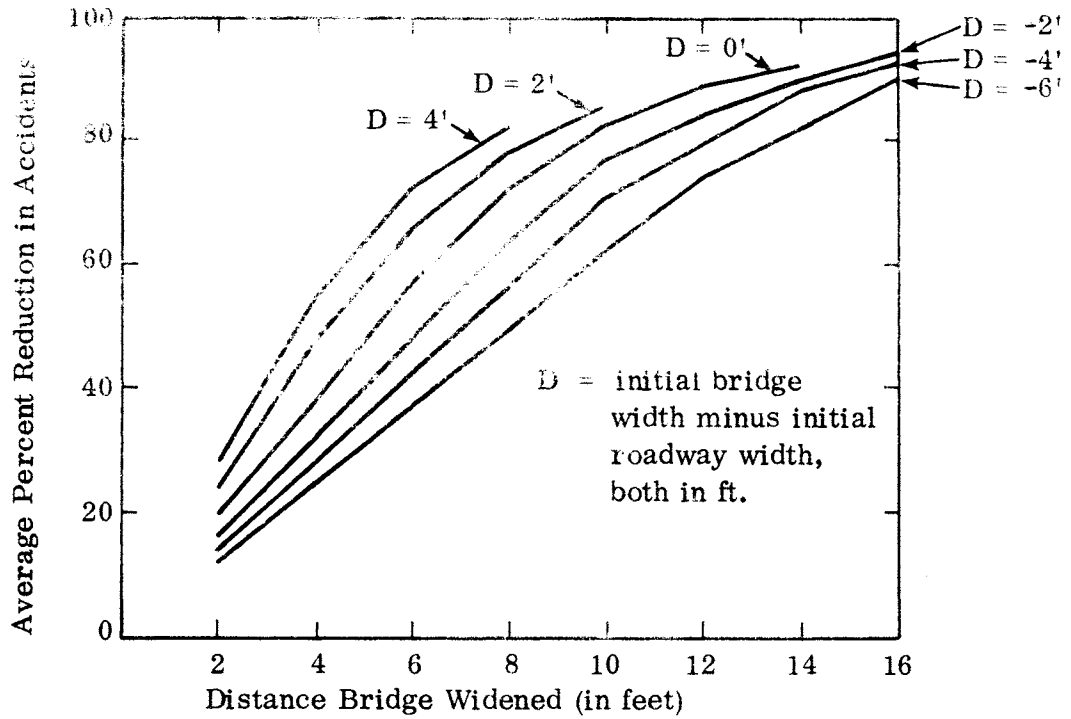
Curves which can be used to forecast accident reductions and fatality-injury and property damage reductions through the widening of bridges have been developed by Jorgensen and Associates<sup>(18)</sup> and are shown in Figures 10 and 11. By extrapolating the curve  $D = 0$  of Figure 10, it can be estimated that an average reduction in accidents of approximately 95% can be expected from the 17 ft. widening of bridge #6. A similar reduction in property damages and injuries could be expected by extrapolation of the curves given in Figure 11. Benefit and cost estimates can be calculated for the widening improvement by using the methodology presented in reference 18. Thus, for an annual cost of \$985 the widening of bridge #6 will yield estimated average annual benefits of \$11,350 for a benefit to cost ratio of 11.5. (See Appendix B for calculations.) Since the two structures are quite similar, bridge #1 could be widened for approximately the same cost as bridge #6. The annual cost of such an improvement would be less than one fifth the \$5,728 property damages estimated for the recent series of accidents.

Figure 10. Forecast chart of accident reduction through widening bridges. (From Reference 18.)

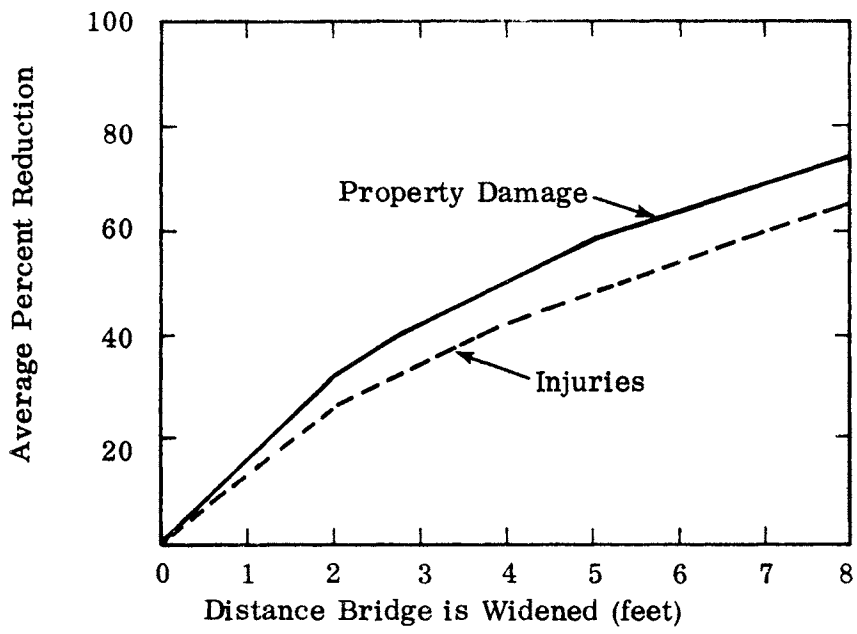
Figure 11. Forecast of fatality-injury and property damage reduction through widening bridges. (From Reference 18.)

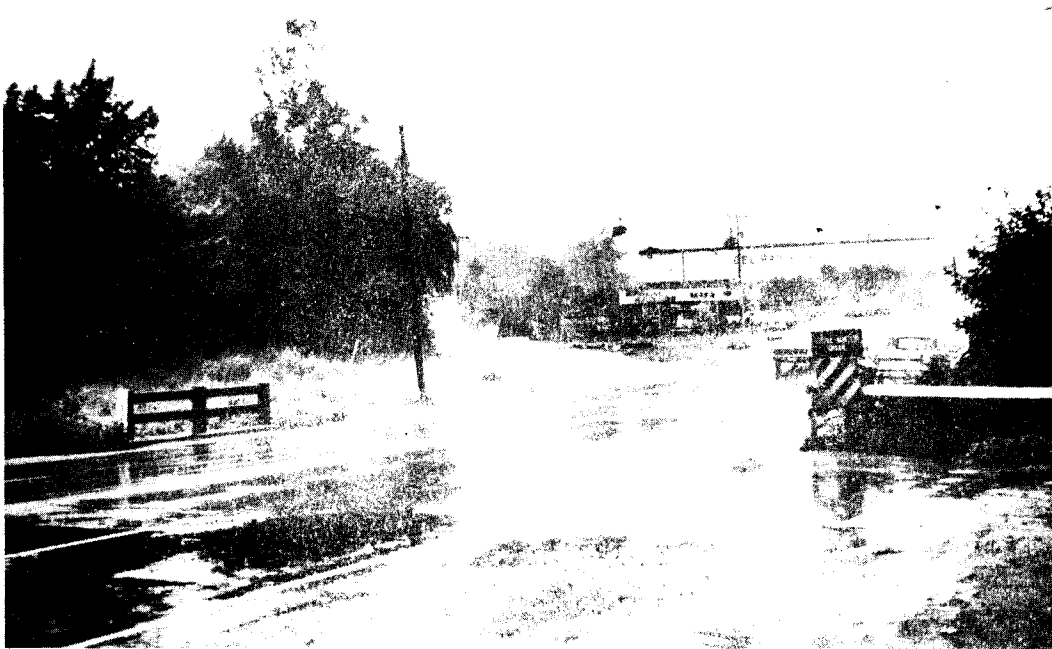
Slowing, stopping, or turning traffic at intersections, business entrances, etc., increase accident potential. When bridges happen to be located adjacent to points of high accident potential their potential for involvement also appears to be increased; thus, to some extent creating a situation of double jeopardy. A typical example is given in Figure 13, which shows a narrow roadway width bridge located adjacent to an intersection where traffic slows or stops for left turns. Collisions with the right-hand bridge rail have resulted from situations where one vehicle maneuvers to avoid collision with other vehicles making turning or lane change maneuvers. A business entrance adjacent to the right approach to the bridge probably adds to the traffic conflicts at this particular location. Widening of the short span bridge would probably be the best alternative for removing this particular fixed object hazard.

Figure 13. A narrow roadway width bridge located adjacent to an intersection (center) and business entrance (right foreground). A temporary wooden rail replaces the knocked out concrete rail on the right side of the bridge. (Bridge #24, Table IV.)

The results from this study as illustrated by the last two examples, suggest that intersections should be located as far away from bridge sites as possible in design. Where intersections are located adjacent to structures the main roadway pavement edge marking should be continued across the intersection. When advantage can be taken of main roadway gradients, intersections should be located to give maximum sight advantage over the bridge railings.

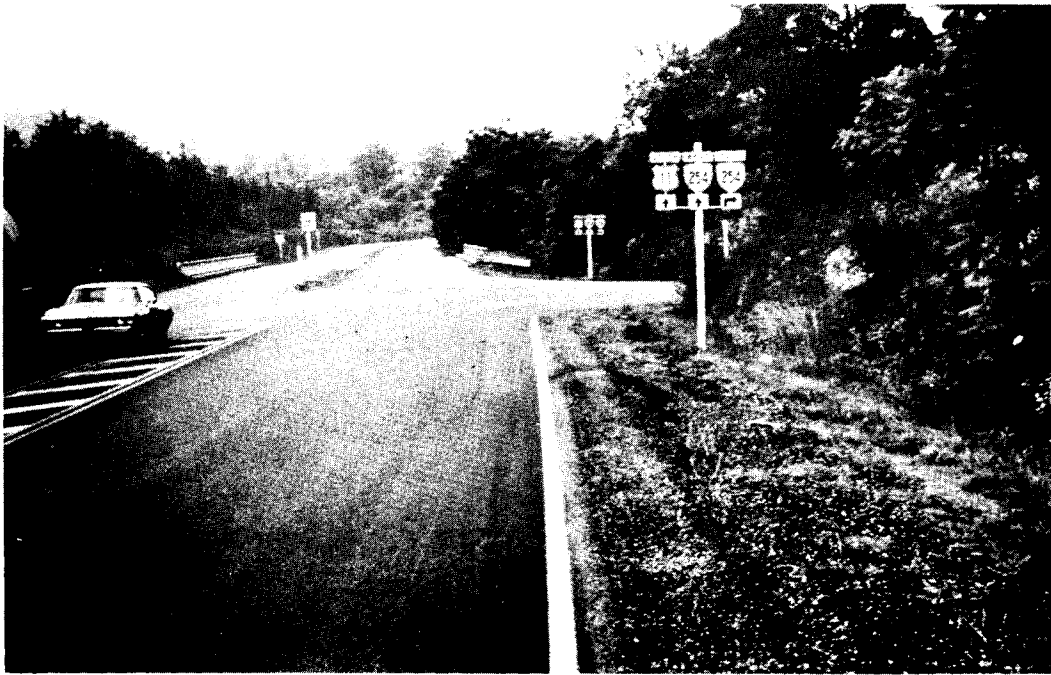
In the next case study seven fatalities have resulted from single vehicle collisions with the right endpost of the bridge rail. In two separate collisions within a period of several weeks six fatalities resulted from the first, and one from the last. Both accidents occurred at night and visibility was poor due to fog or rainy conditions. In these two accidents and another in the 1966-67 period driver fatigue could have been a factor. Approaching the bridge (Figure 14) there is a transition from two to four lanes occurring simultaneously with a curve to the left. The approach pavement edge marking is discontinued on the right at an adjacent intersection, and there is no centerline lane marking in the pavement transition area. Considering these factors and the environmental and visibility conditions existing at the time of the accidents it is possible that each driver mistook the intersection to the right for the main roadway. Accordingly, they could have been misled to the extent that their recovery course headed into the bridge endpost. Alternately, if the pavement edge marking was being used as a guide, one would be headed on a course beginning from the point where the pavement edge marking is discontinued and directed toward the bridge endpost -- while the road actually curves leftward. Thus, under the circumstances, the pavement transition, the curve to the left, the intersection to the right, and the discontinuation of the pavement edge marking could all have been contributing factors in these accidents.

Figure 14. A bridge located at the end of a pavement transition section. Two fatal accidents have occurred in collisions with the right-hand endpost. (Bridge #10, Table IV.)

Each of the last two examples demonstrates the general finding that pavement transitions on bridge approaches should be avoided. When transitions are necessary, however, they should be completed well in advance of the structure to allow drivers maximum opportunity to adjust to the change prior to entering the bridge. Forbes<sup>(21)</sup> reports that driver tasks, depending upon the degree of complexity, can require up to 3 or more seconds. Allowing for lower illumination and other conditions which reduce visibility this response time might be more than doubled. If additional adjustment time were allowed, 10 to 12 seconds might be a reasonable time estimate; and at normal speed limits a minimum distance of 1000 to 1200 ft. between the bridge and the completion of a lane transition should be allowed.

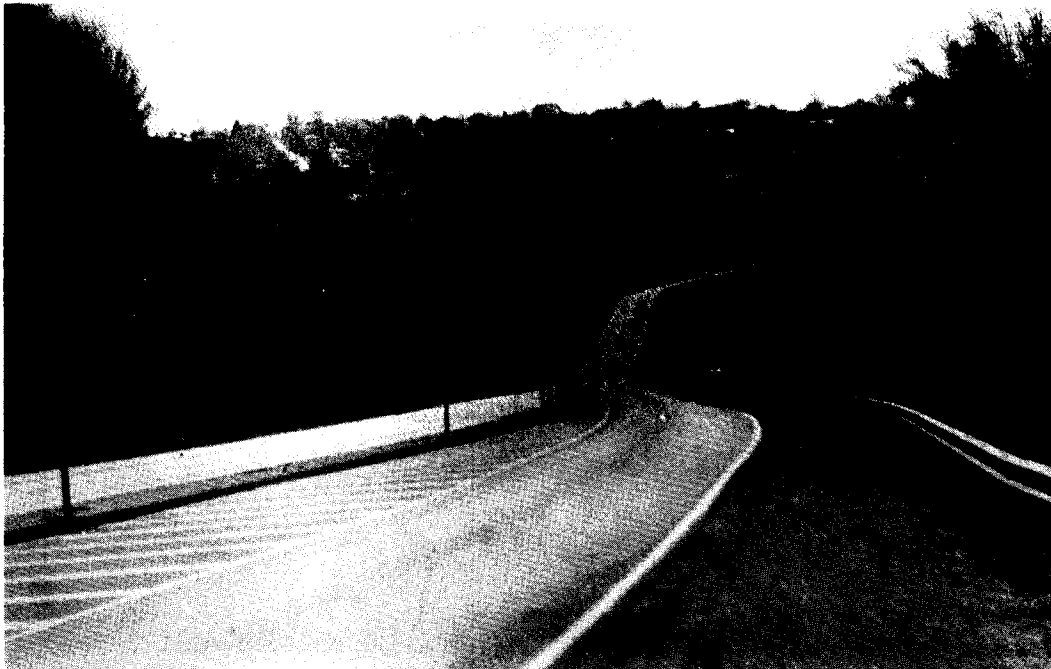
Figure 15. A transition from four lanes to two lanes on the approach to a major bridge crossing. (Bridge #22, Table IV.)

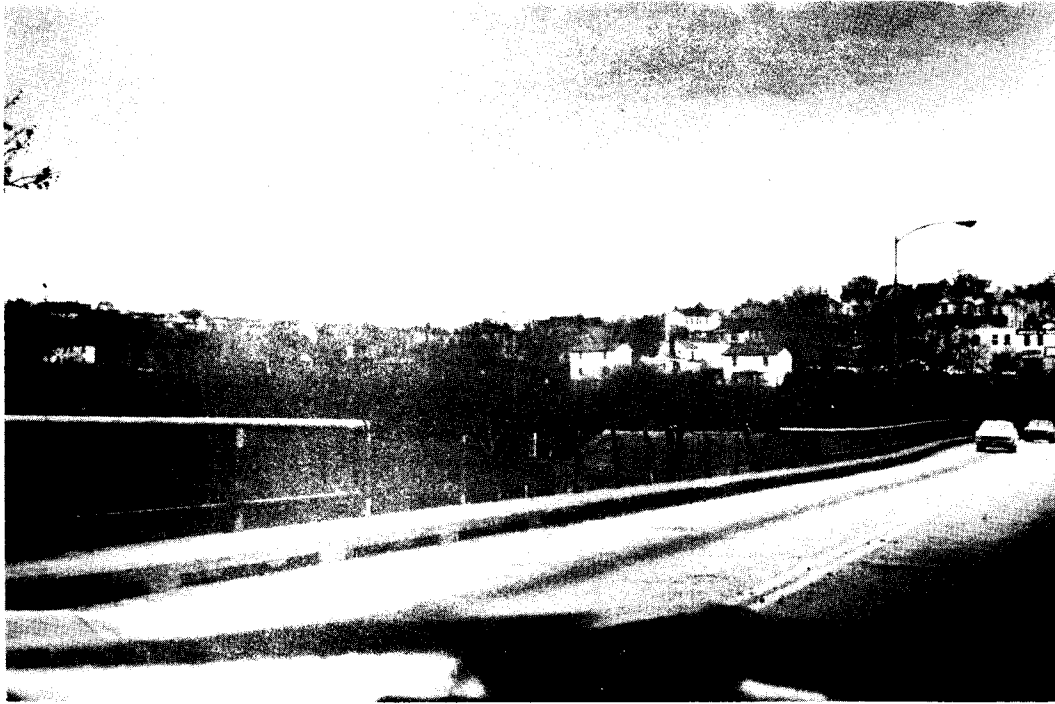
Figure 16. Penetration of the steel railing of bridge #22 resulting from a truck collision.

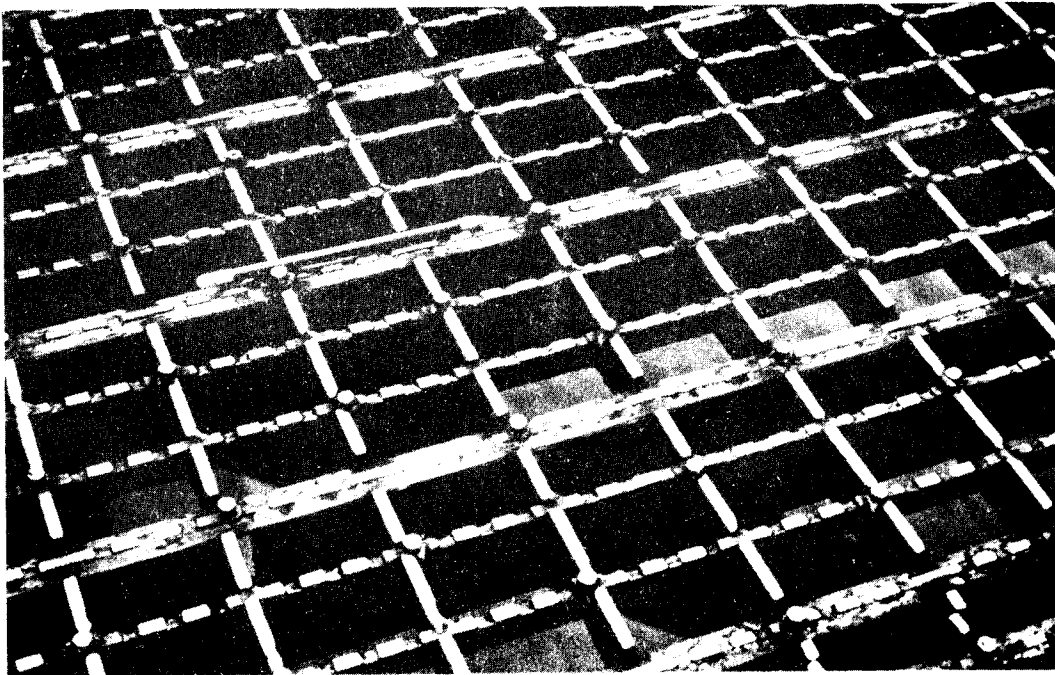
In 1966 there were 9 accidents reported on the Rte. 17 bridge over the York River. All occurred on the steel grating; seven during rainy weather and one during snowy conditions. In 1969, after the application of the steel studs, there were 3 accidents reported — all of which occurred during dry surface conditions and the steel deck was not considered to be a contributing factor. Neglecting a slight increase in traffic volume between 1966 and 1969, the 67% decrease in accidents indicates that the application of the studs has been very beneficial. Significant reductions in accidents have also been reported<sup>(23)</sup> in Pennsylvania where studs were applied to a number of steel deck bridges in 1967.

Figure 18. Steel grated deck with steel studs attached to improve skid resistance.

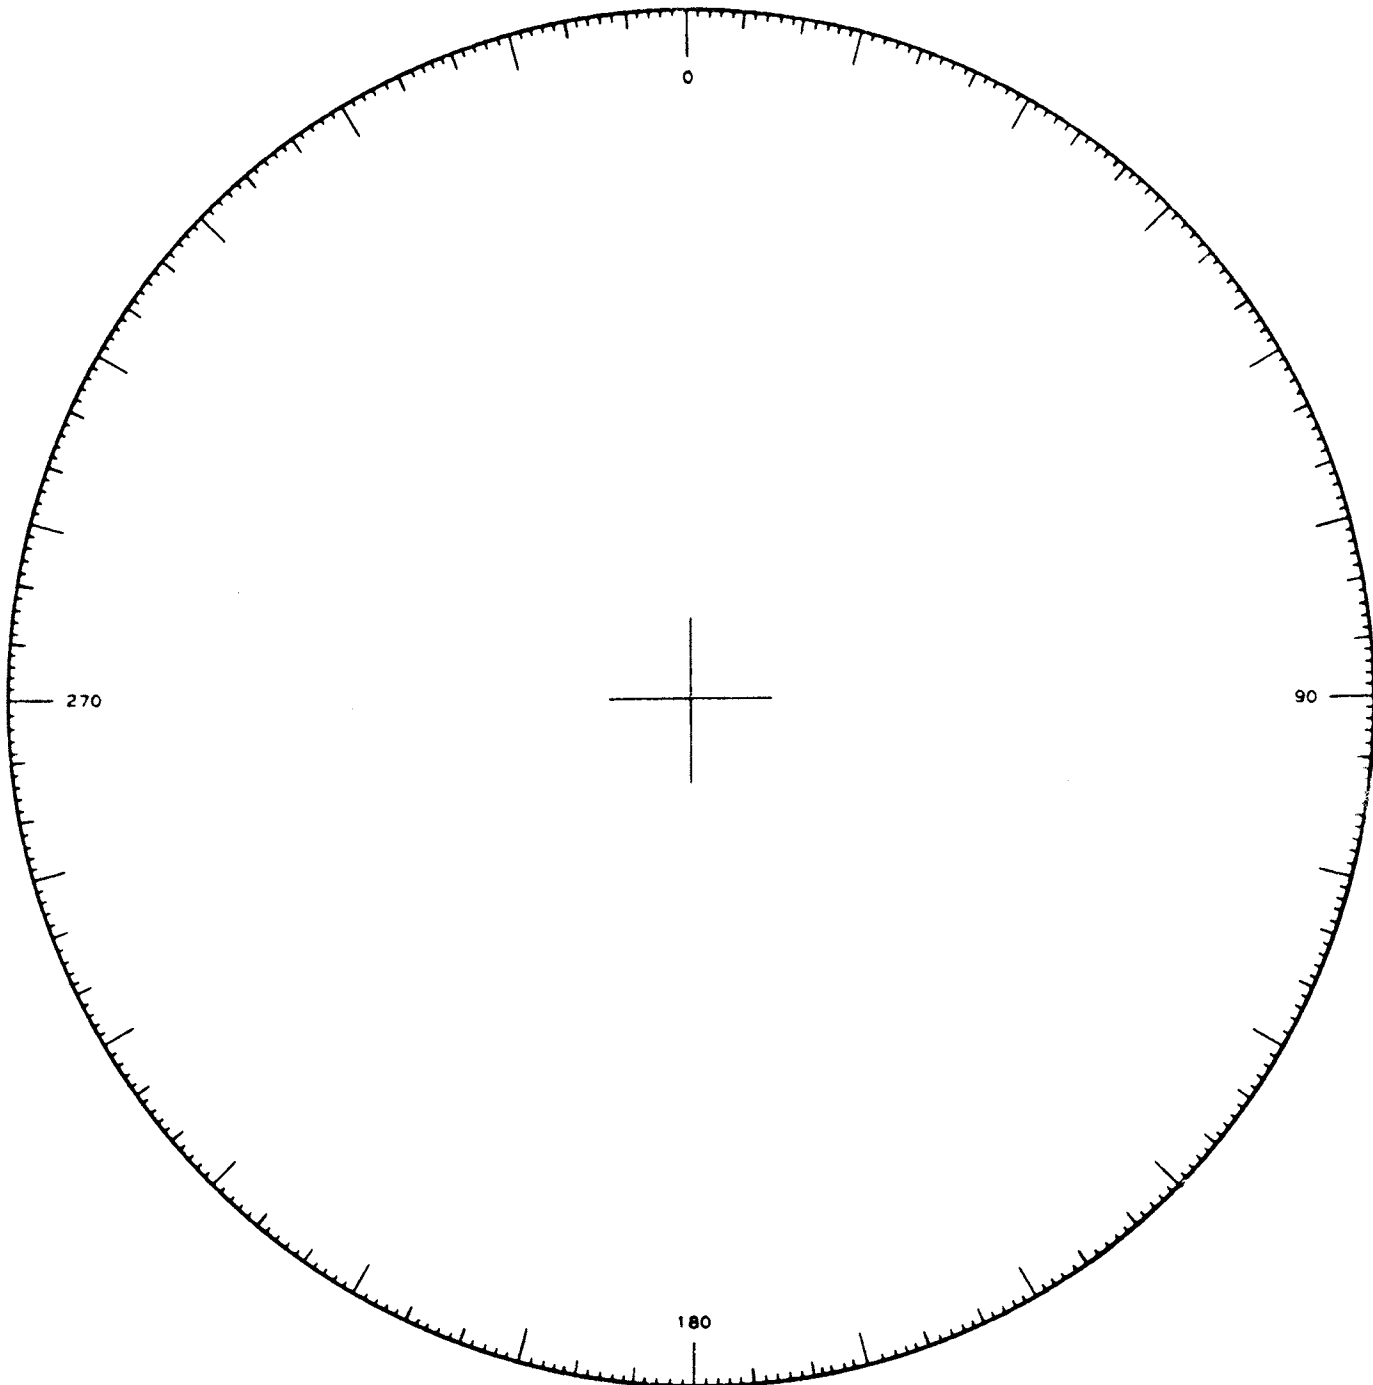
Figure A-1. (From Reference 11.) See instructions for use on next page.
