## TWO-COURSE BONDED CONCRETE BRIDGE DECK CONSTRUCTION

Interim Report No. 2

Concrete Properties and Deck Condition Prior  
to Opening to Traffic

July 1976  
VHTRC 77-R3

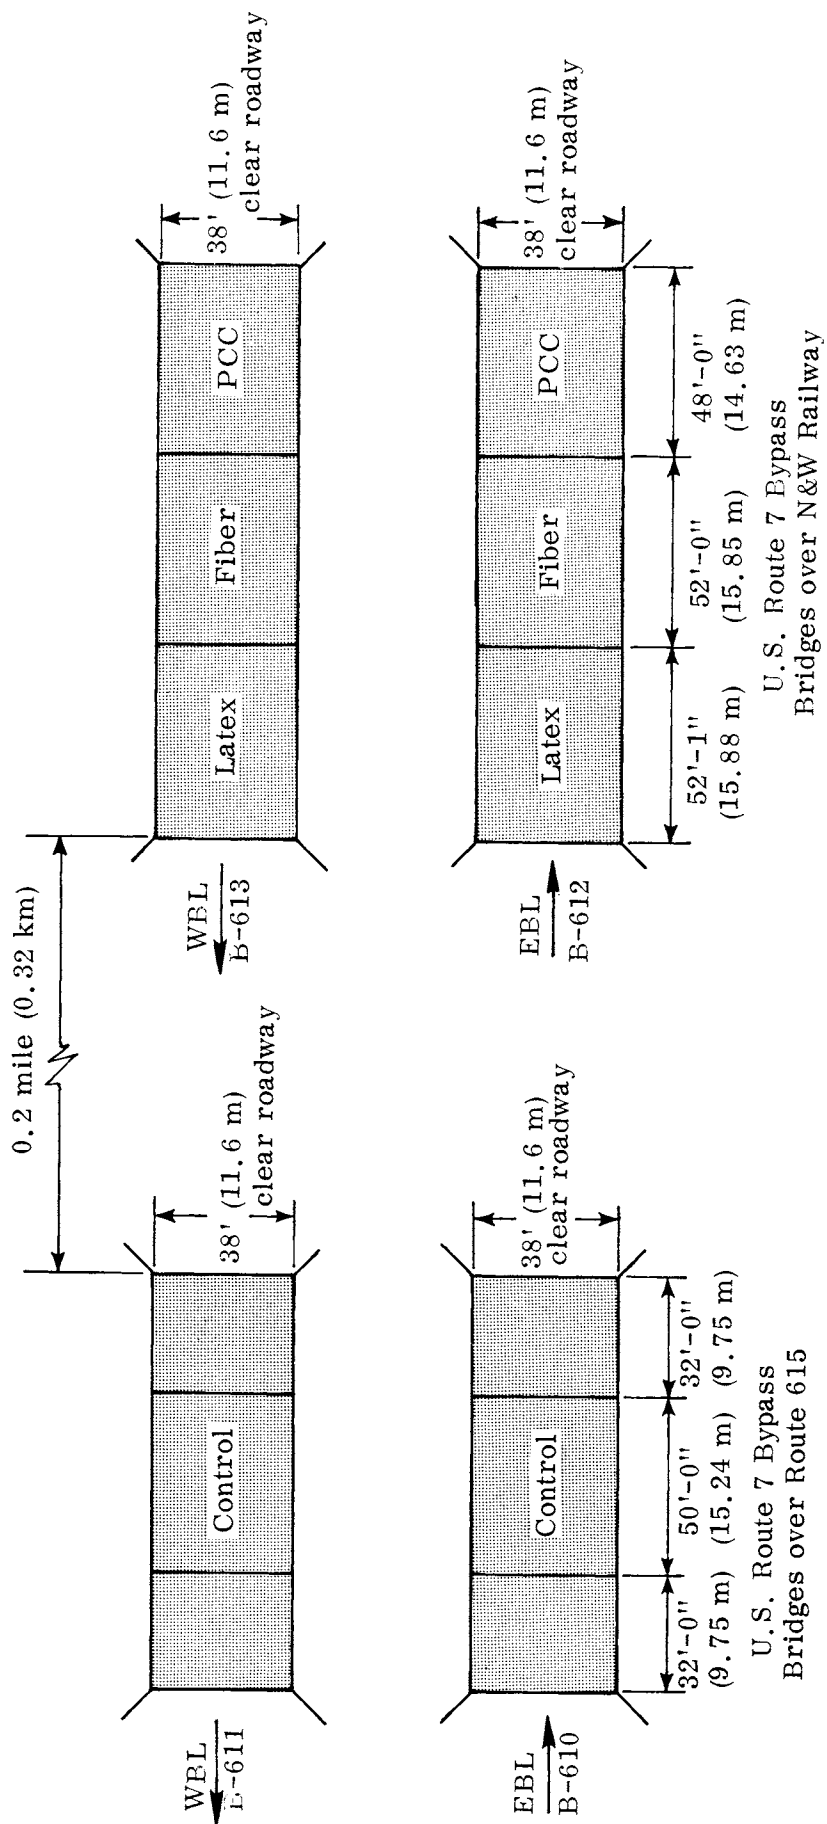
Figure 1. Plan view of bridge structures.

The project plan for the six two-course decks is depicted in Figure 1, along with that for the two control decks on nearby structures that were constructed within the same contract by a conventional, single-lift technique. Each of the three special wearing course concretes was applied as an overlay for two of the two-course decks.

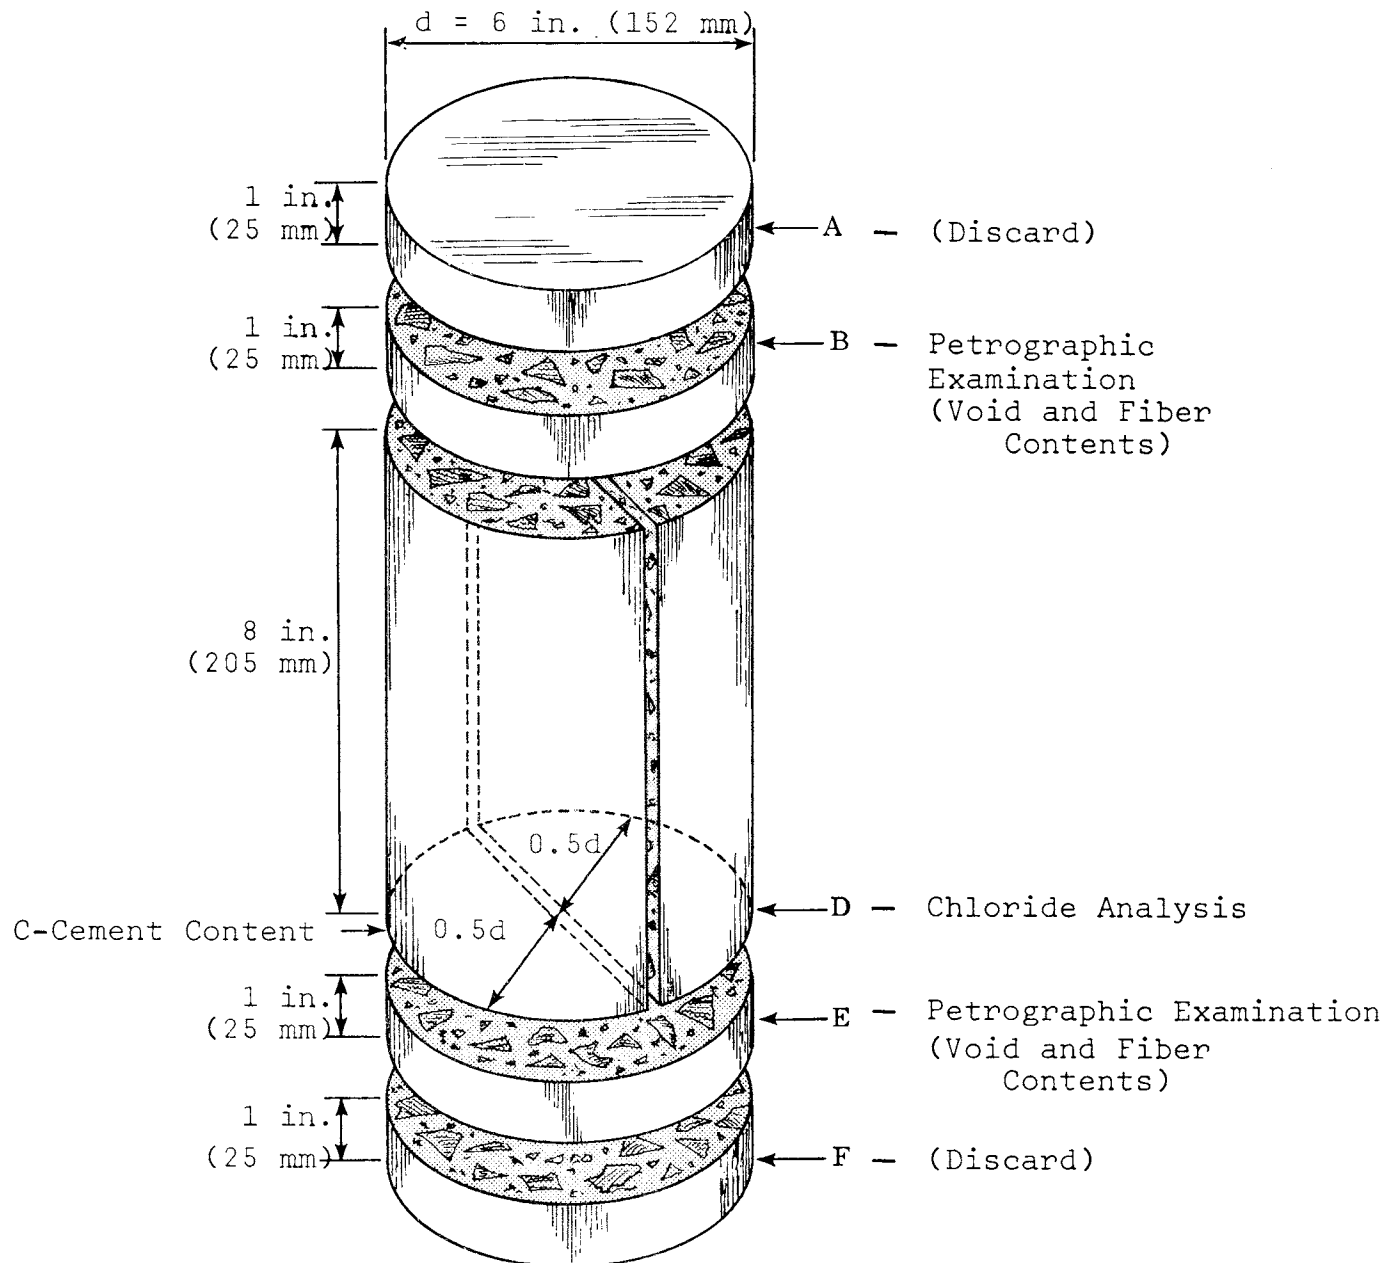
Figure 2. Pattern used to cut cylinders for analysis and examination.

On this experimental project normal procedures were used by the contractor to satisfy requirements for the concretes in the control decks and in the base layers and overlays of the two-course decks. In subsequent sections of this report the results of routine acceptance testing, based on air contents, slump, temperature, and strength, and other tests of the hardened concretes as cement, void and fiber contents and freeze-thaw resistance are presented to indicate the degree of conformance achieved in the concrete mixtures. These additional tests on the hardened concretes were made using samples cut from cast cylinders as depicted in Figure 2.

The cement contents specified for the concretes in the control decks and in the base layers and overlays of the two-course decks were shown in Table 2. The proportions of each concrete were monitored during batching and subsequently the cement contents of the hardened concretes were determined from sections of cast cylinders as shown in Figure 2.

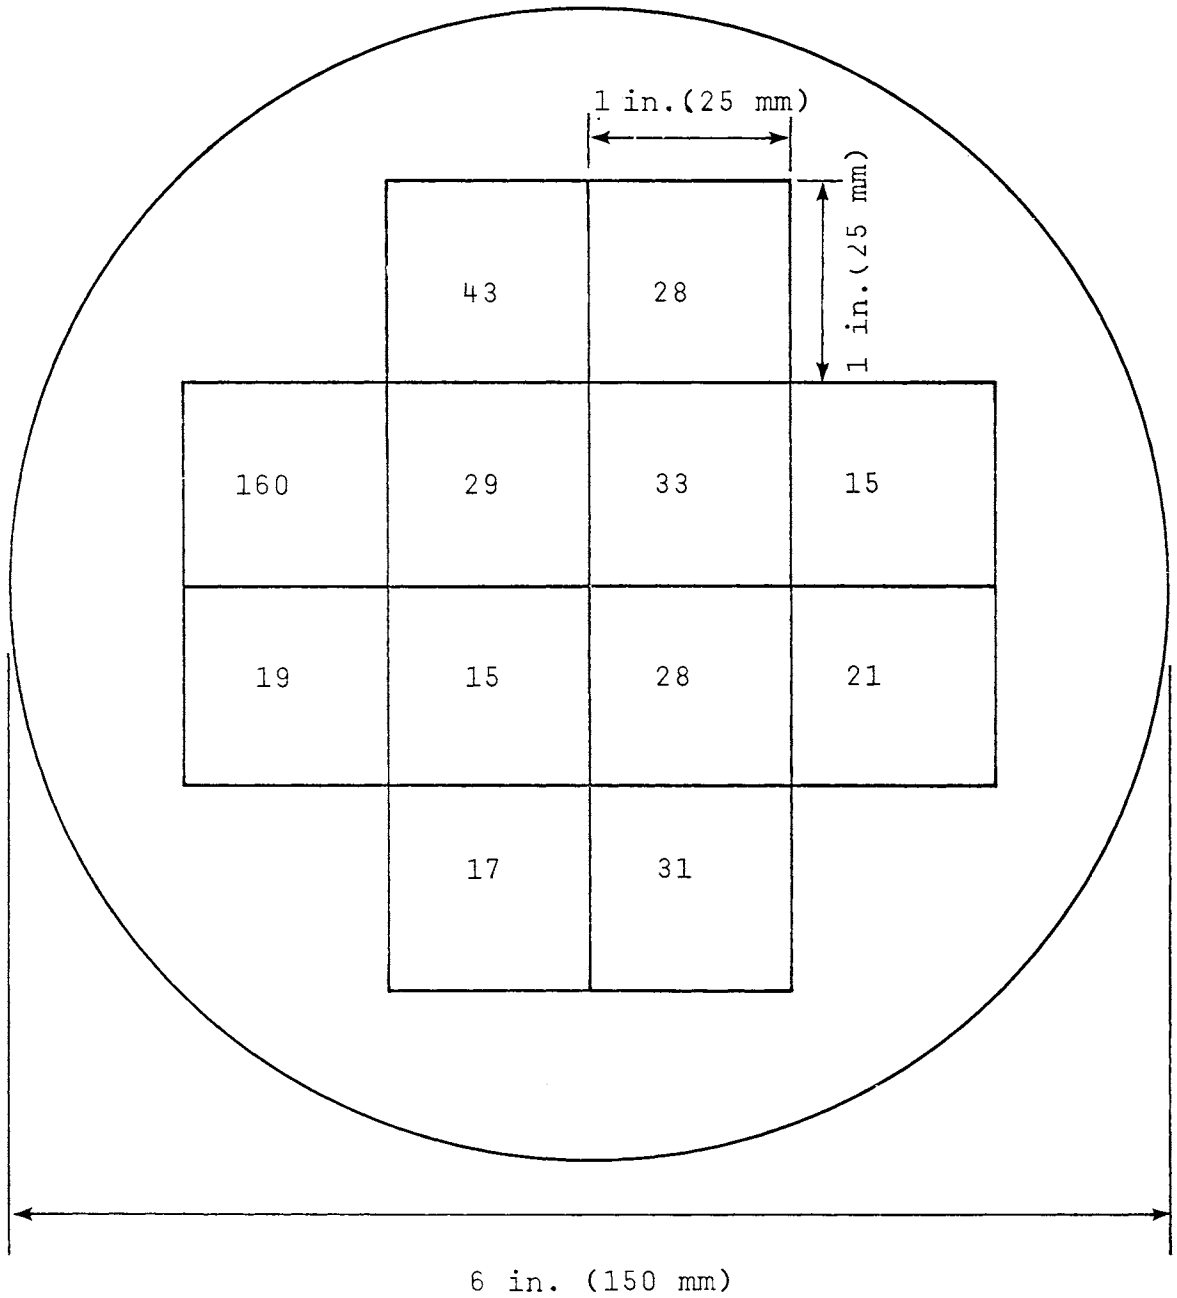
Figure 3. Grid pattern, with fiber counts, used to determine the wire fiber distribution in 6 in. x 12 in. (150 mm x 300 mm) cylindrical concrete specimens.

The desired random distribution of the fibers in the mix may not necessarily be indicated by the close agreement between measured and specified fiber contents, because clumping of the fibers during mixing can cause concentrations. By dividing the surface of a cut section into a grid pattern as depicted in Figure 3, and counting the total number of fibers that appeared in each grid section, an assessment of the distribution was made. The grid consisted of 1 in. (25 mm) squares with the fiber counts recorded in the squares. The typical distribution of fibers per 1 in.<sup>2</sup> (645 mm<sup>2</sup>) varied from 15 to 43. A concentration of 160 fibers in one grid section is the result of the clumping, or balling, mentioned earlier. No reduction in durability is anticipated since a microscopic examination of such areas showed them to be filled with a continuous mortar having intimate contact with the fiber surfaces. This condition in test specimens under laboratory conditions has been found to inhibit corrosion, even in the presence of large amounts of chloride ions. Such fiber concentrations would, however, reduce the effectiveness of this reinforcement since fewer fibers than desired can be available in the remaining concrete matrix.

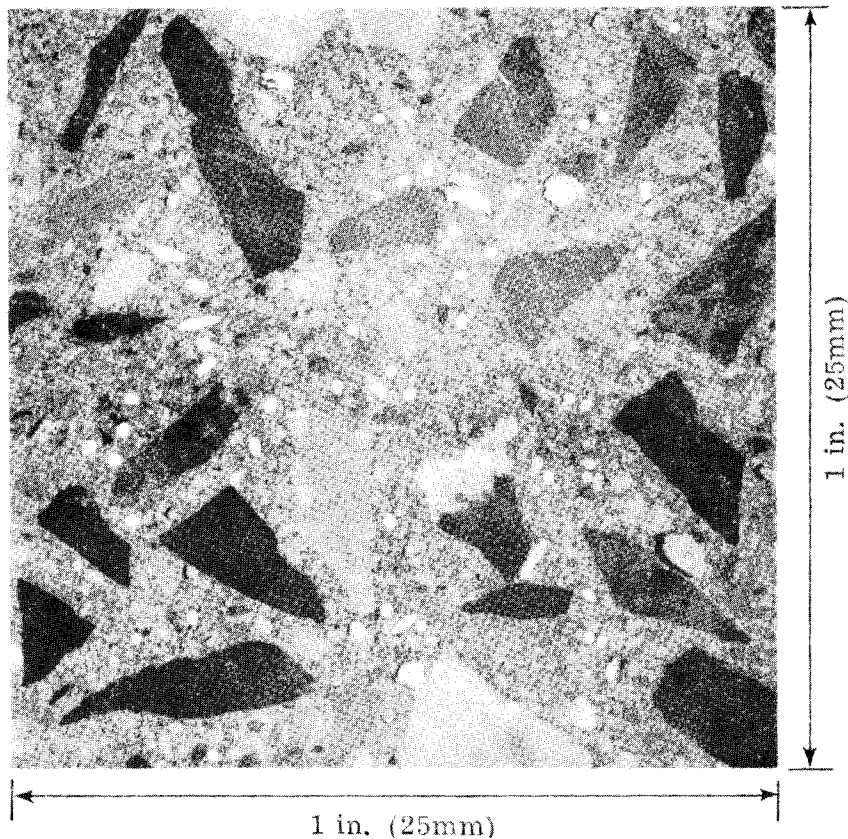
Figure 4. Typical grid section from which the orientations of wire fibers were computed.

The fiber inclinations with respect to a horizontal datum plane (0 degrees), were computed from measurements of the elliptical fiber sections in a typical grid section as shown in Figure 4. Their inclinations varied from 15° to 90°, with an average of 51°. This average based on a small sampling reflects a skewed distribution favoring the vertical orientation of fibers due to the rodding involved in the cylinder preparation. The distribution of fiber orientations in the overlays has been assumed to be skewed towards the horizontal due to the screeding operation across the decks.

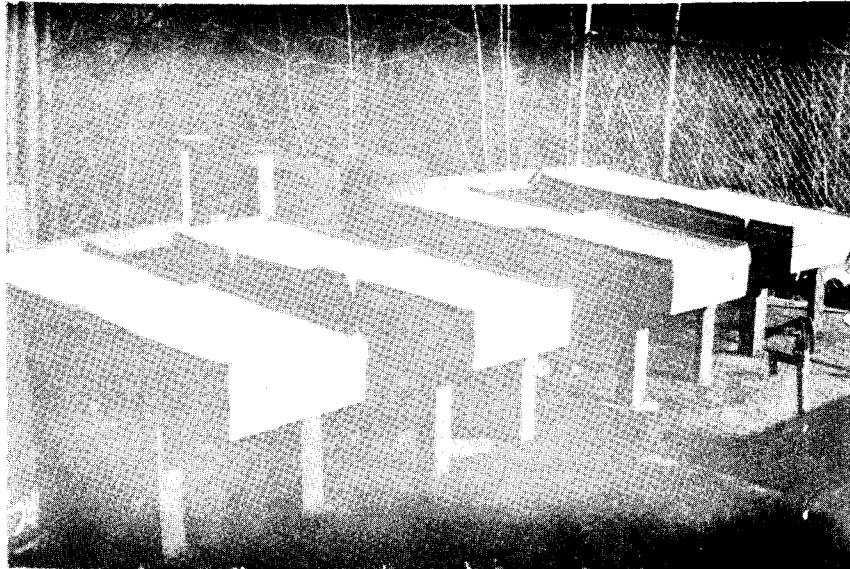
Figure 5. Two-course and single-lift deck models in outdoor exposure area.

Outdoor exposure slabs fabricated with concretes from the project are being subjected to natural freeze-thaw cycles with heavy applications of deicing salts. These slabs, shown in Figure 5 in the Council's outdoor exposure area, are two-course and single-lift deck models having overall dimensions of 2 ft. x 3 ft. x 8.5 in. (0.6 m x 0.9 m x 216 mm) and containing the same reinforcing steel pattern as the structural decks. The deck models have undergone two winters of natural freeze-thaw cycles with no scaling or other indication of deterioration.

Another purpose of these exposure slabs is for determinations of the rates at which the several concretes are infiltrated by chloride ions, and the results of this accelerated exposure testing will be used to suggest the relative protective qualities of these concretes.

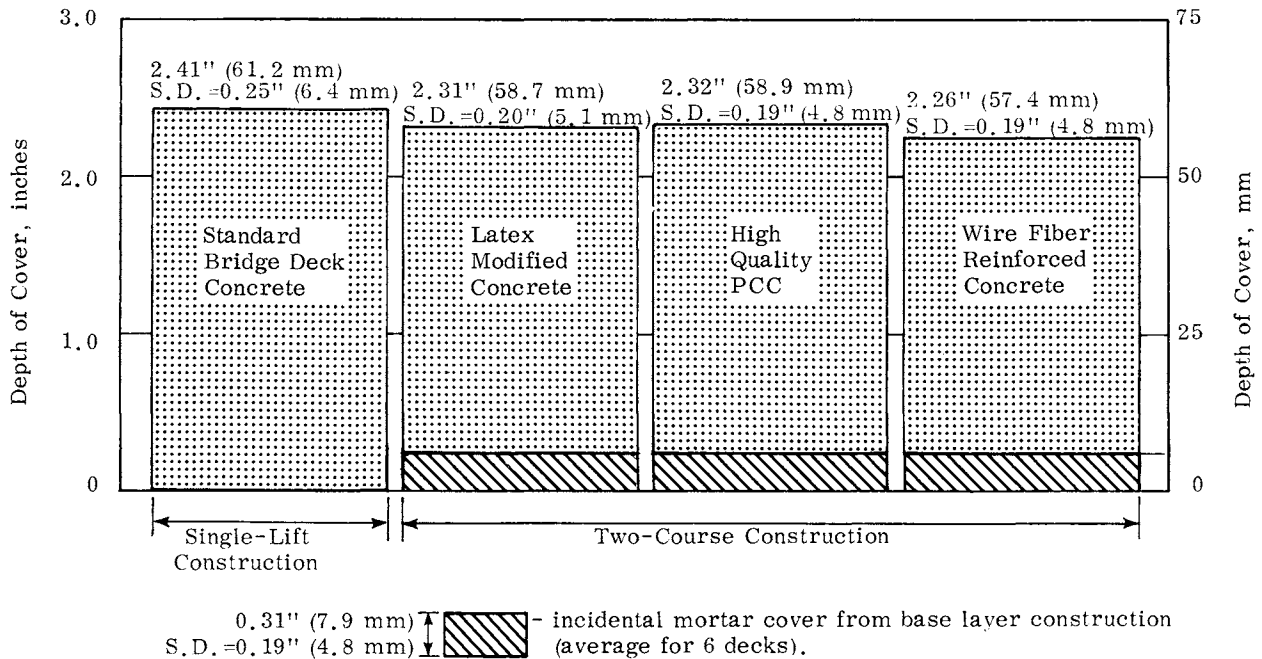
Figure 6. Depth of cover over topmost reinforcing steel for eight study decks.

The depth of concrete cover over the topmost reinforcing steel of the study decks was determined by direct probes in the fresh concrete during construction and the statistical results from the depth probes are shown in Figure 6. The total depth of cover provided by the two-course technique was found to be equivalent to that provided by conventional, single-lift construction for identical deck designs.

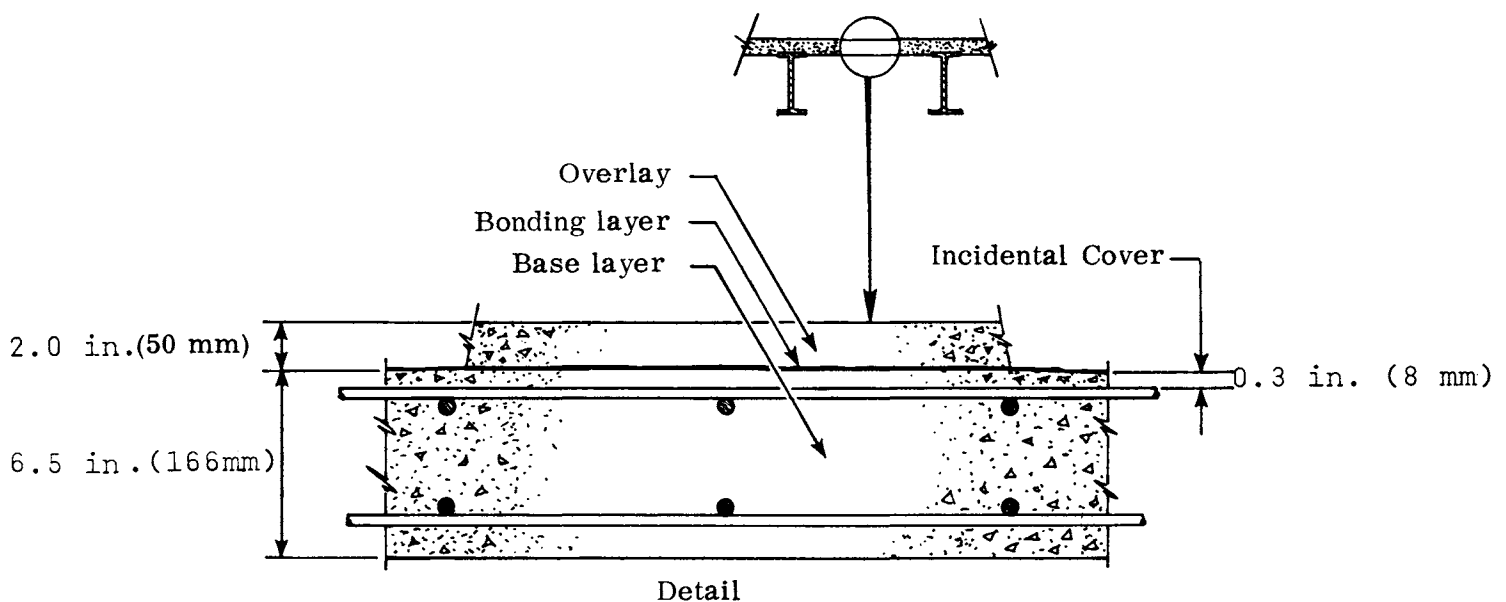
Figure 7. Typical transverse section of two-course bonded concrete bridge decks as constructed in Virginia.

Direct probes of the overlay course are desirable during construction when the concrete remains plastic to assure the attainment of specified cover depths while corrections can most easily be made. Also, since the direct probe data correlate closely with conventional pachometer readings, it is not necessary to obtain pachometer readings on two-course decks when making comparisons of cover between two-course and existing conventional decks. On the basis of direct probes of the concrete in the study decks, the six two-course decks were found to have average depth dimensions as shown in the typical transverse section in Figure 7.

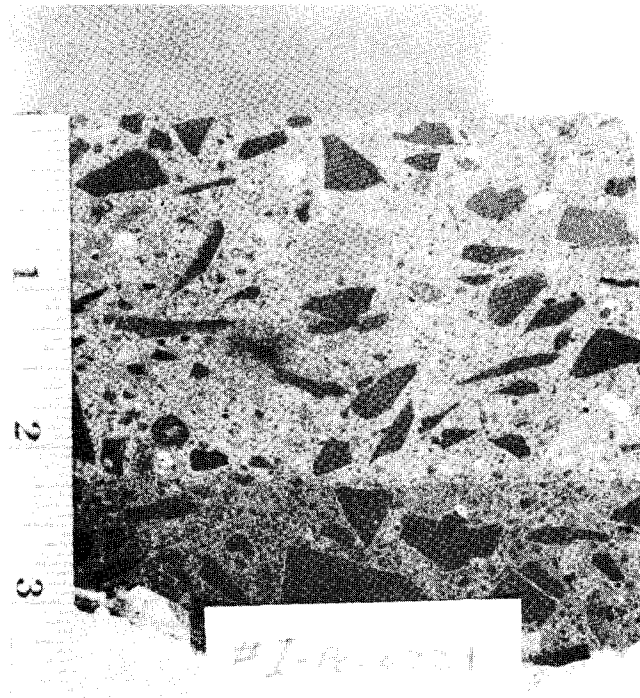
Figure 9. Vertical polished section through 4 in. (100 mm) diameter core showing latex modified concrete, bond layer, and base concrete.

The bond zones adjacent to the horizontal interface between the base layers and overlays of the two-course decks were examined in 4.0 in. (100 mm) diameter cores. One core was extracted from each of the six decks, cut vertically, and polished. Cores representing each type of overlay concrete — latex modified concrete, PCC and wire fiber reinforced concrete — are shown in Figures 9, 10, and 11. Microscopic examination revealed a uniformly intimate contact interface without voids or cracks between the two concretes in every case. The good condition of the bond zones is indicative of the adequacy of the consolidation effort imparted to the overlay concretes by the surface vibrator.

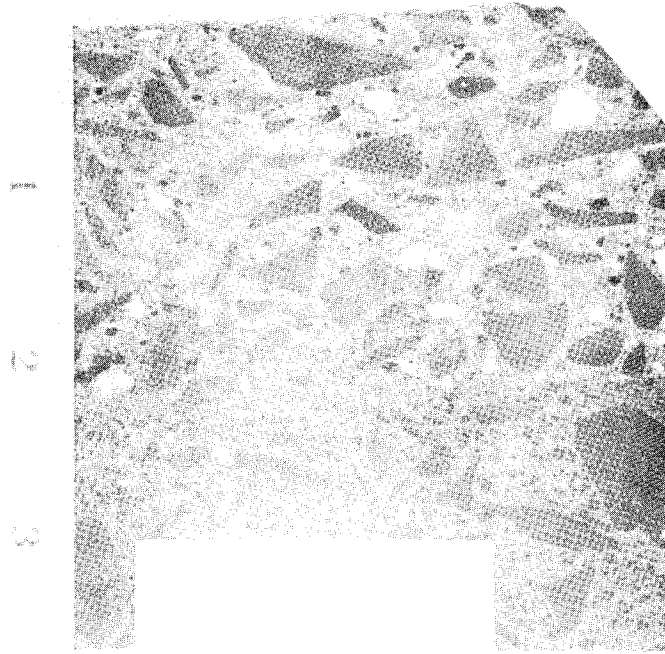
Figure 10. Vertical polished section through 4 in. (100 mm) diameter core showing high quality PCC, bond layer, and base concrete.

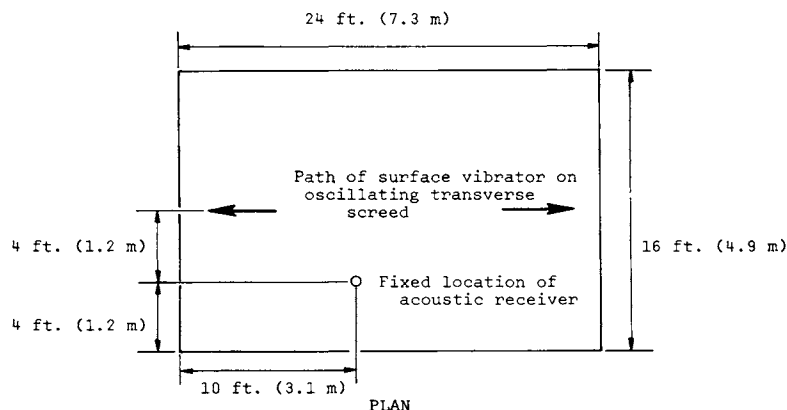
Figure 12. Acoustic monitoring of surface vibrator on a trial slab.

After some initial laboratory testing the acoustic device was used to monitor the vibration of a trial overlay installation of wire fiber reinforced concrete; however, due to funding limitations, the device was not used on the bridge decks in this project. In Figure 12, the 16 ft. x 24 ft. (4.9 m x 7.3 m) area for the trial installation is depicted. A base layer of concrete with a maximum depth of 4 in. (100 mm) was placed on grade and cured for 3 days, at which time the overlay concrete was placed. As shown in Figure 12 the acoustic receiver was located at a fixed position in the 2-in. (50 mm) deep overlay while the surface vibrator traversed the overlay on the transverse screed.

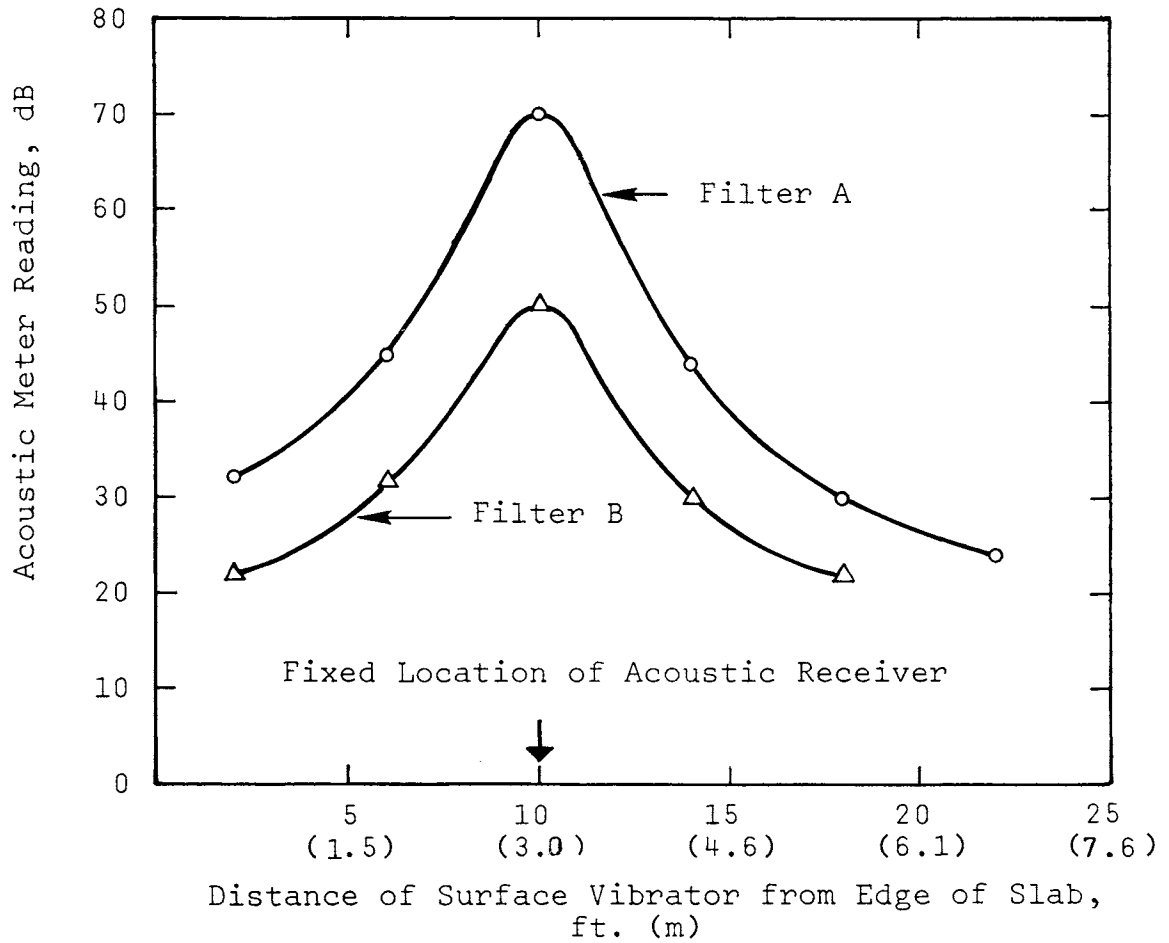
Figure 13. Typical patterns resulting from acoustic monitoring of surface vibrator.

Results of the monitoring for the single vibrator path are shown in Figure 13. The upper curve was plotted with stable, or maximum, meter readings obtained after two passes of the vibrator. The lower curve represents additional readings for the same path but with a different noise filter in the system. These results indicate a good potential for the employment of such equipment for controlling the density of portland cement concrete; however, the equipment will probably need to generate its own standardized acoustic signal rather than to rely on the random and variable signals from construction equipment.

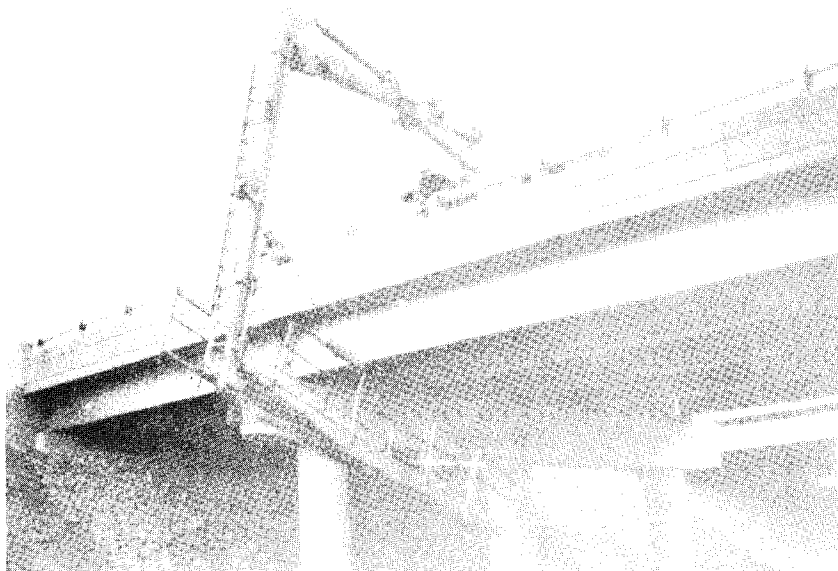
Figure 16. Work platform extending beneath deck.

Work beneath the spans was performed on the platform shown in Figure 16. Radio communication between the crew members on the platform and those on the deck surface was maintained for safety and to coordinate the placement of the two transducers for readings. The transmitter and receiver, shown in use in Figures 17 and 18, respectively, were coated periodically with a fluid couplant to provide suitable contact with the concrete for signal transmission. The transmitted and received signals were monitored on a cathode-ray oscilloscope as shown in Figure 18. A hand portable 110-volt generator was used to supply power for the system. The results of the sonic testing are in Table 13, where the 44 measurements from each deck are presented as average pulse velocities and standard deviations. The relative quality of concrete in the two-course decks appears to be better than that of concrete in the single-lift decks, as would be expected from the differences in compressive strengths previously discussed.

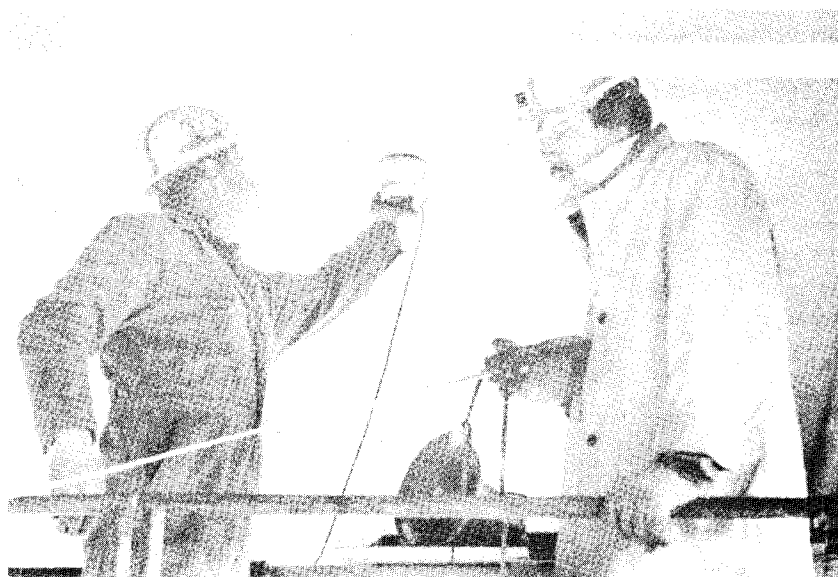
Figure 17. Sonic transmitter held against bottom surface of deck.

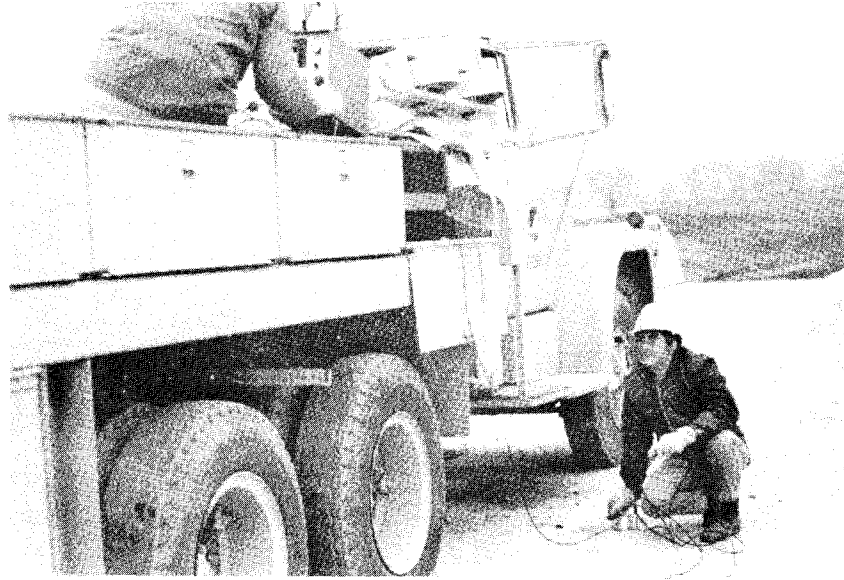
Figure 18. Sonic receiver and monitoring equipment.
