## FINAL REPORT

CONSTRUCTION OF PRESTRESSED CONCRETE SINGLE-TEE  
BRIDGE SUPERSTRUCTURES

May 1977

VHTRC 77-R50

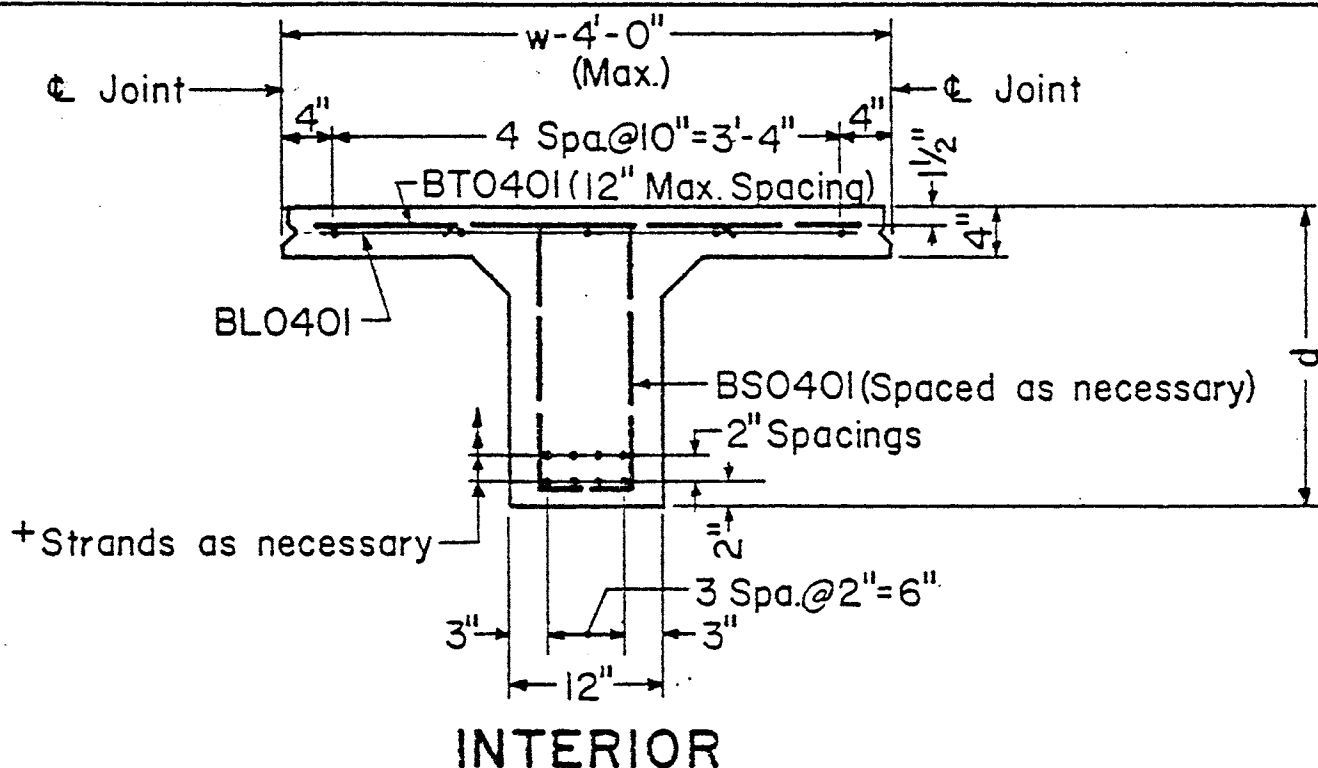
Tee depths were based on 4'-0" flange width (effective width used was 3'-10").

Design moments used were based on a reduction of span length by 1'-6". Reduction of 1/4" in deck slab thickness was used in computing composite section properties.

Figure 1. Systems tee-beam shape. (From Reference 2).  
(1 ft. = 30 cm)

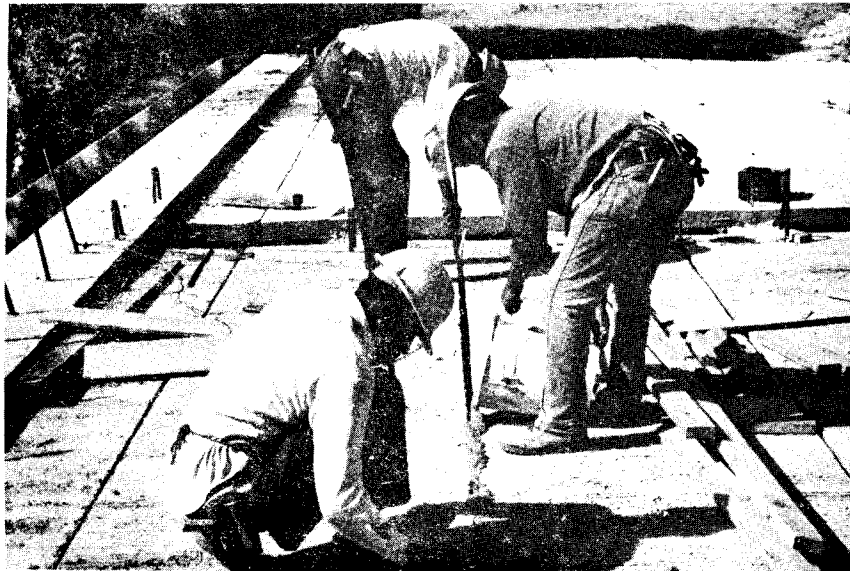
Figure 4. Nonshrinking cement paste placed between adjacent tee beams.

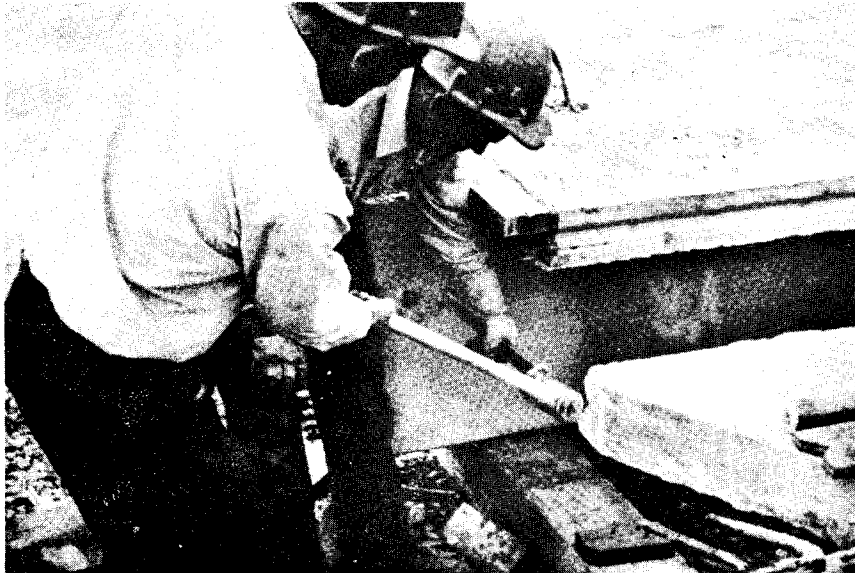
Figure 11. Inserts that provide voids for the diaphragm steel are removed.

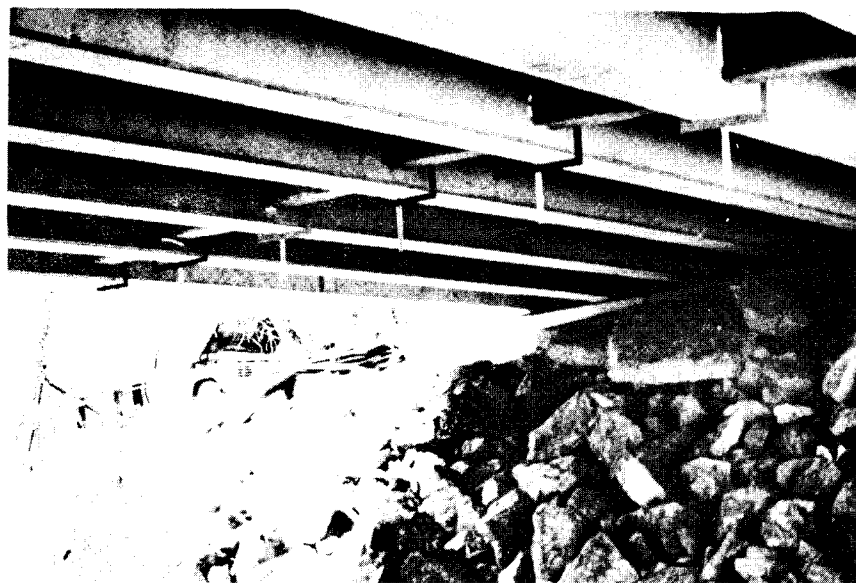
Figure 24. Scales attached at midspan for measuring beam deflections as the overlay was placed.

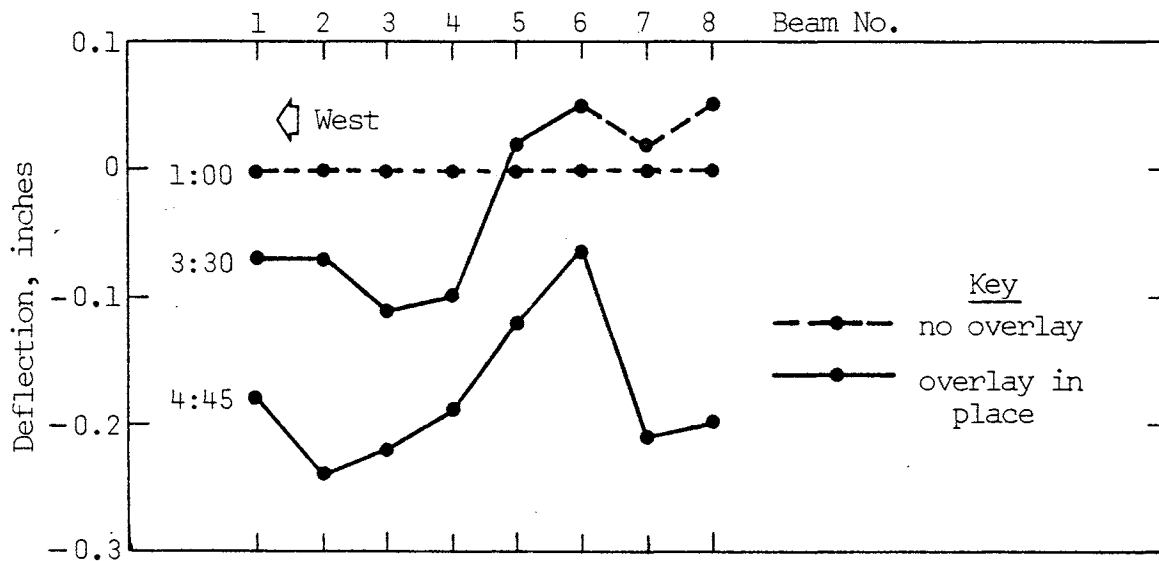
Figure 26. Midspan beam deflections, span C of B639, Floyd County. Construction level on west side of span. (1 inch = 2.54 cm)

It is apparent from Figures 25 and 26 that the beams deflected both up and down over a 24-hour period due to thermal loadings in the deck and beams. Table 5 shows the temperature distribution in two typical tee beams at various times. Although the data are limited there are enough to establish the presence of a temperature differential throughout the depth of the beams. A beam will move to equalize the stresses caused by differential temperatures.

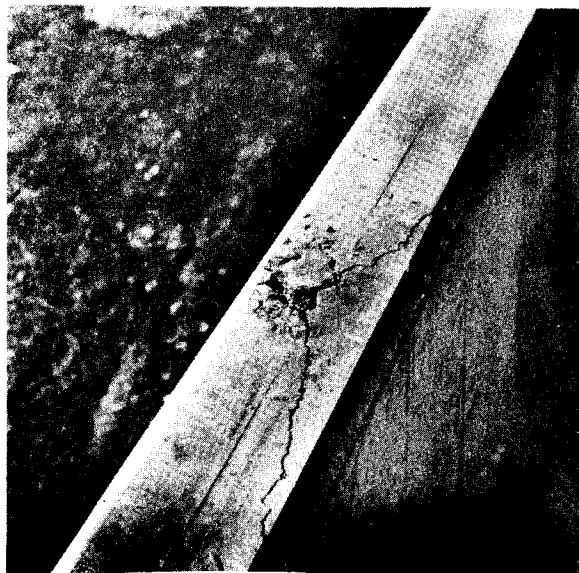
Figure 32. Structural cracking and spalling of precast parapets in vicinity of mortar-filled void.

Several of the parapet sections on B602 in Norton developed structural cracks and began to spall in the vicinity of the threaded insert (see Figure 32). It is believed that the cement mortar was not properly mixed and therefore provided an absorbent passage through which water could infiltrate the parapet. Also temperatures dropped to about 25°F\* for four consecutive nights after the cement mortar was placed, even though daytime temperatures were as high as about 50°F. Continued freezing and thawing of the water in the highly absorbent mortar likely caused the structural cracks and spalling in the parapets.

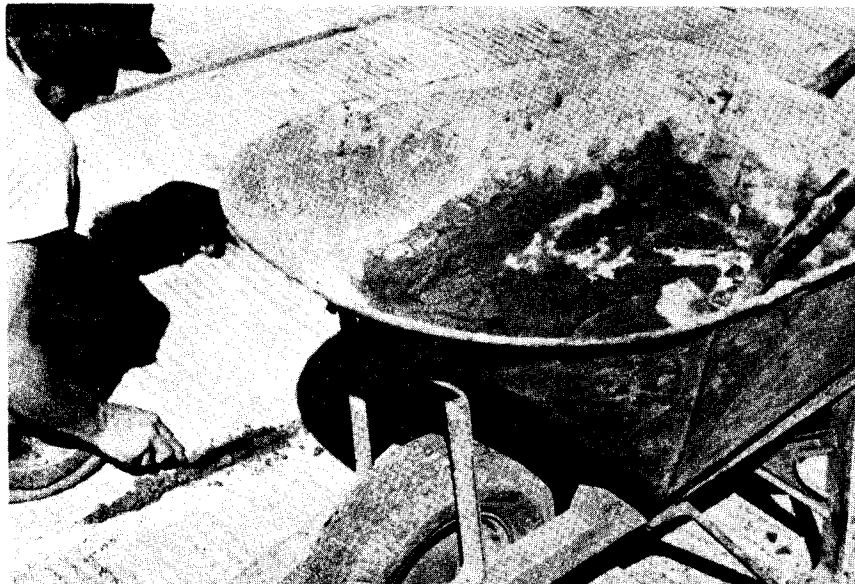
Figure 33. Nonshrink cement paste used to fill voids in precast parapets and the keyways between the tee beams was hand mixed at the bridge site.

Since the cement mortar and cement paste used to anchor the parapets were mixed in small batches at the bridge site (see Figure 33) with little quality control, it is believed that the problem will continue to occur unless the contractor is required to submit a mix design for the mortar and paste and an inspector is present at all times to ensure compliance with the mix design. A portable mixer should be used to mix the mortar and hand mixing of the mortar in a wheelbarrow should not be allowed. Furthermore, nonshrink cements require more water for proper curing than do conventional cements. "There is no point in using shrinkage-compensating cement unless protection from early evaporation is provided within an hour after casting."(6) The plans for the Norton bridges did not require any type of curing for the paste-filled parapet voids. A specification must be prepared to ensure that the paste and mortar are properly batched, placed, and cured. Concrete for a site-cast parapet would be batched under strict quality control and therefore, the paste and mortar used to secure the parapet should receive the same amount of attention. For economy, it may be desirable to cap the voided area in the parapet with a waterproof epoxy and permit the use of conventional cement mortar for grouting around the threaded insert. Filling the entire void with a neat mix of nonshrink cement is not economical. Furthermore, absorption tests conducted at the Research Council have indicated that a neat Durcal mix is 400% - 700% more absorbent than the A5 concrete used in the parapet. Mixing one part sand to one part Durcal reduces the absorption to between 200% and 300% of the A5 concrete. The mortar-and paste-filled voids and the mortar bed are likely to control the durability of the precast parapets.

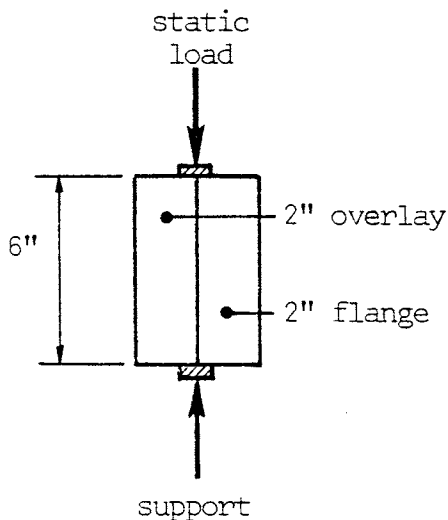
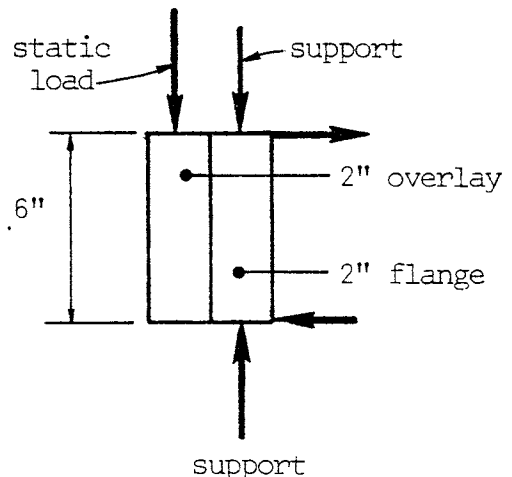
Figure 41. Geometry for static test loading of deck models.

The models were loaded at midspan as shown in Figure 41. In 9 of the 12 models failure was initiated between the Durcal keyway and one of the lower slabs, and propagated upward through the center of the keyway and eventually through the overlay. The 1 model containing the reinforcement extending through the keyway failed at two points, each coinciding with the termination of the overlay of the reinforcement through the keyway. Failure in each of the full-depth models was initiated at one or two points several inches to the left and/or right of midspan.

The 24 specimens remaining after completion of the load test for positive moment were load tested for flexural strength under a negative moment loading condition (see Figure 41). Since no keyways were subjected to tensile loadings under this loading condition, all 24 specimens yielded at about the same magnitude of loading and, disregarding the 2 unreinforced specimens, the ultimate strengths were about the same. It is safe to conclude that the design for negative bending moment in tee beam decks may be the same as that for conventional full-depth decks.

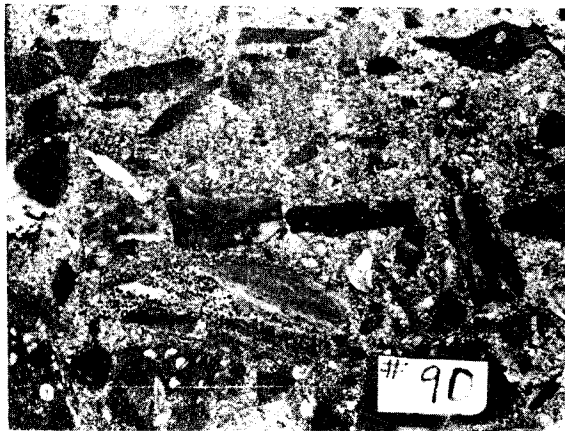
Figure 46. Core from span B of B602 shows that much of the cement mortar and air has been lost.

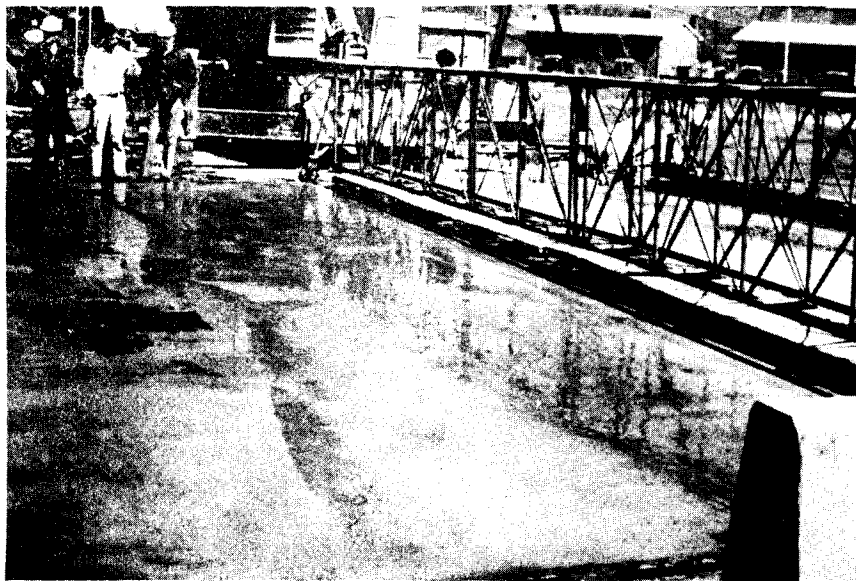
Figure 47. Excess bleed water covers most of span C of B603 as screeding and finishing operations are completed.

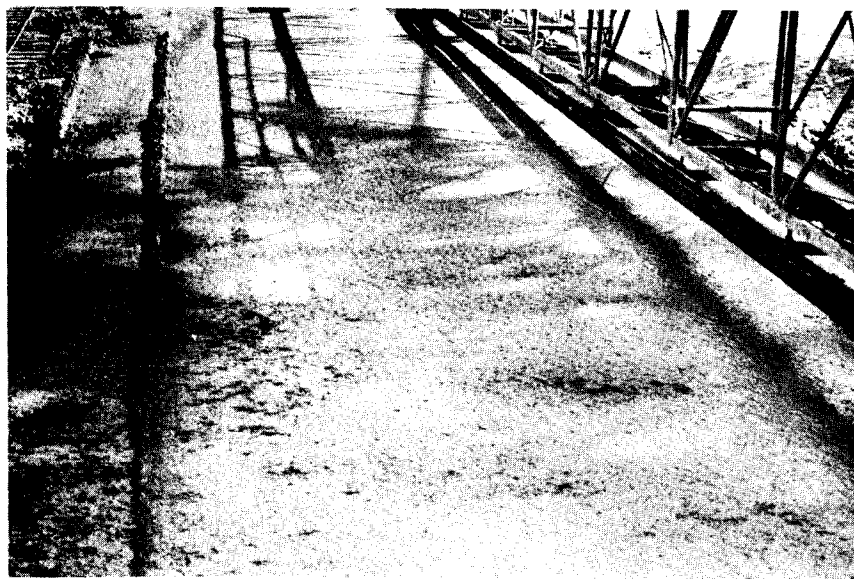
Figure 48. Variable consistency concrete pulls in lower part of figure and flows in upper part.
