EVALUATION OF THE CONSTRUCTION AND PERFORMANCE OF
POLYMER CONCRETE OVERLAYS ON FIVE BRIDGES

Interim Report No. 1

"Construction and Condition of the Overlays Initially
and After One Year in Service"

February 1983
VHTRC 83-R29

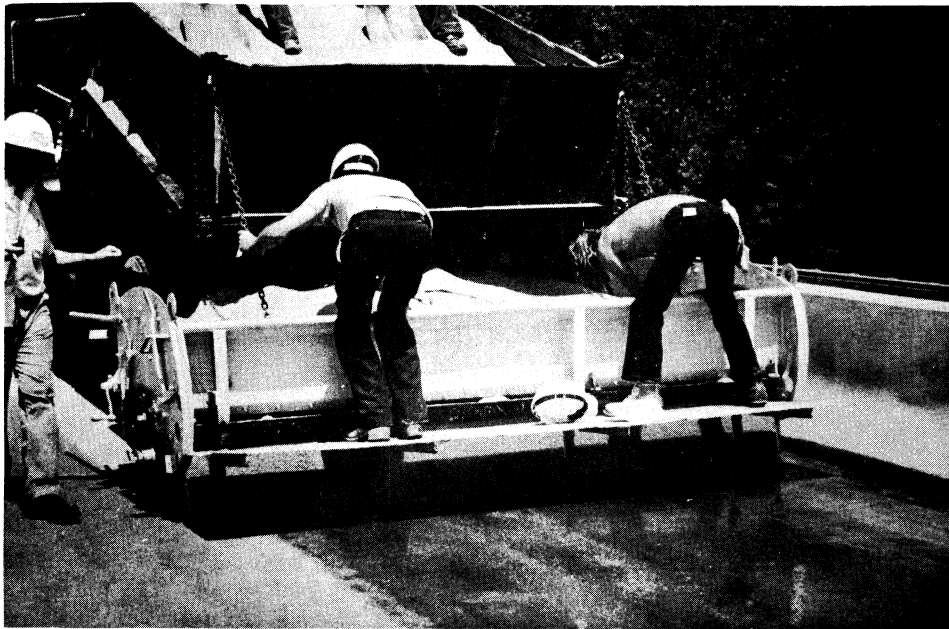
Figure 2. Silica aggregate is broadcast over resin.

The aggregate application equipment was shown earlier in Figure 2. It consisted of a 10-ton (89 kN) dump truck that pushed an aggregate spreader as it was backed over the freshly placed resin. Two cranks were installed on the tailgate of the truck so that a proper flow of aggregate could be obtained between the elevated bed and the spreader. The spreader placed aggregate over a maximum width of 10 ft. (3.1 m). Therefore, it was necessary to apply the aggregate by hand along the sides when the resin was sprayed over a width greater than 10 ft. (3.1 m). The gate on the spreader was adjustable, and with considerable experience the proper combination of truck speed and gate adjustment was obtained. A wooden block was used to block part of the opening when an application width of less than 10 ft. (3.1 m) was desired. A front-end loader was used to fill the dump truck with aggregate stored in bulk at the Virginia Department of Highways and Transportation's Skiffs Creek Area Headquarters located near the bridges.

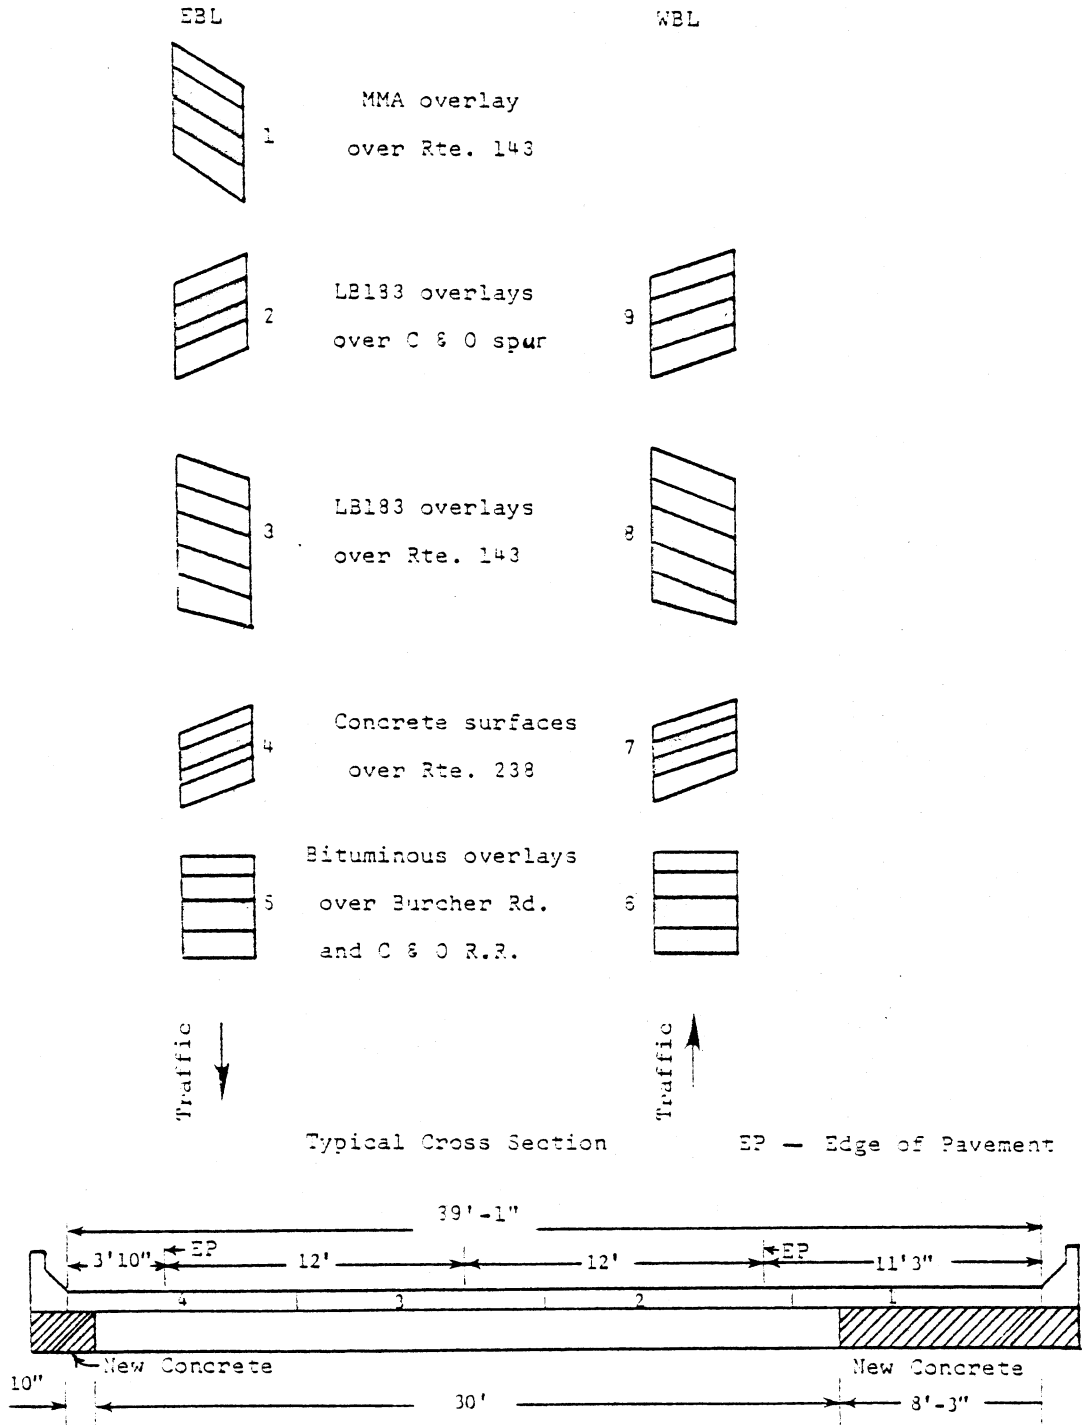
Figure 3. Locations and typical cross section of study bridges.
 2.54 cm = 1 in., 0.305 m = 1 ft.

In addition to the five bridges that were overlaid with the polymer concrete, four others were selected as controls — bridges 4, 5, 6 and 7, as shown in Figure 3. In the EBL bridges 1, 2, and 3 received polymer overlays, 4 was selected as a control bridge to represent an exposed concrete deck, and 5 was selected as a control bridge to represent a concrete deck covered with a waterproofing membrane of rubberized asphalt and a bituminous concrete overlay. In the WBL bridges 6, 7, 8, and 9 are similar to bridges 5, 4, 3 and 2, respectively.

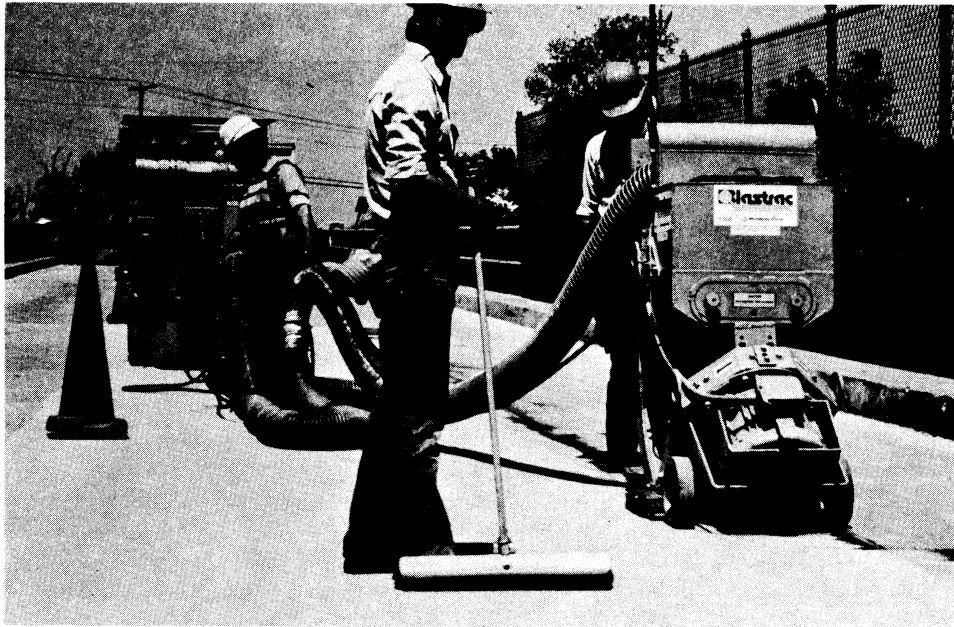
Figure 5. Shotblasting equipment similar to that used on the bridges near Williamsburg.

Prior to placement of the first layer of polymer and after all major spalls had been repaired, the deck surface was cleaned with steel shot impinged upon the deck with equipment supplied by Porta-Shot Blast, a Division of the Nelco Manufacturing Company located in Chesapeake, Virginia. The equipment, which is similar to that shown in figure 5, collects the steel shot and the latience removed from the surface and provides a more uniform and completely cleaned deck surface than is generally achieved with sandblasting.

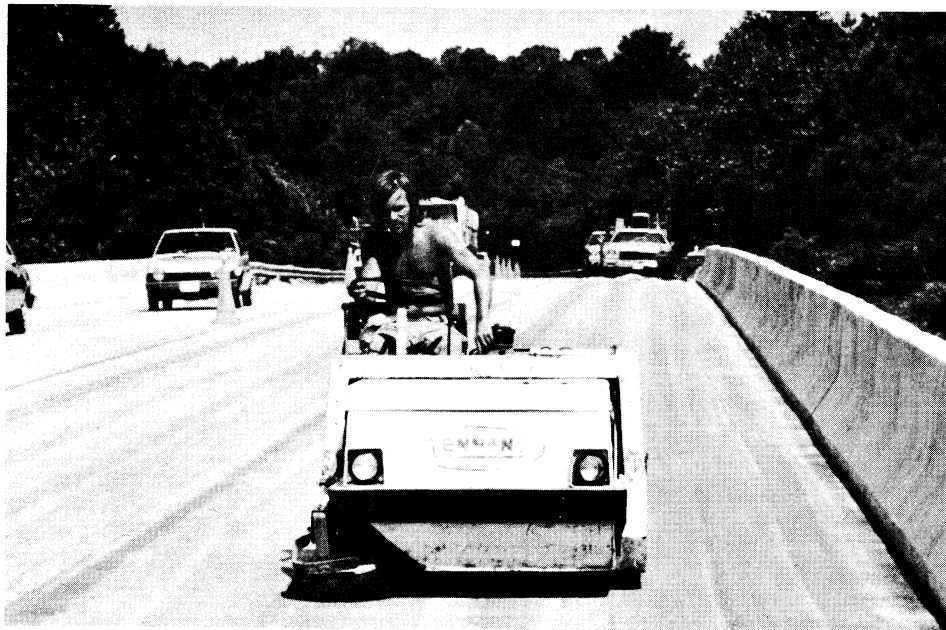
Figure 7. Sweeper-broom type vacuum truck removes excess aggregate.

A self-propelled, sweeper-broom type vacuum truck was used to remove excess aggregate from the surface approximately 1 hour after the resin had gelled (see Figure 7). Approximately 20 minutes were required to remove the excess aggregate from two placement lanes.
