CONTROL OF REFLECTION CRACKING IN A FABRIC-REINFORCED OVERLAY
ON JOINTED PORTLAND CEMENT CONCRETE PAVEMENT

K. H. McGhee
Senior Research Scientist

Virginia Highway and Transportation Research Council
(A Cooperative Organization Sponsored Jointly by the Virginia
Department of Highways & Transportation and
the University of Virginia)

VHTRC 83-R8

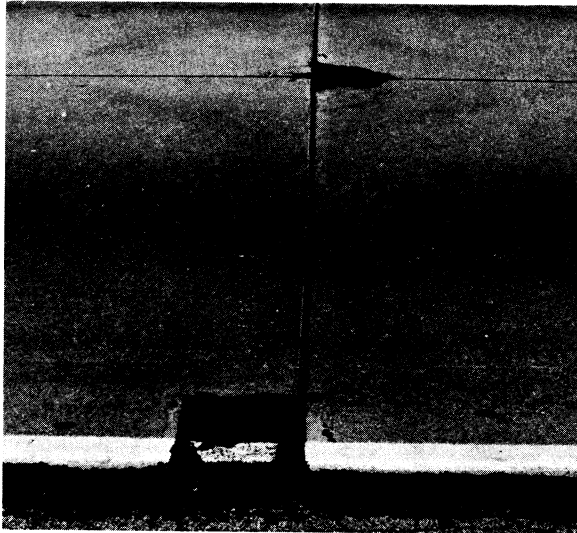
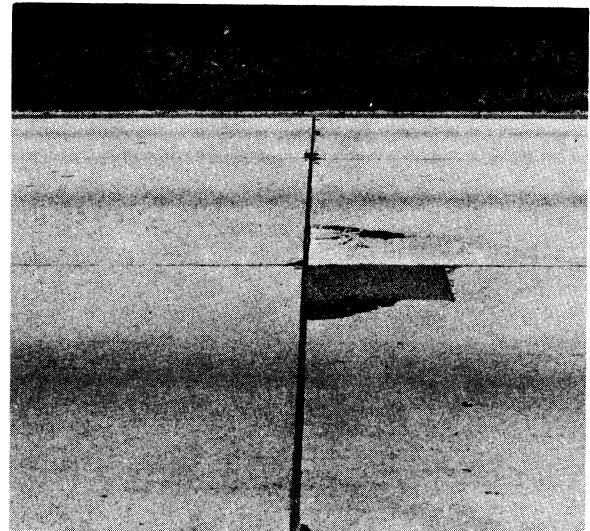
Figure 1. Typical joint on test section (left) and control section before treatment.

1. Large irregularities such as joint spalls were filled to approximate grade with asphaltic concrete type S-5. Many small spalls and cracks were ignored since the fabric suppliers claim the material will overcome small irregularities. Joints typical of both the test and control sections after this preparatory work are depicted in Figure 1. Surveys of the outside lane joints showed that 19 of the 20 on the test section were mildly to seriously spalled, as were 16 of the 20 in the control section.

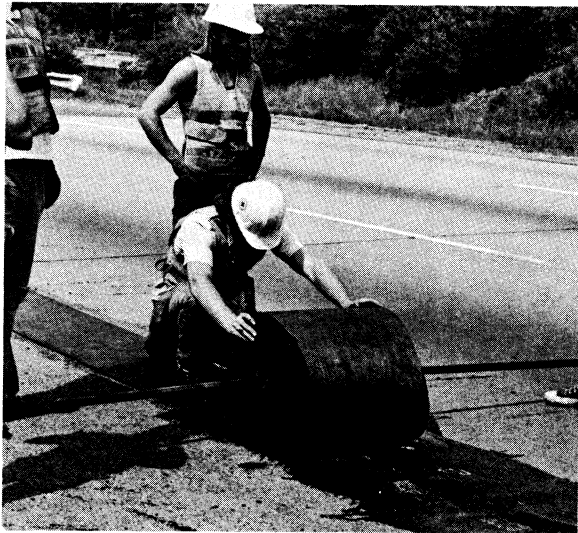
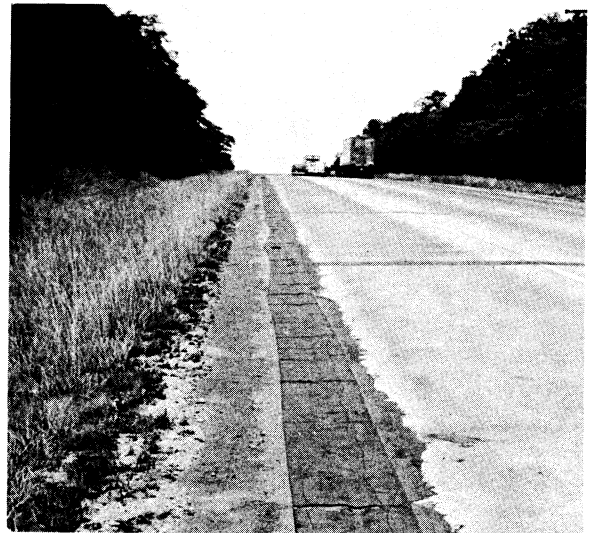
Figure 2. Installing fabric over pavement shoulder joint (left), and finished job.

3. After a few minutes of cooling to achieve tackiness of the liquid asphalt, the fabric was unrolled, aligned with the joint, and seated in the asphalt by brooming. The 20 in. (0.50 m) wide fabric applied in this manner formed a ribbon spanning approximately 10 in. (0.25 m) on either side of the treated joints as shown in Figure 2.

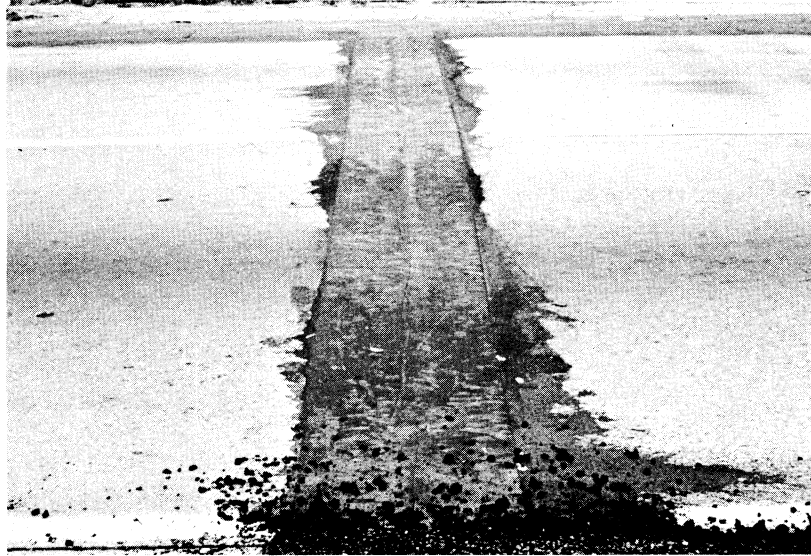
Figure 3. Fabric after four weeks under traffic.

Condition surveys immediately prior to the overlay showed the fabric to be in excellent condition. The only small defects noted were some wheel path locations where the fabric had been mildly frayed by traffic. Figure 3 shows the condition of the fabric at the time of the overlay.

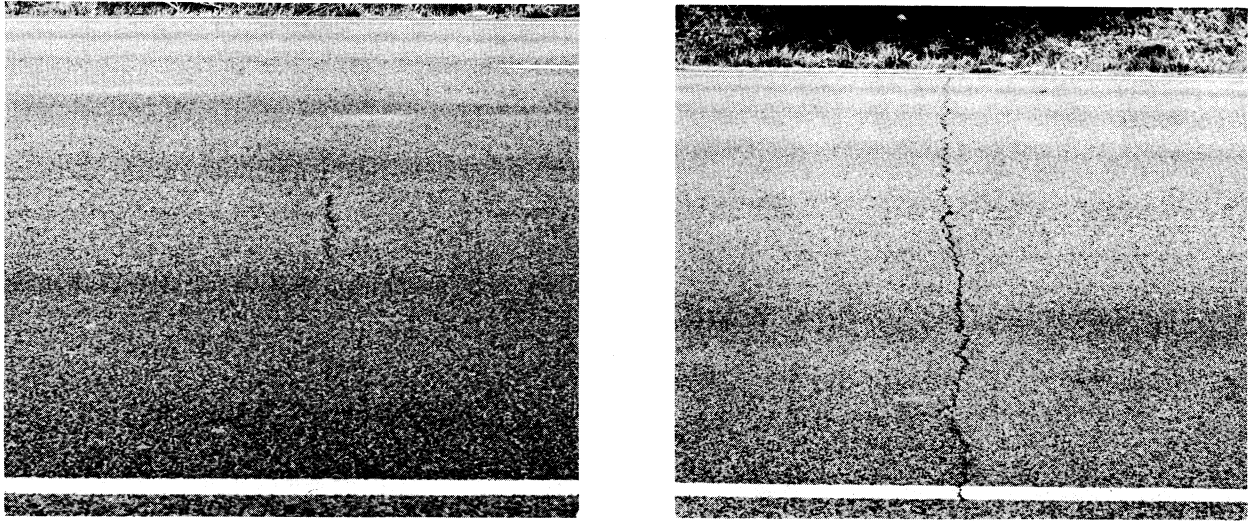
Figure 4. Typical reflection cracks on test section (left) and control section after two years.

As demonstrated in Table 2, the fabric has been very beneficial for three years under traffic. While cracking has reflected through the fabric at most of the joints, many are faint cracks discernable only upon close inspection (Figure 4). Roughness tests indicate that such cracks do not yet contribute to a reduction in pavement ride quality. Joints at which there was no cracking after three years are those shown by earlier deflection tests to fully transfer wheel loads.

Although not shown in Table 2, after three years all joints in the control section have resulted in obvious cracks in the outer lane overlay (Figure 4). This cracking may soon contribute to a rougher than desirable ride.

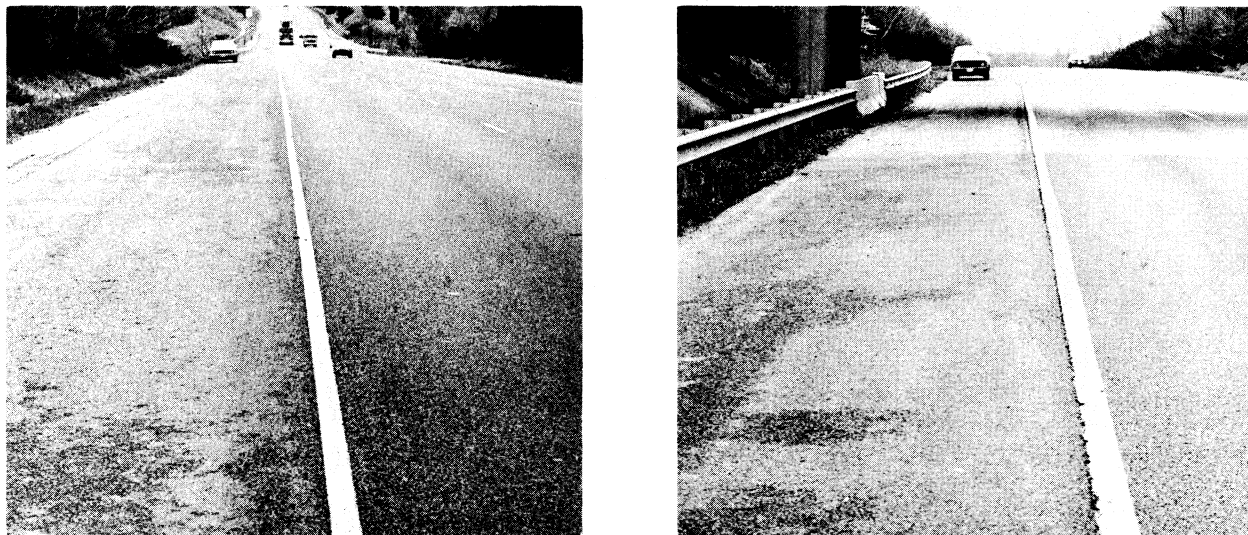
Figure 5. Edge joints on test section (left) and control section after two years.

Perhaps the most significant benefit of the test materials is the apparent control of cracking over the longitudinal edge joints. At the end of two years there was no evidence of such cracking in the test section while the control section was fully cracked (Figure 5). These joints at the pavement-shoulder interface are acknowledged by many to be a major path of water into the pavement structure. For this reason, the elimination of edge joint reflection cracking could provide an important contribution to pavement performance.
