## PRECAST CONCRETE REPLACEMENT SLABS FOR BRIDGE DECKS

Virginia Highway & Transportation Research Council  
(A Cooperative Organization Sponsored Jointly by the Virginia  
Department of Highways & Transportation and  
the University of Virginia)

July 1982  
VHTRC 83-R2

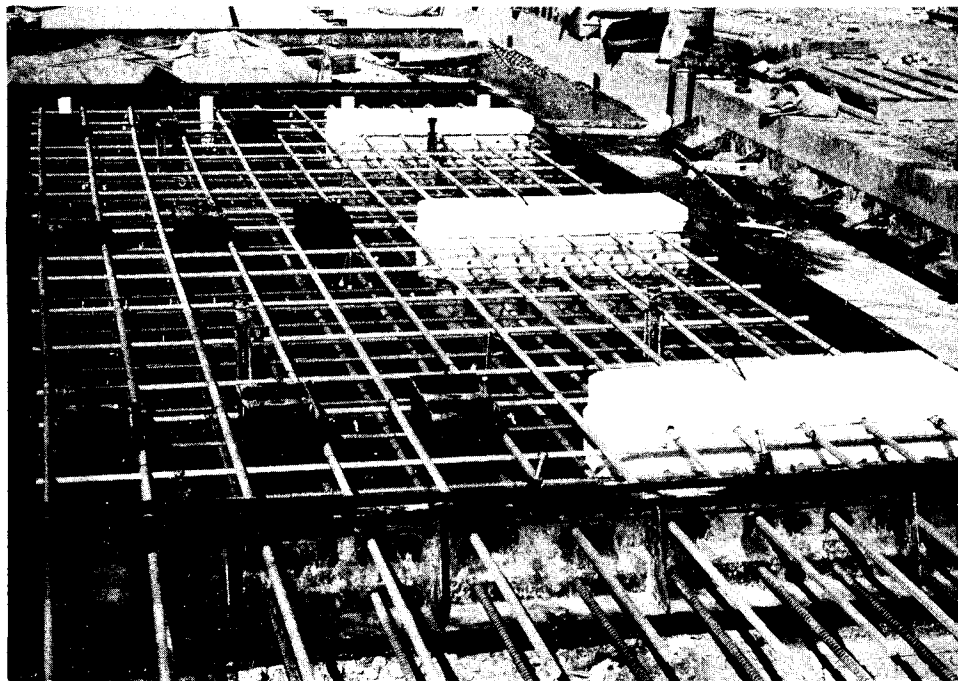
Figure 2. Forms are prepared for the casting of an end slab.

The daily production routine involved stripping forms in the morning, assembling the formwork and steel at midday, casting the concrete in the afternoon, and applying accelerated curing with steam at night. Typically two slabs were produced each day. The fabrication of the slabs is illustrated in Figures 2 and 3.

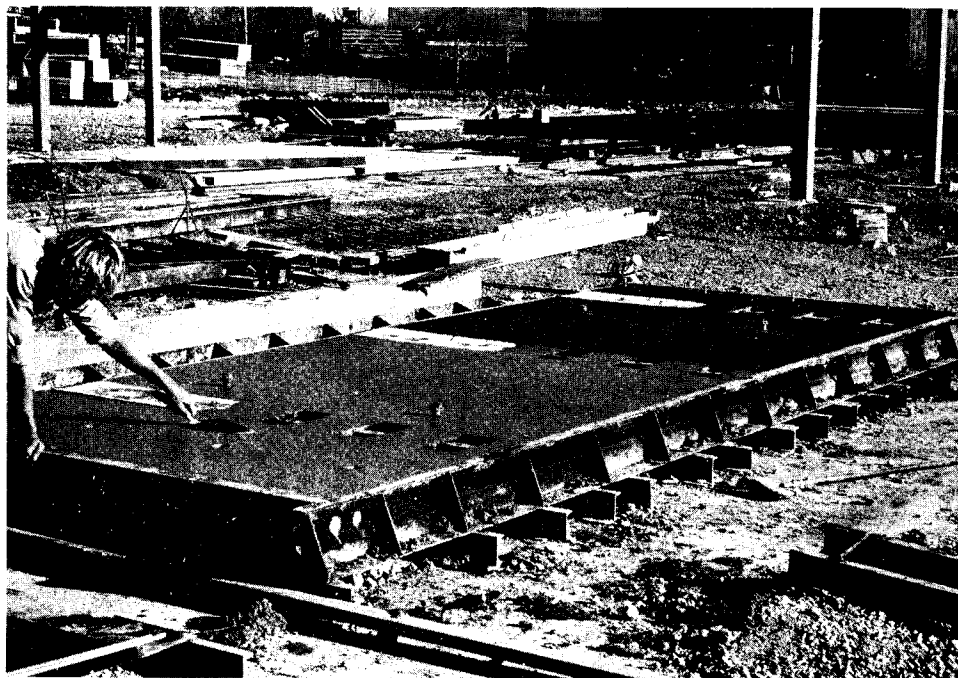
Figure 3. Finish is placed on an end slab.

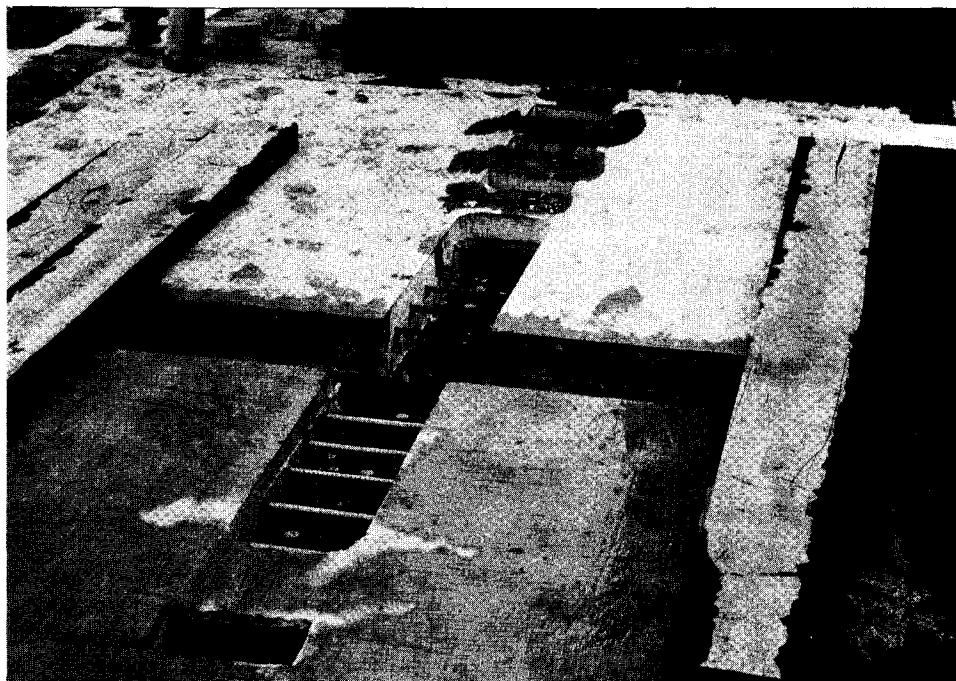
Figure 8. Timbers were used to prevent cracking of the end slabs as the crane was moved from one span to the next.

To allow the placement of the slabs on the two middle spans the crane was supported on the slabs that had been placed on the end spans (see Figures 5 and 7). Timbers were placed across the joints that separated two spans to allow the crane to move from one span to the next without cracking the end panels (see Figures 5, 7, and 8). The crane supports were positioned directly above the stringers.
