AN EVALUATION OF THE MODEL 66 RAISED PAVEMENT
MARKER SYSTEM BY STIMSONITE

June 1988
VTRC 88-R26

INSTALLATION SITE

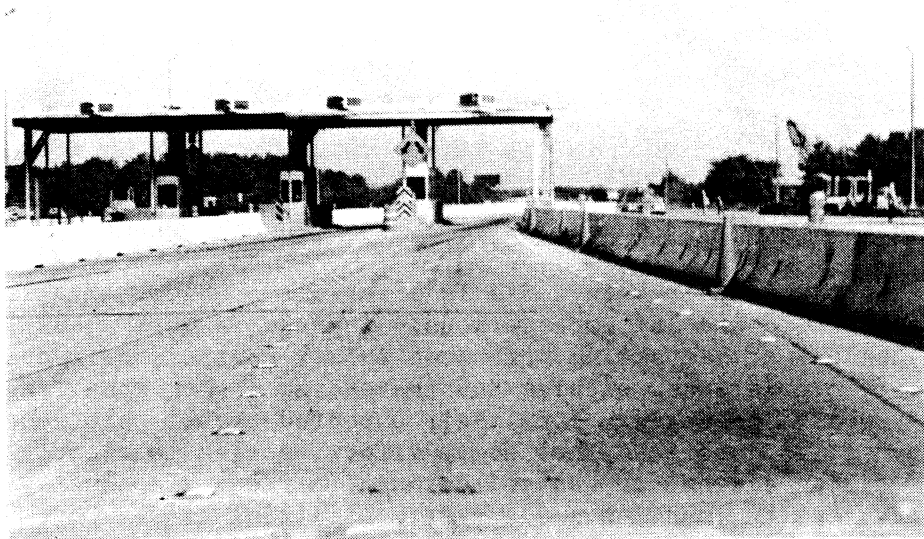
A site was chosen on Interstate 85 at the toll booths in Dinwiddie County. Figure 1 shows the northbound approach to the toll booth after the markers were installed. Since the toll booths were being removed, it was necessary to move traffic to the southbound lanes (2 way) while the northbound booths were being dismantled and to the northbound lanes while the southbound booths were being dismantled. This required traffic to be directed around the work area, which provided a good site for testing the effectiveness and durability of the Stimsonite system.

Figure 1. Study site at I-85 toll booth.

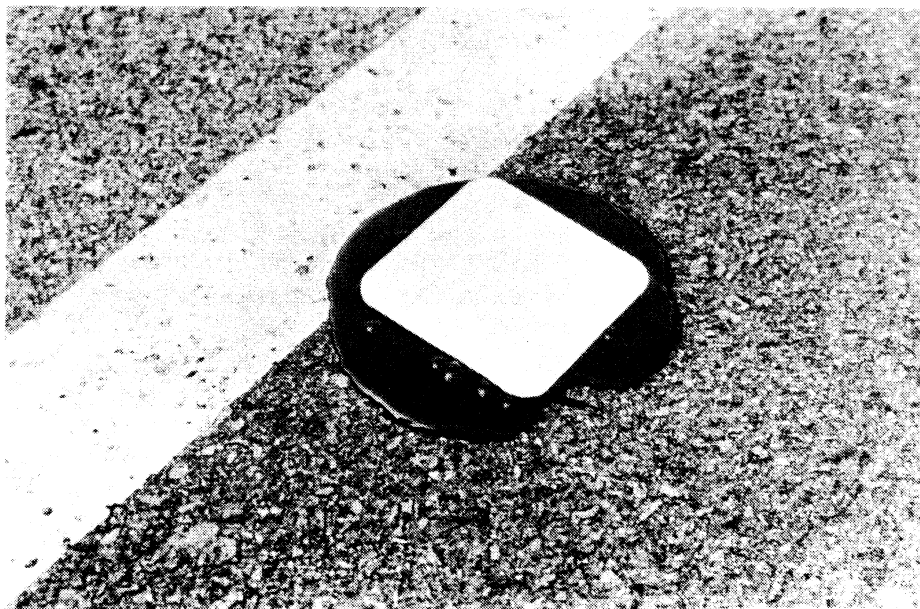
A construction zone marking system by Stimsonite, designated as "Model 66," was installed. The markers, shown in Figure 2, are made of a plastic material and provide reflectivity by using corner-cube reflectors.

Figure 2. Raised markers used for delineation.

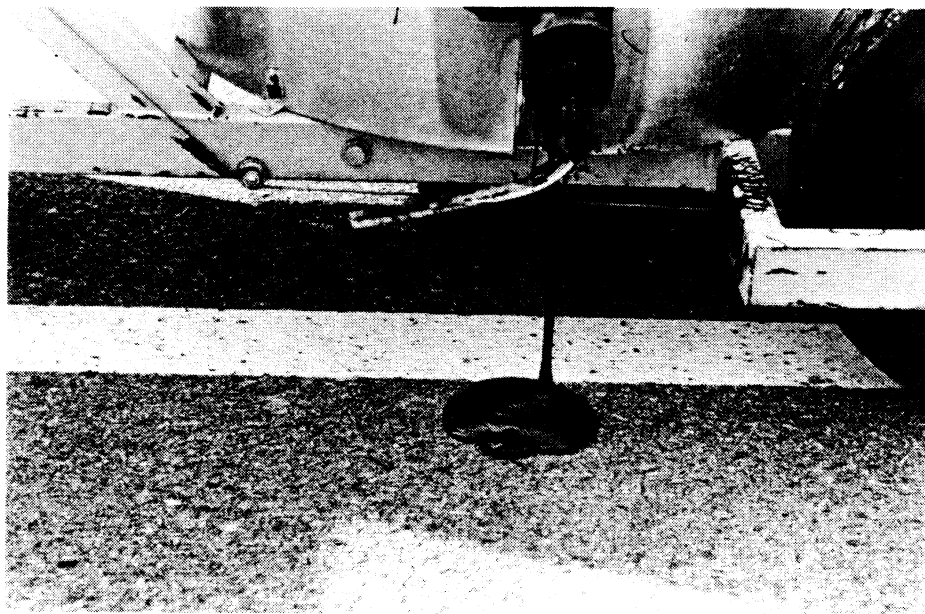
The markers were placed on five-foot centers along the centerlines and edgelines using a bituminous adhesive. Solid pieces of the bituminous adhesive were placed in an applicator for melting. After reaching melting temperature, the adhesive was applied at predetermined spots along the road. Figures 3 and 4 show the adhesive being applied and the positioning of the markers. The system is applied without stripping since the close spacing and marker color is supposed to simulate pavement stripping.

Figure 3. Application of adhesive for securing raised markers.

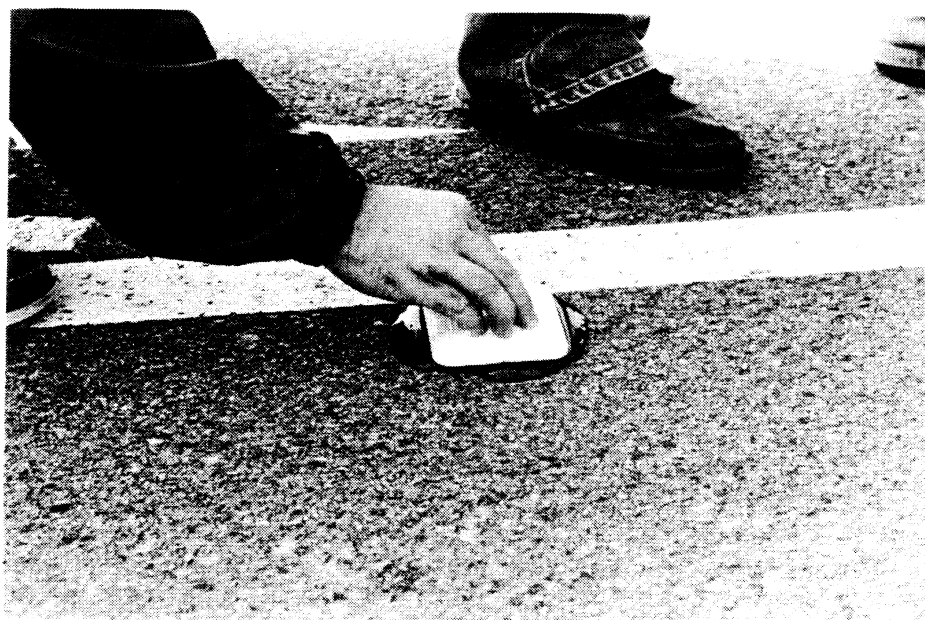
Figure 4. Placement of raised markers on adhesive.

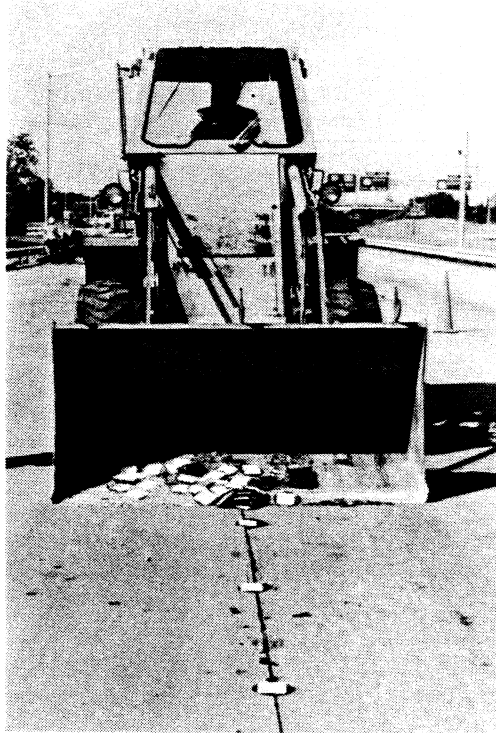
After the demonstration, the remaining markers were removed using a loader bucket as shown in Figure 5.

Figure 5. Removal of raised markers.

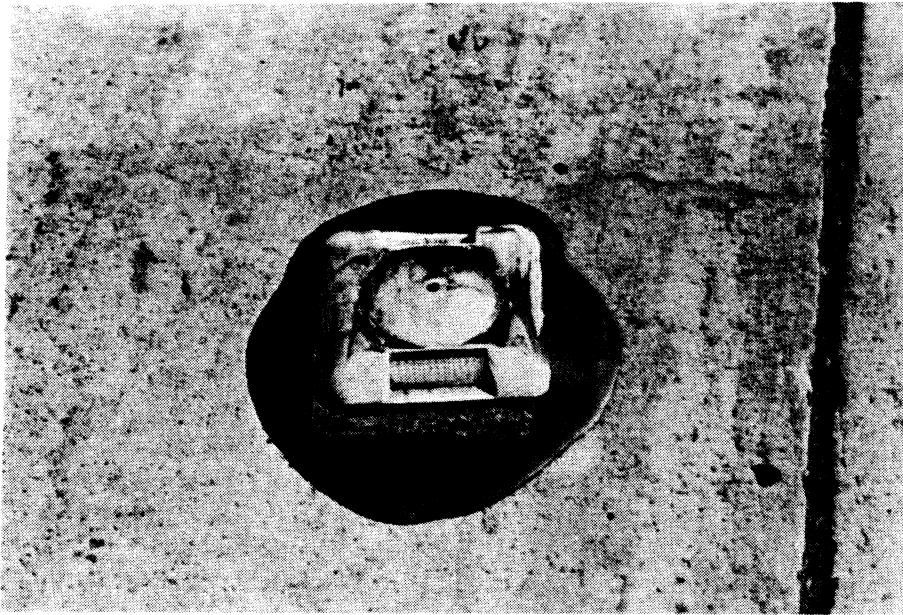
Discoloration was evident in areas where traffic encroached on the markers. Figure 6 shows an example of "tire black" on the markers. The movement of some markers from their original position on the concrete pavement was observed.

Figure 6. An example of discoloration.

The difficulties with lane delineation are compounded whenever markers are lost or become dirty since they are the only source of delineation.

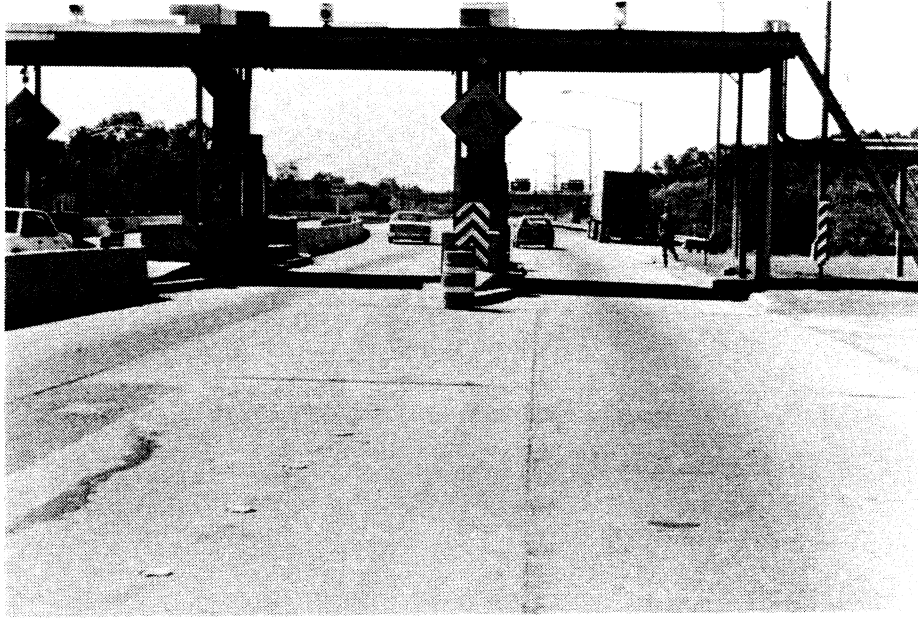
It was felt that during daylight the marking system did not adequately provide the required pavement marking for lane delineation. Effective marking of the desired paths of travel was not provided since the raised markers, which were the only source of guidance, did not significantly contrast with the pavement. This problem was aggravated by differences in pavement texture and pavement color, old pavement markings, and the fact that pavement joints were not parallel to the travel lanes. Figures 7, 8, and 9 show some of the markers in the vicinity of the toll booth.

Figure 7. Marker placement on the approach to the toll booths.

The unanimous opinion of the task force was that these markers are unacceptable for the purpose of guiding motorists. It was felt that effective guidance through work zones is critical, and it is thus necessary to provide continuous stripping supplemented with raised pavement markers when necessary.

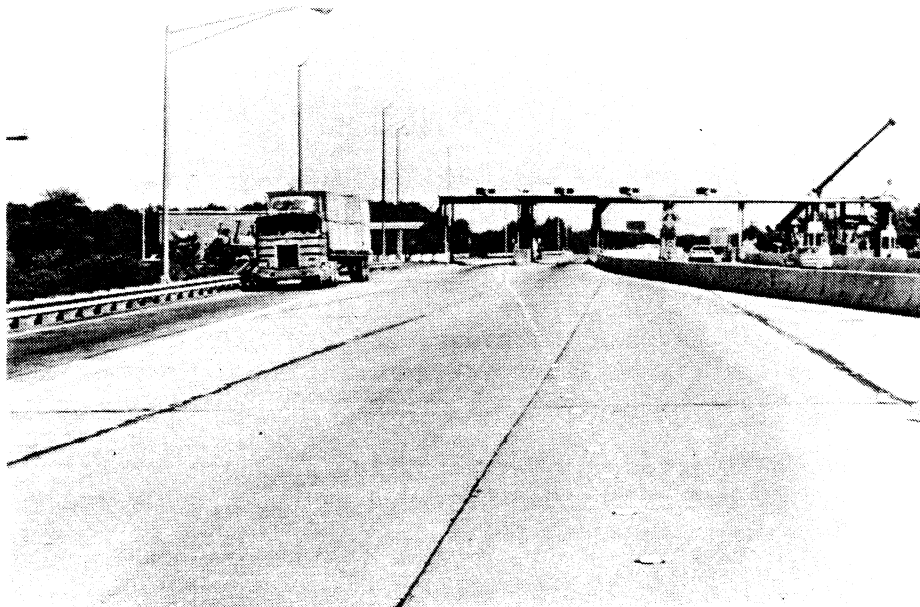
Figure 8. Marker placement on the lanes existing the toll booths.

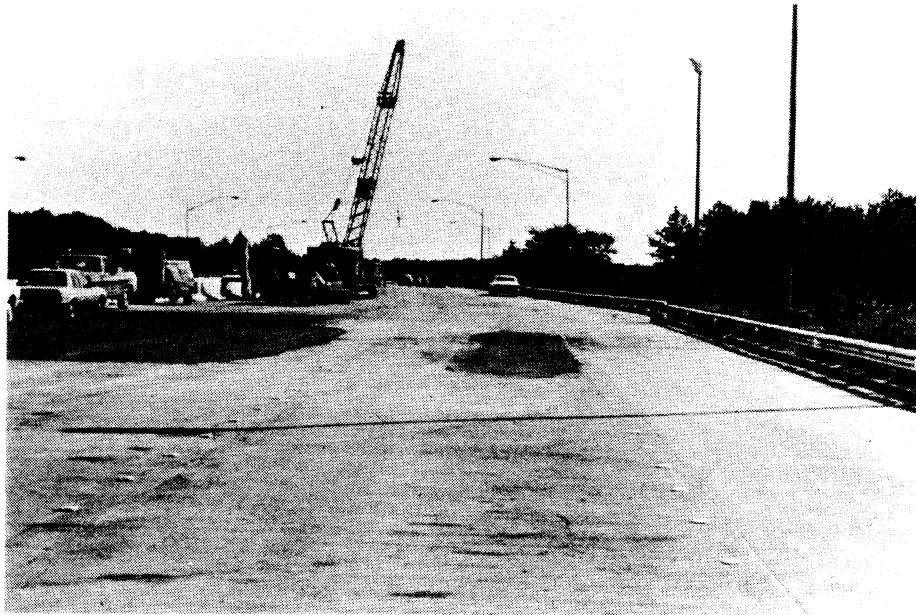
Figure 9. Marker placement beyond toll booths.

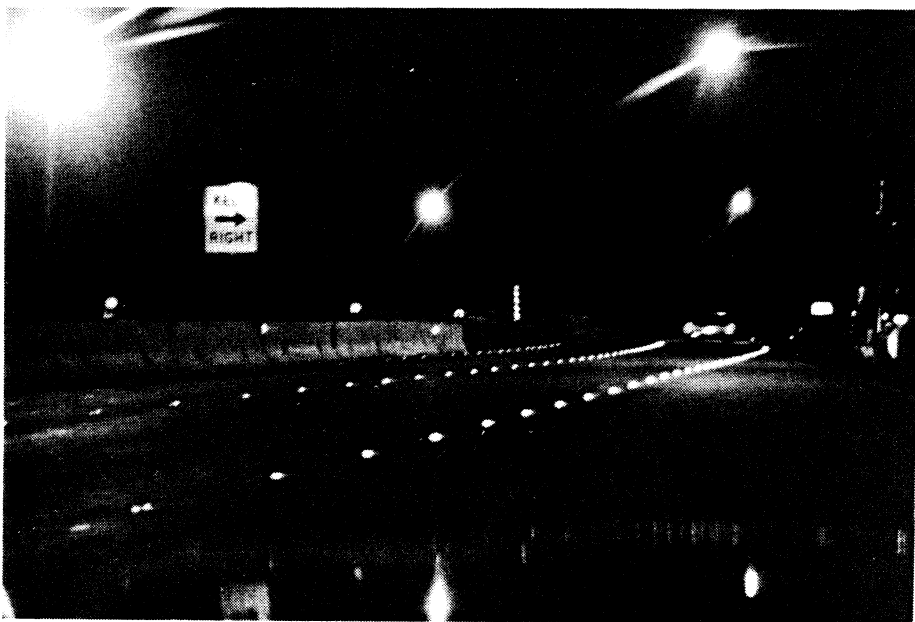
The lane delineation was better during darkness because of the good retroreflectivity and brightness provided by the closely spaced markers. Figure 10 shows the markers at night.

Figure 10. Visibility of marker system at night.

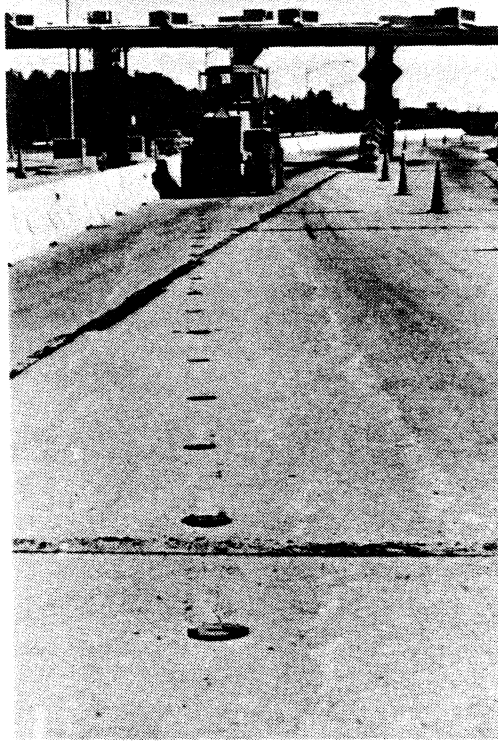
Markers were removed using a tractor loader blade, which easily dislodged them from the pavement. In most cases, part of the adhesive remained on the roadway (see Figure 11). Also, there were instances in which part of the bituminous pavement was dislodged along with the markers (see Figure 12).

Figure 11. Concrete pavement after marker removal.

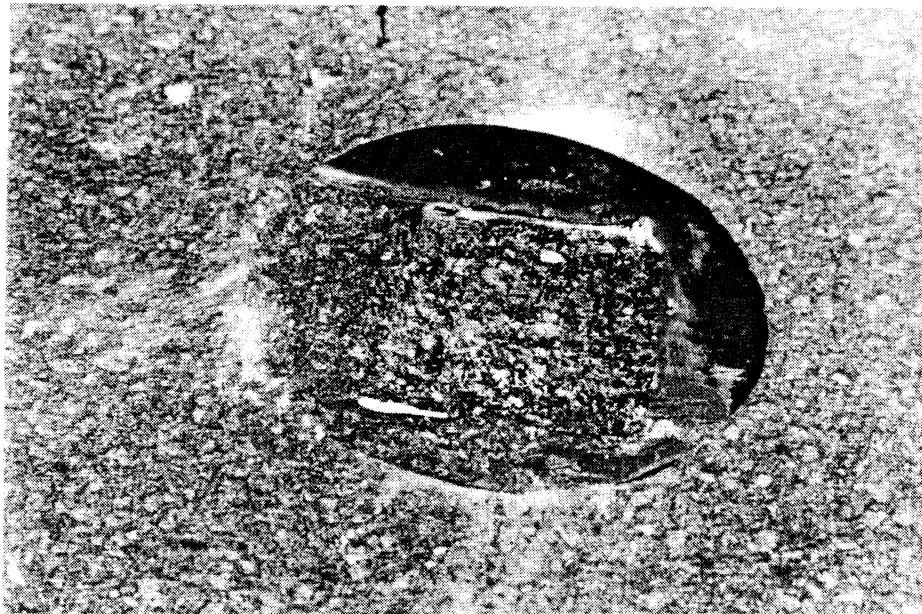
Figure 12. Bituminous pavement after marker removal.
