1. Report No. FHWA/VA-89/R2	2. Government Accession No.	3. Recipient's Catalog No.	
4. Title and Subtitle An Examination of the Operation and Motorist Usage of Virginia's Highway Rest Areas and Welcome Centers		5. Report Date July 1988	6. Performing Organization Code

AN EXAMINATION OF THE OPERATION AND MOTORIST USAGE
OF VIRGINIA'S HIGHWAY REST AREAS AND WELCOME CENTERS

July 1988
VTRC 89-R2

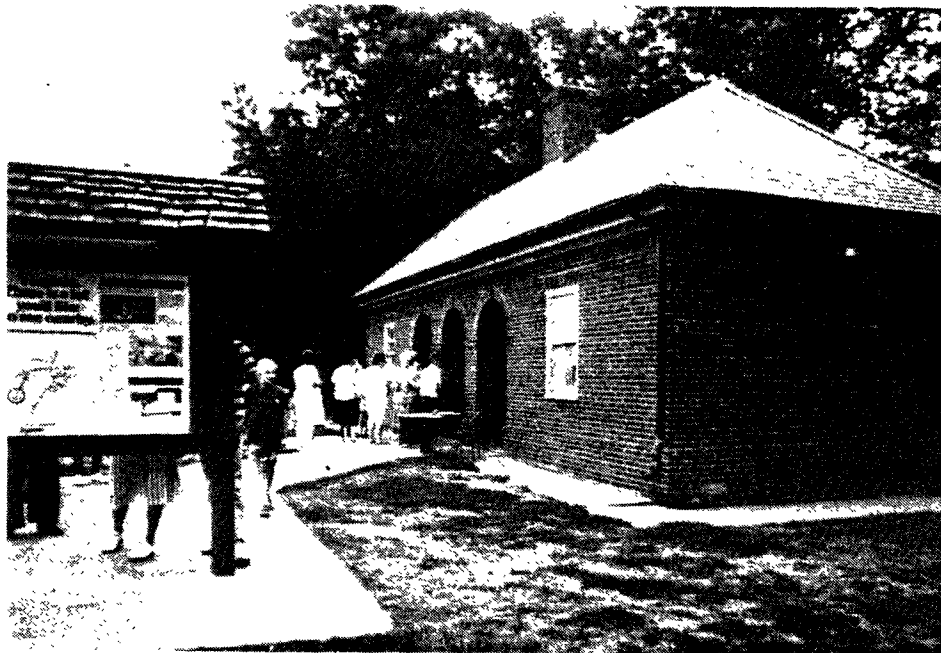
Figure 2. Women's restroom facility at site no. 10.

First and foremost, most of the restrooms at the sites visited needed degrees of refurbishment. Most were of insufficient size to accommodate the number of people using them. This appears to be especially true of the women's restrooms. Larger, more modern facilities in almost all instances should be the first priority for any refurbishment plan. At many sites during the summer months, there was always a noticeable amount of water on rest room floors. According to the custodians, this was caused by condensation on the pipes dripping to the floor. While this phenomenon is not only unsightly and tends to cause odors to form, it renders the floor surface slippery, resulting in an unsafe condition. Although continual mopping of these areas helps, other less labor intensive remedies that would solve this problem might include air conditioning the restrooms, warming the water flowing to the rest room buildings, or insulating the pipes.

use the comfort facilities. Refurbishment and enlargement appears warranted at a number of sites. Standing water, which was a result of condensation dripping from pipes to the floor, was noticed in many restrooms. Means for alleviating this condition need exploration, as it renders the facilities unsightly, unsafe, and often produces foul odors.

To eliminate the tendency for condensation to form on cold water pipes and to drop on the floor, thus creating an unsightly, unsafe, and potentially foul smelling condition, air conditioning of the restrooms is desirable. Should this measure prove to be too expensive, an alternative method for solving the standing water problem should be sought. This might involve simply insulating the pipes that supply cold water. Finally, at rest areas containing three restrooms, custodians should be encouraged to open all three simultaneously during peak travel periods.

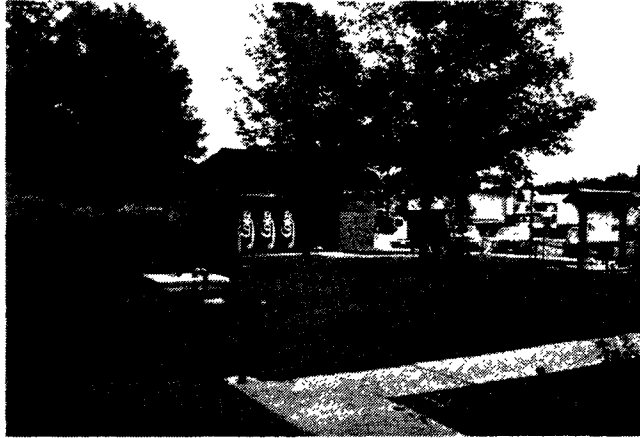
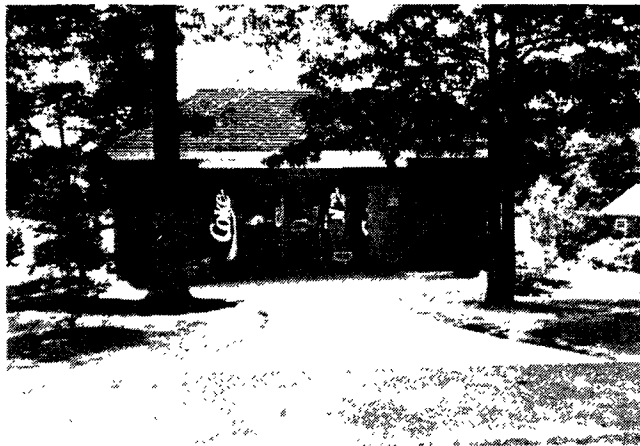
snacks, and cigarettes were placed in each. Figure 5 shows three of the vending machine installations.

Figure 5. Vending machine operation.
