**IMPROVING WORK-ZONE DELINEATION
ON LIMITED ACCESS HIGHWAYS**

1. Report No. FHWA/VA-89/16	2. Government Accession No.	3. Recipient's Catalog No.	
4. Title and Subtitle Improving Work-Zone Delineation on Limited Access Highways		5. Report Date January 1989

FINAL REPORT

IMPROVING WORK-ZONE DELINEATION ON
LIMITED ACCESS HIGHWAYS

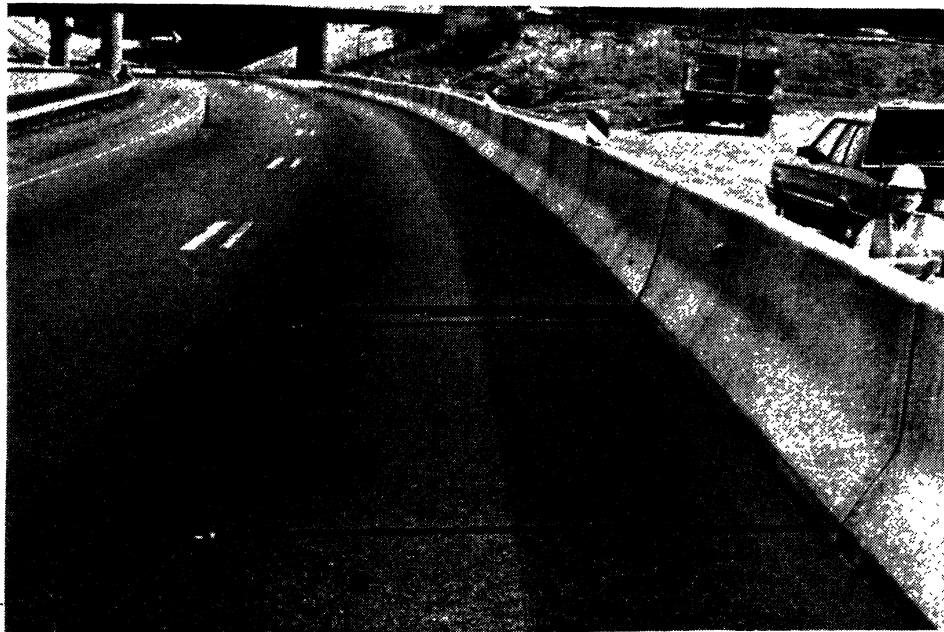
Figure 3. Site 2, Interstate 85, Petersburg, Virginia.

Site 2 (see Figure 3) was an interstate highway that had temporary concrete barriers placed on the right shoulder. There were 17 delineators spaced 48 ft apart on the top of the temporary concrete barricade.

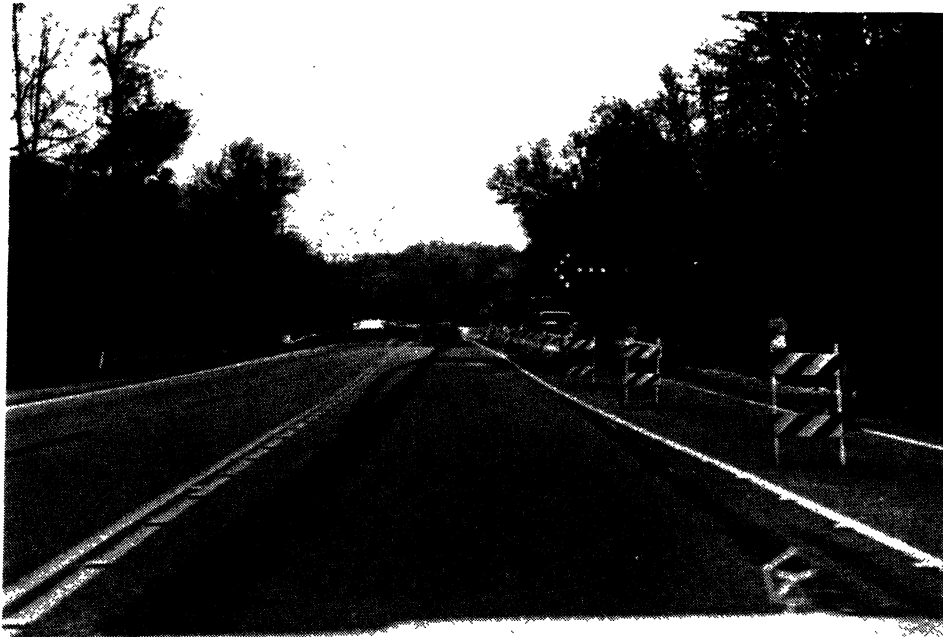
Figure 10. Site 2, Route 1, Fredericksburg.

Site 2 (see Figure 10) was a four-lane highway with the right lane closed. Raised pavement markers were added to the existing markings along both the right transition and left centerline. The schematic in Figure 11 shows the location and spacing of the markers.

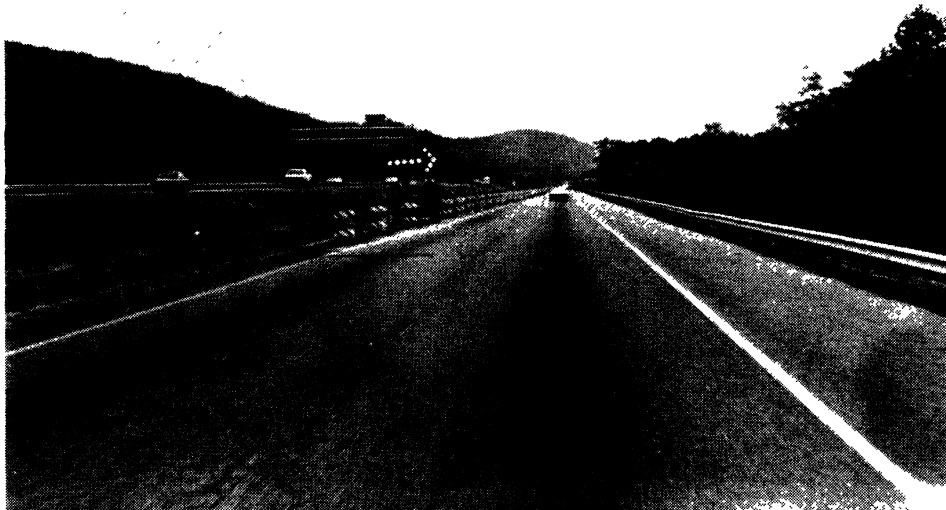
Figure 12. Site 3, Interstate 81, Salem.

Site 3 (see Figure 12) was an interstate, left lane closure, with raised markers supplementing the existing left edgeline transition. The markers were placed directly on the new preformed tape. The schematic in Figure 13 shows the marker placement and data collection points.

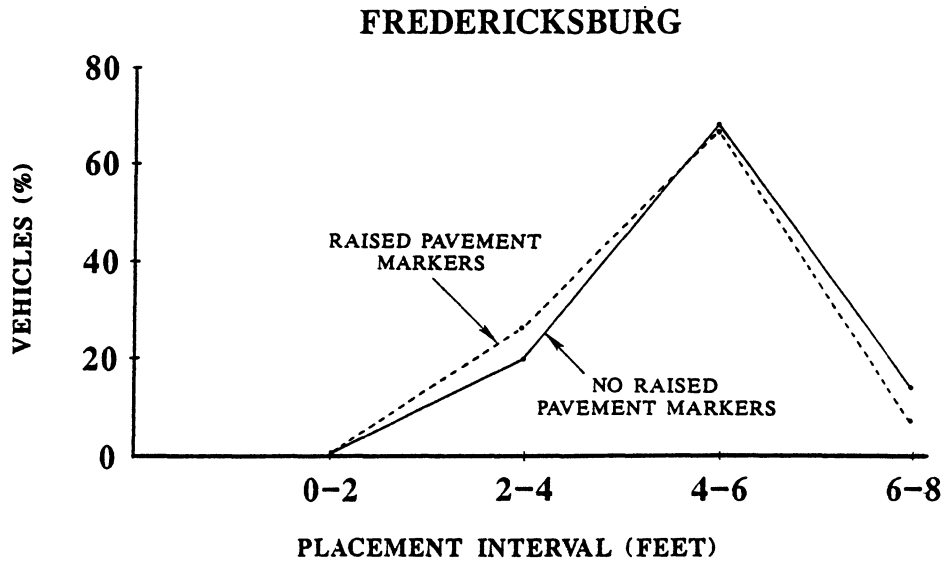
Figure 14. Percent vehicle placement from 9:00 p.m. to 1:00 a.m. (Site 2 - Fredericksburg)

Vehicle placement was measured for sites 2 and 3. Figures 14 and 15 show vehicle placement for site 2 from 9:00 p.m. to 1:00 a.m. and from 1:00 a.m. to 5:00 a.m. For both time intervals, there were more vehicles in the 2- to 4-ft interval for the raised pavement markers as compared with no raised markers. Fewer vehicles were in the 6- to 8-ft interval from 9:00 p.m. to 1:00 a.m. and in the 4- to 6-ft interval from 1:00 a.m. to 5:00 a.m. for the raised markers. With a 12-ft pavement width at the point at which the placement was taken, this means that vehicles were staying closer to the center of the lane.
