Report No. VTRC 90- R17	Report Date March 1990	No. Pages 13	Type Report: Addendum to Final Report Period Covered: March 1989 through May 1990	Project No. : Contract No.:
Title and Subtitle Addendum to Final Report - The Use of Hydrated Lime as an Antistripping Additive			Key Words Hydrated lime Stripping Test sections Performance Asphalt hardening	
Author(s) G. W. Maupin, Jr.				
Performing Organization Name and Address Virginia Transportation Research Council Box 3817, University Station Charlottesville, Virginia 22903-0817				
Sponsoring Agencies' Names and Addresses Va. Dept. of Transportation University of Virginia 1221 E. Broad Street Charlottesville Richmond, Virginia 23219 Virginia 22903				
Supplementary Notes				
Abstract The subject report describes a follow-up evaluation of test sections that were installed in 1982 and 1983 and reported on in 1987. Each test section contained three asphalt concretes: (1) with no additive, (2) with hydrated lime, and (3) with one or more chemical additives. The hydrated lime continues to deter stripping as well or better than the chemical additives that were being used when the sections were installed.

ADDENDUM TO FINAL REPORT
THE USE OF

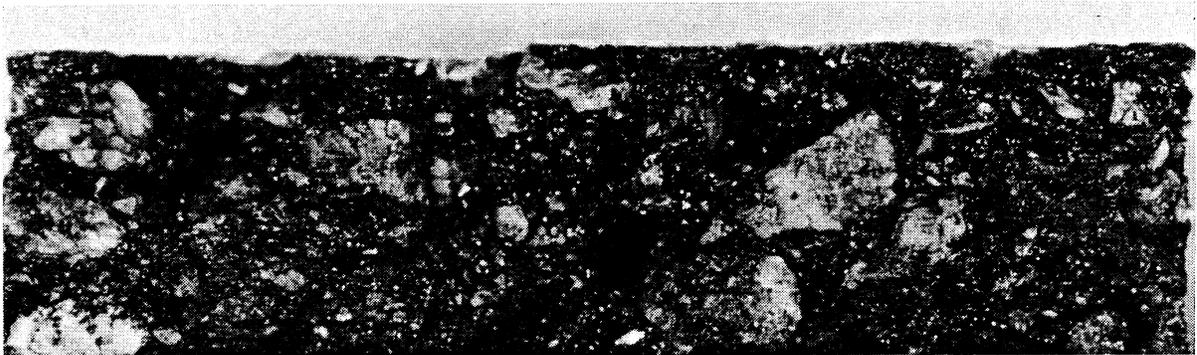
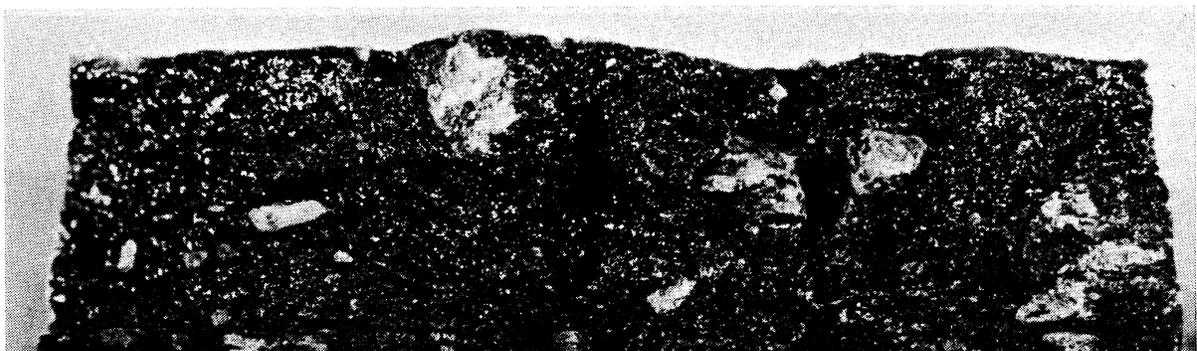
Figure 4. Pavement samples from Route 250 after 6 years.

All of the test sections were in good condition with no cracking; however, the surface appeared very dense. An adjacent lane containing chemical additive, which was not monitored as part of the original investigation, had severe raveling and cracking.

a. No additive.

b. Chemical additive.

c. Hydrated lime.

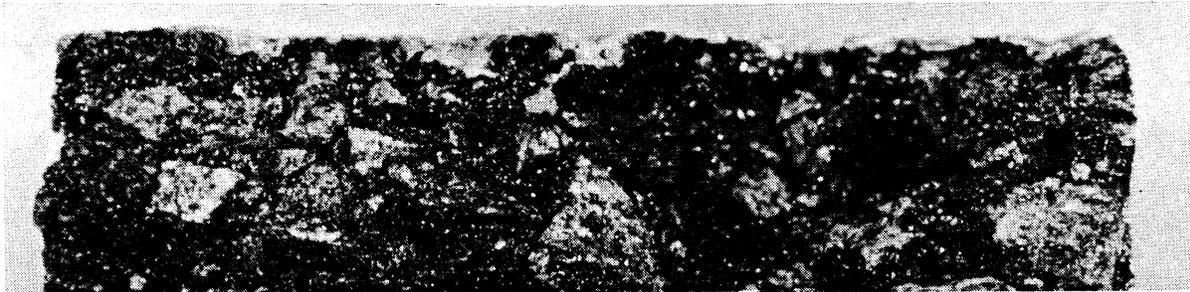
Figure 6. Pavement samples from Route 360 (B) after 6 years.

There was no noticeable distress present in any of the sections, although there was considerable stripping in the pavement samples, as discussed subsequently.

Generally, the samples from sections with hydrated lime exhibited much less stripping than the samples with chemical additives. The only exceptions were Route 10 where none of the mixes stripped and Route 360 (B) where all of the mixes displayed considerable stripping. These exceptions may be related to the permeability of these mixes. The mixes on Route 10 were relatively impermeable, and the mixes on Route 360 (B) appeared to be very permeable.

Chemical No. 2 on Route 360 (B), which was supposed to be an improved additive, did not reduce stripping more than the conventional chemical

a. No additive.

b. Chemical additive No. 1.

c. Chemical additive No. 2.

d. Hydrated lime.
