1. Report No. FHWA/VA-91-R22	2. Government Accession No.	3. Recipient's Catalog No.	
4. Title and Subtitle A Geophysical System Combining Electrical Resistivity and Spontaneous Potential for Detecting Delineating and Monitoring Slope Stability		5. Report Date June 1991

**FINAL REPORT****A GEOPHYSICAL SYSTEM COMBINING ELECTRICAL RESISTIVITY  
AND SPONTANEOUS POTENTIAL FOR DETECTING,  
DELINEATING, AND MONITORING SLOPE STABILITY**

**June 1991  
VTRC 91-R22**

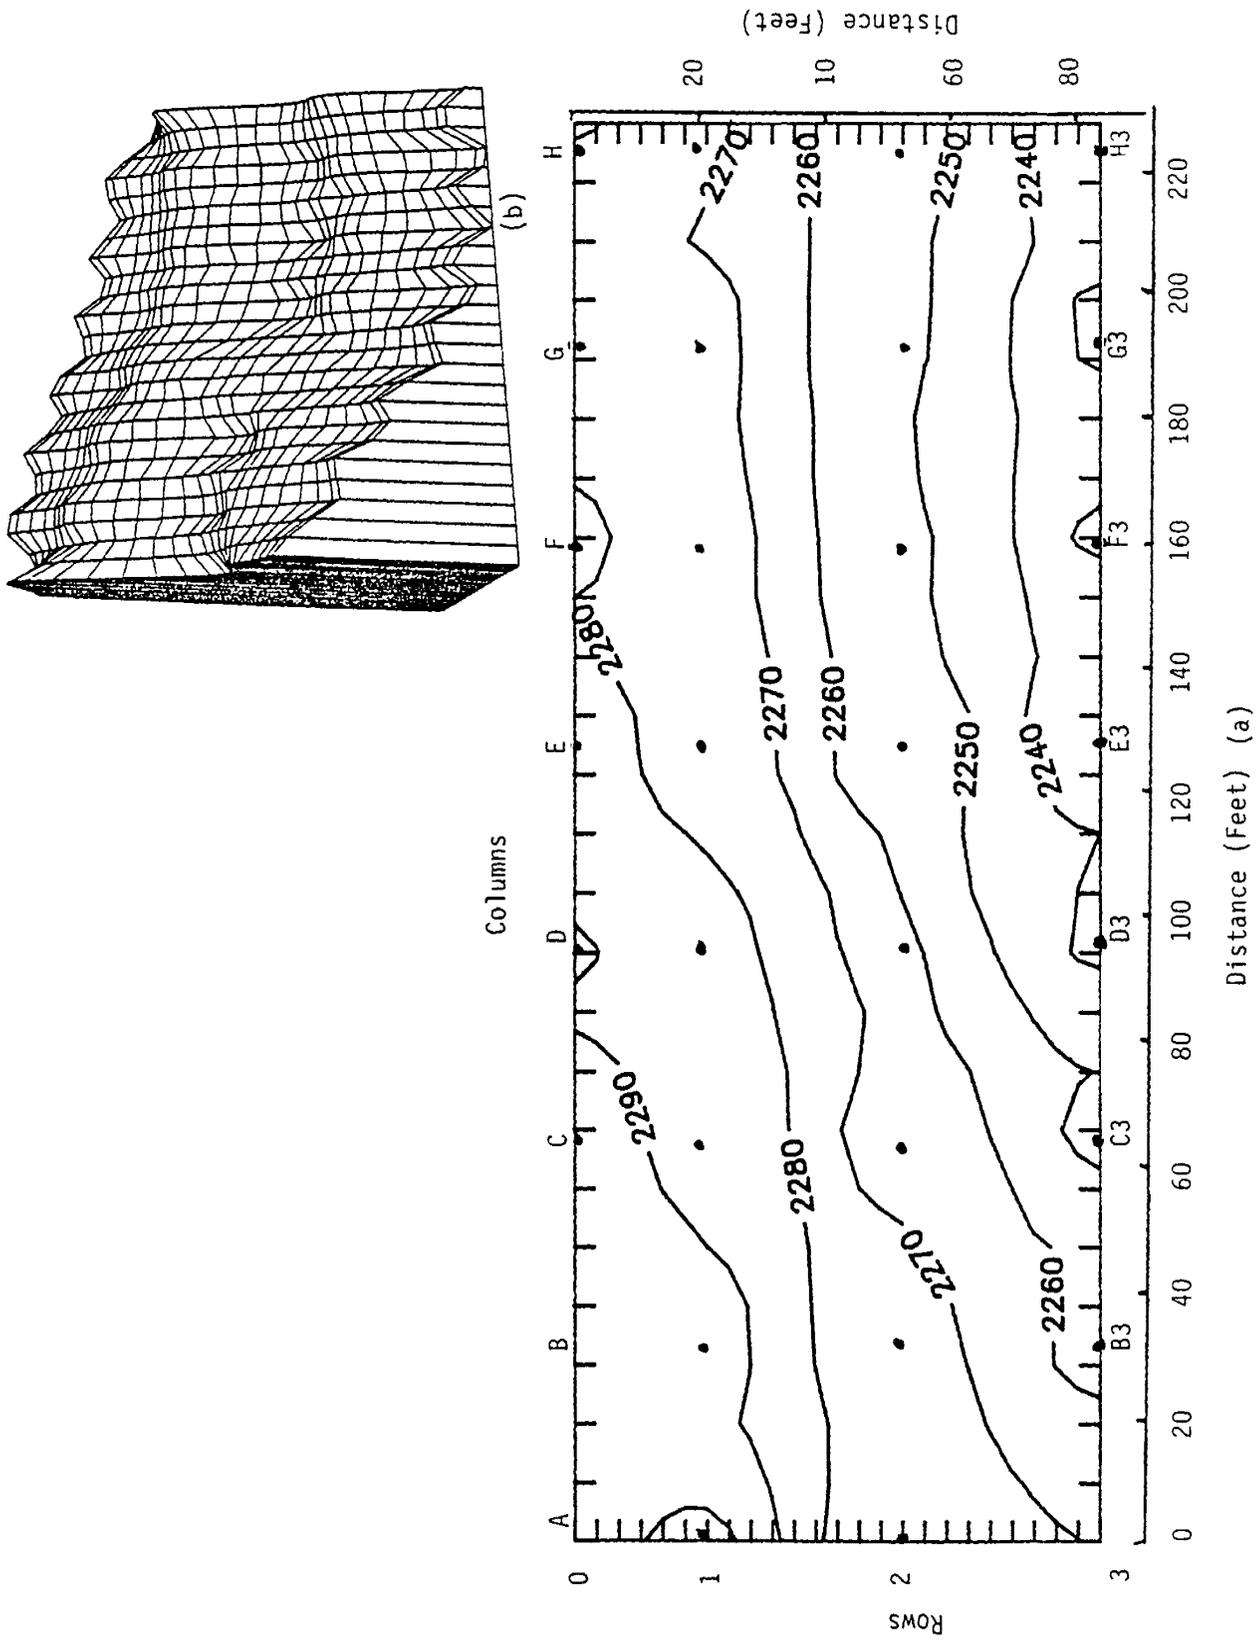
Figure 6. Elevation Contour (A) and Surface (B) Maps of Site I. The contour interval is 10 ft.

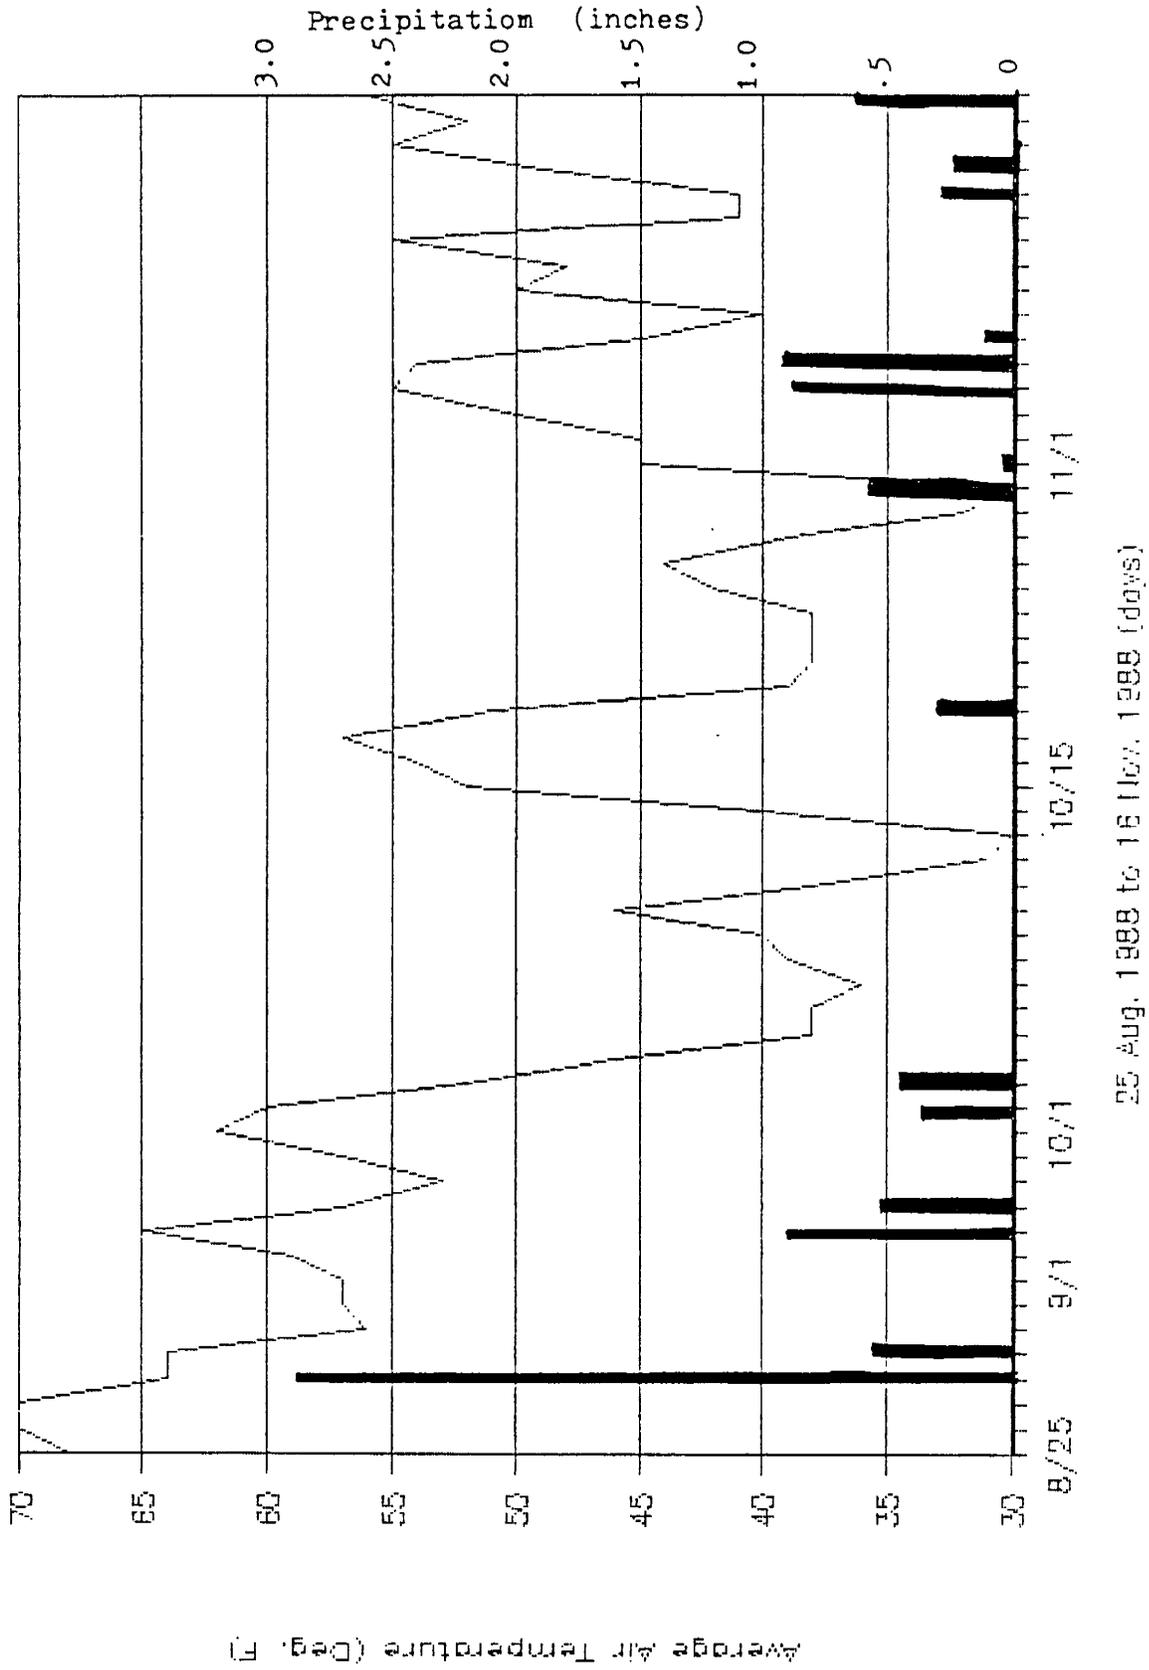
Figure 10. Temperature and Precipitation at Sites I and II from August through November 1988.

The other major environmental factor affecting SP values is precipitation. Precipitation generally has two effects on SP values: (1) as the slope becomes saturated with moisture, the SP values will increase; and (2) as the slope drains, high rates of subsurface flow and high hydraulic gradients will lead to reduced SP values. This was especially evident during the period August 28 to September 4, 1988, when nearly 5 in of rainfall was recorded.

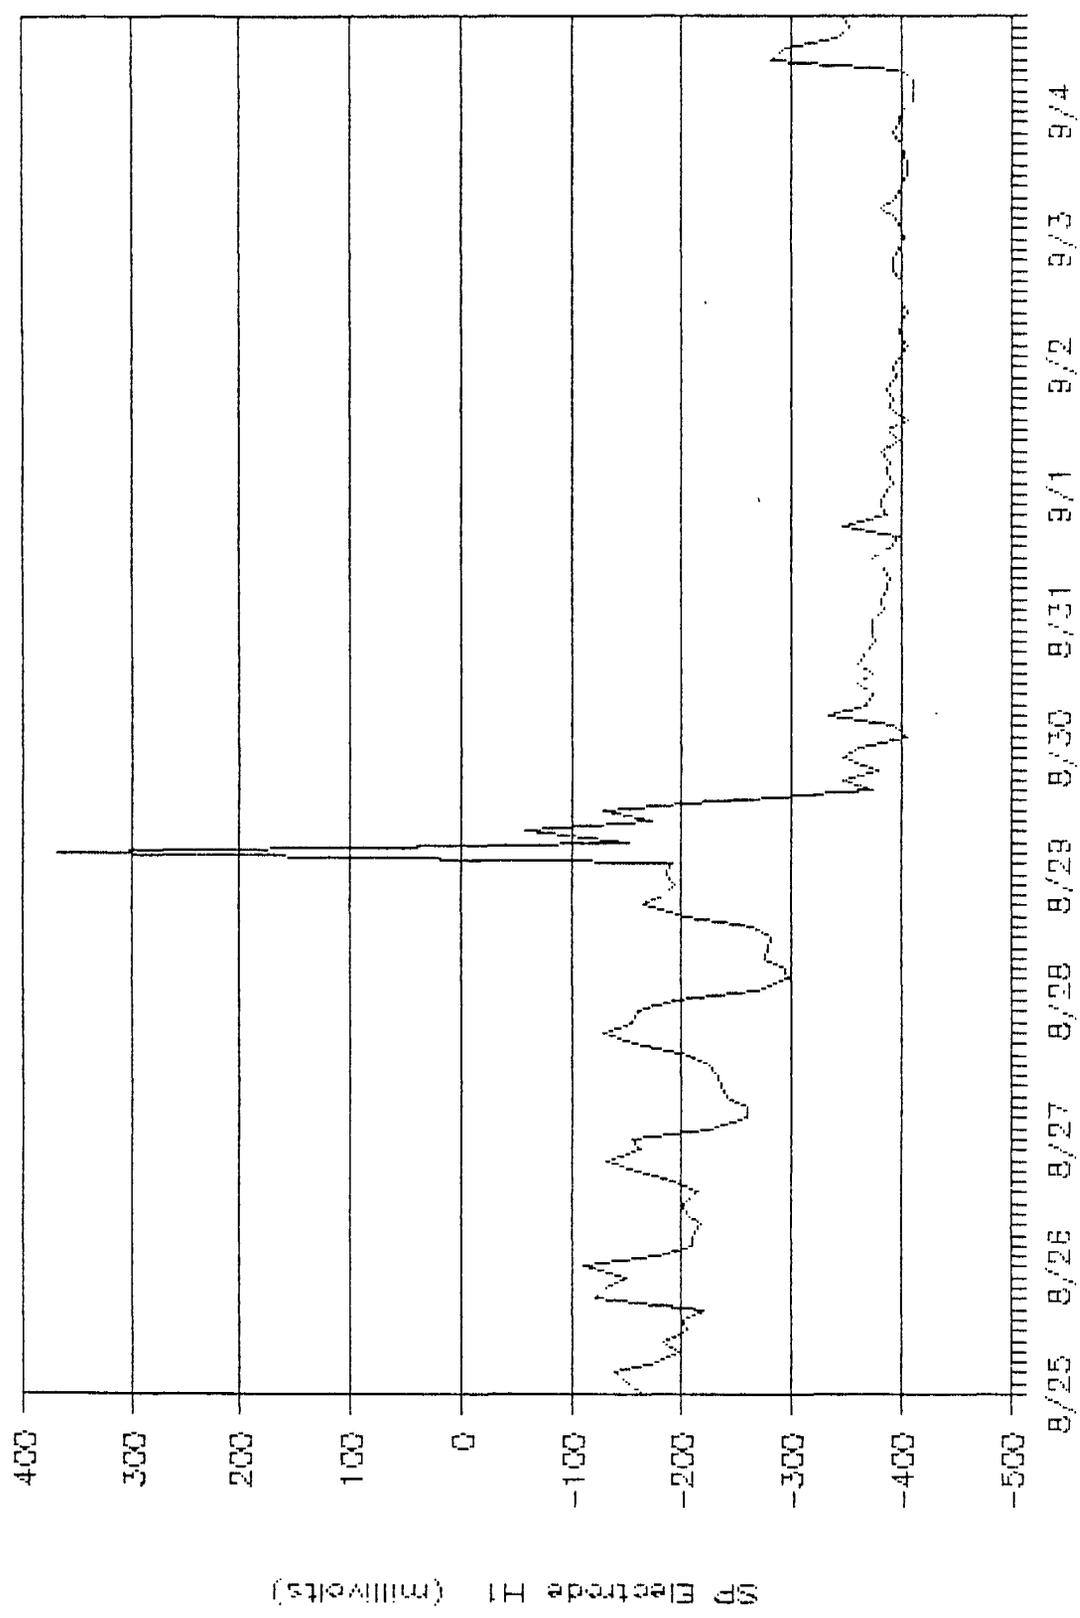
Figure 11. Hourly Spontaneous Potential Measured at Electrode H1 versus Time for the Period August 25 through September 4, 1988.

During the period August 28 to September 4, 1988, all SP electrodes monitored peaked or had their highest SP value (400 mv) at 5 p.m. on August 29 (see Appendix A and Figure 11). These high SP values occurred after the heavy rainfall of August 28 and 29. This would be indicative of a saturated slope condition, and although failure did not occur, it would be at such a condition that one might expect failure. Had more rainfall occurred and high positive values continued on all electrodes, the stability of this slope would probably be in extremis. Twelve hours or more after significant precipitation, the values of SP decreased as subsurface water flows and hydraulic gradients increased due to slope drainage. Another aspect of the change in SP values as a result of precipitation can be seen in Figure 12. In Figure 12, the daily average SP values for August 29 and September 1 are plotted for row 1, electrodes A1 through H1. After the high rainfall of August 28, all electrodes in this row increased in SP value. Then, when slope drainage occurred (September 1), there was a significant decrease in SP values. This shows how SP can be used to monitor a slope and "see" the slope expand as it saturates and contract as it drains during precipitation. Since most slope failures in Virginia are triggered by precipitation, a measuring system that could monitor and indicate an extremis situation would be extremely valuable.

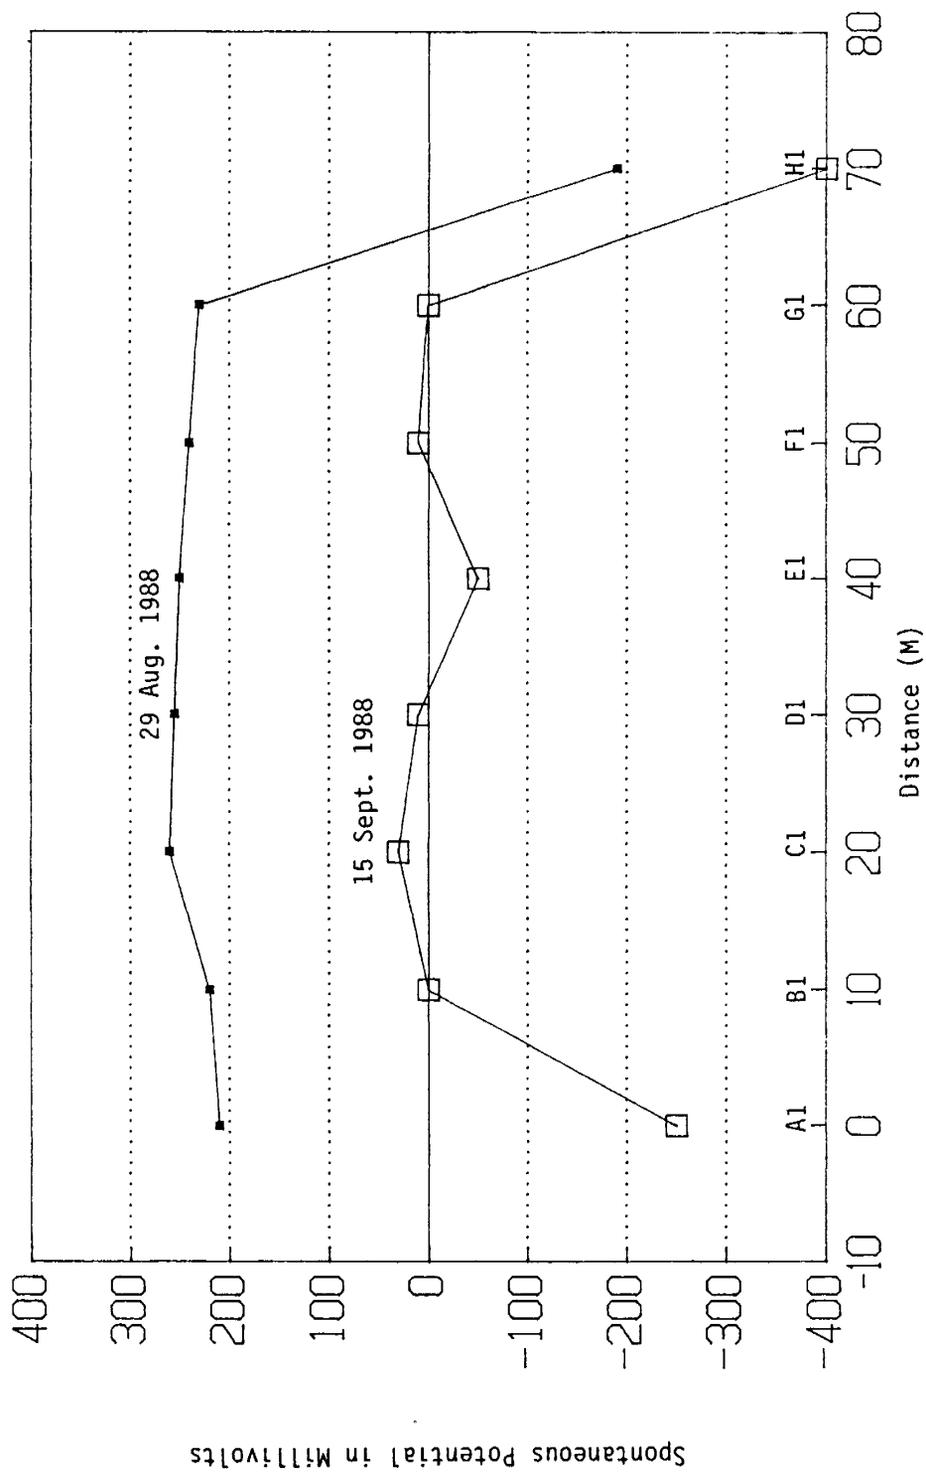
Figure 12. Daily Average of Spontaneous Potential Values Along Row 1 at Site I during August 29 and September 1, 1988.

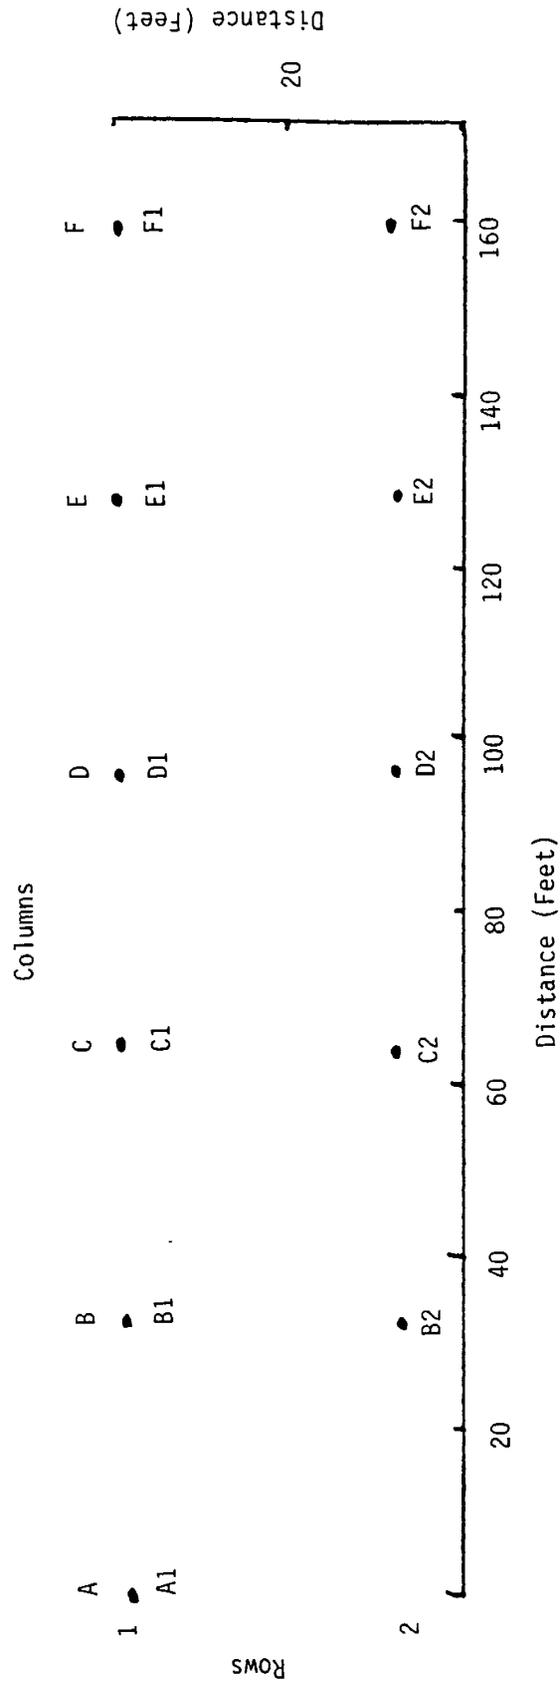
Figure 13. Spontaneous Potential Electrode Array Pattern at Site II.

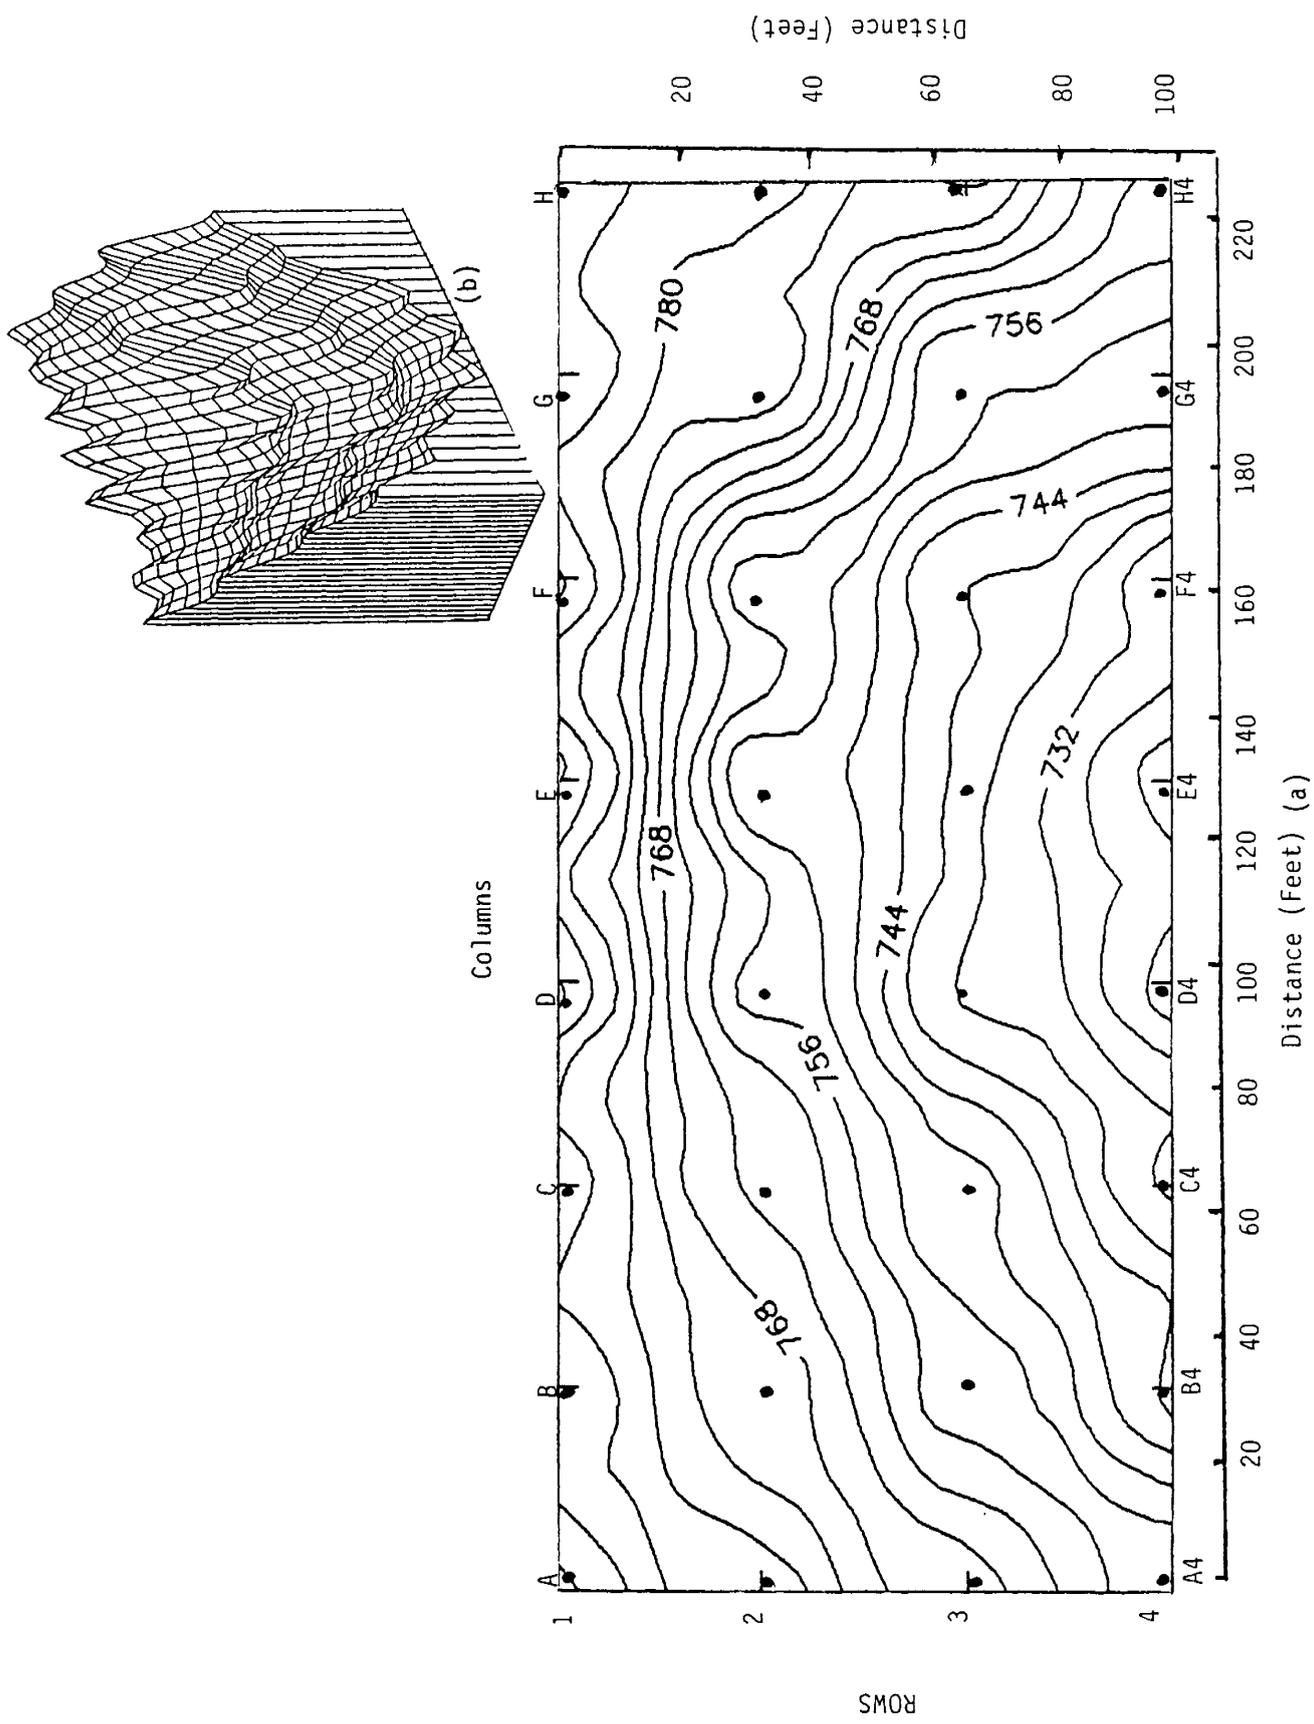
Figure 16. Contour (A) and Surface (B) Maps of 1988 Elevation Data at Site III. The contour interval is 4 ft.

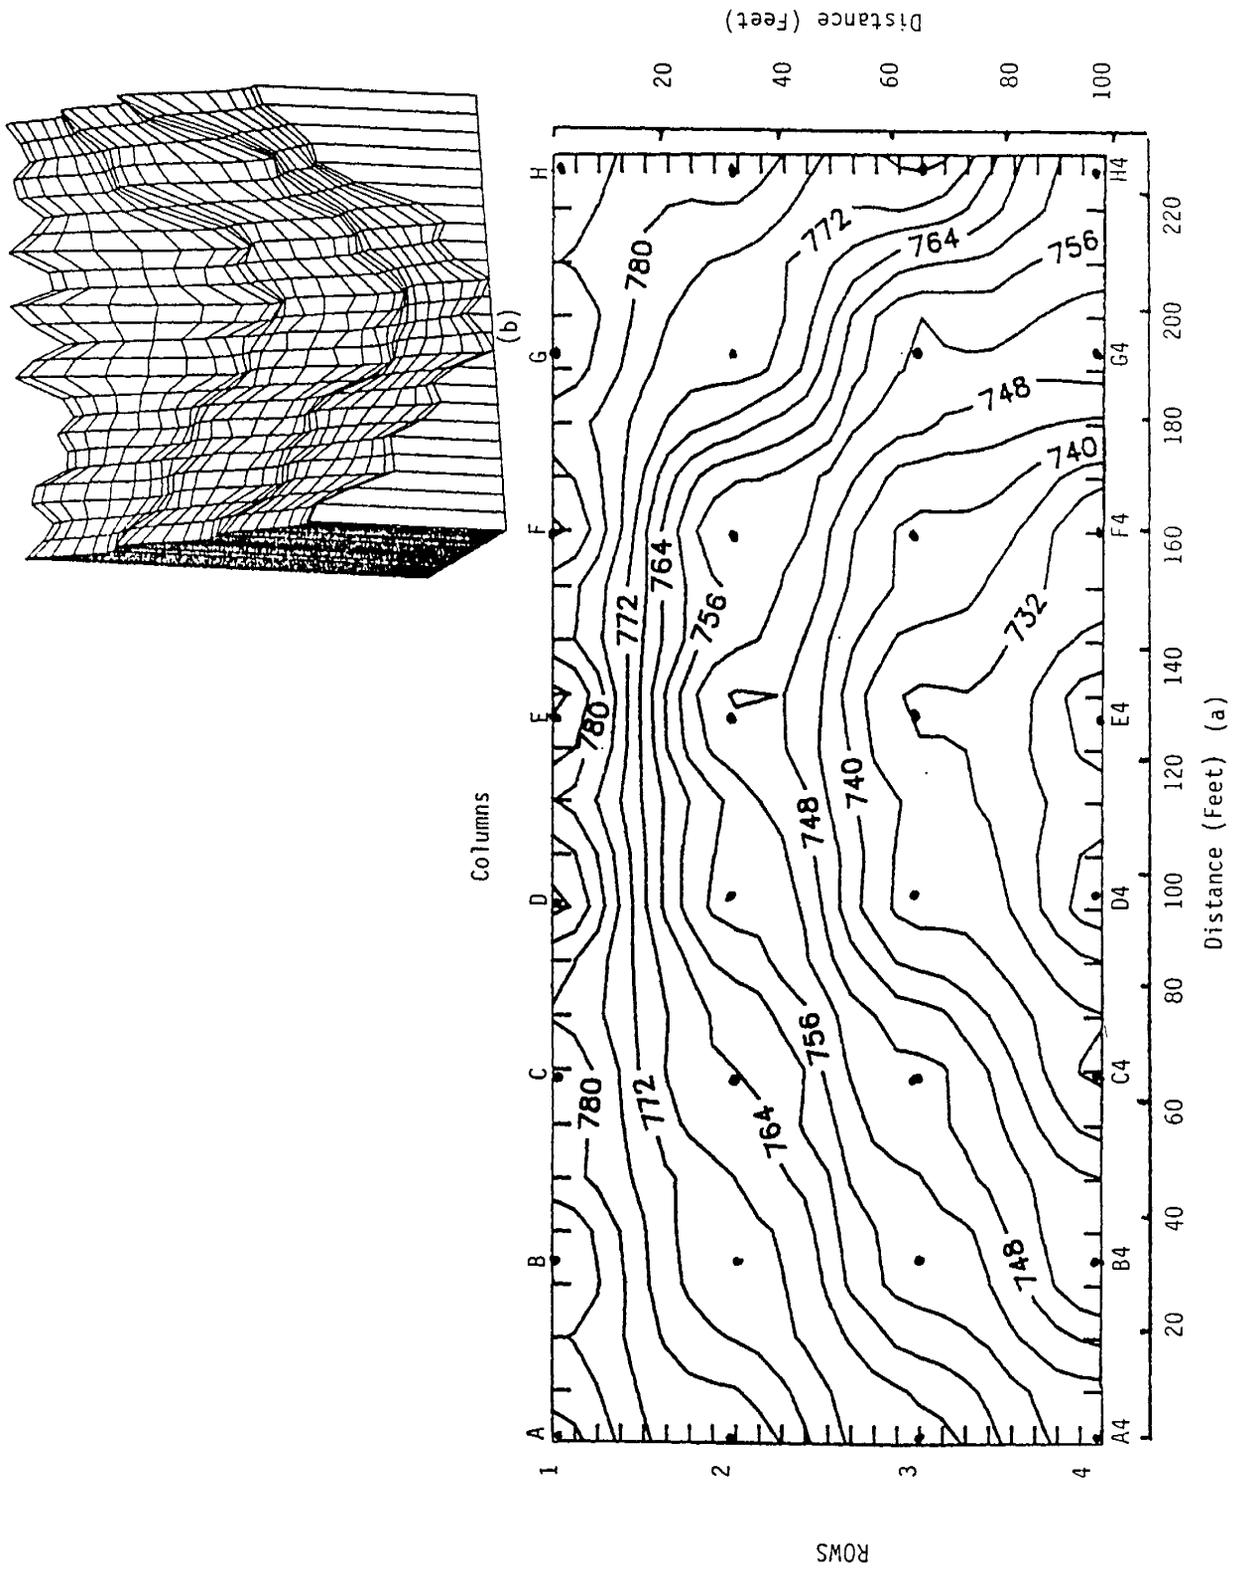
Figure 17. Contour (A) and Surface (B) Maps of 1990 Elevation Data at Site III. The contour interval is 4 ft.

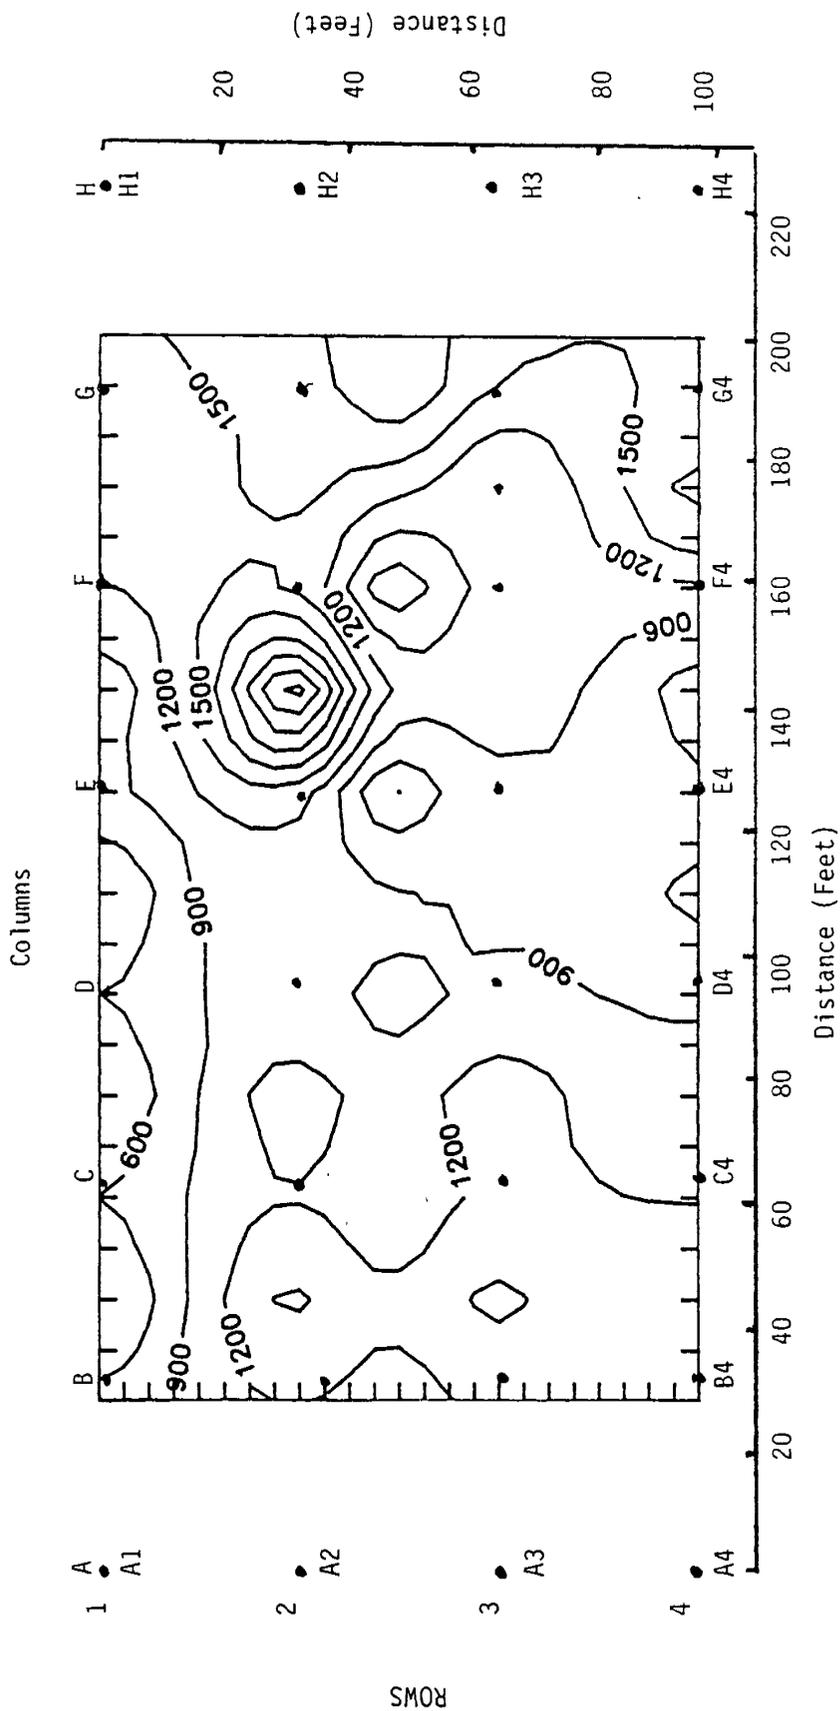
Figure 20. Electrical Resistivity Contour Map for Site III. The contour interval is 300 ohm-ft.

geological studies in this area. In addition, since water is generally the conducting medium in an unconsolidated material, the central failed area of the slope should be closer to the water table and should be associated with higher conductivity values. The ER survey is shown in Figure 20 and confirms the TCM survey.

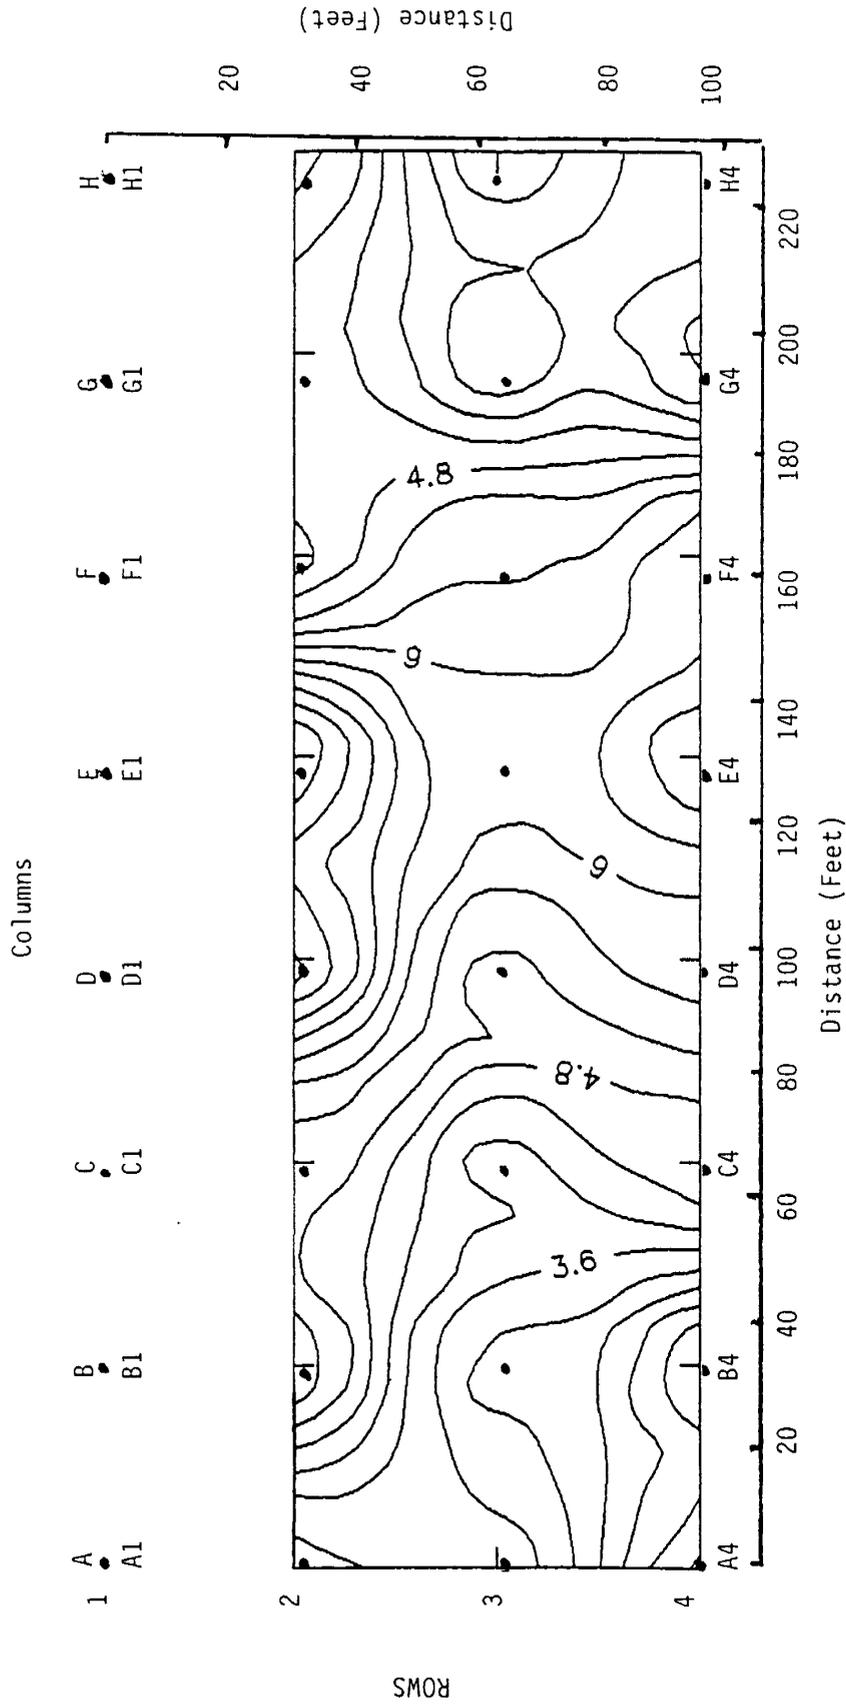
Figure 21. Conductivity Contour Map to a Depth of 24.6 ft at Site III Using the Terrain Conductivity Meter. The contour interval is 0.4 milliSieman per meter (mS/M).

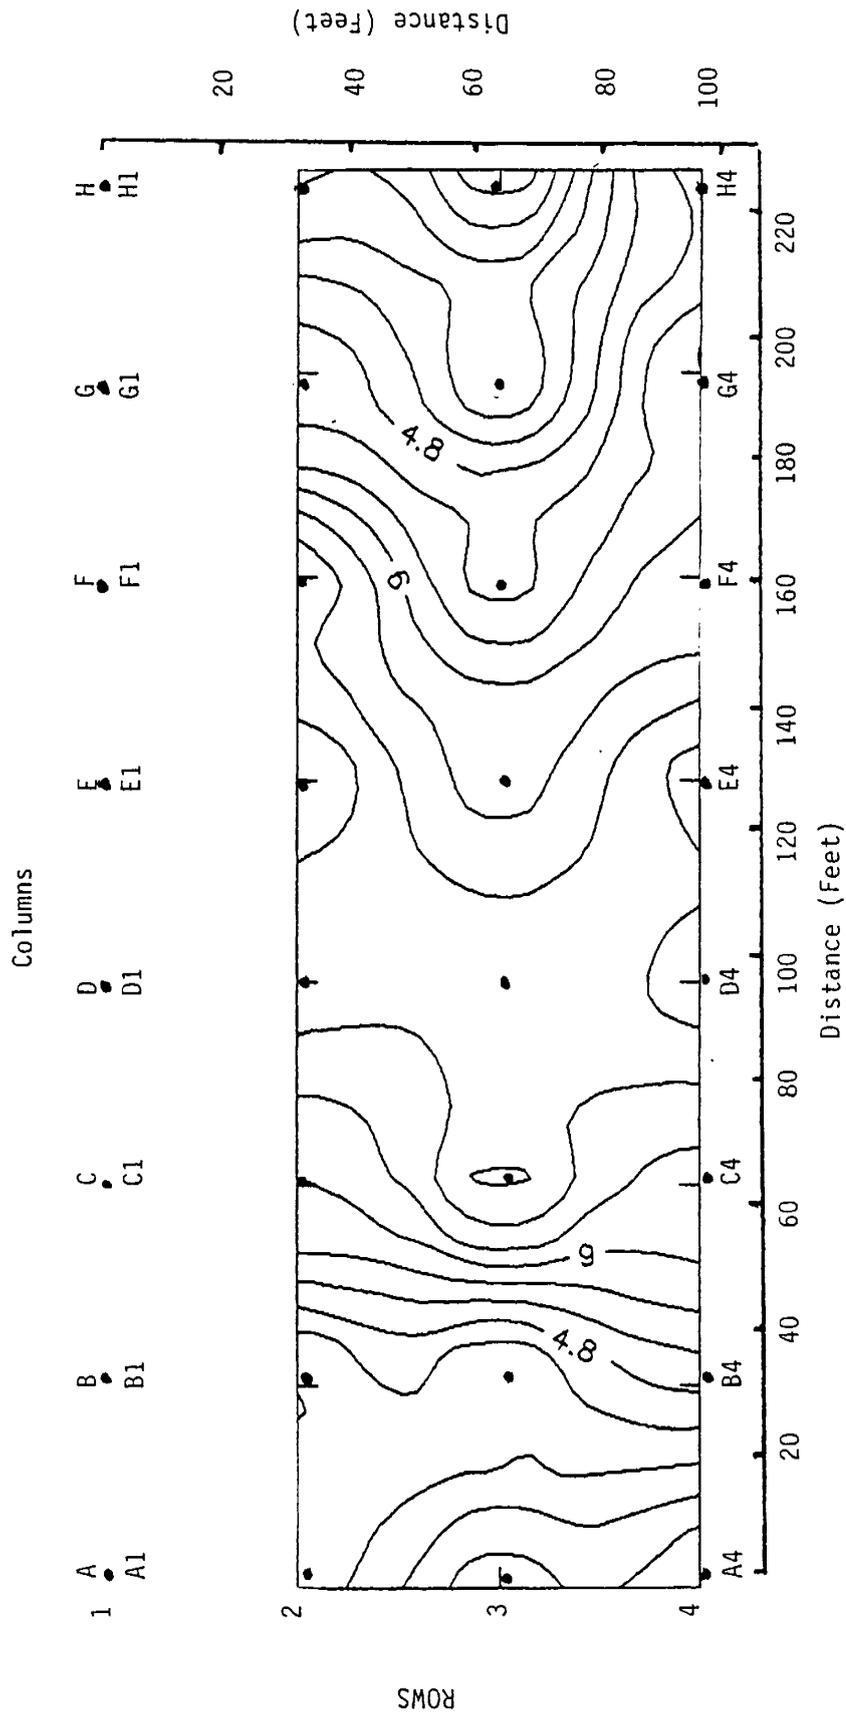
Figure 22. Conductivity Contour Map to a Depth of 49.2 ft at Site III Using the Terrain Conductivity Meter. The contour interval is 0.4 milliSieman per meter (mS/M).

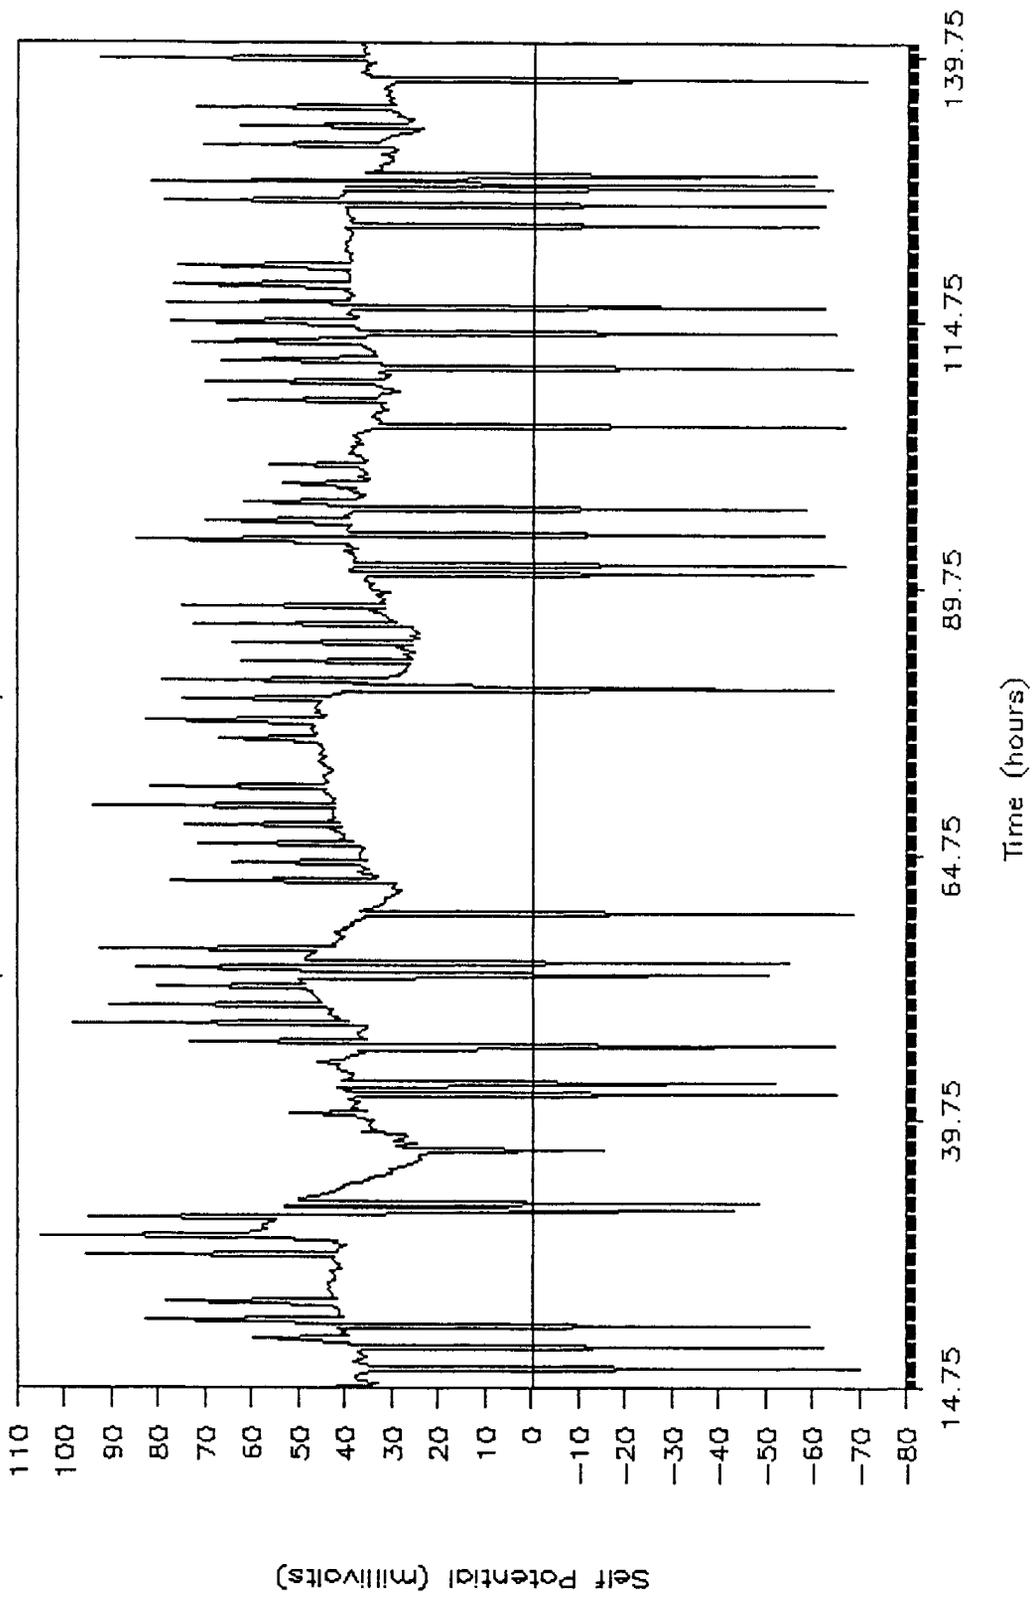
Figure 23. Spontaneous Potential Data for Electrode A3 at Site III.

Those electrodes that remained intact during the AMS measuring period were A3, A4, B2, B3, and D2. The data for these electrodes are presented graphically in Appendix C. The data collection rate was every 15 min. Data for the first 6 days at this sampling rate (September 1 to 6, 1989) are shown unfiltered for electrode A3 in Figure 23. The AMS or electromagnetic air and ground signals could have caused spurious readings. In Figure 24, the obviously spurious readings were filtered. Also shown in Appendix C is the filtered signal for each electrode during this 6-day period. In Figures 25 and 26 are the 15-min sampling rates for air and ground temperatures taken at site III. The temperature of the surface of the ground lags slightly behind the air temperature, as would be expected. Also noted is the inverse effect temperature has on the SP value of each electrode; i.e., as temperatures increase and warm the SP electrode, the SP value decreases, and as temperatures decrease, the SP value increases.

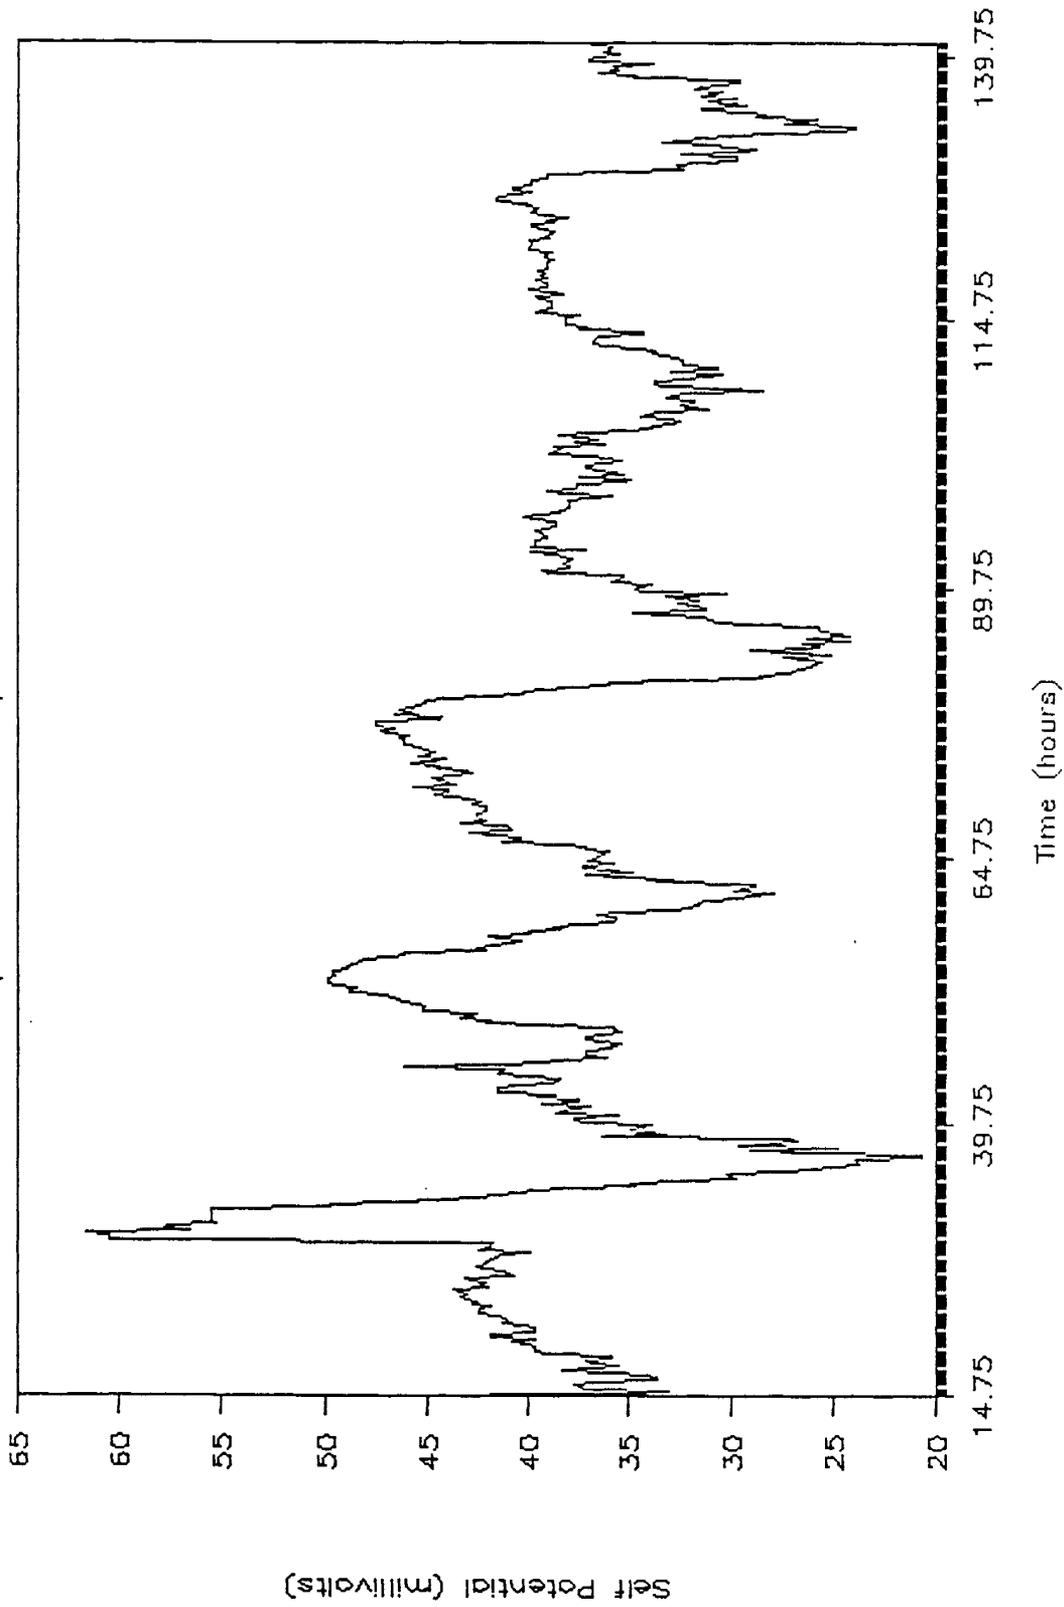
Figure 24. Filtered Spontaneous Potential Data versus Time for Electrode A3 at Site III.

To eliminate the diurnal temperature effects, all SP values were averaged and this daily average SP value was plotted for all these electrodes for the entire AMS measuring period (September 1989 to April 1990) and are shown in Appendix C. The breaks in the record are the result of equipment difficulties, lack of solar power supply, disc overloading, or an oversight in installing and programming a new disc to record data. An example of an electrode plot over the entire AMS

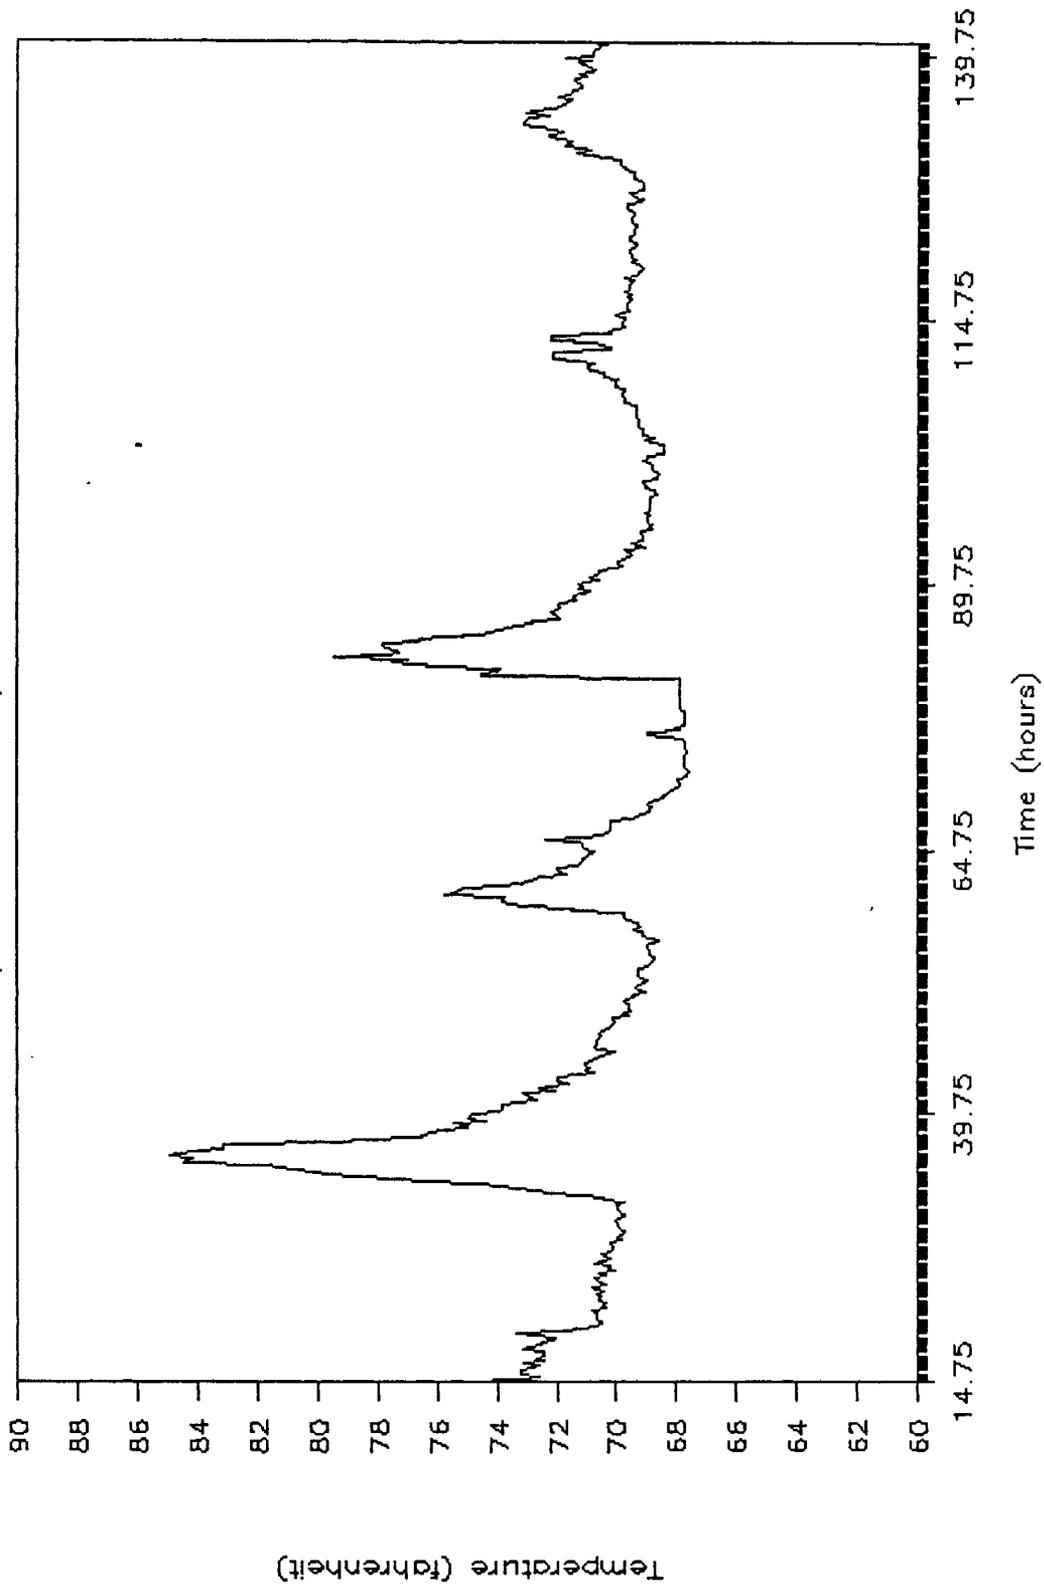
Figure 26. Ground Temperature versus Time at Site III.
