1. Report No. FHWA/VA-91-R22	2. Government Accession No.	3. Recipient's Catalog No.	
4. Title and Subtitle A Geophysical System Combining Electrical Resistivity and Spontaneous Potential for Detecting Delineating and Monitoring Slope Stability		5. Report Date June 1991

**FINAL REPORT****A GEOPHYSICAL SYSTEM COMBINING ELECTRICAL RESISTIVITY  
AND SPONTANEOUS POTENTIAL FOR DETECTING,  
DELINEATING, AND MONITORING SLOPE STABILITY**

**June 1991  
VTRC 91-R22**

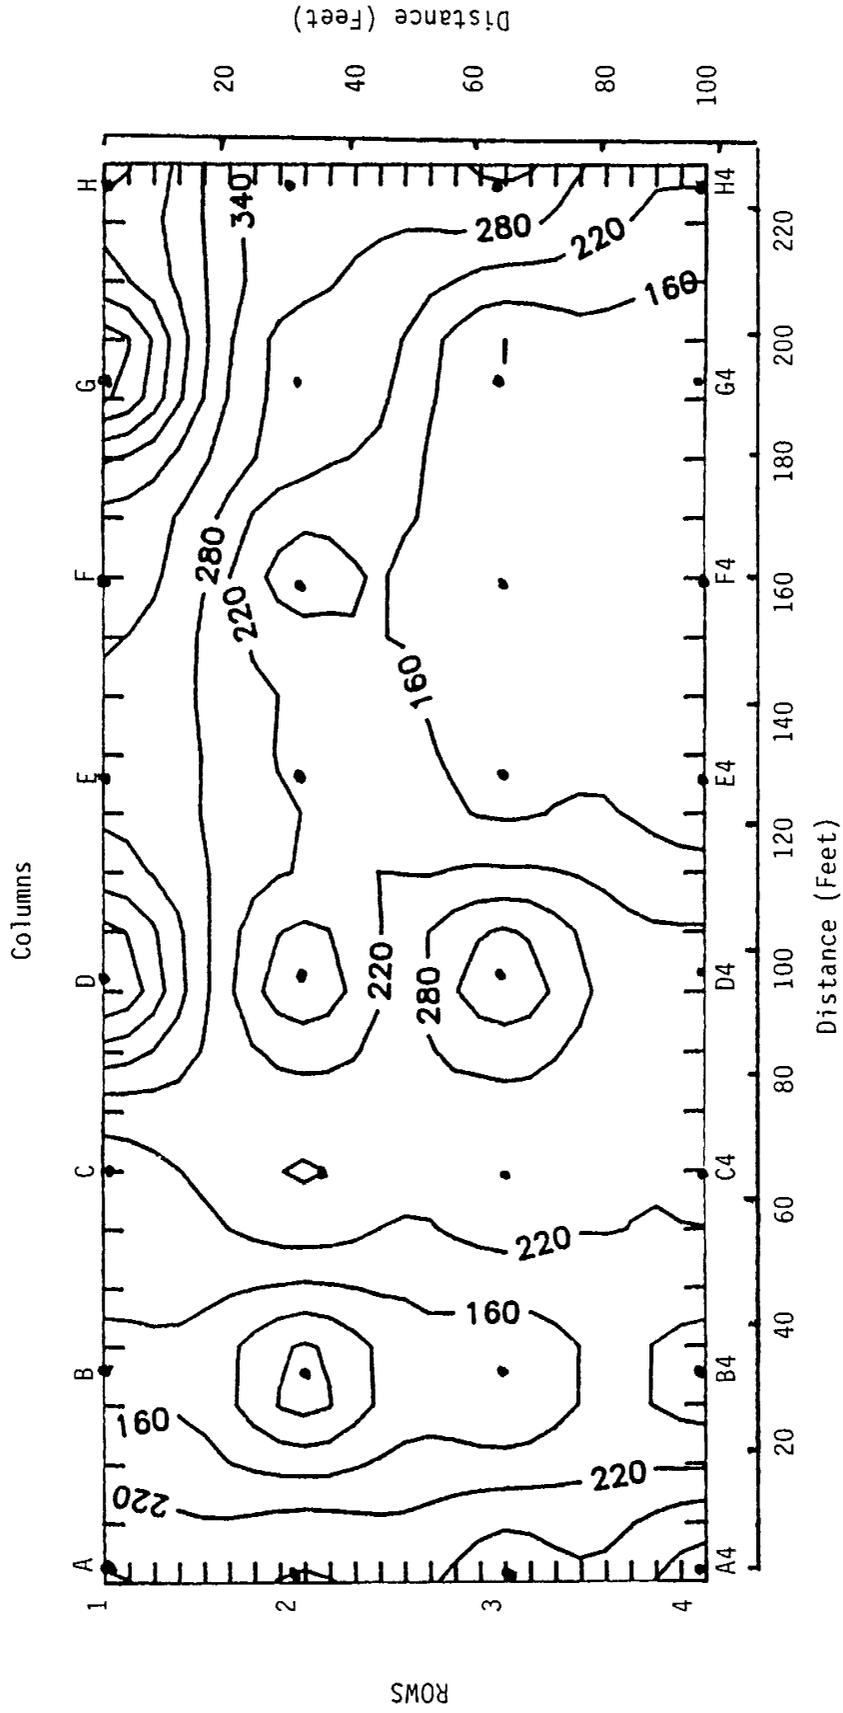
Figure 28. Normalized Spontaneous Potential Data at Site III for May 4, 1988. The contour interval is 60 mv.
