FINAL REPORT**BENEFITS OF MEASURING HALF-CELL POTENTIALS
AND REBAR CORROSION RATES IN CONDITION SURVEYS
OF CONCRETE BRIDGE DECKS**

**Gerardo G. Clemeña, Ph.D.
Principal Research Scientist**

**June 1992
VTRC 92-R16**

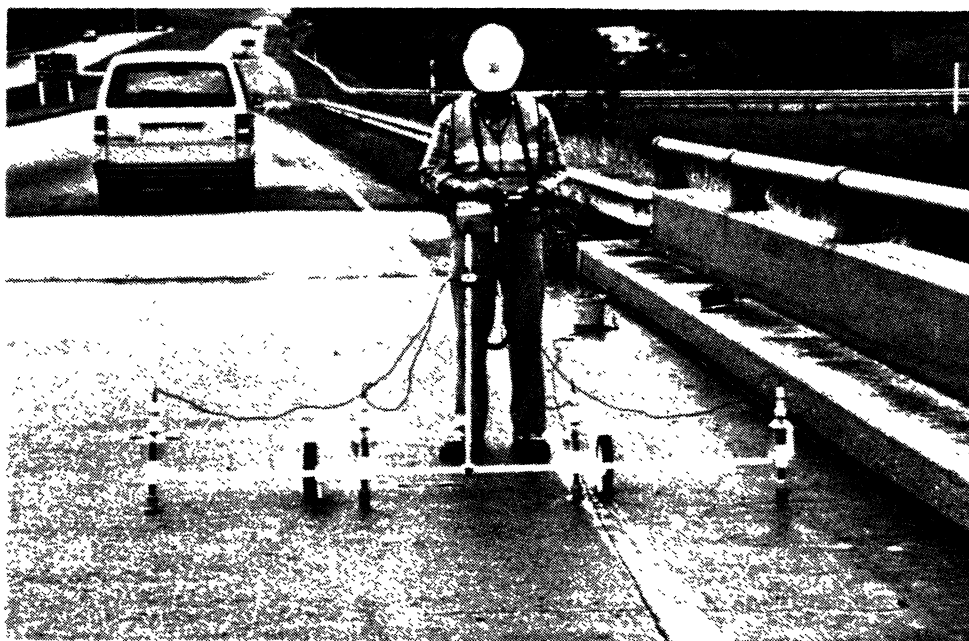
Figure 1. A half-cell array, consisting of four Cu/CuSO₄ reference cells, being used on a concrete bridge deck.

The measurement of half-cell potentials was facilitated by the use of a multiple half-cell array, which consisted of an array of four Cu/CuSO₄ electrodes (see Figure 1). Depending on the grid spacing to be used in a survey, the electrodes were spaced at 1.0 to 2.5 ft apart on the graduated metal mounting bar. A battery-powered portable data logger (Polycorder 700), which was preprogrammed to serve as a digital voltmeter (with a resolution of 1 mV), was used in conjunction with the half-cell array to store automatically, throughout each survey, all potential readings from the four electrodes (see Figure 2). The stored data were then subsequently downloaded to a desktop computer for iso-potential contour mapping and statistical analysis, using an appropriate graphic software.

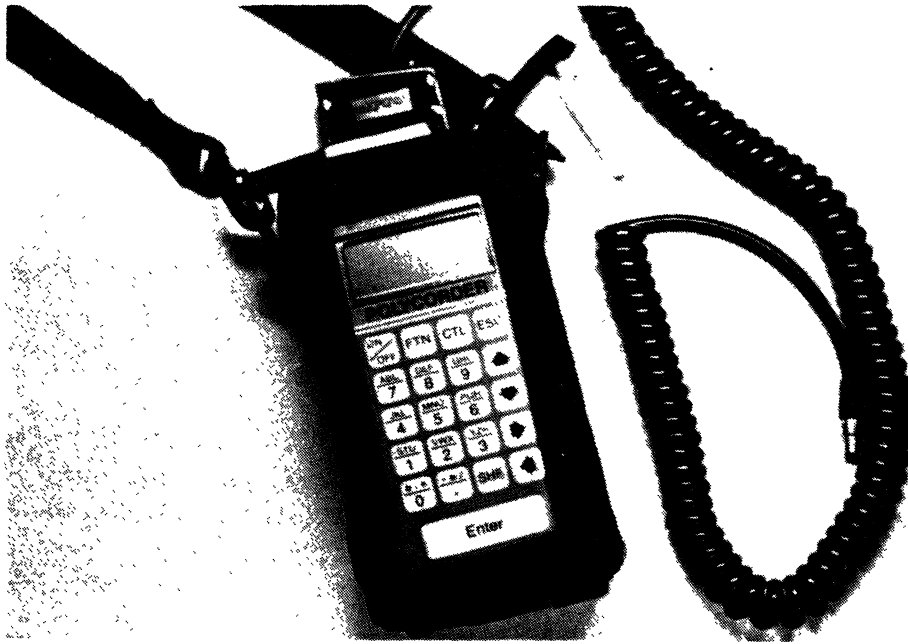
Figure 2. A microprocessor-based data logger used for measurement and automatic logging of half-cell potentials.

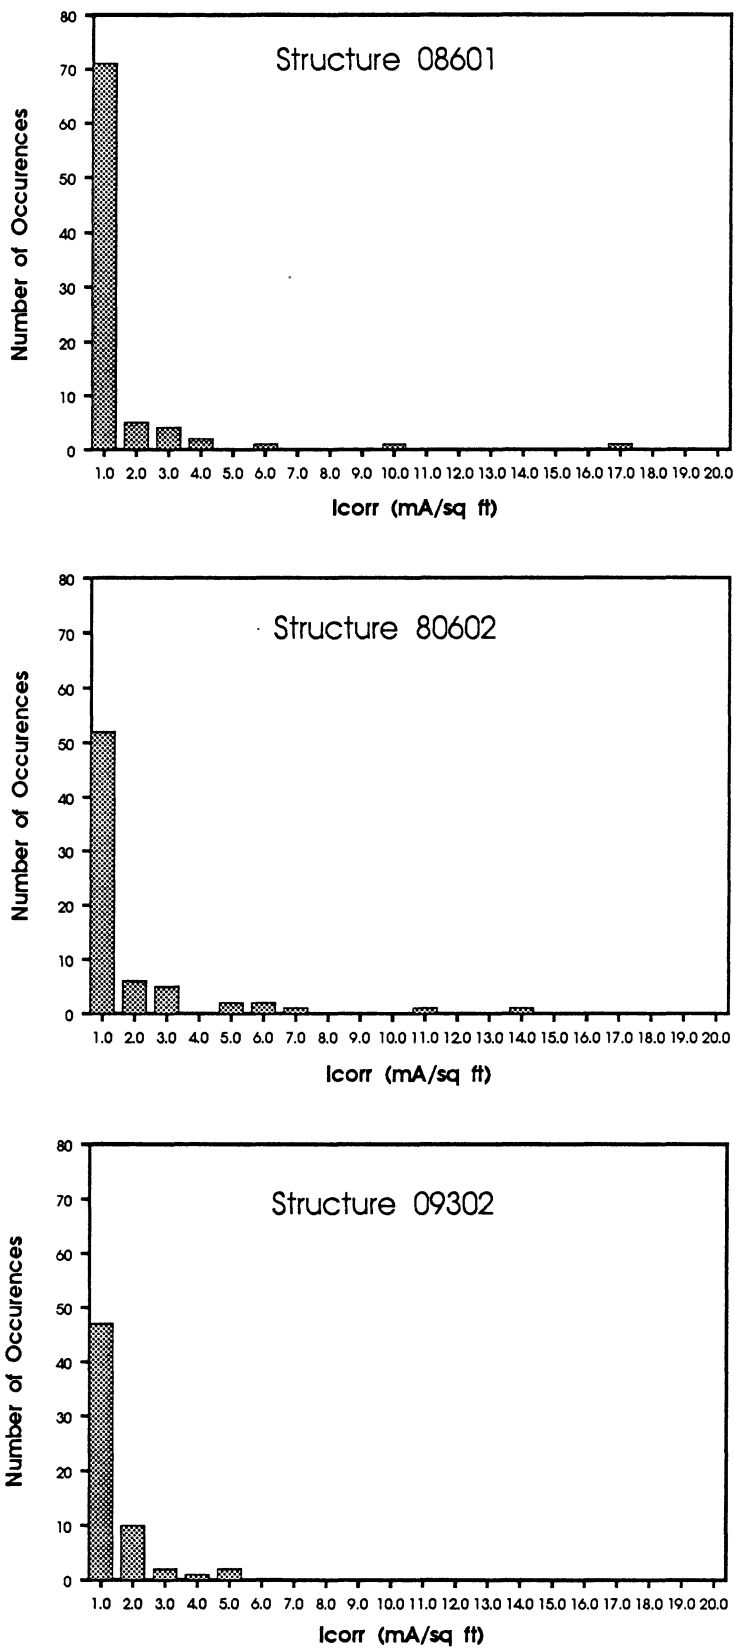
Figure 19. Frequency distributions of rebar corrosion rates observed in three concrete bridge decks.

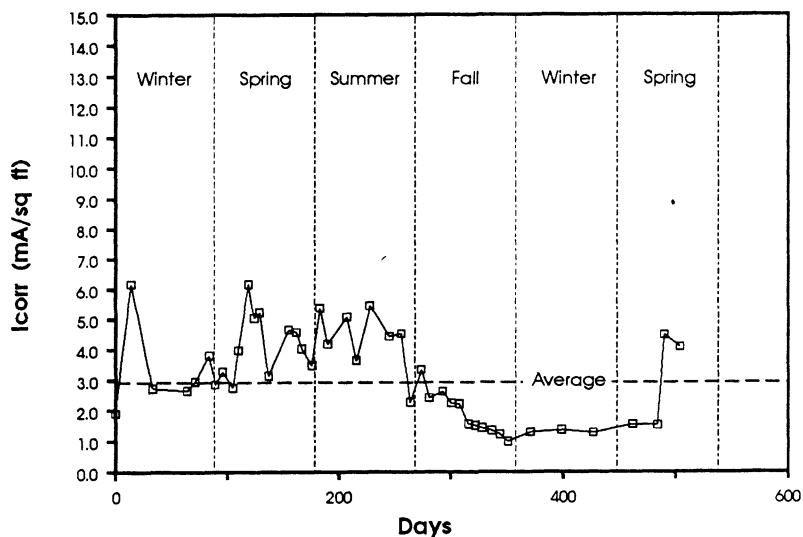
Figure 22. Observed average rebar corrosion rates in test-reinforced concrete slabs of varied concrete covers: (a) 1.0 in., (b) 2.0 in., and (3) 3.0 in.

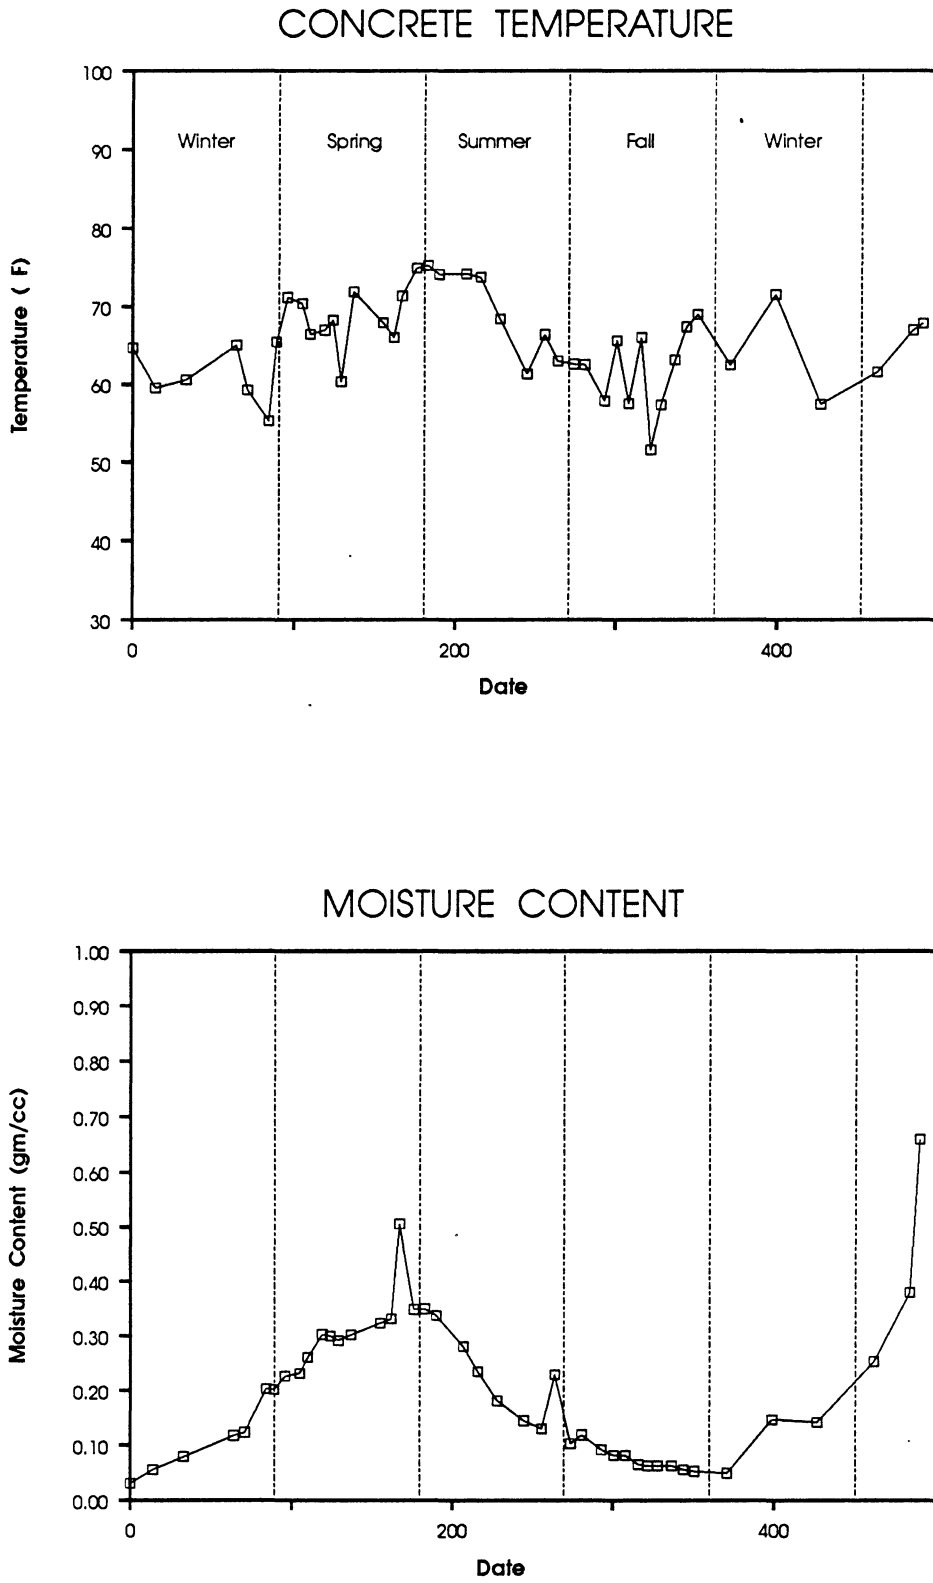
Figure 23. Fluctuations of average temperature and moisture content in test concrete slabs.

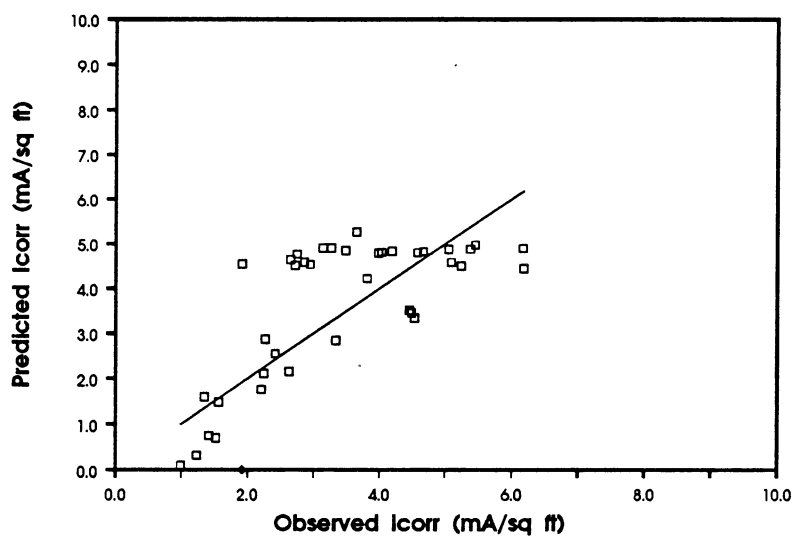
Figure 24. Comparison between observed corrosion rates and those predicted based on concrete moisture and temperature.

where a , b , c , m , and n are constants. However, the corresponding correlation coefficients varied considerably between the slabs: with 84% for slab 1, 48% for slab 2, and 66% for slab 3 (see Figure 24).
