1. Report No. FHWA/VA-92-R10	2. Government Accession No.	3. Recipient's Catalog No.	
4. Title and Subtitle <i>Field Performance of a Porous Asphaltic Pavement</i>		5. Report Date July 1992

**FINAL REPORT**  
**FIELD PERFORMANCE OF A POROUS ASPHALTIC PAVEMENT**

## ABSTRACT

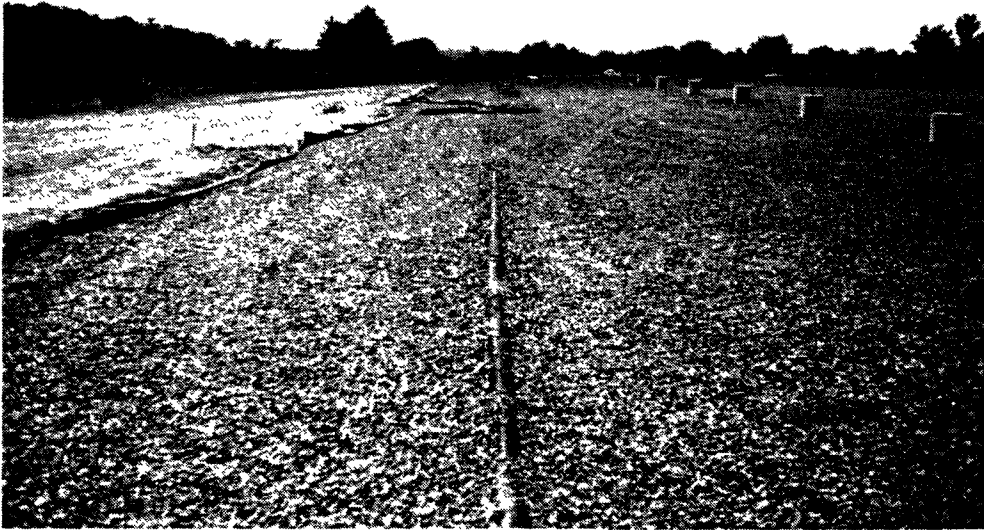
Figure 6. Pipe wrapped in geotextile in No. 57 aggregate base layer.

underneath the roadway by the loading island into the lower porous pavement parking area. The two remaining segments of pipe were placed along the lower end of the porous pavement areas to carry the overflow into a drop inlet that was in the storm sewer system. This drop inlet also served as the monitoring station for this study. As shown in Figures 4 and 6, the 6-in drainage pipe was placed at the top of the No. 57 aggregate base layer. The drain holes in the pipe were within 2 in of the top of the pipe, so theoretically, 6 in of water was designed to be in the base layer prior to having any overflow. These pipes were wrapped with a geotextile during placement. A woven geotextile was used as the wrap as well as the separator between the No. 57 aggregate base material and the subgrade soil (Figure 7).

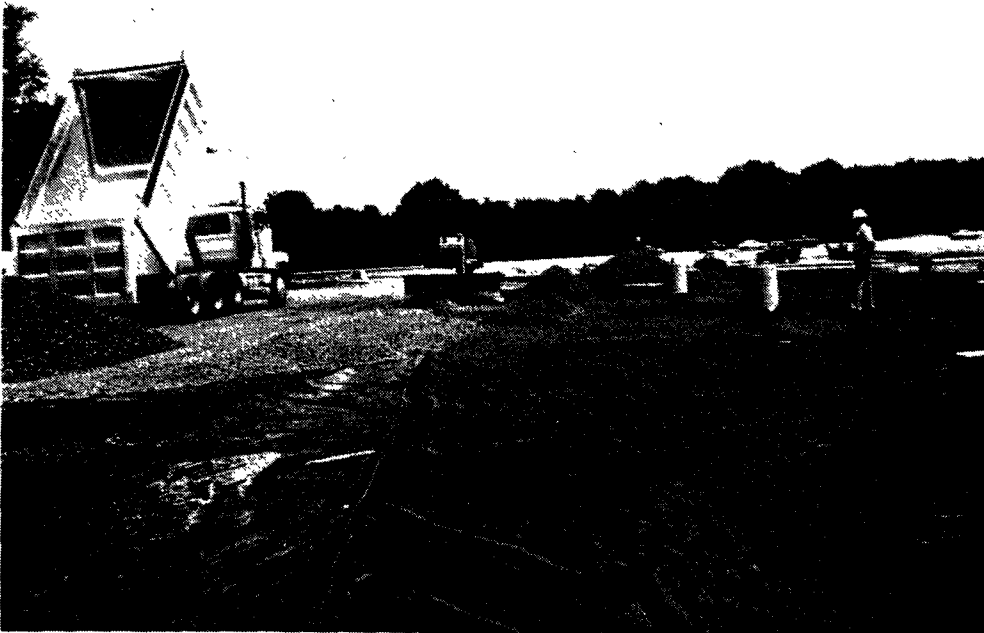
Figure 7. Placement of stone on geotextile.

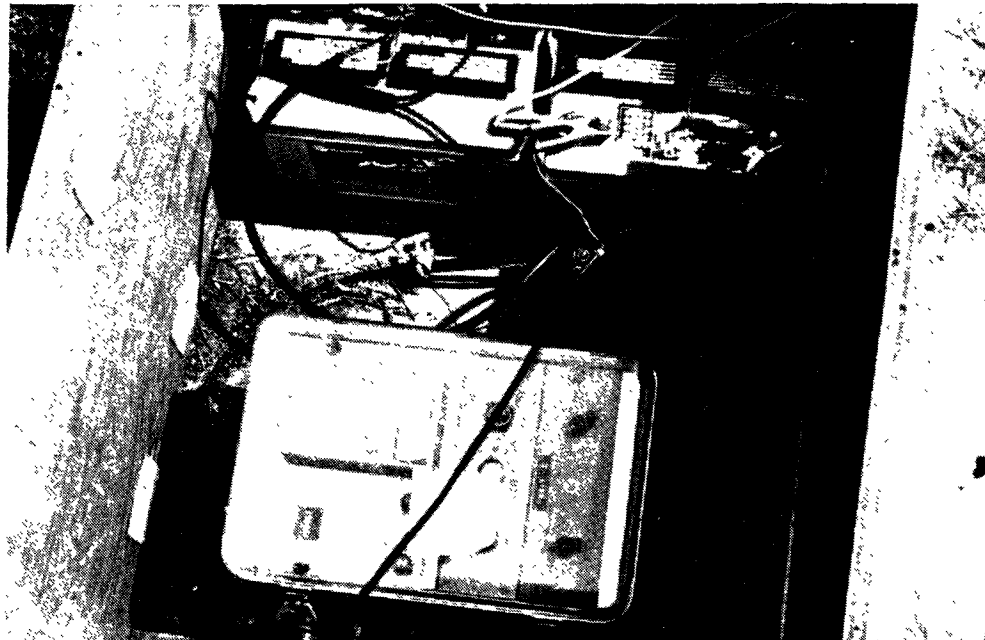
Figure 11. Flow meter with batteries.

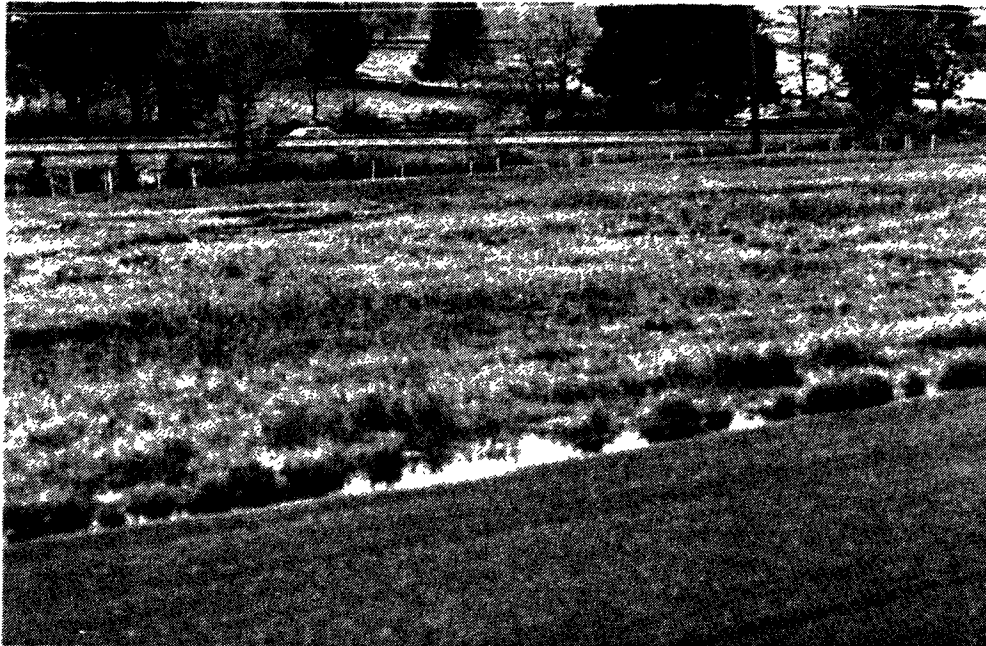
Figure 48. Blowout and runoff channel at lower end of parking lot.

With storage being one of the objectives for selecting porous asphaltic pavement and storage appearing to be lacking at this site, this researcher began to ascertain the reason. After investigating the site, it was determined that the water passing through the stone layers was mostly being forced back up through the system and the adjacent soil on the lower edge of the lot (below standpipes 1 through 3) by the hydrostatic head being created by the slope across the parking lot. The hydrostatic head on the water was calculated to be approximately 360 lb/ft<sup>2</sup>. Water

was bubbling up through the system and the adjacent soil and running across the vegetated area between the lot and Rt. 29 to a drop inlet in the middle of the grassed area (Figure 48). The loss of water from the system through the lower end also caused the flow curves to respond differently. For example, Figure 19 shows little increase in flow when the most intense portion of the rain storm had just occurred (Figure 18).
