# ALKALI-SILICA REACTIVITY IN VIRGINIA

Report No. VTRC 94-R17	Report Date June 1994	No. Pages 70 pages	Type Report: Final Report Period Covered: 9/14/90-8/31-93	Project No.: 9276-010-940 Contract No.:
Title and Subtitle Alkali-Silica Reactivity in Virginia			Key Words concrete aggregates cracking deterioration alkalies silica reactivity	
Author(s) D. Stephen Lane				
Performing Organization Name and Address: Virginia Transportation Research Council 530 Edgemont Road Charlottesville, Virginia 22903				
Sponsoring Agencies' Names and Addresses Virginia Department of Transportation 1401 E. Broad Street Richmond, Virginia 23219 University of Virginia Charlottesville Virginia 22903				
Supplementary Notes None				
Abstract <p>This project examined occurrences in Virginia of alkali-silica reactivity, which is a major cause of the deterioration of concrete. Concretes were studied to determine the mineral aggregates being affected, and test methods for identifying such aggregates were evaluated. Technical literature on alkali-silica reactivity was reviewed to develop a way of dealing with this problem.</p> <p>The results of this study reveal that the mineral primarily affected by alkali-s

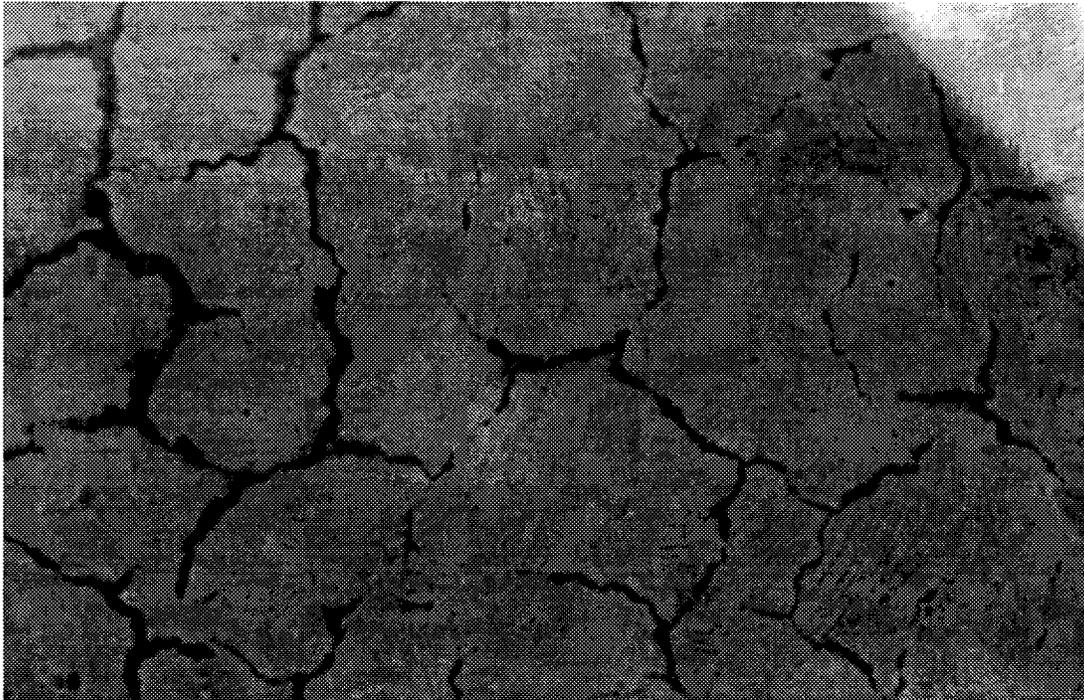
Figure 1. Map cracking on bridge wingwall.

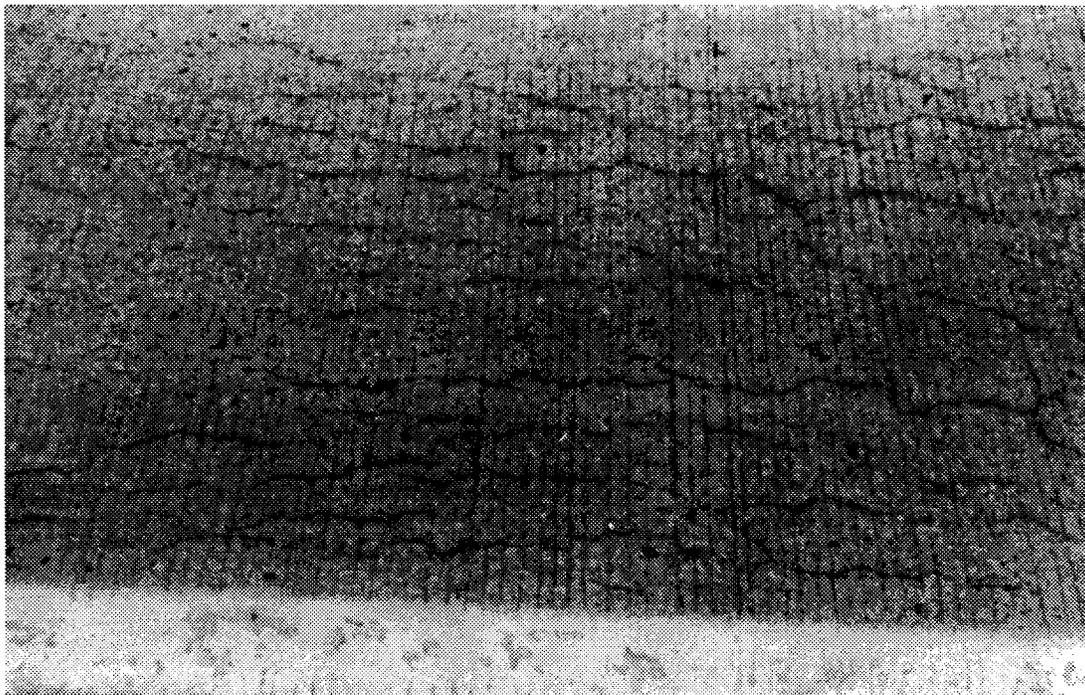
Figure 2. Longitudinal map cracking of continuously reinforced concrete pavement.

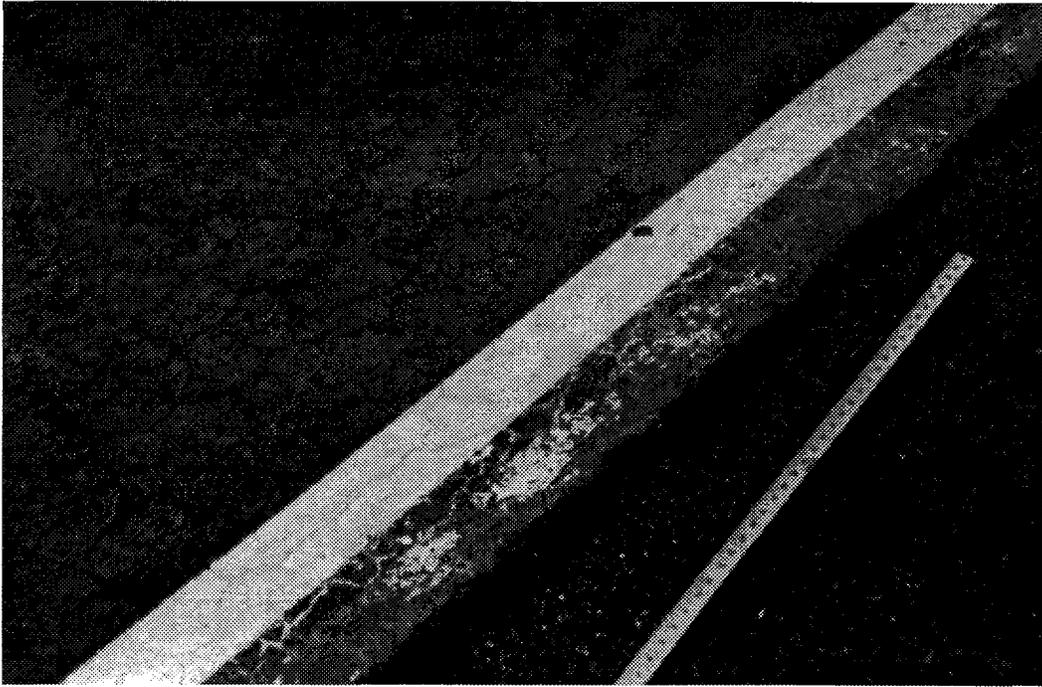
Figure 4. Longitudinal map cracking of CRCP on I-64 between Shadwell and Zion Crossroads.

crete (see Appendix 3). Progressive deterioration (see Figure 4) and mounting maintenance problems resulted in the removal and replacement in 1987 of 6 miles of pavement with new concrete containing a mineral admixture (ground granulated blast-furnace slag). It was concluded that the greenstone was reactive because of the darkened periphery of the greenstone particles and the presence of deposits of carbonated alkali-silica gel in microcracks in the aggregate and surrounding paste, which was observed on fractured surfaces (see Appendix 3) (see Figures 5-6).

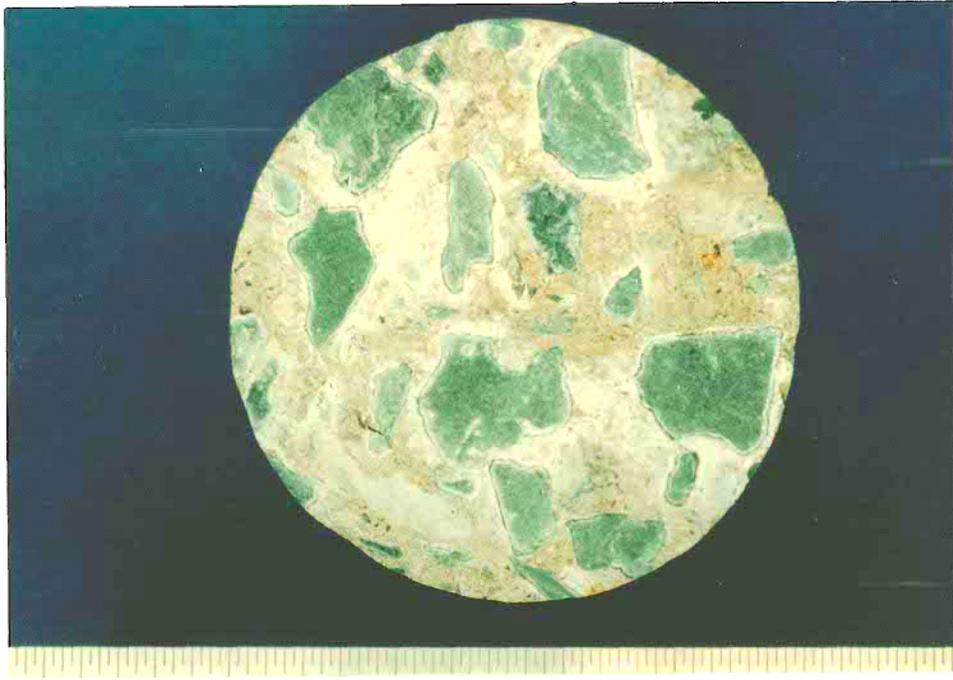
Figure 6. Darkened periphery and collections of ASR gel around greenstone aggregates in I-64 concrete.

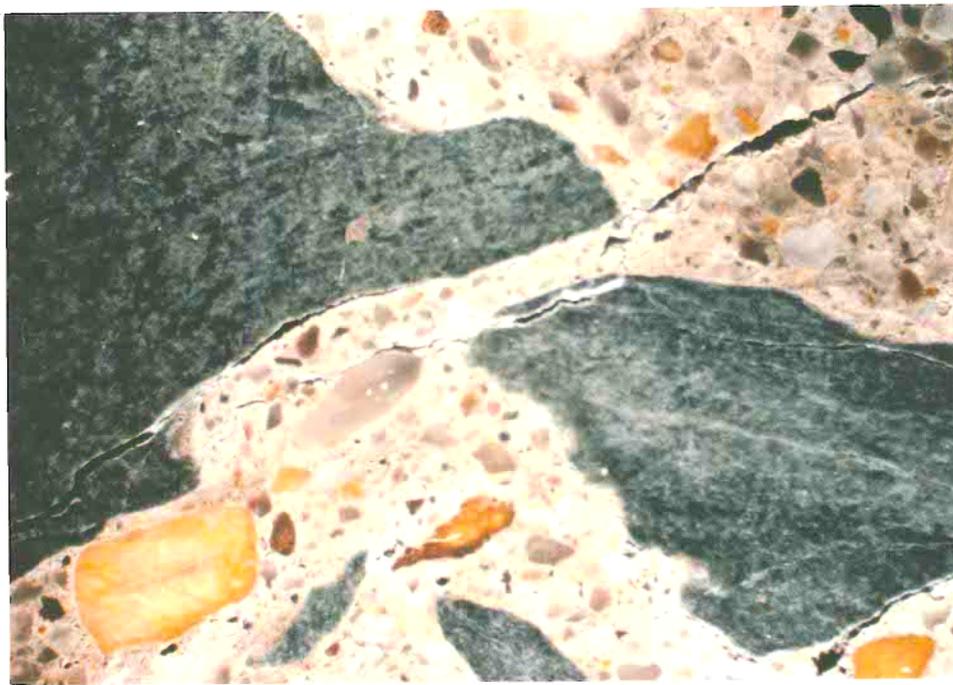
Figure 7. Cracks in greenstone aggregate extend into concrete paste. Cracks are partially filled with ASR gel.

Samples retained at the VTRC were examined during the course of this project. Figure 7 is a polished surface of a core showing cracks in aggregate particles partially extending into the paste. Deposits of ASR gel can be seen in cracks in the aggregate. In addition to confirming the observations of the previous study, it was observed that chert particles in the fine aggregate had also cracked as a result of ASR.

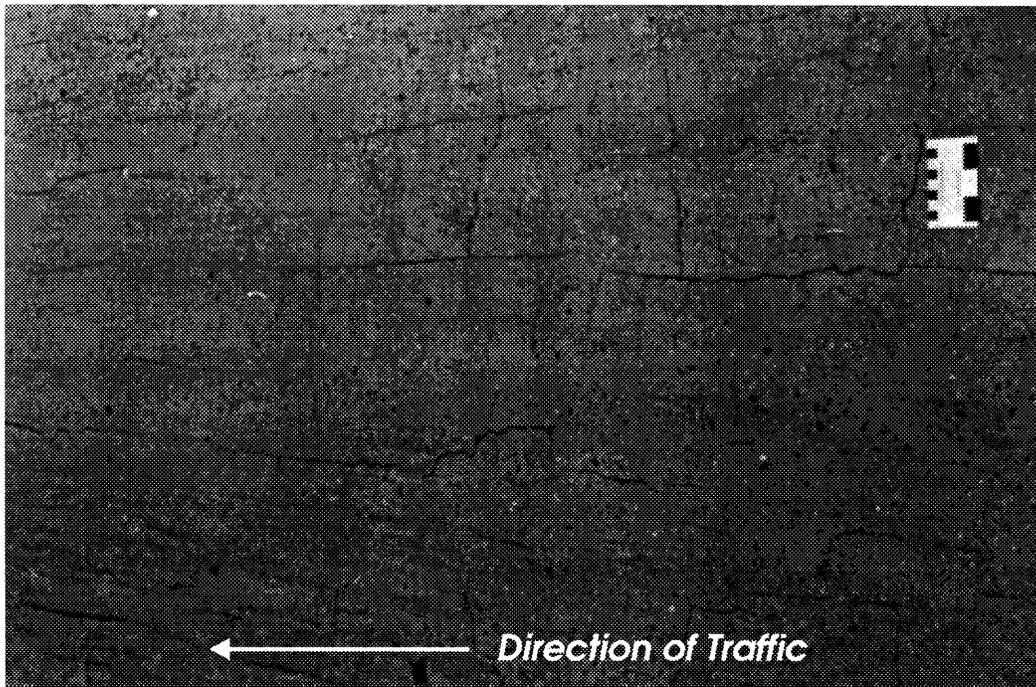
Figure 8. Closely-spaced longitudinal map cracking in I-64 pavement near Ivy. Coarse aggregate is Red Hill granite gneiss.

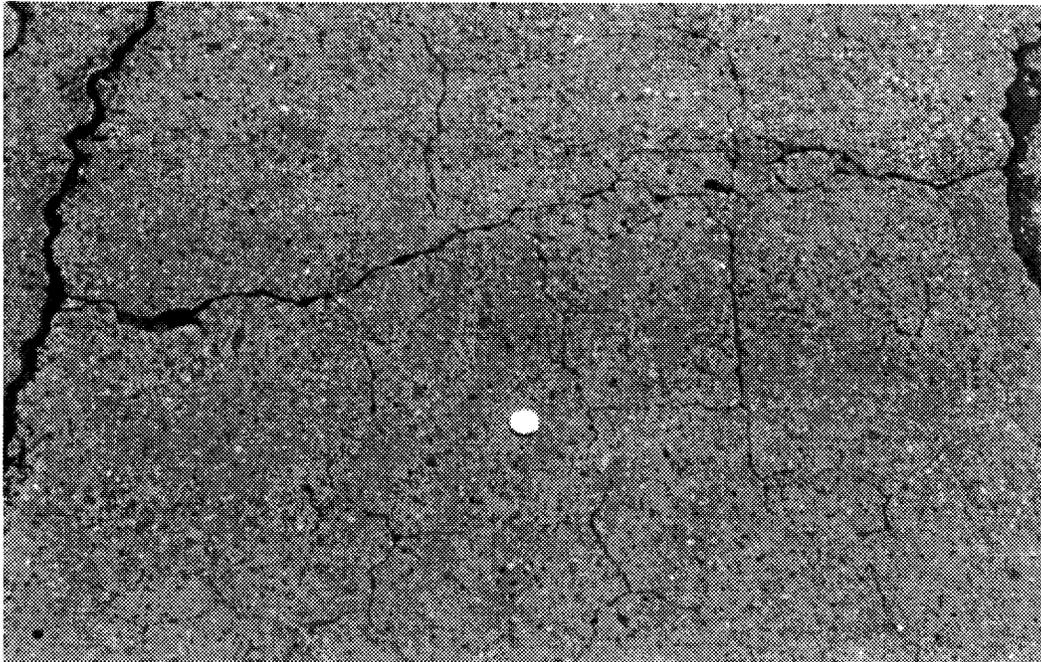
Figure 9. Map cracking in bridge approach slab on I-64 WB at Charlottesville.  
Red Hill granite gneiss.

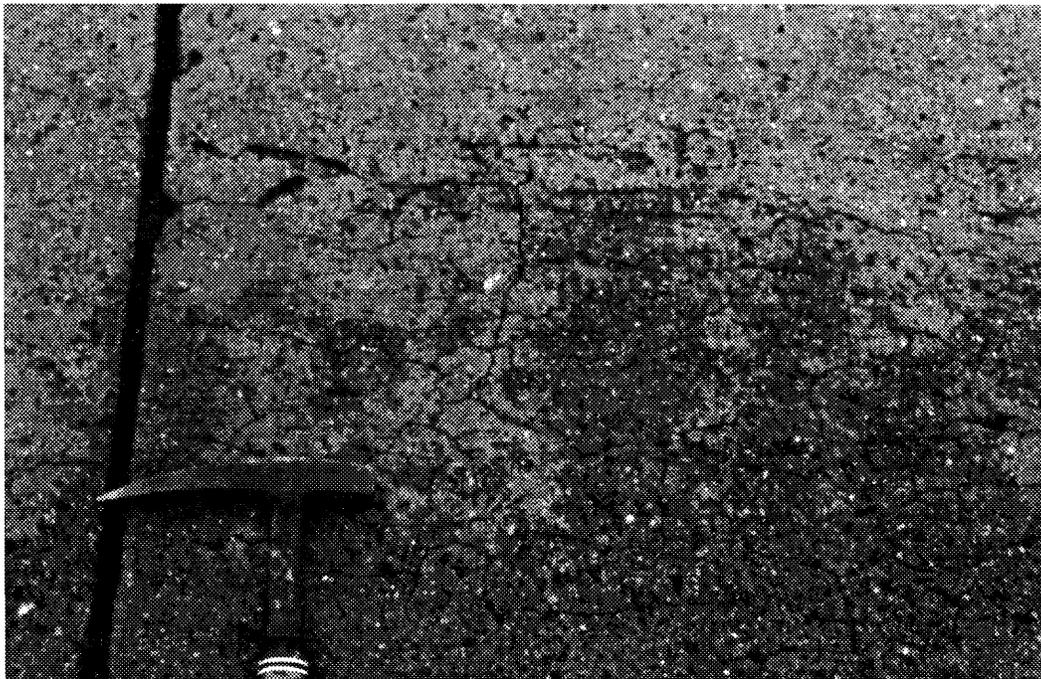
Figure 10. Map cracking of plain-jointed off-ramp on I-64 EB to U.S. 29 NB at  
Charlottesville.

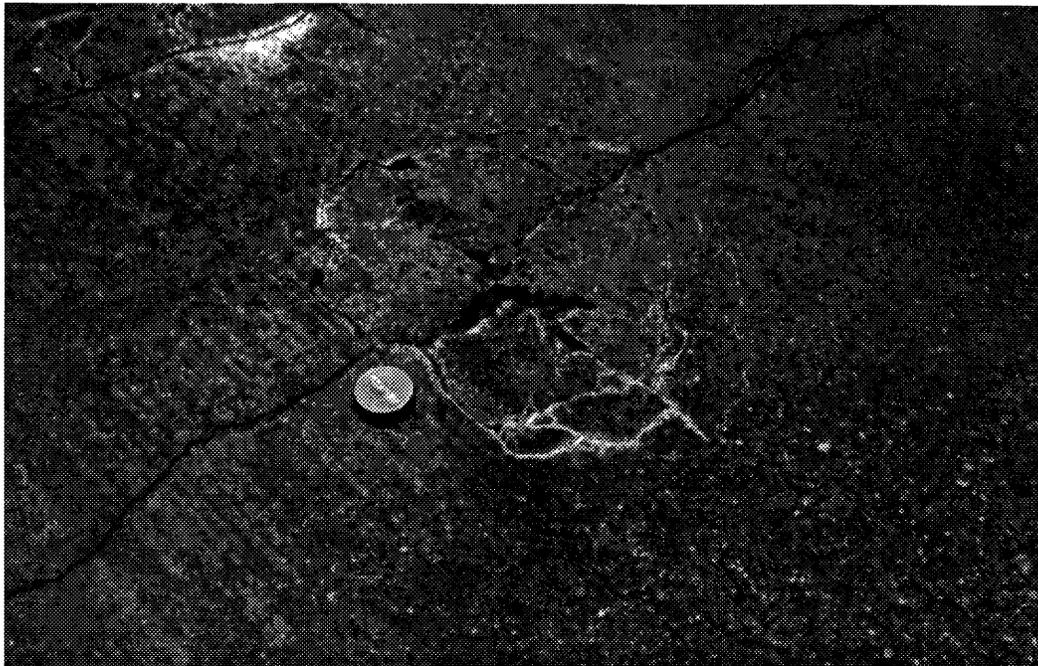
Figure 11. Punchout failure at transverse crack on I-64 WB near Ivy. Secondary products are exuding from cracks; map cracking is faint.

which occur at closely spaced transverse cracks (see Figure 11). Repair of these areas required full-depth slab removal and patching. In many of these areas, the slab had delaminated near the level of the reinforcement. After the punchouts were patched, edgedrains were installed, and the pavement was overlaid with asphalt concrete. The eastbound lane was patched in 1992 and overlaid in 1993, and the westbound lane was patched and overlaid in 1993.

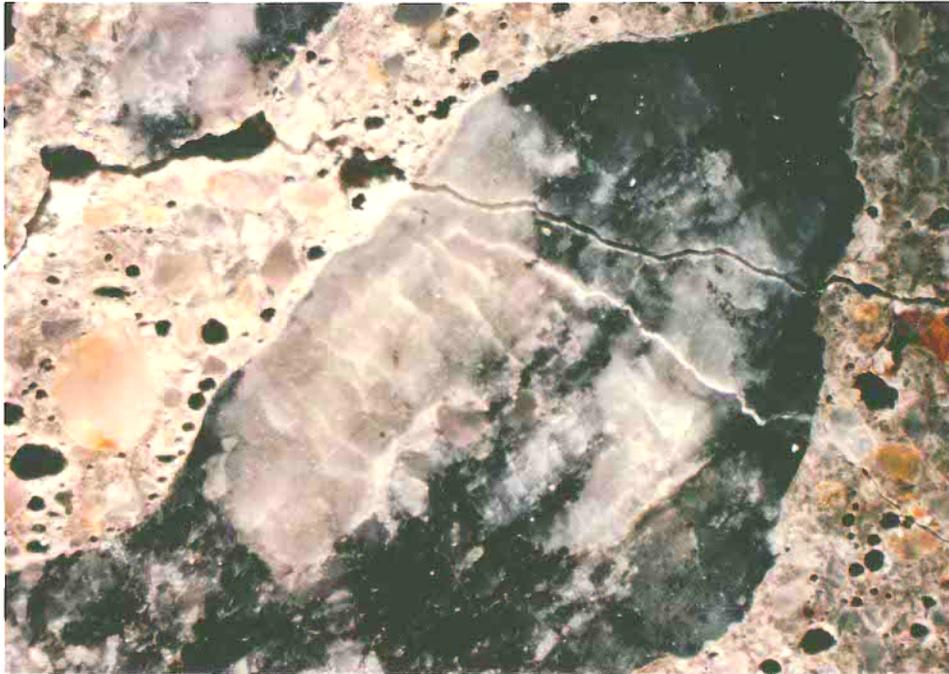
Figure 13. Cracks in granite gneiss aggregate extending into paste. White ASR gel filling crack in aggregate just below major crack.

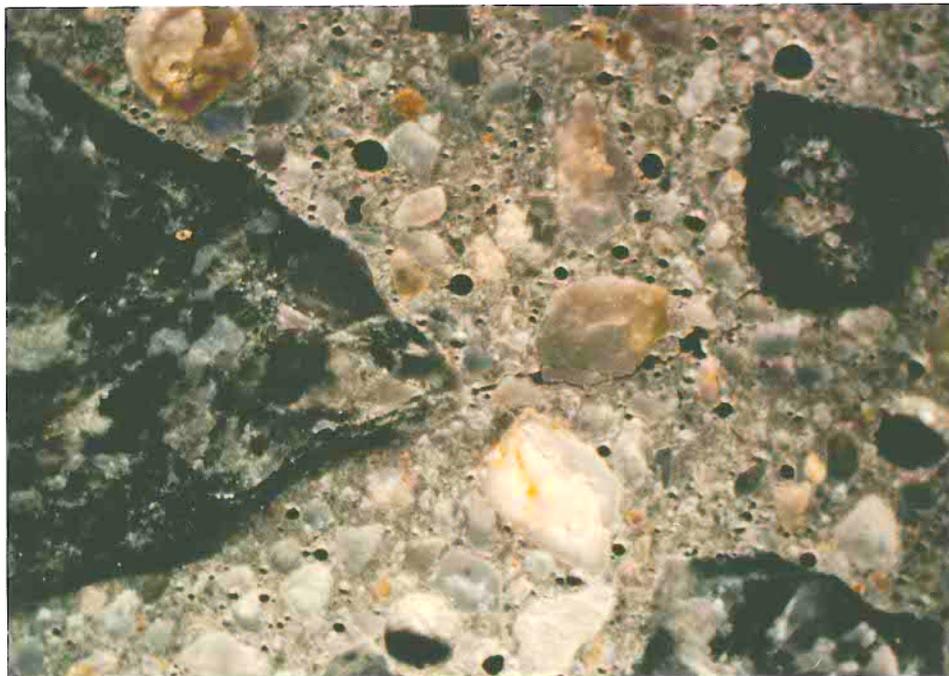
Figure 14. Cracking, corrosion, and darkened rims of granite gneiss particles in concrete from approach slab on I-64 at Charlottesville.

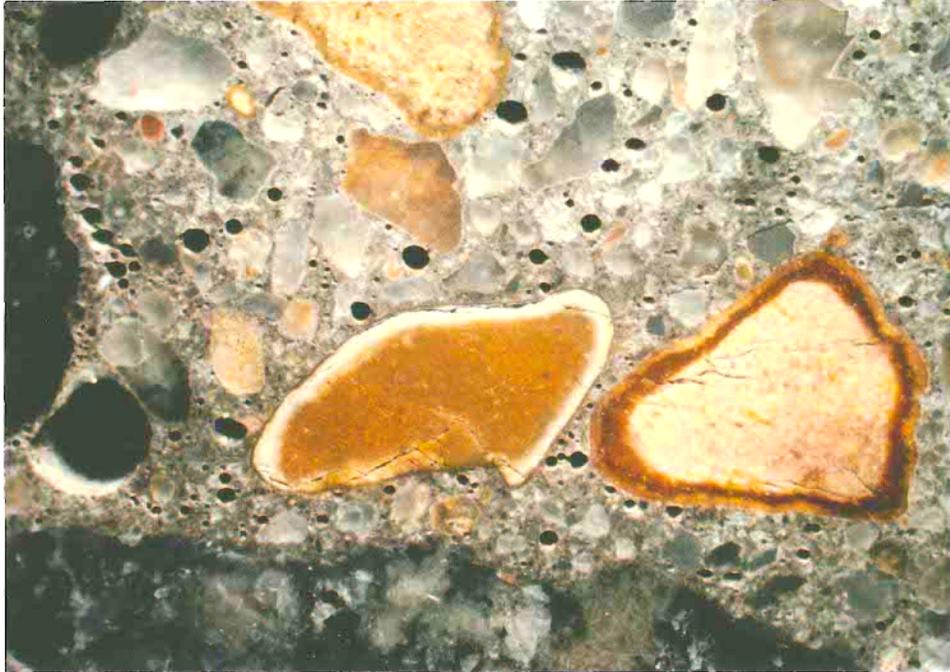
Figure 15. Darkened rim of granite gneiss particle and cracking of chert particles in fine aggregate portion of concrete from I-64 approach slab at Charlottesville.

In the fine aggregate, some quartzite particles had clarified rims and were cracked. Many chert particles were also cracked (see Figure 15). Most cracks in the paste were associated with cracked particles of aggregate.

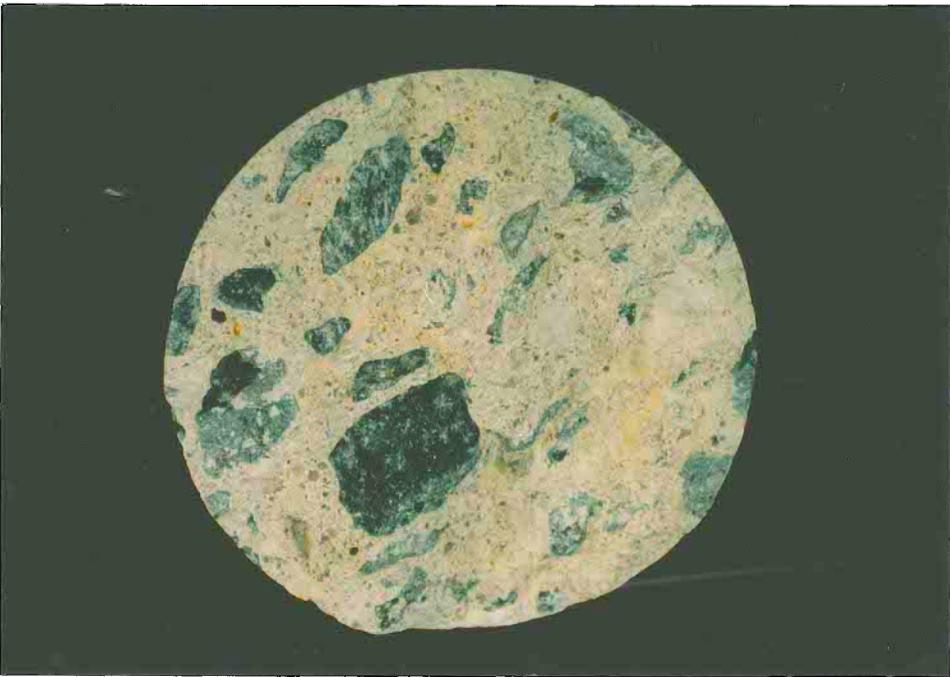
Figure 16. End of core from retaining wall at Shelburne Building treated with uranyl acetate and illuminated with white light.

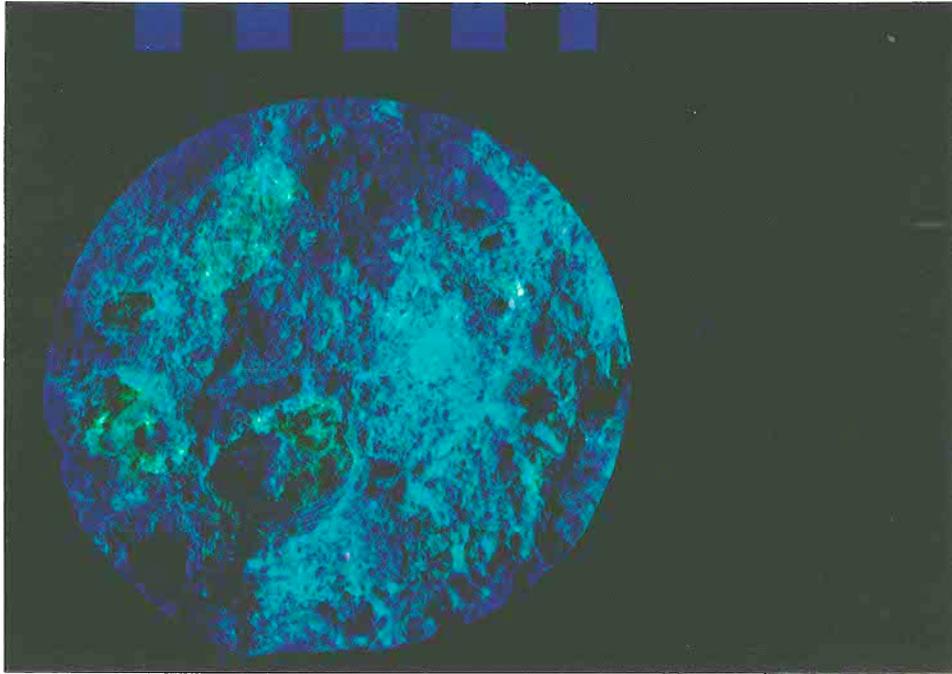
Figure 17. End of core from retaining wall at Shelburne Building treated with uranyl acetate and illuminated with shortwave ultraviolet light. Note greenish fluorescence of fractured surfaces of granite gneiss particles.

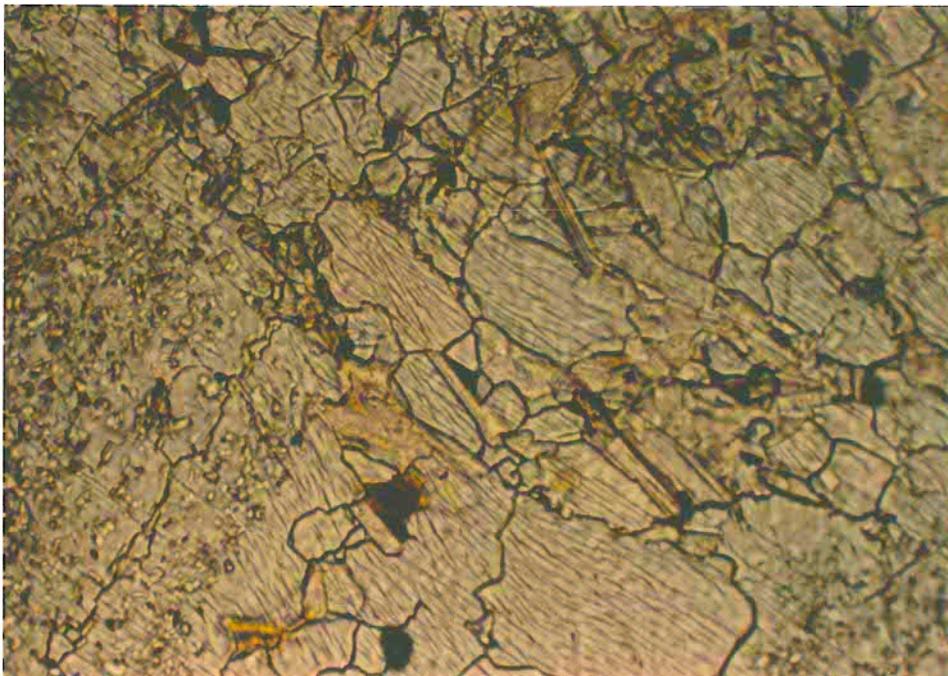
Figure 18. Photomicrograph of thin section of granite gneiss particle from retaining wall viewed with plane light. Central portion of view composed primarily of fine-grained strained quartz (100X).

Figures 18 through 22 are photomicrographs of a thin section impregnated with a UV-fluorescent dye. The intergranular corrosion of a fine-grained area is illustrated in Figures 18, 19, and 20 viewed with plane polarized, crossed polarized, and UV light, respectively. Bright areas in Figure 20 indicate areas where dye was able to penetrate. Figures 21 and 22 show a granite gneiss particle and the surrounding paste under plane and UV light. Fluorescence of the paste indicates a high porosity. Cracking of the aggregate and paste are indicated by bright fluorescence as are corroded grain boundaries in the aggregate's interior. The dark zone at the aggregate's periphery where little dye penetrated corresponds to the darkened rim observed in reflected light.

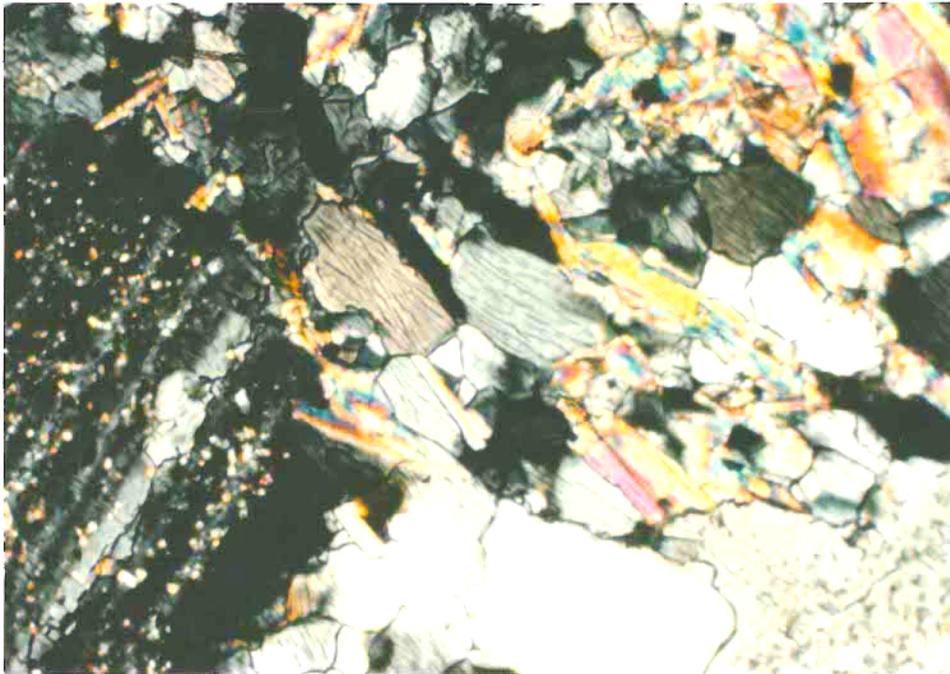
Figure 19. Same field as Figure 19 viewed with crossed-polarized light.

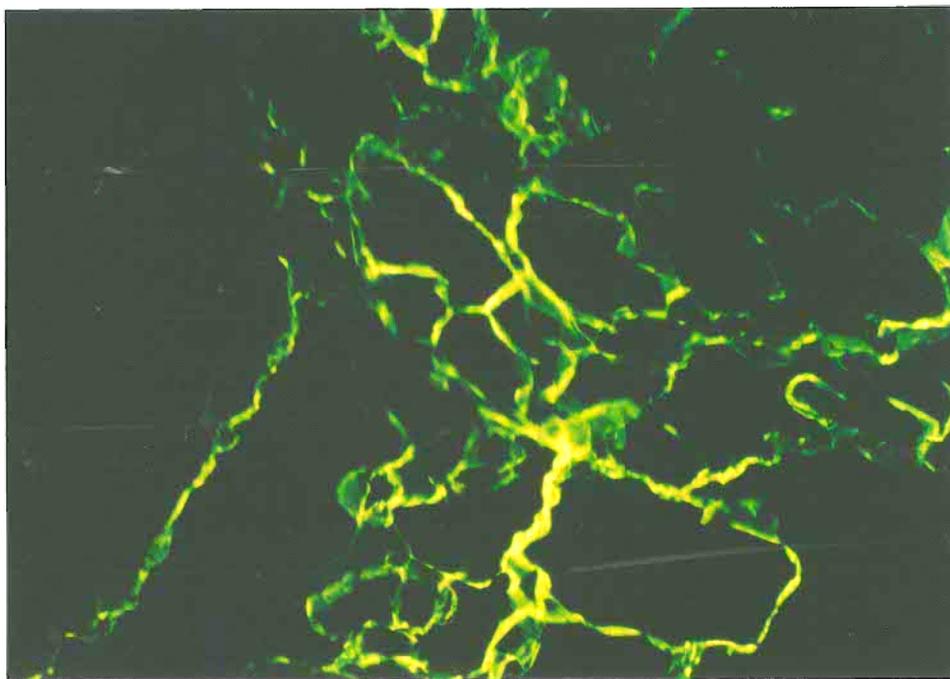
Figure 20. Same field as Figures 19 and 20 illuminated with ultraviolet light. Fluorescing dye indicates corroded intergranular areas.

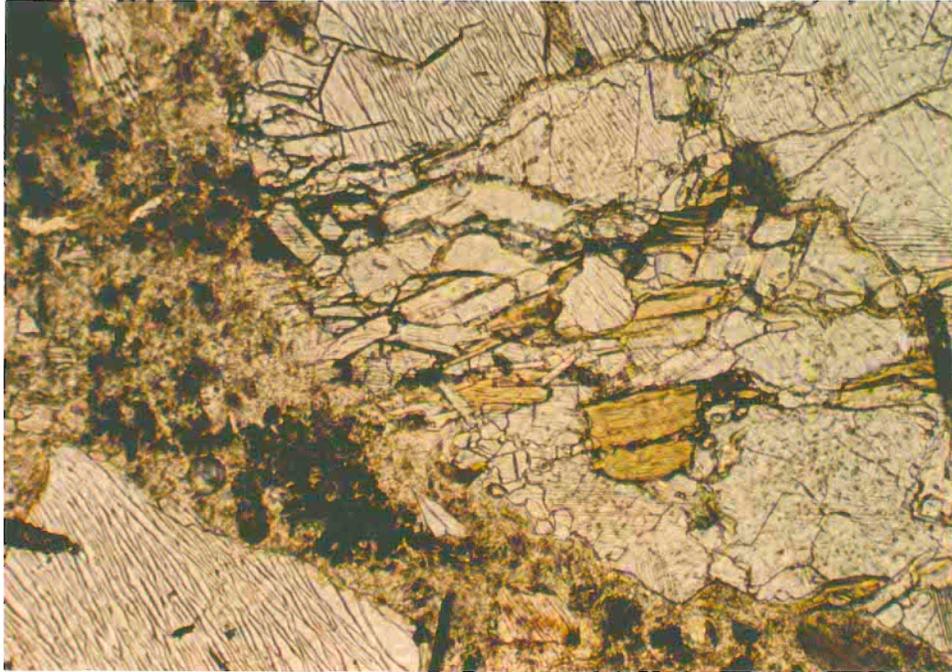
Figure 21. Thin section of concrete from retaining wall. Right side of field is a granite gneiss particle. Mottled brownish material is cement paste. Viewed with plane light (100X).

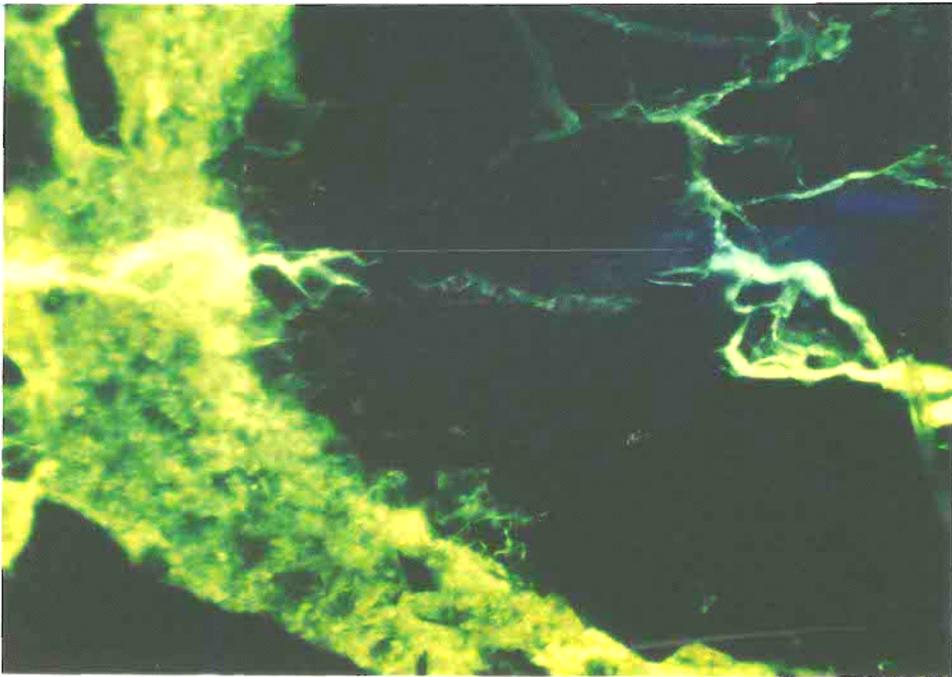
Figure 22. Same field as Figure 21 viewed with ultraviolet light. Bright fluorescence of area in the aggregate interior indicates intergranular corrosion. At periphery, crack extends into paste. Between interior and periphery, crack is partially filled with ASR gel. Fluorescence of paste indicates high porosity.

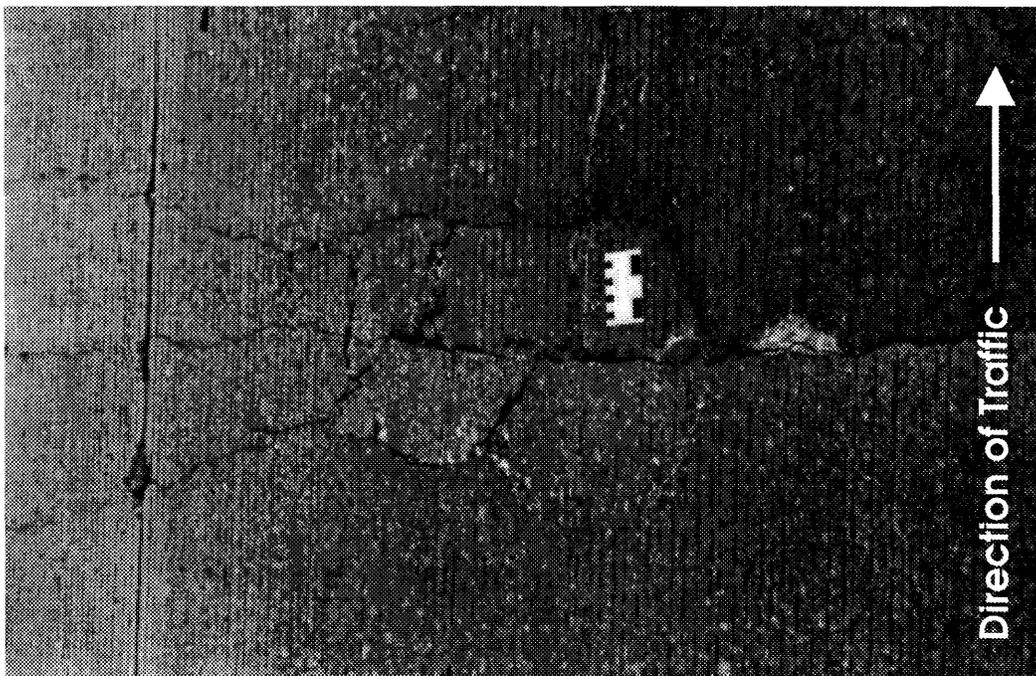
Figure 23. Punchout at transverse crack in CRCP on I-64 in New Kent Co.

In this section of CRCP, punchouts were developing in locations where transverse cracks were closely spaced (see Figure 23). No closely spaced longitudinal map cracking was observed. During full-depth removal of slabs for patching, it was noted that many slabs had delaminated near the reinforcement in a manner similar to the delaminations in the pavement of I-64 near Charlottesville (see Figure 24). An examination of cores showed the concrete contained a natural gravel consisting of quartz, quartzite, and chert as the coarse aggregate and a natural sand of similar composition as the fine aggregate. The paste was light tan in color and air entrained. Some quartzite particles had clarified rims, and a few were cracked as were some chert particles. Large deposits of white gel were found in a few voids. Very little cracking of paste associated with particles of aggregate was observed.

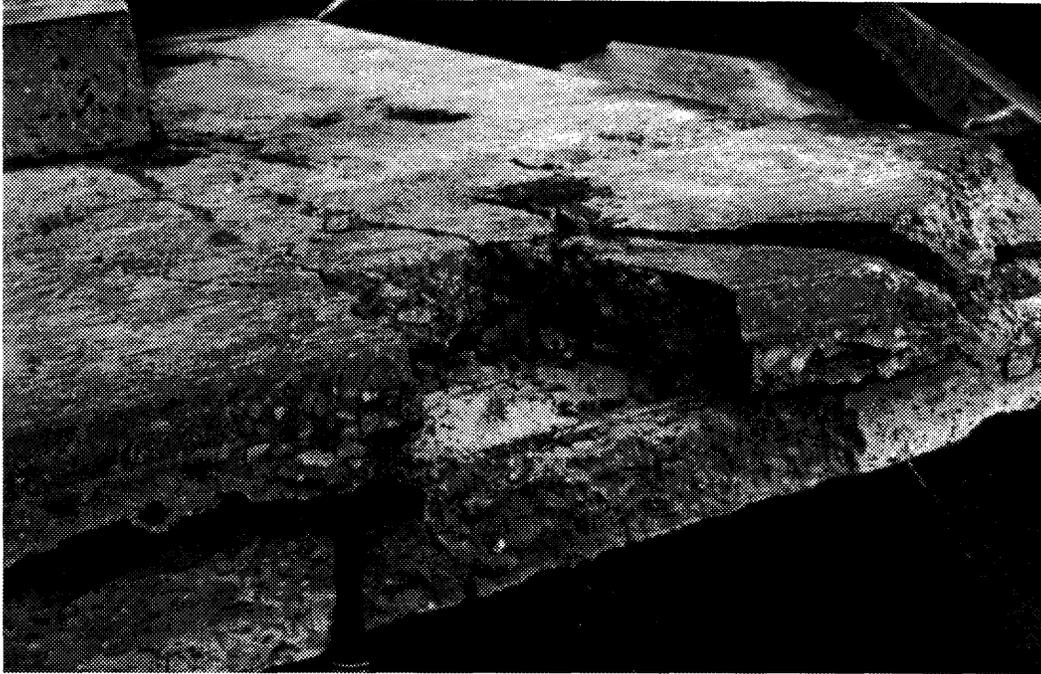
Figure 24. Full-depth pavement removed from distressed area of I-64 in New Kent Co. Pavement delaminated at reinforcement.

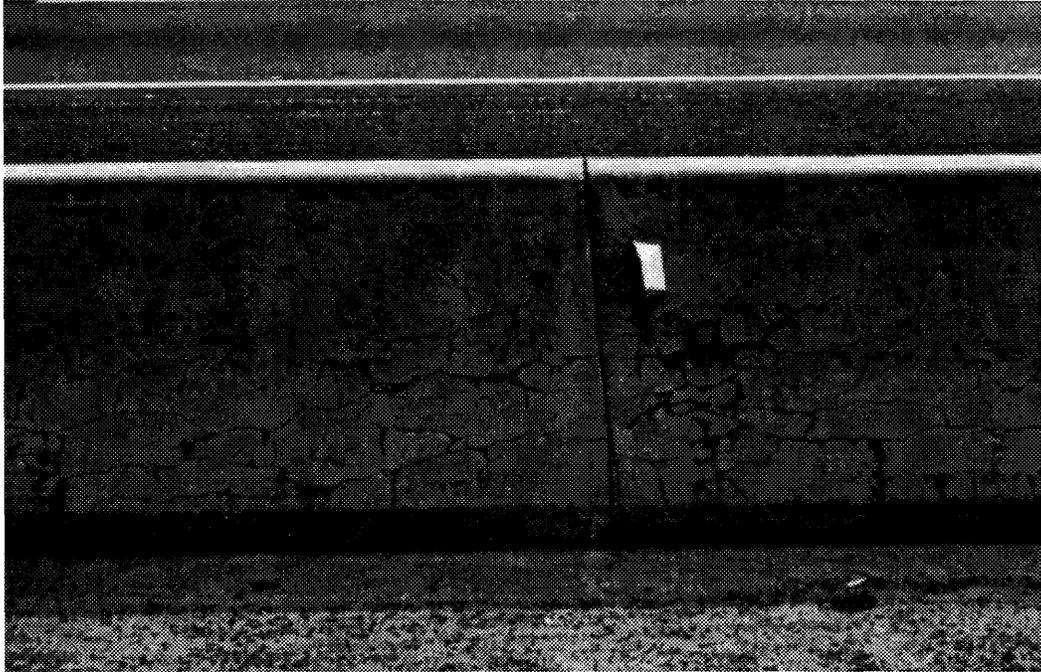
Figure 25. Median barrier on the Richmond-Petersburg Turnpike south of Falling Creek toll plaza.

Approximately 1.5 miles of median barrier exhibited severe distress in the form of map cracking and spalls apparently resulting from crushing (see Figures 25 and 26). This median barrier is believed to have been constructed between 1982 and 1987. It was removed and replaced in 1993 because of concerns about its structural adequacy.

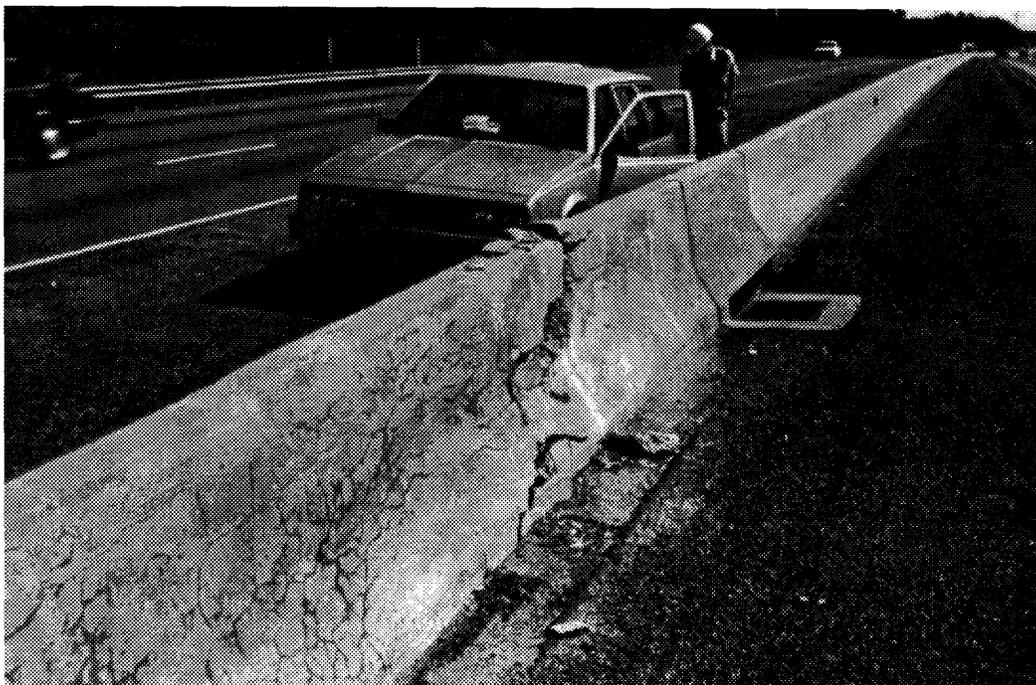
Figure 26. Crushing of median barrier on the Richmond-Petersburg Turnpike south of Falling Creek toll plaza.

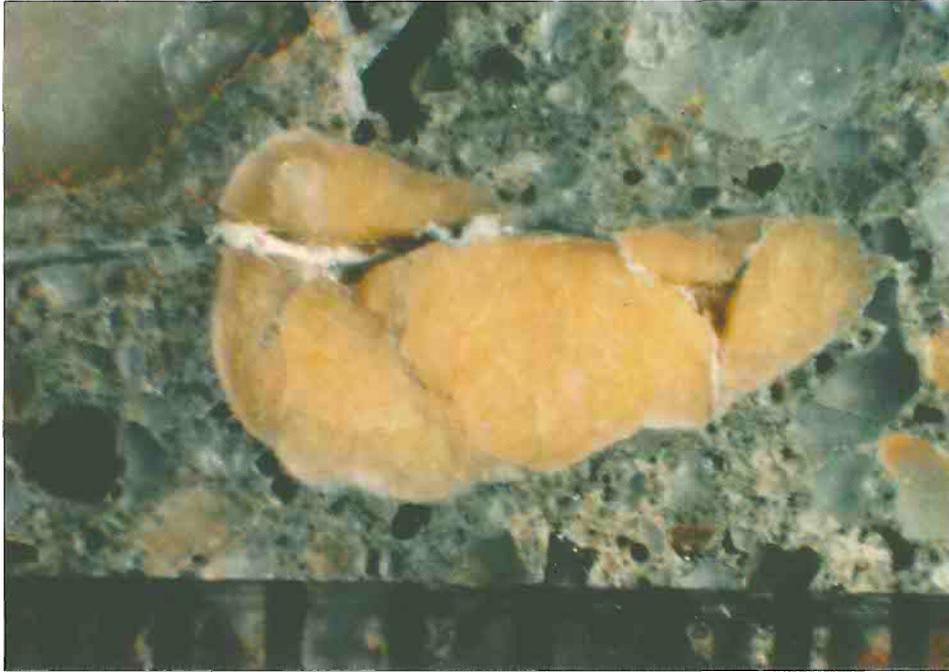
Figure 27. Cracking and ASR gel deposits in quartzite aggregate from median barrier concrete on the Richmond-Petersburg Turnpike. Aggregate rim is somewhat clarified.

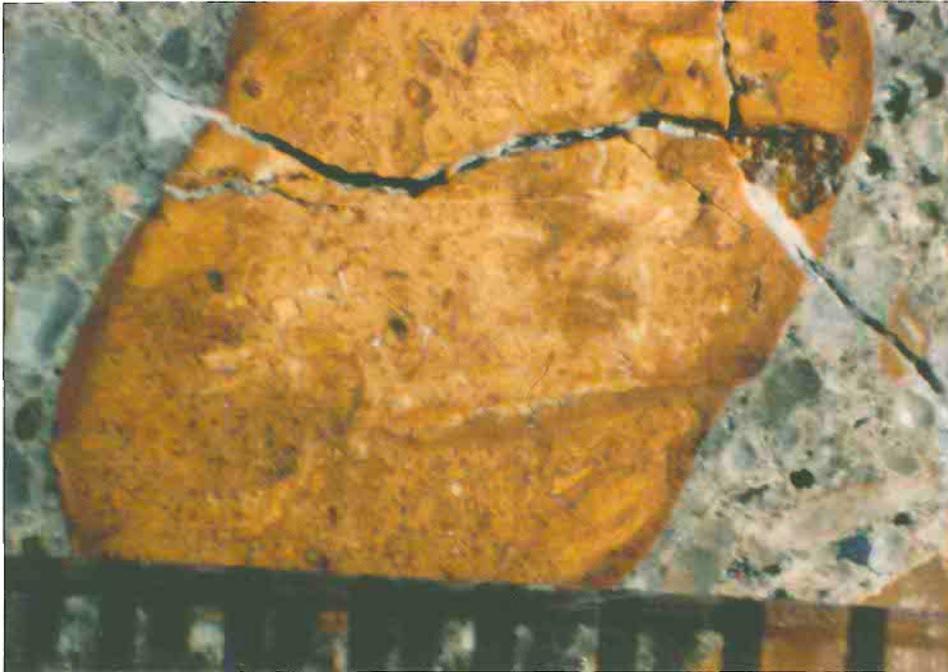
Figure 28. Cracking and ASR gel deposits in chert aggregate in the median barrier concrete on the Richmond-Petersburg Turnpike.

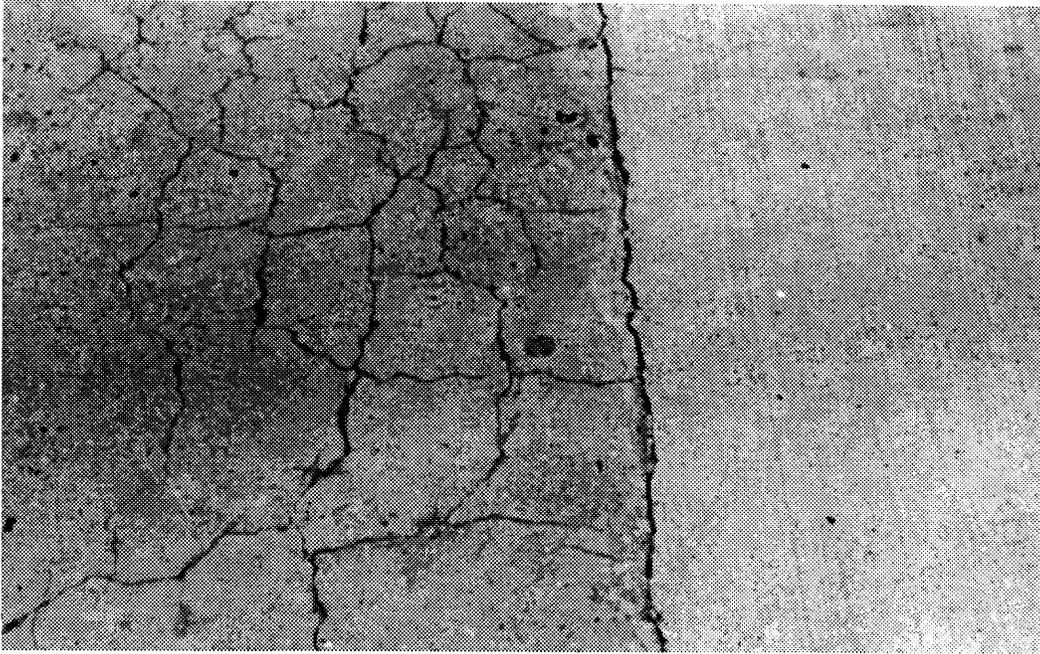
Figure 29. Map cracking of approach slab on U.S. 301 bridge over I-295. Joint was recently repaired.

coarse aggregate was a natural gravel composed primarily of quartz, quartzite, and chert. The fine aggregate was a natural sand of similar composition. The approach slabs, parapets, and substructure have all been affected (see Figures 29 to 31). The parapets show signs of crushing with some spalling. Joints at the approach slab were repaired in 1990.

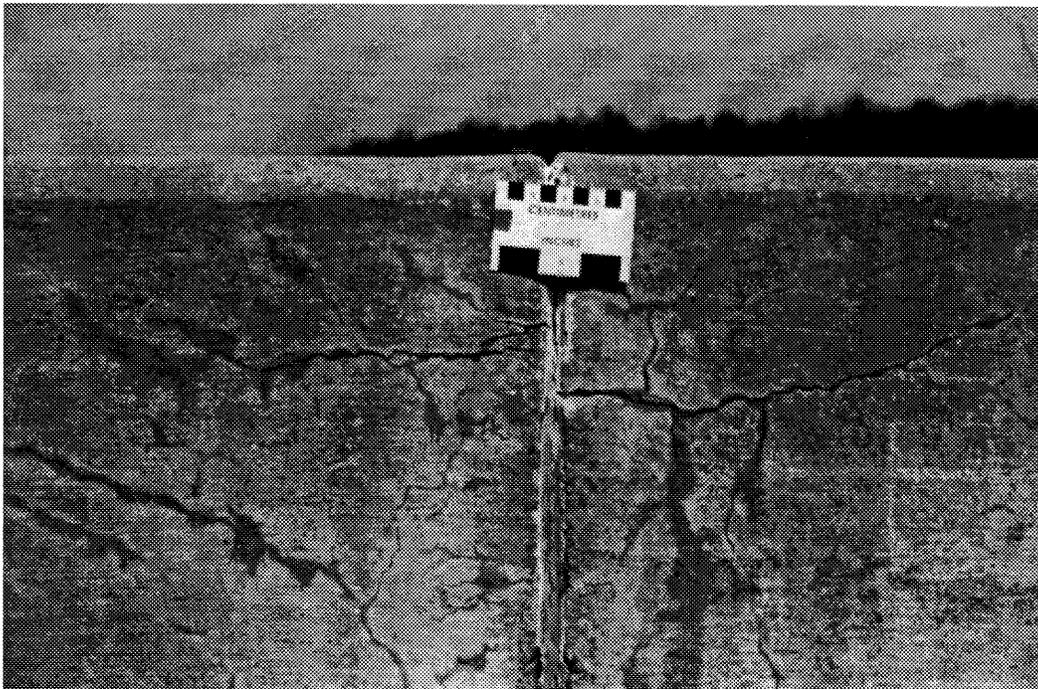
Figure 30. Parapet on U.S. 301 bridge over I-295.

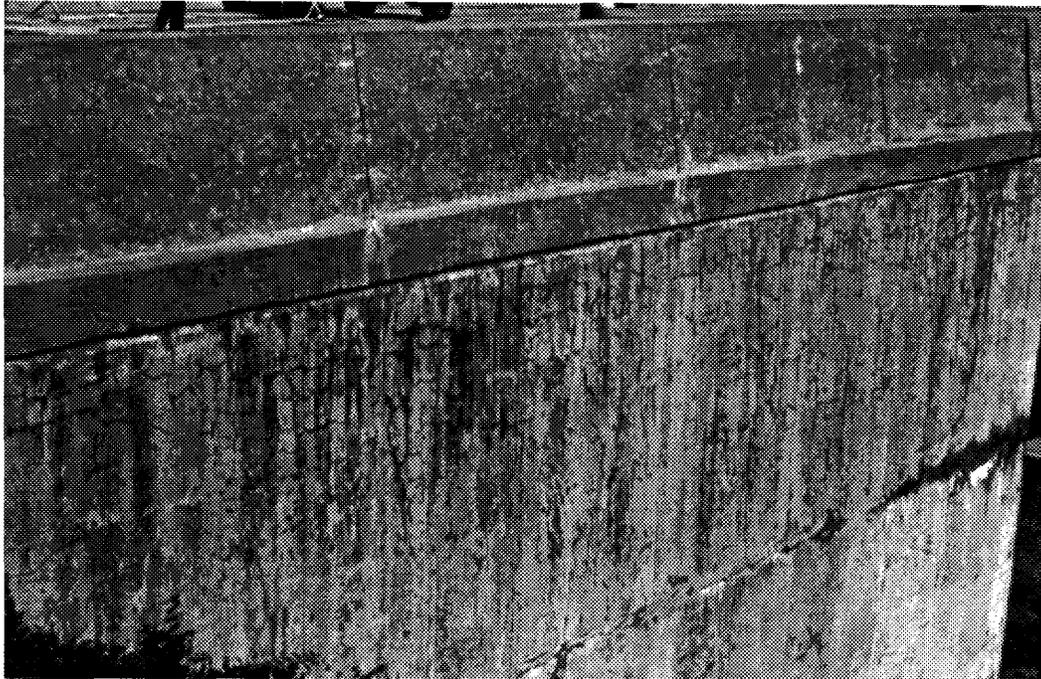
Figure 31. Wingwall on U.S. 301 bridge over I-295.

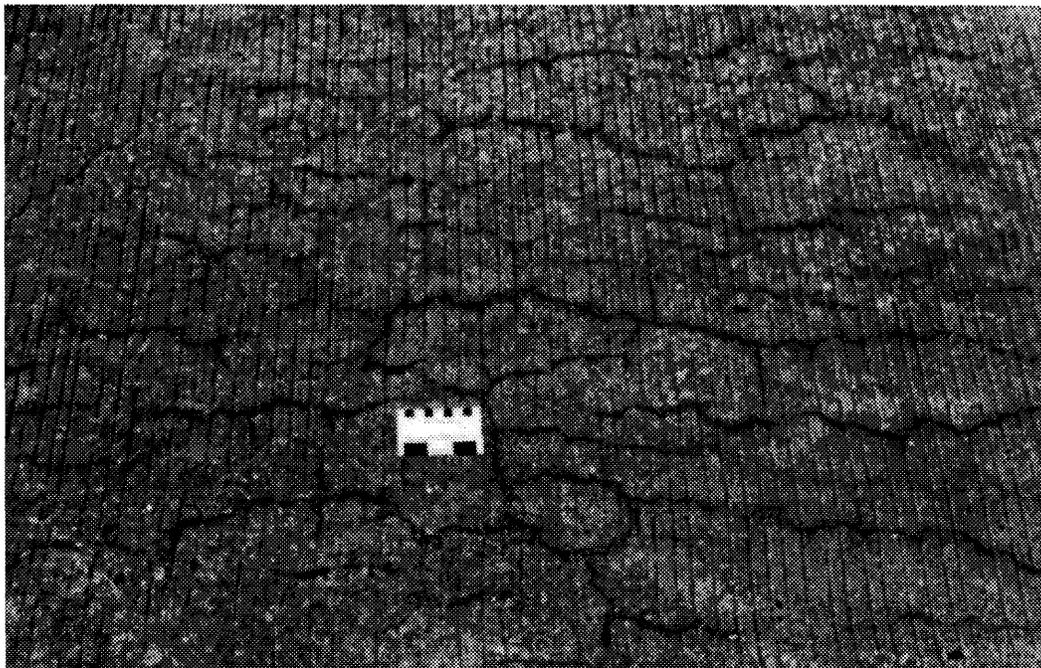
Figure 32. Longitudinal map cracking of CRCP on I-295 EB east of structure 2904.

The CRCP in the eastbound lanes in the vicinity of the Chickahominy River bridge (structure No. 2904) exhibits closely spaced longitudinal map cracking (see Figure 32). The approach slabs for this structure also exhibit map cracking (see Figure 33) as does the substructure. A spalled piece of concrete from the joint of one approach slab was obtained and broken to produce a fresh fractured surface. This surface was treated with uranyl acetate, and when viewed under UV light, streaks of bright fluorescence were observed on a coarse aggregate particle. Cores (P2119-22) were obtained from the pavement and the approach slabs.

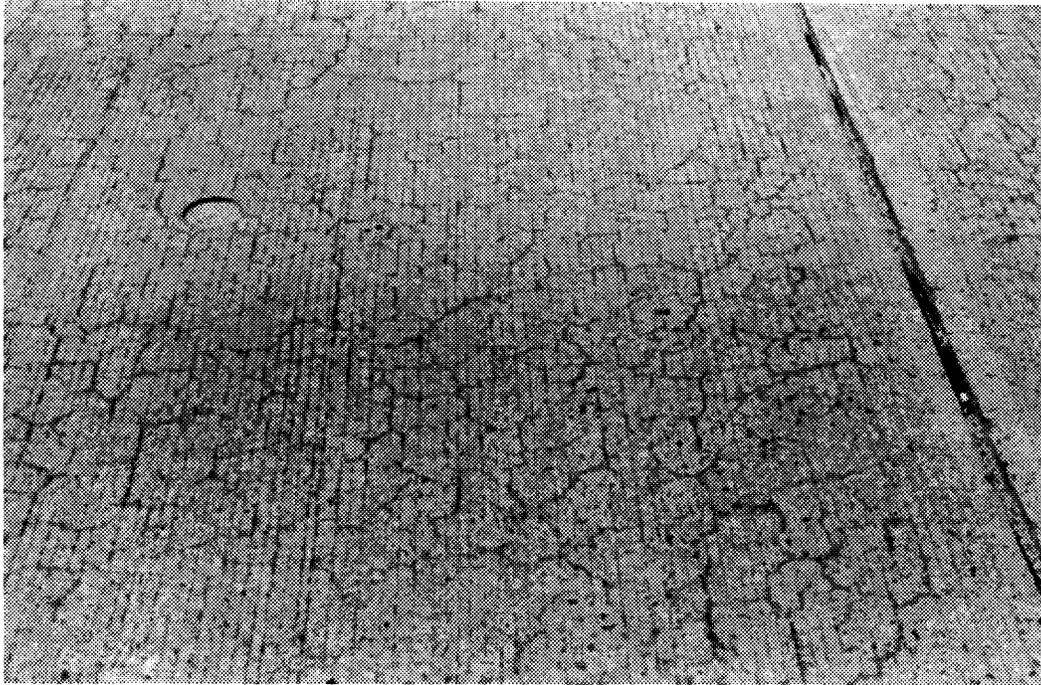
Figure 33. Approach slab at east end of structure 2904 on I-295 EB.
