# ALKALI-SILICA REACTIVITY IN VIRGINIA

Report No. VTRC 94-R17	Report Date June 1994	No. Pages 70 pages	Type Report: Final Report Period Covered: 9/14/90-8/31-93	Project No.: 9276-010-940 Contract No.:
Title and Subtitle Alkali-Silica Reactivity in Virginia			Key Words concrete aggregates cracking deterioration alkalies silica reactivity	
Author(s) D. Stephen Lane				
Performing Organization Name and Address: Virginia Transportation Research Council 530 Edgemont Road Charlottesville, Virginia 22903				
Sponsoring Agencies' Names and Addresses Virginia Department of Transportation 1401 E. Broad Street Richmond, Virginia 23219 University of Virginia Charlottesville Virginia 22903				
Supplementary Notes None				
Abstract <p>This project examined occurrences in Virginia of alkali-silica reactivity, which is a major cause of the deterioration of concrete. Concretes were studied to determine the mineral aggregates being affected, and test methods for identifying such aggregates were evaluated. Technical literature on alkali-silica reactivity was reviewed to develop a way of dealing with this problem.</p> <p>The results of this study reveal that the mineral primarily affected by alkali-s

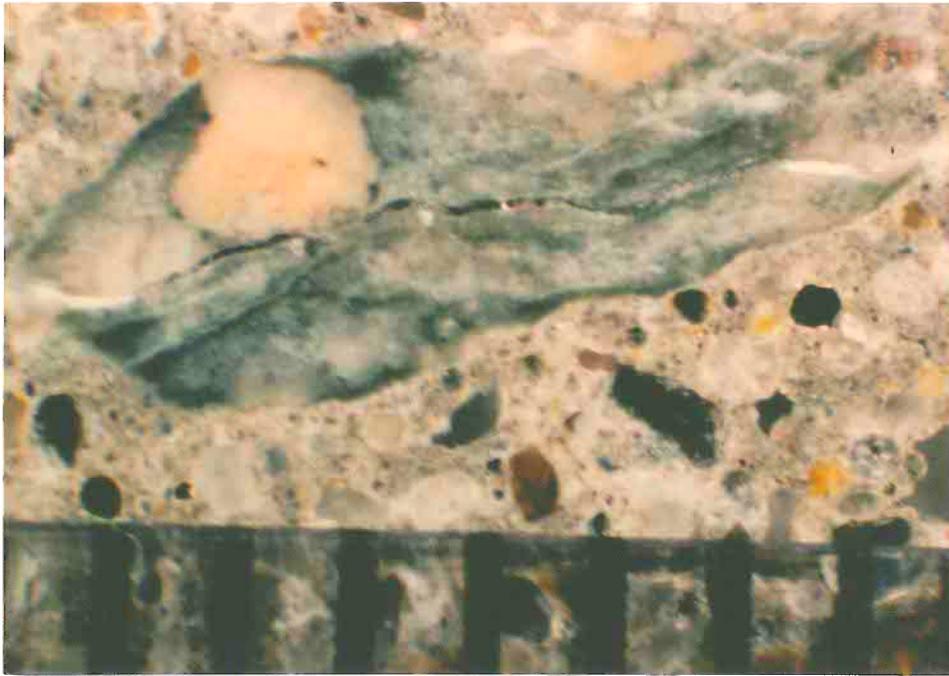
Figure 34. Cracking and ASR gel deposits in metarhyolite aggregate on I-295 pavement east of structure 2904.

In sample 2120, the paste was gray in color, fairly hard, and air entrained. Some voids contained deposits of clear to white gel, and some ettringite was present. The paste was extensively cracked. The coarse aggregate was a metarhyolite from Hylas. The rock is foliated and predominately fine grained. It is composed primarily of feldspar (often as elongated augen), strained microcrystalline quartz, and mica. Many aggregate particles are cracked, often with white gel deposits lining cracks or along grain boundaries

(see Figure 34). The fine aggregate is a natural sand composed of quartz, quartzite, and chert. Some chert and quartzite particles are cracked. The cracking of the paste is associated with cracking of the aggregate particles.

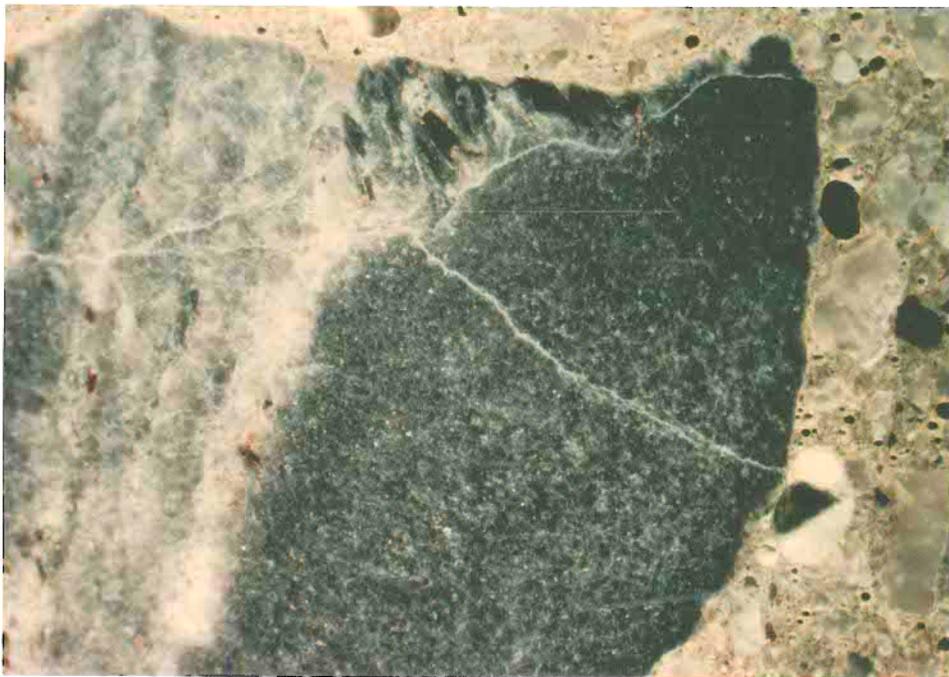
Figure 35. Cracking and ASR gel deposits in Arch Marble aggregate in the approach slab on U.S. 29 over Roanoke (Staunton) River.

The deck, parapets, backwall, and approach slabs exhibit map cracking (see Figure 35). Of these elements, the approach slabs show the most deterioration. This structure was constructed in 1973 and 1974. Cores were obtained from the approach slab and deck.

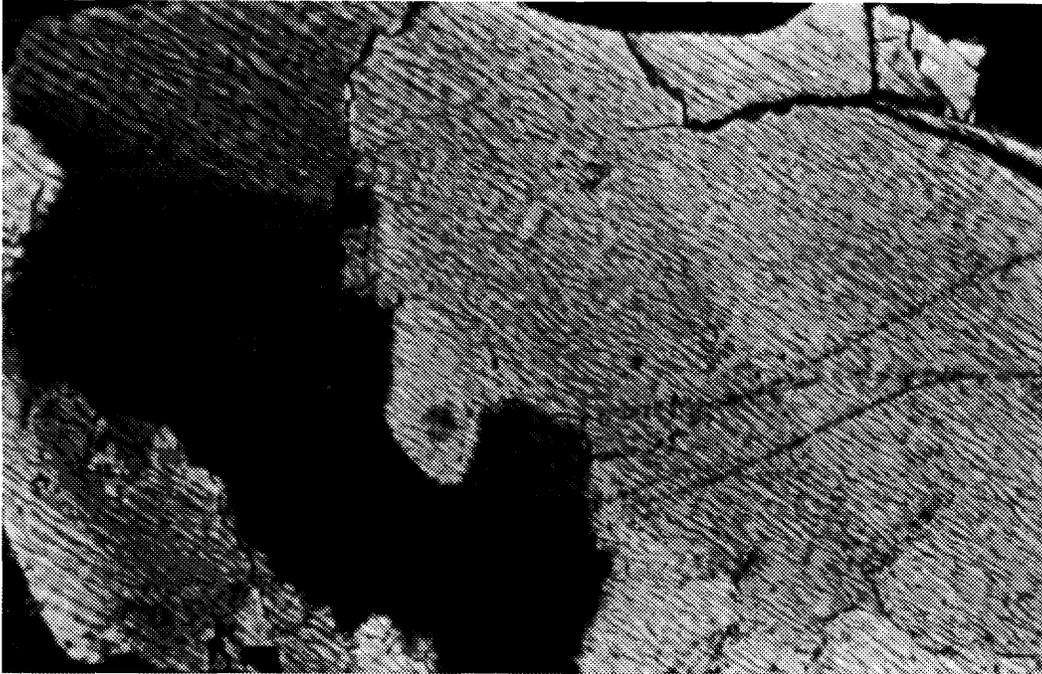
Figure 36. Quartz grains in Shelton aggregate exhibit undulatory extinction when viewed with crossed-polarized light indicating strain.
